MISCELLANEOUS PAPER S-78-1

GEOPHYSICAL SURVEY OF CAVERNOUS AREAS, PATOKA DAM, INDIANA

January 1978

Final Report

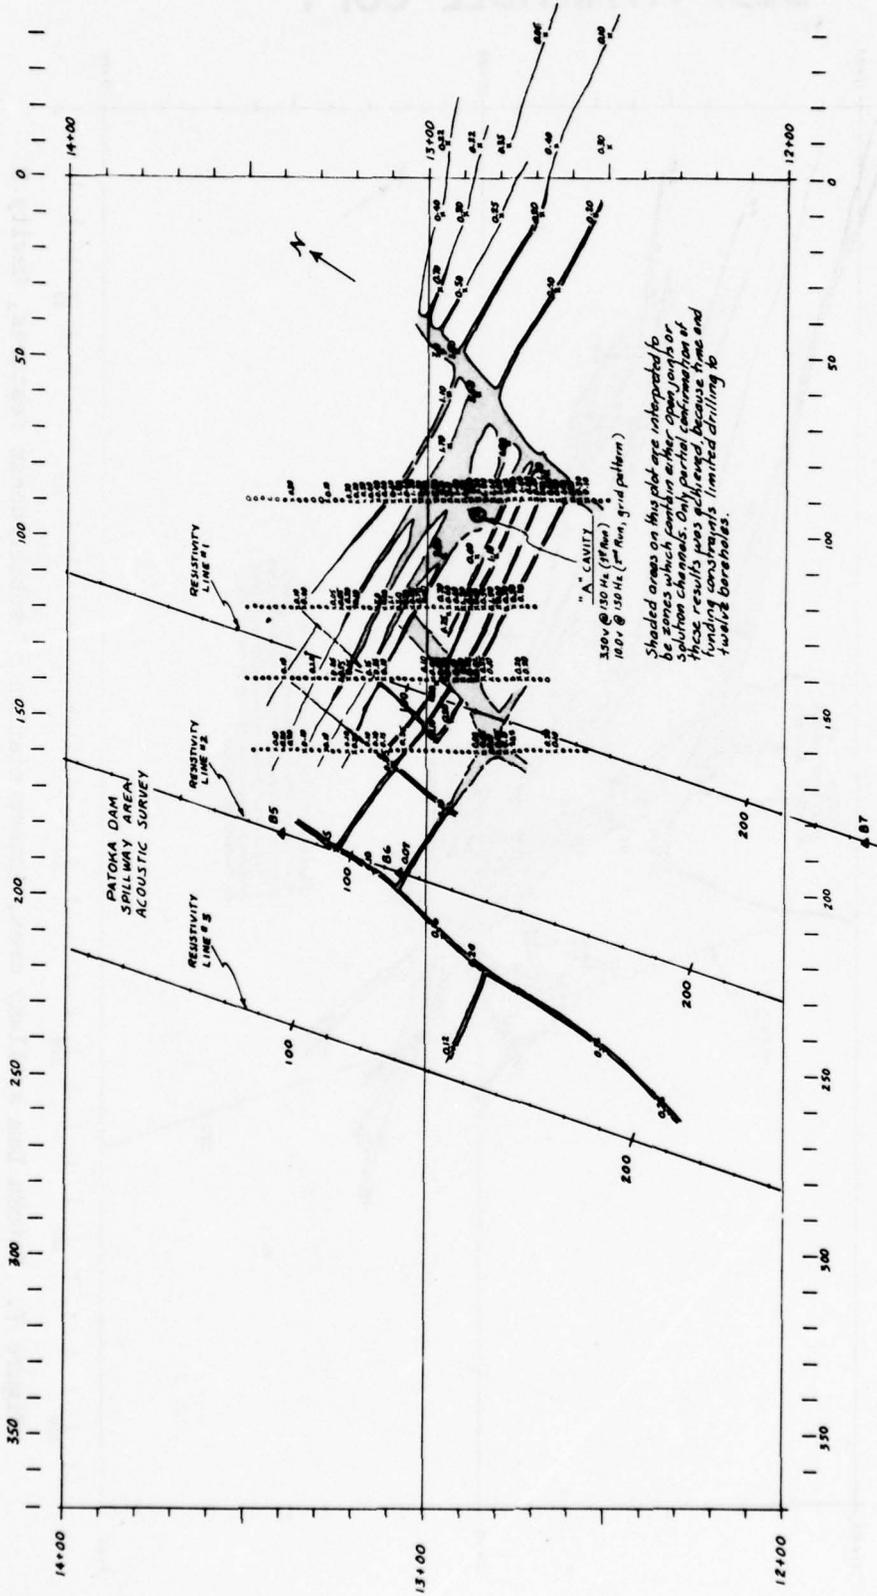
Figure 6. Patoka Dam spillway area, interpretation of subterranean features, Cavity A

9. It was not known whether the 15-in.-diam speakers used by WES could provide a signal of sufficient strength for cavity detection in rock, so the investigation of cavity "A" proceeded on an experimental basis. However, it was discovered that driving the speaker with an input signal level of 1.5 amps, at cavity resonance, did produce sufficient ground motion so that meaningful measurements could be made at source to detector ranges up to 200 ft. Unfortunately, inputting this relatively high level signal to the speaker resulted in its failure after about 4 hours of operation. Minor speaker distortion was audible at all times, and tended to increase in intensity until failure occurred. However, the signal received by the detector was not appreciably affected by the distortion, presumably because of attenuation effects in the rock mass. While the speaker was operating, a number of measurements were made in the area around cavity "A." These data are shown in Figure 6. After some experimentation with the detector, an attempt was made to track signal paths by taking measurements at increasing distances from the source (speaker). Measurements were first made at approximately 2 ft intervals in a roughly concentric pattern about the cavity mouth. Once a data trend was observed, additional measurements were made in the trend direction.

in the vicinity of cavity "C." Boring B4 penetrated a cavity at the
Mansfield-Glen Dean contact, between 6 and 8 ft in depth. Borings B1-B3
penetrated some thin soft zones and the cuttings were reddish brown in
color to about 15 ft in depth, indicating weathering of the limestone
and possibly some minor mud filled voids. Borings B6 and B7 were simi-
lar in character to borings B1-B3. Boring B5 encountered hard limestone
between 2 and 30 ft in depth (bottom of hole); cuttings from this bore-
hole were white in color (unweathered limestone) and drilling was com-
paratively slow. While only boring B4 revealed a cavity, borings B1-B3
and B6-B7 strongly indicated the presence of solution activity in the
immediate vicinity. It was decided to make additional borings at cav-
ity "C" because the driller recalled drilling into a cavity in that vi-
cinity in earlier exploratory borings. Boring B8 was drilled at a loca-

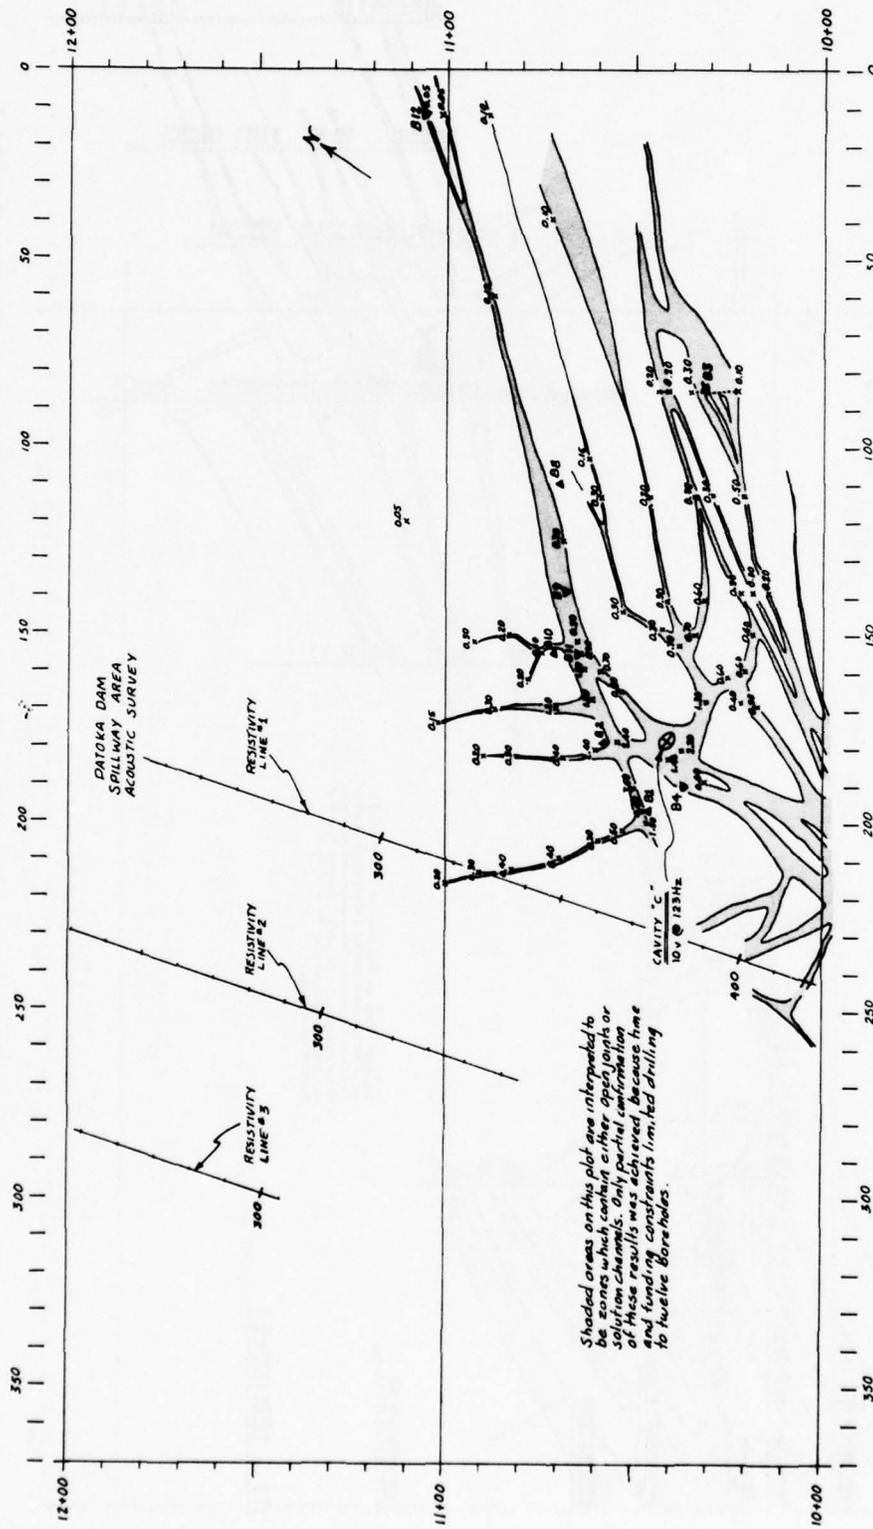
Figure 8. Patoka Dam spillway area, interpretation of subterranean features, Cavity C

tion corresponding with the drillers recollection, and this boring
encountered very weathered limestone with occasional minor soft zones
from 7 to 13 ft in depth. Boring B9 was located closer to an area more
densely populated with acoustic data points. This boring encountered
very weathered limestone with occasional soft to very hard lenses from
6 to 13 ft in depth. At 13 ft in depth in boring B9 a tool drop
occurred, and no bottom was found to 30 ft in depth, indicating the
presence of a 17 ft deep cavity. Only a few acoustic measurements had
been made in the area of boring B9. However, available data points
did indicate NE-SW trend so the remaining borings were located accord-
ingly. Boring B10 was offset from the indicated line and was located in
an area where acoustic data suggested the presence of a NW-SE feature
intersecting the principal NE-SW data trend. Slightly weathered to
hard limestone was encountered in boring B10 between 6 and 20 ft in

depth, and the hole was discontinued. Boring B11 was located 8 ft south
of boring B10 and directly over an acoustic data point. Relatively
high level signals had been recorded in this vicinity along a roughly
NE-SW line. Hard limestone was encountered in boring B11 from 6 to 8 ft
in depth, and a tool drop occurred from 8 to 21 ft in depth. When re-
moved from boring B11 the drill pipe was coated with wet, red brown
clay, indicating that this cavity was wet and at least partially soil

filled. The acoustic data and boring results both indicated a cavity whose path was northeastward from boring B11 so boring B12 was located on the outermost acoustic data point in that direction. Boring B12 encountered hard limestone from 6 to 7 ft in depth, and cavities from 7-10 and 9-13 ft in depth. The hole was stopped at a depth of 20 ft, in hard limestone because the air-trac rig was needed for shot hole drilling, and no further borings could be undertaken. The drill pipe was found to be coated with red clay mud and water upon final removal from boring B12.

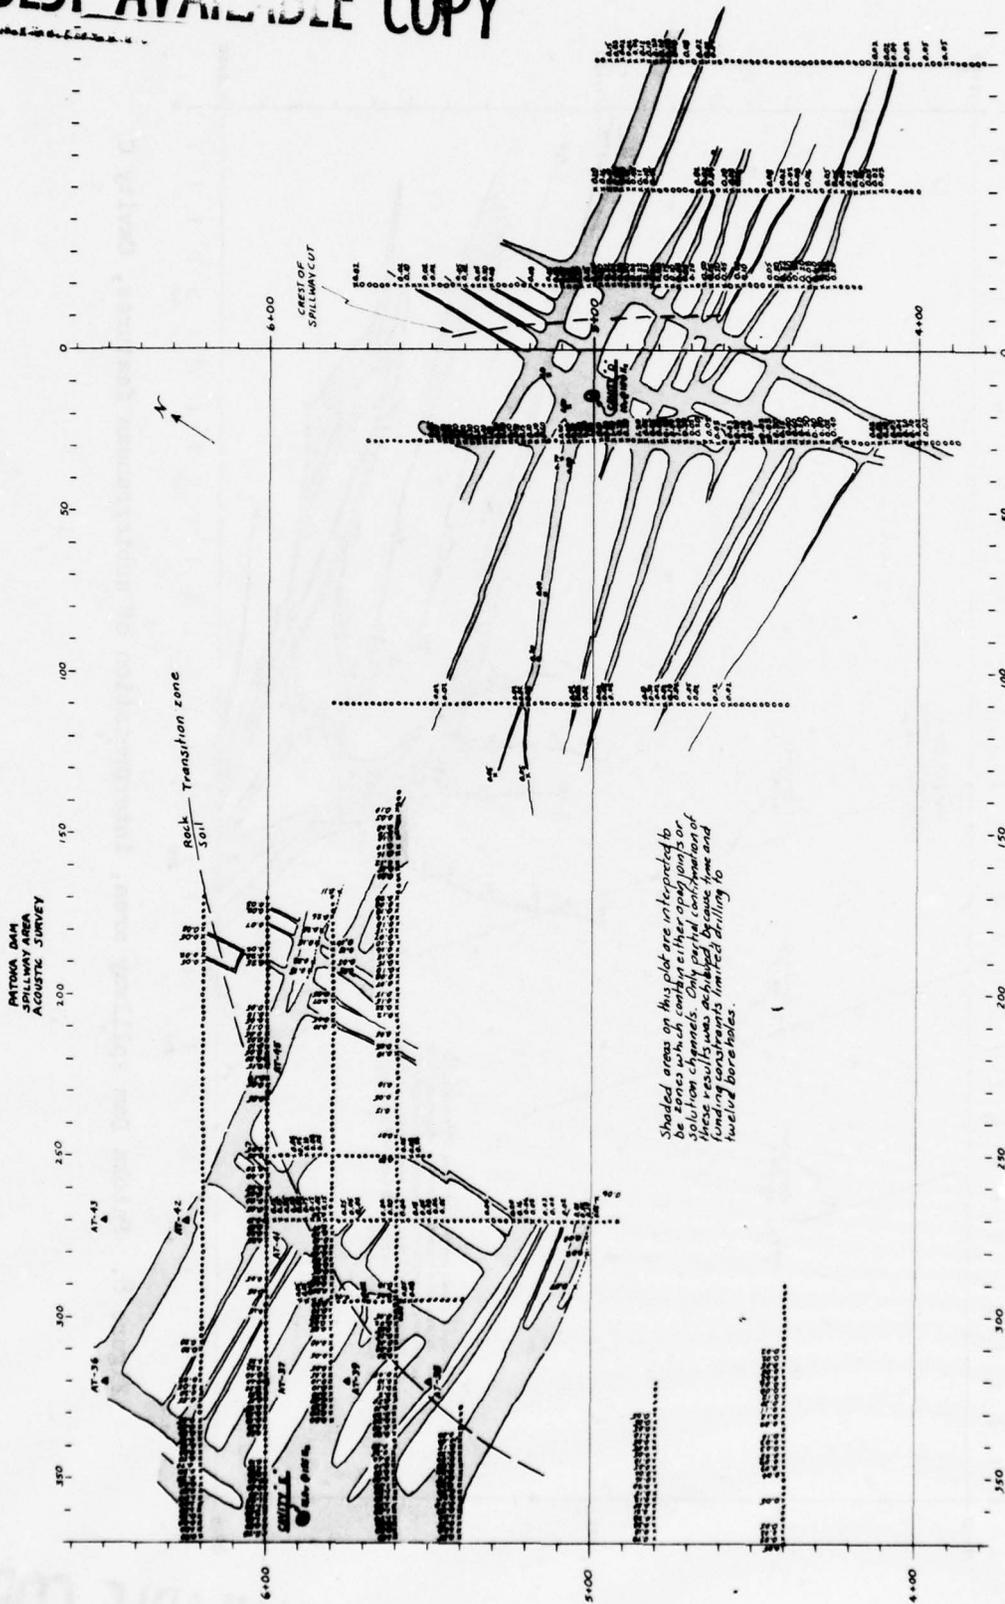
Figure 9. Patoka Dam spillway area, interpretation of subterranean features, Cavity D and Cavity E

have improved performance characteristics, including an increased output
level. A modified procedure was used for cavities "D," "E," and for
cavity "F" which was located in the dike area. These areas were sur-
veyed using an irregular rectangular grid pattern with measurements
of 2 ft centers. The irregular grid lines resulted primarily from sur-
face conditions such as mud holes, standing water, rock piles, material
storage piles, etc., rather than from preference. A final grid pattern
acoustic survey was also done at cavity "A," both to acquire additional
data and to provide a comparison of the two data acquisition techniques
used. These data are shown in Figure 6.

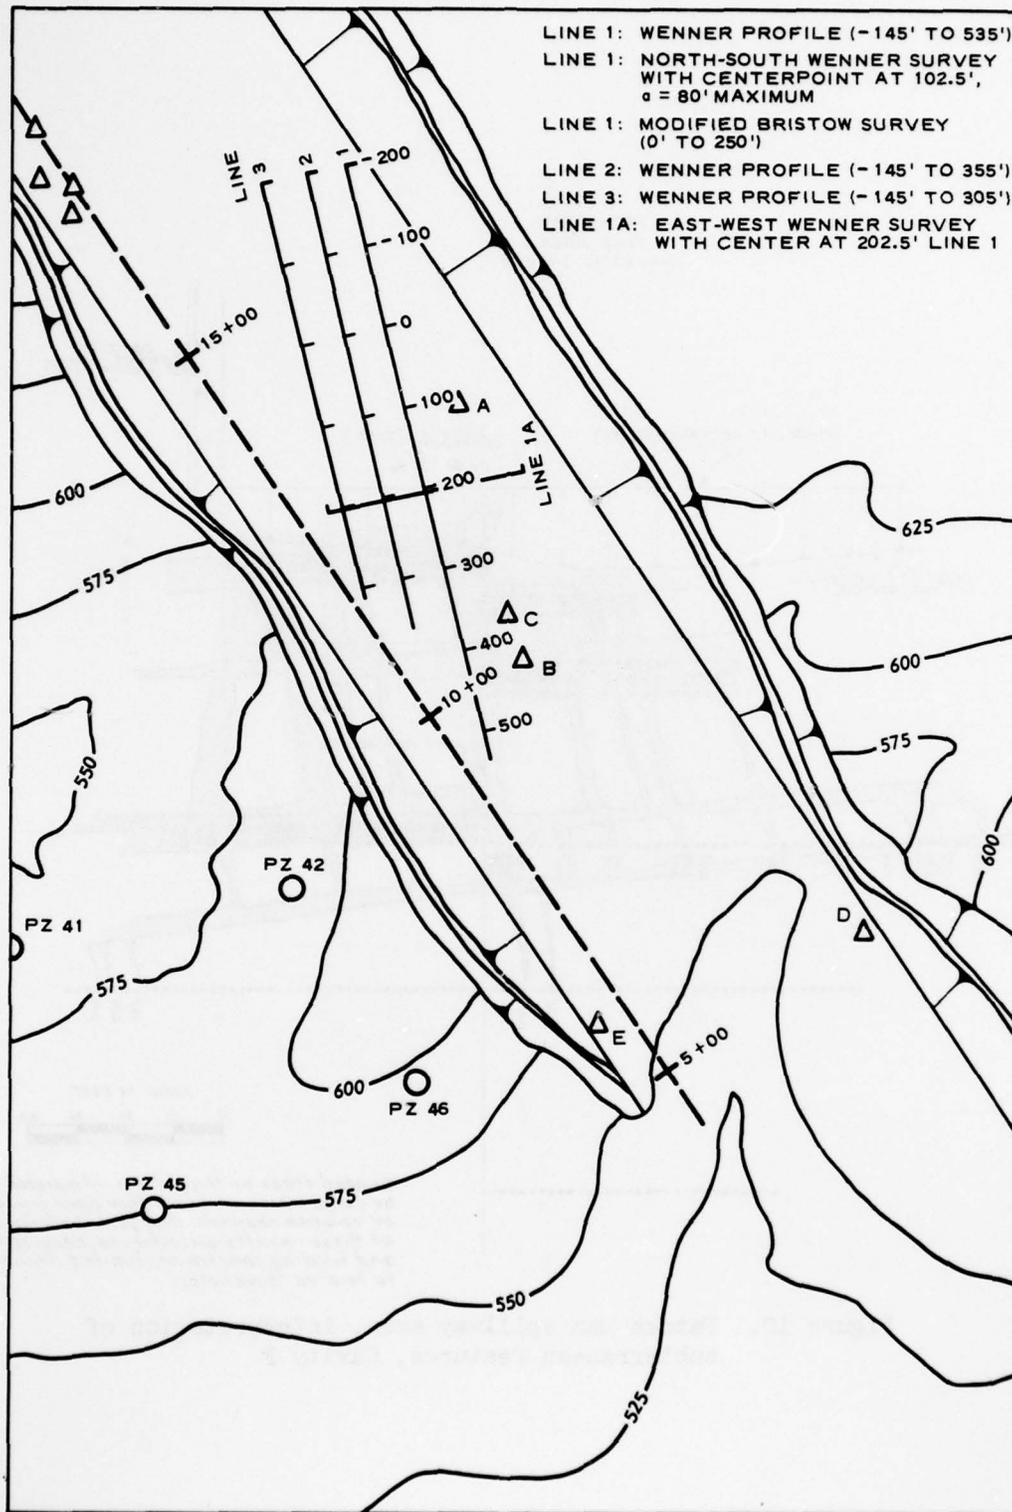
Figure 11. Location of electrical resistivity lines performed in the spillway area

30. Profile line 1 was established as shown in Figure 11. It is the same location as that of the modified Bristow survey and the North-South trending Wenner sounding. This line was profiled, at least in part, three times. The Wenner 30-ft electrode spacing was used for reasons discussed earlier. As discussed, one segment was also profiled at 5 and 20 ft spacings, for comparison. The results of profiling this line at the three electrode spacings are shown in Figure 21. The 5 ft spacing provides only a shallow depth of penetration, and results were influenced mostly by variations in the top layer of highly fractured and friable sandstone. Air-trac borings performed later in the survey revealed a variable (2 to 6 ft) depth of sandstone in this area, and this, together with material and water content variations, probably accounts for the erratic results. Profiles obtained along line 1 using the 20- and 30-ft electrode spacing exhibit a much less eratic behavior. However, a close examination reveals that the highs and lows do not always correspond. This is almost certainly due to the fact that the 30 ft spacing has a greater depth of penetration and hence averages a considerably larger volume of material than does the 20 ft spacing. The Wenner sounding does confirm the base line resistivity for each spacing at sta 102.5. It was observed that the Wenner sounding results indicated resistivity values of 540 Ohm-ft for the 20 ft spacing and 760 Ohm-ft for the 30 ft spacing. At location 102.5 (the center point of the

N-S Wenner sounding) the 20 and 30 ft profile lines also give resistivity values of 540 Ohm-ft and 760 Ohm-ft, respectively. The results of the line 1 profile seemed to indicate that the resistivity highs might be indicative of shallow depth of burial air-filled cavities. Resistivity lows, on the other hand, were not as sharply contrasting. Profiling continued in the spillway with profile lines 2 and 3. The locations of these lines were offset to the west by 50 and 100 ft, respectively (Figure 11). The results are shown on Figures 22 and 23. The Wenner profile of line 2 was similar to line 1 in resistivity contrasts. Line 3, however, indicated greater resistivity contrasts than either of the other lines. Since lines 1 and 2 crossed the acoustic data spread, it was decided to locate exploratory borings on lines 1 and 2 rather than line 3, even though line 3 had higher resistivity contrasts.

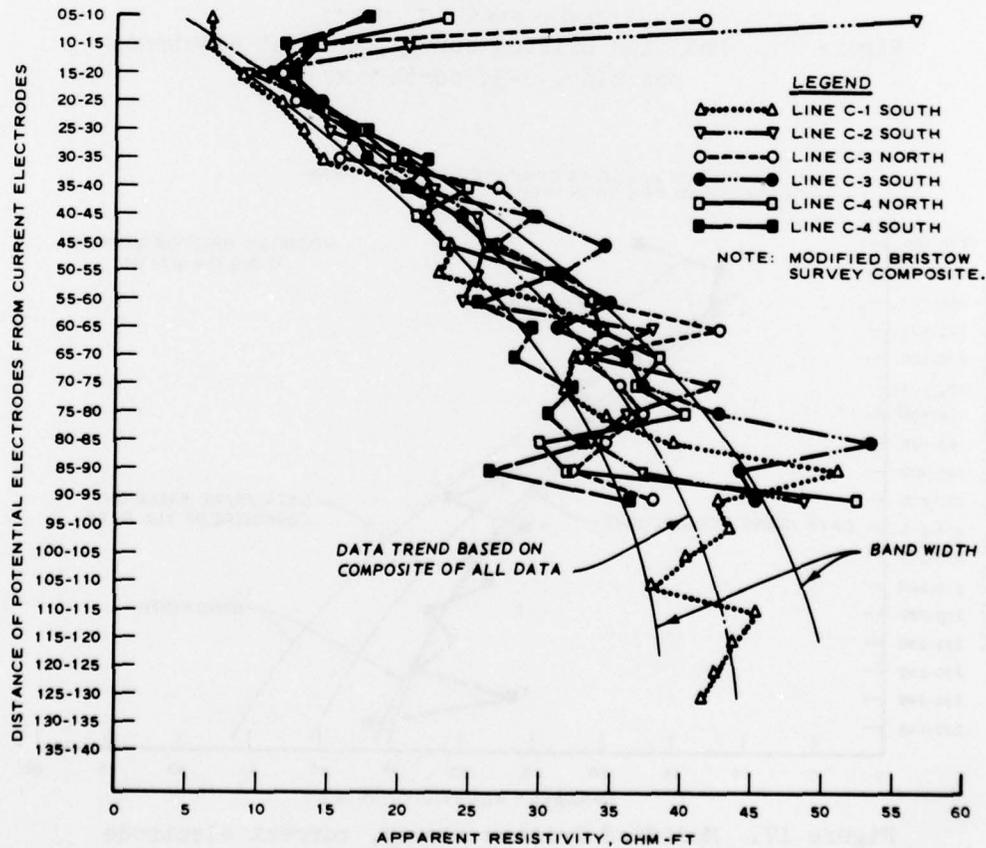
Figure 19. Modified Bristow survey, composite of all runs

27. From an inspection of Figures 13-19, two important facts emerge: (a) there does appear to be a fairly well defined trend or bandwidth of limited extent, and (b) there are some substantially higher or lower apparent resistivity values, even compared to the bandwidth. Two plausible interpretations are offered, based on arbitrary upper and lower data bounds. The first, and most conservative interpretation was done by choosing only high and low values that fell outside the average data bandwidth. The results are shown in Figures 28 and 29. Figure 28 is a plot of the zones showing high resistivity values. The stippled zone represents the zone of earth which contained the high resistivity anomaly; the black zones formed by the intersection of three or more zones indicate possible air-filled cavities. The locations of the features are given approximately by the locations of the intersections and the size is thought to be roughly equal to the area enclosed by the three zones.

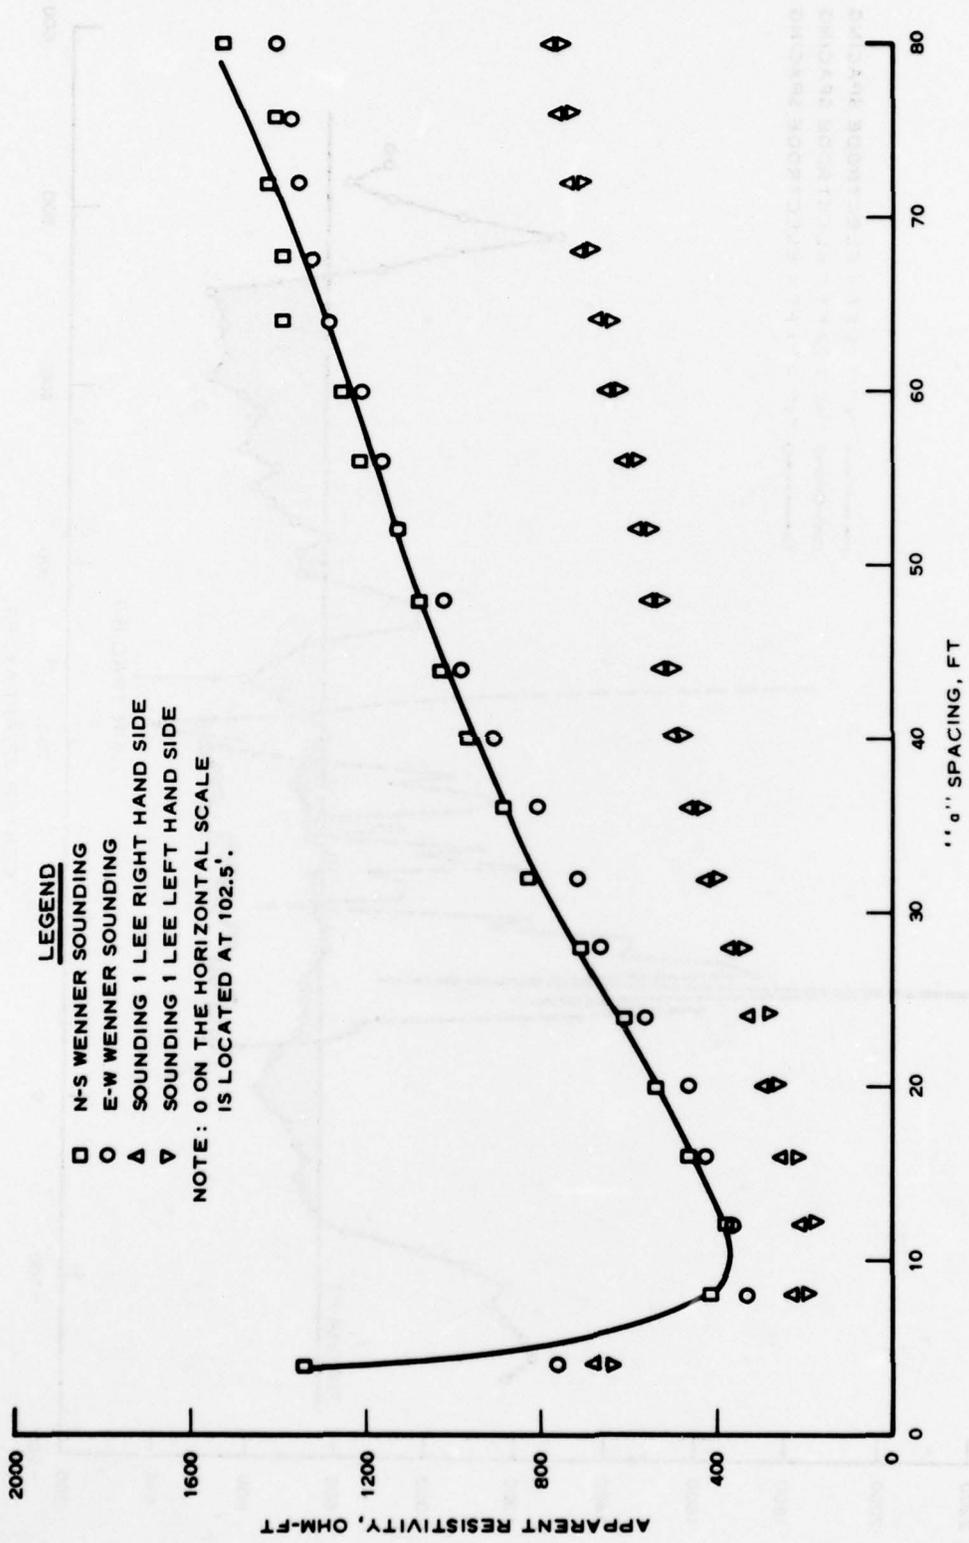
Figure 20. Plot of Wenner soundings performed in the spillway area

at sta 202.5. The results are shown in Figure 20.

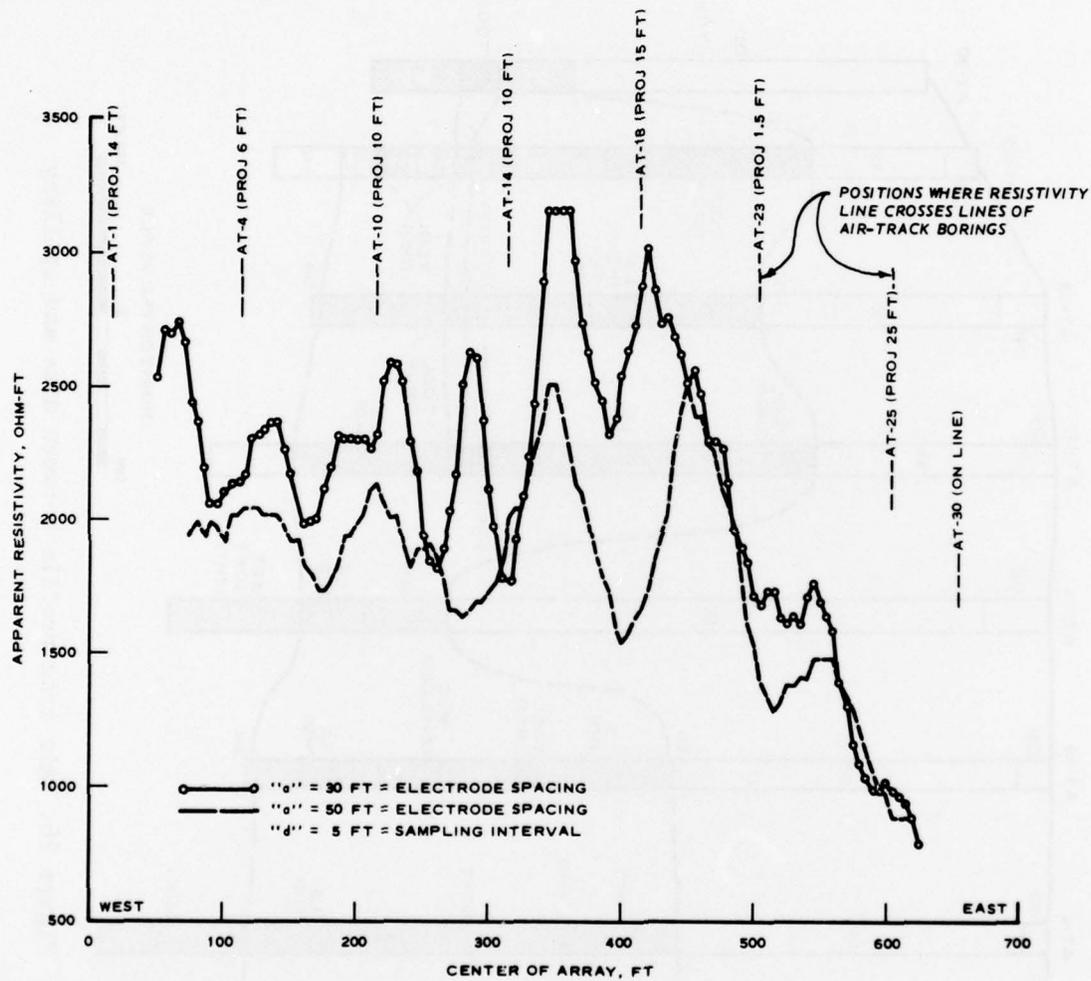
Figure 25. Wenner profile between dike and spillway,
along 560 ft contour, approx

34. As previously discussed, Wenner "a" spacings of 30 and 50 ft were employed in this area. The resistivity profiles are plotted in Figure 25. From Figure 25, it can be seen that the occurrence of high and low resistivity anomalies for the 30 and 50 ft spacings are in reasonably good agreement. The substantial decrease in resistivity at the east end of the survey line is thought to be due at least in part to the presence of a fill area, indicated by air-trac boring AT-30, Figure 26. The air-trac borings in the area record numerous open cavities and soft (mud) zones which must be soil-filled cavities. The resistivity profiles likewise indicate extensive zones of solution activity. Comparing Figures 25 and 26, it can be seen that the locations of borings AT-4, 14, 18, 23, and 25 coincide with broad resistivity lows recorded using the 50 ft Wenner electrode spacing. The 50-ft Wenner electrode spacing provides a greater depth of investigation than the 30 ft spacing and is also less influenced by variations in the overlying sandstone. It is again interesting to note that there is generally good correlation between the 30- and 50-ft profile results, in terms of general trends. This suggests that the solution zones in this area involve both the Mansfield and Glen Dean members, and that

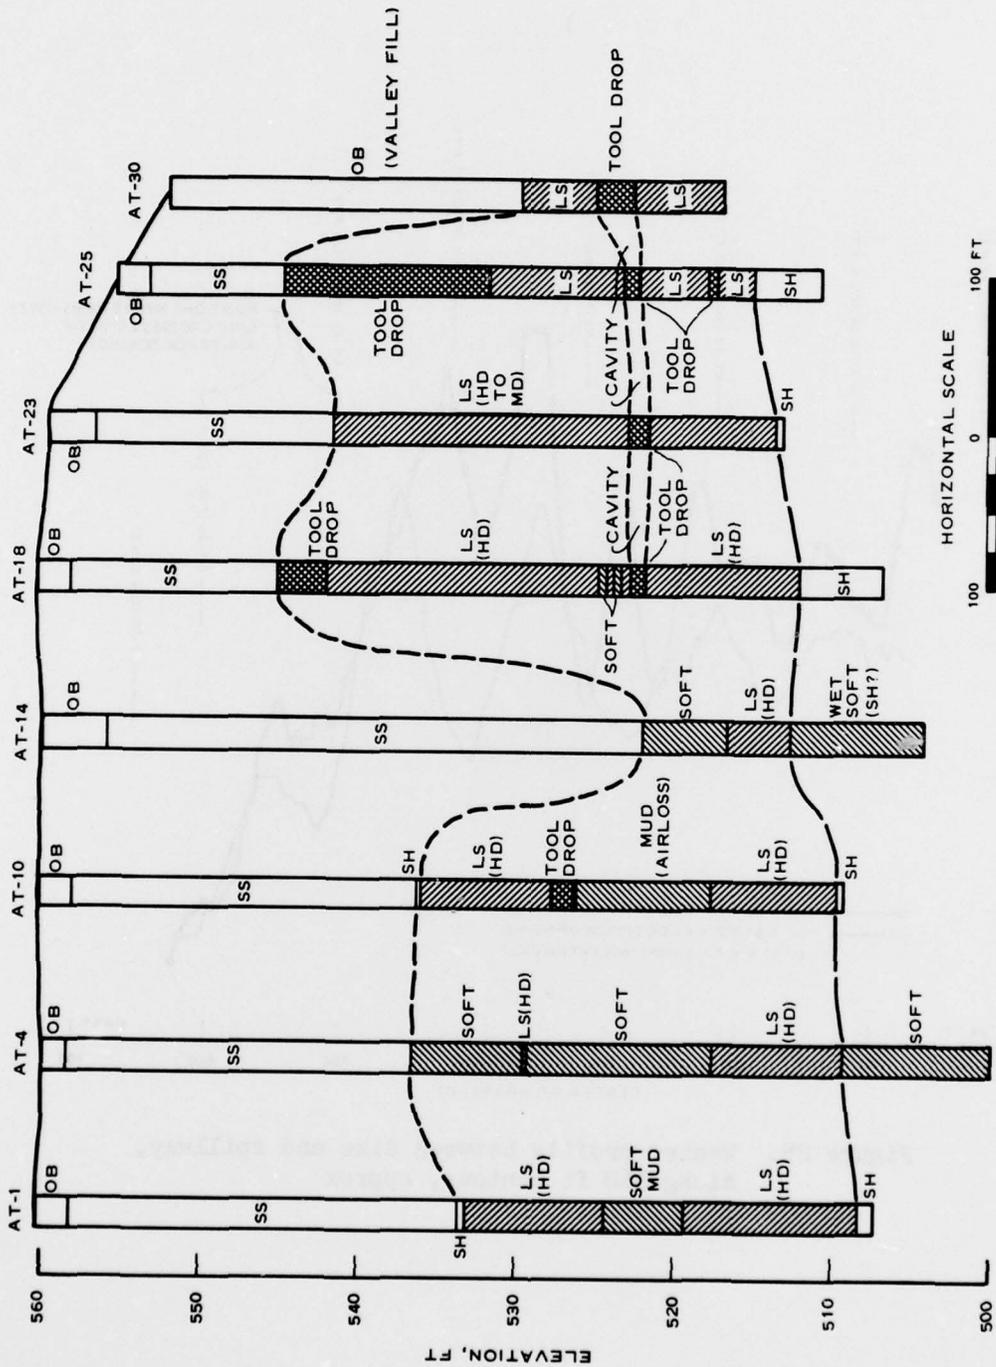
Figure 26. Air trac profile between dike and spillway

33. The area between the dike and the spillway was the last locale surveyed using electrical resistivity techniques. The Wenner profiling technique was employed as a time and cost effective method to cover this relatively large area in the time remaining. Also, it was thought to be as effective as any other method in detecting zonal variations. This Wenner profile was run along the 560 ft contour line of the abutment between the dike and spillway as shown in Figure 24. Air-trac borings had been previously made in this area, and they indicated a variable thickness of sandstone ranging from 0 to 33 ft (see Figure 26).

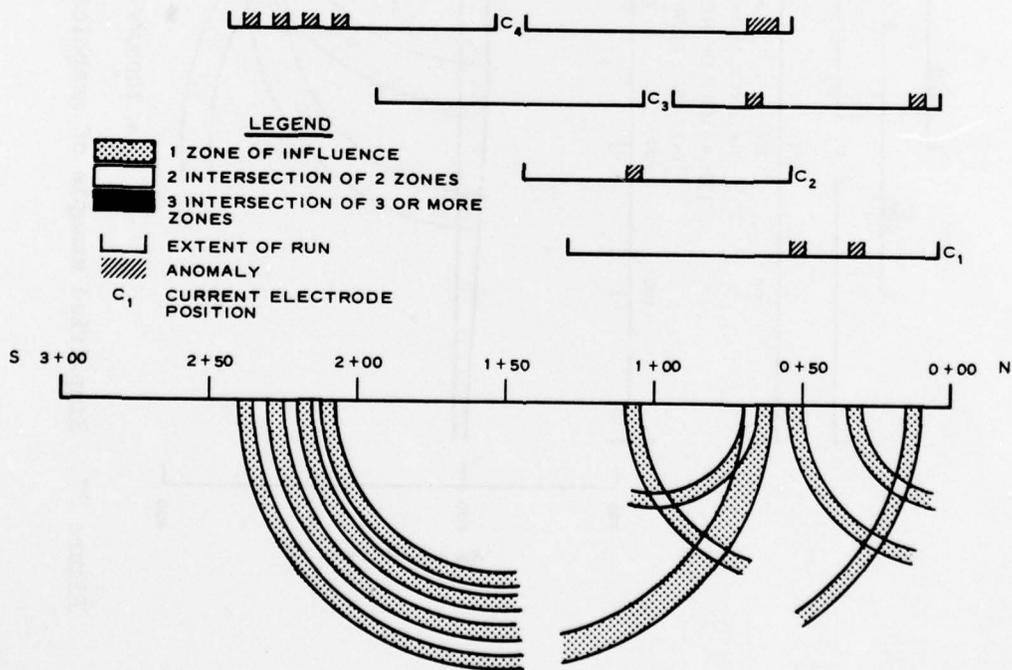
Figure 29. Modified Bristow survey, low resistivity
values outside bandwidth

28. Zones with resistivity values that were considered anomalously low as compared to the bandwidth are shown in Figure 29. A low resistivity value can be an indication of a soil, mud, or water-filled cavity. There are few low values resulting from this interpretation, and in no instance is there a zone defined by more than two intersecting arcs. This interpretation, however, is very conservative from the standpoint that so many high and low resistivity anomalies were discounted because they fell within the bandwidth. A somewhat more liberal interpretation was made, taking advantage of the trends established for each individual run. In this instance, high and low values that were judged to obviously deviate from the individual trend were plotted. The points that were plotted have been noted with an asterisk. The graphical interpretations for the high and low anomalous resistivity values are given in Figures 30 and 31, respectively. The intersection of two shaded zones has been left blank and the intersection of three shaded zones has been indicated. It is apparent that when the bandwidth criterion was imposed, the interpretation was biased toward high resistivity anomalies.

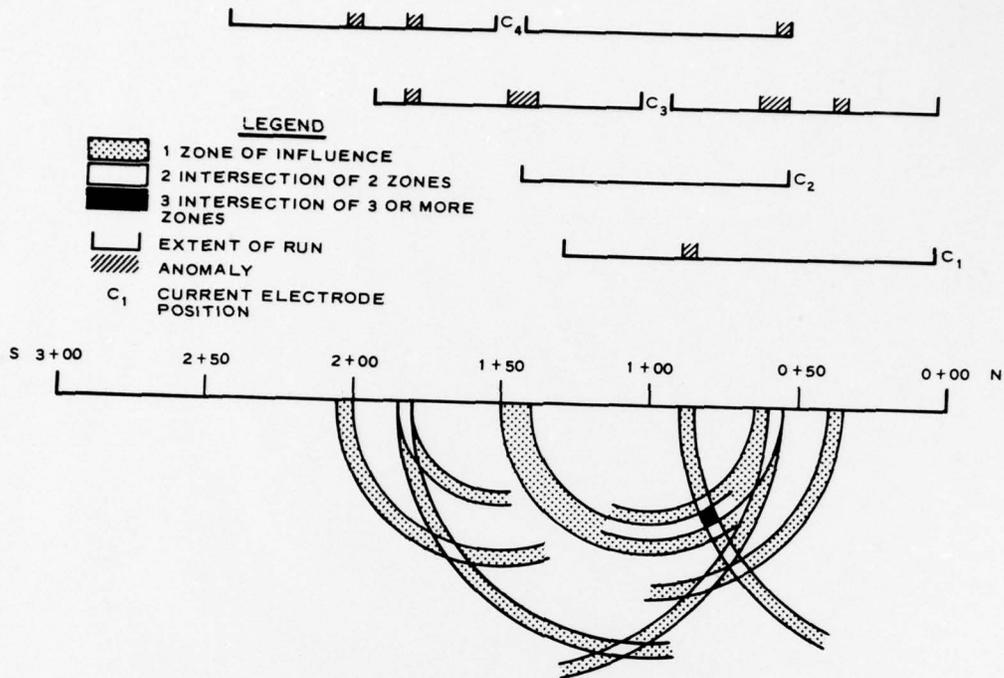
Figure 30. Modified Bristow survey, high resistivity

38. A final comparison can be made using the Bristow resistivity data obtained along line 1 in the area of cavity "A." The acoustic data indicate that a number of solution features, which are interpreted to be primarily open joints, cross resistivity line 1 between sta 69.0 and sta 130.0. Figures 28, 29, 30, and 31 give the Bristow resistivity interpretations for this interval. Figures 28 and 30 show the interpretation of resistivity highs. These apparent high values fall at about sta 53.0, 72.0, 77.5, and 95.0 on resistivity line 1. All of these are centered in blank (no signal) areas of the acoustic data spread, and do not coincide with any zone where the acoustic interpretation indicates solution activity. However, the Bristow resistivity low interpretation offered in Figure 31 is in good agreement with the acoustic data. The low resistivity zones centered at about sta 70.0, 107.0, and 125 fall in areas where the acoustic data (and interpretation) indicate some solution activity has occurred.
