ADVANCED CRYOGENIC ROCKET ENGINE PROGRAM
AEROSPIKE NOZZLE CONCEPT -- MATERIALS AND PROCESSES
RESEARCH AND DEVELOPMENT REPORT

Rocketdyne, A Division of
North American Rockwell Corporation
6633 Canoga Avenue
Canoga Park, California

Technical Report AFRPL-TR-67-278

November 1967

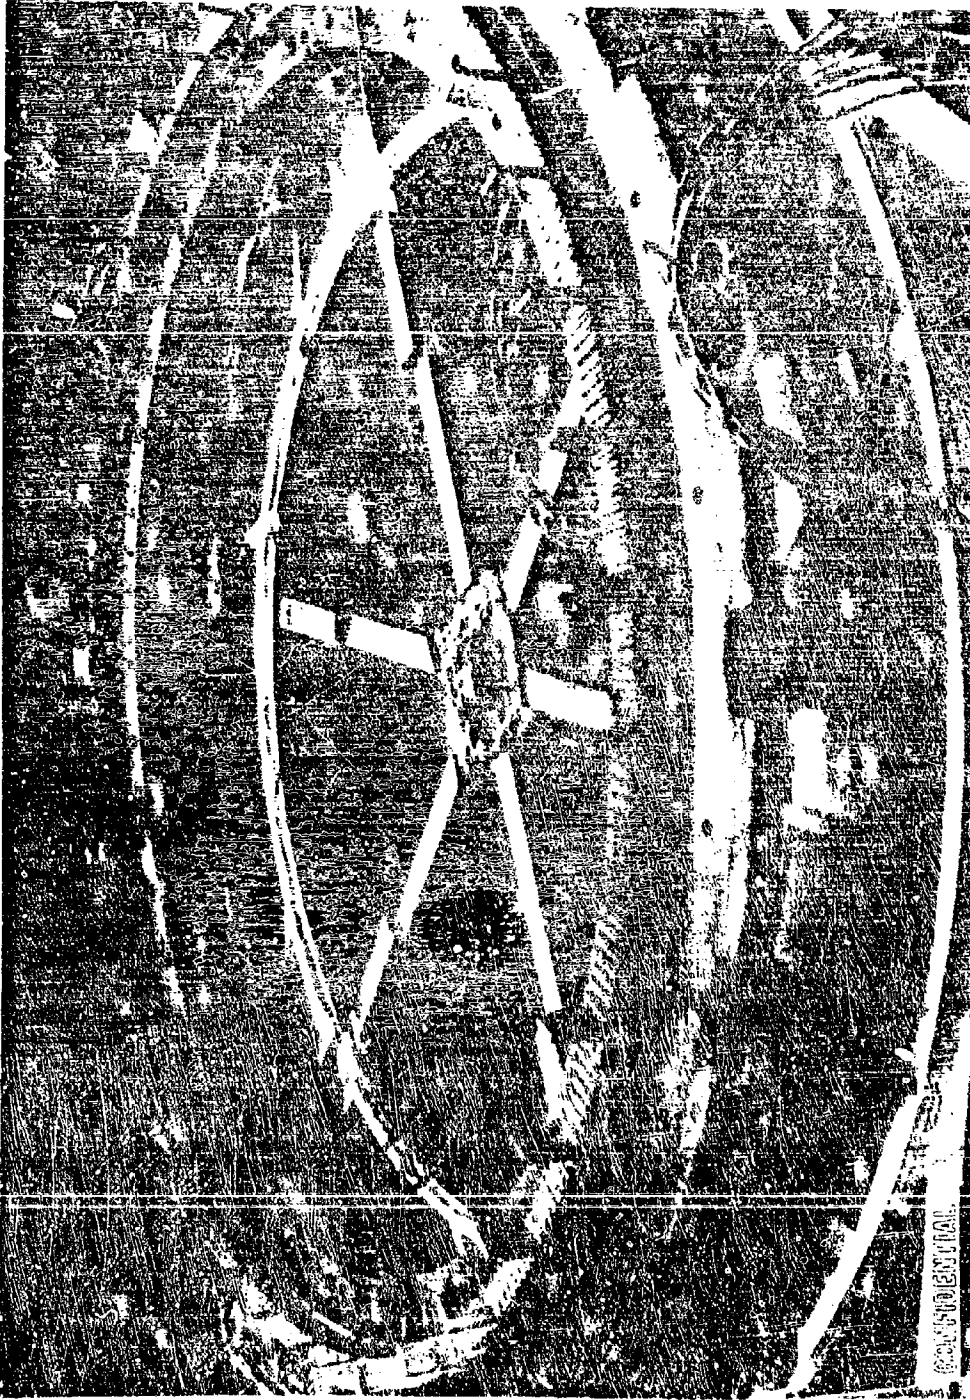
A - No. 8 thermocouple attached
B - No. 9 thermocouple attached
C - Position of thermocouples for retort outlet

Figure 38. Partial Thermocouple Attachment

(U) Figure 38 shows an injector assembly with some of the thermocouples attached. Figure 39 shows the injector retort on the furnace hearth with the purge gas lines, thermocouple duct, and vacuum duct attached.

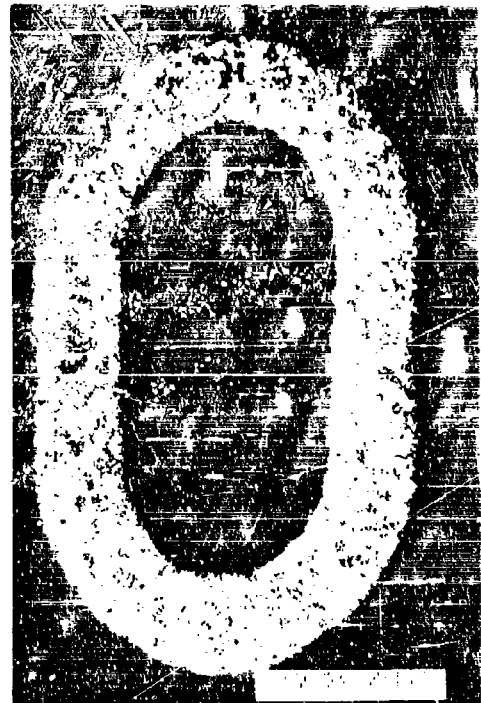
a. Photomicrograph of cross section configuration at cross section B (Fig. 46)
 H - hot-gas crown, specimen etched with Anaconda reagent
 Mag: 25X

b. Photomicrograph of cross section configuration at cross section D (Fig. 46).
 Note concavity in side walls and thickening of wall 180 degrees from hot-gas crown (H). Specimen etched with Anaconda reagent. Mag. 25X

c. Photomicrograph of hot-gas crown at cross section B showing OD surface laps (arrows). Specimen etched with Anaconda reagent. Mag: 150X

Figure 47. Typical Conditions Observed on Book Die Formed OFHC Copper Tubes for 2.5K Segment

(U) After book die forming, a random sample of finish formed tubes were subjected to metallurgical evaluation. During this evaluation, it was revealed that a number of tubes had a flat spot on the hot-gas crown at the throat region. This flat spot was a result of die mismatch which was corrected early in the forming operation; however, a number of tubes were rejected because of the condition. Figure 46 shows the location of metallographic specimens removed from the finish formed tubes. Figure 47 shows the results of evaluations conducted on finish formed tubes and depicts conditions observed. In addition to the routine metallographic examination conducted on sample tubes after tapering, tapering and annealing, and final forming, the thermal treatment test described previously was also conducted on a section of each tube submitted for metallurgical evaluation. This test was accomplished to increase the assurance that all tube material was OFHC copper. None of the tubes tested in this manner showed any evidence of hydrogen embrittlement.
