6 PRELIMINARY FLIGHT TEST DATA.

UH-1B HIGH PERFORMANCE HELICOPTER
WITH AUXILIARY PROPULSION.

11 February 1964,

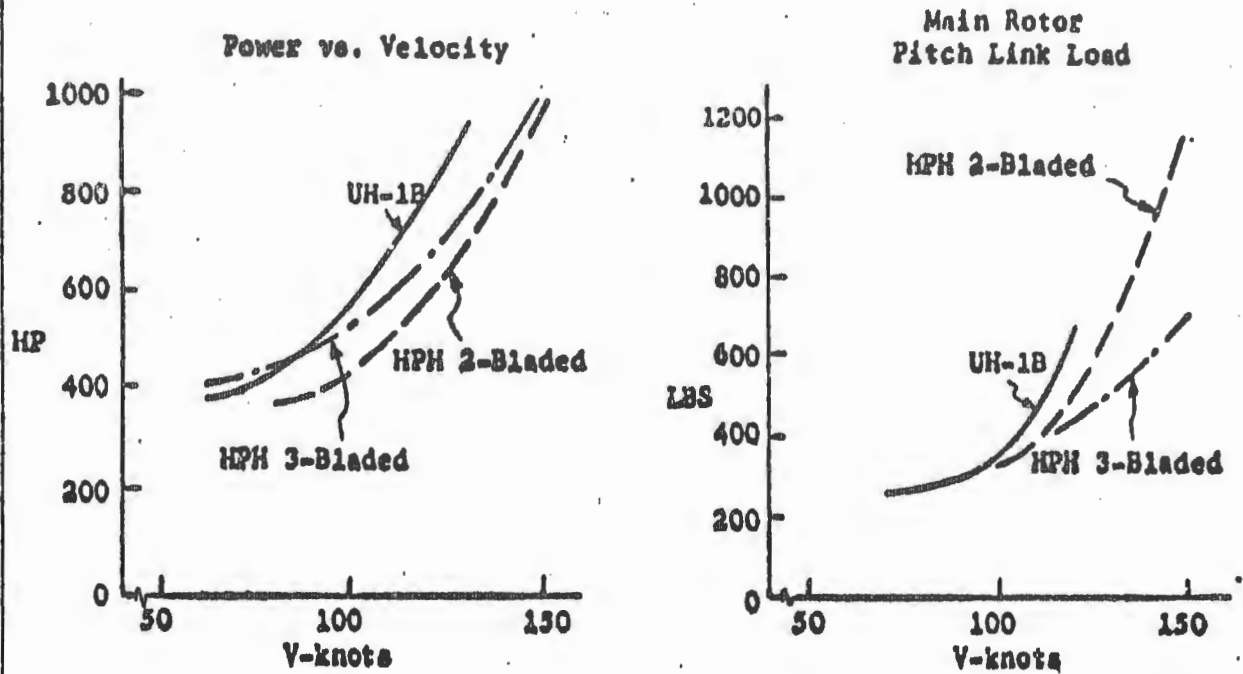
Figure 1

**Summary of High Performance Helicopter
Flight Test Results**

Note: HPH 2-Bladed is with Standard UH-1B Rotor.

MAIN ROTOR

Section 1 - The following pages present some of the previous flight test results achieved with the high performance UH-1B helicopter operating as a pure helicopter and in a winged configuration.

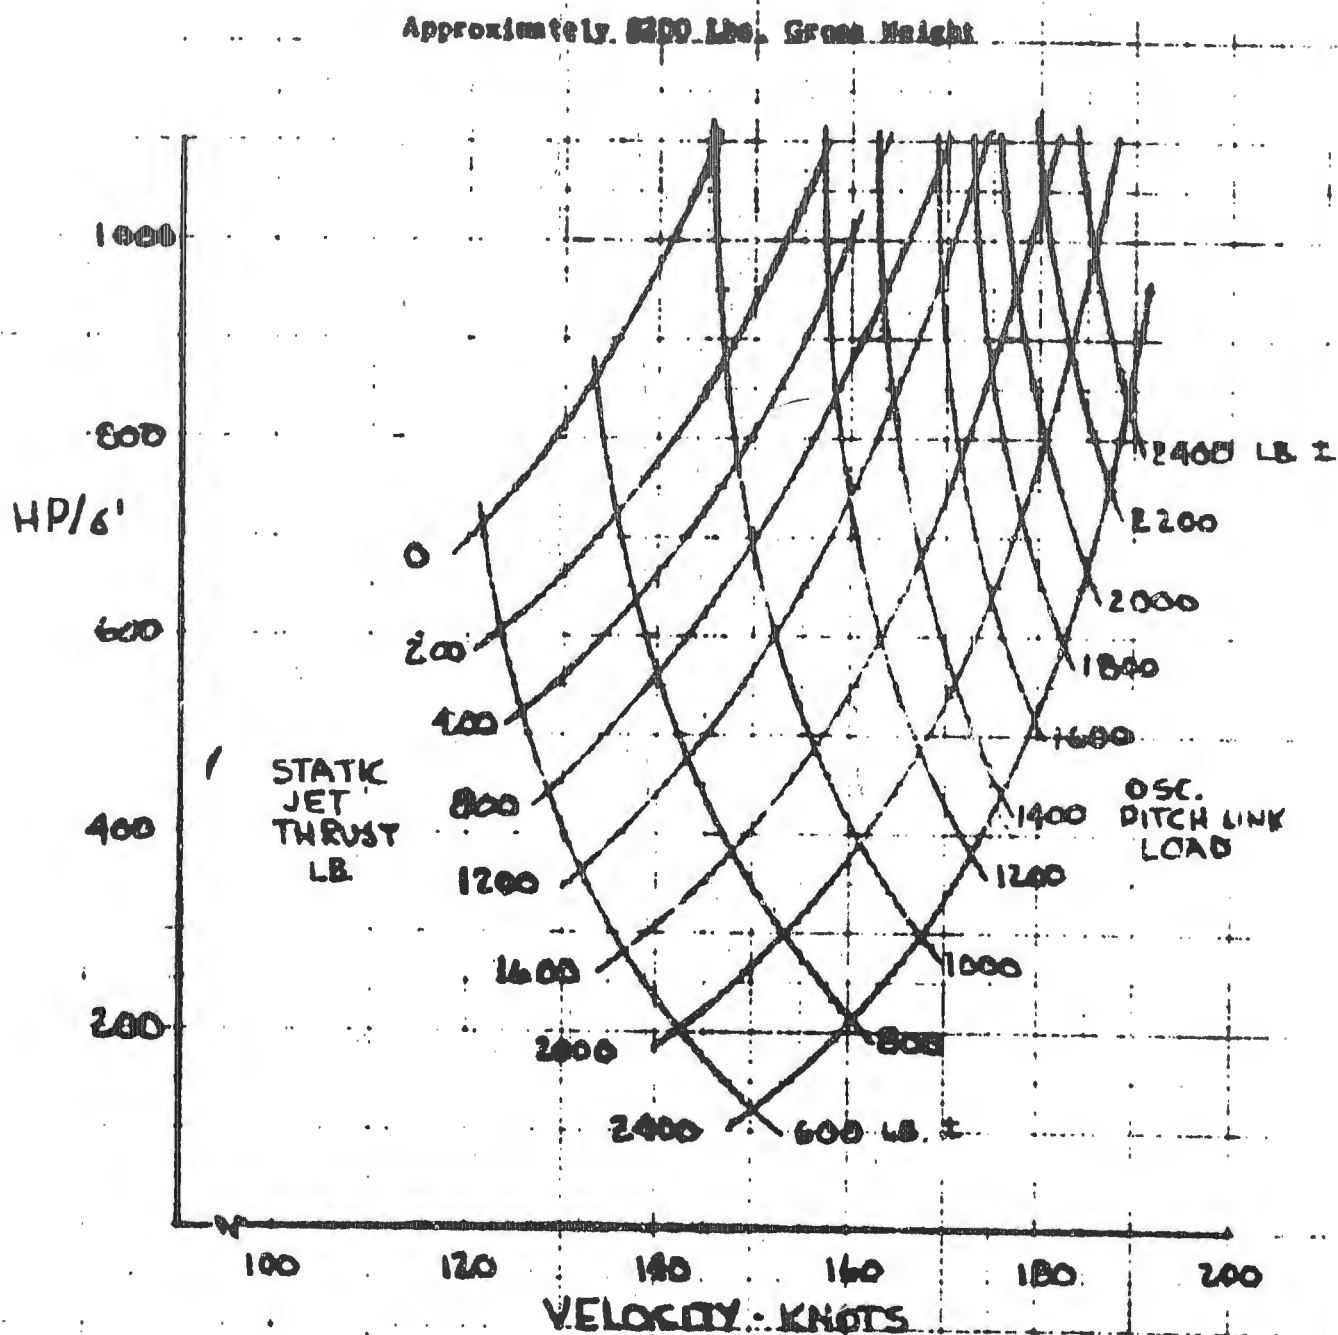
6.11 - CONSERVATIVE WORKING CURVE FOR FLIGHT LIMIT

Estimated oscillatory pitch link loads versus airspeed for various combinations of auxiliary propulsion and shaft horsepower.

NOTE: Data shown are conservative - used for planning maximum performance flight.

Data based on Flights 548, 549, and 553

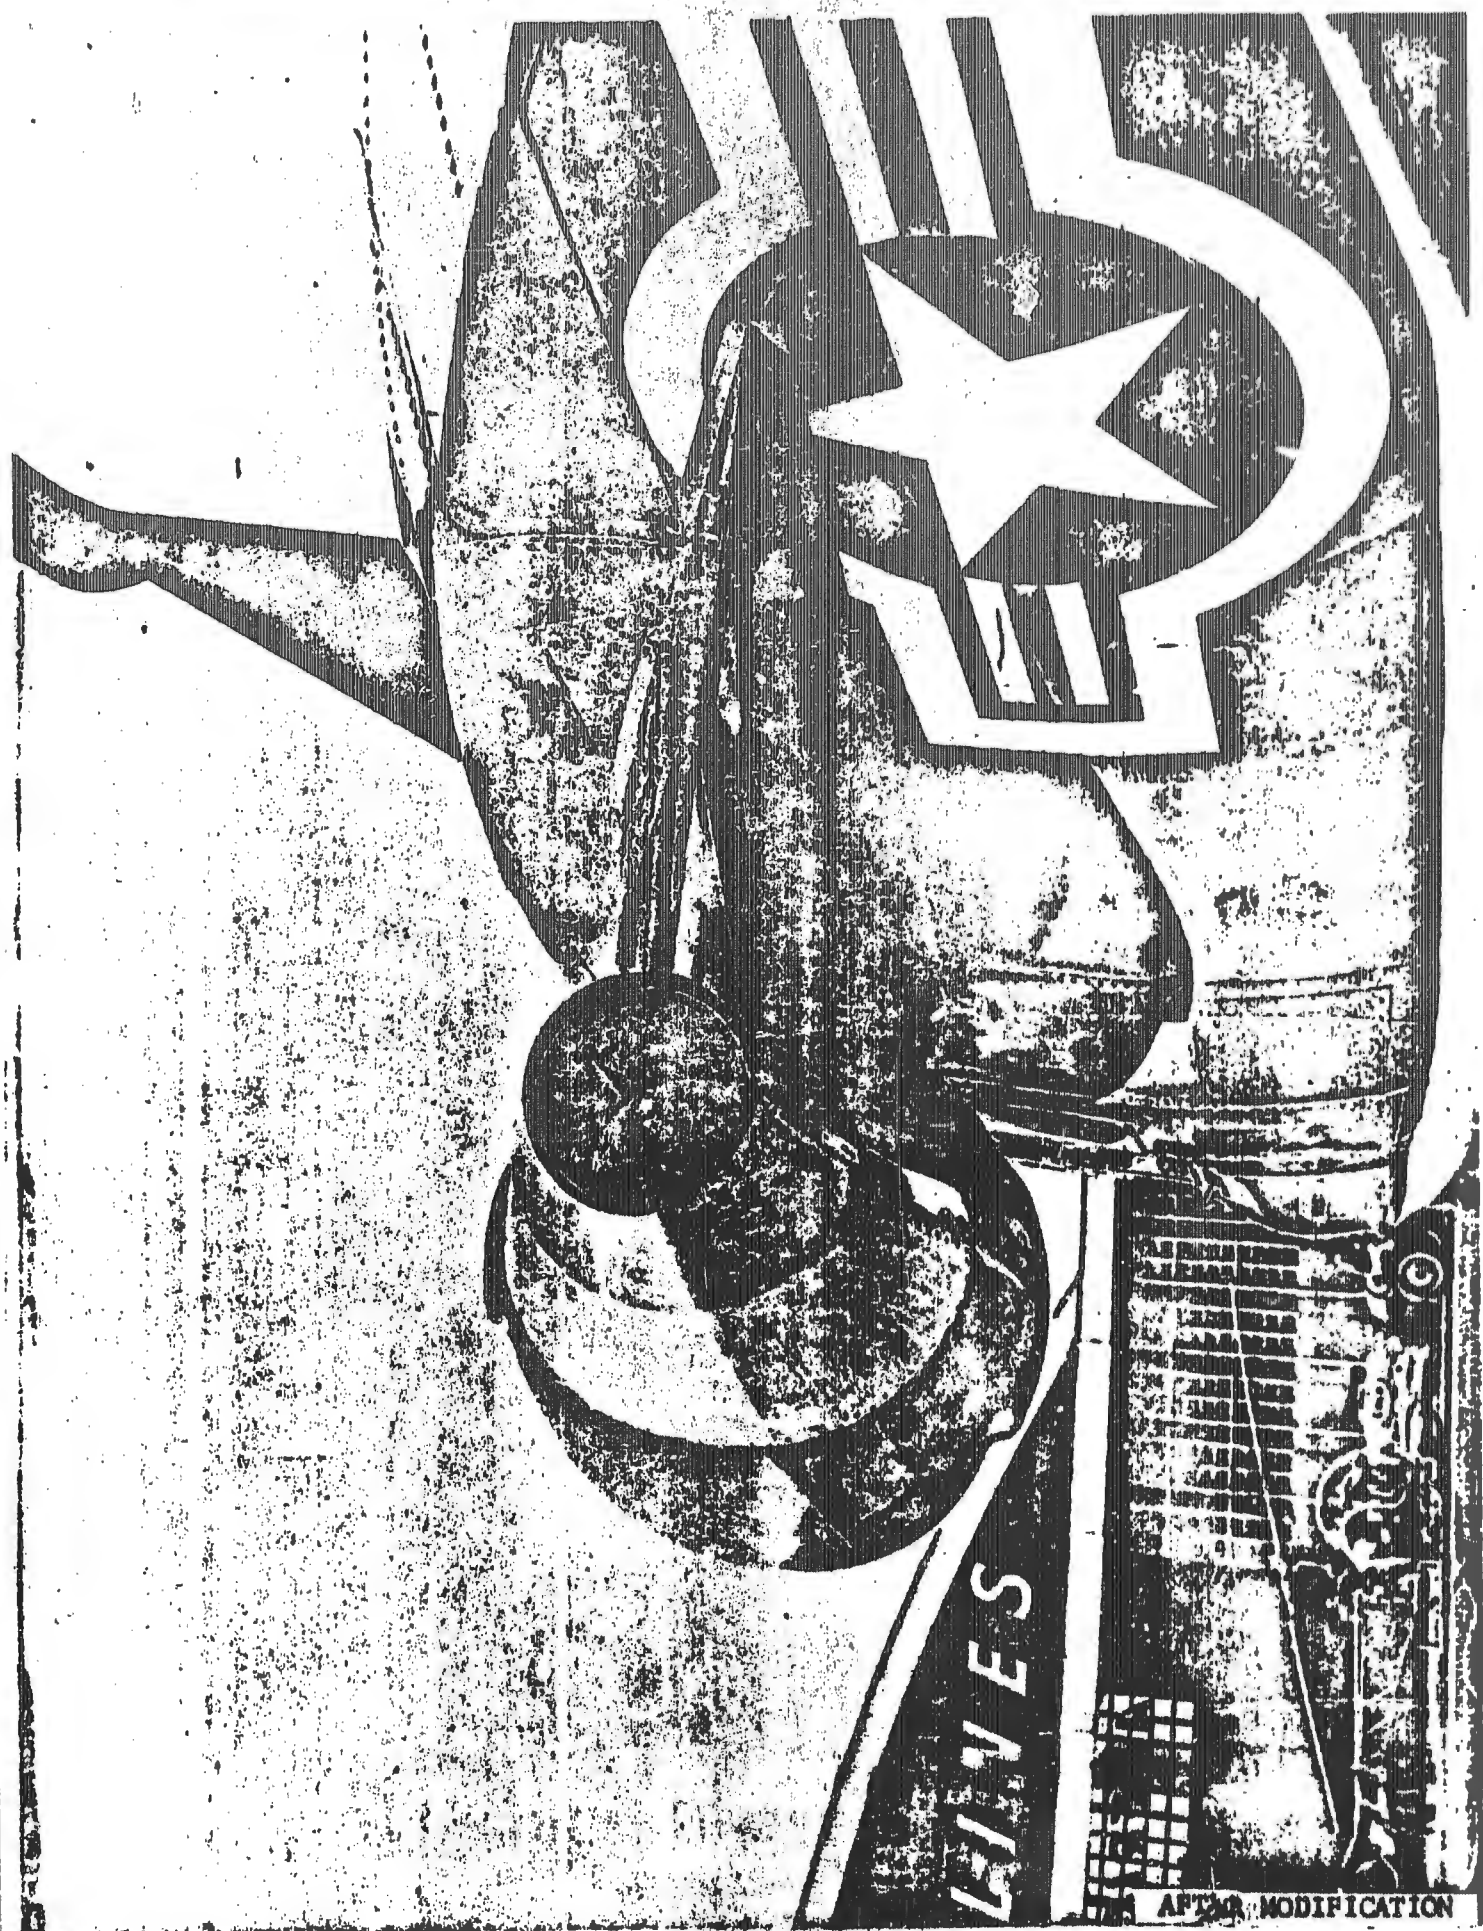
AFTER MODIFICATION

Interference Drag - Interference between jet nacelles and fuselage resulted in Δ drag of about 3-4 sq. ft. New engine pylon fairing designed, fabricated, and installed. Problem corrected.

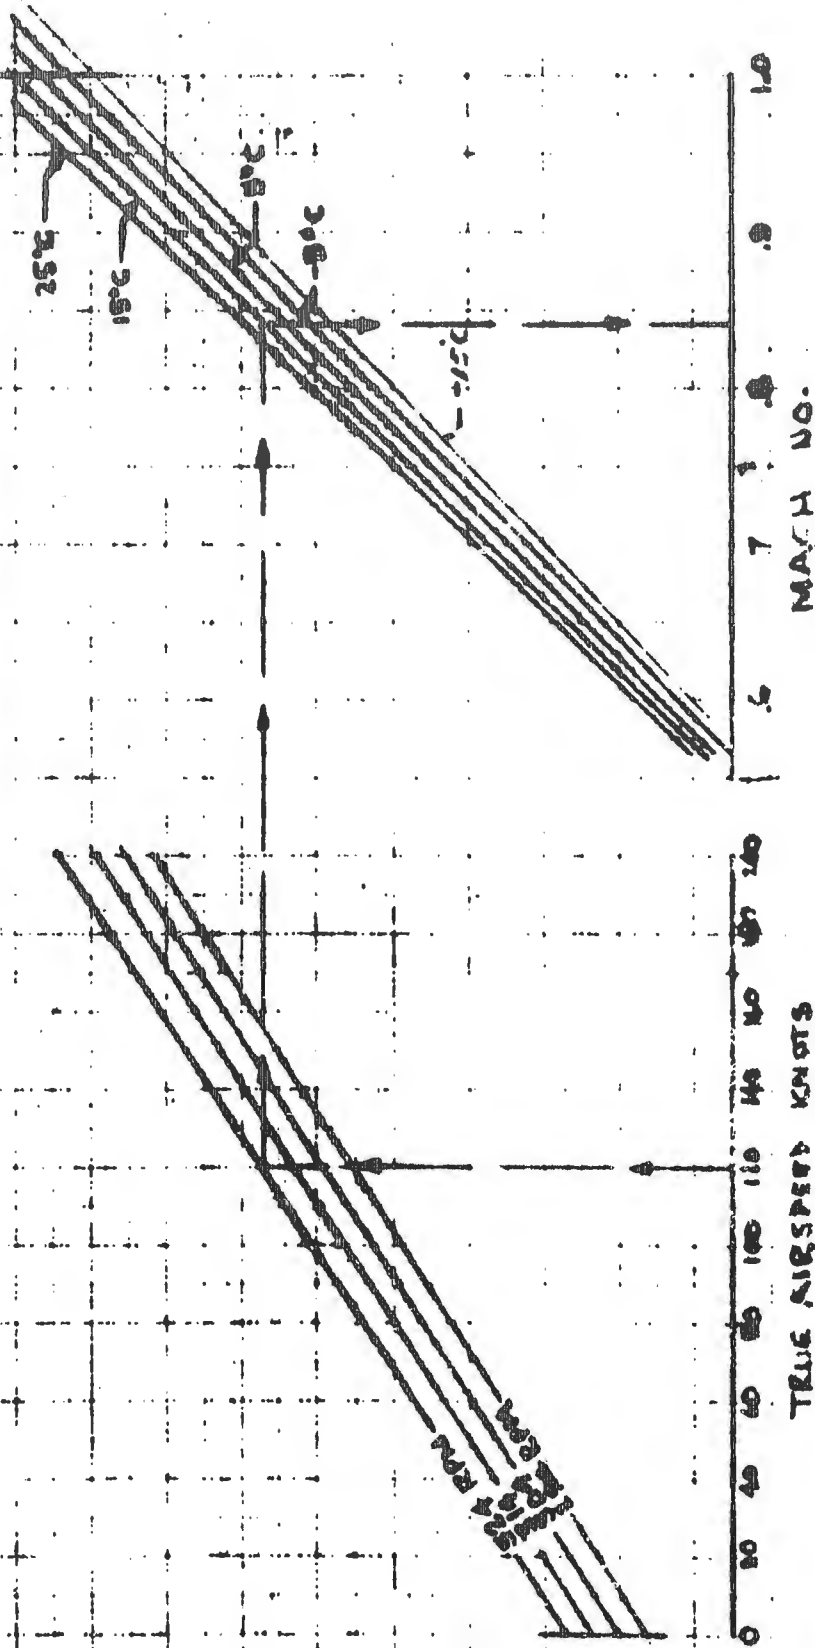
ADVANCING TIP MACH NUMBER 44 FL ROTOR

EXAMPLE: 1024 ROTOR BLADE TIP SPEED .84 AT 110 KNOTS, 15%

The weather requirements were particularly severe as low temperature could result in extremely high Mach number on advancing blade at anticipated maximum speed condition (.989). Mach number effects could increase control loads. Maximum performance flight delayed over a week due to this.
