RL-TR-96-98
Final Technical Report
July 1996

RELIABILITY ASSESSMENT OF OPTO-ELECTRONIC INTEGRATED CIRCUITS

Uniphase Telecommunications Products

Karl M. Kissa and Hogan Eng

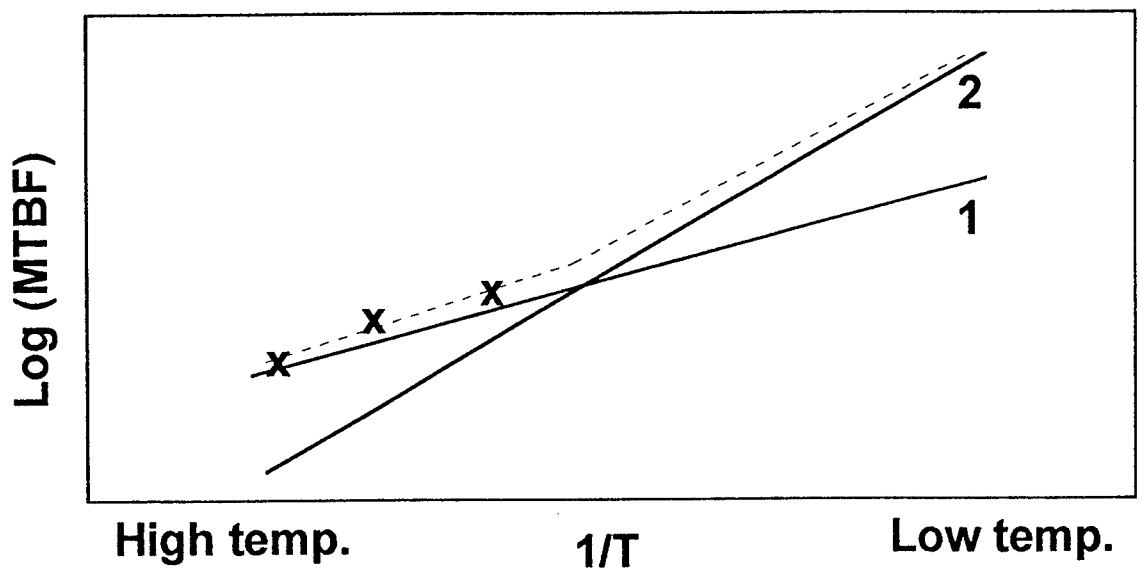
Figure 4: Illustration of two step failure mechanism. Solid lines represent Arrhenius plots of actual MTBF for each failure mechanism. Dashed line represents overall MTBF, which is sum of MTBF's from each step. Crosses represent measured data from which extrapolations are made.

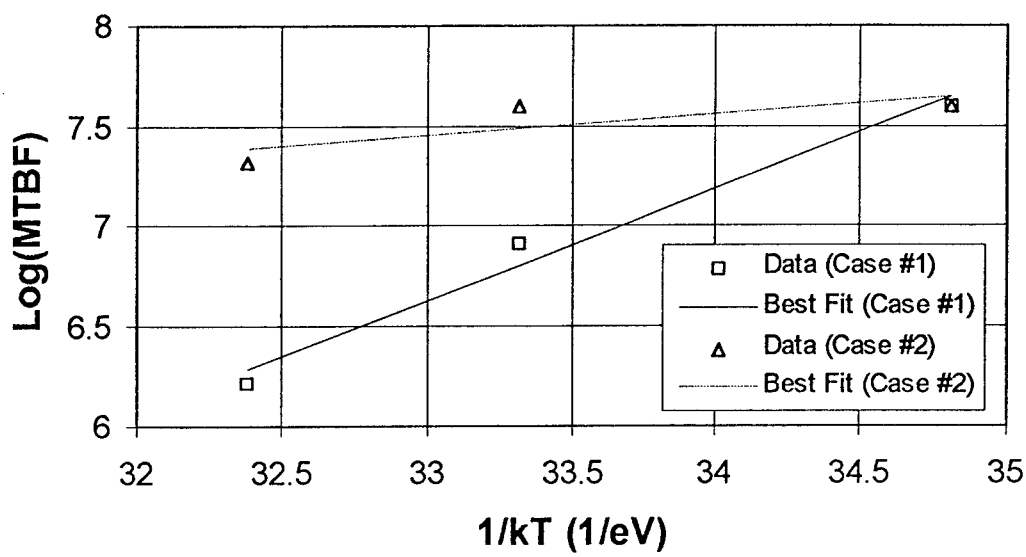
The MTBF can be estimated at lower temperatures, by making an Arrhenius plot of the data, performing a least squares straight line fit, and extrapolating the least squares fit to lower temperatures. Uncertainty in measured MTBF at the higher temperatures can have a dramatic impact on the estimated MTBF; therefore, the extrapolation is performed for two extreme cases. Case #1 uses the minimum values for MTBF for Lots 3 and 4, whereas Case #2 uses the maximum values for those lots. It should be noted that the uncertainty in the MTBF at 75°C / 90% RH actually has a minor effect on the least squares fit, influencing the value at 25°C by less than 1%. The estimated MTBF at lower temperatures is mainly influenced by the values assumed for Lots 2 and 4. Figure 5 contains the Arrhenius plots of the MTBF data including the least squares fits. The measured and straight line fit MTBF are given in Tables 12 and 13 for the two cases and the activation energies are listed in Table 14. The MTBF from 25°C to 85°C is plotted in Figure 6. Note that the uncertainty in measured MTBF at higher temperatures creates large uncertainty in the estimated MTBF at lower temperatures. For example, MTBF at 25°C / 90% RH is estimated to be between 3200 hr and 20600 hr (2.3 yr).

Figure 5: Arrhenius plot of MTBF data and least squares straight line fit. Case #1 and #2 use minimum and maximum possible values MTBF at high temperature, respectively.

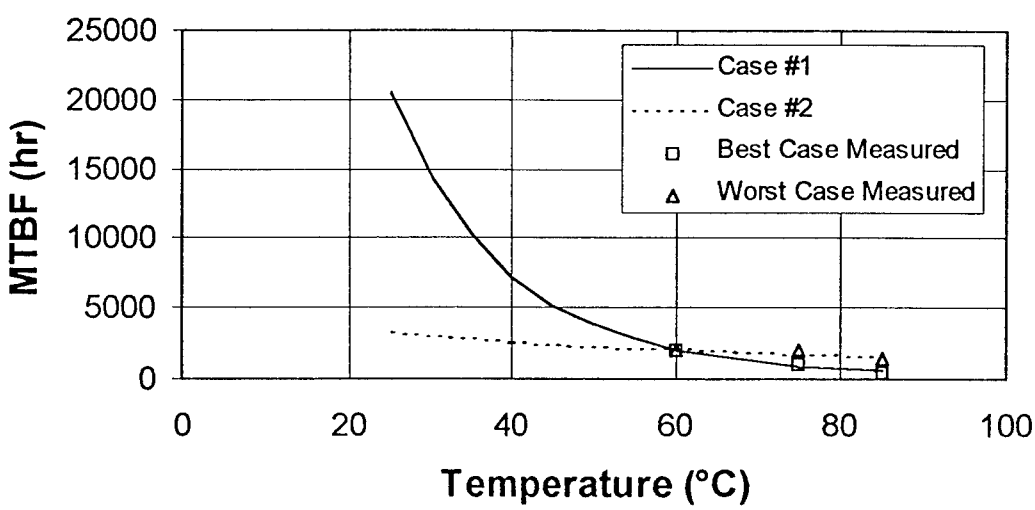
Figure 6: Plot of estimated MTBF at 90% RH for case #1 and #2, two extremes of possible values for MTBF, along with measured data. See text for explanation of large uncertainty in estimated MTBF at low temperatures.

The statistical impact of the small number of devices in each lot needs to be addressed. If the failure time for each device was accurately known, the distribution of failures with time would also be known, allowing an uncertainty in each measured MTBF to be determined. Given the small lot sizes and large time between measurements, this issue can only be addressed qualitatively. All of the devices in Lots 3 and 4 went from completely functional, with no detectable loss, to completely non-functional, that is, not passing light. The similarity of behavior suggests that the statistical effect of small lot size is much smaller than the uncertainty caused by the large sampling interval (1000 hr). It is possible that all the failures occurred abruptly over a period of a few hundred hours or less. Stated differently, increasing the size of the lots would not have changed the result much. All would have been functional at the start of the exposure period. All would have failed at the end. Lot 2 behaved differently in that the degradation occurred more gradually. One failure took place between 500 and 1000 hr and another failure occurred between 1000 and 2000 hr. The failures are likely to occur over a much larger period of time, perhaps 1000 hr. The impact on MTBF is significant. An uncertainty of 500 hr in the MTBF for Lot 2 translates into a factor of 2 uncertainty in the MTBF at 25°C / 90% RH.

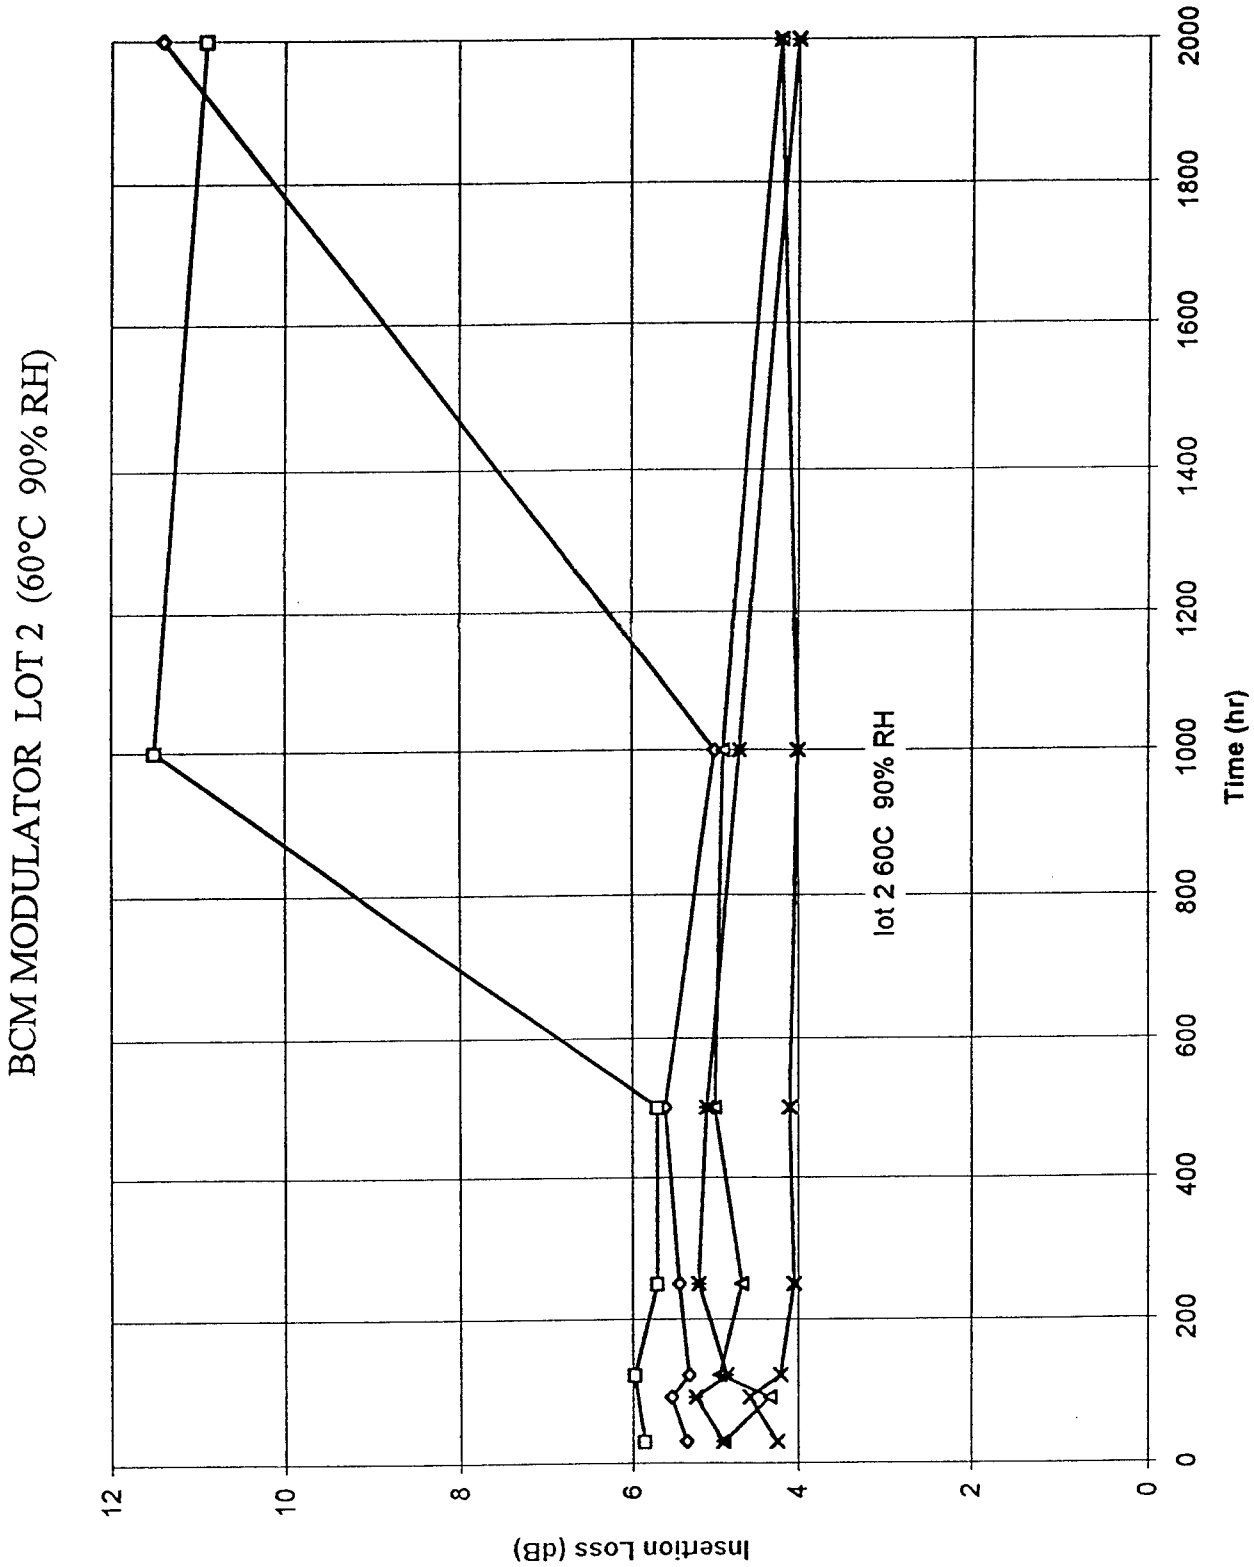
Appendix G.2

<u>Lot 2 (60°C / 90% RH):</u>
1) 1 failure between 500 and 1000 hr (loss increased by 6 dB)
2) 1 failure between 1000 and 2000 hr (loss increased by 6 dB)

Opening the packages and examining the epoxy revealed that the cause of these failures was hydrolysis of the epoxy, a chemical reaction between water vapor and the epoxies used inside the package. The epoxy at the pigtail became soft and darkened in color.

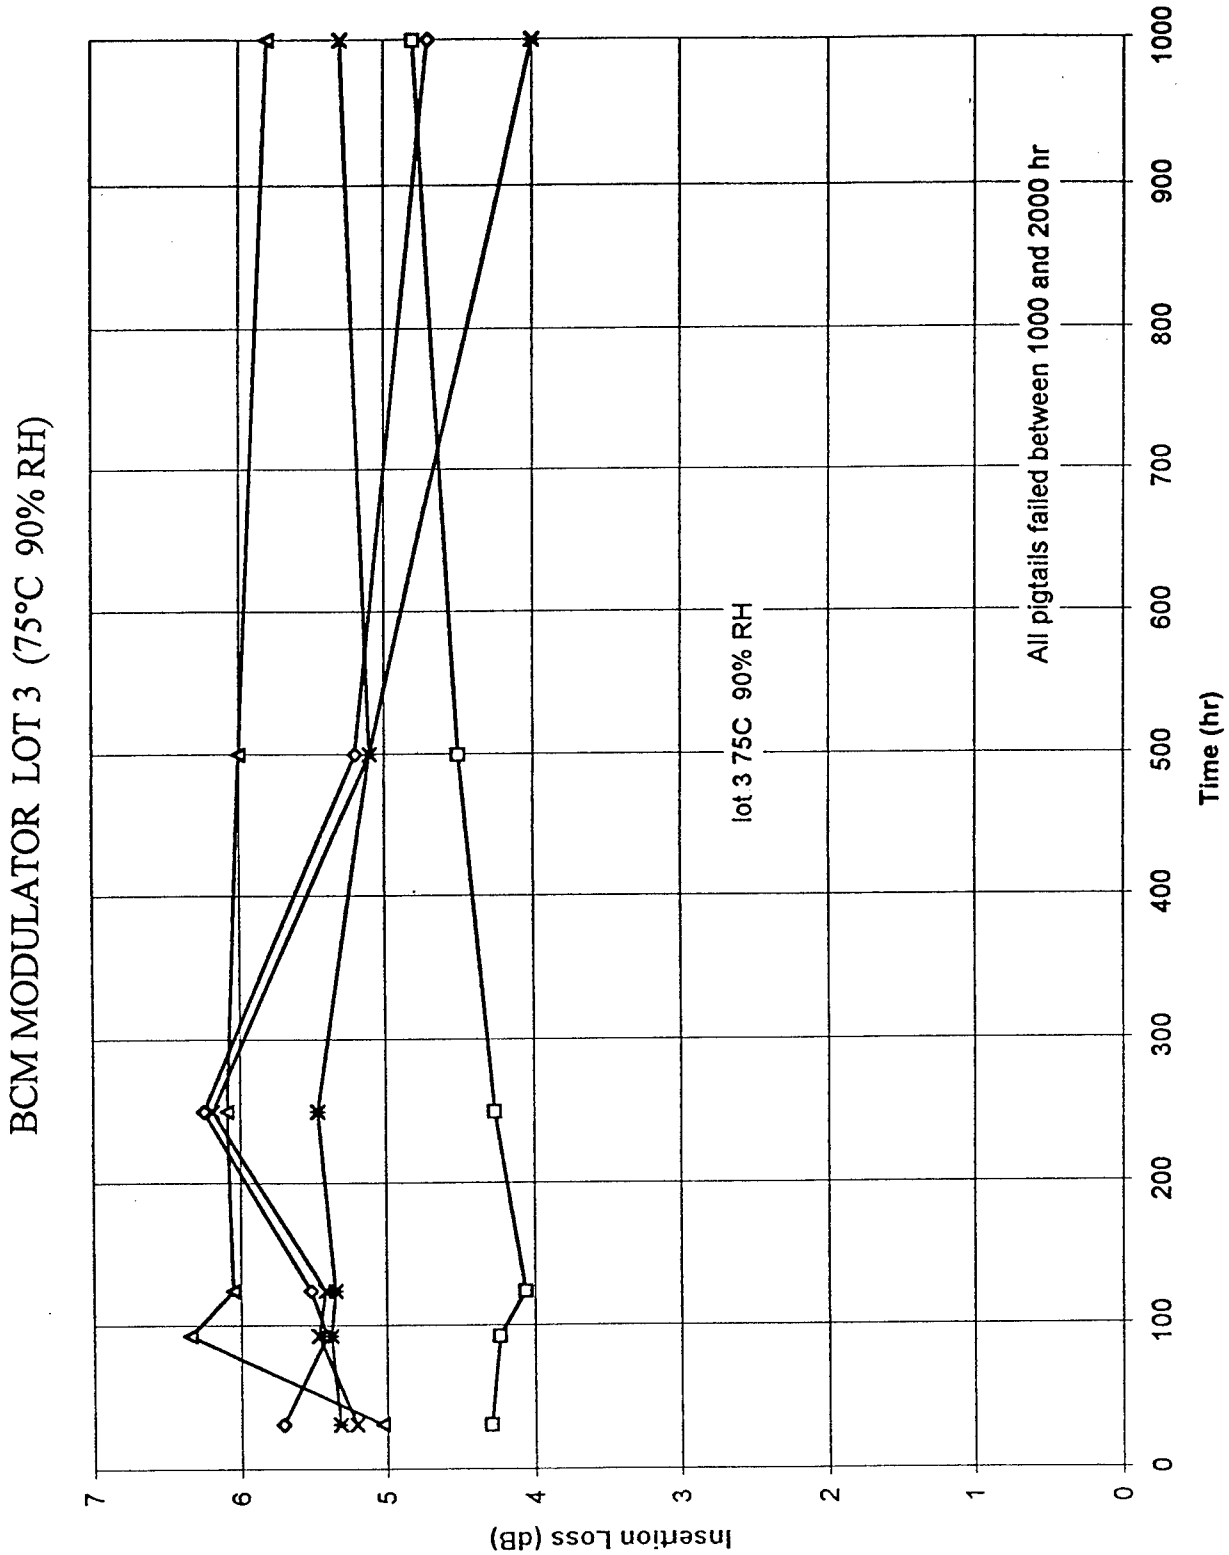
<u>Lot 3 (75°C / 90% RH):</u>
1) all failed between 1000 and 2000 hr (does not pass light)

BCM MODULATOR LOT 3 (75°C 90% RH)
Insertion Loss (dB)
0
1
2
3
4
5
6
7
Time (hr)
0
100
200
300
400
500
600
700
800
900
1000
lot 3 75C 90% RH
All pigtails failed between 1000 and 2000 hr

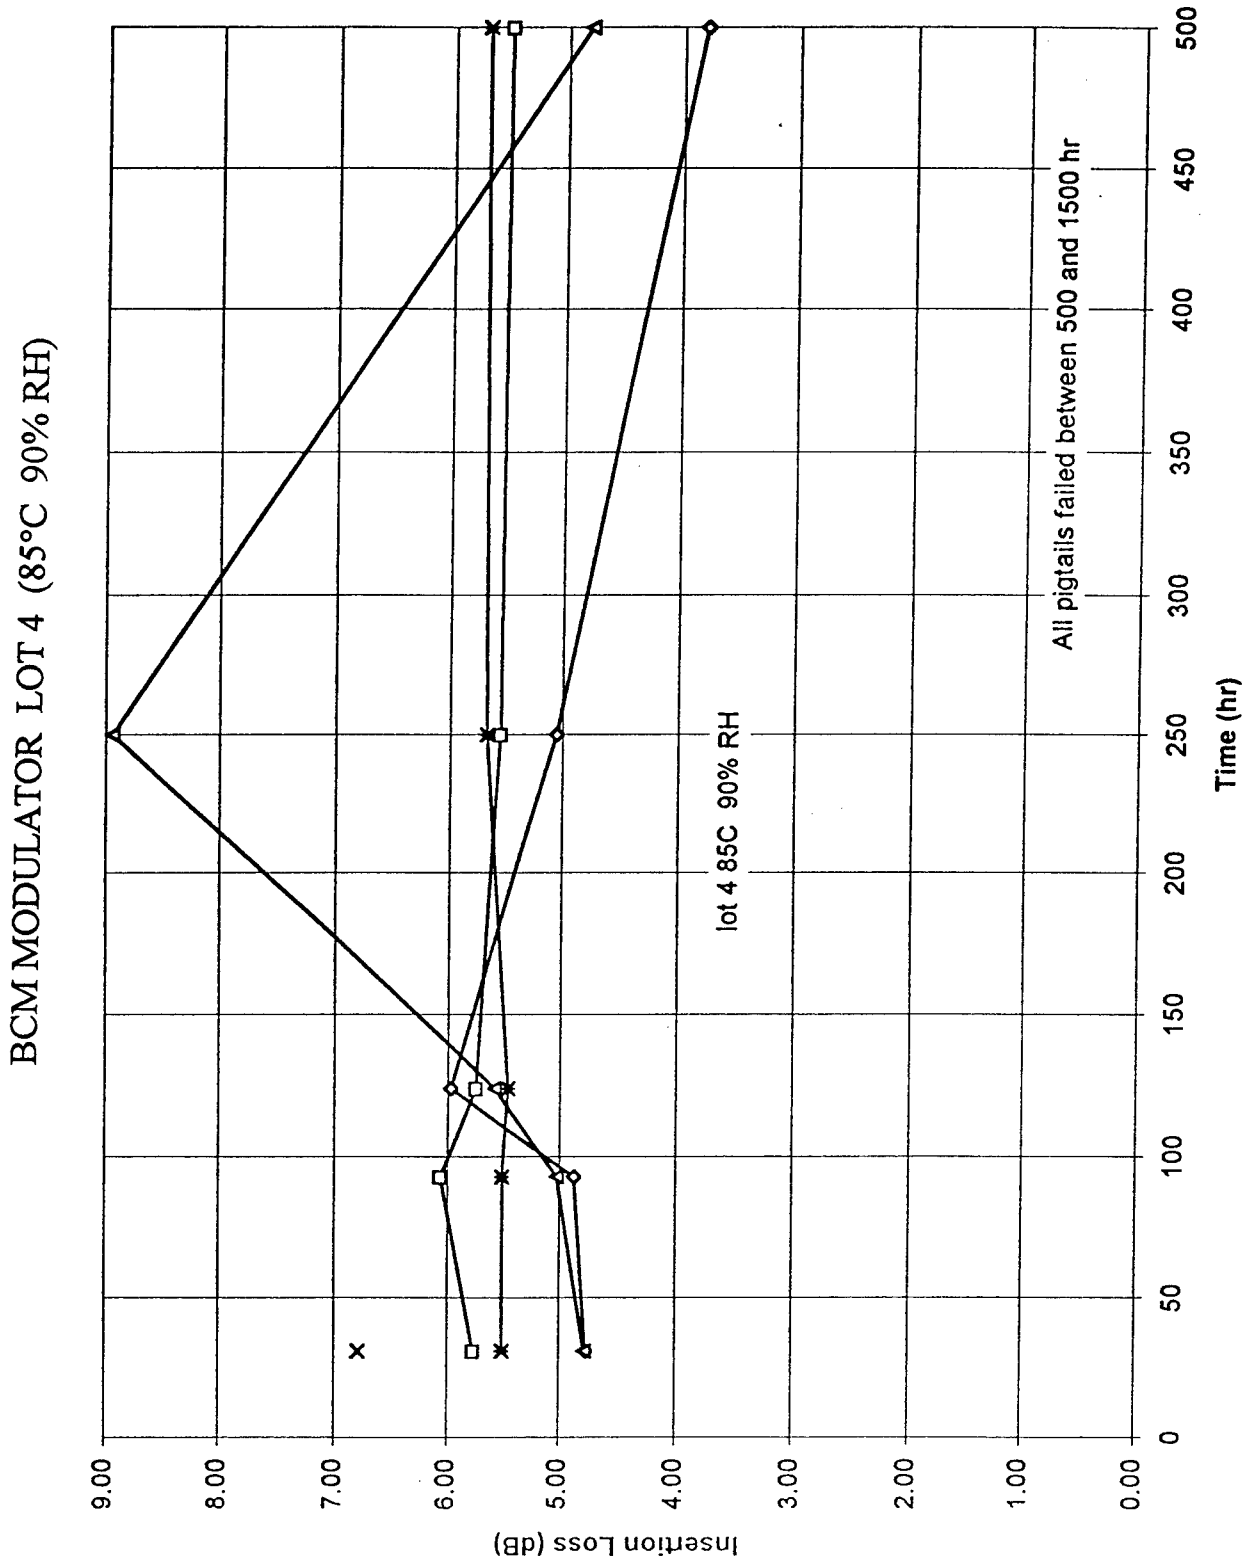
<u>Lot 4 (85°C / 90% RH):</u>
1) all failed between 500 and 1500 hr (does not pass light)

Note that the measured loss of one device in Lot 4 increased to 8.9 dB at 250 hr and then returned to 4.8 dB at 500 hr. The fluctuation was probably caused by the measurement error problem discussed earlier.

BCM MODULATOR LOT 4 (85°C 90% RH)
Insertion Loss (dB)
9.00
8.00
7.00
6.00
5.00
4.00
3.00
2.00
1.00
0.00
0
50
100
150
200
250
300
350
400
450
500
Time (hr)
lot 4 85C 90% RH
All pigtails failed between 500 and 1500 hr

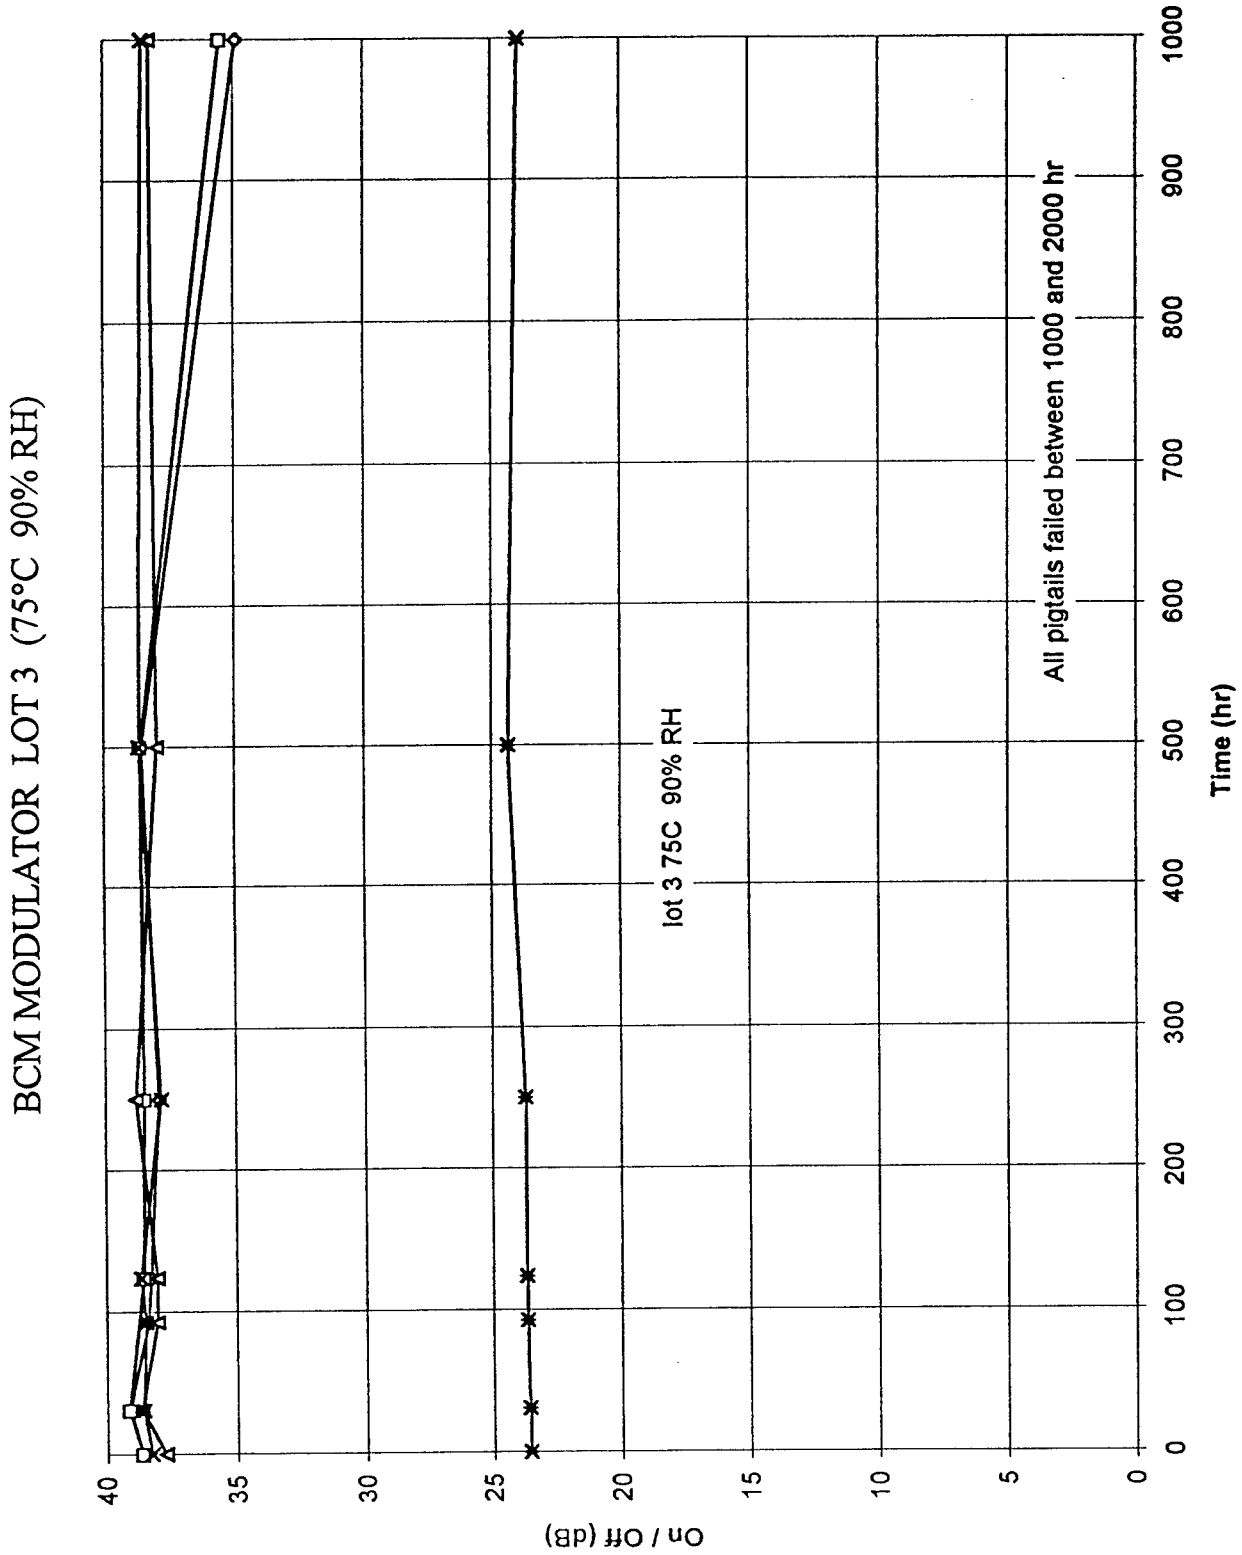
BCM MODULATOR LOT 3 (75°C 90% RH)
On / Off (dB)
40
35
30
25
20
15
10
5
0
0
100
200
300
400
500
600
700
800
900
1000
Time (hr)
lot 3 75C 90% RH
All pigtails failed between 1000 and 2000 hr

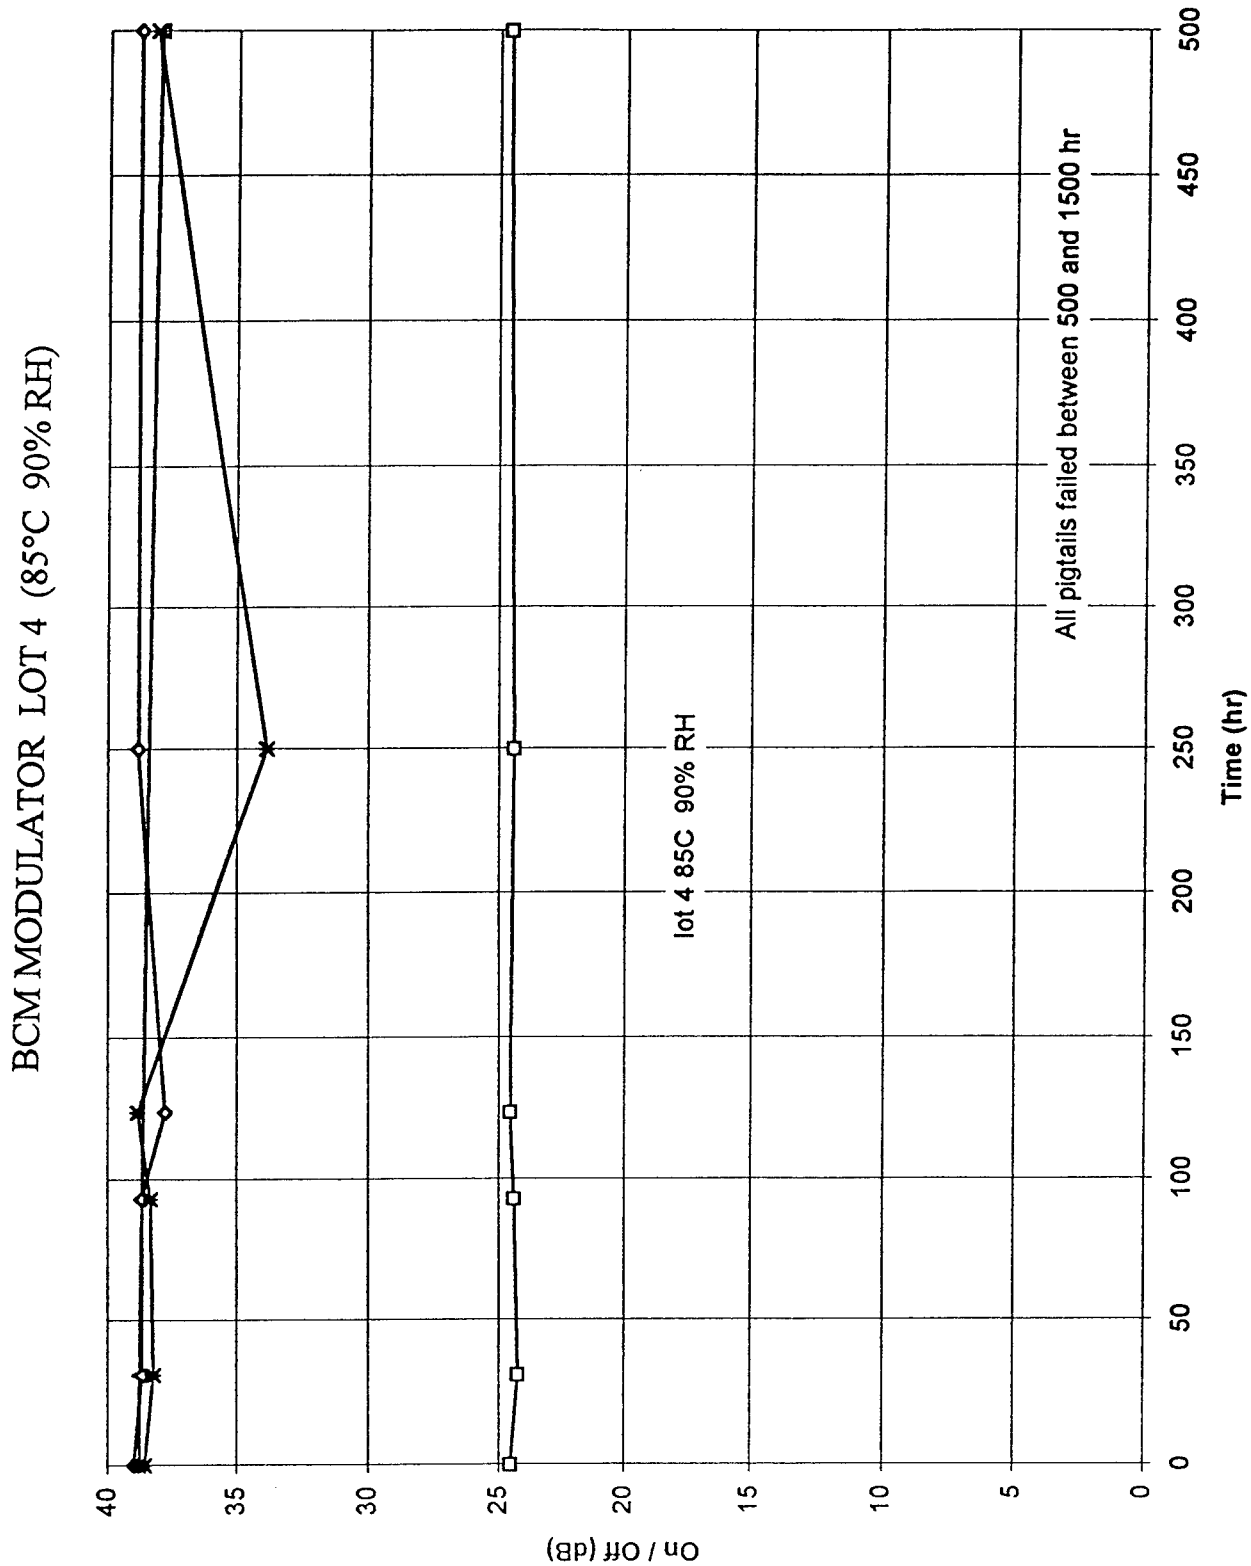
BCM MODULATOR LOT 4 (85°C 90% RH)
lot 4 85C 90% RH
All pigtails failed between 500 and 1500 hr
Time (hr)
On / Off (dB)
0
50
100
150
200
250
300
350
400
450
500
0
5
10
15
20
25
30
35
40

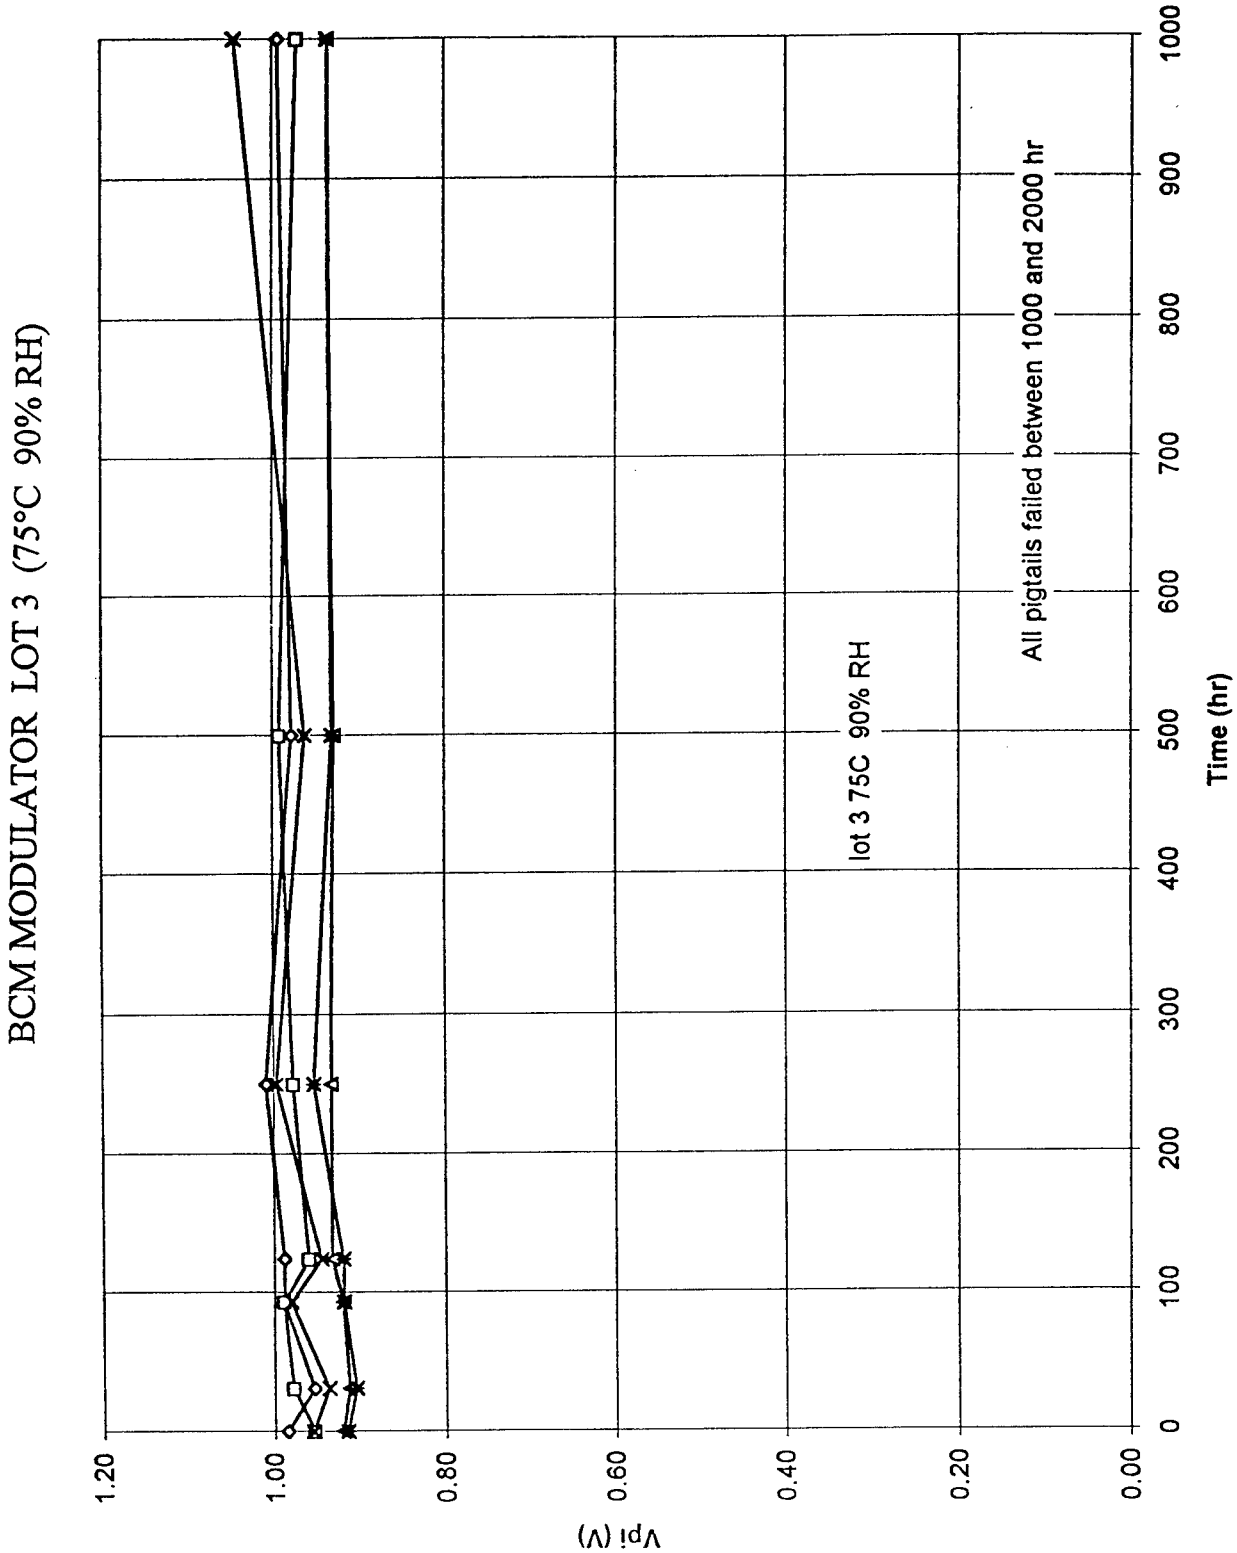
BCM MODULATOR LOT 3 (75°C 90% RH)
Vpi (V)
1.20
1.00
0.80
0.60
0.40
0.20
0.00
0
100
200
300
400
500
600
700
800
900
1000
Time (hr)
lot 3 75C 90% RH
All pigtails failed between 1000 and 2000 hr

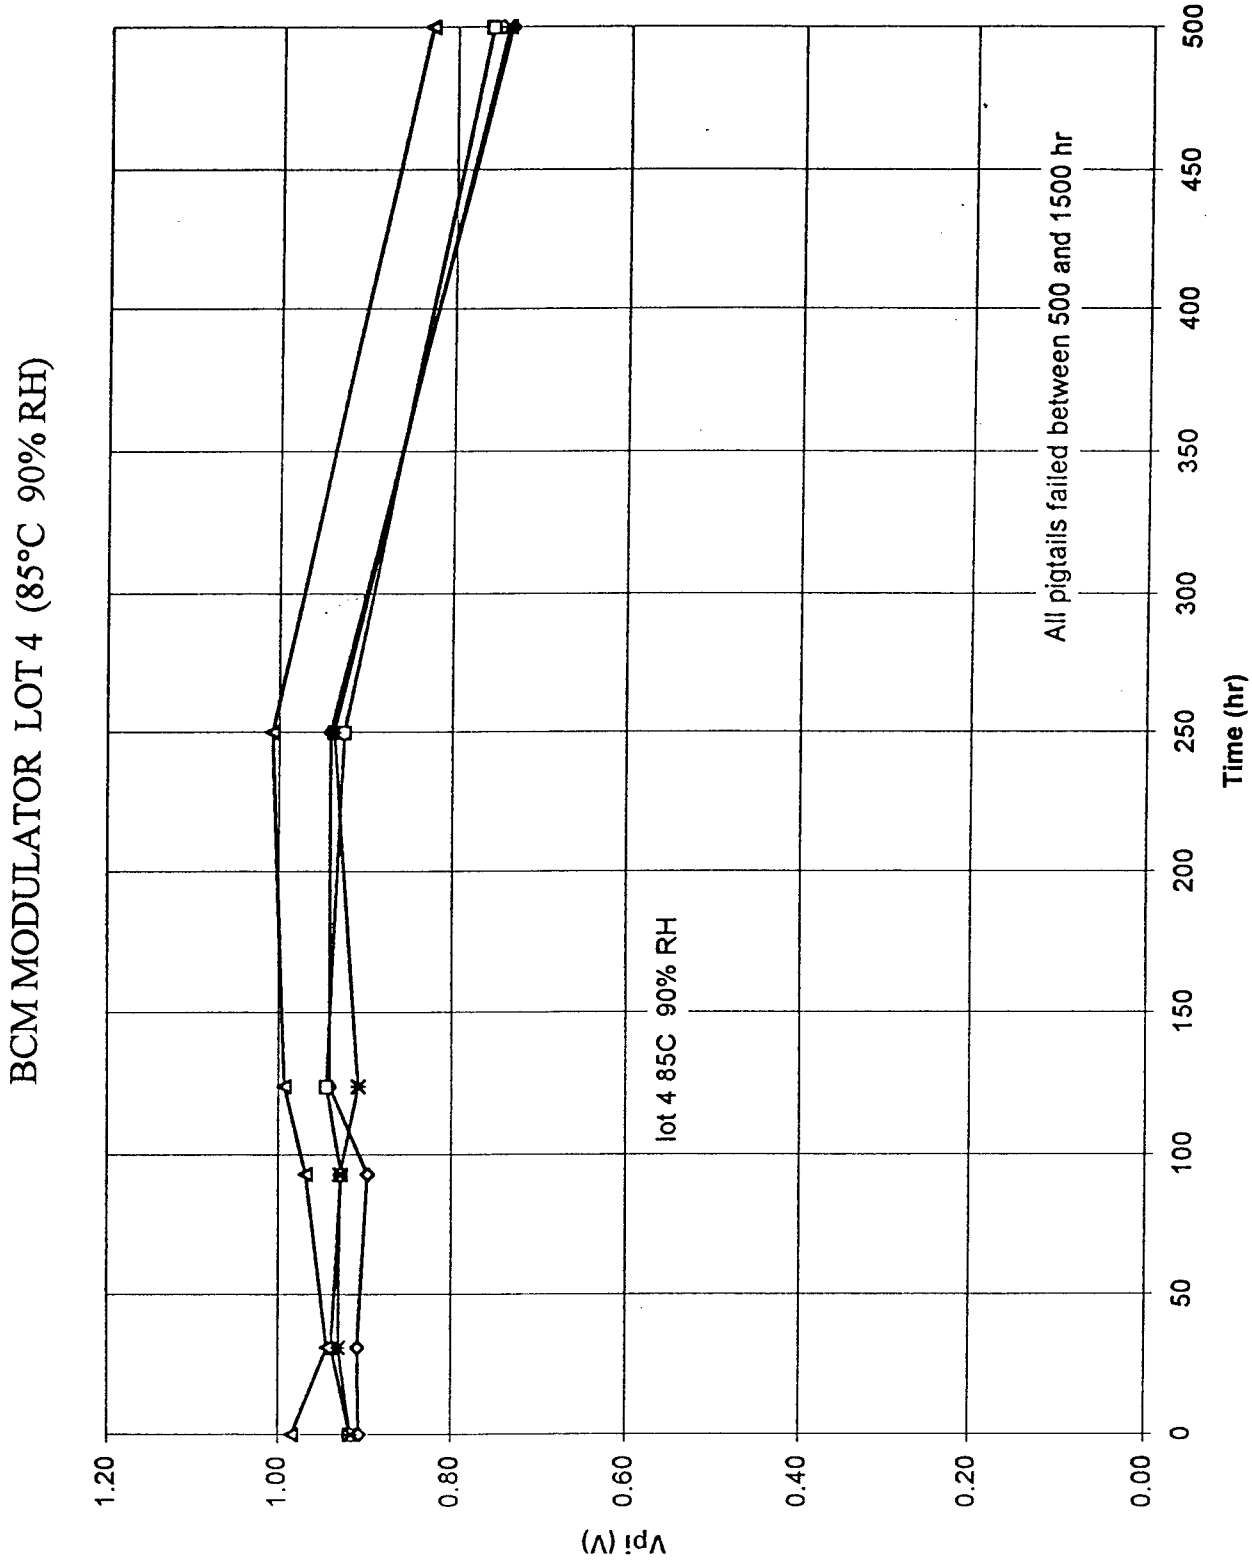
BCM MODULATOR LOT 4 (85°C 90% RH)
lot 4 85C 90% RH
All pigtails failed between 500 and 1500 hr
Vpi (V)
1.20
1.00
0.80
0.60
0.40
0.20
0.00
Time (hr)
0
50
100
150
200
250
300
350
400
450
500

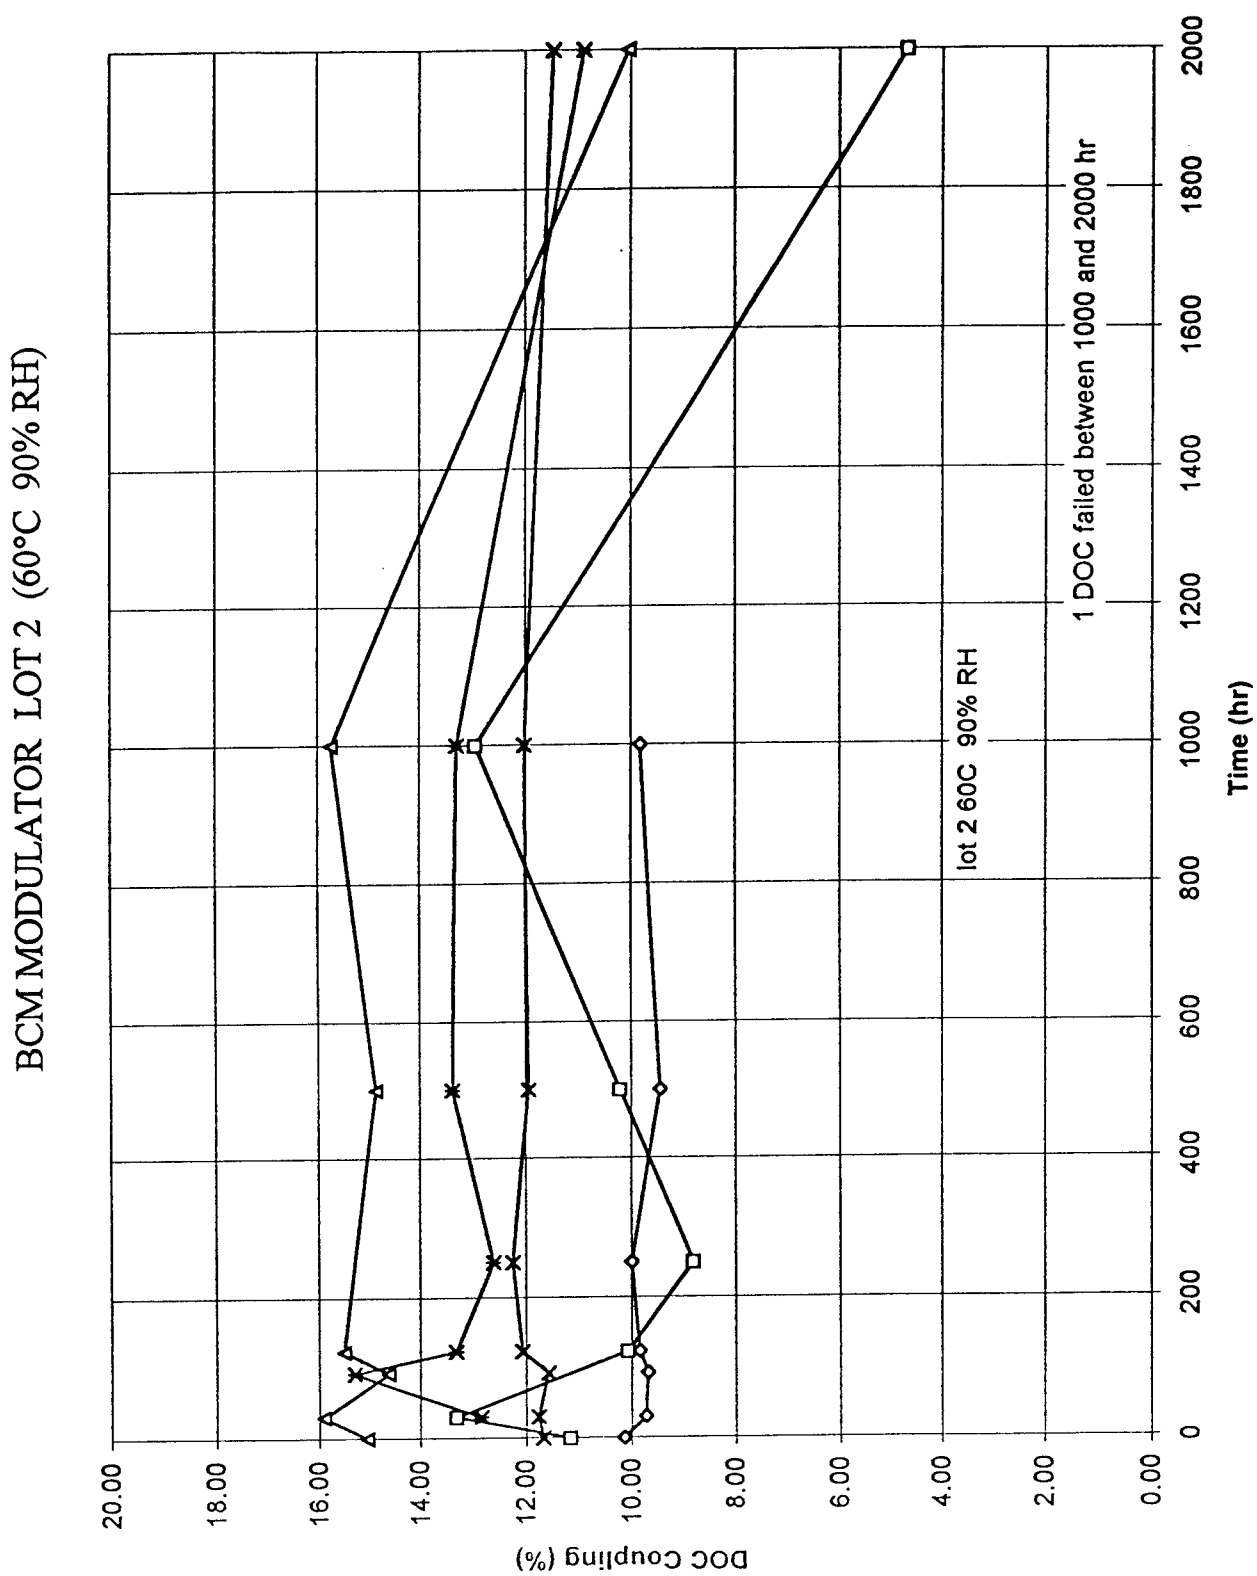
A second cause of the electrical degradation in BCM modulators was failure of the DOC on devices that were exposed to elevated temperature/humidity. On five devices, the voltage on the PD pin of the package became unusually high (> 1V), an indication that the DOC became shorted. Failure analysis of two devices confirmed the suspicion that the DOC itself was shorted, as opposed to the electronics surrounding the DOC. Further examination of the devices revealed degradation of the epoxies used to mount the DOC and the pigtail to the OEIC. These epoxies not only became soft and changed color from transparent to slightly brown, but became airborne and deposited themselves on the surface of the OEIC and the wire bonds. It is possible that the airborne material contaminated the DOC causing a short. Hydrolysis of the epoxy may have also created harmful chemical by-products which leached out and attacked the DOC. Once the DOC's performance was degraded, the bias control loop either functioned poorly or not at all.

Lot 2 (60°C / 90% RH):
1) 1 failure between 1000 and 2000 hr

BCM MODULATOR LOT 2 (60°C 90% RH)
DOC Coupling (%)
20.00
18.00
16.00
14.00
12.00
10.00
8.00
6.00
4.00
2.00
0.00
0
200
400
600
800
1000
1200
1400
1600
1800
2000
Time (hr)
lot 2 60C 90% RH
1 DOC failed between 1000 and 2000 hr

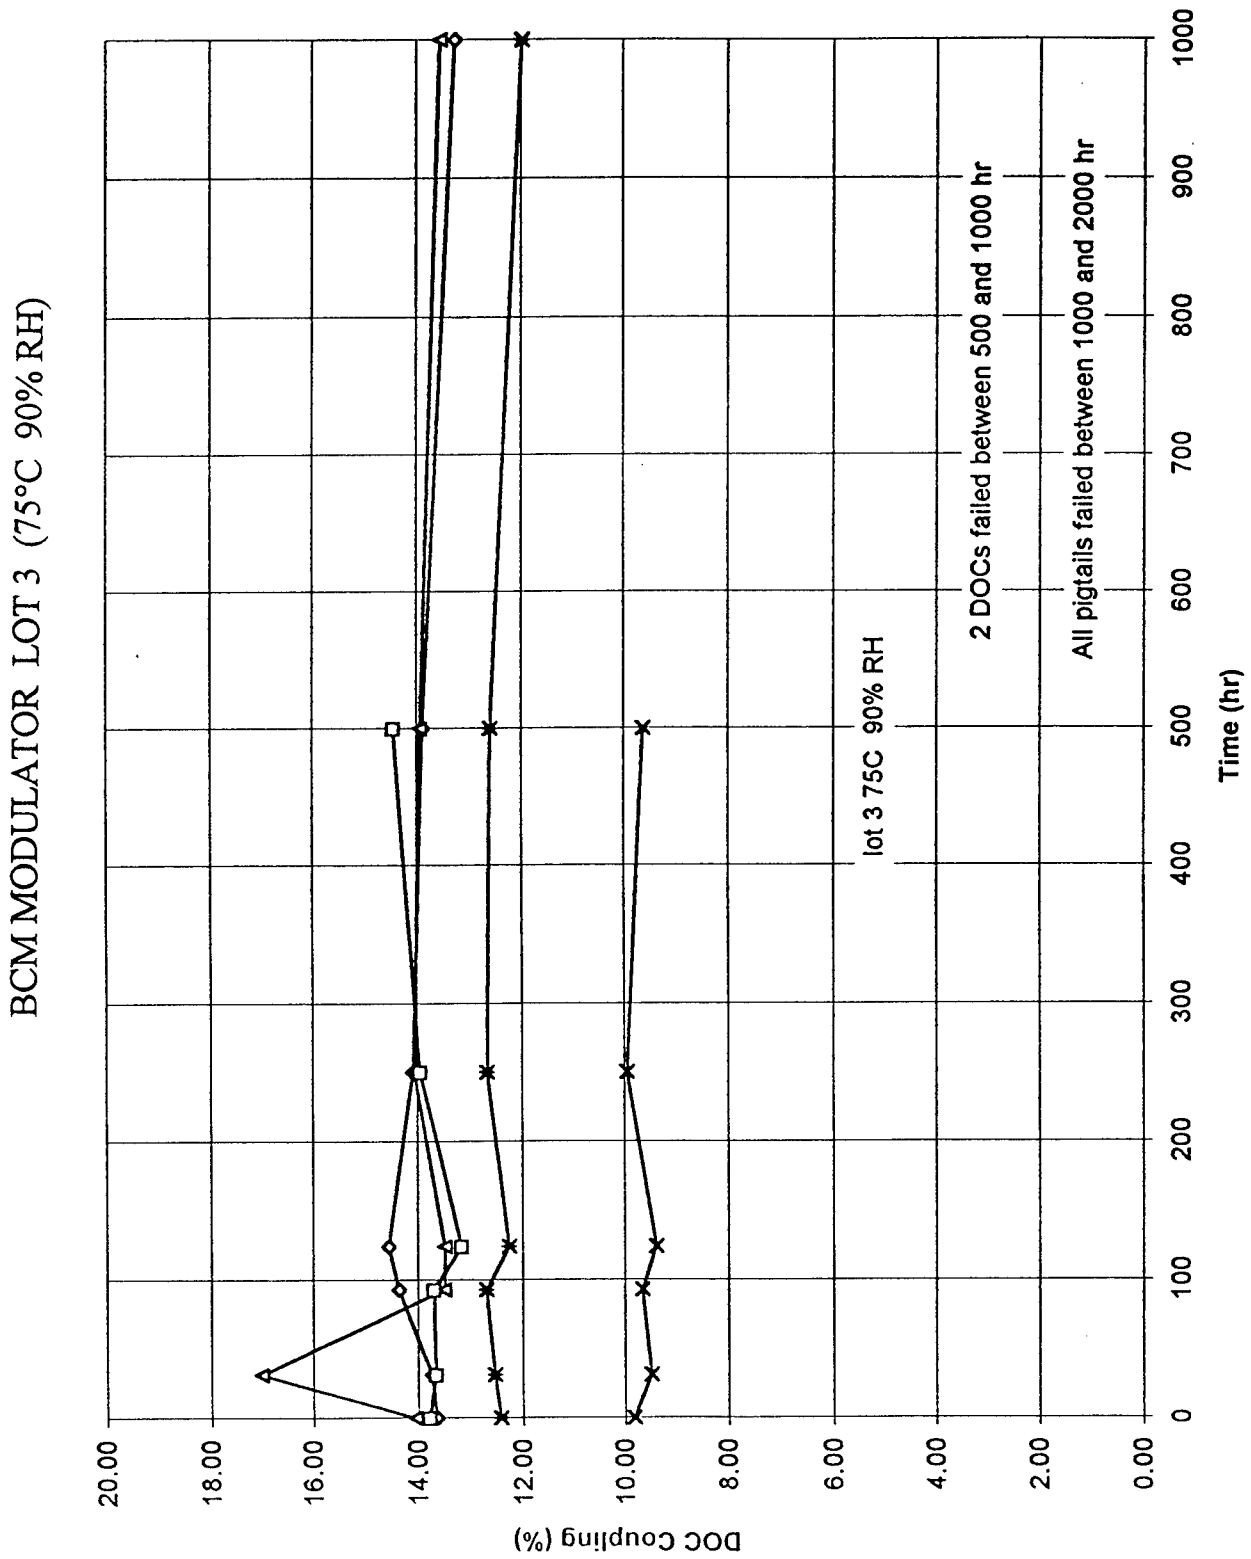
Lot 3 (75°C / 90% RH):
1) 2 failures between 500 and 1000 hr

BCM MODULATOR LOT 3 (75°C 90% RH)
DOC Coupling (%)
20.00
18.00
16.00
14.00
12.00
10.00
8.00
6.00
4.00
2.00
0.00
0
100
200
300
400
500
600
700
800
900
1000
Time (hr)
lot 3 75C 90% RH
2 DOCs failed between 500 and 1000 hr
All pigtails failed between 1000 and 2000 hr

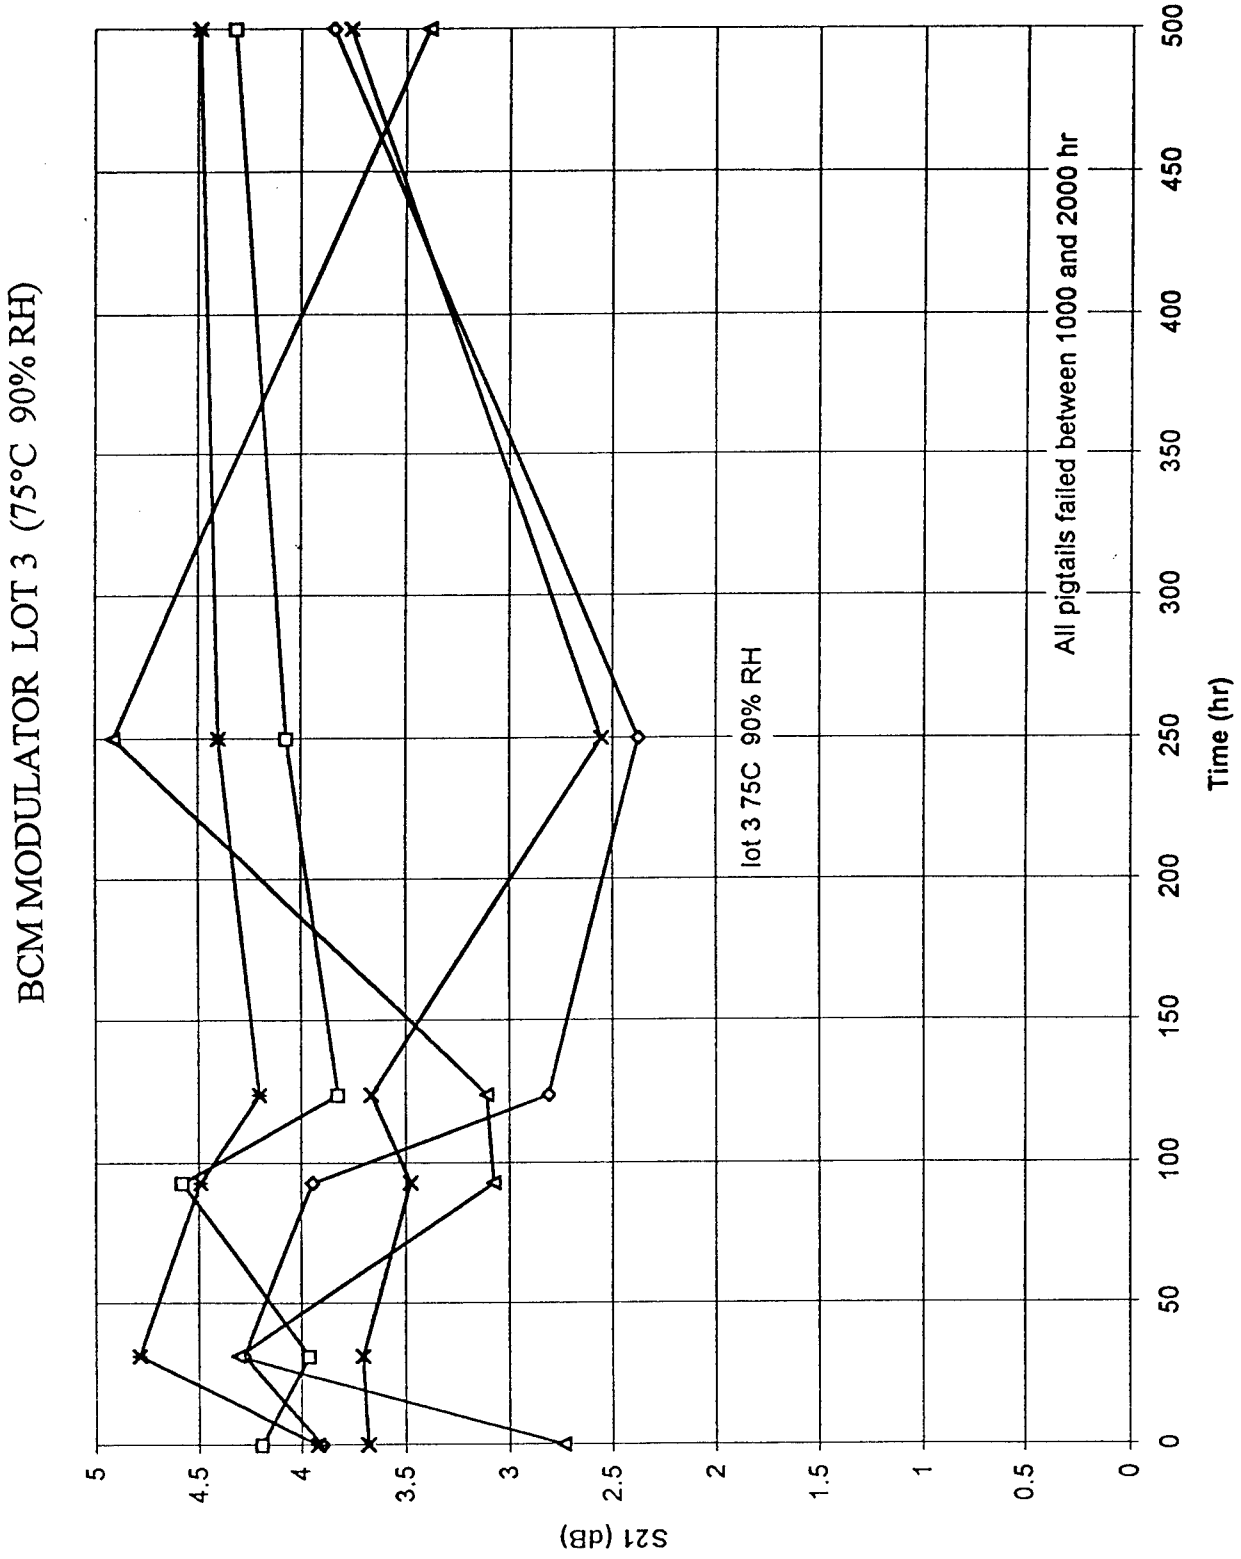
BCM MODULATOR LOT 3 (75°C 90% RH)
S21 (dB)
5
4.5
4
3.5
3
2.5
2
1.5
1
0.5
0
0
50
100
150
200
250
300
350
400
450
500
Time (hr)
lot 3 75C 90% RH
All pigtails failed between 1000 and 2000 hr
