RL-TR-96-98
Final Technical Report
July 1996

RELIABILITY ASSESSMENT OF OPTO-ELECTRONIC INTEGRATED CIRCUITS

Uniphase Telecommunications Products

Karl M. Kissa and Hogan Eng

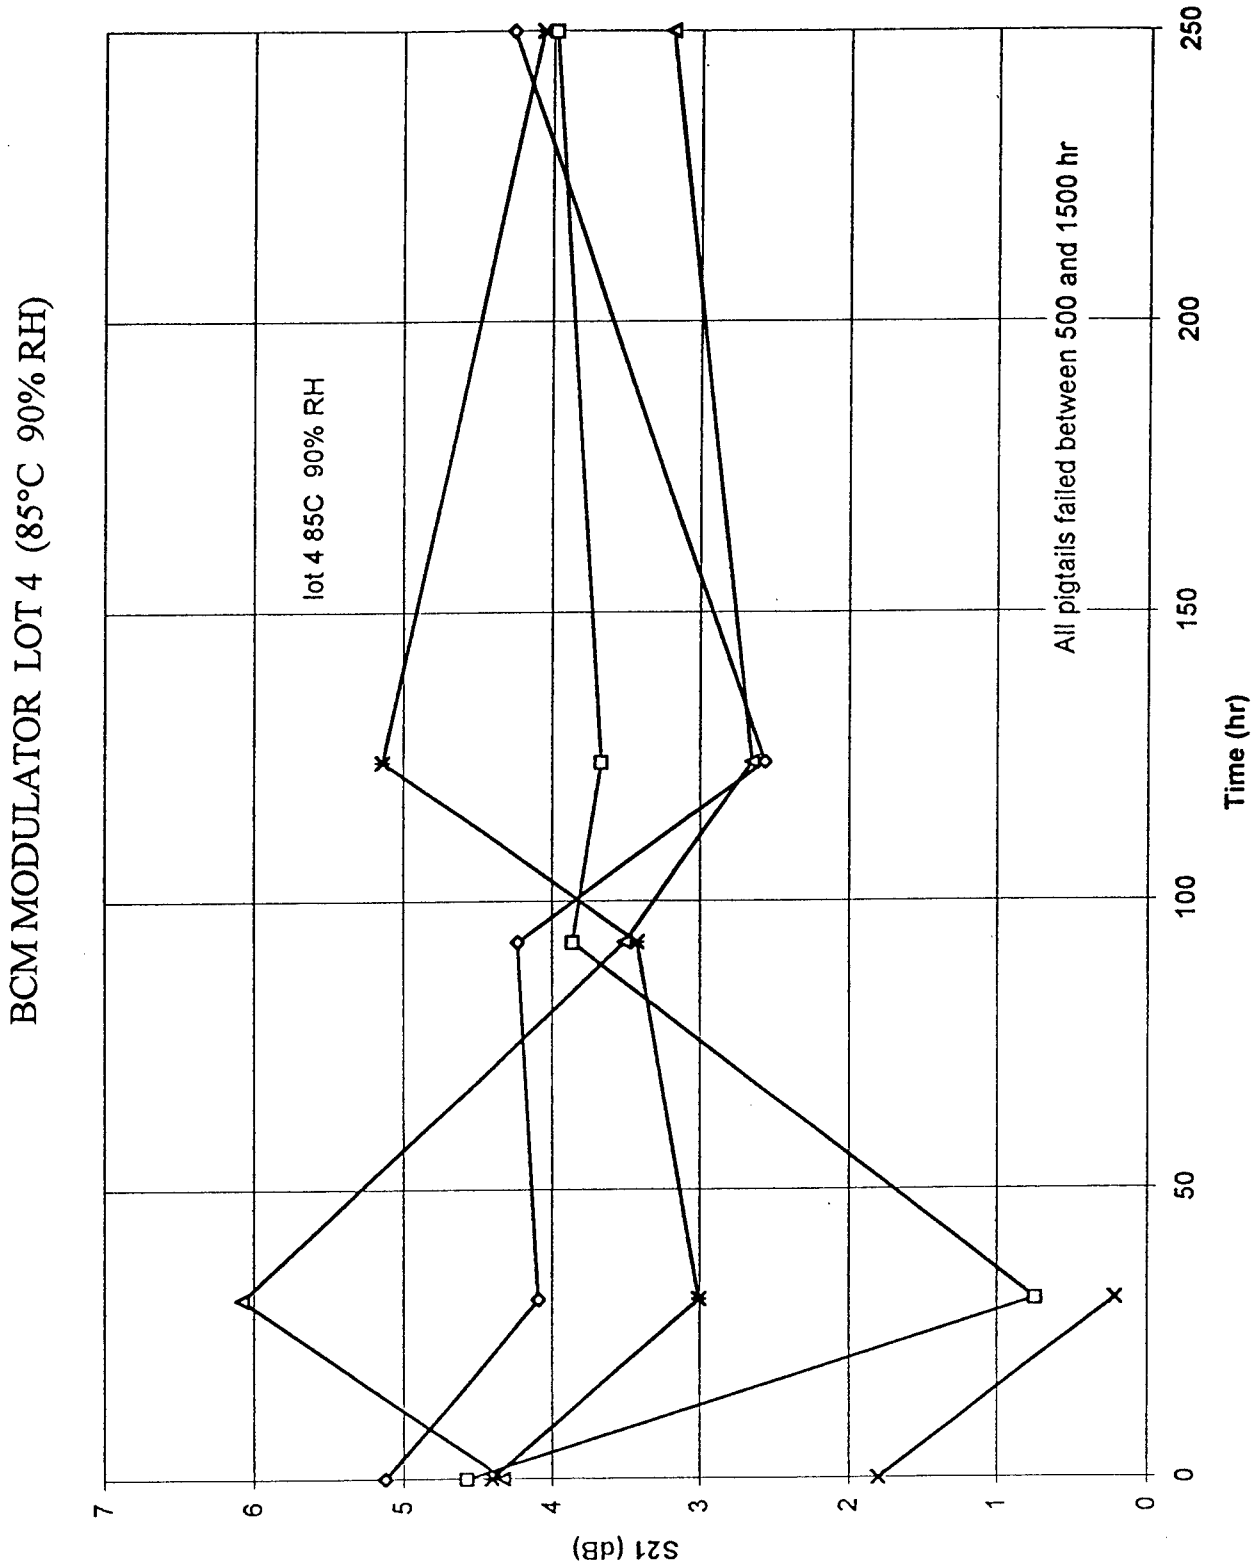
BCM MODULATOR LOT 4 (85°C 90% RH)
lot 4 85C 90% RH
All pigtails failed between 500 and 1500 hr
S21 (dB)
Time (hr)
0
1
2
3
4
5
6
7
0
50
100
150
200
250
