FINAL REPORT

TWO-AXIS ANGULAR RATE AND ACCELERATION MULTISENSOR TEST

CENTRAL INERTIAL GUIDANCE TEST FACILITY

AUGUST 1975

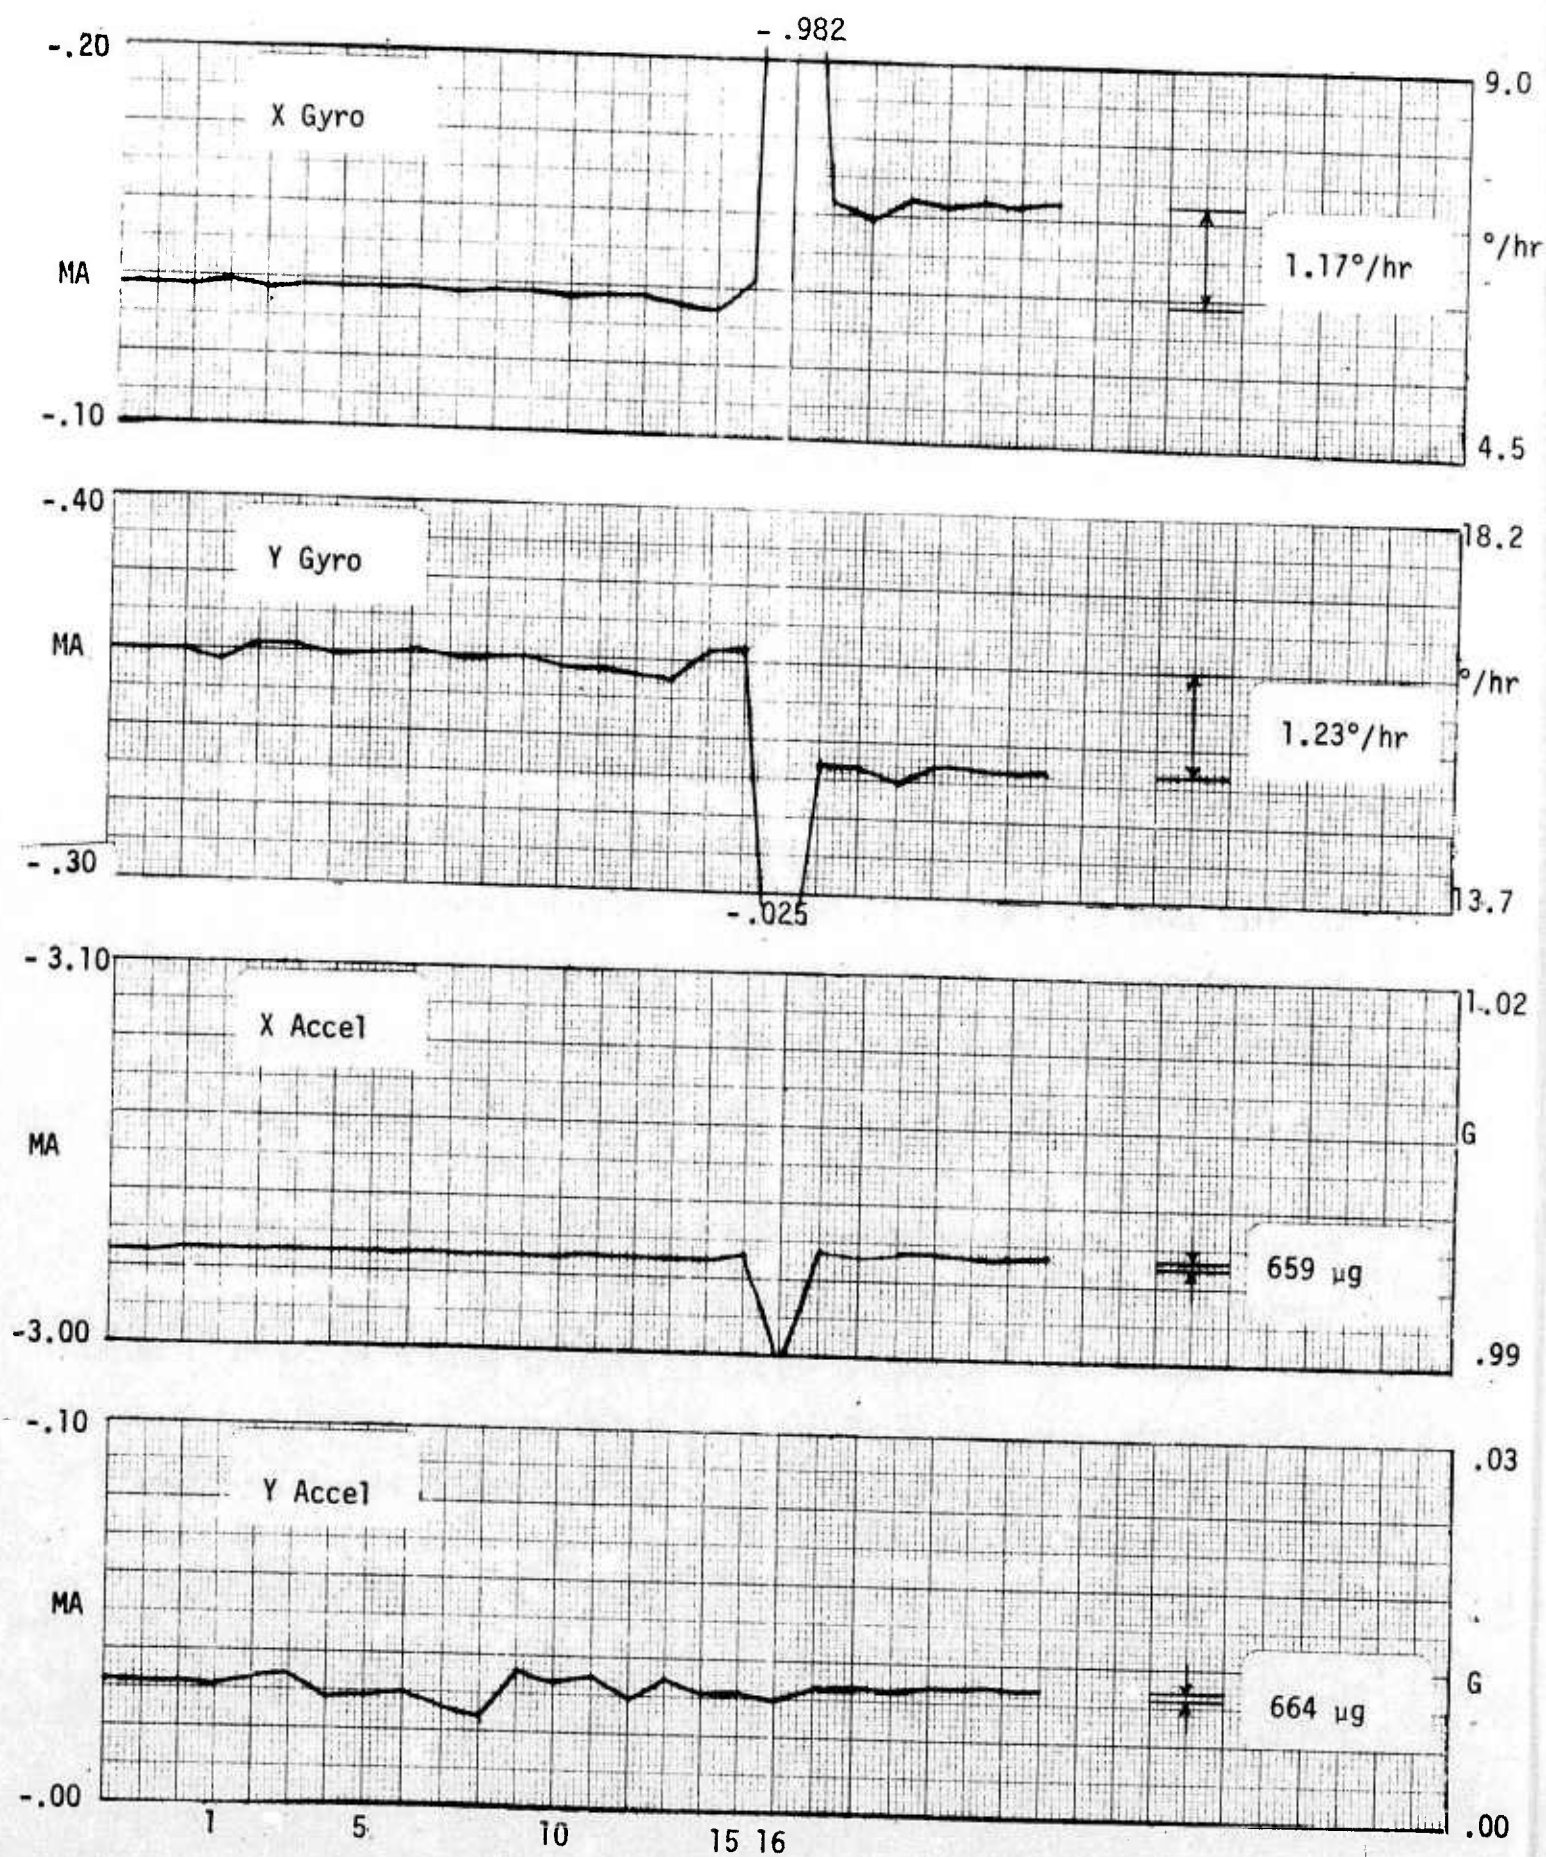
Figure B-1.   Torquer Outputs - Vibration #1

Vibration started during the integration time for point 1 of Figure B-1 and the shut-down occurred during the integration time for point 16. Table B-I gives the relationship between data point number, elapsed time and the approximate frequency of vibration at that time.

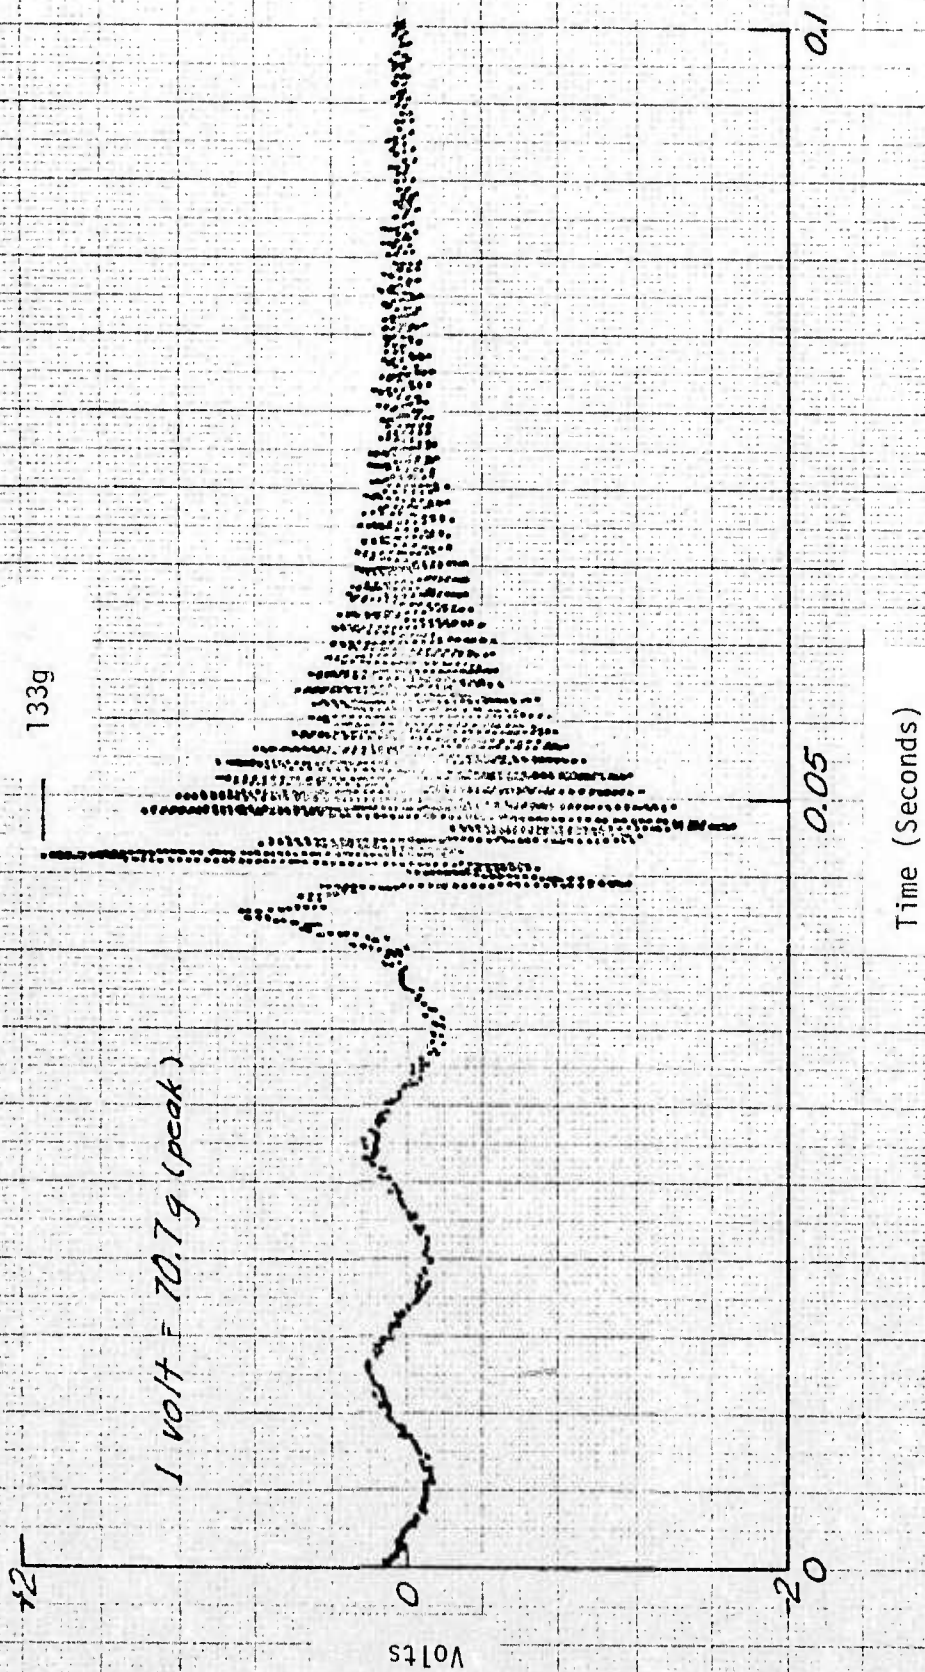
Figure B-2 shows the output of the acceleration monitor on the vibrator during the shut-down. Prior to the halt, the vibrator was operating at 9 g's and 68 Hz. The peak acceleration seen by the instrument during the halt was

133 g's after which the vibrator oscillated to a stop at its resonant frequency of 1025 Hz.

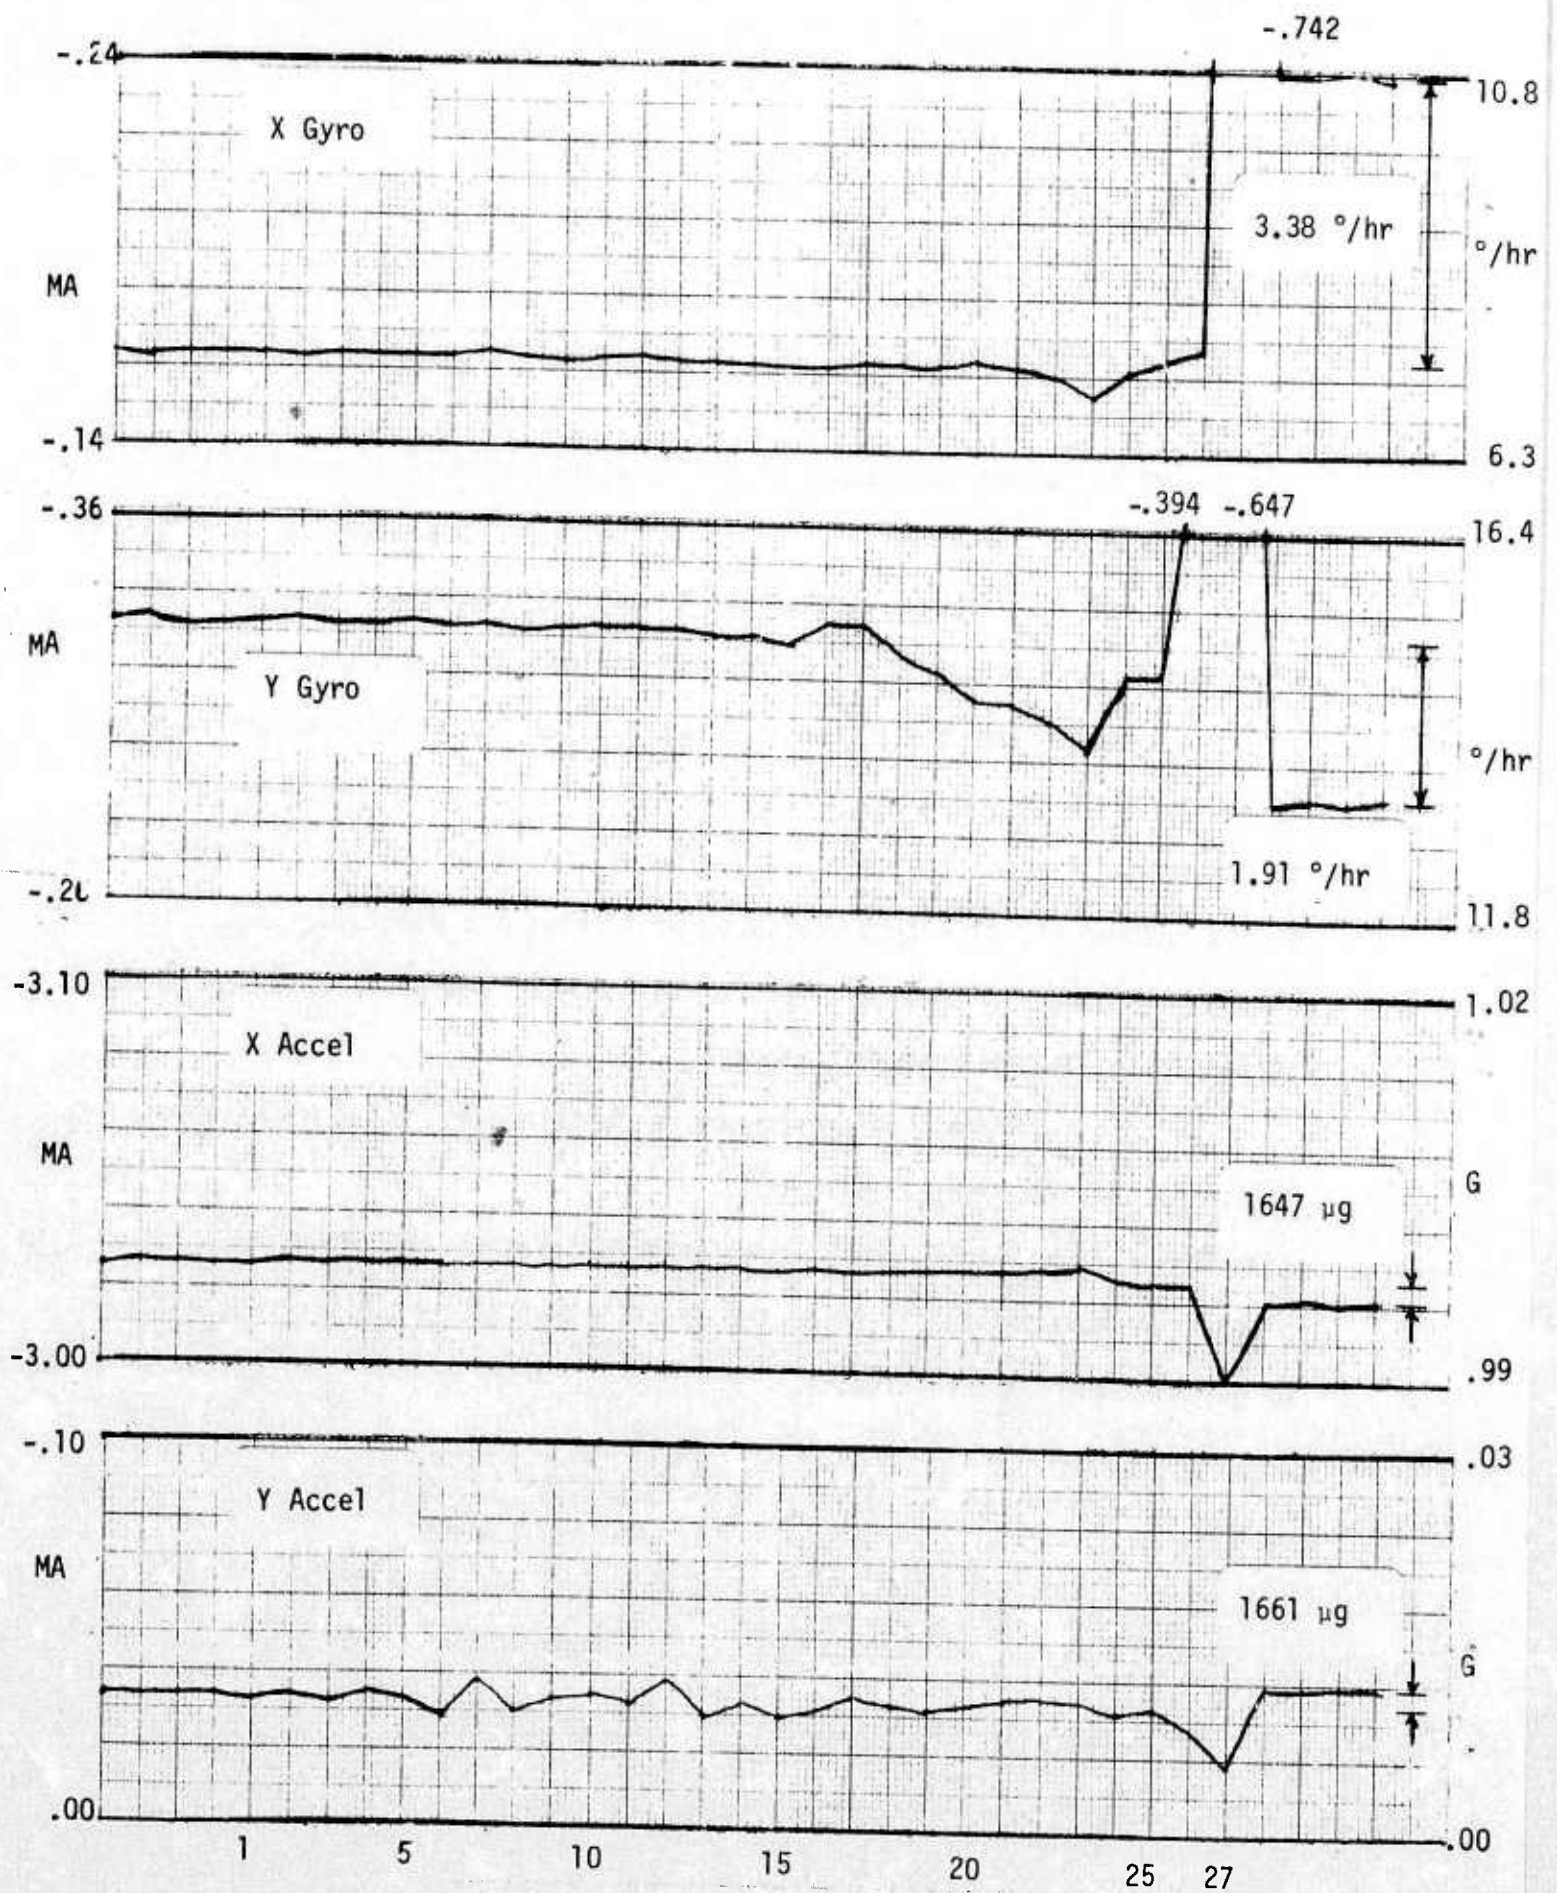
Figure B-3. Torquer Outputs - Vibration #2

The torquer data taken during the second vibrator shut-down is shown in Figure B-3. The relationships of Table B-I hold for this plot also.

The test results indicated conclusively that the instrument's rotor hinges were damaged and dictated the cancellation of the program due to lack of an instrument for testing.
