DMIC Technical Note  
June, 1964

FIRE HAZARDS ASSOCIATED WITH THE USE OF  
TITANIUM IN AIRCRAFT

DEFENSE METALS INFORMATION CENTER  
BATTELLE MEMORIAL INSTITUTE  
COLUMBUS, OHIO

D. J. Maykuth and R. H. Ernst

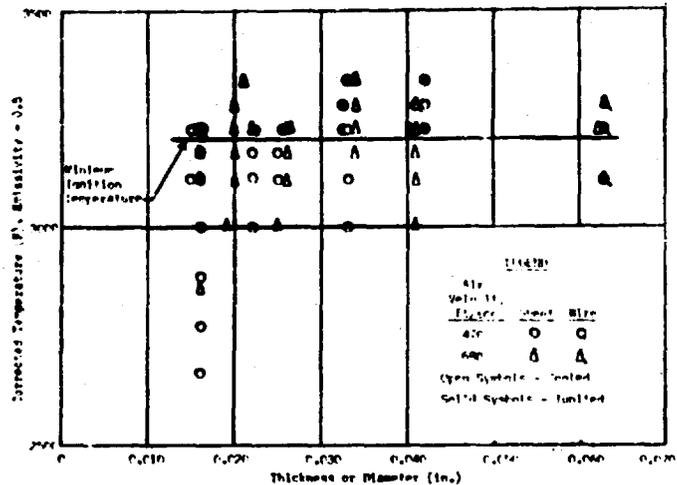
FIGURE 1. IGNITION BEHAVIOR OF TITANIUM AS A FUNCTION OF THICKNESS AND AIR VELOCITY(6)

Similar results were obtained in early tests at Douglas,(6) using self-resistance heating methods for

five thicknesses of sheet (0.016-, 0.020-, 0.025-, 0.032-, and 0.040-inch) and one diameter of wire (0.0625 inch), all of commercially pure titanium. In this case, after reaching the desired temperature, the materials were subjected to an air or oxygen blast from a 3/16-inch-diameter jet situated perpendicular to the surface of the specimen at a distance of 1/2 inch. The ignition behavior of these materials as a function of thickness and air velocity is summarized in Figure 1. No difference in ignition temperatures was found when oxygen was substituted for air in the impinging jet. It was concluded that "the spontaneous ignition temperature of commercially pure titanium sheet and wire in an air or oxygen stream at 470 and 680 ft/sec... (was) in excess of 3000 F."
