USAAMRDL TECHNICAL REPORT 72-12

DESIGN STUDY OF REPAIRABLE MAIN ROTOR BLADES

Paul F. Maloney
Carrol R. Akeley

July 1972

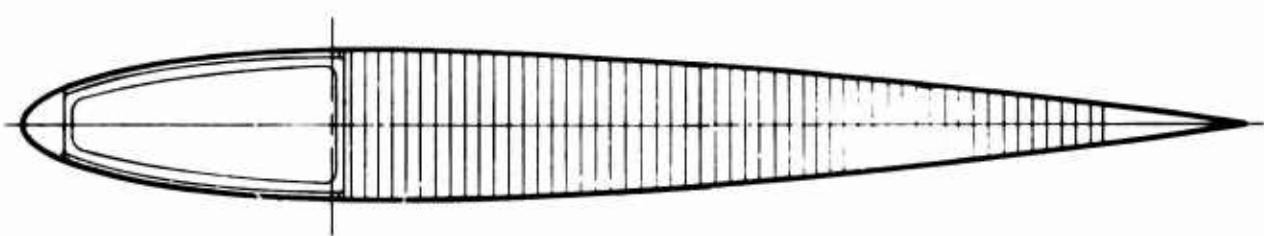
DESIGN CONSIDERATIONS

1. MINIMUM CHANGE FROM CURRENT UH-1 BLADE.
2. FIBERGLASS SKINS PROVIDE SIGNIFICANT INCREASE IN REPAIRABILITY.
3. MINIMUM RESUBSTANTIATION REQUIRED.
4. UTILIZES EXISTING RETENTION.
5. SEGMENTED STEEL LEADING-EDGE SHEATH.
6. FIBERGLASS SPAR DOUBLER OUTBOARD.

Figure 7. Configuration I, Repairable Rotor Blade Using UH-1 Structural Components.

SECTION A

SECTION B

This design, illustrated in Figure 7, makes maximum use of existing UH-1 blade structural components and yet provides a significant advance in repairability. The basic spar, trailing-edge spline, root end doublers, and leading-edge ballast are common to the current blade, while the skins, spar doubler, and leading-edge sheath are modified designs. Outboard of station 152, the skin consists of two layers of unidirectional glass fiber with a ± 45 -degree orientation with an inner and outer ply of 120 fiberglass cloth also with a 45-degree orientation. Inboard of this station, this skin is doubled in thickness; and again at the blade root, additional doubling plies are added. For inboard portions of the blade, the shear strength and stiffness exceed that of the current aluminum skin; while outboard, where the loads and the influence on natural frequencies are reduced, the skin properties are less than the current aluminum skin.

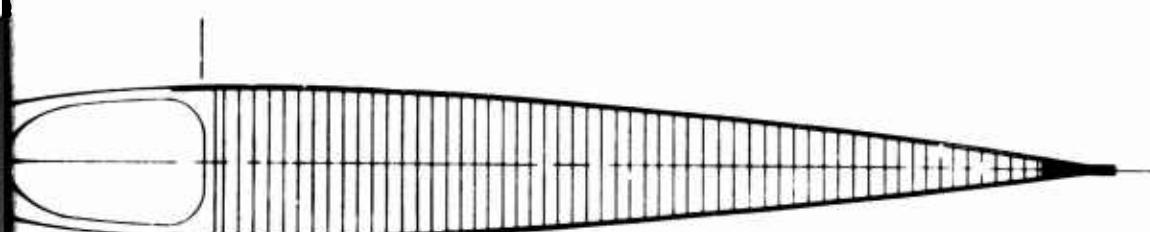
DESIGN CONSIDERATIONS

1. HEAVY-WALL ALUMINUM SPAR FOR EASY BLENDING OF DAMAGE.
2. INTEGRAL ROOT END STRUCTURE , STEP EXTRUSION.
3. GLASS FIBER SKINS AND TRAILING EDGE.

FABRICATION

1. SPAR MACHINED FROM STEP EXTRUSION TO MINIMIZE MACHINING AND MATERIAL WASTE .
2. BONDING OF AFT STRUCTURE SIMILAR TO CURRENT BLADE, NO MAJOR DOUBLER BUILDUP REQUIRED.

REPAIRABILITY

1. LEADING EDGE READILY BLENDED TO REMOVE DAMAGE .
2. GLASS FIBER AFT STRUCTURE READILY REPAIRED WITH PROPERLY DESIGNED KIT.

Figure 9. Configuration III, Repairable Rotor Blade Using Heavy Wall Aluminum Spar.

SECTION AT ROOT END

OUTBOARD SECTION

This design, based on a heavy-wall, stepped-extrusion main spar, is illustrated in Figure 9. The intent of this configuration is to supply a rugged spar which can withstand damage from external sources and continue in operation with only minor blendings, as is done with many propeller blades. No separate erosion protection is normally required; however, for a severe erosion environment, special protection may be provided for the tip area. The stepped extrusion reduces the possibility for inherent damage by making the buildup at the main retention pin an integral part of the spar.

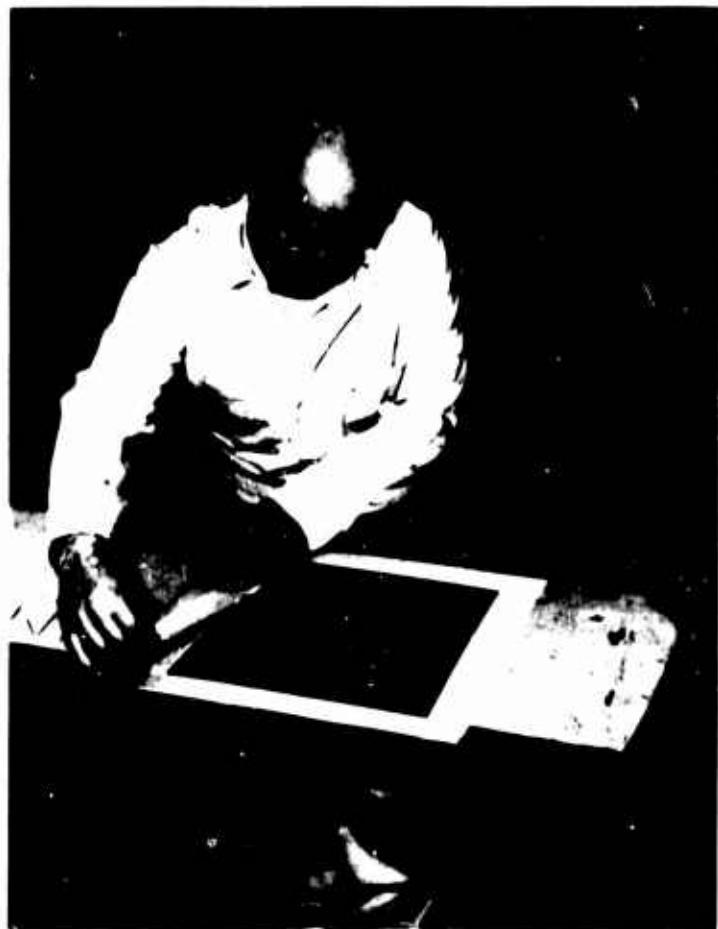
1. Position template to encompass complete damage area.
2. Use knife to sever skins and cut through core, top and bottom. Remove plug and even edges with hacksaw blade.
3. After cutting the hole to proper size, solvent wipe around periphery with MEK to remove all paint from surfaces to be bonded.
4. Mask off area approximately 1/8 inch beyond perimeter of patch, both surfaces (Figure 30).

Figure 30. Masking Blade Repair Area.

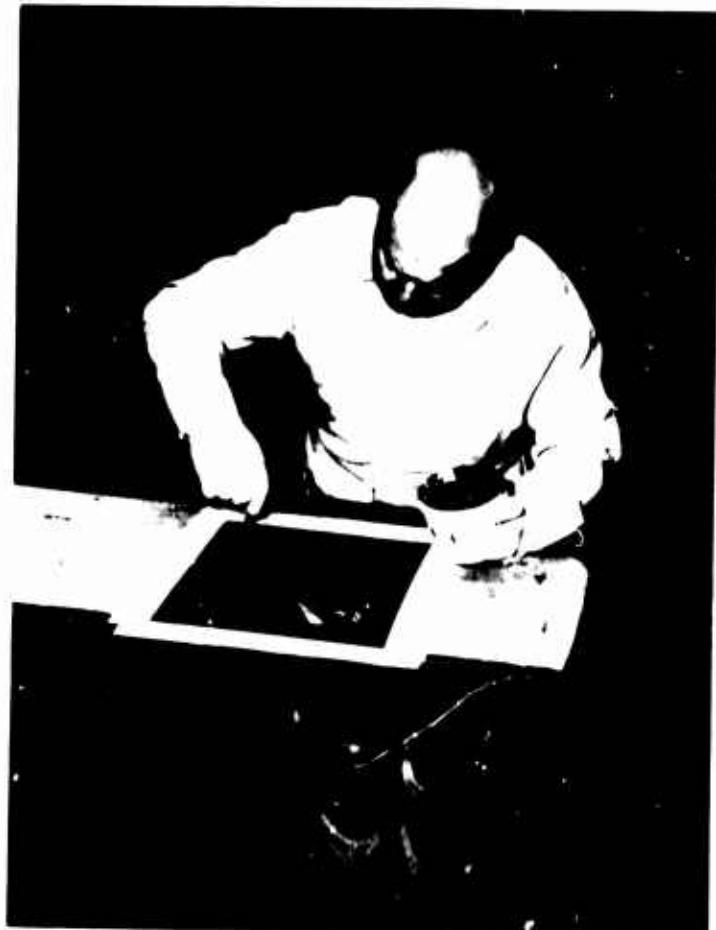
5. Lightly abrade bonding surfaces on both sides with #240 emery paper to remove gloss from skins but not to cut through the fibers of the fabric.
6. Solvent wipe abraded surfaces with MEK and clean cheesecloth. Wipe dry before solvent evaporates.
7. Mix 255 grams of EC 2216 paste epoxy adhesive.
8. Apply EC 2216 to exposed core edges, 4 sides, using the spatula and on the bonding surface around the hole using the finely serrated adhesive spreader (Figure 31).

Figure 31. Spreading Adhesive.

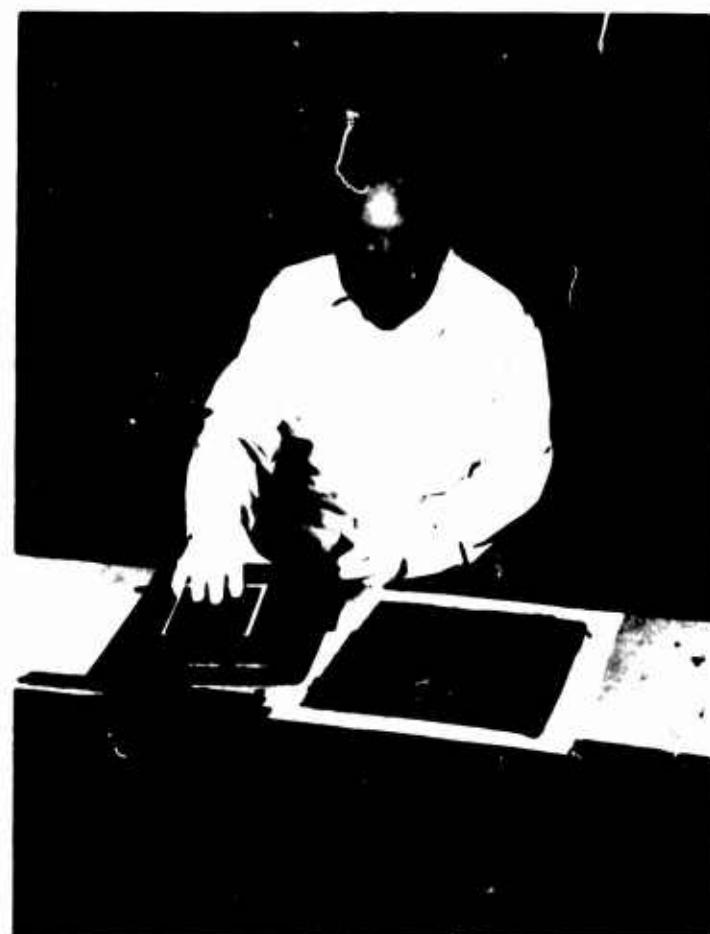
9. Remove protective peel ply from the flange of the insert (Figure 32).

Figure 32. Removing Peel Ply From Insert.

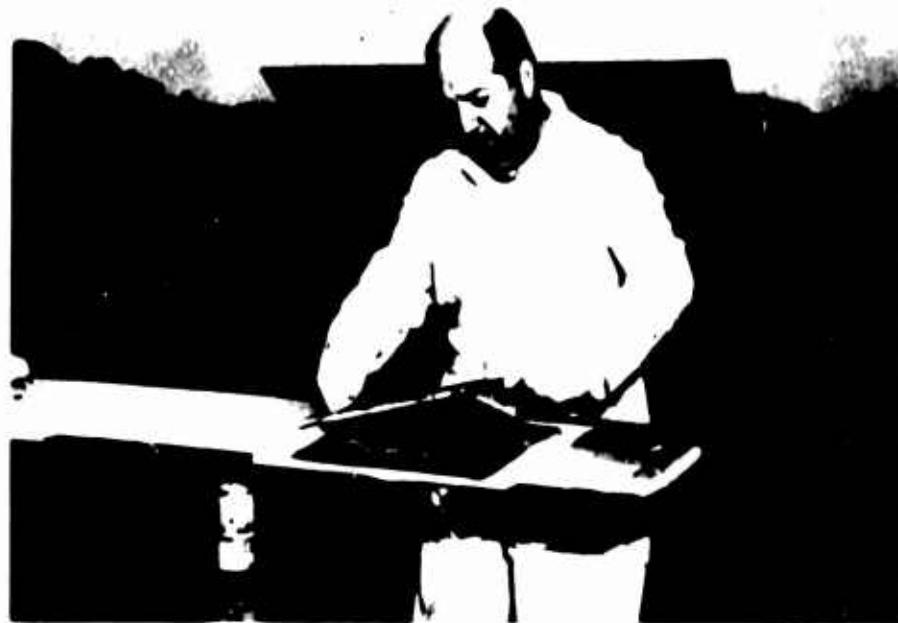
11. Position repair section into hole in blade and tape in place with 2-inch-wide green Mylar tape, straddling the joint edge along 4 sides (Figure 33).

Figure 33. Inserting Repair Section.

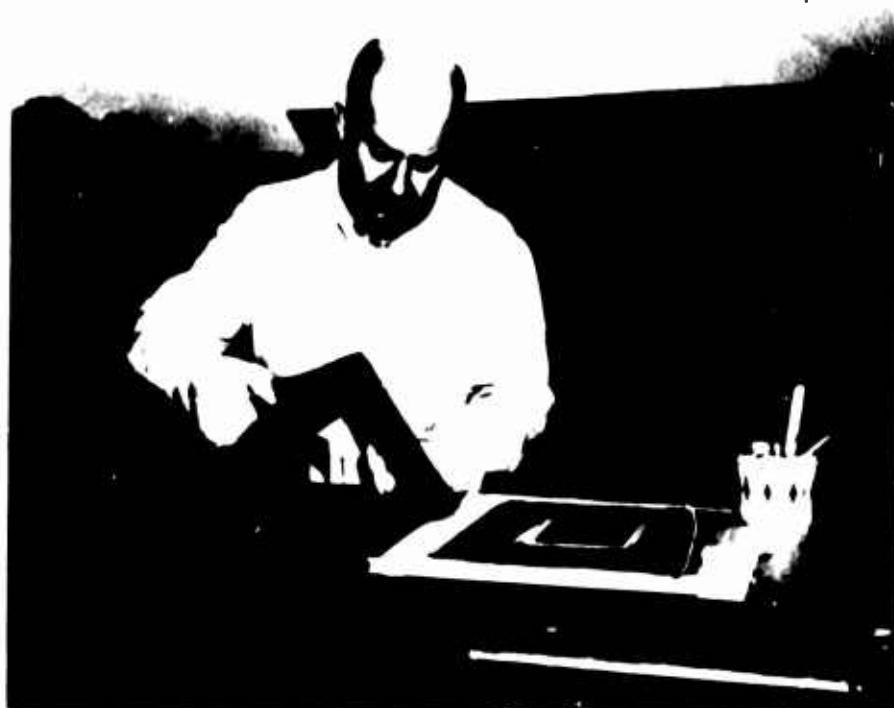
14. Remove the protective peel ply from the bonding surface of the picture frame doubler and spread adhesive with the serrated spreader (Figure 34).

Figure 34. Removing Peel Ply From Doubler.

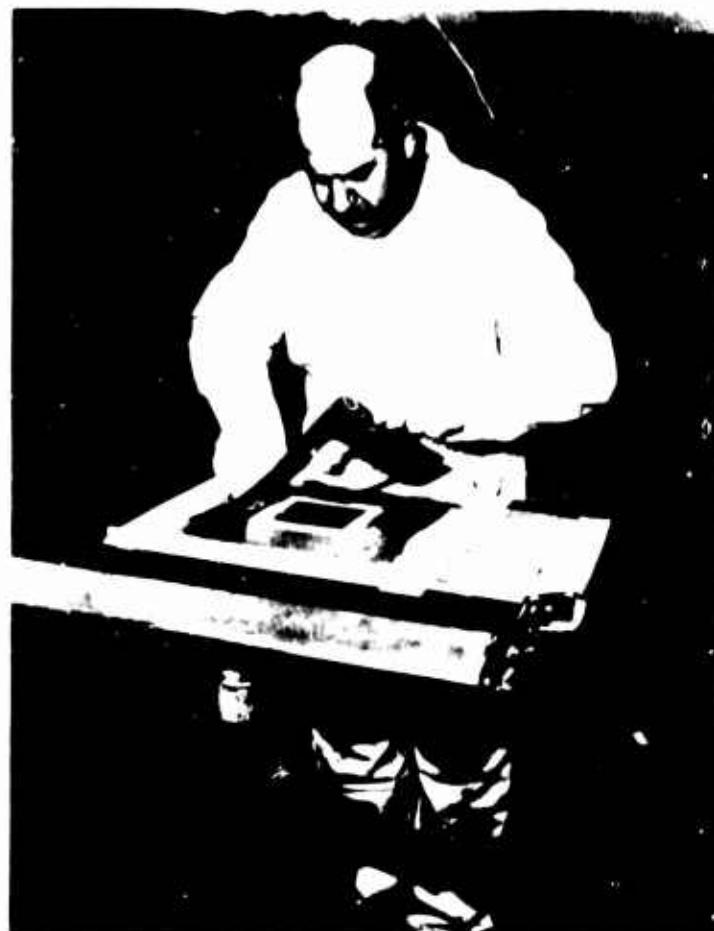
15. Position the doubler over the core plug joint and tape in place by 2-inch-wide green Mylar tape straddling the joint on all edges (Figure 35).

Figure 35. Positioning Doubler.
