REVIEW OF SOILS DESIGN, CONSTRUCTION AND  
PERFORMANCE OBSERVATIONS JOHN H. KERR  
PROJECT ( BUGGS ISLAND AND ISLAND CREEK  
DAMS).

REVIEW OF SOILS DESIGN, CONSTRUCTION  
AND PERFORMANCE OBSERVATIONS  
JOHN H. KERR PROJECT  
(BUGGS ISLAND AND ISLAND CREEK DAMS)  
VIRGINIA

TECHNICAL REPORT NO. 3-464

U. S. Army Engineer Waterways Experiment Station  
CORPS OF ENGINEERS

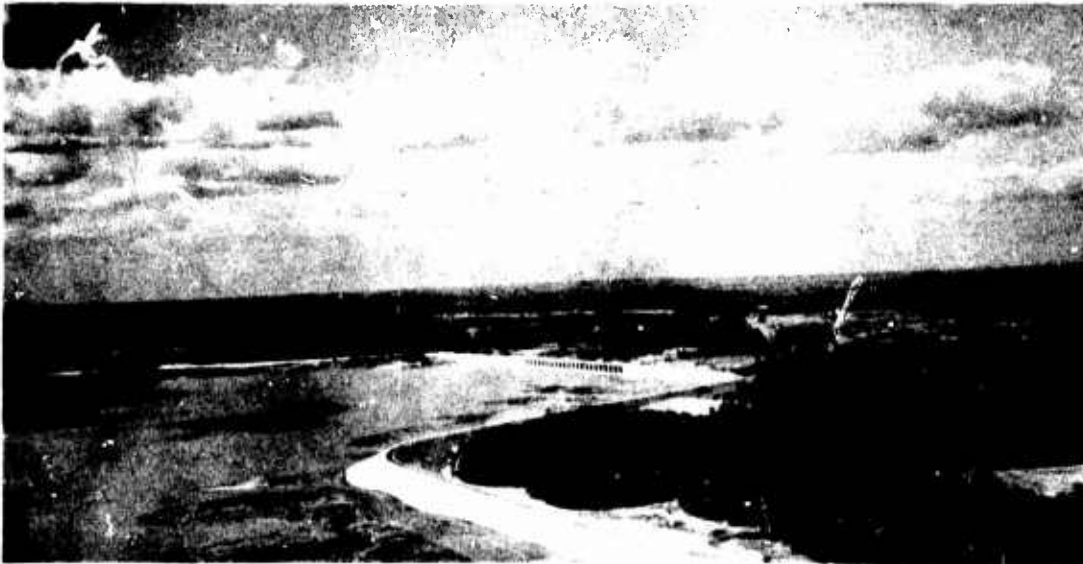
Fig. 2. Aerial view of Buggs Island Dam with the concrete gravity section in the center flanked by earth wing dikes

4. Construction of the rolled fill was begun on 16 January 1951. The left wing dike was completed 12 July 1951, the right wing dikes were completed 1 April 1952, and the earth construction including saddle dikes was accepted on 1 July 1952. Fig. 2. is an aerial photograph of the concrete gravity section and wing dikes.

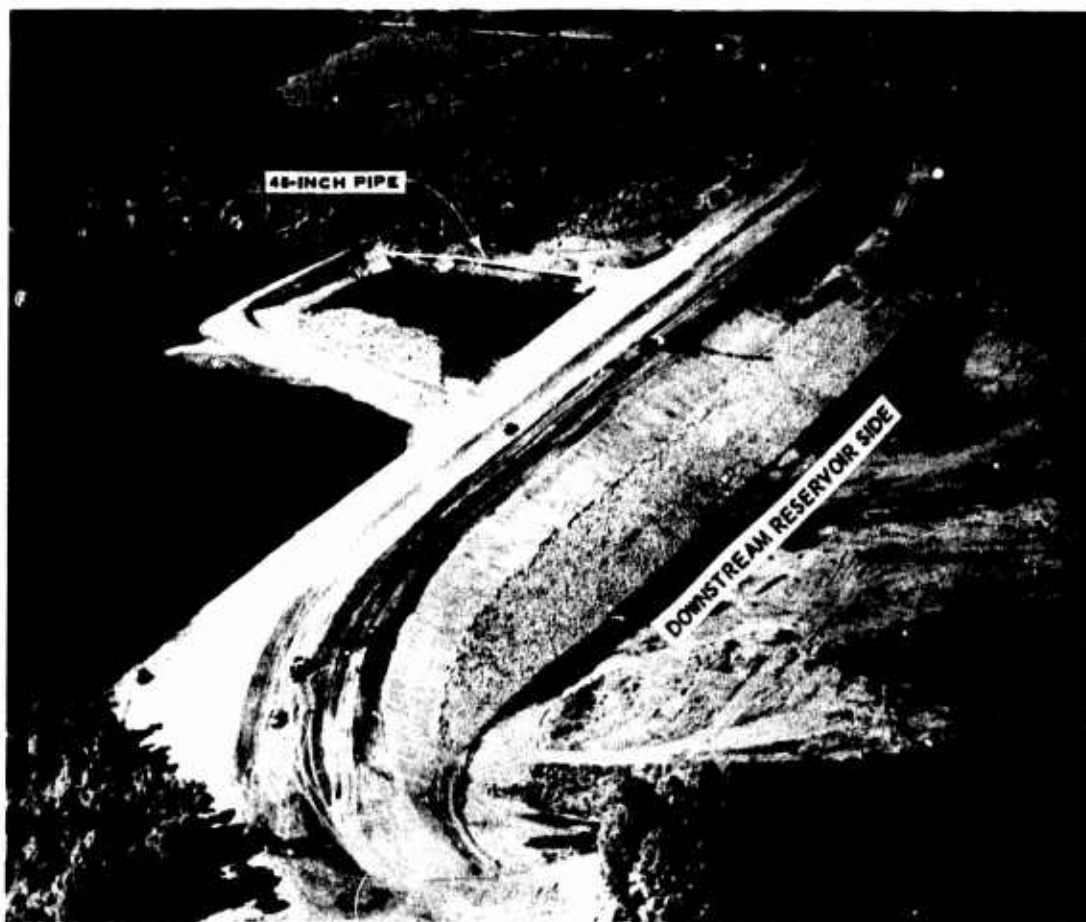
Fig. 3. Island Creek Dam from the downstream (reservoir) side. The 48-in. pipe, shown in the upper center, was used to discharge water through the cofferdam and conduit after closure of the dam during final stages of construction

7. Construction was begun in September 1950 and was completed in September 1951. Fig. 3 shows the partially completed embankment.

77. Stream diversion. As soon as clearing operations permitted, cofferdams were constructed both upstream and downstream, and the creek was diverted through a channel at sta 102+00 and into the creek bed 175 ft below the downstream cofferdam. The concrete conduit was then constructed at sta 96+62. In the second stage of stream diversion, a cofferdam was used to cut off the diversion channel; water was passed through the upstream cofferdam and into the conduit by means of a 48-in.-diam steel pipe (see fig. 3). The water was carried by a ditch from the conduit outlet to the creek.
