**CREEP OF NEXTEL 720/ALUMINA CERAMIC MATRIX COMPOSITE WITH  
DIAMOND-DRILLED EFFUSION HOLES AT 1200°C IN AIR AND IN STEAM**

THESIS

Megan L. Harkins, Major, USAF

AFIT-ENY-MS-19-M-218

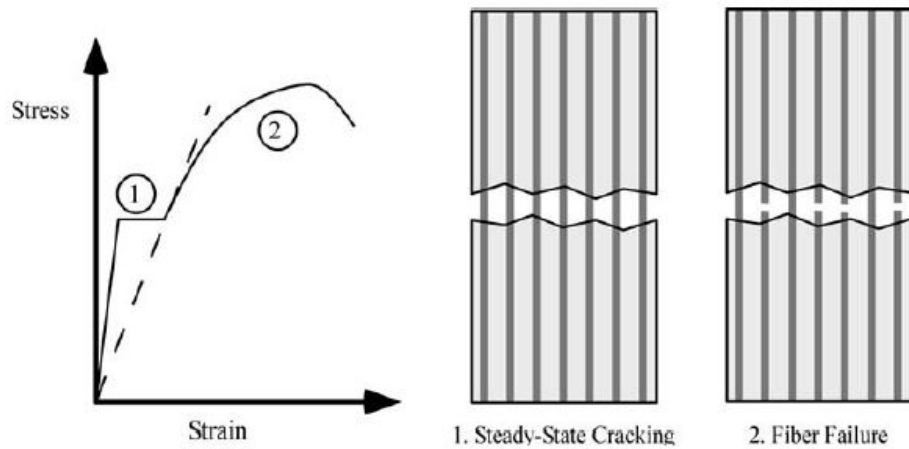
**Figure 4: Stress-strain behavior of fiber-reinforced ceramic composites [5]**

As the interface continues to debond and therefore deflect a propagating crack back into the matrix, the matrix will naturally reach ultimate failure first, but will gradually transfer the load to the fibers as the crack progresses. This phenomenon is referred to as fiber bridging, and is ultimately what produces the quasi-ductile material response seen in Figure 4 [5]. The damage in the composite accumulates gradually until final failure occurs. As a result, the material now displays improved fracture toughness and damage tolerance via a non-catastrophic failure mode.

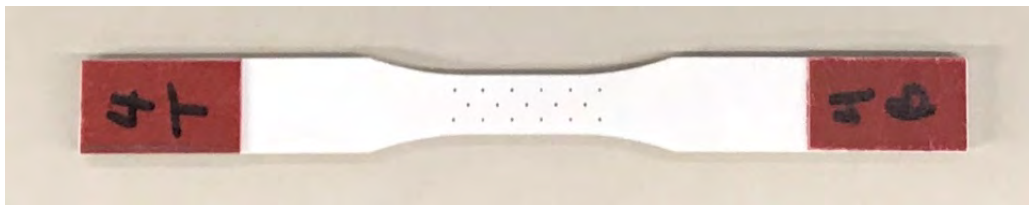
**Figure 8: Specimen ready for testing**

The final step in preparing the specimens for testing was to attach 1/16-inch thick fiberglass tabs to the gripping ends of each specimen. The tabs were bonded using M-Bond 200 adhesive, and served to protect the specimen surface from the pressure applied by the hydraulic wedge grips during testing. Figure 8 shows a specimen, ready for testing.

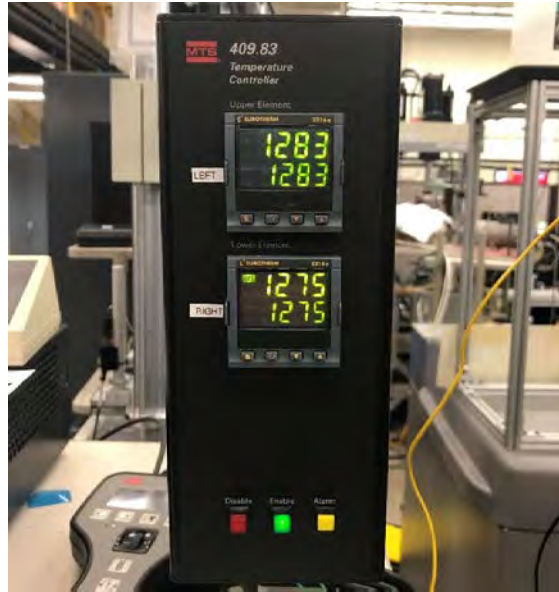
**Figure 10: MTS Temperature Controllers**

A temperature of 1200°C was maintained for all tests using a compact, dual zone AMTECO hot-rail furnace system (Figure 9) controlled by two MTS (Model 409.83) Temperature Controllers (Figure 10).

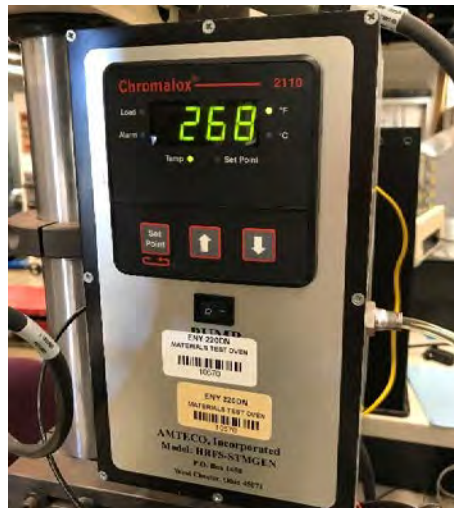
**Figure 13: AMTECO steam generation system**

In order to produce a near 100% steam environment, an alumina susceptor was specifically designed to house the gage section of the specimen while providing an opening for a steam feeding tube and slots for the two extensometer extension rods (Figure 12). Steam was provided to the susceptor from an AMTECO HRFS-STMGEN steam generation system (Figure 13) in a continuous flow at a rate sufficient to displace the dry air and create a near 100% steam environment around the specimen gage section.

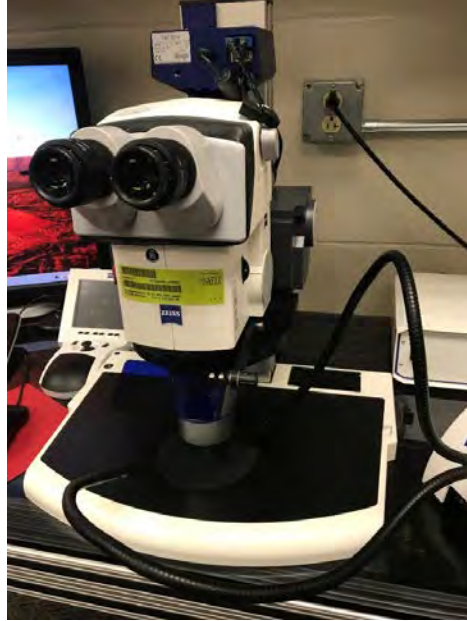
**Figure 15: ZEISS optical microscope**

A ZEISS SteREO Discovery.V12 optical microscope (Figure 15), equipped with an AxioCam HRc digital camera and AxioVision software (version 4.8) was used before and after testing to examine the microstructure surrounding a few randomly selected holes as well as the post-test fracture surfaces.

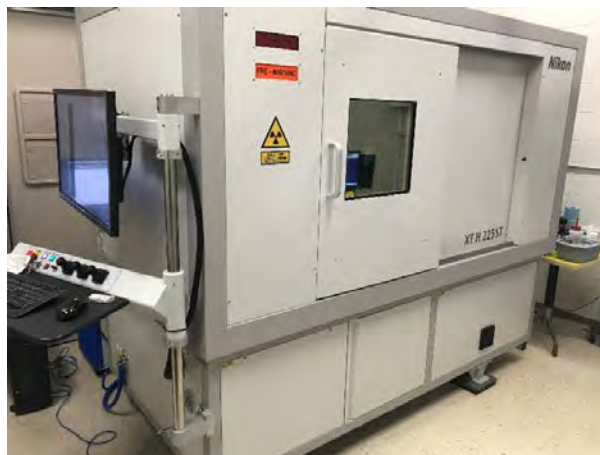
**Figure 16: Nikon CT scanner**

A Nikon XT H 225 ST Computed Tomography (CT) scanner (Figure 16) was used to examine specimens after testing to provide additional insight into interior damage zone penetration that may not be captured via optical microscopy.

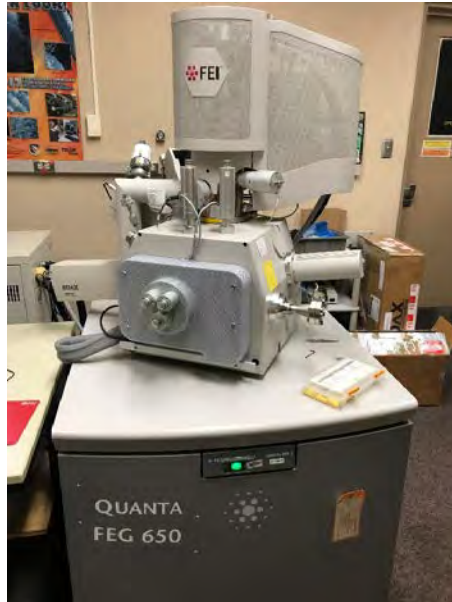
**Figure 17: Quanta FEG SEM**

A Quanta FEG 650 (Figure 17) and MAIA3 Triglav TESCAN SEM (Figure 18) were used to further characterize the microstructure of the material by examining the fracture surfaces. Unlike the optical microscope, the SEM can achieve a resolution on

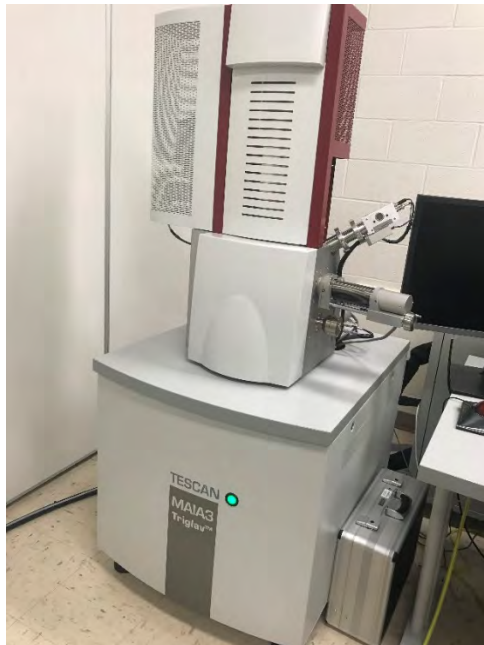
**Figure 18: MAIA3 TESCAN SEM**

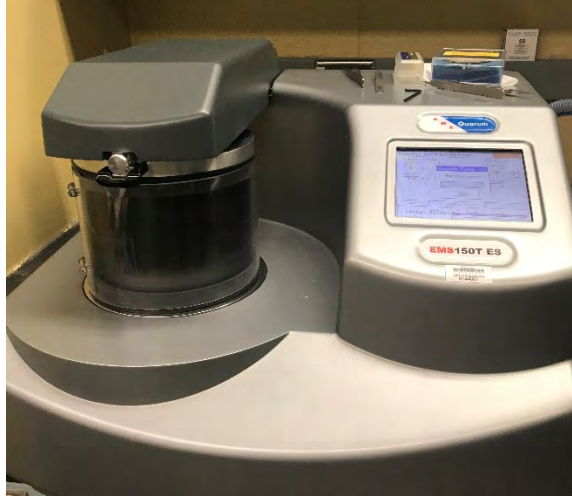
**Figure 19: EMS Quorum sputtering machine**

the order of nanometers; however, the specimen must have conductive properties for a clear image to be collected. Considering that the N720/A constituents are both poor conductors, an EMS Quorum sputtering machine (Figure 19) was used to coat the fracture surfaces with a gold-palladium (Au-Pd) alloy prior to SEM examination.

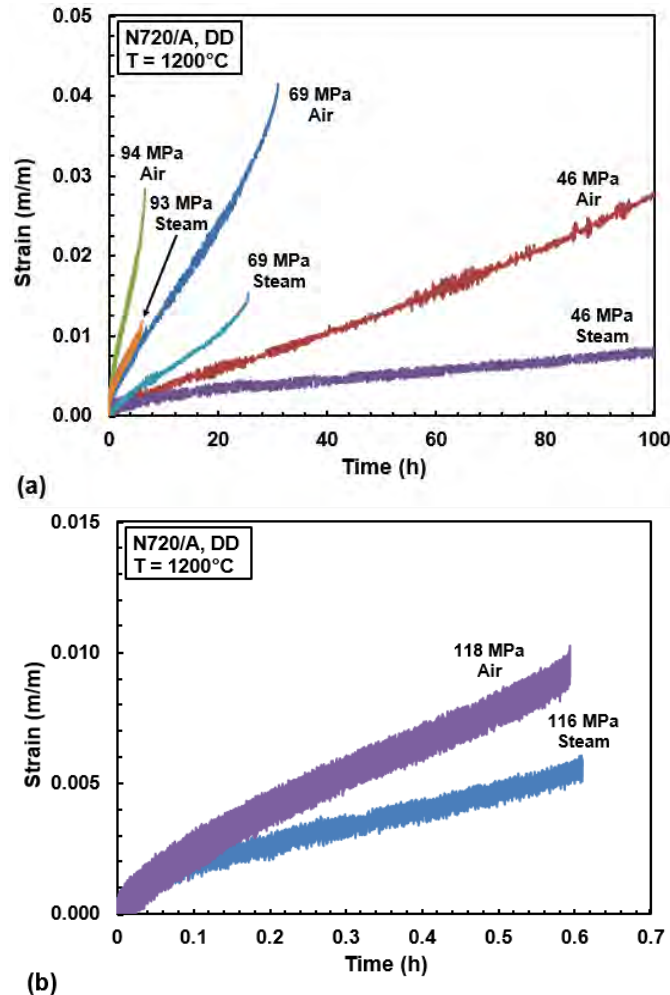
**Figure 24: Creep strain vs time curves obtained for N720/A specimens with an array of diamond-drilled holes in air and steam at 1200°C: (a) time scale selected to show results obtained at 46-94 MPa, and (b) time scale selected to show creep curves obtained at higher creep stresses**

Results of the creep-rupture tests in air and steam environments for N720/A specimens containing an array of diamond-drilled (DD) holes are presented in Figure 24 and Table 10.

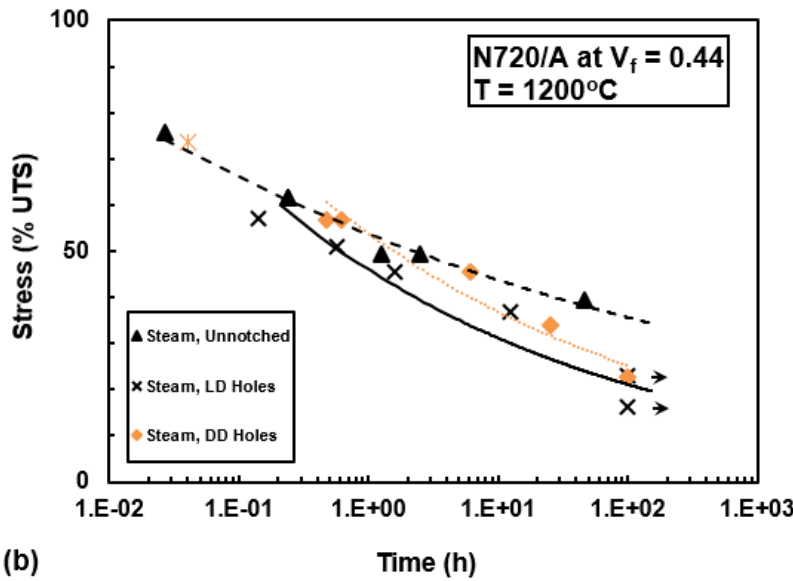
Figure 29: Creep stress vs time to rupture for unnotched, laser-drilled and diamond-drilled N720/A specimens in steam at 1200°C: (a) stress in MPa, and (b) stress in % UTS

In order to make similar comparisons for the steam data, an extrapolation was necessary to estimate the run-out stress for unnotched specimens in steam. Referencing Figure 29, it can be estimated that run-out would be achieved at ~73 MPa (36% UTS). Note that creep run-out was achieved by LD specimens at 27 MPa (16% UTS) and DD specimens at 46 MPa (22% UTS). Therefore, it appears that at 1200°C in steam, the

presence of holes decreased creep run-out stress by 63% for LD holes and by 37% for DD holes. This confirms an earlier observation that steam is least degrading to specimens with DD holes.

Within the steam environment, the data suggests that LD holes are just as degrading to creep lifetimes as they are in air (>90%); however, DD holes are less degrading. For stresses  $\leq 50\%$  UTS, the presence of DD holes reduces creep lifetimes in steam by an average of 67%; however, for stresses  $> 50\%$  UTS, the presence of DD holes has little effect on creep lifetimes. In fact, when referencing the % UTS plot below, it appears that specimens with DD holes actually perform similar to unnotched specimens at stresses over 45% UTS in steam. This observation further supports the assumption that the presence of DD holes is more degrading to the creep resistance of this CMC than the presence of steam. Finally, relative to LD holes in a steam environment, DD holes significantly improve creep lifetimes; extrapolated results suggest an average ratio of DD to LD lifetimes of ~11.

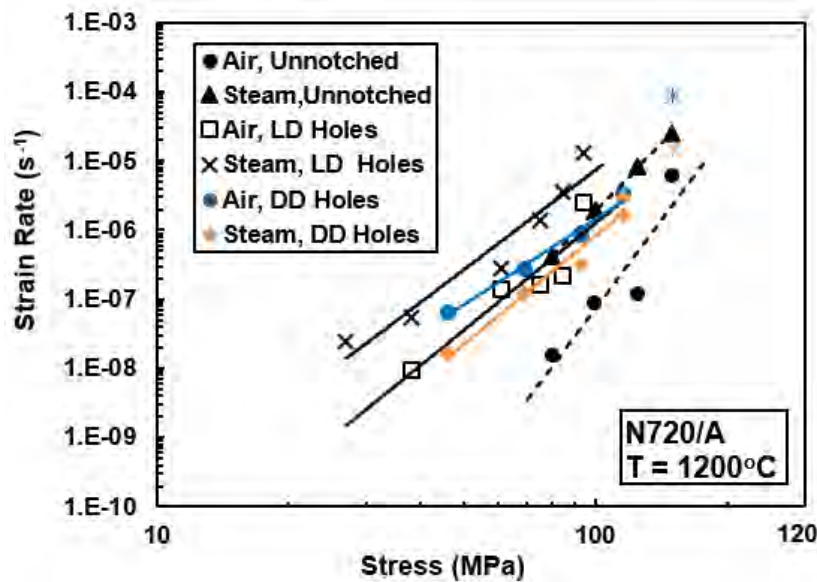
Continuing the minimum creep rate discussion, Figure 32 consolidates DD, LD and unnotched specimen creep rates in air and steam at 1200°C. One obvious difference identified from this comparison is the impact that steam had on the results. For both the unnotched and LD specimens, the presence of steam accelerated the minimum creep strain rates; however, the opposite was true for the DD specimens.

**Figure 32: Minimum creep rate vs creep stress for unnotched, laser-drilled and diamond-drilled N720/A specimens tested in air and steam at 1200°C**

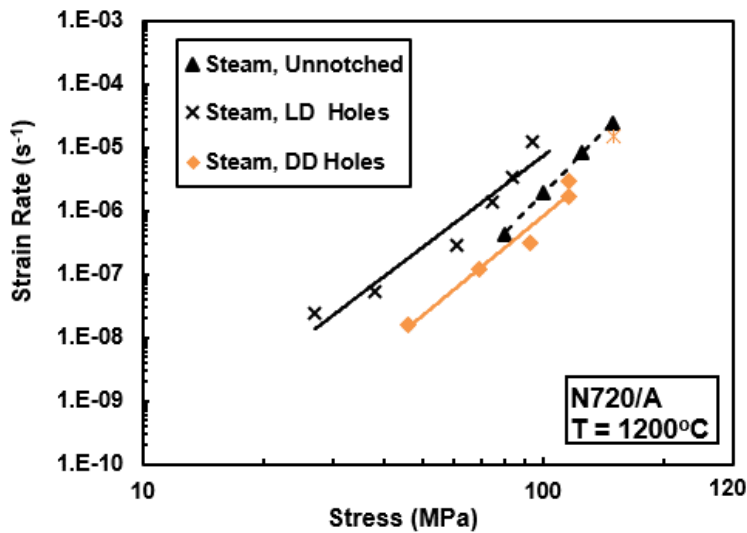
**Figure 34: Minimum creep rate vs creep stress for unnotched, laser-drilled and diamond-drilled N720/A specimens tested in steam at 1200°C**

A closer examination of the creep rates obtained in air (Figure 33) suggest that the presence of a hole (LD or DD) does accelerate minimum creep rates, but the method of hole fabrication has little influence. However, in a steam environment (Figure 34), the creep rates produced by the DD specimens are similar to those of unnotched specimens. These observations suggest that the dominant damage mechanism at play for the DD specimens is different than the damage mechanisms operating for the unnotched and LD specimens. One possible explanation stems from considerations of matrix porosity. Recall that the N720/A composite relies on a porous matrix for its damage tolerant behavior, and that a minimum porosity is required for this concept to work. If the DD holes did not negatively affect the composite microstructure aside from making the CMC more porous, it could be that there exists an upper porosity limit beyond which the creep resistance of the material begins to degrade. This degradation manifests itself in faster creep strain rates which ultimately reduce creep lifetimes. In this case, the added matrix sintering that is present in a steam environment could potentially return the overall porosity of the DD specimens to acceptable levels. While this explanation may be debated, the data indicates that the presence of steam changes the dominant damage mechanism such that strain rates for DD specimens in steam are not only lower than the strain rates seen in air, but are also in-line with rates reported for unnotched specimens.

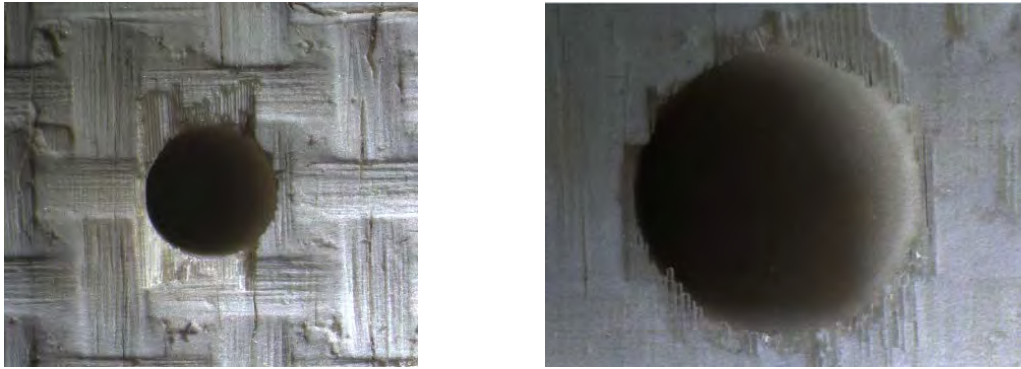
**Figure 37: Pre-test optical micrographs of N720/A specimens with diamond-drilled holes showing material in the vicinity of randomly selected holes**

Similarly, this effort sought to use optical micrographs to characterize the composite microstructure in the area surrounding the DD holes. Figures 37-39 show representative optical micrographs of composite microstructure for untested DD specimens (Figure 37), and DD specimens tested in creep at  $1200^\circ\text{C}$  in air (Figure 38) and in steam (Figure 39). The key takeaway from this analysis is the lack of a glassy phase in the vicinity of any DD hole. Additionally, there appears to be more fiber pull-out and less fiber-matrix bonding relative to optical micrographs of LD holes (Figure 40)

[3]. These observations suggest that the diamond drilling process is less damaging to the composite microstructure than laser drilling.

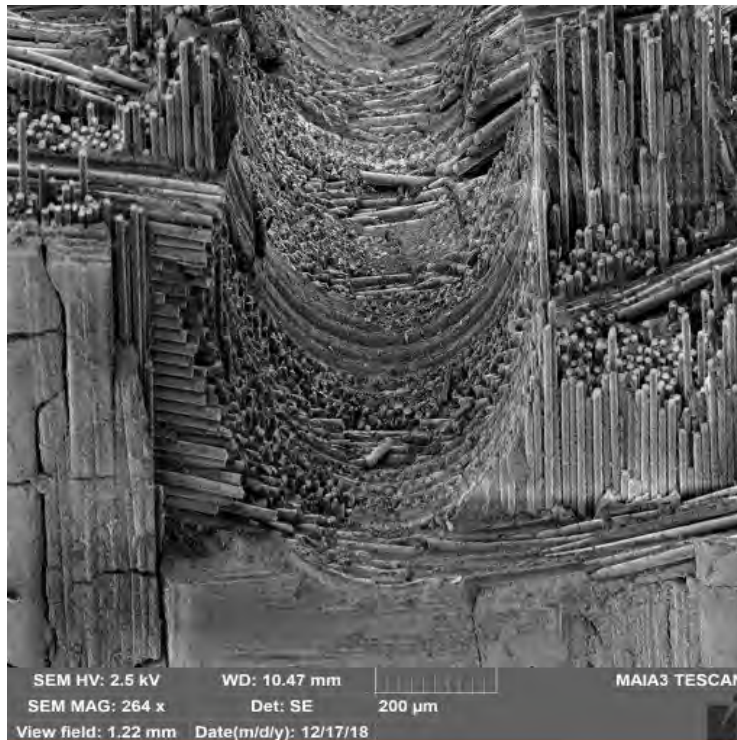
**Figure 49: Fracture surface of an N720/A specimen with diamond-drilled holes tested in creep at 1200°C in air ( $\sigma_{cr} = 93$  MPa,  $t_f = 6.55$  h)**

Representative SEM micrographs obtained in this work are shown in Figures 48-53. Note that some SEM images were produced with the Quanta FEG 650 SEM and some with the MAIA3 TESCAN SEM. Figures 48-50 present typical features of a fracture surface obtained from creep tests performed at 1200°C in air, and Figures 51-53, similarly capture features from creep tests performed at 1200°C in steam.

These micrographs consistently show a grainy surface on the hole interior, where both fibers and matrix are readily discernable. Additionally, both air and steam fracture surfaces show signs of fiber pull-out in the vicinity of the holes, with little matrix remaining bonded to the exposed fibers. The lower magnification micrographs also show more regions of coordinated fiber failure for specimens tested in steam, which ultimately contributes to the more planar fracture surface. While matrix sintering is not a distinct feature that can be measured via SEM, it is the presumed cause for the correlated fiber failures in steam based unnotched creep results [11, 12, 14].

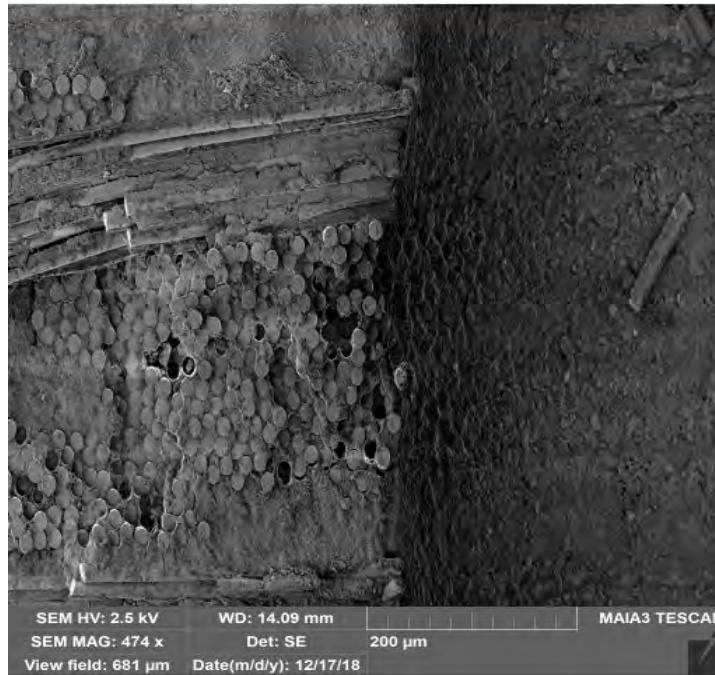
**Figure 52: Fracture surface of an N720/A specimen with diamond-drilled holes tested in creep at 1200°C in steam ( $\sigma_{cr} = 93$  MPa,  $t_f = 6.05$  h)**

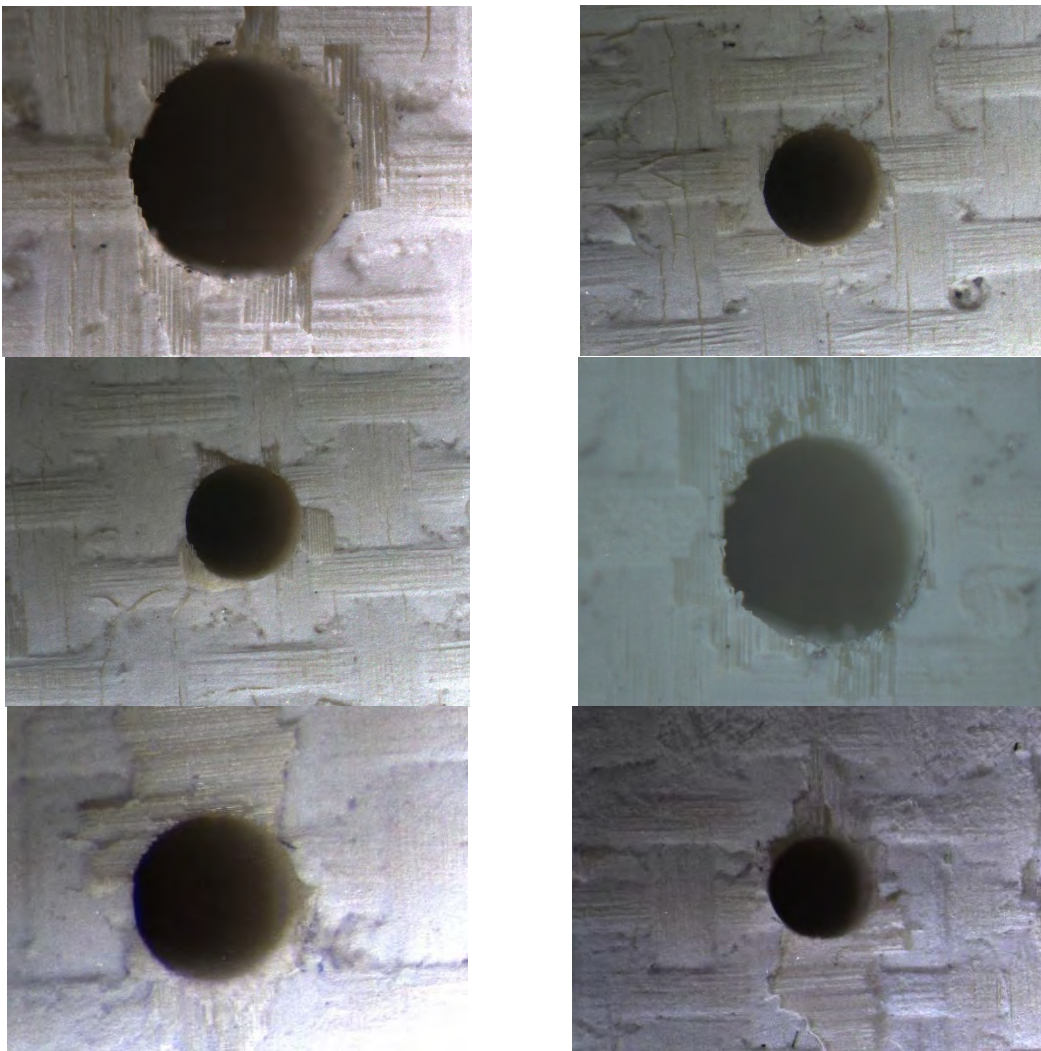
Figure A. 2: Pre-test optical images of randomly selected holes

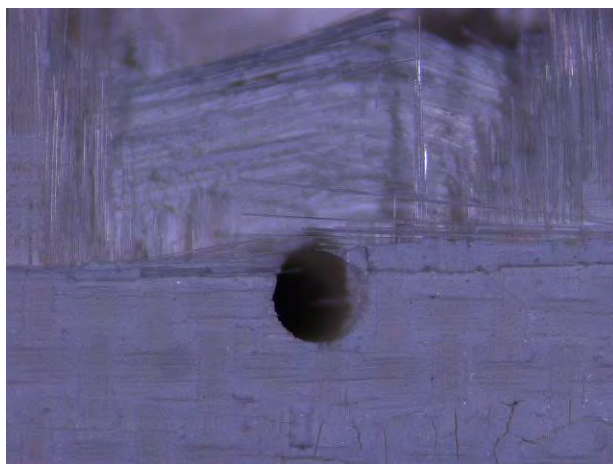
**Figure A. 34: Fracture surface of specimen #8, tested in creep at 1200°C in air ( $\sigma_{cr} = 150$  MPa,  $t_f = 0.01$  h)**

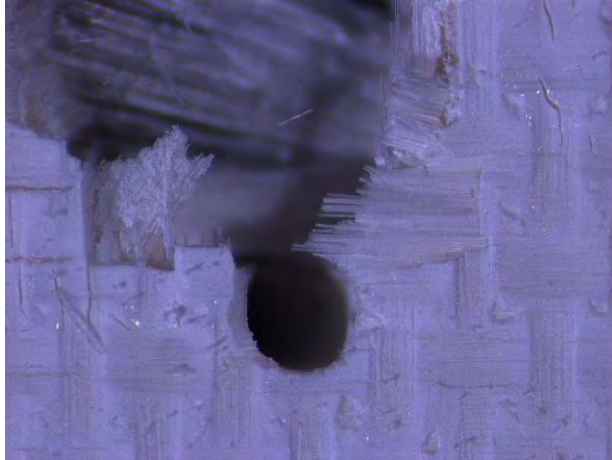
**Figure A. 37: Fracture surface of specimen #12, tested in tension to failure following 100 h creep at 46 MPa at 1200°C in steam**

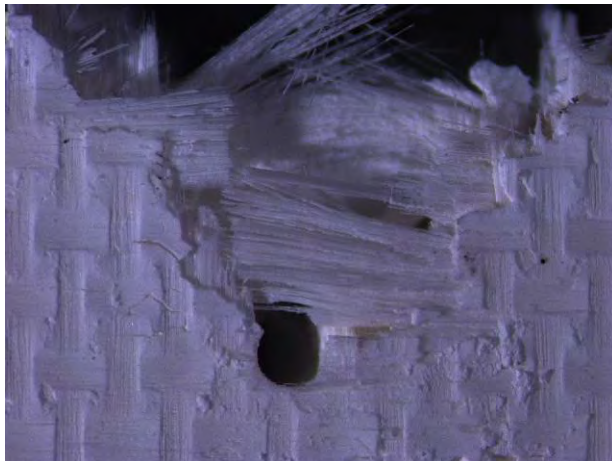
**Figure A. 38: Fracture surface of specimen #12, tested in tension to failure following 100 h creep at 46 MPa at 1200°C in steam**

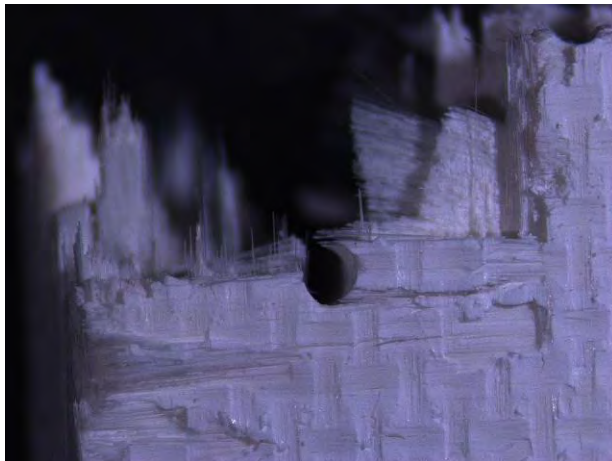
**Figure A. 41: Fracture surface of specimen #12, tested in tension to failure following 100 h creep at 46 MPa at 1200°C in steam**

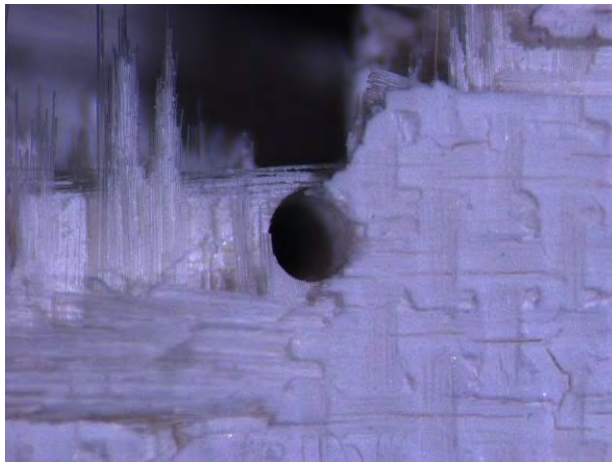
**Figure A. 42: Fracture surface of specimen #12, tested in tension to failure following 100 h creep at 46 MPa at 1200°C in steam**

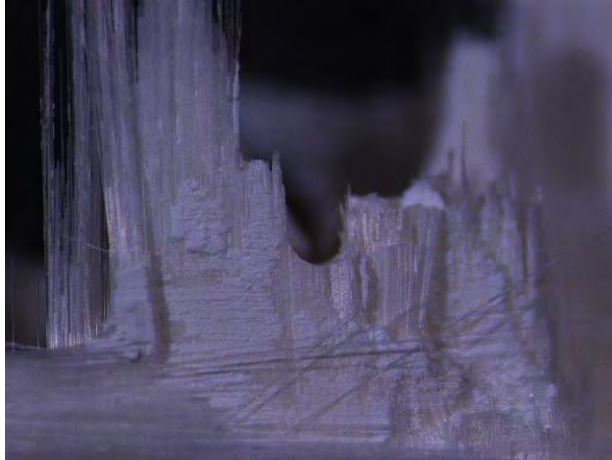
**Figure A. 48: Fracture surface of specimen #9, tested in creep at 1200°C in steam ( $\sigma_{cr} = 116$  MPa,  $t_f = 0.61$  h)**

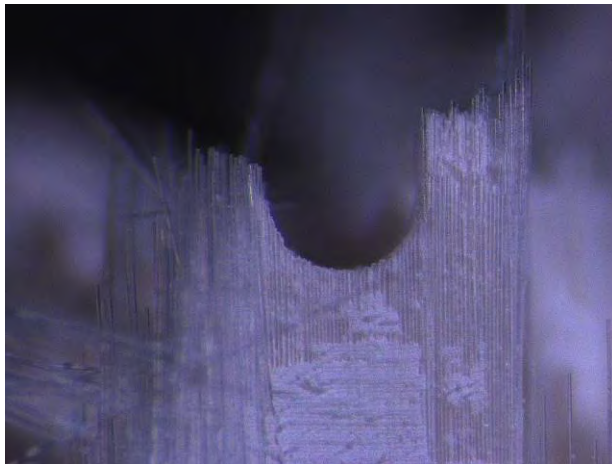
**Figure A. 53: Fracture surface of specimen #9, tested in creep at 1200°C in steam ( $\sigma_{cr} = 116$  MPa,  $t_f = 0.61$  h)**

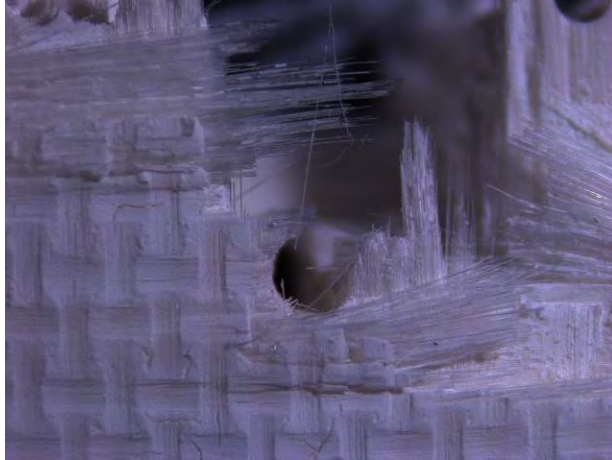
**Figure A. 54: Fracture surface of specimen #9, tested in creep at 1200°C in steam ( $\sigma_{cr} = 116$  MPa,  $t_f = 0.61$  h)**

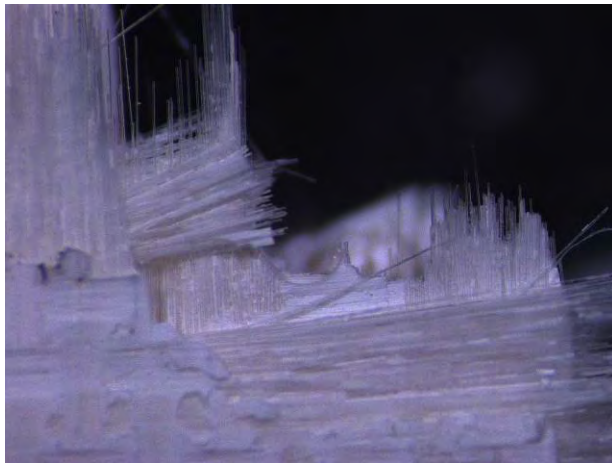
**Figure A. 55: Fracture surface of specimen #9, tested in creep at 1200°C in steam ( $\sigma_{cr} = 116$  MPa,  $t_f = 0.61$  h)**

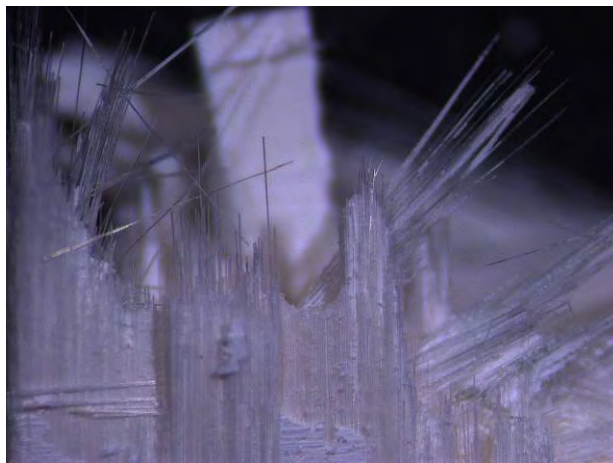
**Figure A. 60: Fracture surface of specimen #11, tested in creep at 1200°C in steam ( $\sigma_{cr} = 150$  MPa,  $t_f = 0.04$  h)**

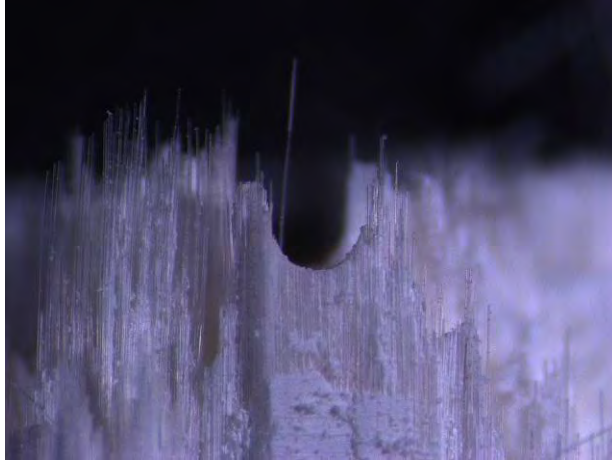
**Figure A. 62: Fracture surface of specimen #11, tested in creep at 1200°C in steam ( $\sigma_{cr} = 150$  MPa,  $t_f = 0.04$  h)**

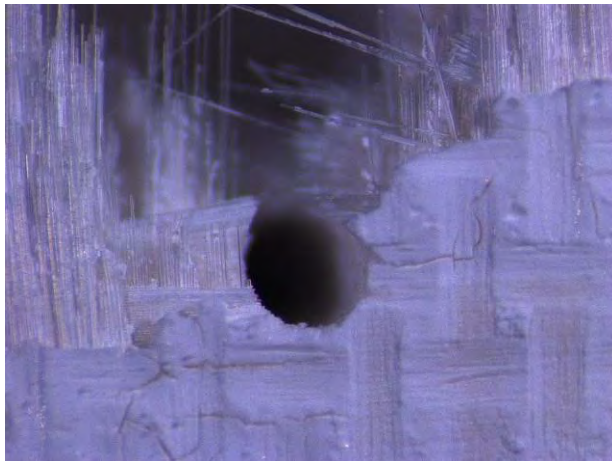
**Figure A. 63: Fracture surface of specimen #11, tested in creep at 1200°C in steam ( $\sigma_{cr} = 150$  MPa,  $t_f = 0.04$  h)**

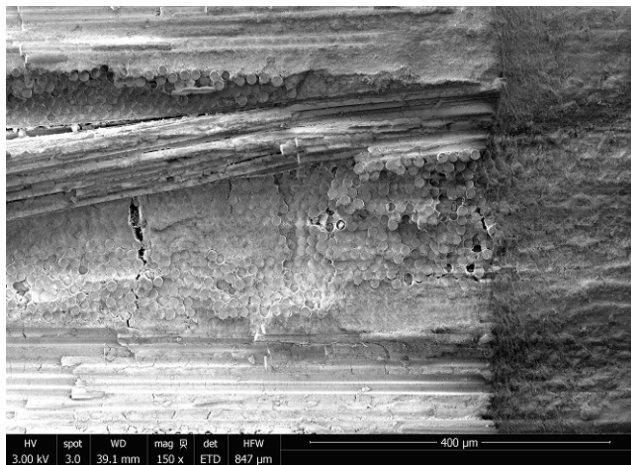
**Figure C. 46: Fracture surface of specimen #10, tested in creep at 1200°C in steam ( $\sigma_{cr} = 93$  MPa,  $t_f = 6.05$  h)**
