# Preliminary Reports of the X-24B Flight Records (Flights 18-28)

**AF/NASA X-24B Project Team**

PRELIMINARY RESULTS OF X-24B

FLIGHT B-9-16

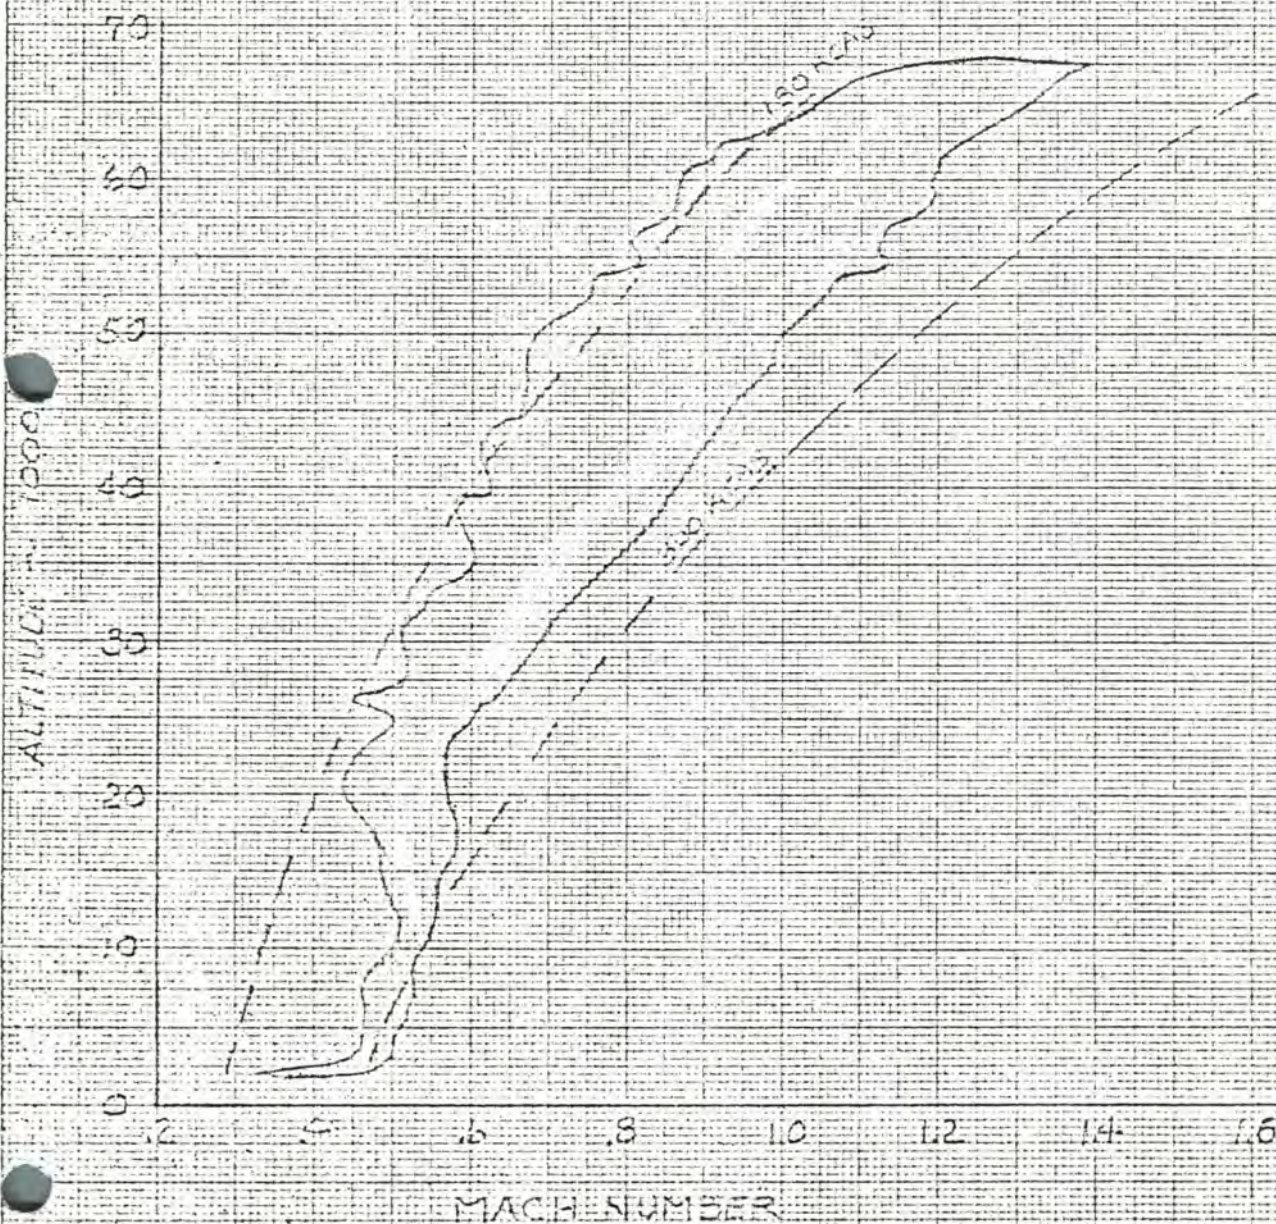
X-24B

MACH NO. VS ALTITUDE

ENVELOPE

FLIGHTS 1 THRU 13

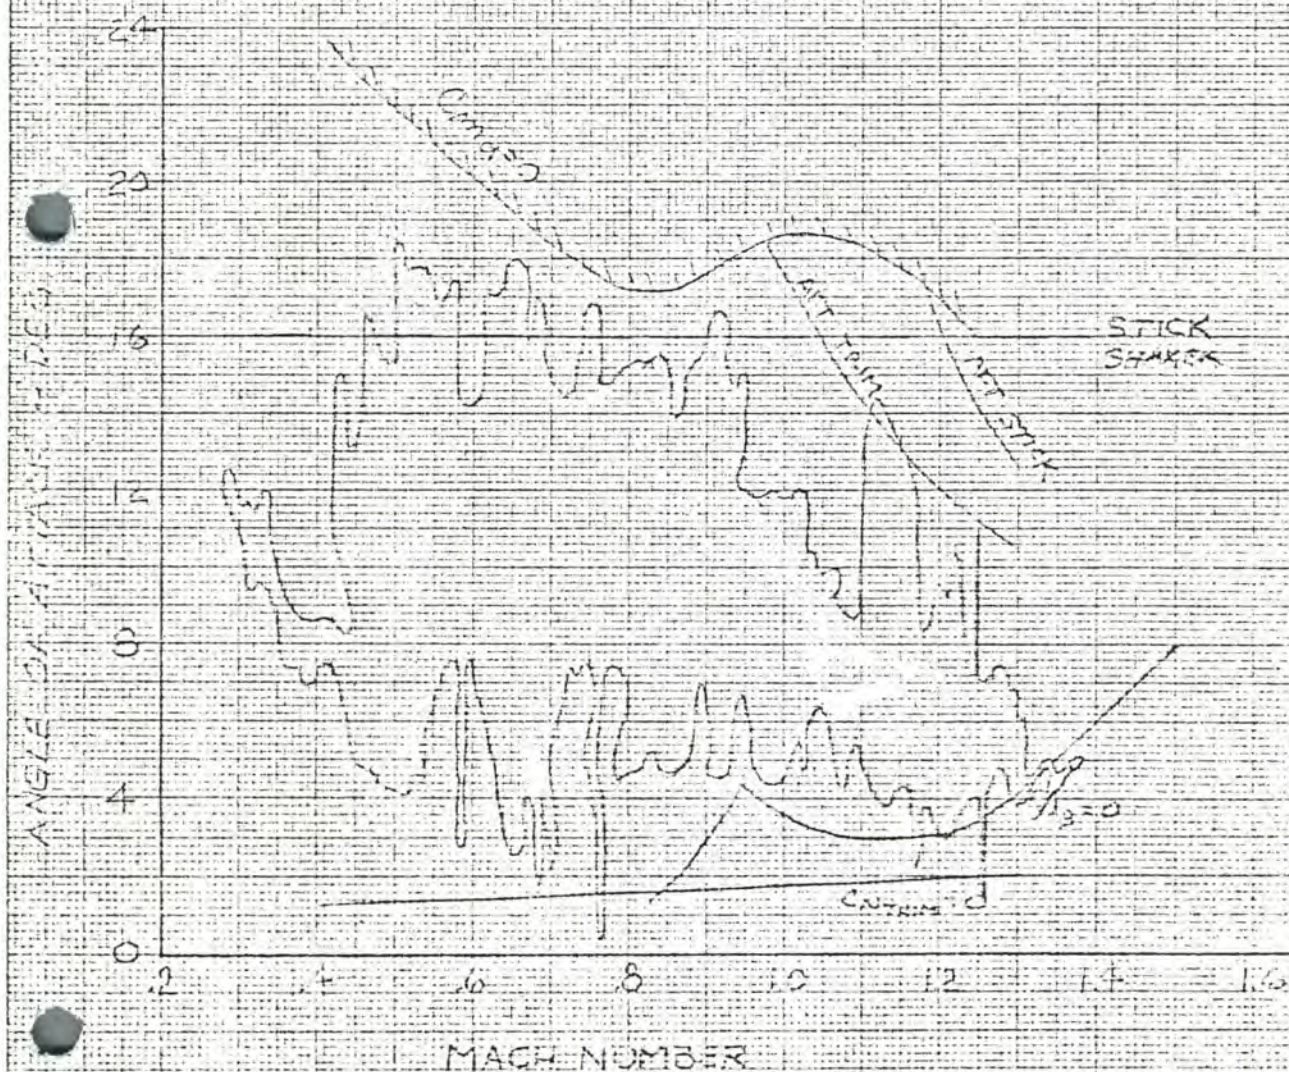
X-24B

MACH NO. VS. ANGLE OF ATTACK

ENVELOPE

FLIGHTS 1 THRU 13
