Corrosion Surveys of Army Ground Assets to Identify Leading Issues and Opportunities for Corrosion Prevention

J. Peter Ault, P.E. and John Repp, P.E.- Elzly Technology Corporation

Dr. Thomas Sanders and Scott Porter – TARDEC MECC

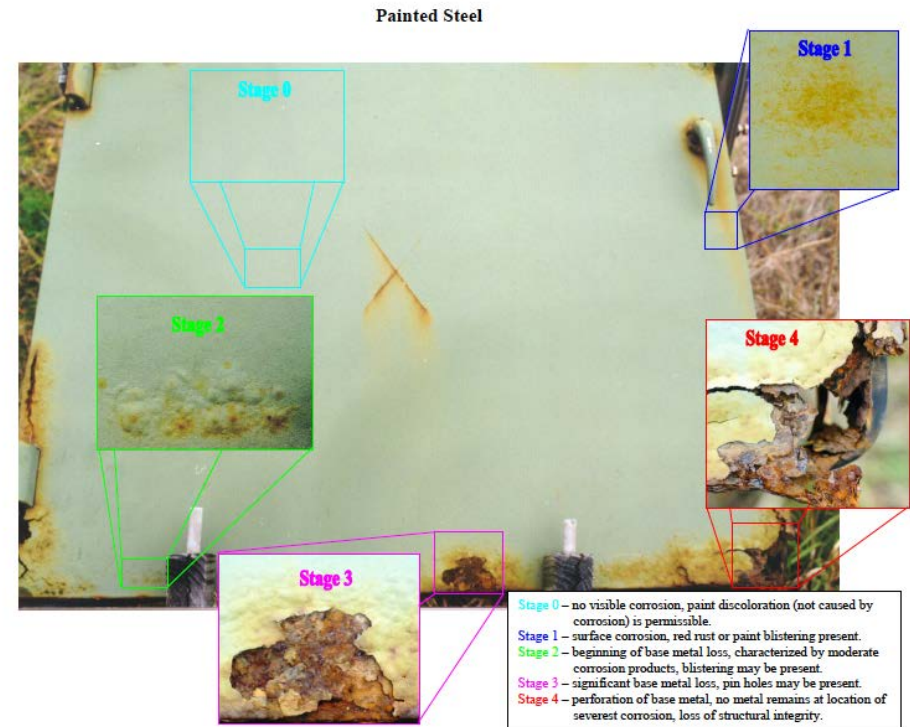
- Severity by stage
 - Stage 1 corrosion initiation
 - Stage 4 perforation (metal loss) due to corrosion
- Corrosion type
 - General corrosion
 - Galvanic corrosion
 - Crevice corrosion
 - Pitting corrosion
- Coating damage
 - Mechanical damage
 - Coating delamination
 - Needs repainting
 - Faded

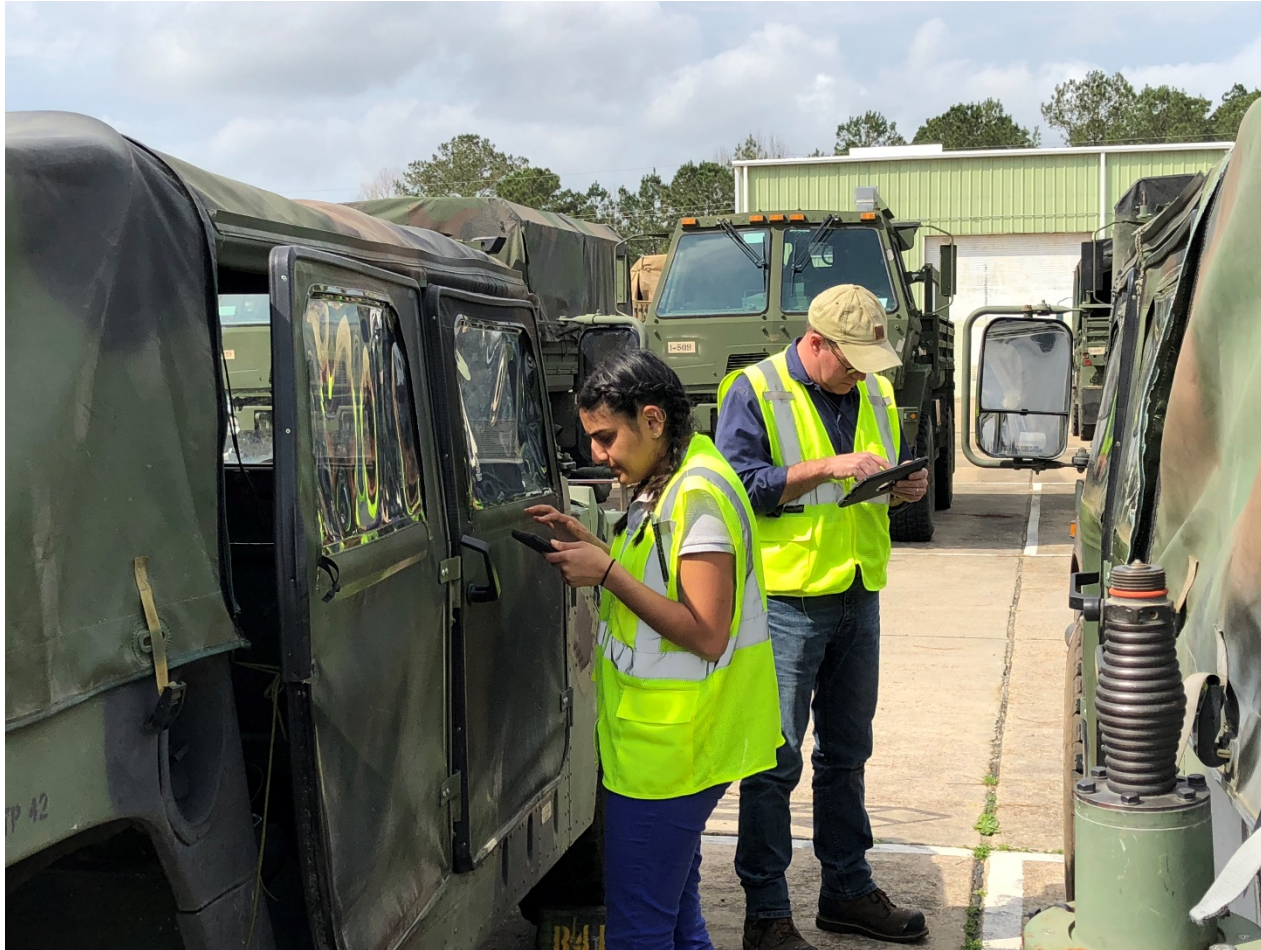
- Tool requirements
 - Perform survey at asset without need to move/operate
 - Collect asset identification and corrosion data rapidly
 - Include capture of photographs that are linked to the parts, asset, and location
 - Rapid reporting for out-brief and 45-day AMC report
- Tool features
 - Utilized tablet (Apple iPad™) for data collection
 - Developed tool using COTS database software for data collection
 - Developed and programmed analysis methods for rapid collection and summarizing of data – no data transcription, photo re-naming, etc.
 - Created dashboards for units/installations

Survey Tool Interface (Left Screen):

Survey Tool Interface (Right Screen):

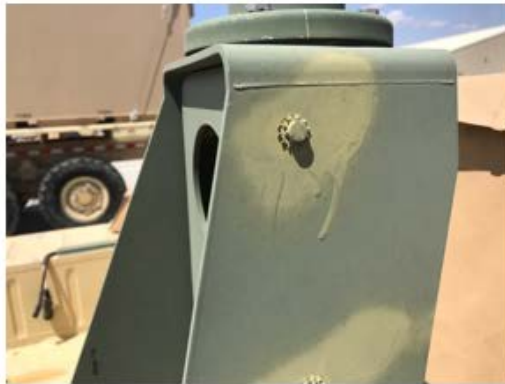
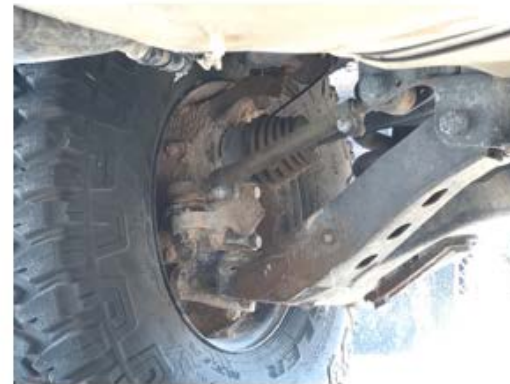
Near-term Opportunities

- Items/areas for additional operator/user maintenance
 - Opportunity for use of CARC aerosol products for touch-up and registration marking
 - CARC aerosols include epoxy primer and polyurethane (CARC) topcoat
 - Washing/cleaning of undercarriages and other areas
