**Navy Experimental Diving Unit  
321 Bullfinch Rd.  
Panama City, FL 32407-7015**

**TA 18-12  
NEDU TR 19-07  
Jan 2020**

## **REVISED SSGN AND VIRGINIA CLASS SUBMARINE PROCEDURES FOR SCREENING DIVER QUALITY AIR**

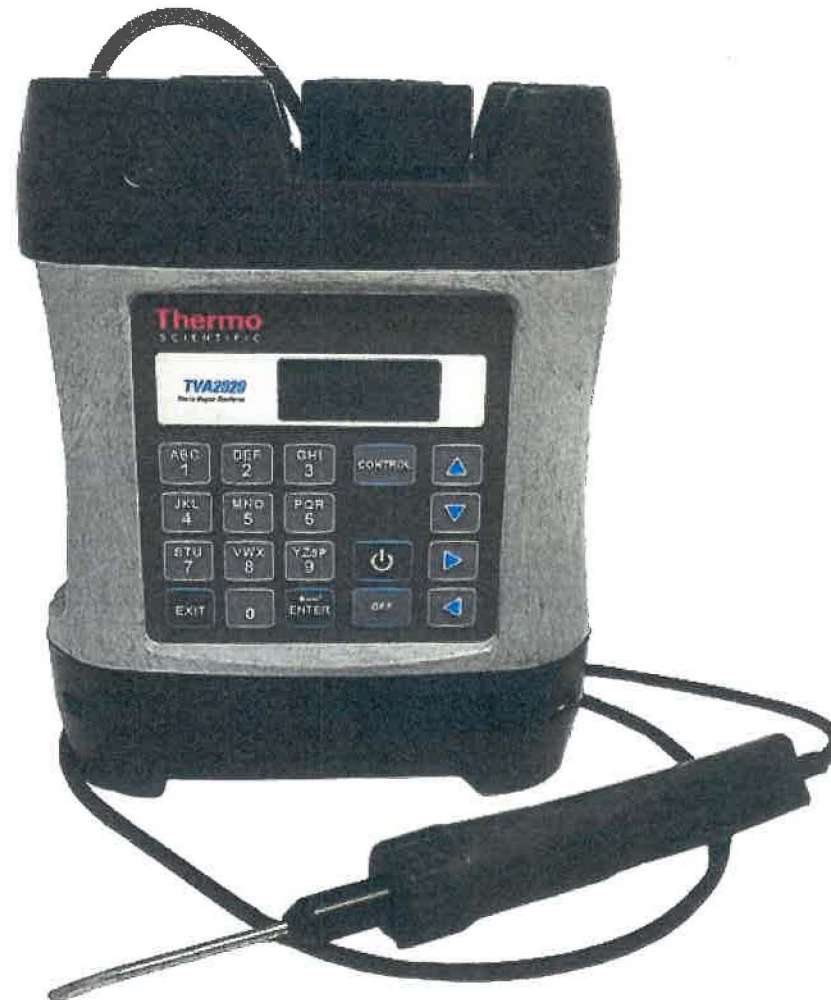
**FIGURE 2. TVA2020 (new replacement).**

The recent replacement of the TVA-1000B (Figure 1) with the TVA2020 (Figure 2) by the manufacturer now requires that the current procedures be revised. However, although the TVA-1000B was believed to be a good choice for this application at the time the current procedures were produced, NEDU believes that newer alternatives to the TVAs (both to the current TVA-1000B, and to the new version TVA2020) exist that may simplify, improve the reliability, and reduce the cost of the DQA screening process.

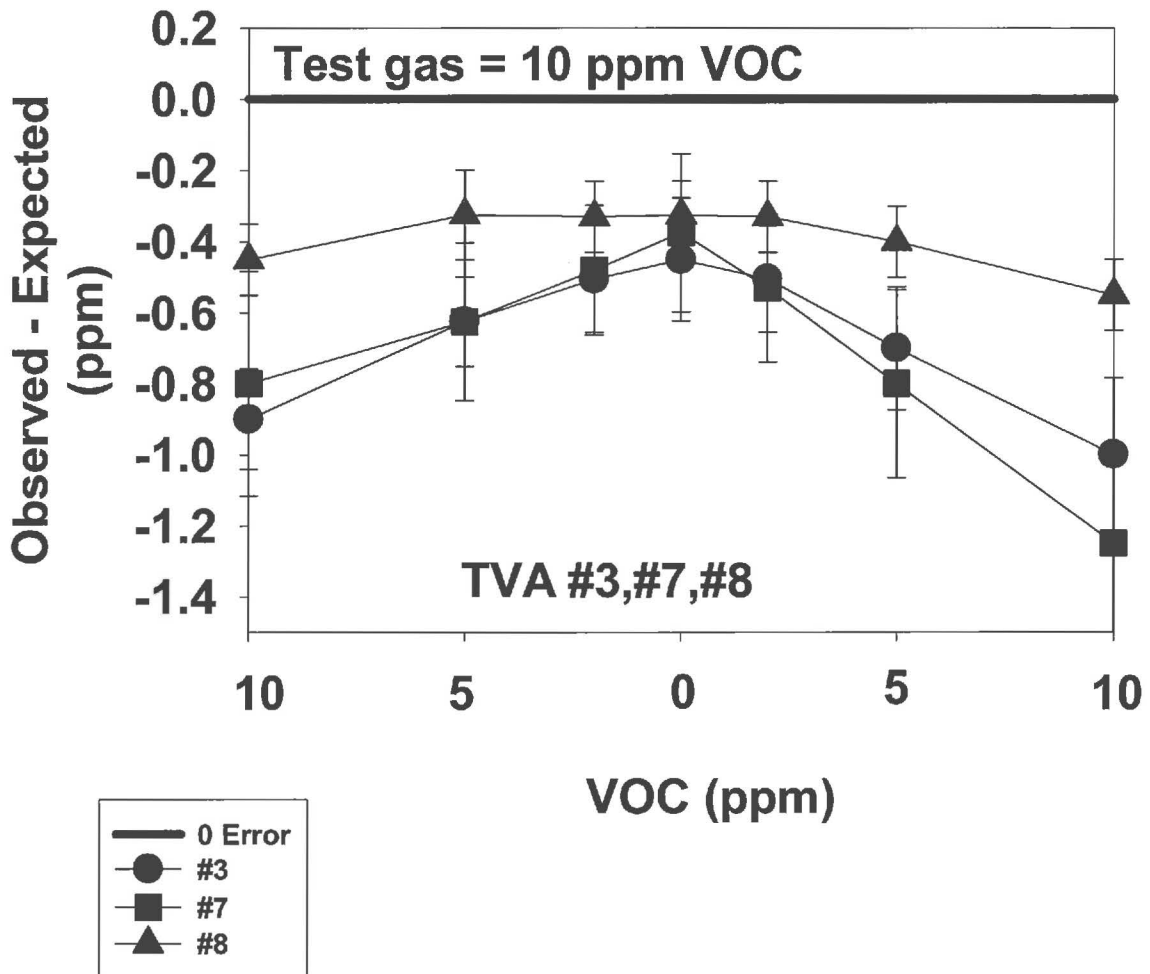
**FIGURE 8. STEC accuracy on bench.**  
**FID (ppm)**  
**Means and SDs, N=4**

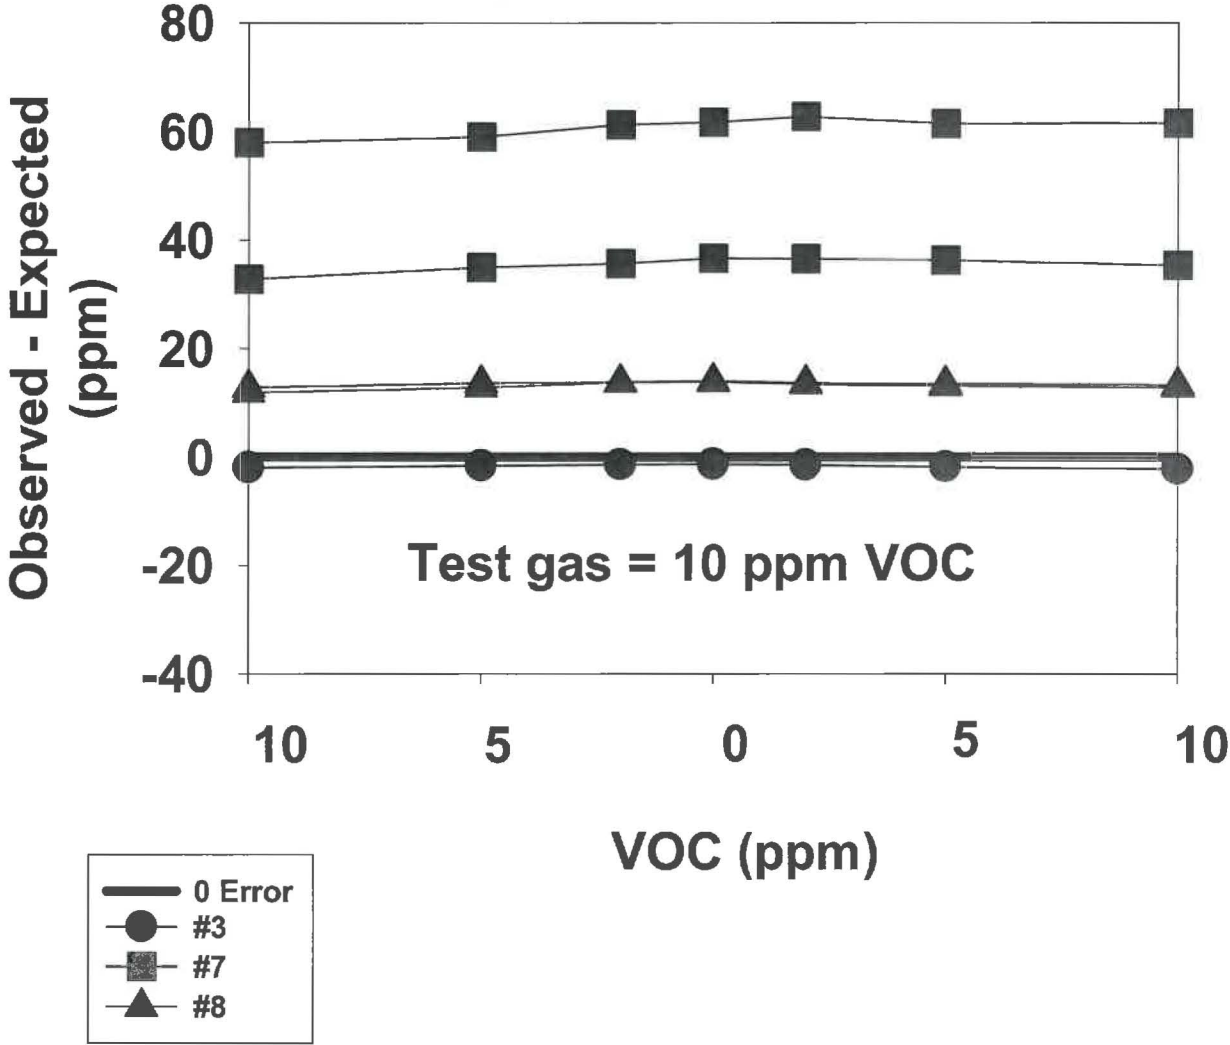
**FIGURE 12. STEC 42C chamber accuracy.  
 FID (ppm)  
 N=2 tests for each TVA**
