AFRL-RX-WP-TR-2022-0037

DAMAGE PROGRESSION IN GENERIC CERAMIC MATRIX COMPOSITE TURBINE AIRFOILS

**31 JANUARY 2022
Final Report**

**AIR FORCE RESEARCH LABORATORY
MATERIALS AND MANUFACTURING DIRECTORATE
WRIGHT-PATTERSON AIR FORCE BASE, OH 45433-7750
AIR FORCE MATERIEL COMMAND
UNITED STATES AIR FORCE**

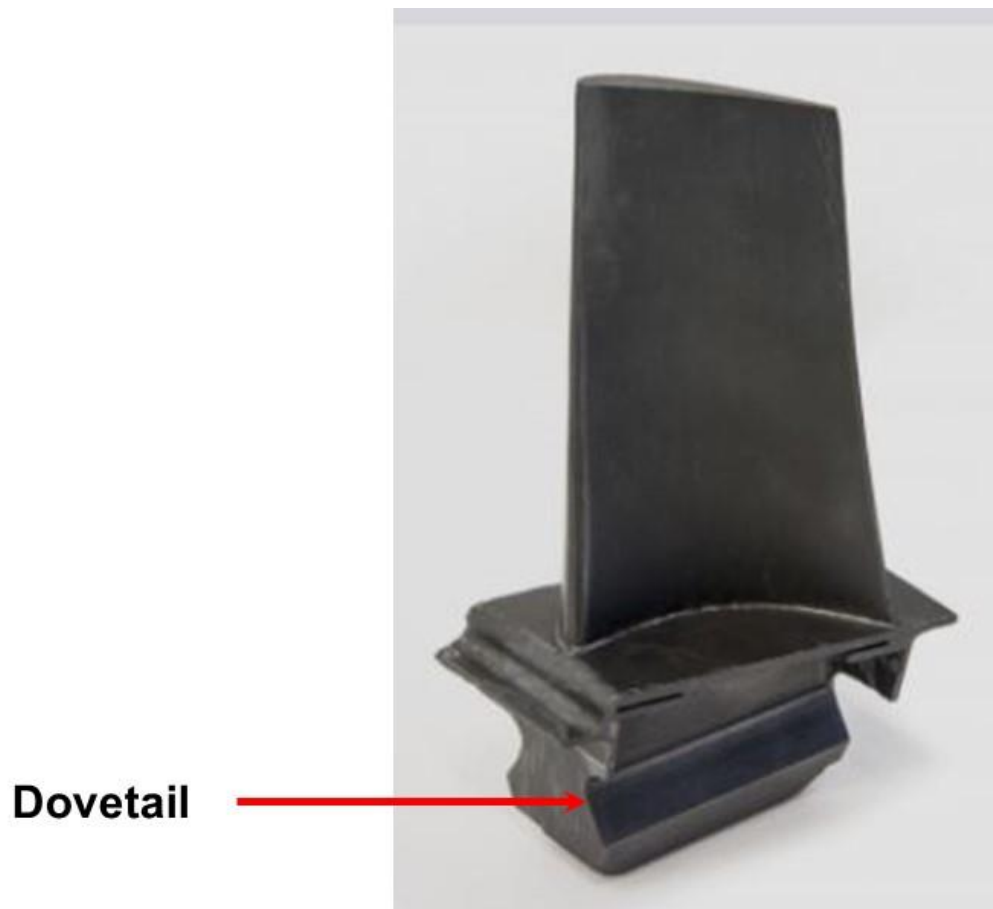
Figure 1. Photograph GE Aviation Jet Engine Turbine Blade Made From CMCs (2015 Paris Air Show)

The next step will be to introduce CMCs into rotating aerospace turbine engine components such as low pressure turbine blades. GE Aviation is actively pursuing these components. In 2015 GEA unveiled a CMC turbine blade at the Paris Air Show. A photograph of that CMC turbine blade is presented in Figure 1. This is an example of a fully functional CMC turbine blade with a dovetail attachment arrangement and integral platforms. GEA has also successfully engine tested a complete set of solid CMC low pressure turbine blades in an F414 engine as shown in Figure 2. In addition, IHI in Japan has been actively researching CMC airfoils since 2005. An example of one of their CMC airfoils is presented in Figure 3.[3,4]

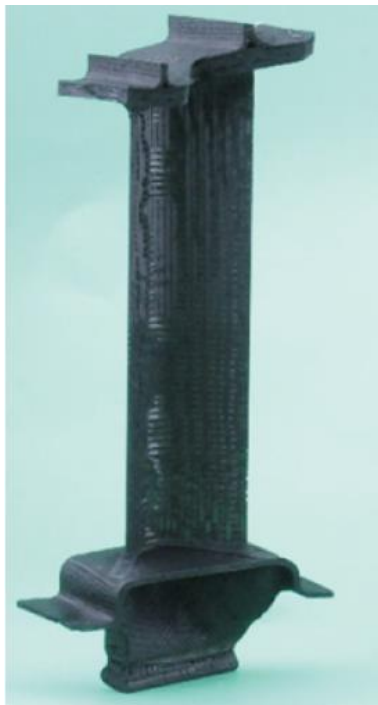
Figure 3. Photograph Of Prototype CMC Turbine Blade By SNECMA

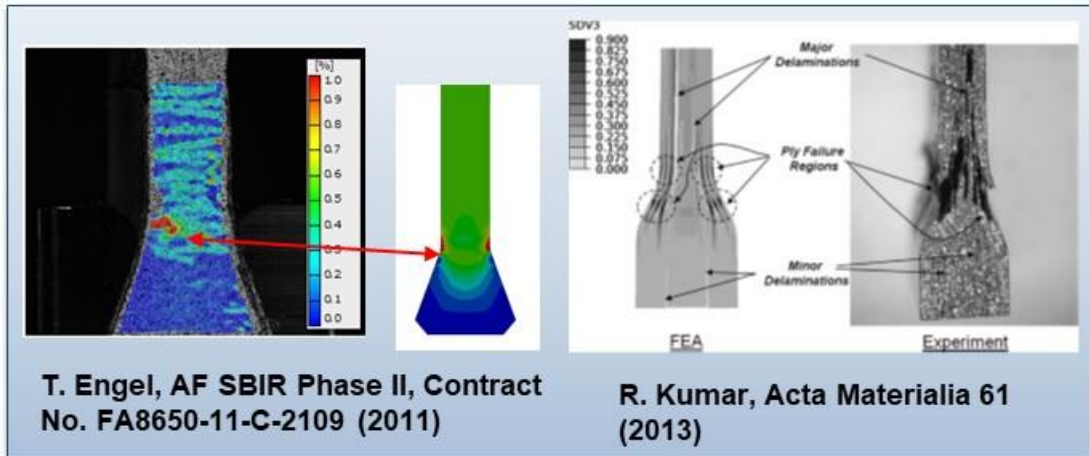
Figure 4. Previous Studies Of CMC Airfoil Attachments

turbine engine turbine blades. There are two studies in the literature that have addressed attachment features for CMC airfoils. Engle [5] has conducted a Small Business Innovative Research (SBIR) Phase I and Phase II program that studied attachments. In addition, attachment features have also been studied by Kumar [6]. Both of these studies were limited to monotonic loading conditions, and the attachment geometries that they studied are presented in Figure 4.

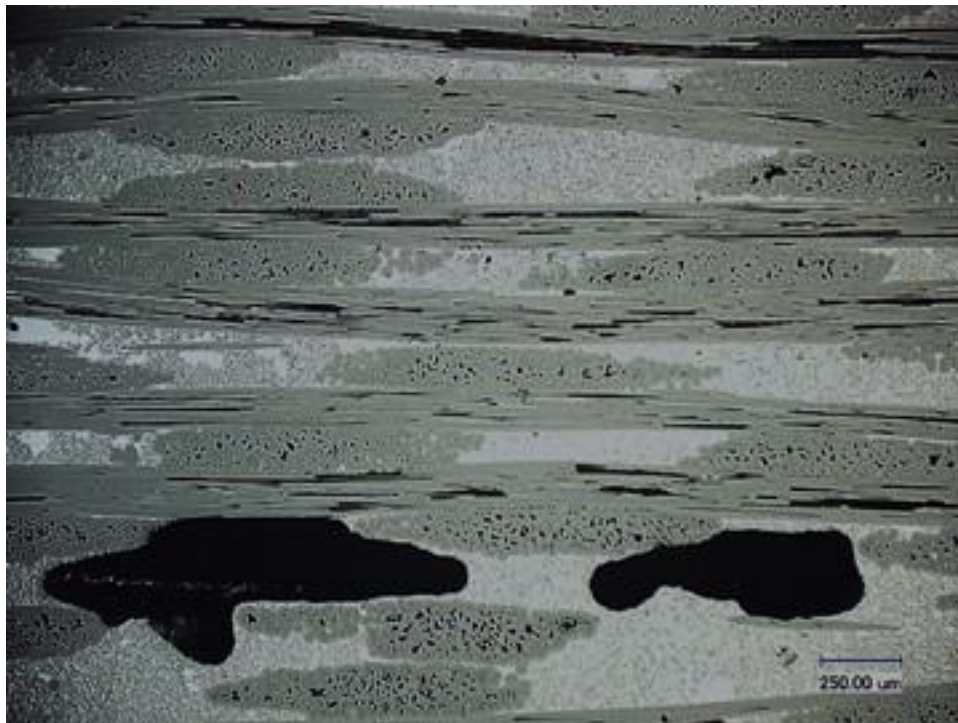
Figure 6. Intermediate Magnification Image of SMI SiC/SiC Showing Large Pores

The SiC/SiC material studied in this investigation was manufactured by using plies of Hi-Nicalon™ Five-Harness Satin Weave (5HSW) fabric to create a preform. The fibers in the preform were given a BN containing coating using chemical vapor infiltration (CVI). A silicon carbide matrix was applied over the BN using CVI. The preform was densified using a silicon carbide based slurry casting process followed by silicon melt-infiltration (SMI). The material and subelements were manufactured by Rolls Royce HTC. Examples of typical large pores are shown in Figure 5 for a low magnification image of the entire cross section of a flat panel while Figure 6 shows the large porosity at a slightly higher magnification. Examples of fine porosity typically found within fiber tows is presented in Figure 7.

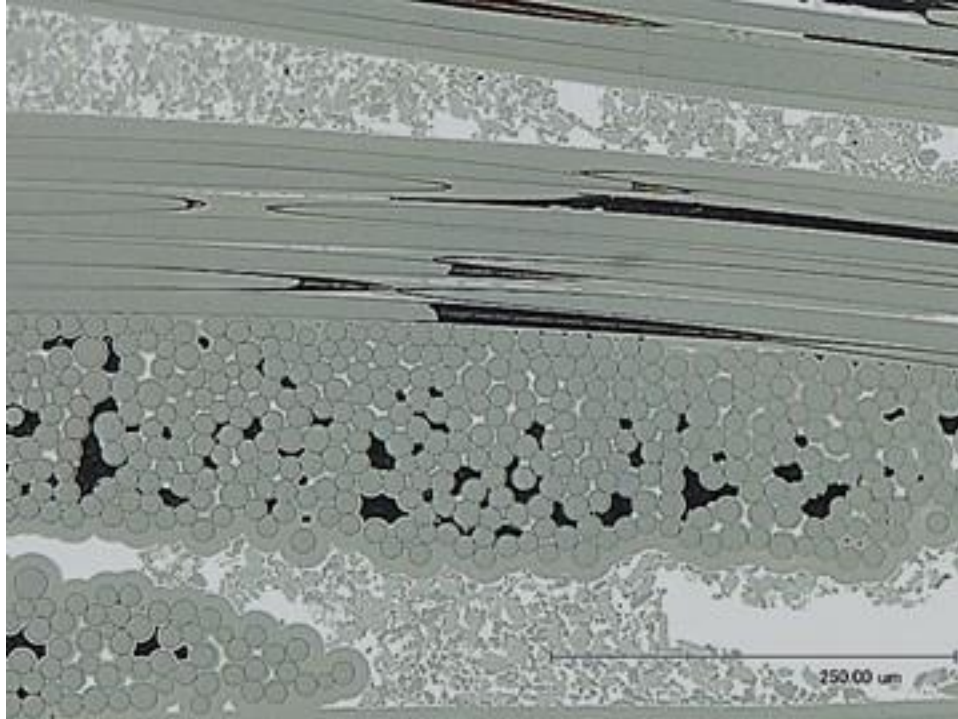
**Figure 7. High Magnification Image of SMI SiC/SiC
Showing Pores Within Fiber Tows**

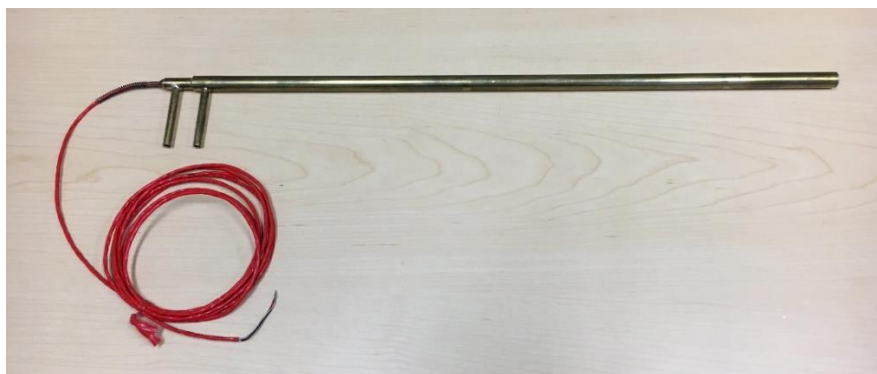
Figure 20. Optical Photograph Of Calorimeter Used To Measure Heat Flux

A calorimeter was used to measure heat flux. A schematic of the calorimeter is presented in Figure 19, and a photograph of the calorimeter used is presented in Figure 20. Calibration data for this particular calorimeter is presented in Table 7. This calorimeter was specially ordered with a length of the body of 20" in order to work in the burner rig. Each calorimeter is ordered for a specific maximum flux value. The team was not sure what flux the HVOF gun would generate. Therefore, a calorimeter was ordered that would be able to measure 100 W/mm² at 10 mV. The manufacturers stated that the calorimeter could be run to more than 50% of that value as long as the cooling water was effective.

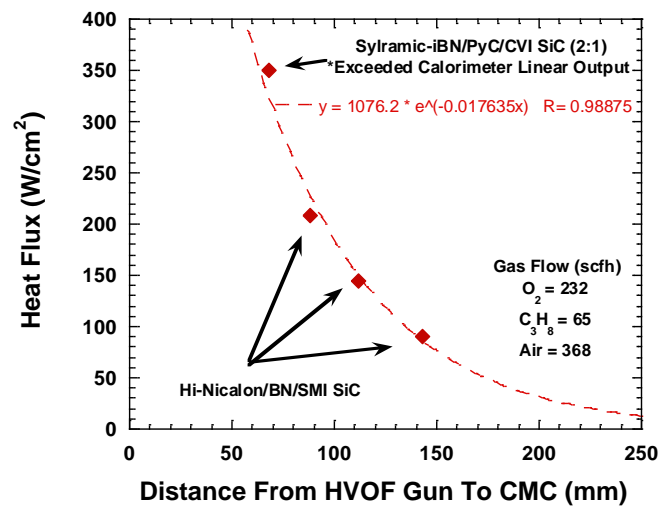
Figure 22. Heat Flux Shows a Exponential Relationship With Position Of The HVOF Gun Nozzle

are also presented graphically in Figure 22. Heat flux versus CMC temperature is presented in Figure 23. The data suggests there is an exponential relationship between heat flux and temperature for these SiC/SiC CMCs.

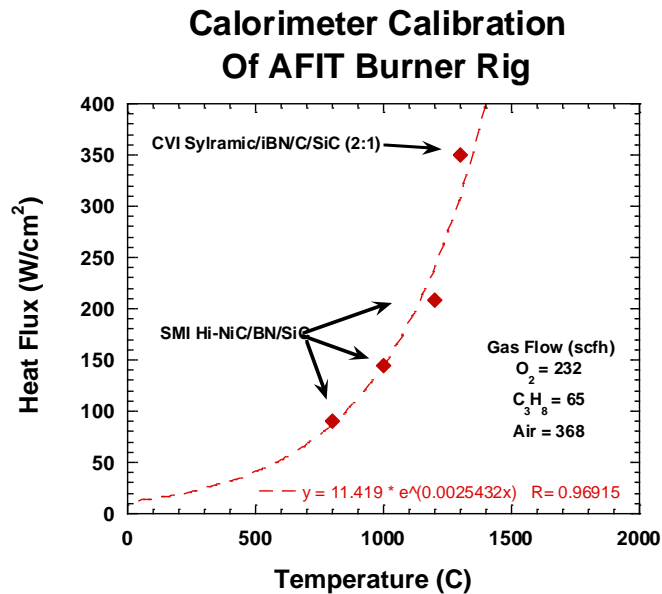
Figure 23. Heat Flux Versus SMI SiC/SiC Specimen Surface Temperature

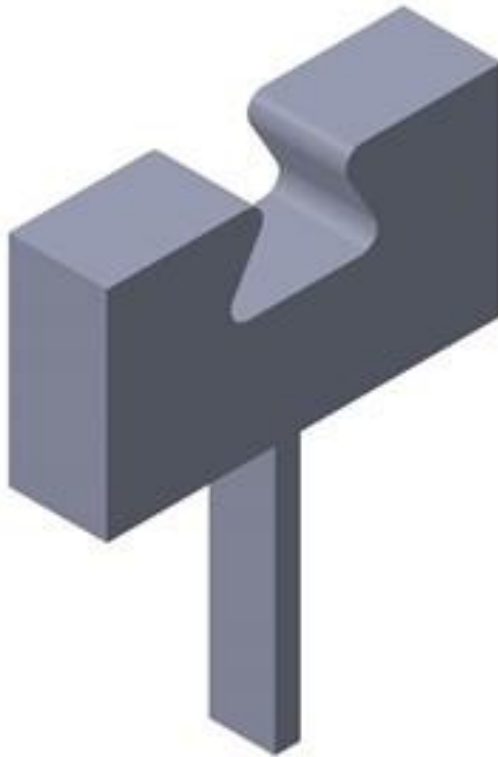
Figure 26. Schematic OF Wedge Grip Insert Used To Grip Subelement

A prototype grip fixture was first created using a 3-D printing method and it worked perfectly. The grip fixture was then machined out of IN100, which is a high temperature nickel-based superalloy that retains almost all of its strength up to 815°C and still exhibits reasonable strength up to 1000°C. A schematic of the gripping fixture is shown in Figure 26. The stem of the fixture was gripped in the MTS 647 wedge grips and the specimen is simply slid into the feature cut-out. The straight-side of the subelement was tabbed and gripped by the top 647 wedge grip. A photograph of the actual grip insert used to grip the subelement is shown in Figure 27. It is important to note that for the burn rig testing the stem of the grip was rotated 90° to accommodate how the grips were mounted in the test frame and the orientation of the HVOF gun.

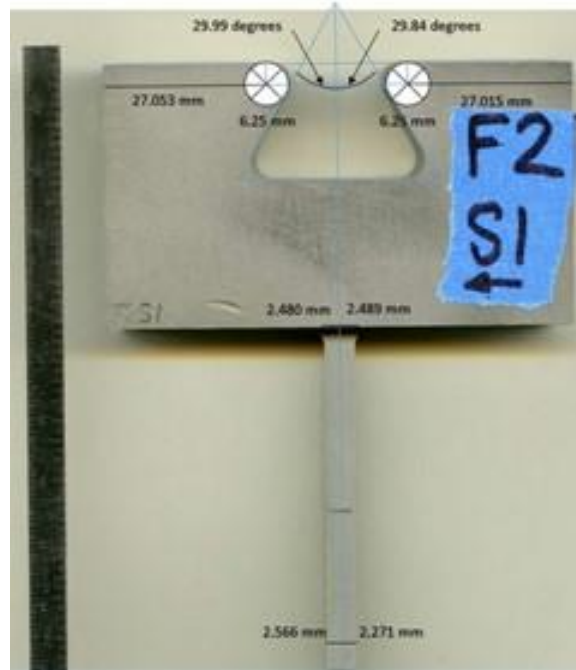
Figure 27. Photograph Of Wedge Grip Insert Used To Grip Subelement

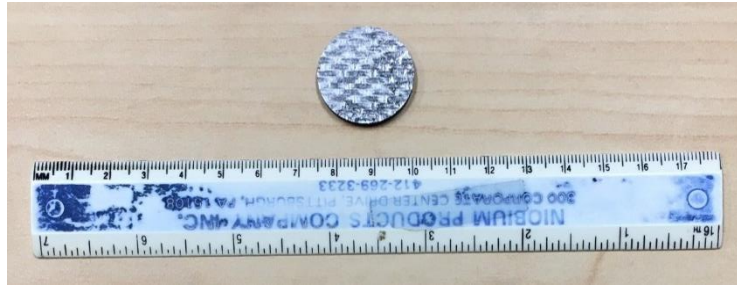
Figure 33. Photograph of Interlaminar Tension Specimen

The flat panel was machined into four ILT specimens, nine DNC specimens, and eight dogbone specimens. The dogbone test specimens were designed to be used for both tension testing as well as elevated temperature creep rupture testing. Specimens were machined from the panel using diamond tooling following established practices identified by ASTM. A schematic of how the panel was machined from the flat panel is shown in Figure 31. The drawing for the ILT specimen is shown in Figure 32 while an optical photograph of the ILT specimens is shown in Figure 33. The DNC specimen drawing is presented in Figure 34 while an optical image of the DNC specimen is presented in Figure 35. The dogbone specimen drawing is shown in Figure 36 while an optical image of one of the test specimens is presented in Figure 37.

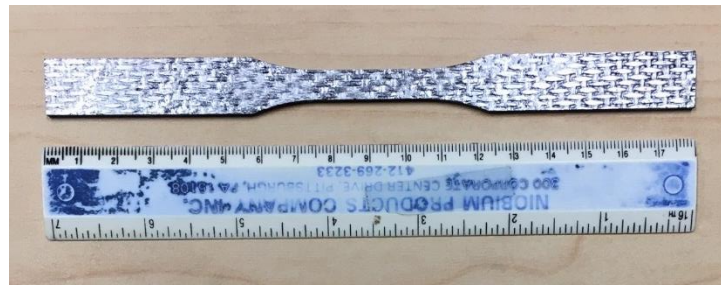
Figure 37. Photograph of Dogbone Specimen Used For Tension and Creep Rupture Testing

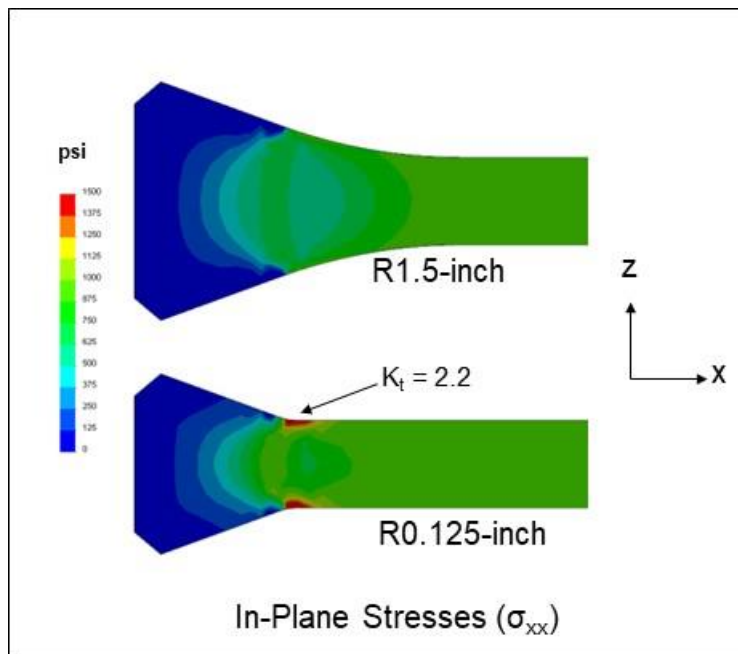
Figure 41. Schematic Showing Orientation of In-Plane Stresses (σ_{xx})

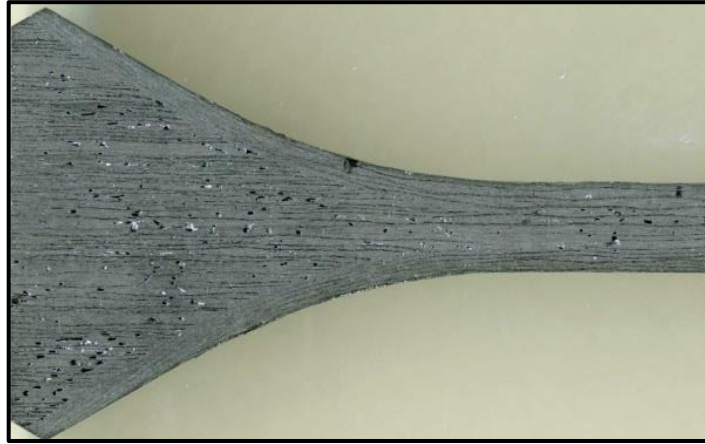
Figure 55. Optical Image of Dovetail Section Of Subelement Test Specimen

inserts that were added to the stack-up of plies. An optical micrograph showing the edge of the dovetail attachment region of an as-manufactured subelement test specimen is shown in Figure 55, while a photograph of an as-manufactured subelement test specimen is shown in Figure 56. It is important to note that the complexity of the subelement dovetail attachment architecture (i.e. ply drops, curved plies, etc.) did not contribute to additional porosity. It is also important to again specify that this is a generic design intended to promote high ILT stress levels in the dovetail section of the subelement test specimen and does not represent any actual CMC airfoil fiber architecture.

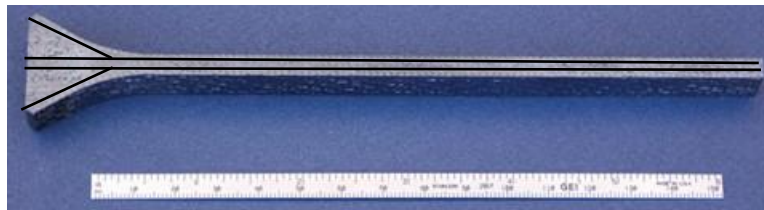
Figure 56. Optical Photograph Of An As-manufactured Subelement Test Specimen

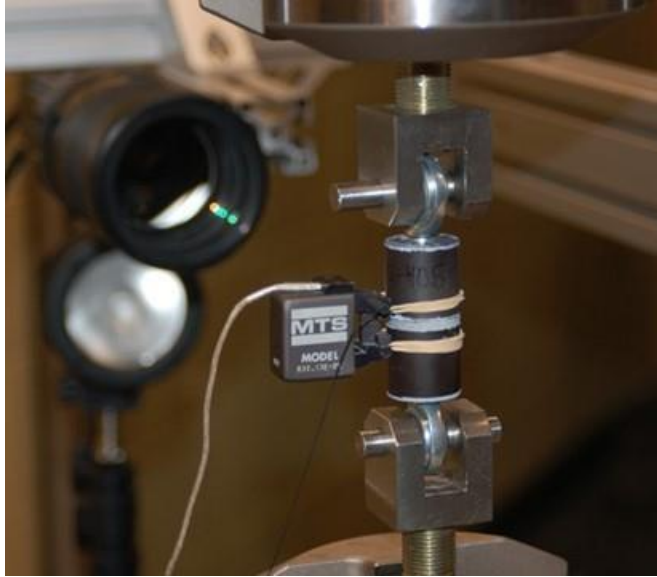
As part of an experiment, these tests were set up with a MTS knife edge extensometer as well as with a speckle pattern and a camera for DIC analysis to demonstrate if strain data could effectively be captured during an ILT test. Figure 60 shows an optical photograph of the ILT test setup. A 12.7 mm gage length extensometer was used to measure displacement in an attempt to determine if a through thickness modulus value could be calculated. However, even this short 12.7 mm gage length included the CMC test specimen, two layers of the FM1000 adhesive used to bond the button specimen to the steel pull-fixtures, and a few mm of the steel fixtures. Calculation of an ILT modulus using this strain data was therefore not possible as the strain versus load data was not usable. The DIC data was also very difficult to interpret, as the noise in the data was of equal magnitude to the displacements being measured. This was further complicated by the small field of view in focus (due to the round specimen) and the relatively large size of the speckle pattern. Therefore, no useful data was generated by the DIC measurement technique.

Figure 60. Photograph of Test Set-up For Room Temperature ILT Test on SMI SiC/SiC

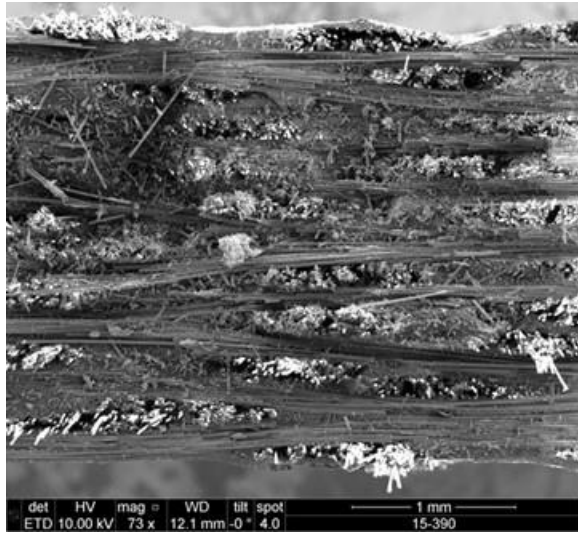
Figure 66. SEM Images of Fracture Surfaces for 1200°C Tensile (a) & c)) And Creep (b) & d)) Tested Specimens of SMI-SiC/SiC

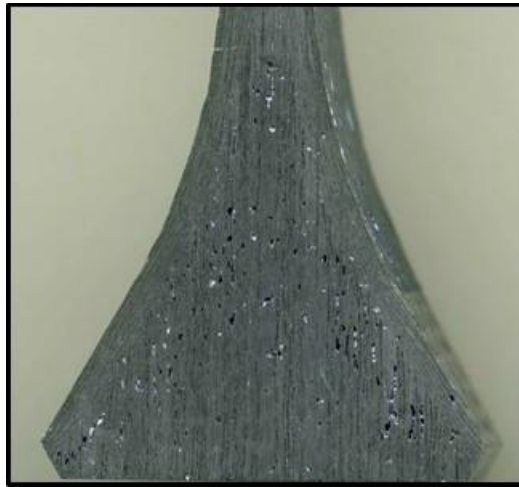
Figure 68. Optical Image Of The Dovetail Edge Of Specimen 15-453

To begin the study, a monotonic tension test was performed on subelement test specimen 15-543. The intent was to document stress-strain response and establish the failure mechanism. Each subelement was carefully inspected before being tested. Examples of how each subelement was inspected will now be provided. Figure 68 is an optical photograph of the subelement showing the edge of the dovetail region. There is some small porosity present and it is very small (< 0.1 mm) and well distributed. This observed porosity is of the size and distribution to the porosity

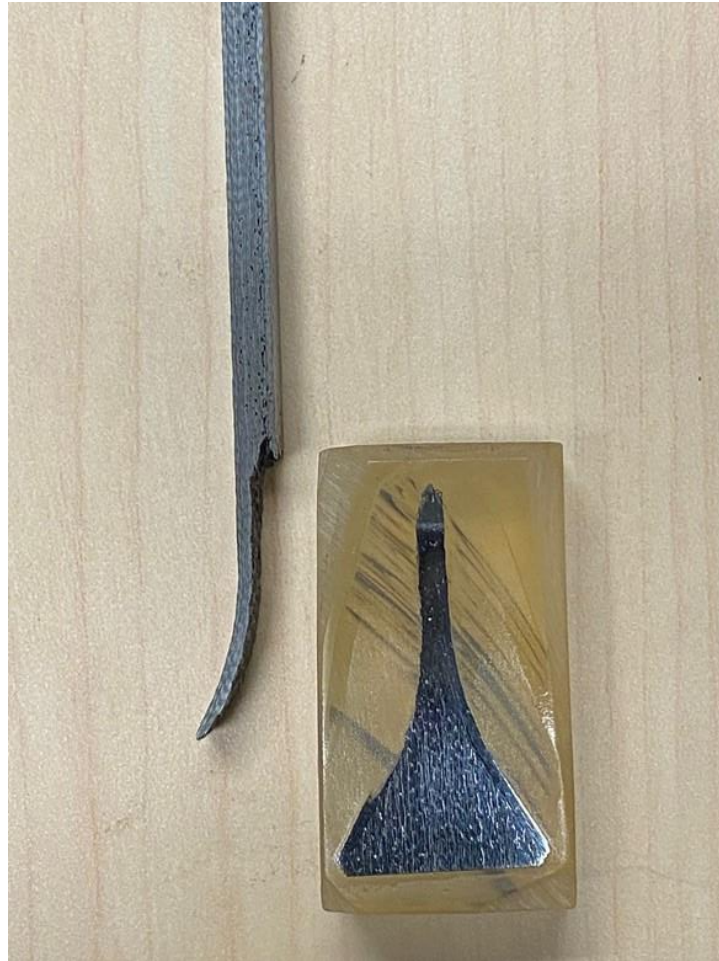
Figure 114. Photograph Of Failed Subelement Stem And Dovetail For Burner Rig Tested at 600°C And 200 MPa (15-546)

For this test the temperature was lowered to 600°C and the stress was kept at 200 MPa. The cycle count limit was set at 10,000 cycles. The specimen failed in the dovetail section of the subelement at only 79 cycles. A photograph of the failed test specimen is shown in Figure 114. The specimen failed in the dovetail section between the outer plies and the interior wedge filler plies in a manner very similar to the earlier test specimens that failed. Figure 115 is an expanded

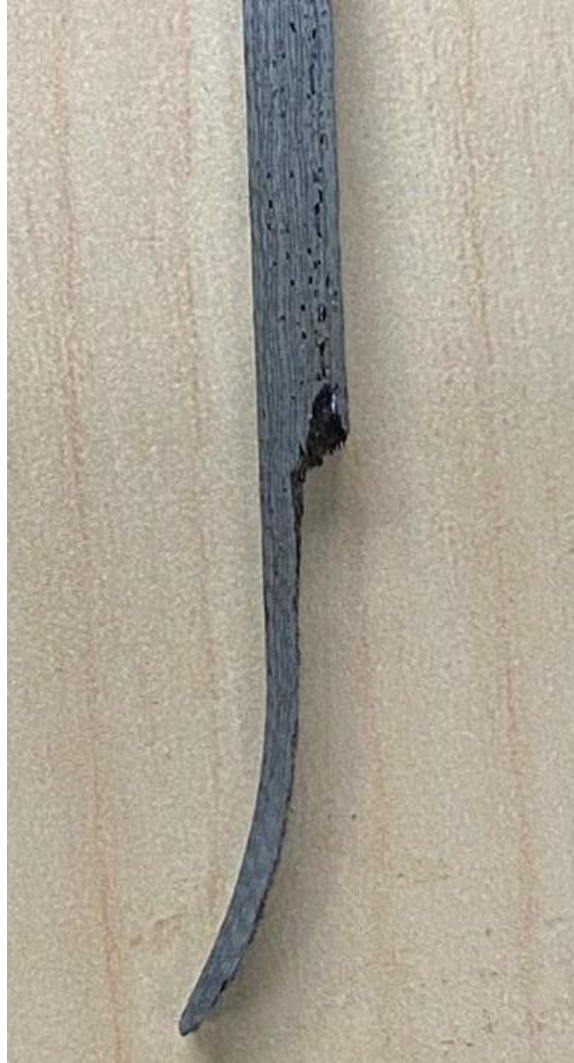
**Figure 115. Photograph Of Failed Subelement Burner Rig Tested at 600°C And 200 MPa
(15-546)**

view of where the failure occurred in the straight sided stem region. The specimen failed on the side that appears to have slightly more porosity in the stem as can be observed in the photograph. There appears to be a one ply in the stem that appears to have stringer type porosity, and this porosity is observed along the entire length of the subelement and is located a few plies deep from the surface. The specimen failed with the crack forming in the dovetail between the 10 outer plies and the wedge inserts. Failure was identical to the other subelements that failed in the dovetail region, so it was suspected that the porosity in the stem did not cause the early failure.
