MAJOR ORIENTATION-ERROR ACCIDENTS IN REGULAR ARMY UH-1
AIRCRAFT DURING FISCAL YEAR 1971: ACCIDENT FACTORS

W. Carroll Hixson and Emil Spezia

U. S. ARMY AEROMEDICAL RESEARCH LABORATORY
NAVAL AEROSPACE MEDICAL RESEARCH LABORATORY

July 1975

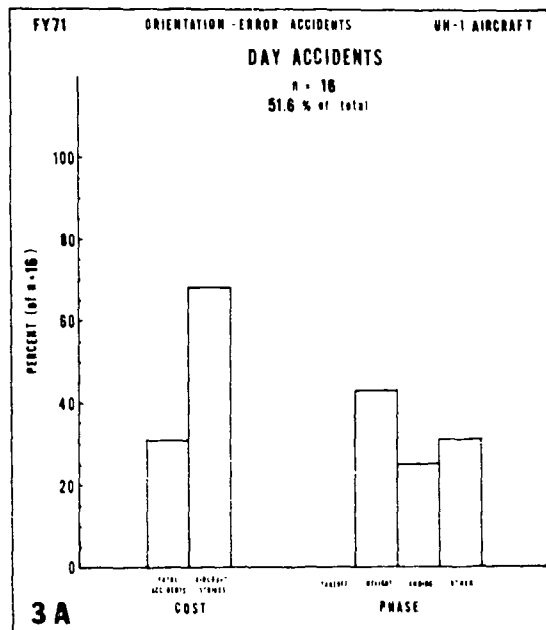
Figure 3

Comparison of percent incidence of fatal accidents, aircraft strikes, and flight phases for the 16 orientation-error accidents that occurred under daylight visibility conditions (A) and the 15 accidents that occurred under night visibility conditions (B).

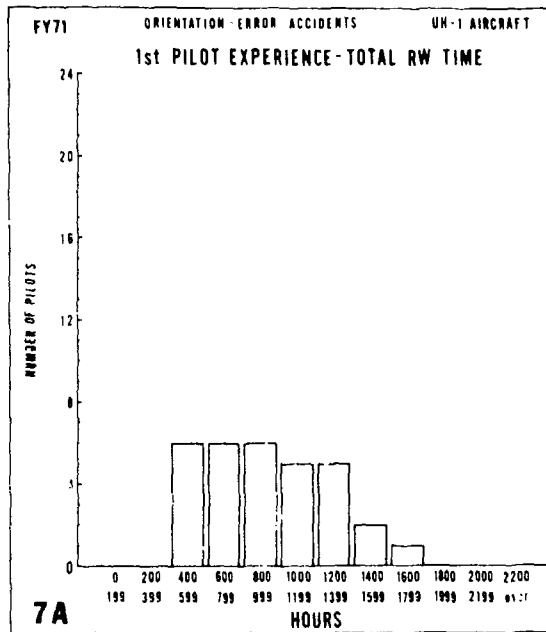
Figure 7

Distribution of total flight hours experience in military rotary-wing aircraft of the first pilots (A) and second pilots (B). The medians were approximately 887 and 400 hours, respectively. These data do not include any additional fixed-wing experience.

Data pertaining to the military rank of the first and second pilots are shown in Figures 5A and 5B, respectively. Age distribution data for the pilots are listed in Figure 6. Aviator experience in terms of total flight hours both in all types of military rotary wing (RW) aircraft and in the UH-1 aircraft is described in Figures 7 and 8, respectively. The median for the total recorded RW experience was 887 hours for the first pilots and 400 hours for the second pilots. In terms of UH-1 flight experience, the median time was 550 hours for the first pilots and 175 hours for the second pilots.

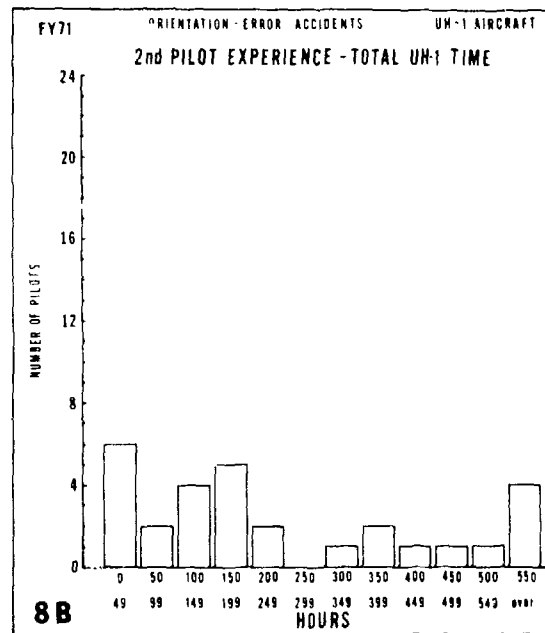
Figure 8

Distribution of total flight hours in the UH-1 aircraft of the first pilots (A) and second pilots (B). The median times were approximately 550 and 175 hours, respectively.
