REPORT NO. CG-ECV-1-77

# MARINE BORERS

CIVIL ENGINEERING DIVISION  
OFFICE OF ENGINEERING  
UNITED STATES COAST GUARD HEADQUARTERS  
WASHINGTON, D.C. 20590

AUGUST 1977

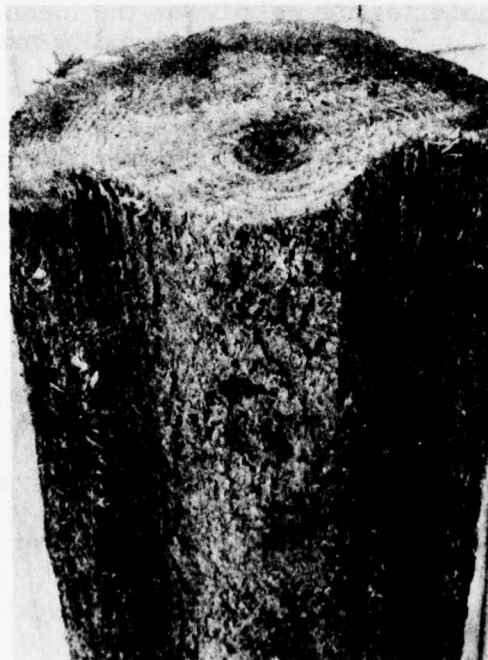
Extensive *Limnoria* damage to piles reducing bearing capacity and restricting usage of facility well under expected service life.

Surface gouging effect of *Limnoria tripunctata* on creosoted pile showing galleries in both the treated and untreated parts of the wood.

Although many techniques have been used to combat marine borers, they cause an estimated \$50 million of damage per year to foreshore marine installations in the United States. Figure 1 shows a facility in Los Angeles Harbor that has sustained extensive damage to creosoted piles in less than (7) years, well under the original contemplated thirty (30) years life of the facility.

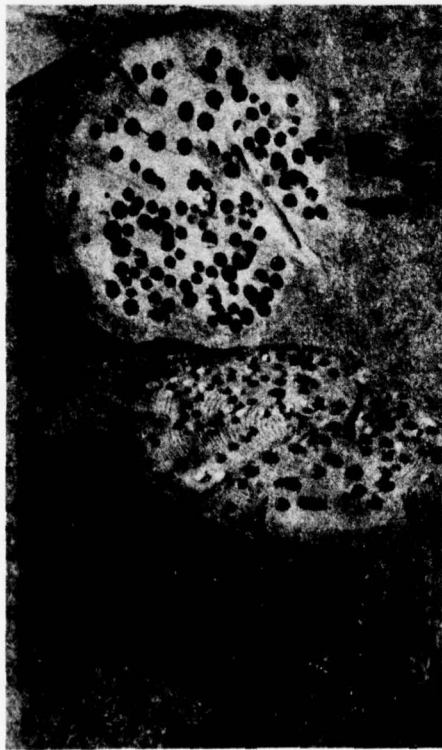
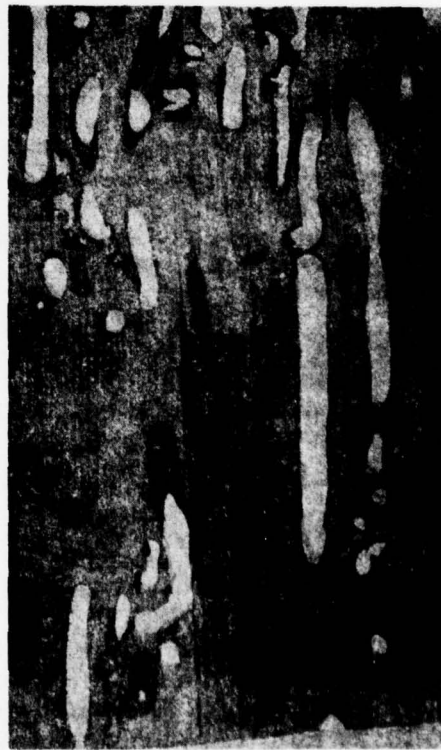
Figure 2

Creosote Treated Pile Section with no visible damage.

Cross-section of Above Pile showing heavy Teredine damage and loss of cross-section.

Longitudinal Section of Same Pile showing the eccentricity of the voids and extensive loss of cross-section.

The most destructive borers and also the most difficult to detect are in the Mollusca Subfamily. Results of their actions are shown in Figure 2. The *Teredo* (Mollusca Subfamily) can destroy an unprotected pile in less than a year, whereas *Limnoria* (Crustacea Subfamily) may take up to 8 years. The area of attack of the marine borer generally extends from the mud line to the high water line, as shown in Figure 6. In the past it was thought that *Limnoria* showed the greatest attack at the mean tide and *Teredo* at the mud line. However, experiments have shown that this is not necessarily the case. In some localities *Teredo* or *Limnoria* may show a particular area of concentration relative to the mean tide line of the pile, yet the point of attack on a pile in another locality may be different.

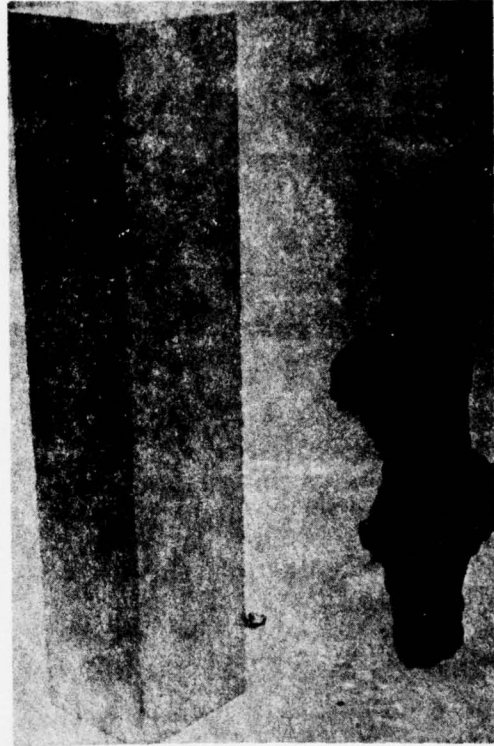
Figure 5

Surface Borer *Limnoria lignorum*  
approximately 2-3 mm in length.

Test material before and after  
Limnoria attack.

Pile in foreground with classic *Limnoria* 'hourglassing',  
two other piles completely destroyed.

2. Crustacean Borers - There are three important Crustacean borers: *Limnoria*, *Sphaeroma* and *Chelura*. *Limnoria*, the most widely distributed of the genera, is illustrated in Figure 5. The *Limnoria* are surface gougers which resemble small lobsters or wood lice about  $1/8$  inch (3.2 mm) in length and a width of about  $1/3$  the length. The mouth of the *Limnoria* contains a pair of strong, horny-tipped mandibles with which the boring is done. Its body has numerous pairs of legs ending in sharp, hooked claws so that it can move freely and cling to timber. It uses its gill plates for swimming. *Limnoria* destroy timber by producing a lacy network of tunnels at the wood surface, seldom penetrating more than a  $1/4$  of an inch (6.4 mm). As these lacy networks of tunnels are eroded away by wave action the animal penetrates deeper into the wood. As many as 400 borers per square inch (645 sq. mm) have been counted on timber under heavy attack. The points of greatest concentration are found near the mud line and mean tide level (See Figure 6) but they may be either distributed uniformly or concentrated anywhere between these limits.

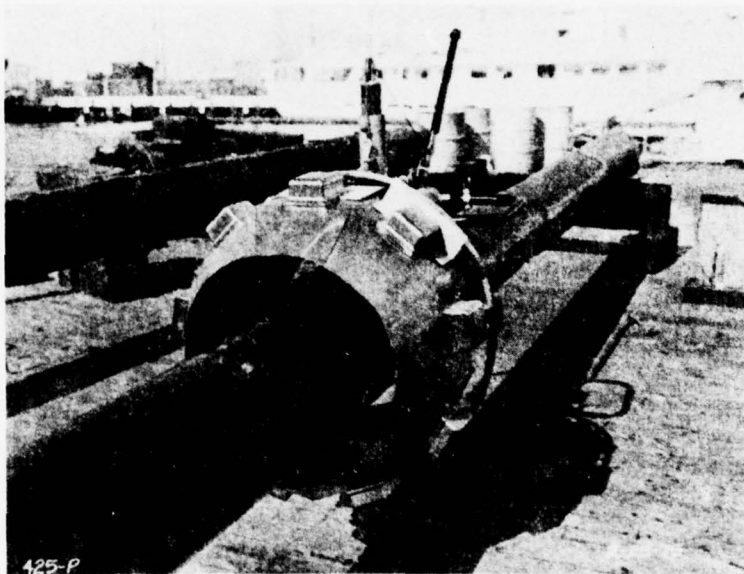
Figure 10

Heat Shrinking Unit shrinking 20 mil (0.5 mm) polyethylene film tightly to the pile. The Port of Los Angeles has handled and driven numerous piles without damaging the film.

(3) Heat Shrink Polyethylene to Timber Piling - Port of Los Angeles Engineering personnel have developed a unit for the application of 20 mil (0.51 mm) polyethylene by heat shrinking directly onto the pile before it is driven. The unit consists of an annular windscreen enclosing a ring of propane fired ceramic burners. (See Figure 10) The polyethylene is applied in 10' 6" sections (3.2 meters). As the unit passes over the polyethylene film, it shrinks circumferentially and tight against the pile and at the same time makes a heat seal at the overlapped portion. The result is a one-piece continuous film of 20 mil (0.51 mm) polyethylene tightly shrunk to the pile. About 5 to 7 feet (1.5 to 2.1 meters) is left uncovered at each end so that the pile may be handled without damaging the film. After driving, all areas of the pile exposed to seawater immersion are protected with polyethylene.

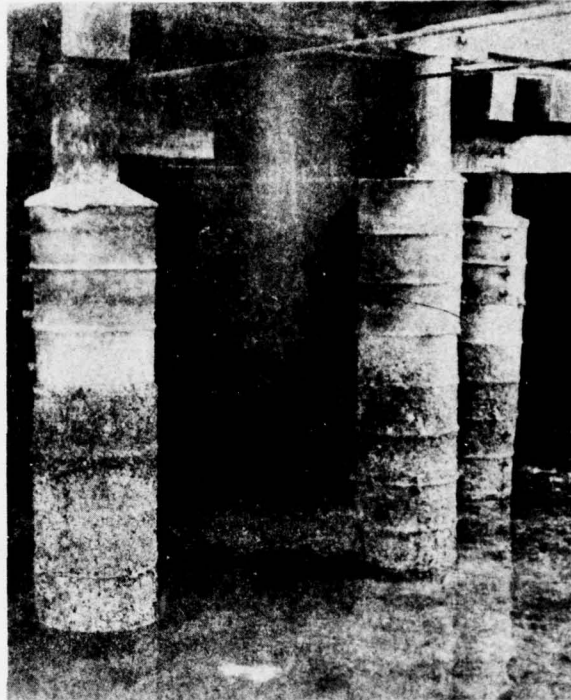
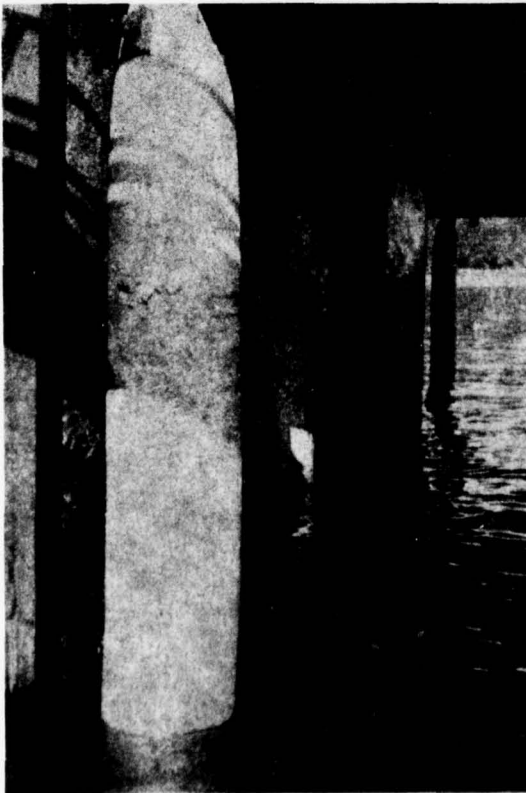
Figure 13

Fabric "sock" or bag installed as a mold around length of damaged pile, reinforcing steel placed and bag pumped full of concrete. Works well on steel H-beam, pipe and pre-stressed concrete pilings as well as on wood.

is installed as a mold around the length of a damaged pile, reinforcing mesh or rods are placed around the pile inside the sock and the sock is pumped full of concrete. (See Figure 13). This process has been used successfully even on piling which are subjected to considerable lateral bending.
