FAA-NA-77-41

FAA-RD-77-169

**THE ANALYSIS OF NATIONAL TRANSPORTATION SAFETY BOARD
LARGE FIXED-WING AIRCRAFT ACCIDENT/INCIDENT REPORTS
FOR THE POTENTIAL PRESENCE OF LOW-LEVEL WIND SHEAR.**

11
DECEMBER 1977

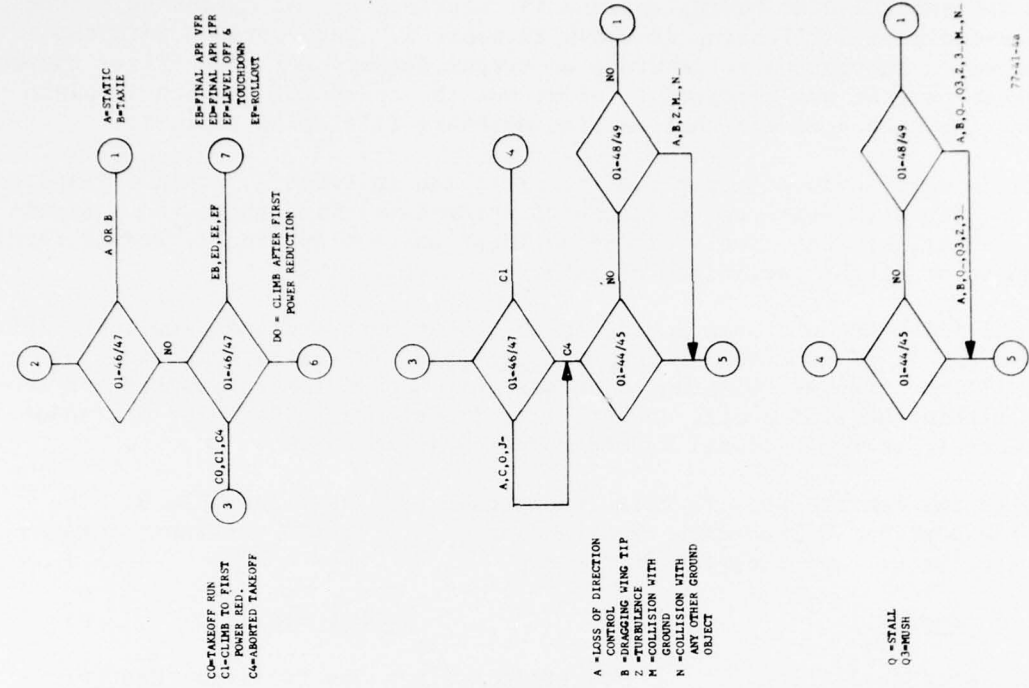
FIGURE 2. COMPUTER FLOW DIAGRAM FOR SCREENING NTSB DATA BASE (Sheet 1 of 2)

The flow diagram for the software to screen the NTSB data base is shown in figure 2 using the NTSB coding defined in reference 5. An expansion of the software-controlled filtering is shown in table 1. Incorporated into the program was a subroutine to generate an output summary for each filter control. A separate program was prepared to print out the coded information in plain language for each accident that met the software filtration criteria.

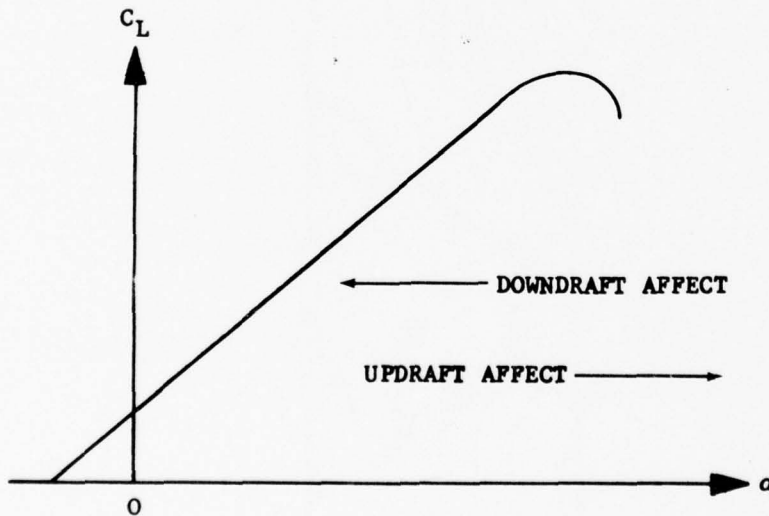
FIGURE A-4. VARIATION IN LIFT COEFFICIENT WITH ANGLE OF ATTACK

and a typical graphic presentation of the lift coefficient versus angle of attack (α) (figure A-4).

The wing angle of attack is the vector summation of the aircraft's pitch attitude, corrected for the wing's angle of incidence and the direction of the prevailing wind. Thus, an encounter with an updraft or downdraft when an aircraft is moving toward the runway during an approach (horizontal wind shear) would change this vector. The result would be a change in angle of attack which would affect the " C_L " term in the lift equation (equation 1). This could cause the aircraft to either "balloon" or result in a hard landing. If the change in angle of attack is severe enough, it can result in an overshoot or undershoot depending upon whether it is an updraft or downdraft.
