NAVAL POSTGRADUATE SCHOOL

EFFECTS OF DISSIMILAR METAL COUPLING,
POTENTIAL DISTRIBUTION, AND TEMPER CONDITION
ON GALVANIC CORROSION OF 5086 ALUMINUM ALLOY
IN SYNTHETIC SEAWATER

January 1978

Technical Report No. 5 ✓
To the Office of Naval Research
Contract No. N00014-77-WR-70215 ✓
NR-036-120

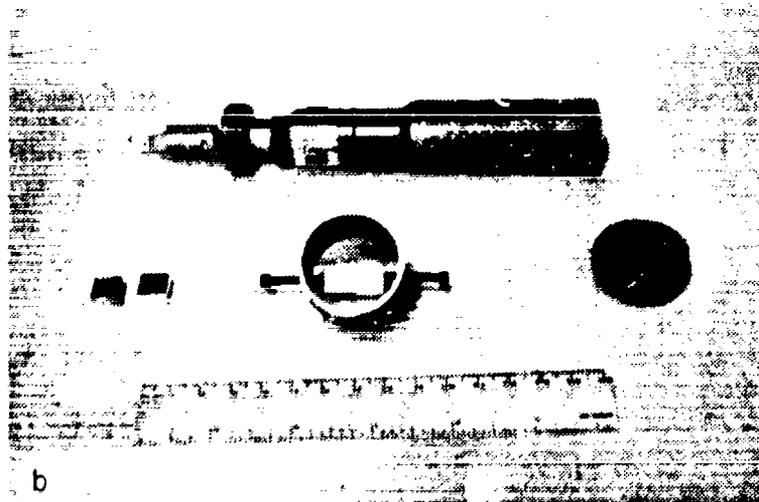
Figure 2: (a) Experimental equipment used for exposure of galvanic couples
(b) Mounting equipment used to form proximate galvanic couples
Shown are torque wrench, sample coupons, mounting ring, and
final mounted couple.

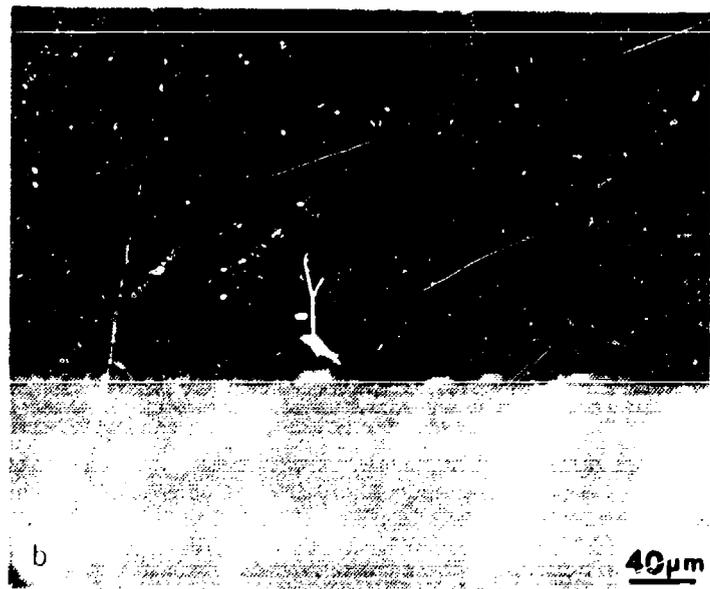
Figure 3: (a) Initial condition of bimetallic interface in proximate bimetallic couples, 550x. (b) Initial condition of metal: plastic interfaces of mounted samples, 240x.

The observed feature of a degree of increased attack at the plastic:Al interfaces occurred because the specimen design employed could not avoid some finite elevation difference at these interfaces (see Fig. 3), so that some concentration of electrode current occurs at these locations. Some of the results reported in the next section, for samples cleaned of corrosion products, will support these explanations of sample mount edge effects. It should be noted that these edge effects were not so great as to confuse observations of general corrosion product form and distribution over the members of the galvanic couples.

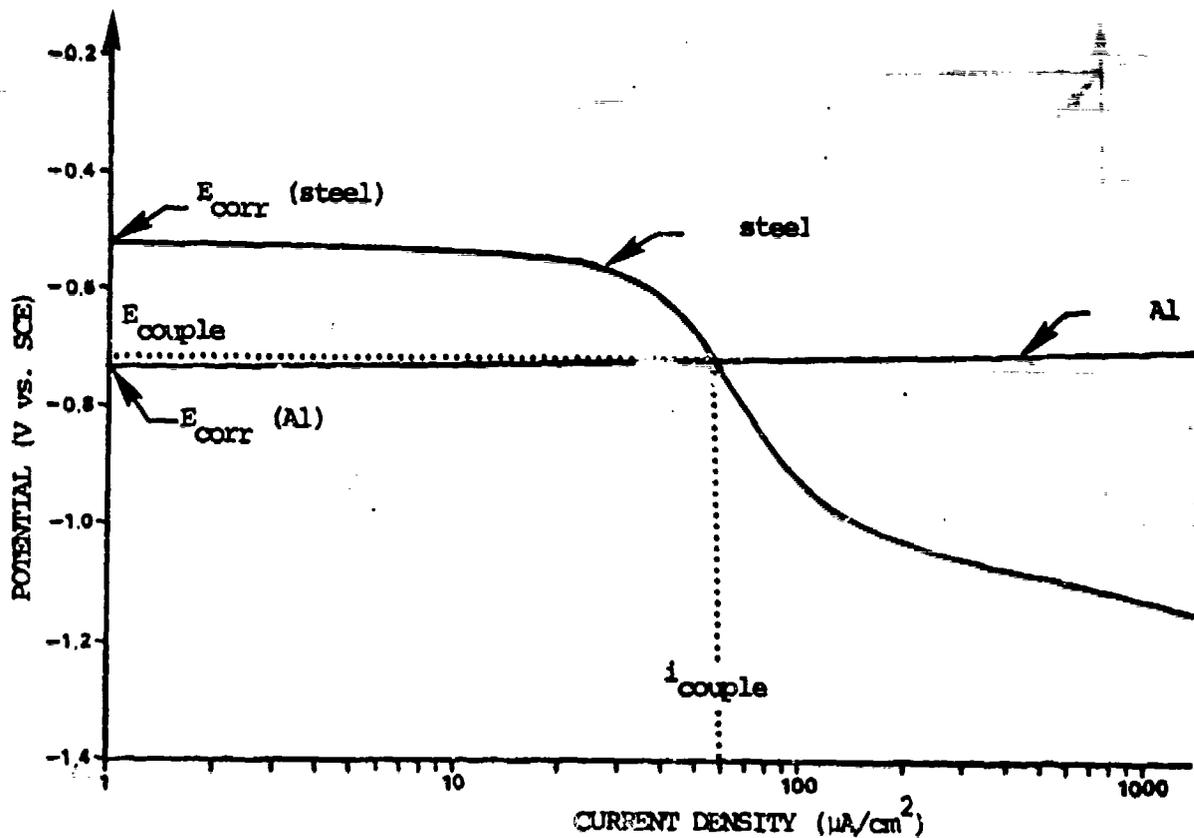
Figure 4: Potentiodynamic polarization curves for 5086 aluminum and 1040 steel in aerated synthetic seawater.

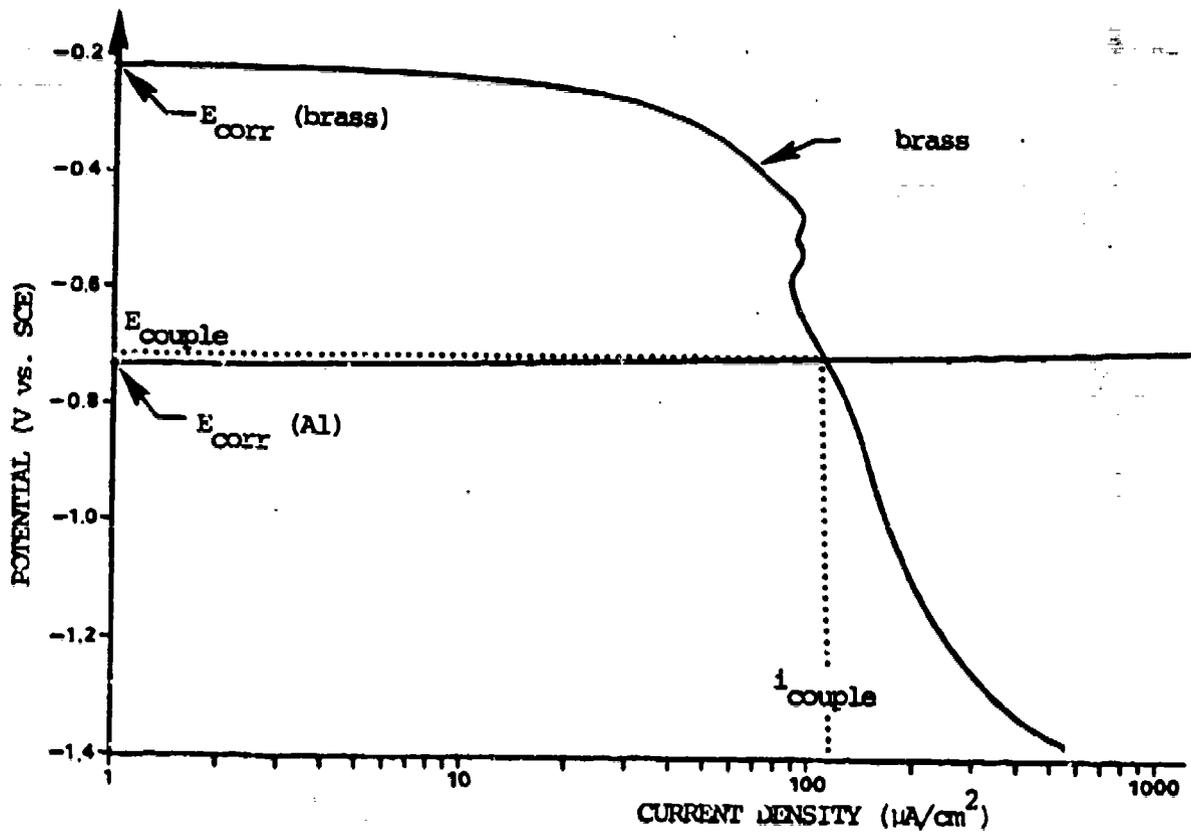
Figure 5: Potentiodynamic polarization curves for 5086 aluminum and naval brass in aerated synthetic seawater.

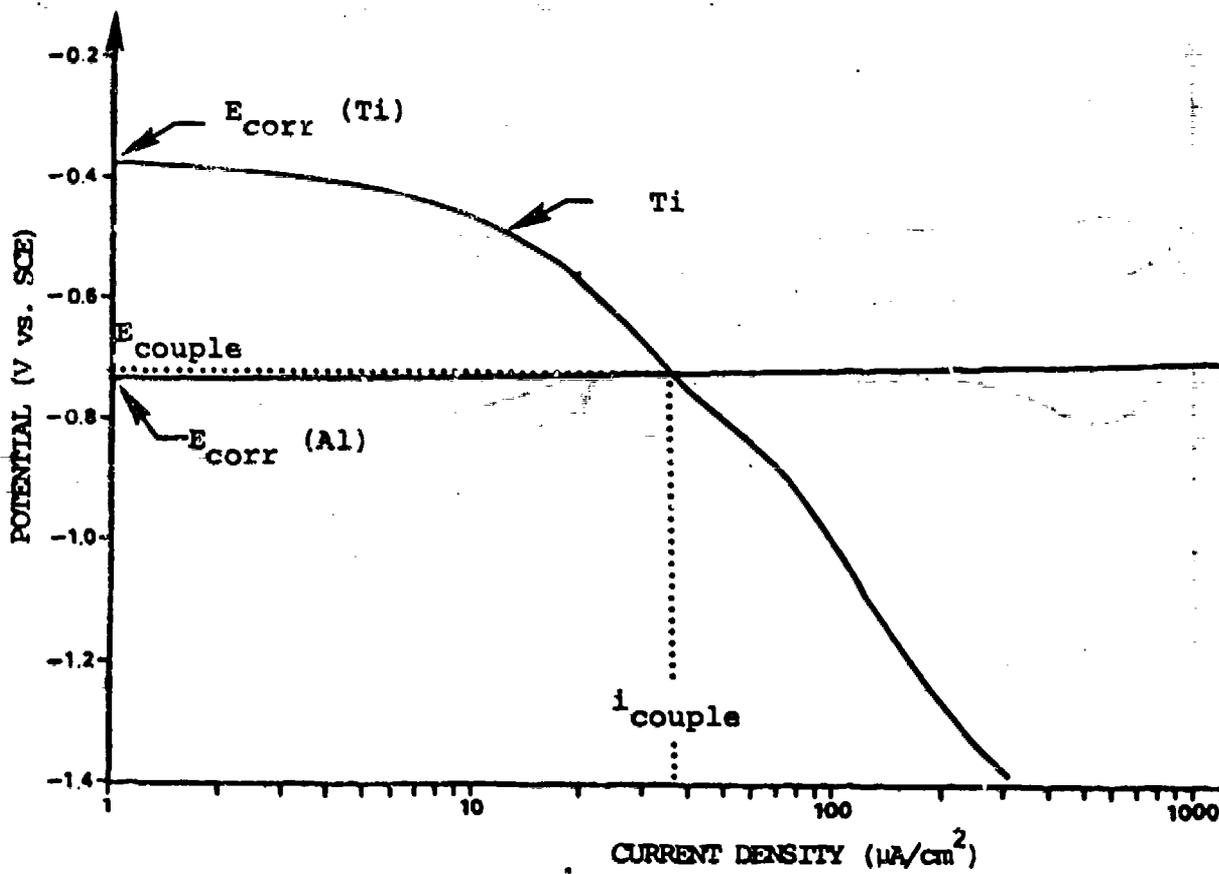
Figure 6: Potentiodynamic polarization curves for 5086 aluminum and T1-150A titanium in aerated synthetic seawater.

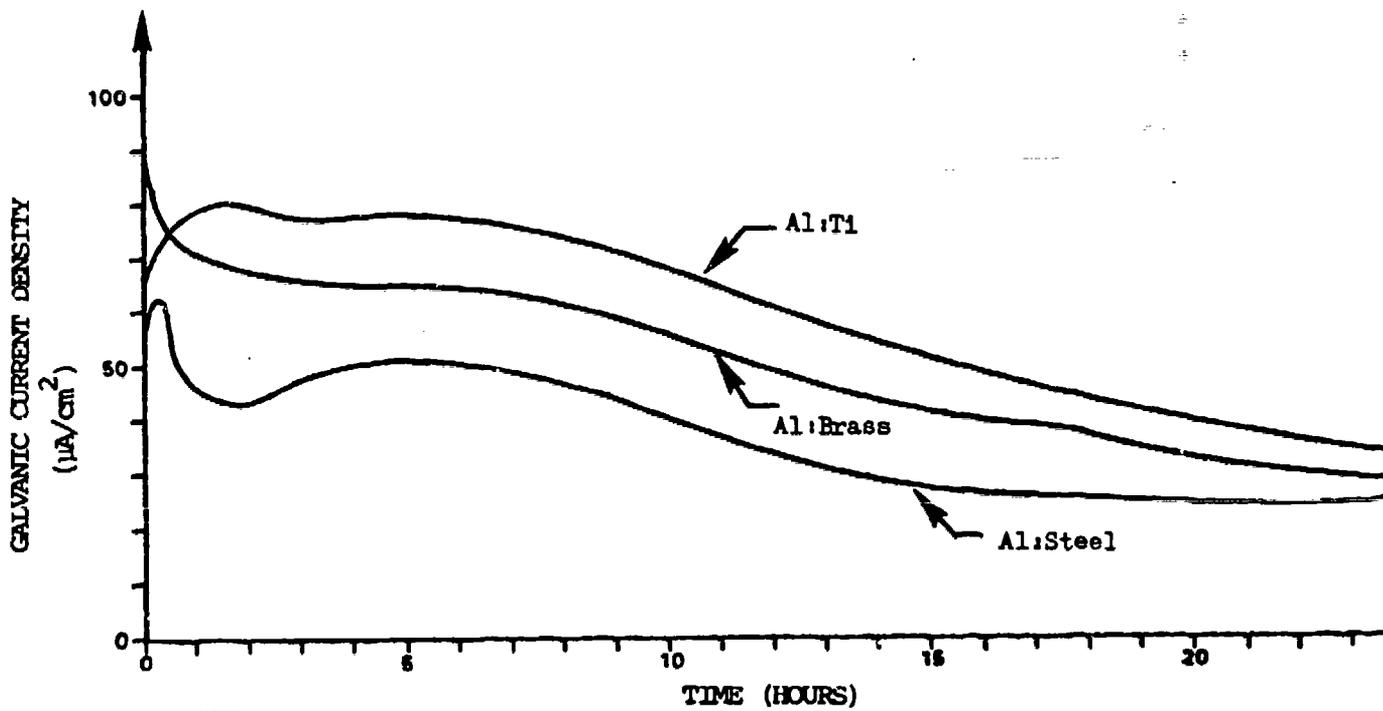
Figure 7: Variation of galvanic current density over a 24 hour period for 5086-H32 aluminum couples with 1040 steel, naval brass, and Ti-150A.

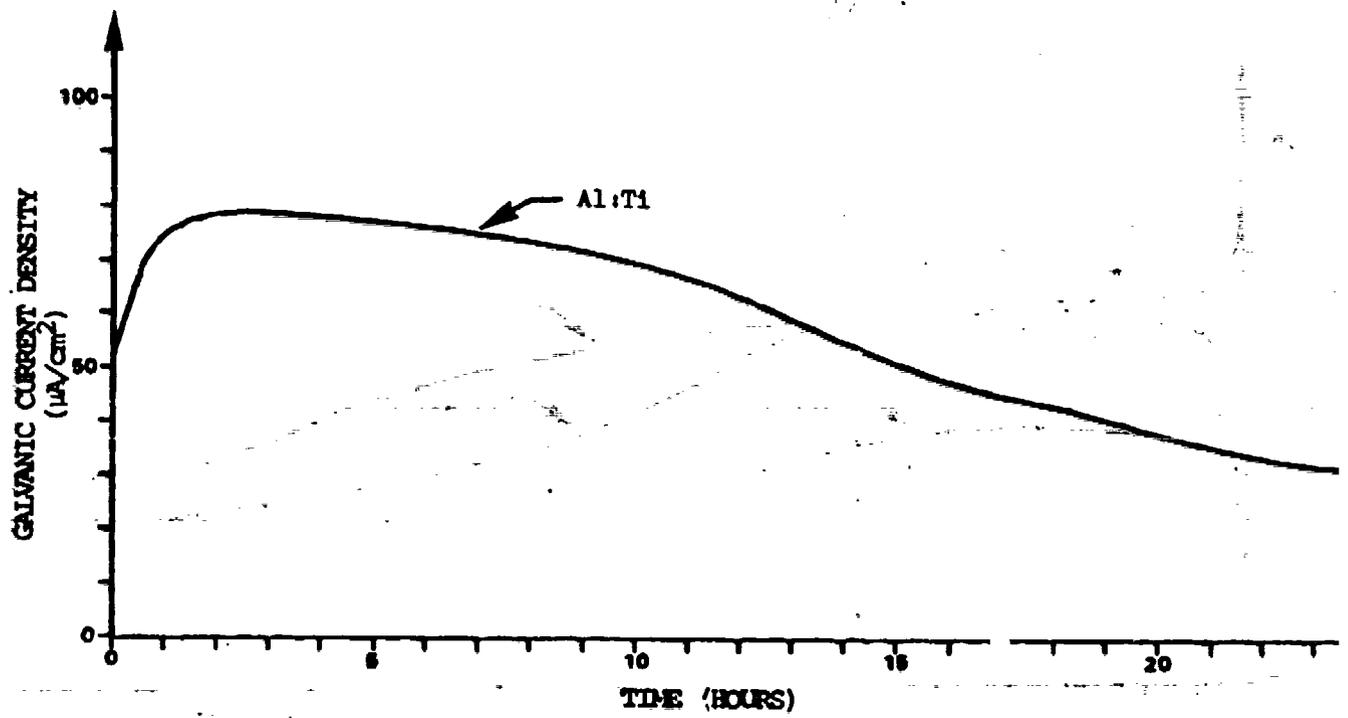
Figure 8: Variation of galvanic current density over a 24 hour period for 5086-H116 aluminum couple with Ti-150A.

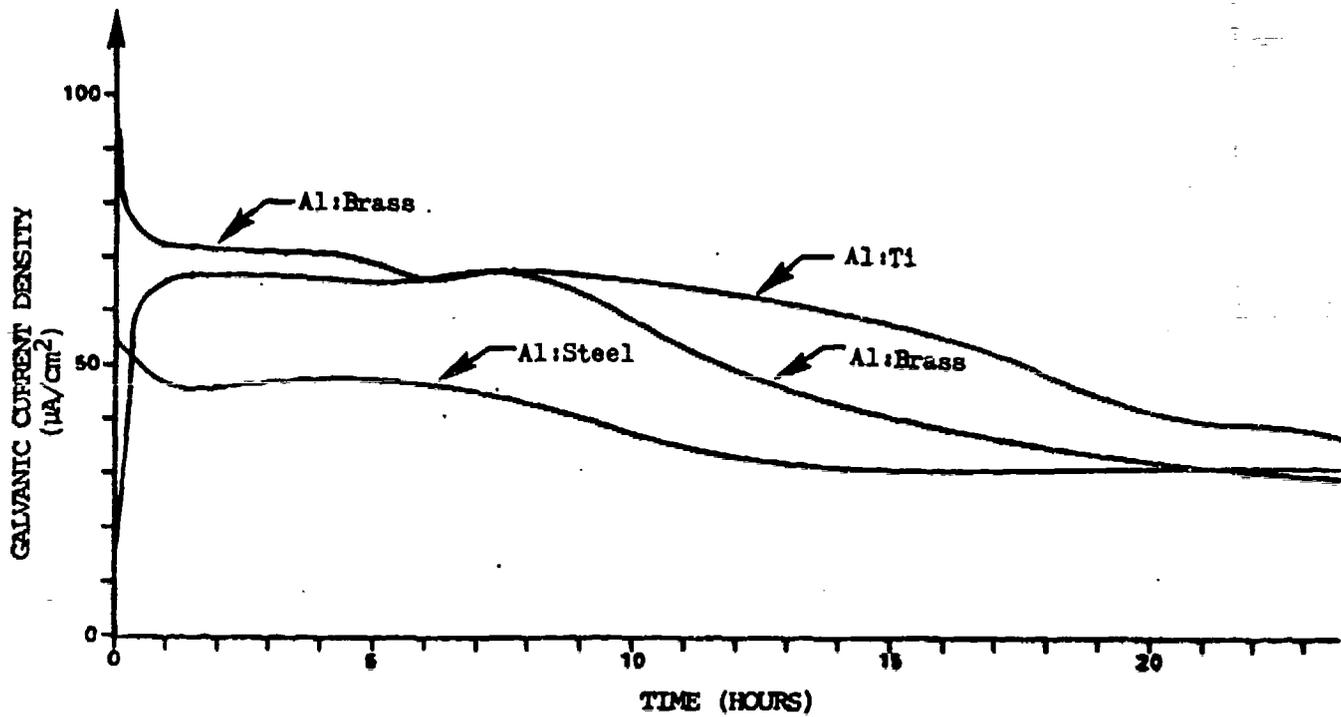
Figure 9: Variation of galvanic current density over a 24 hour period for 5086-H117 couples with 1040 steel, naval brass, and T1-150A.

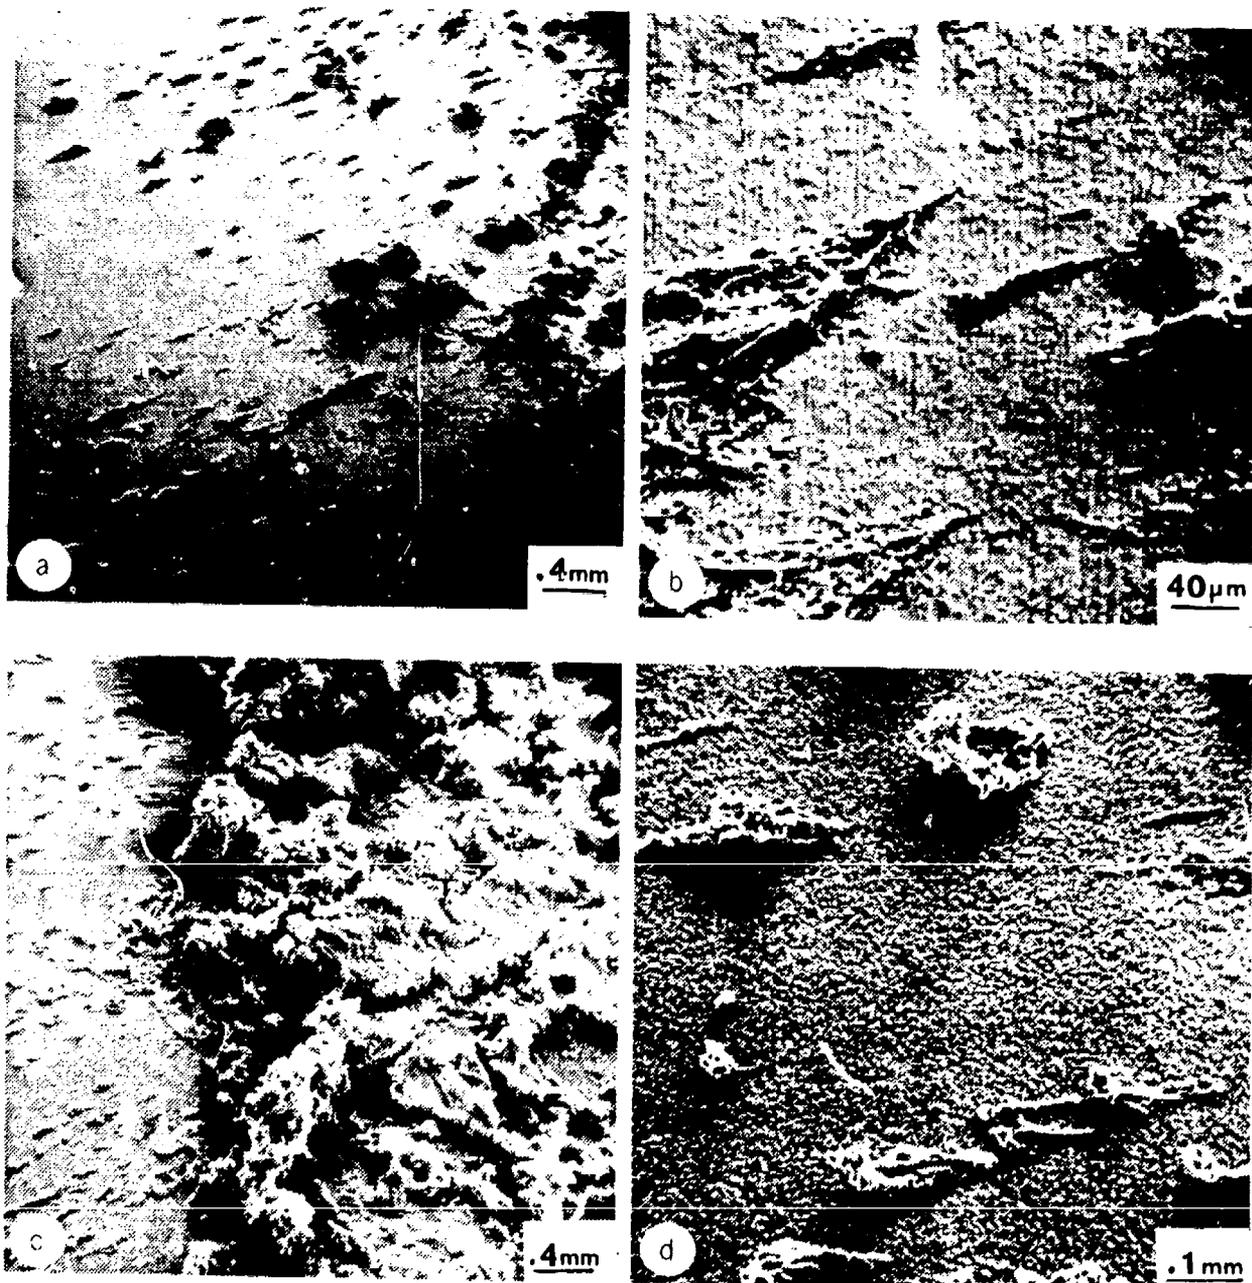
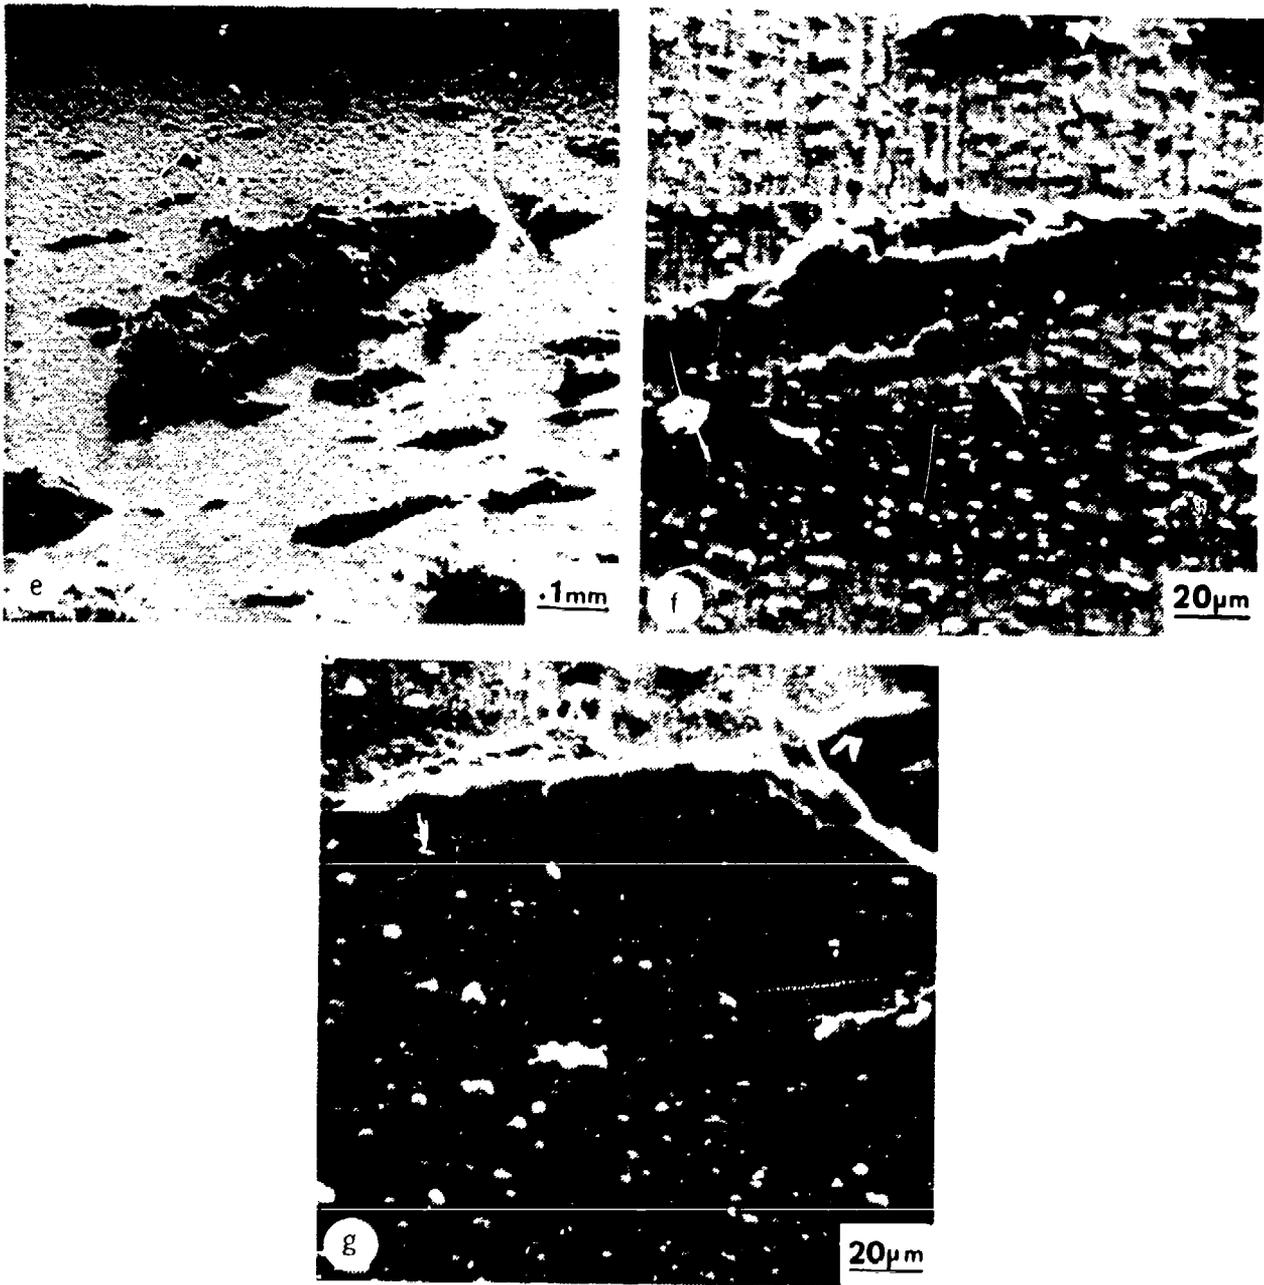
Figure 12: General ridge-like morphology of corrosion product outcroppings found in accumulations on cathodic members of proximate couples in aerated synthetic seawater: (a) on titanium member of Ti/5086-H116 couple exposed for 3 weeks, 24X (b) same, 240X, (c) on titanium member of Ti/5086-H32 couple exposed two weeks, 24X (d) same, 110X (e) on naval brass members of brass/5086-H32 couple exposed 550X three weeks, (f) on titanium member of Titanium/5086-H116 couple exposed two weeks, 105X (g) on 1040 steel member of steel/5086-H32 couple exposed one week, 540X.
