DAMAGE PROFILES IN SILICON AND THEIR
IMPACT ON DEVICE RELIABILITY

G. H. Schwuttke, Principal Investigator, 914 - 897-3140

International Business Machines Corporation
East Fishkill Laboratories
Hopewell Junction, New York 12533

Final Report
April 1, 1978

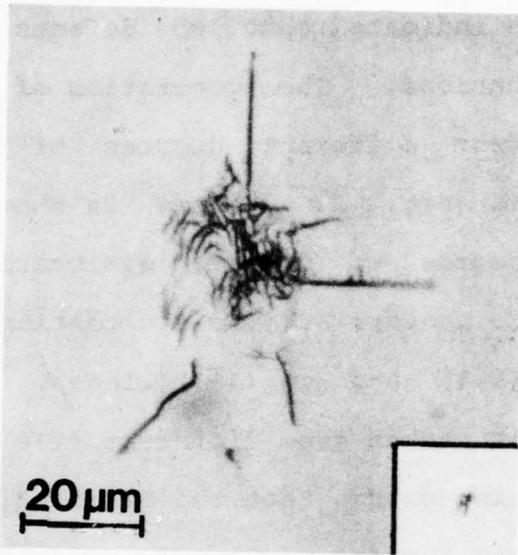
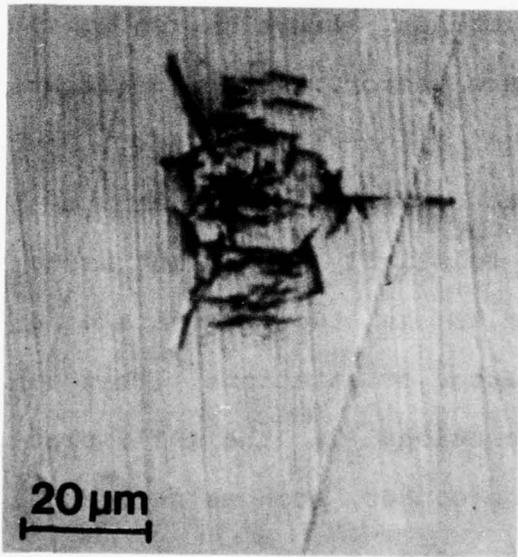
Fig. 1 Optical micrographs showing the compressive mode of ISS damage in (a) (001) and (b) (111) wafer surfaces.

On (001) surfaces, the compressive mode generates damage sites roughly of square shape as shown in the insert of Fig. 1a. After preferential etching a dense network of defects is revealed. This network consists of one group of defects clustering around a damage center and another group that radiates from the center and propagates in $\langle 110 \rangle$ directions. Similar characteristics are observed for wafers of (111) surface orientation, Fig. 1b.

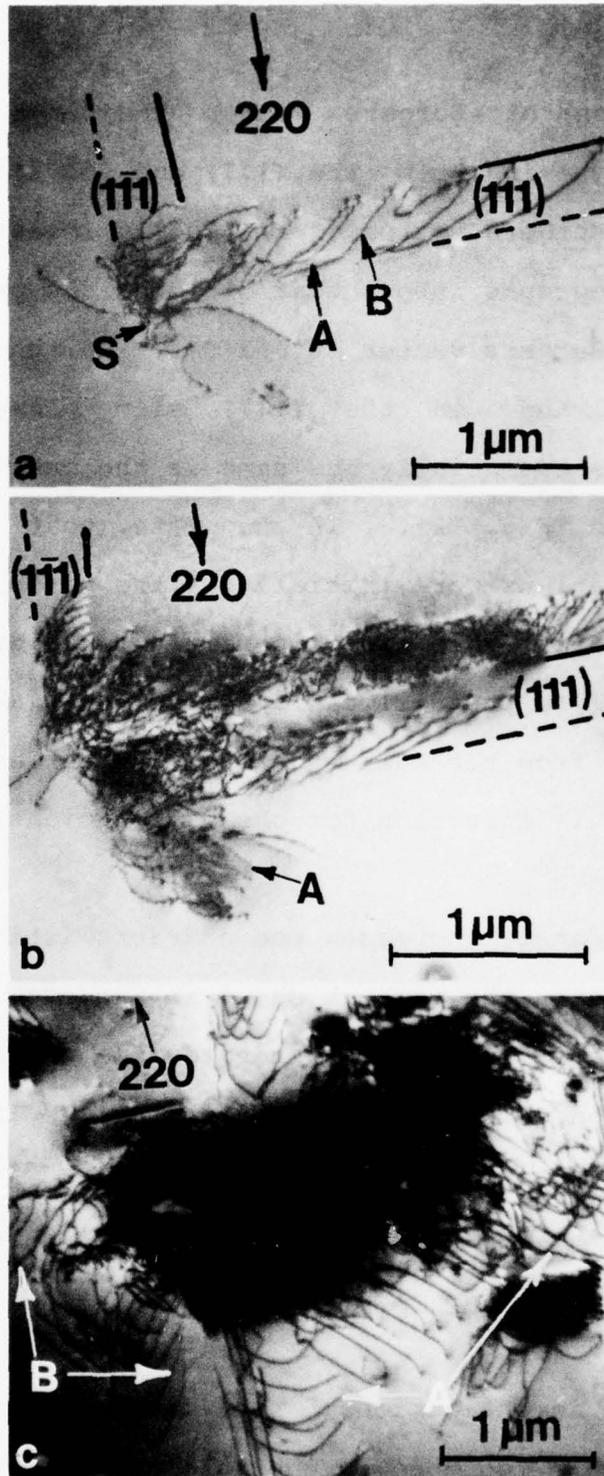
Fig. 2 Transmission electron micrographs showing the generation of dislocation arrays induced by the compressive ISS damage. The density of the dislocations generated increases as the degree of damage increases from (a) through (b) to (c).

TEM investigations indicate that the defects revealed by etching are dislocations. The generation of dislocation arrays resulting from different degrees of compressive damage is shown in Fig. 2. Figure 2a shows that at a relatively low degree of damage, dislocation arrays emanate from a damage center, S. The dislocations propagate predominantly in (111) and in ($1\bar{1}1$) planes. Analysis of dislocation contrast taken from different (110), (400) and (113) reflections indicates that the dislocations in both planes have a common Burgers vector of $a/2[10\bar{1}]$. Thus the main characteristic of the compressive damage is the generation of dislocation arrays in two (111) slip planes with a common Burgers vector. As the dislocations move by conservative motion in a slip plane, one end of a dislocation tends to be pinned at the damage center, while the other end glides relatively easily and exits through the surface. This results in two segments of a dislocation lying in two different orientations. This can be clearly seen for the dislocations in the (111) plane. Segments pinned at the damage center, such as segment A, are in the $[1\bar{1}0]$ direction and make a 60° angle with its Burgers vector. The segments which exit through the surface, such as segment B, are nearly in screw orientation.

As the degree of damage increases, the dislocations so generated become denser and the distance of dislocation movement from the damage center increases as shown in Fig.

2b. Determination of Burgers vector indicates that the dislocation arrays in both the (111) and the $(1\bar{1}1)$ plane have a common Burgers vector of $a/2[10\bar{1}]$. Investigations using stereomicrographs show that dislocations present in cluster A have a Burgers vector of $a/2[0\bar{1}\bar{1}]$ and tend to move in the $(\bar{1}\bar{1}1)$ and in the $(1\bar{1}1)$ slip plane. This characteristic is essentially the same as the one discussed in context with Fig. 2a. It suggests that the ISS generated dislocations are initially of the screw type and subsequently propagate into two slip planes containing their Burgers vectors. As the dislocations move, they experience more resistance from the bulk than from the surface. This leads to a change in direction for the dislocations.

As the amount of damage increases the characteristics of the dislocations remain the same as shown in Fig. 2c. For the case shown in Fig. 2c the damage generates two groups, A and B, of dislocation arrays: Group A dislocations lie in the $(\bar{1}11)$ and the (111) plane with $b = a/2[01\bar{1}]$, while group B dislocations lie in the $(1\bar{1}1)$ and in the (111) plane with $b = a/2[10\bar{1}]$.

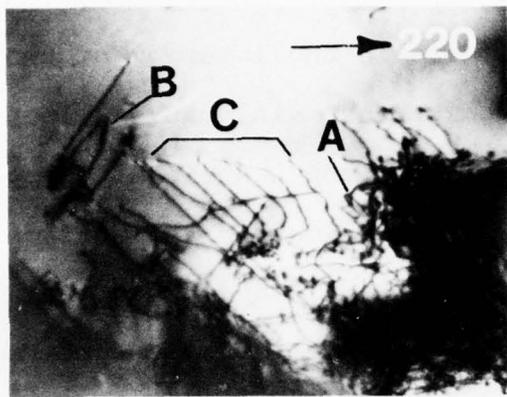
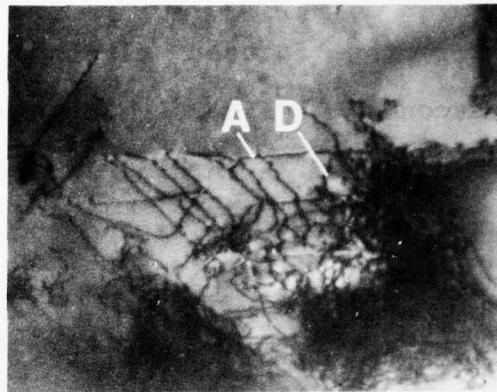
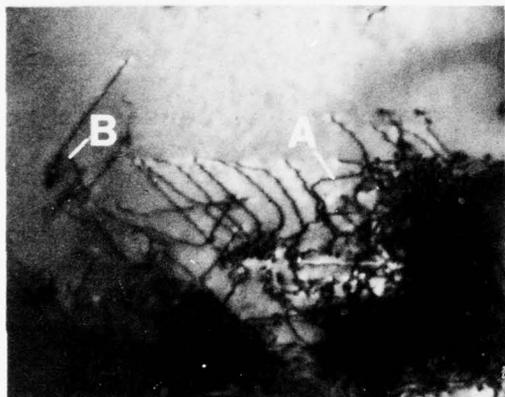
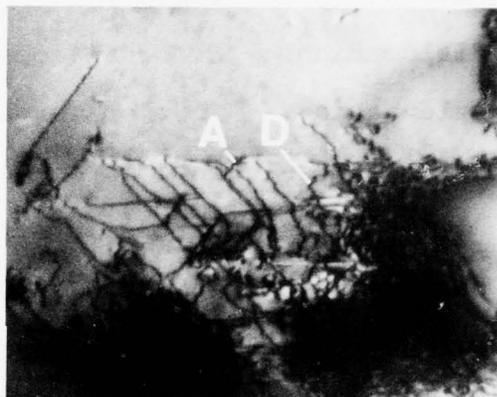
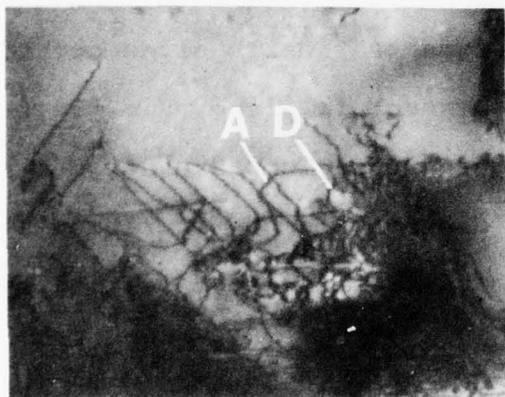
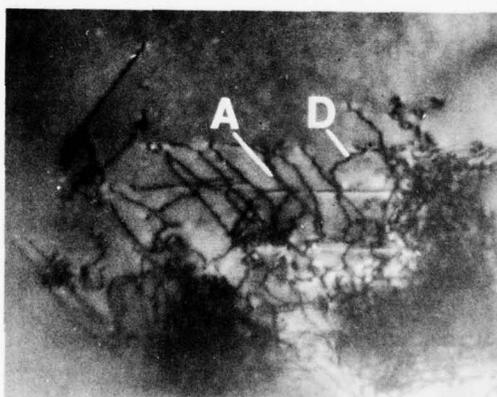
Fig. 3 Transmission electron micrographs showing dislocation movement during electron beam exposure. Dislocation loops A and D expand while B shrink. The interval of exposure time is about two seconds.

During the TEM investigations, the dislocations near a damage center were found to be unstable and to move easily during electron beam exposure. A sequence of such a dislocation movement is shown in Fig. 3. The exposure time

for the focused electron beam is in the interval of two seconds. Figure 3b shows that the dislocation loop designated A in Fig. 3a expands while loop B shrinks. Loop A continues to expand and loop B glides out to the surface in Fig. 3c. It should be noted that loop A and dislocation arrays C lying in the $(1\bar{1}1)$ plane have the same Burgers vector, $a/2[10\bar{1}]$, but of opposite sense. The opposite sense follows from the opposite curvature between loop A and dislocations C. Dislocations C are close to screw orientation. Further expansion of loop A causes it to arrange itself into three segments in $\langle 110 \rangle$ directions, Fig. 3c. One segment is in screw orientation and the other two make an angle of 60° with the Burgers vector. Once the screw segment moves close enough to one dislocation in C, the attraction force between the two parallel screw dislocations of opposite Burgers vector tends to bind them together, Fig. 3d. The 60° segments finally glide out to the surface leaving the screw segment in place, Fig. 3e,f. It can also be seen in these figures that loop D undergoes a similar expansion process. The dislocation configuration of dislocation arrays A and B in Fig. 2c are best described by such an expansion process.

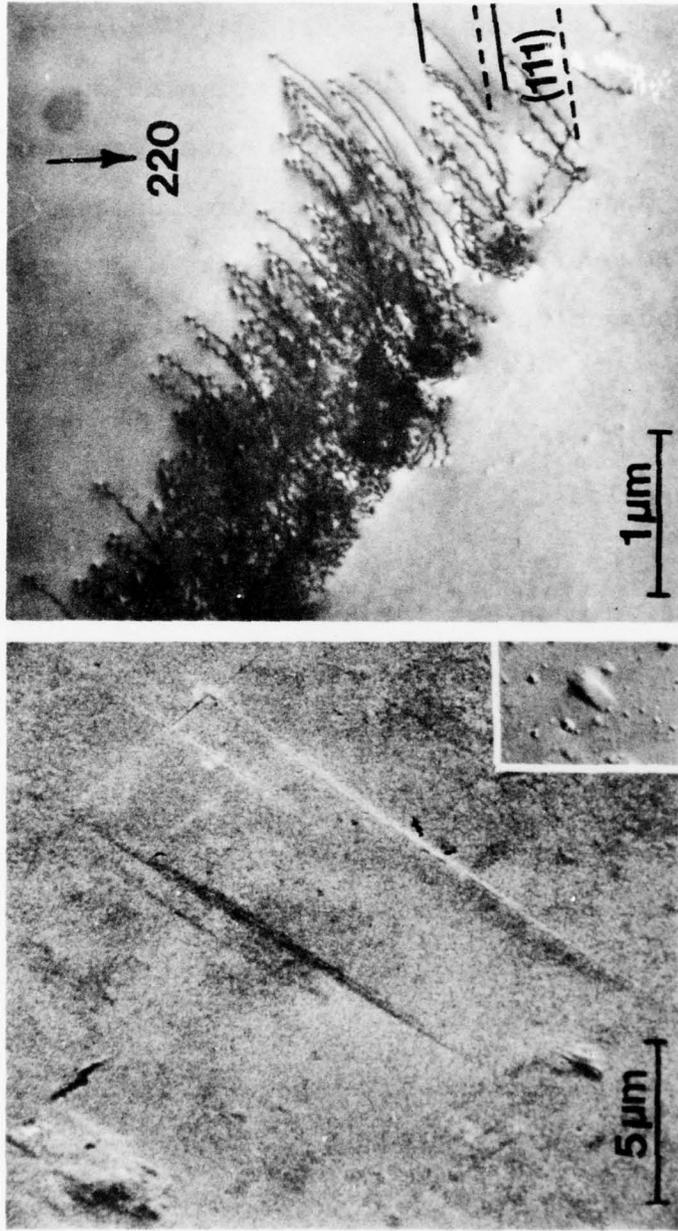
Fig. 4 (a) Scanning electron micrograph showing the abrasive ISS damage which appears as long fine scratches on the wafer surfaces.
(b) Transmission electron micrograph showing that the abrasive damage generates a group of dislocations in parallel (111) planes.

Abrasive damage is observed less frequently. It appears as long fine scratches, Fig. 4a. TEM investigation shows that

this mode of damage essentially generates a group of dislocations in parallel (111) planes, Fig. 4b. The Burgers vector of these dislocations is $a/2[10\bar{1}]$. Most of the dislocations are close to screw orientation. The characteristics of these dislocations are essentially similar to those generated by compressive damage. The abrasive damage, however, tends to generate dislocations predominantly in groups of parallel (111) planes. This is shown in Fig. 4b.

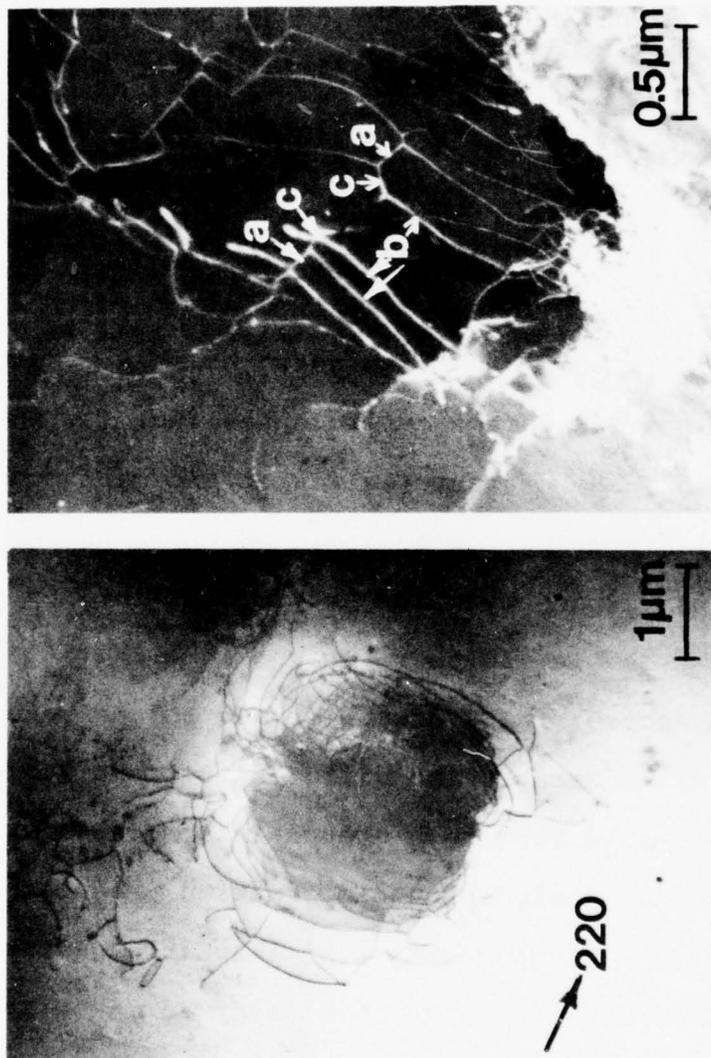
Fig. 5 Transmission electron micrographs showing that (a), annealing of ISS damage results in formation of dislocation networks in a damage center, and (b) the networks extend to the vicinity of a damage center when the ISS damage is sufficiently high.

Annealing of ISS damage at high temperatures causes substantial changes in damage characteristics. The changes involve transformation of dislocation arrays into dislocation networks, dislocation loops and stacking faults. The formation of dislocation networks is usually associated with the relief of stress in a damage center as shown in Fig. 5a. When the ISS damage is sufficiently high, the networks extend quite often to the vicinity of a damage center, Fig. 5b. Examination of stereomicrographs shows that the networks are three-dimensional and consist of dislocation segments approximately in $\langle 110 \rangle$ directions. The segments are relatively long for those in the $\langle 110 \rangle$ directions parallel to the (001) surface and relatively

short for those in the inclined $\langle 110 \rangle$ directions. It is evident in Fig. 5b that the intersection of two dislocations results in the formation of a triple node. Analysis of the Burgers vectors indicates that the Burgers vectors of the dislocations a, b and c is $b_a = a/2[\bar{1}10]$, $b_b = a/2[01\bar{1}]$ and $b_c = a/2[\bar{1}10]$, respectively. The corresponding dislocation directions are in the $[1\bar{1}0]$, $[110]$ and $[101]$ directions. Thus, they are all 60 degree dislocations.

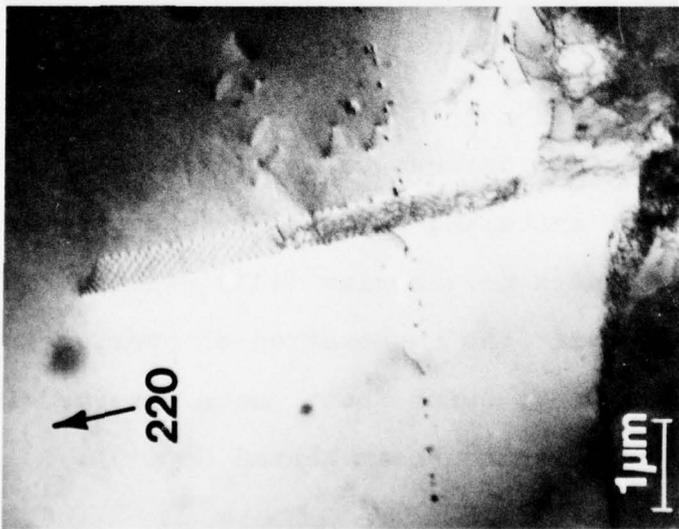
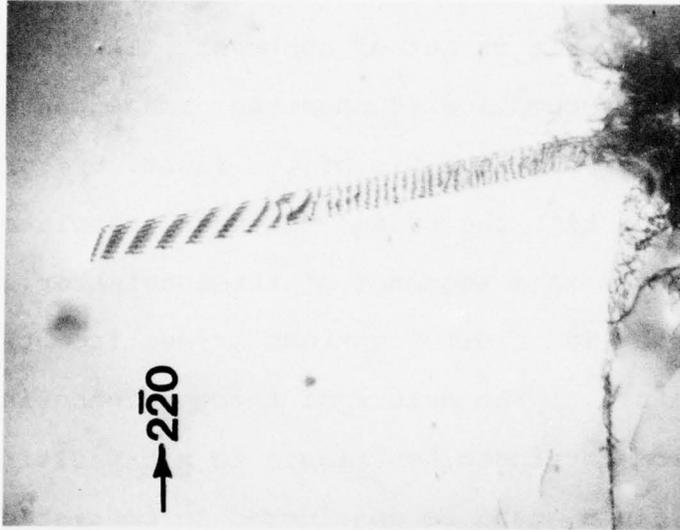
Fig. 6 Transmission electron micrographs showing the formation of stacking faults due to stress relief of ISS damage during annealing. (a) (220) and (b) (220) reflections.

general, the formation of these faults is due either to stress relief of ISS damage or due to the dissociation of dislocations. A fault generated by stress relief is shown in Figs. 6. Figure 6a is taken with the diffraction condition such that the fault is out of contrast. The Moire fringes shown are very complicated near the damage center and become regular arrays at the tip of the fault. Figure 6b shows that, at the tip, the fringe contrast associated with the fault changes in a sequence of three neighboring segments. The change in fault contrast arises from the change in fault nature. The nature of three neighboring segments changes from intrinsic, extrinsic to non-faulting segments. Such a fault can be considered to consist of layers of overlapping twins. The intrinsic segments are one-layer twins, and the extrinsic segments are two-layer twins. The non-faulting segments are three-layer twins. The fringe contrast arising from a three-layer twin is relatively weak. It becomes evident that relaxation of ISS damage stresses during annealing proceeds by shearing and rearranging of bonds between neighboring (111) planes. The onset of this process is the generation of overlapping twins. Similar overlapping twins have been observed in deformed silicon (12) and electron-beam heated Ge (13).

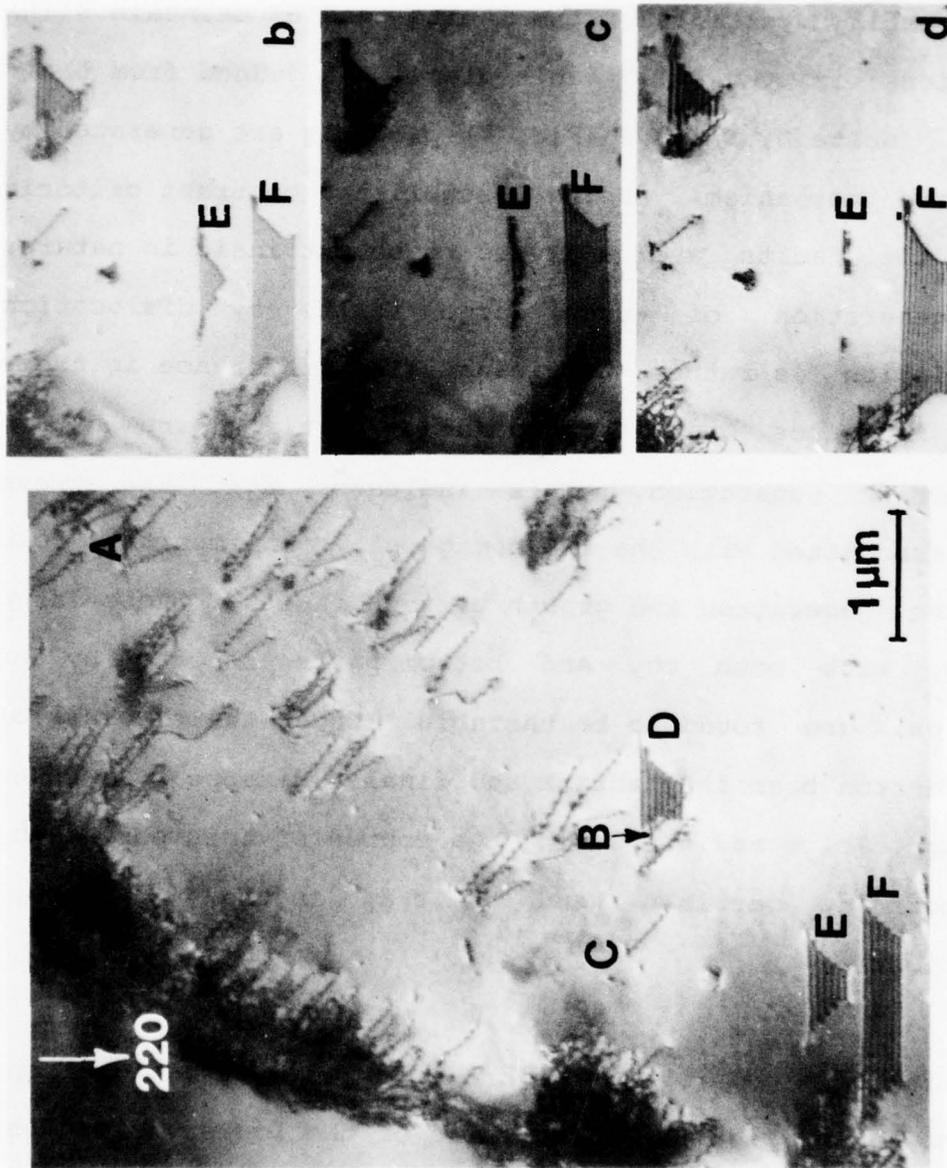
Fig. 7 Transmission electron micrographs showing (a), stacking faults generated by dissociation of screw dislocations in positions A, B, and C. (b), (c) and (d) shows that faults D, E, and F shrink under the exposure of electron beam.

Stacking faults generated by dissociation of screw dislocations are shown in Fig. 7a. It can be seen that

The bounding partials of the faults tend to maintain $\langle 110 \rangle$ directions in the (111) fault plane. As judged from their shape, faults D, E and F (Fig. 7) probably are generated by the same mechanism. Using established contrast criteria (14), the faults are analyzed to be extrinsic in nature. The generation of such large faults by dislocation dissociation is rather surprising. The difference in their sizes indicates that the bounding partials are not in equilibrium separation. This indicates that the stress field associated with the ISS damage plays an important role for the generation and growth of such faults. These large faults, with both top and bottom parts truncated by the surfaces, are found to be unstable. Under the exposure of the electron beam they shrink and finally disappear as shown in Figs. 7b, c and d. During the course of this shrinkage, the bounding partials tend to stay in the $\langle 110 \rangle$ growth directions.

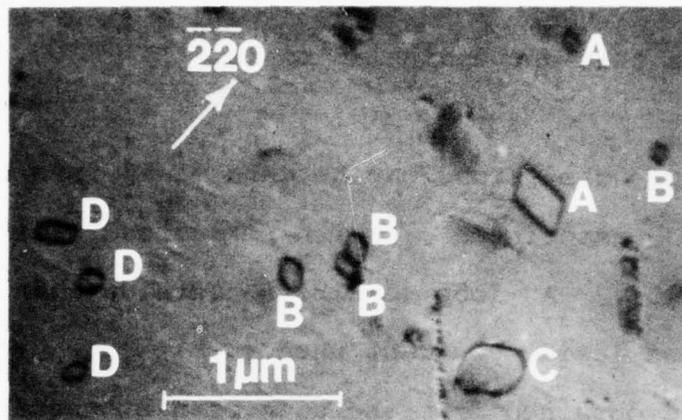
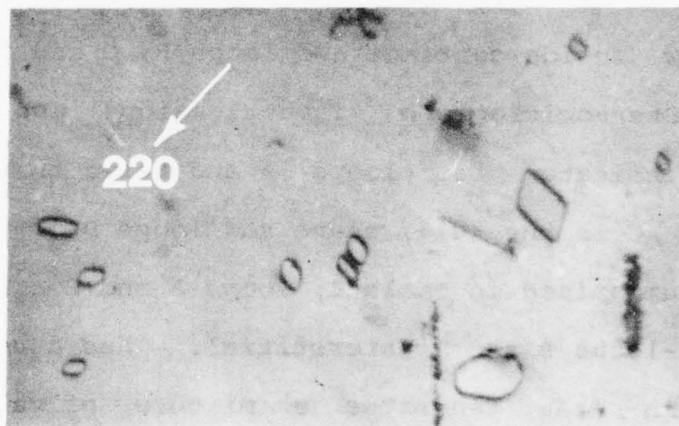
Fig. 8 Transmission electron micrographs showing that annealing of ISS damage also generates a high density of dislocation loops. (a) $(\bar{2}20)$ and (b) (220) reflections.

Annealing also generates a high density of dislocation loops as shown in Figs. 8. The size of the loops varies from several hundred to several thousand Angstroms. These loops lie in $\{110\}$ planes. The Burgers vectors, b , of the loops

The nature of the loops can be determined from the image displacement associated with reversed diffraction conditions (15). A loop exhibits outside contrast when $(g \cdot b)_s > 0$ and inside contrast when $(g \cdot b)_s < 0$. The nature of a loop is obtained from the sign of $n \cdot b$, where n is the loop plane normal. A loop is "interstitial" for $n \cdot b > 0$ or is "vacancy" for $n \cdot b < 0$. In comparing Fig. 8b with Fig. 8a loops A show inside contrast and loops B, C and D outside contrast. Stereomicrograph investigations and tilting experiments indicate that loops A and B lie in the $(\bar{1}01)$ plane, loops C in the (011) plane and loops D in the $(0\bar{1}1)$ plane. As summarized in Table I, loops A and C are vacancy in nature and loops B and D interstitial. Thus annealing of ISS damage in GaAs generates a mixture of vacancy and interstitial loops.

Fig. 8a, $g = \bar{2}\bar{2}0$, $s > 0$							
Loop	Loop plane	Contrast	$(g \cdot b)_s$	$g \cdot b$	$g \cdot n$	$n \cdot b$	Loop nature
A	$(\bar{1}01)$	Inside	< 0	< 0	> 0	< 0	Vacancy
B	$(\bar{1}01)$	Outside	> 0	> 0	> 0	> 0	Interstitial
C	(011)	Outside	> 0	> 0	< 0	< 0	Vacancy
D	$(0\bar{1}1)$	Outside	> 0	> 0	< 0	> 0	Interstitial

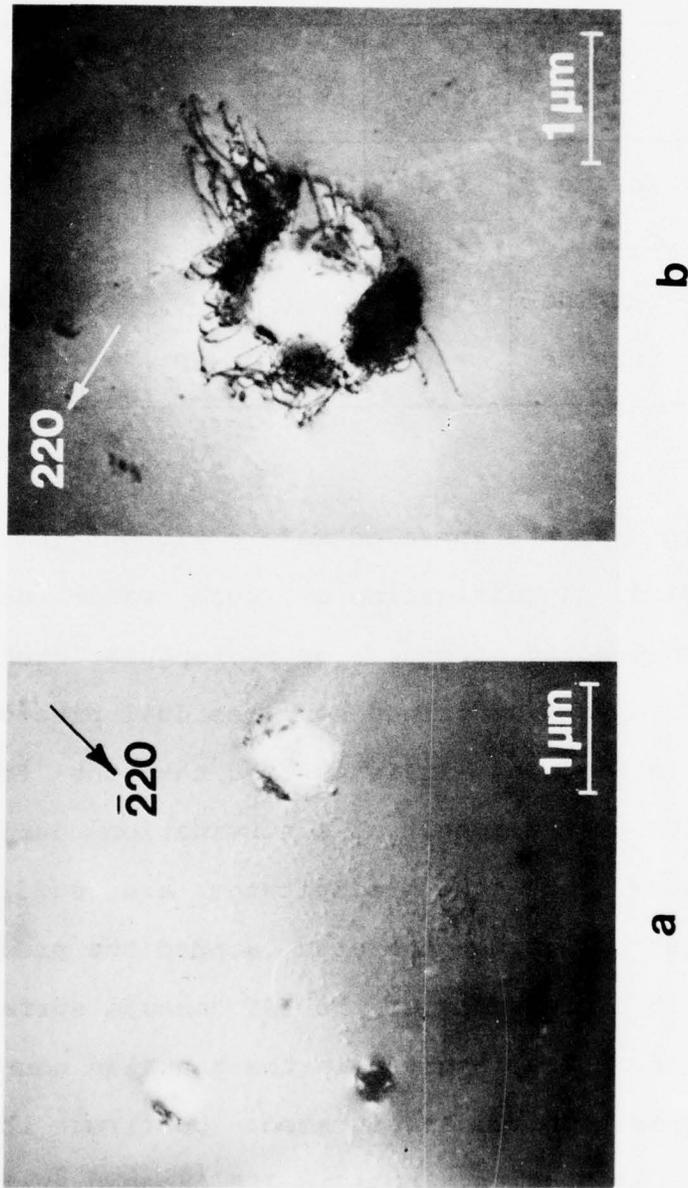
Fig. 9 Transmission electron micrographs showing (a) residual precipitates and (b) dislocations generated due to the relief of the stress set up by the precipitates in the backsides of annealed wafers without ISS damage.

For control measurements annealed wafers without ISS damage were also studied. Investigation of such wafer backsides revealed a high density of square or rectangular etch pits. These etch pits always contained some residual precipitates, and are shown in Fig. 9a. It is assumed that the formation of the etch pits is the result of contamination during the annealing process. When the precipitates are sufficiently large, dislocations are generated around the precipitate sites, Fig. 9b. Contrary to the ISS damaged surfaces, no dislocation loops are observed in the annealed non-damaged surfaces. This control measurement confirms that the formation of dislocation loops in ISS damaged surfaces is related to the stresses generated by the ISS damage.

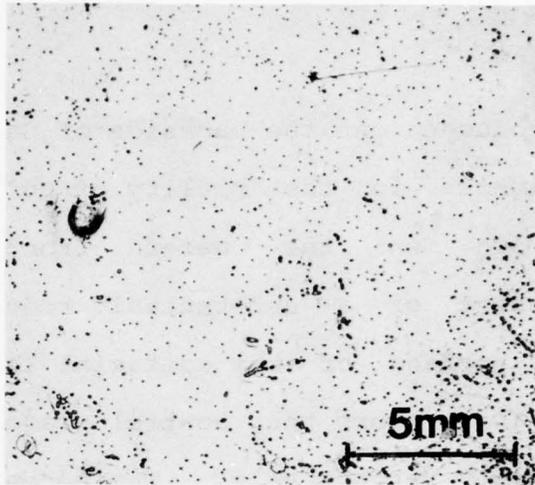
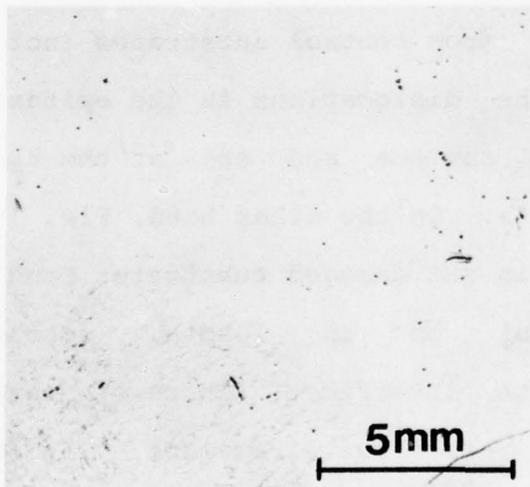
Fig. 10 Optical micrographs showing the pit density at the epitaxial surface for (a) the control wafer, and (b) the ISS damaged wafer.

ISS damage introduced on the backside of GaAs substrates produces improvements in the quality of epitaxial layers subsequently grown on the wafer front side. The improvements consist of a substantial reduction in pit density at the surface of the epitaxial layer. This is shown in Figs. 10a,b for the control wafer and the ISS damaged substrates, respectively. The second improvement results in a confinement of the "threading" dislocations to the epitaxial-substrate interface. Transmission x-ray topographs taken from control substrates (not ISS'ed) show that most of the dislocations in the epitaxial layer are inclined to the surface and end at the epitaxial layer surface, Fig. 11a. On the other hand, Fig. 11b shows that the dislocations in ISS damaged substrates tend to have long segments, several μm in length, confined at the epitaxial-substrate interface. These segments are seen to align almost in the $\langle 110 \rangle$ directions. The confinement of long dislocation segments at the epitaxial-substrate interface causes the dislocations to make a shallower angle to the epitaxial layer surface.

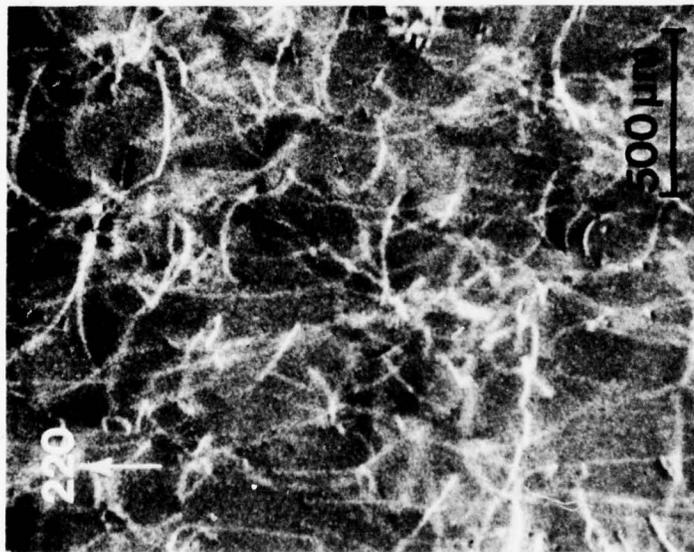
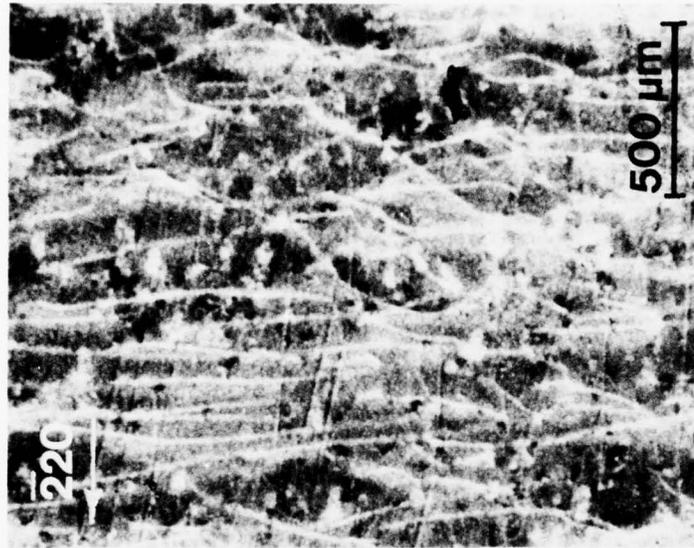
Fig. 11 Transmission X-ray topographs showing (a) most of the dislocations in the epitaxial layer of control substrates are inclined to the surface, and (b) the dislocations in ISS damaged substrates tend to be confined at the epitaxial-substrate interface.

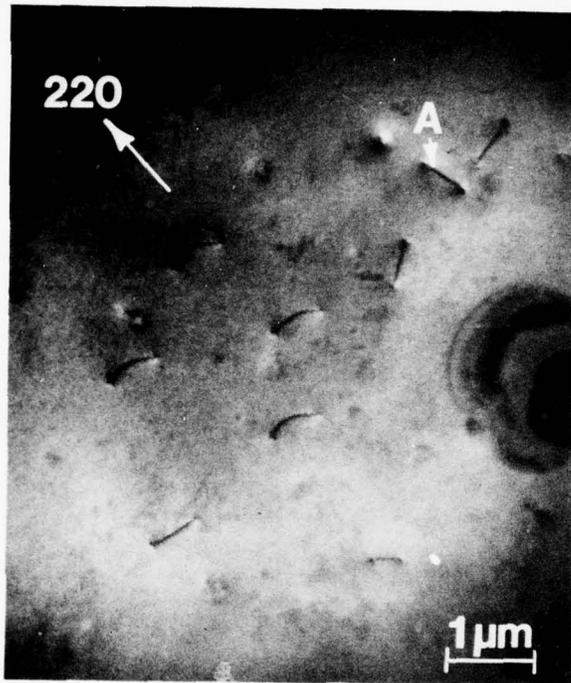
Fig. 12 Transmission electron micrograph showing that the dislocation density in the epitaxial layer of the control substrates is as high as 10^6 to 10^7 per cm^2 .

samples were further investigated through transmission electron microscopy. In the control substrates, the epitaxial layer surface has a high density of dislocations in the range of 10^6 and 10^7 per cm^2 , (Fig. 12). The dislocations are inclined to the surface and are almost in a $\langle 110 \rangle$ direction making an angle of 60° with their Burgers vectors. Most of the dislocations have their Burgers vector also inclined to the surface. In Fig. 12, only dislocation A has a Burgers vector parallel to the surface. Investigations of the epitaxial layer surface on ISS damaged substrates shows a much lower dislocation density in the epitaxial surface. In such epitaxial layers dislocations are rarely observed. If they are present, they make a relatively shallow angle with the epitaxial layer surface. These TEM results are in good agreement with x-ray topographic observations and confirm that ISS can be gainfully employed to produce epitaxial GaAs layers of superior quality.

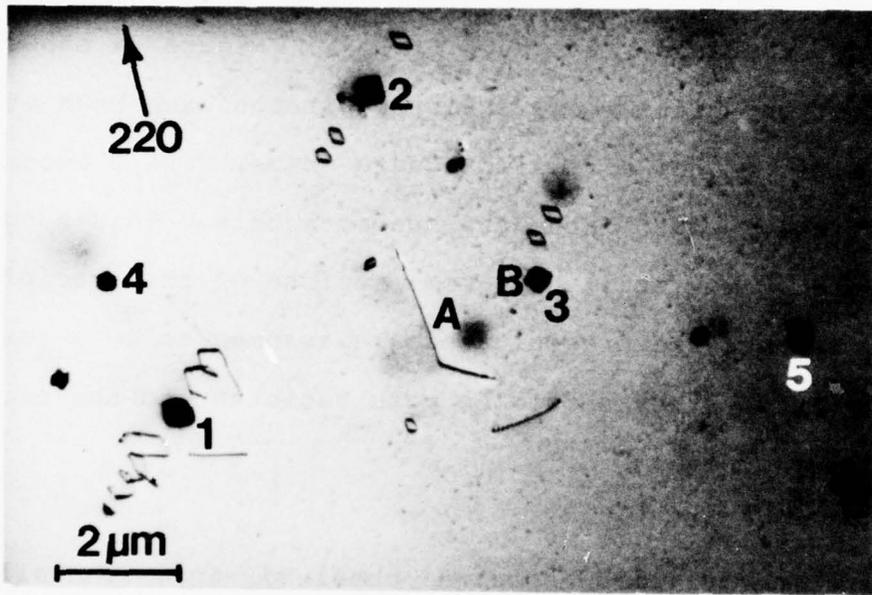
Fig. 1 Transmission electron micrograph showing precipitates and dislocation loops and helices in annealed bulk silicon crystals.

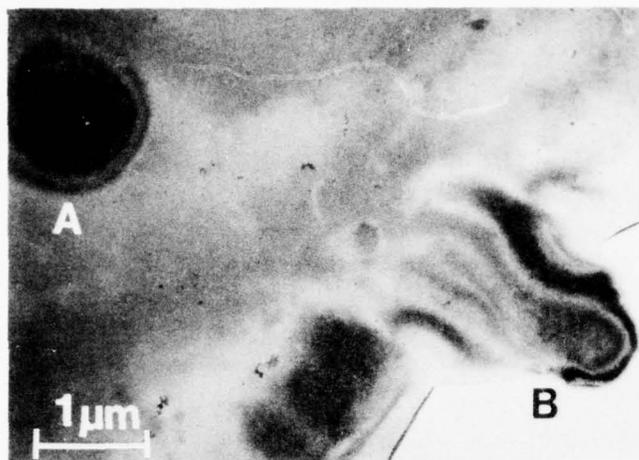
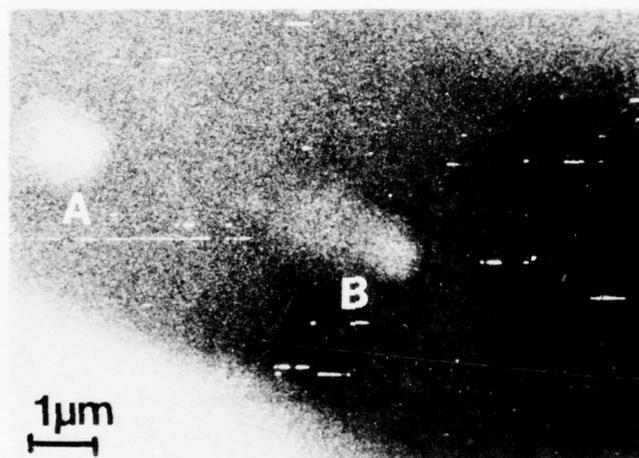
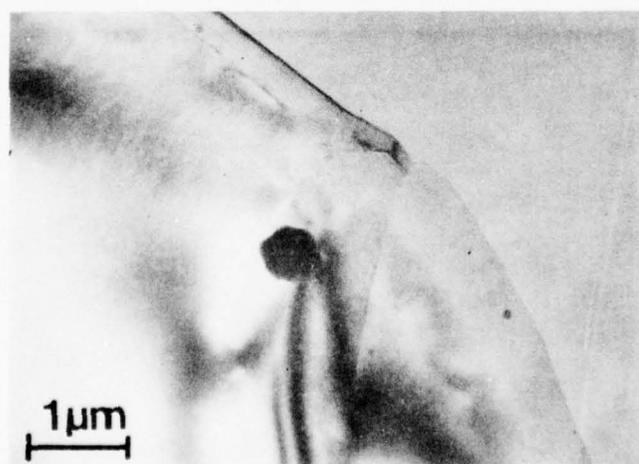
Fig. 2 Transmission electron micrographs showing (a), two precipitation sites, (b), energy filter image of (a) taken at the energy loss of 532 eV, and (c), a precipitate in a region less than 0.1 μm in thickness.

The same etching characteristics persist for a specimen thickness decrease, to 1000\AA or less. Figure 2a shows two precipitation sites where the precipitates have been etched out. Site A has a regular square shape, Site B becomes a bump sticking out into the specimen hole. This suggests that Site B may still have some residue of the precipitate left. Because the precipitates are assumed to be a form of silicon oxide they should be more resistant to the etchant than silicon.

Electron energy loss spectra obtained from the silicon matrix and Site B (Fig. 2a) are shown in Figs. 3a and b, respectively. Both figures show the energy losses at 99 and 149 eV due to excitation of silicon 2p and 2s electrons, respectively, and the plasmon losses of silicon at 17 and 34 eV. The loss peaks between 99 and 149 eV result from the superposition of plasmon losses on the silicon 2p loss edge at 99 eV. One remarkable difference between these figures is that only Site B gives rise to energy loss at 532 eV. The loss at 532 eV is due to the excitation of oxygen 1s electrons. Energy filter images, Fig. 2b, taken at this

energy loss, show that the precipitate sites are brighter than the surrounding matrix, indicating residue of oxide precipitate left in such sites.

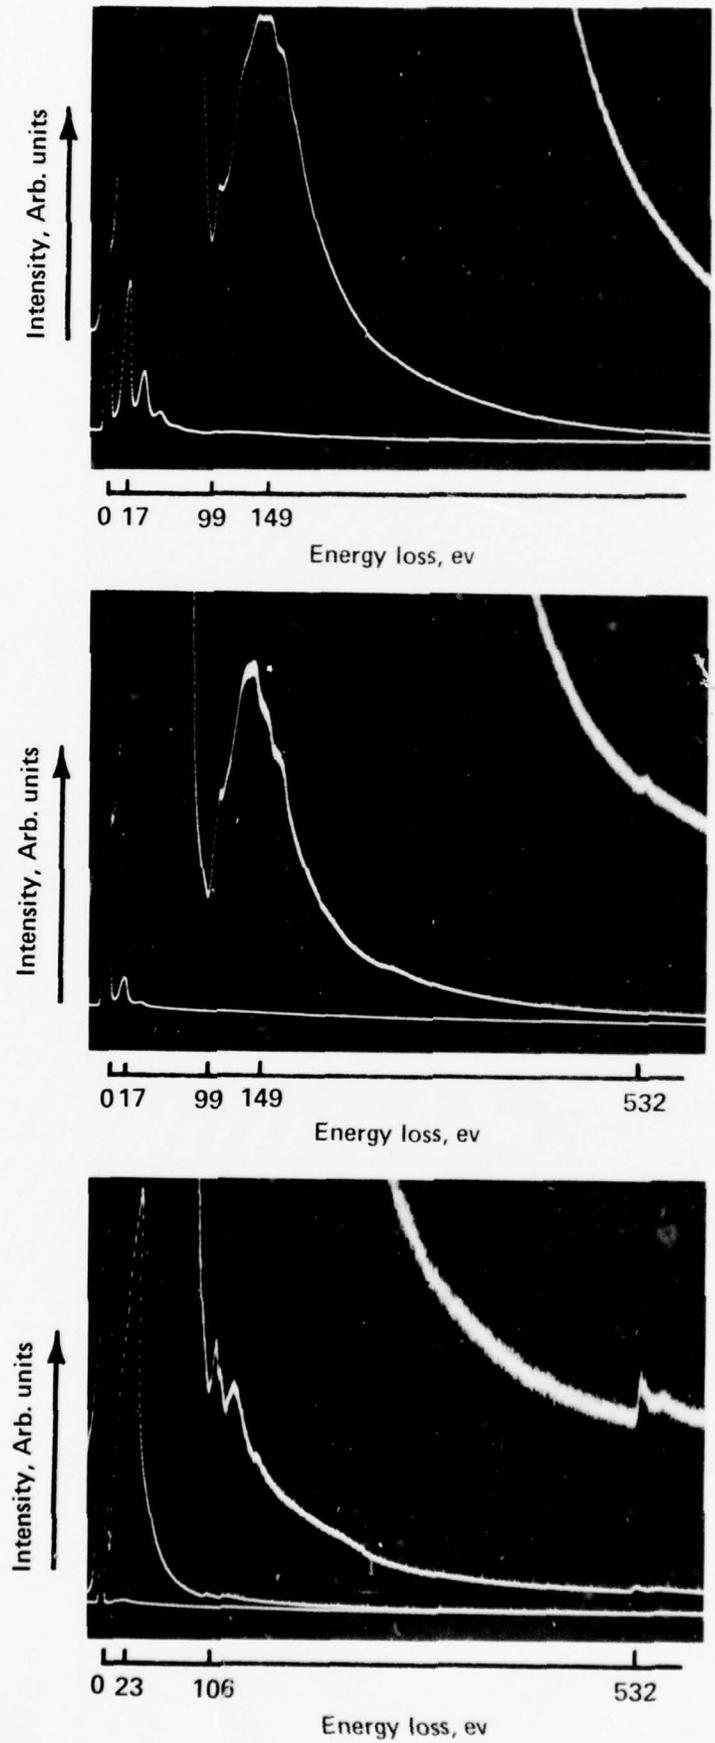
Fig. 3 Electron energy loss spectra of (a), the silicon matrix of Figs. 2(a&b) precipitation site B, and (c) thermally grown SiO_2 .

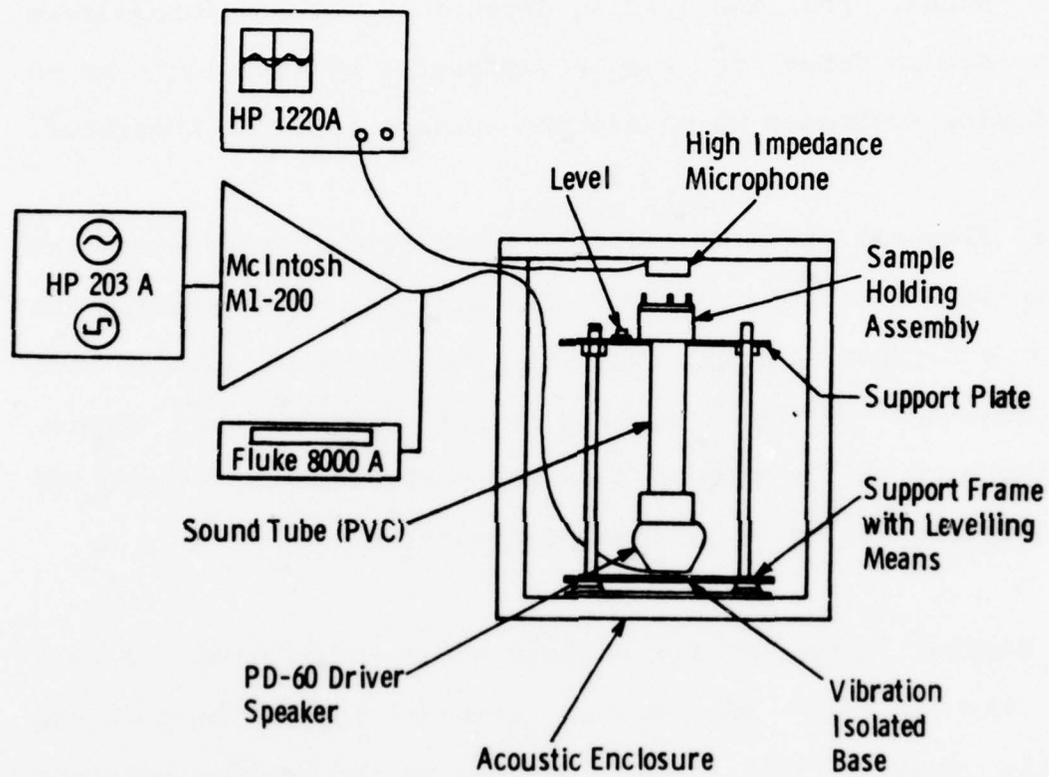
Fig. 1. Schematic of Impact Sound Stressing (ISS) apparatus for GaAs.

A schematic representation of the apparatus is given in Fig. 1. A photograph of the actual equipment as in operation is

The sound tube is a polyvinyl chloride (PVC) pipe attached to the driver by a threaded PVC coupling. The sample holder assembly is threaded to the top end of the sound tube. The effective length of tube, coupling the driver membrane in the sample holder assembly to the driver, is approximately 35 cm. The assembled unit is suspended in the support frame. The support plate rests on adjustment nuts threaded on the three symmetrically placed support rods. This three-point suspension is used to level the apparatus. A button type bubble level placed on the support plate serves as level indicator. The support frame rests on a base equipped with four vibration isolators. It is located in

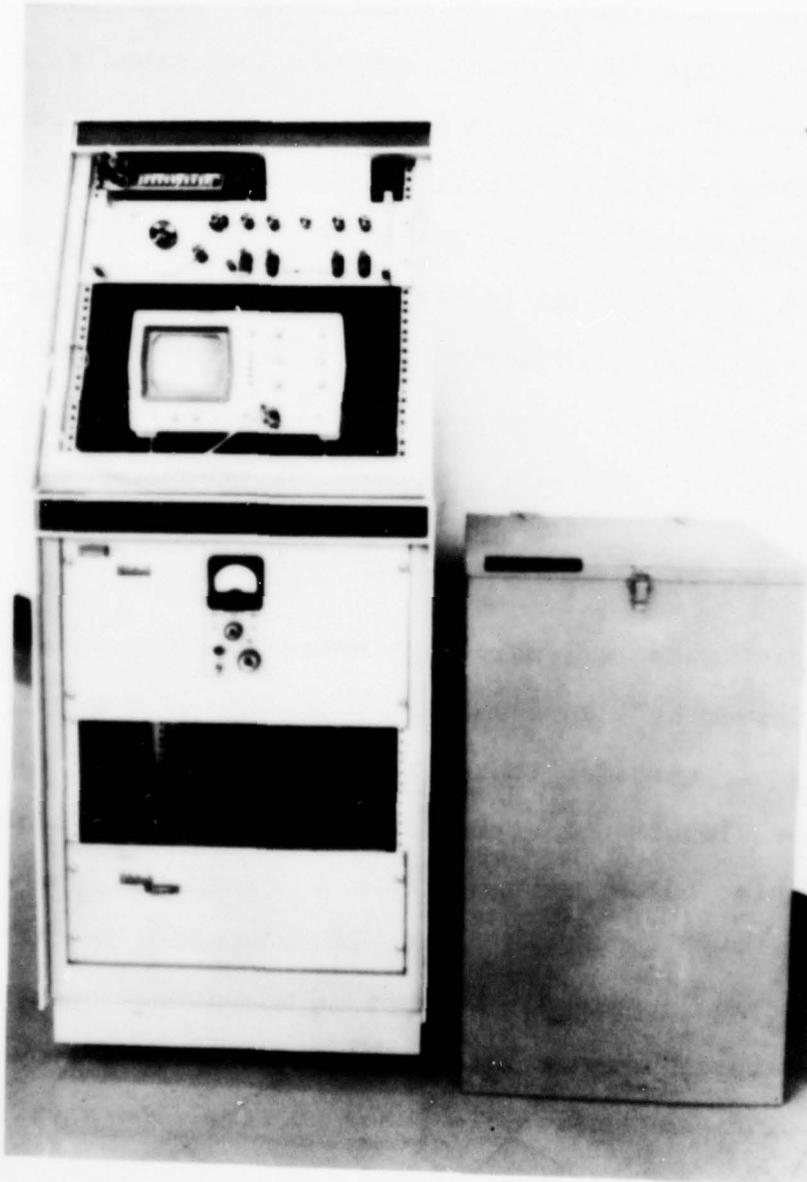
Fig. 2a. Photograph of instrumentation corresponding to Fig. 1 (acoustic enclosure at right).

shown in Fig. 2a, with the acoustic enclosure containing the ISS unit to the right of the controls console containing the electronic equipment. An additional view showing the apparatus within the acoustic enclosure is given in Fig. 2b. The source of sound is the driver portion of a loud-speaker (Atlas Model PD-60T/60 watt), operated by a MacIntosh M1-200 power amplifier. Input power to the acoustic driver is monitored by a Fluke 8000A digital multimeter for coarse setting to avoid overdriving. A Hewlett-Packard HP 203A function generator provides the sinusoidal oscillation. This equipment is also capable of producing square wave pulses.

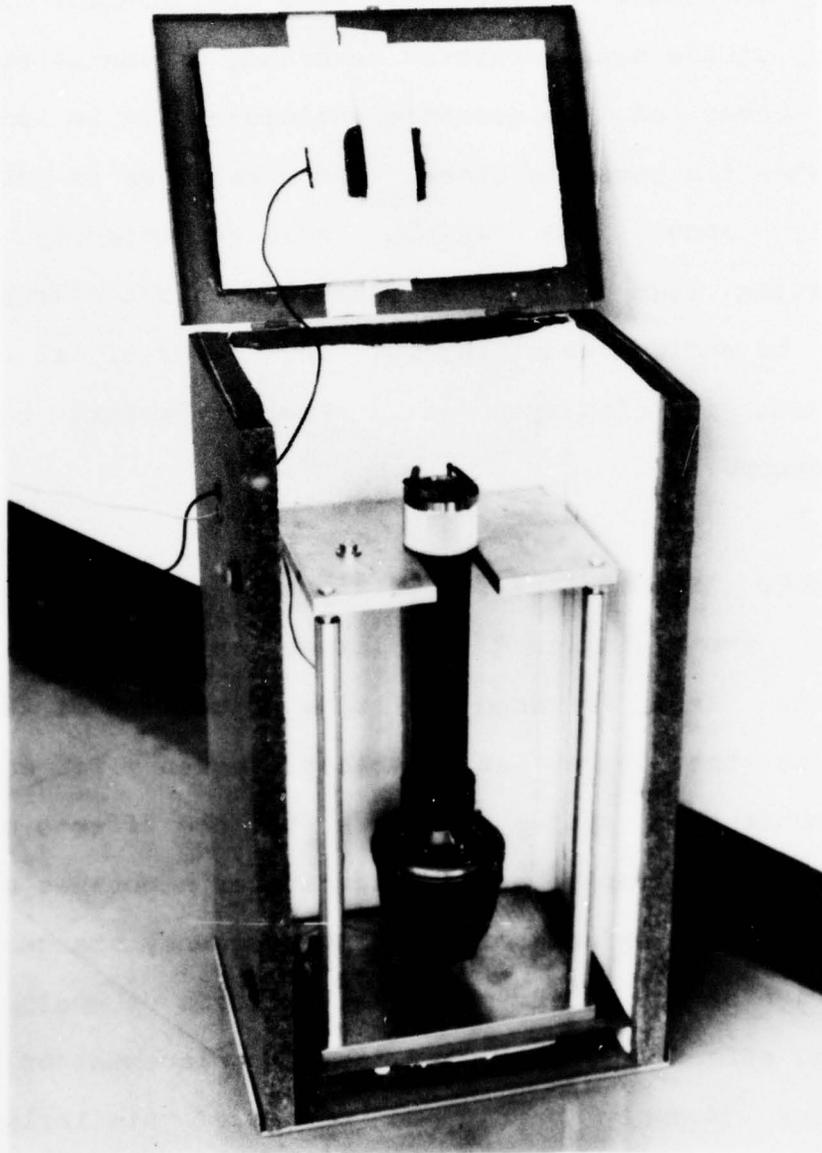
Fig. 2b. Equipment within acoustic enclosure.

the acoustic enclosure which reduces environmental sound to levels acceptable in open laboratory or manufacturing areas. A high impedance microphone, used to monitor the sound emitted at the sample carrier membrane, is installed in the hinged cover of the acoustic enclosure. It is located so that when the cover is closed the microphone is positioned directly above the sample holding assembly. Sound attenuating foam rubber is installed on the microphone as needed to avoid overdriving it. The output signal from the microphone is displayed on a Hewlett-Packard HP 1220A oscilloscope.

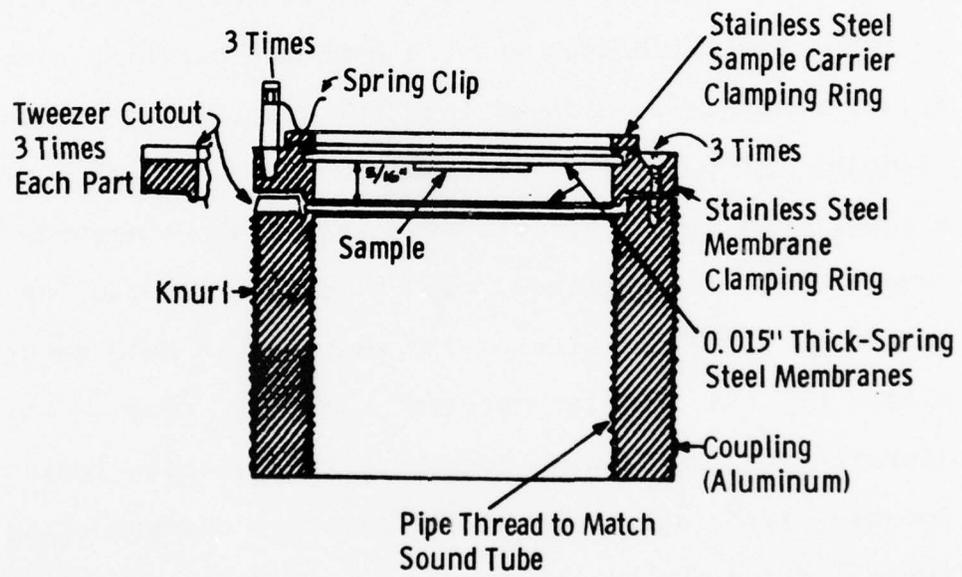
Fig. 3. GaAs sample holding assembly for ISS.

The impact chamber containing the tungsten balls is formed by the two membranes and the membrane clamping ring. The driver membrane is clamped into the coupling by the membrane clamping ring, which is fastened to the coupling by three screws. In Fig. 3, the sample is shown mounted on the sample carrier membrane, which rests in the top of the membrane clamping ring. The membrane is held securely in place by the sample carrier clamping ring. This ring distributes the holding force exerted by three spring clips located 120° apart around the membrane clamping ring. The spring clips may be swivelled away to facilitate removal of the sample carrier clamping ring and membrane for sample

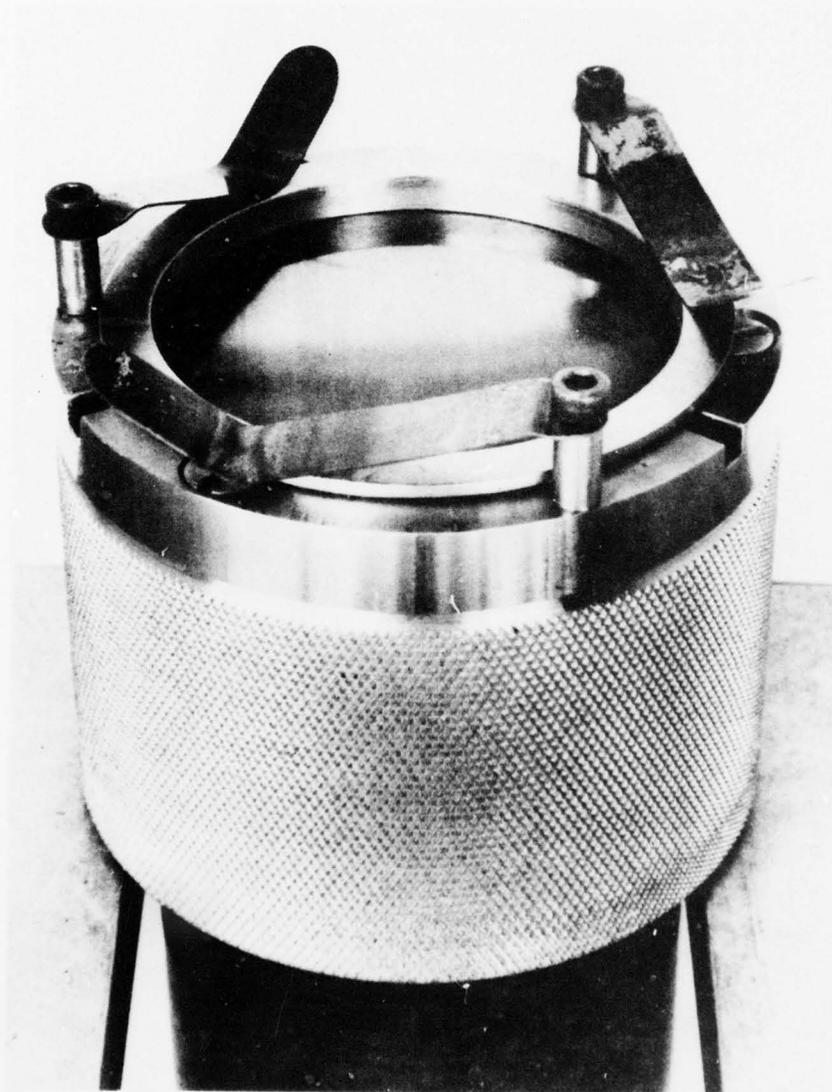
Fig. 4a. Photograph of assembly corresponding to Fig. 3.
