DAMAGE PROFILES IN SILICON AND THEIR
IMPACT ON DEVICE RELIABILITY

G. H. Schwuttke, Principal Investigator, 914 - 897-3140

International Business Machines Corporation
East Fishkill Laboratories
Hopewell Junction, New York 12533

Final Report
April 1, 1978

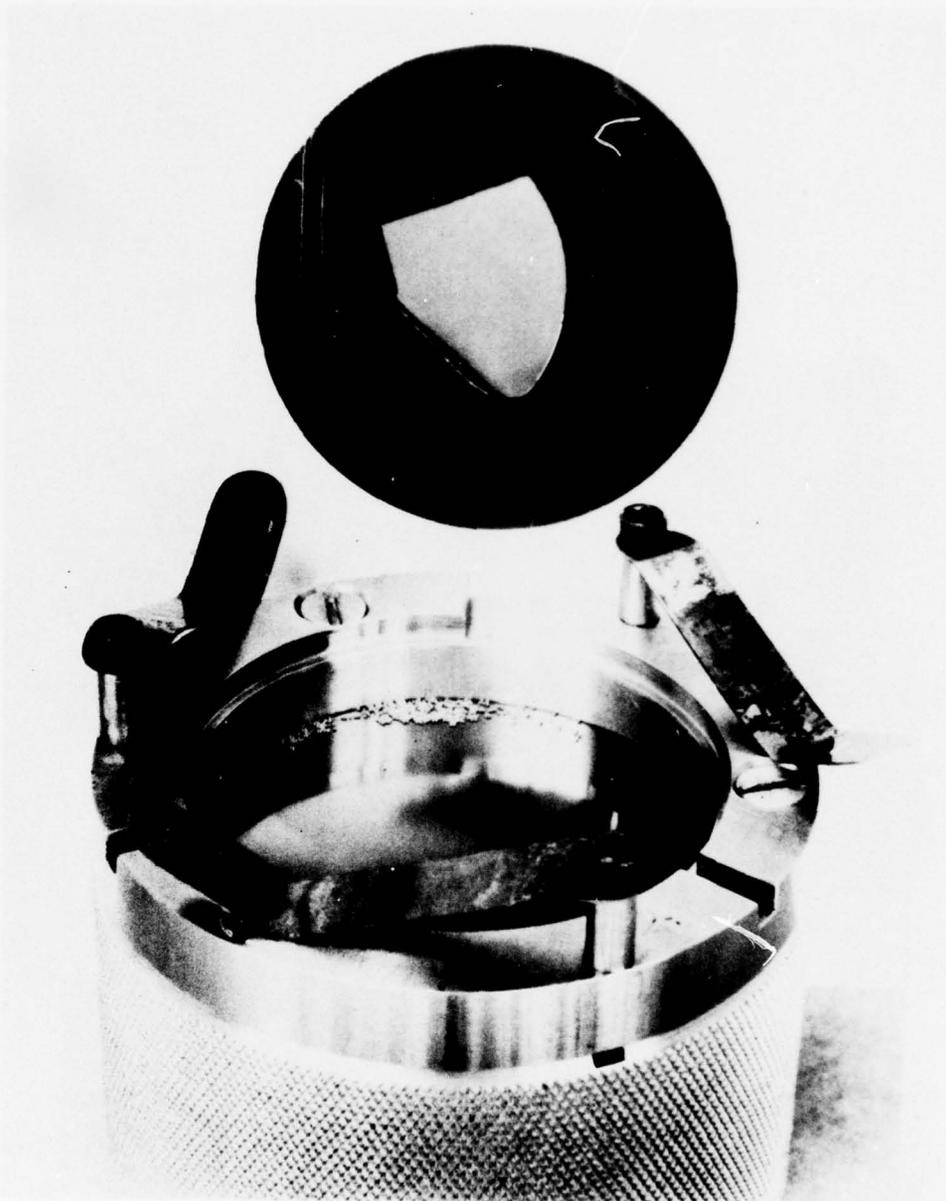
Fig. 4b. Assembly open, loaded with tungsten balls. Sample carrier membrane with sample above.

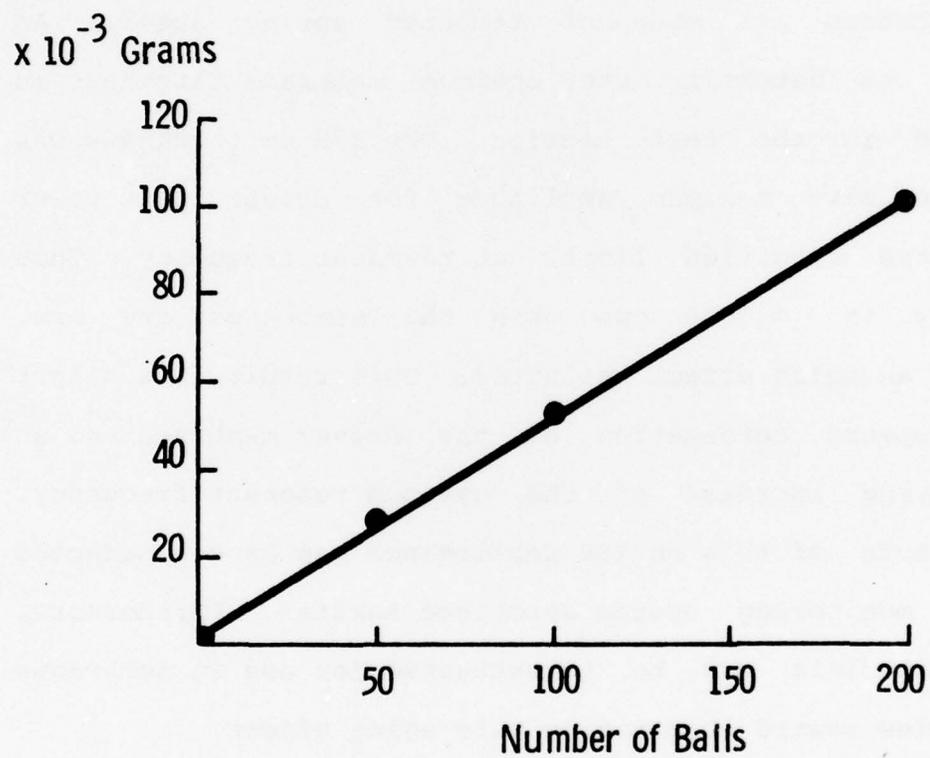
Fig. 5. Plot of weight vs. number of balls. Slope gives a value of 0.0005 g for a single ball.

*The balls are approximately 0.3 mm in diameter and, in order to avoid repeated counting, several quantities were weighted. Figure 5 shows the correlation of weight to the number of balls. The slope of the line gives the weight of one ball. This graph may be used to weight out the correct number of balls to within $\pm 0.05\%$.

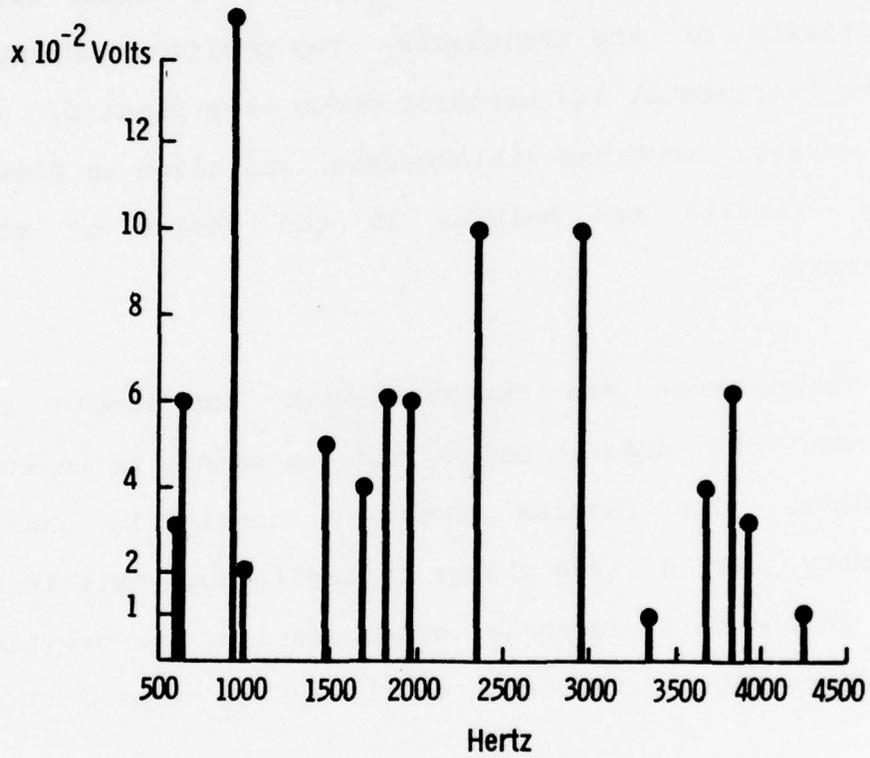
Fig. 6. Output vs. frequency of a 1/8 mm steel diaphragm.

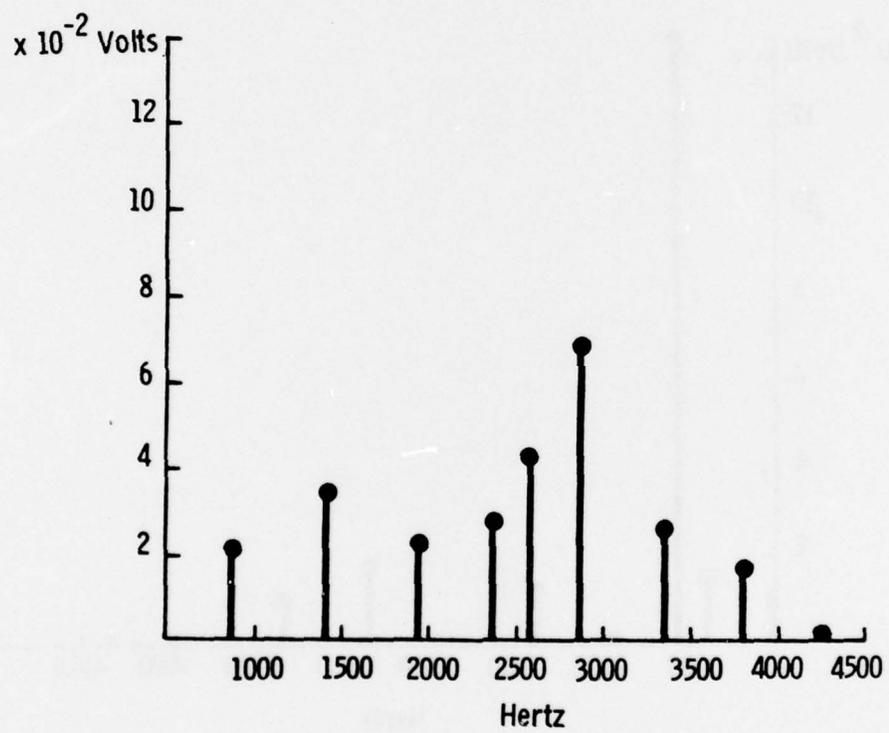
Fig. 7. Output vs. frequency of a 1/4 mm steel diaphragm.

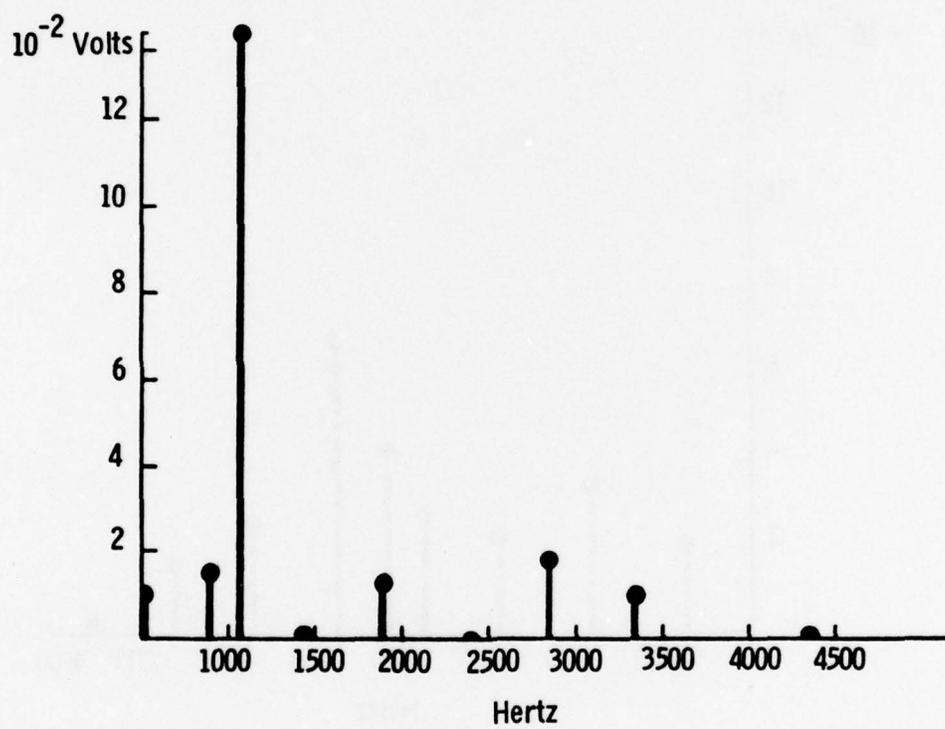
Fig. 8. Output vs. frequency of a 3/8 mm steel diaphragm.

The criterion of maximum coupling led to the selection of the 3/8 mm thick membrane at a frequency of ~ 1000 Hz.

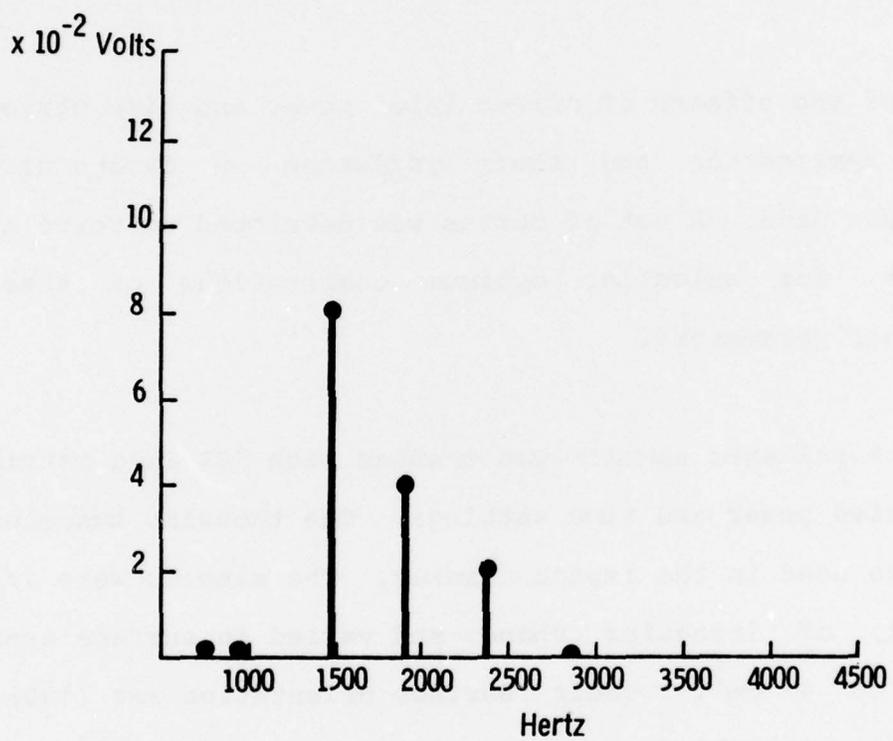
Fig. 9. Output vs. frequency of a 1/2 mm steel diaphragm.

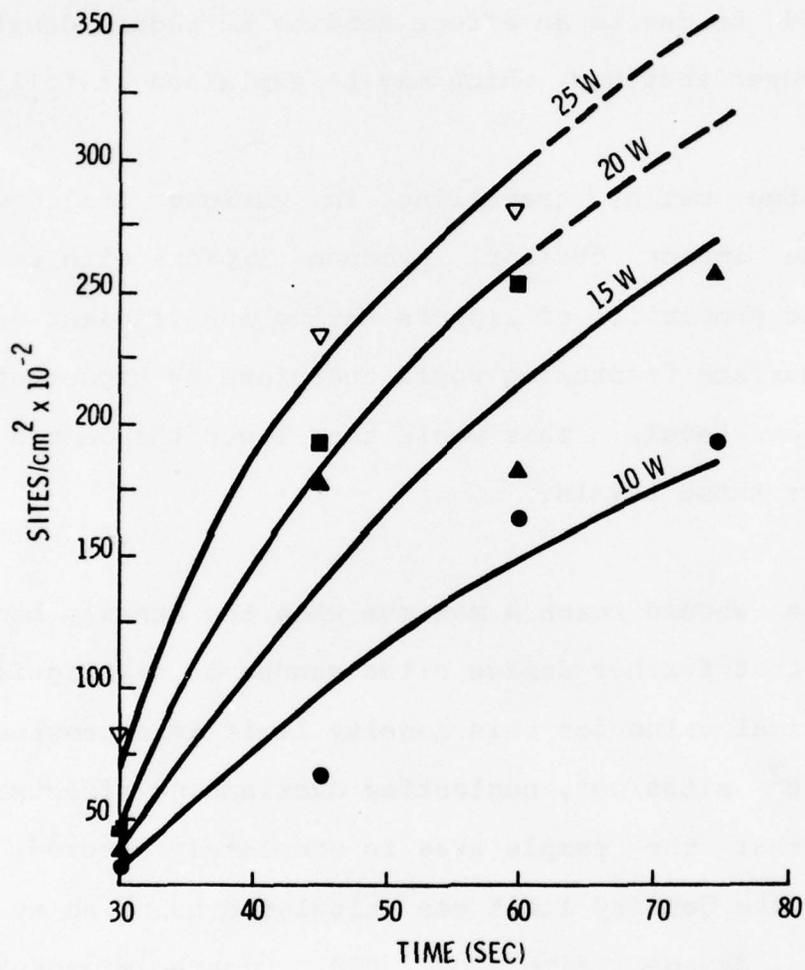
Fig. 10. ISS application time period vs. damage site density at various driver input power levels.

Damage site density obtained from fourteen of the sixteen runs is plotted vs. time period of Fig. 10. Data from runs 15 and 16 was omitted since it appeared to be spurious.

Constant power curves are fitted to the data points. The curves are shown terminated at the matrix time limit of 75 seconds. These curves could be extended, however, since greater densities are possible with longer time periods. Several subsequent runs made at 12.5 watts for 200 seconds yielded a density of 492×10^2 sites/cm². The non-linear

shape of the curves may be due to increased overlapping of damage sites, at higher values of time and power. This would reduce the density count at those values to less than the actual impact density. The lower power curves appear to be flatter, with 10 watt curve approaching a straight line. This could be due to an effect tending to reduce densities at lower power settings, which may be explained as follows.

The curves in Fig. 10 indicate that both time period and input power influence the damage site density. An additional analysis of the experimental data was made to determine the relative effect of these two operating parameters.

The curves in Fig. 10 may be used as a guide in the selection of driver input power and time period of ISS

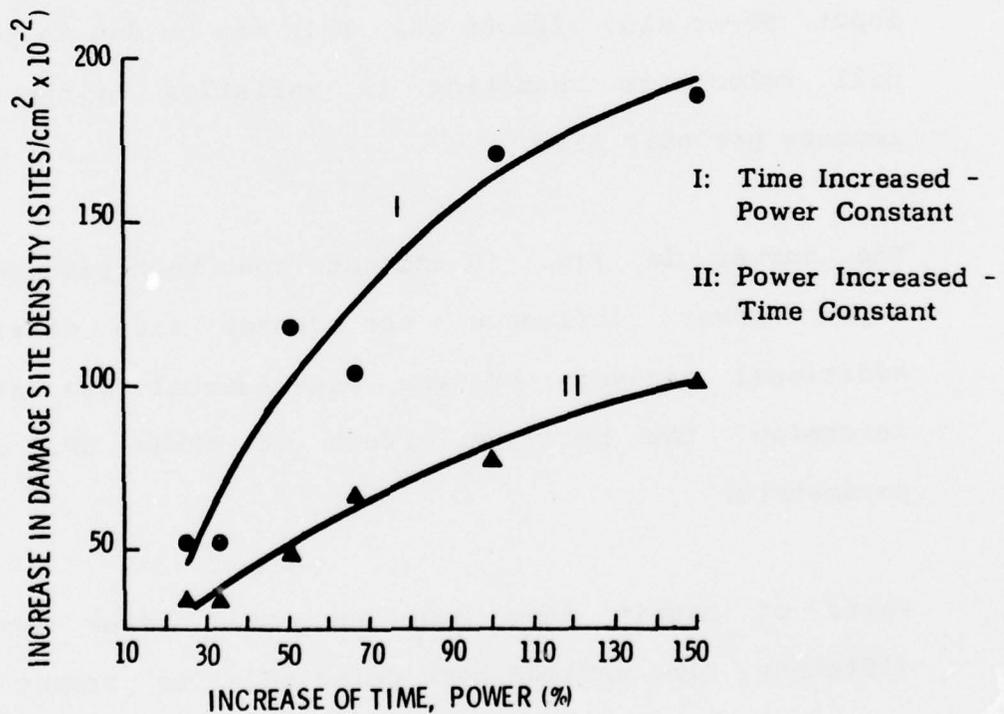
Fig. 11. Damage density vs. time dependency.

average density increase for all pairs with the same time increase percentage, but at different power levels per pair, was calculated. This provides a measure of the influence of time alone, which is shown as curve I in Fig. 11.

determined similarly. The average density increase for all pairs with the same power increase percentage, but run for different time periods per pair, gives a measure of the influence of driver input power alone. This is given with curve II in Fig. 11.

It can be seen from the plots that the length of time period has a greater influence on damage site density than has driver input power. This is shown by the location of curve I above curve II. Their positions on the graph indicate that the relative importance of time to power is about 2:1. The non-linear shape of these curves may be due to the increased probability of overlapping of impact sites when the time or power difference between the runs considered is increased. This would result in a decreased difference in density count. This effect is greater for time, as evidenced by the greater instantaneous slope of curve I, and should be in proportion to the greater influence of time on damage site density.

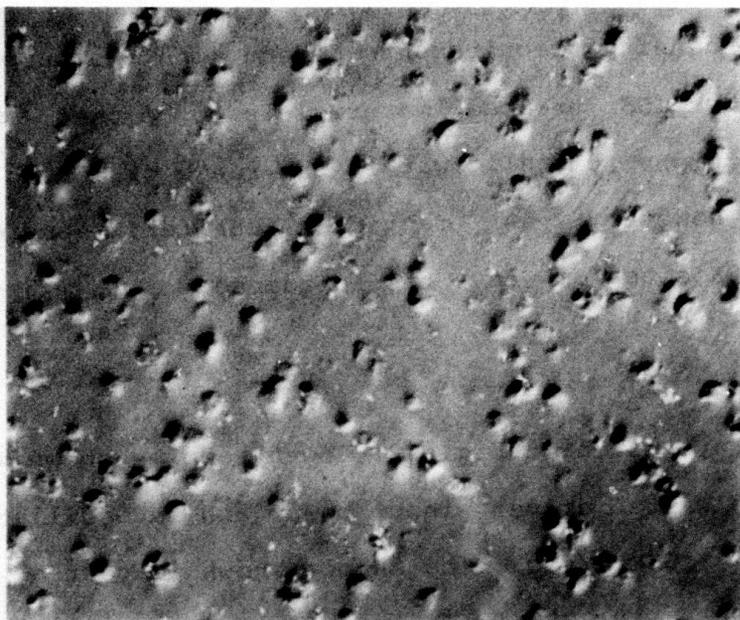
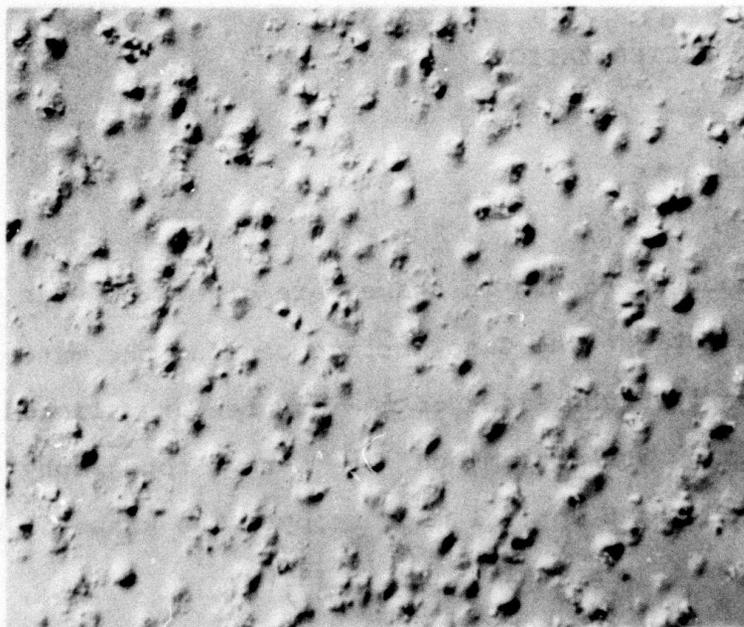
a. 50 sec; 131X magnification.

b. 200 sec; 131X magnification.

Fig. 12. ISS damage on GaAs, 12.5 watts, 1.53 kc/sec at two application time periods.

Two examples are given in Fig. 12. Both samples shown were run at 12.5 watts driver input power and an oscillating frequency of 1.53 kc/sec. The sample shown in part a. was run for 50 seconds; the other one for 200 seconds. The density difference is quite apparent in these micrographs.

The damage sites seen in the relatively low magnification micrographs of Fig. 12 have a pitted appearance. Figure 13,

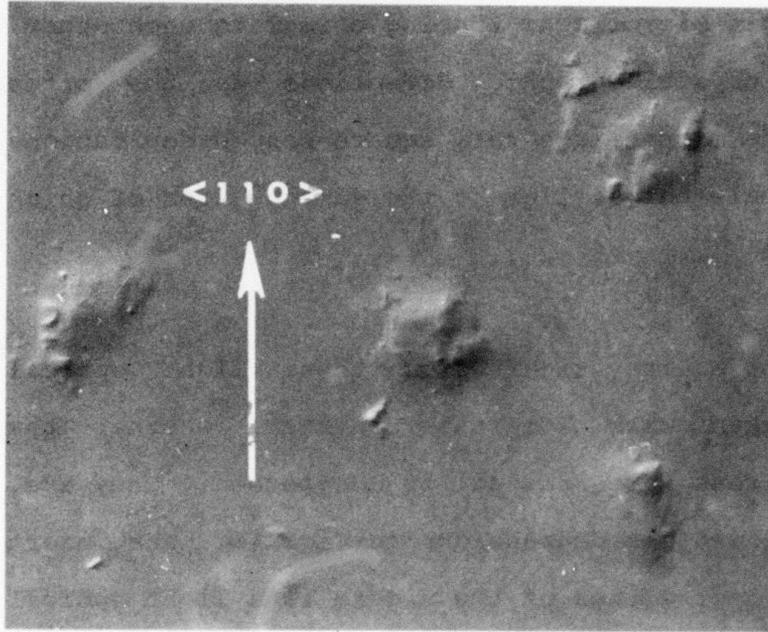
Fig. 13. Crystallographic alignment of ISS damage sites in GaAs; 855X magnification.

Depressions, roughly square in shape, are generated when the tungsten balls strike the GaAs surface causing the material to yield locally. The sides of the squares are aligned in [110] directions as determined by x-ray topography in conjunction with light optical microscopy. The shape of the damage sites can be seen well in Fig. 13.

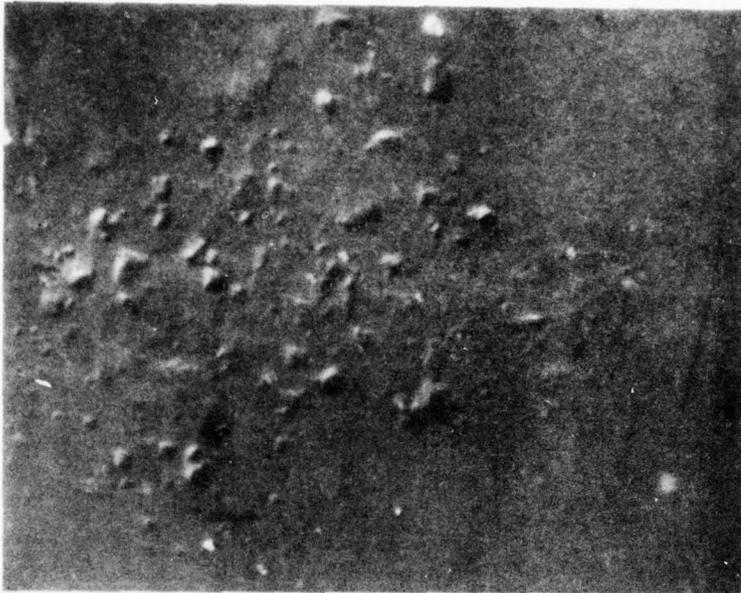
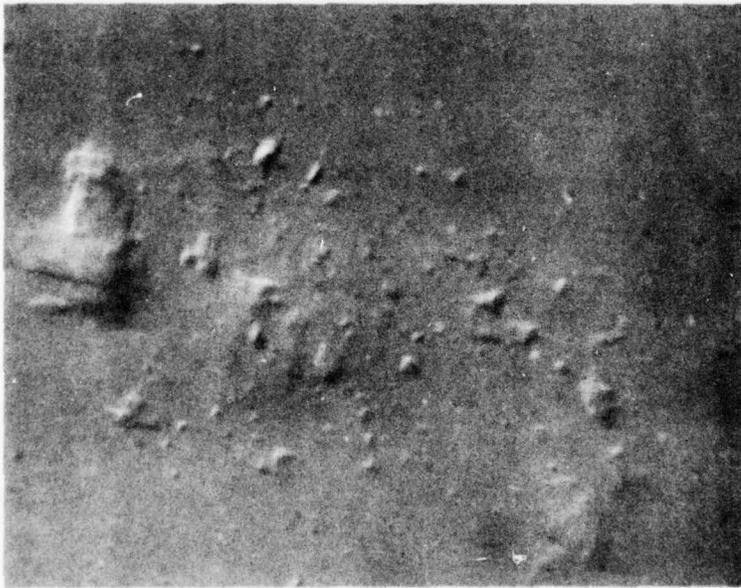
a. Note: Large fracture with curved end at right.

b. Note: Two larger square arrays of microfractures at edges of damage site.

Fig. 14. Clusters of microfractures forming crystallographically oriented $\{110\}$ square arrays at ISS damage sites on GaAs, 1390X magnification.

however, indicates a network of fine linear fractures rather than pits. In the highly magnified views of Fig. 14 it becomes apparent that the damage sites consist of numerous clusters of short microcracks running normal to each other, in the same crystallographic directions as the sites themselves. The microcracks form square-shaped depressions on a smaller scale but similar to the damage sites of which they are a part.

of the damage sites in Fig. 14a. These fractures occur at some damage sites and may have either one or both ends curved. They also lie along crystallographic directions, and may be due to a stress relief mechanism.

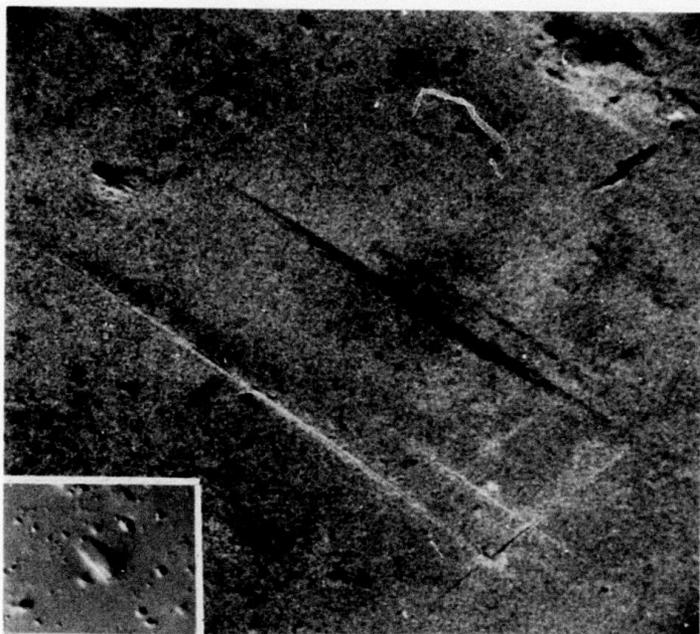
Fig. 15. Scanning electron micrograph of ISS induced square array of microcracks in GaAs; 4300X magnification. Insert shows light optical micrograph of same array; 320X magnification.

It may not be quite clear from these light optical micrographs, taken with Nomarski contrast, whether the square-shaped areas are raised or depressed. They are, however, identified as depressions in Fig. 15. The insert in the lower left corner of the figure is a light optical micrograph (320X magnification) of a square array of ISS induced fractures in GaAs. The main portion of Fig. 15 is a scanning electron micrograph (4300X magnification) of the same array. This shows that the area between the long fractures is a depression rather than a mound as might be concluded from the insert. The SEM illustration also affords a good view of the fine linear fractures running normal to each other, especially near the lower right corner.

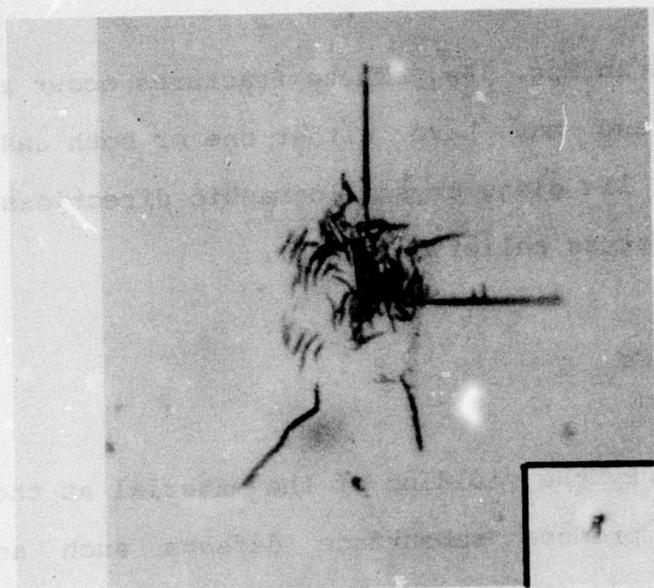
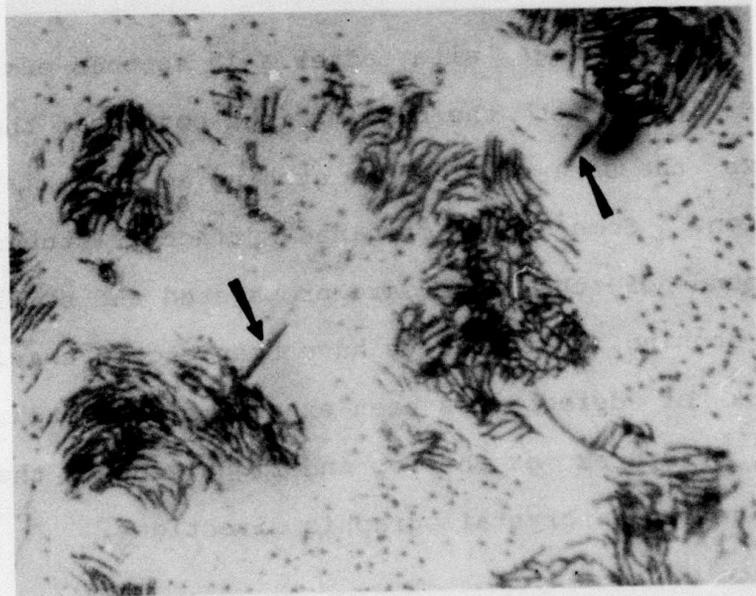
a. 15 sec. etch; 855X magnification.
Insert: Before etching 167X
magnification.

b. 60 sec. etch; 855X magnification.
Arrows point to fractures aligned
in $\langle 110 \rangle$ direction.

Fig. 16. Etch figures of ISS damage sites
on GaAs.

Figure 16a shows a damage site after a 15 seconds etch treatment. The insert at the bottom right corner of the micrograph shows the same site before etching at about 1/5 the magnification. Some of the original surface fractures in the foreground of the site are propagated and still visible after etching, while others have been etched away. A dense network of defects has been exposed by the etch. The two large fractures at the top and right side of the etched damage site run in crystallographic directions.

Another sample, etched for 60 seconds, is shown in Fig. 16b. This displays well the typical intricacy and profusion of the defects below the damage sites. The two fractures,

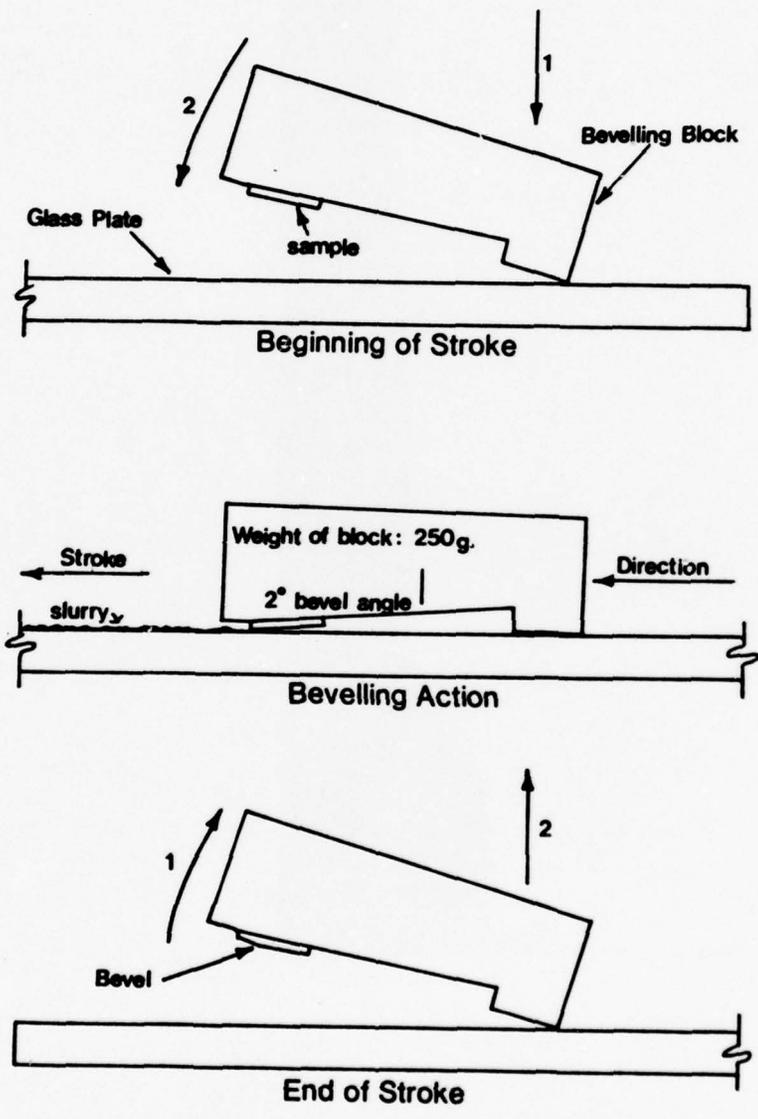
Fig. 1. Bevelling technique.

The bevel is formed by gently moving the block in the direction of the bevel edge. At the end of each stroke the block is lifted off the plate, bevel side first. Upon return to the starting position, the block is lowered gently onto the plate so that the bevelled edge makes contact last. No bevelling pressure is applied other than that provided by the 250g bevelling block. The procedure is schematically illustrated in Fig. 1.

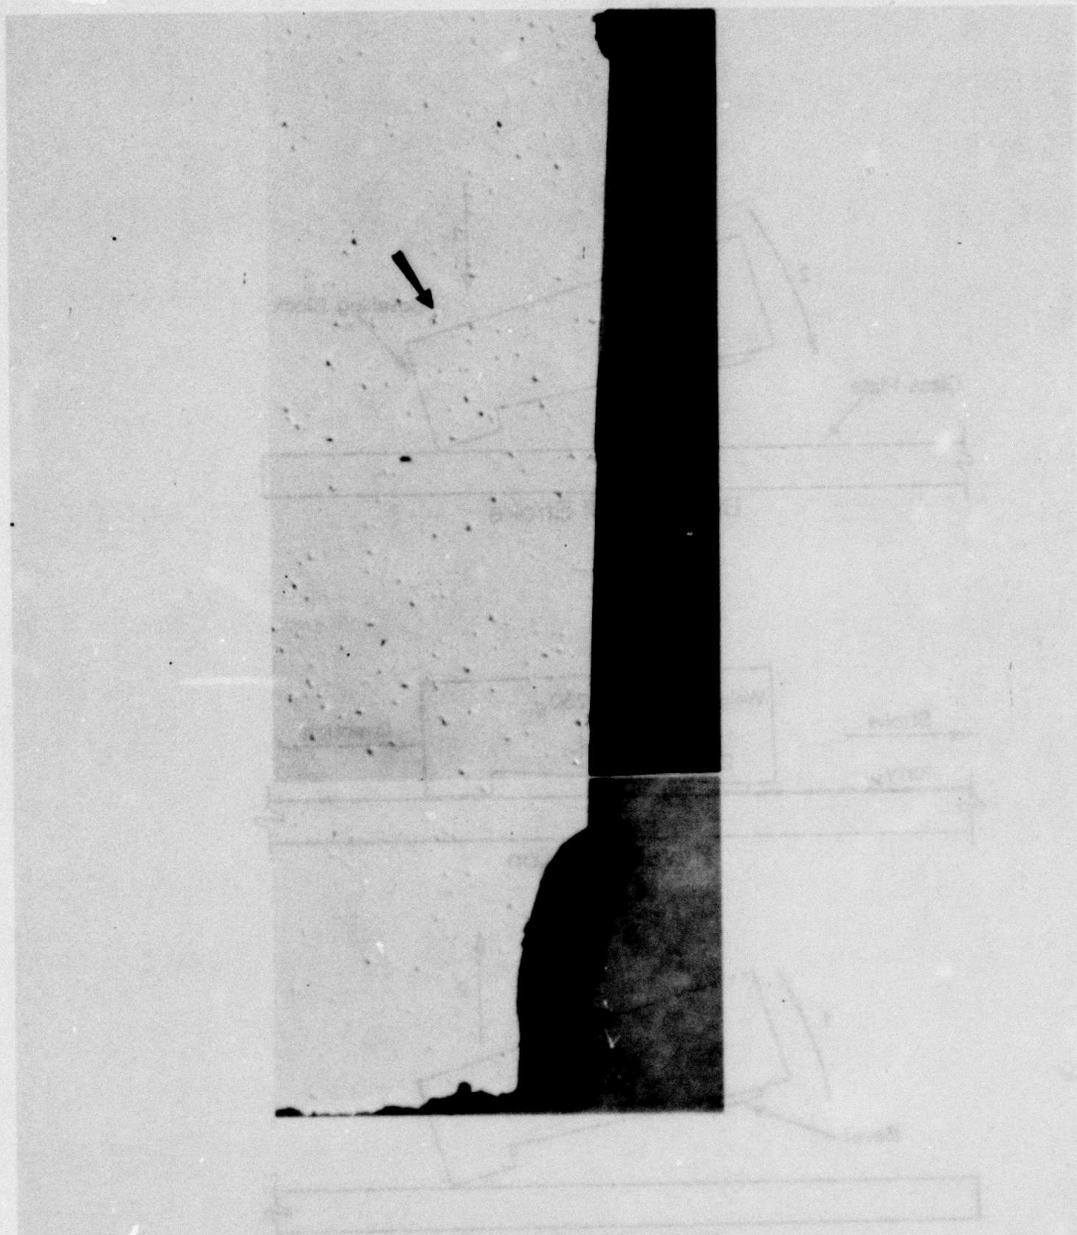
Fig. 2a. Microdamage in GaAs surface, induced by ISS at 6 1/4 watts for 60 sec. Arrow locates damage site visible in Fig. 2b. Sample ID # 6.25/1/10-21. 46X magnification.

A portion of a sample is shown before bevelling, after bevelling, and after etching in Figs. 2a, b, and c, respectively. Several severe damage sites are visible on

the unetched bevel in Fig. 2b. An example is the site marked with an arrow on all three micrographs. In Fig. 2c large numbers of etch figures are seen outlining the damage sites not identifiable before etching.

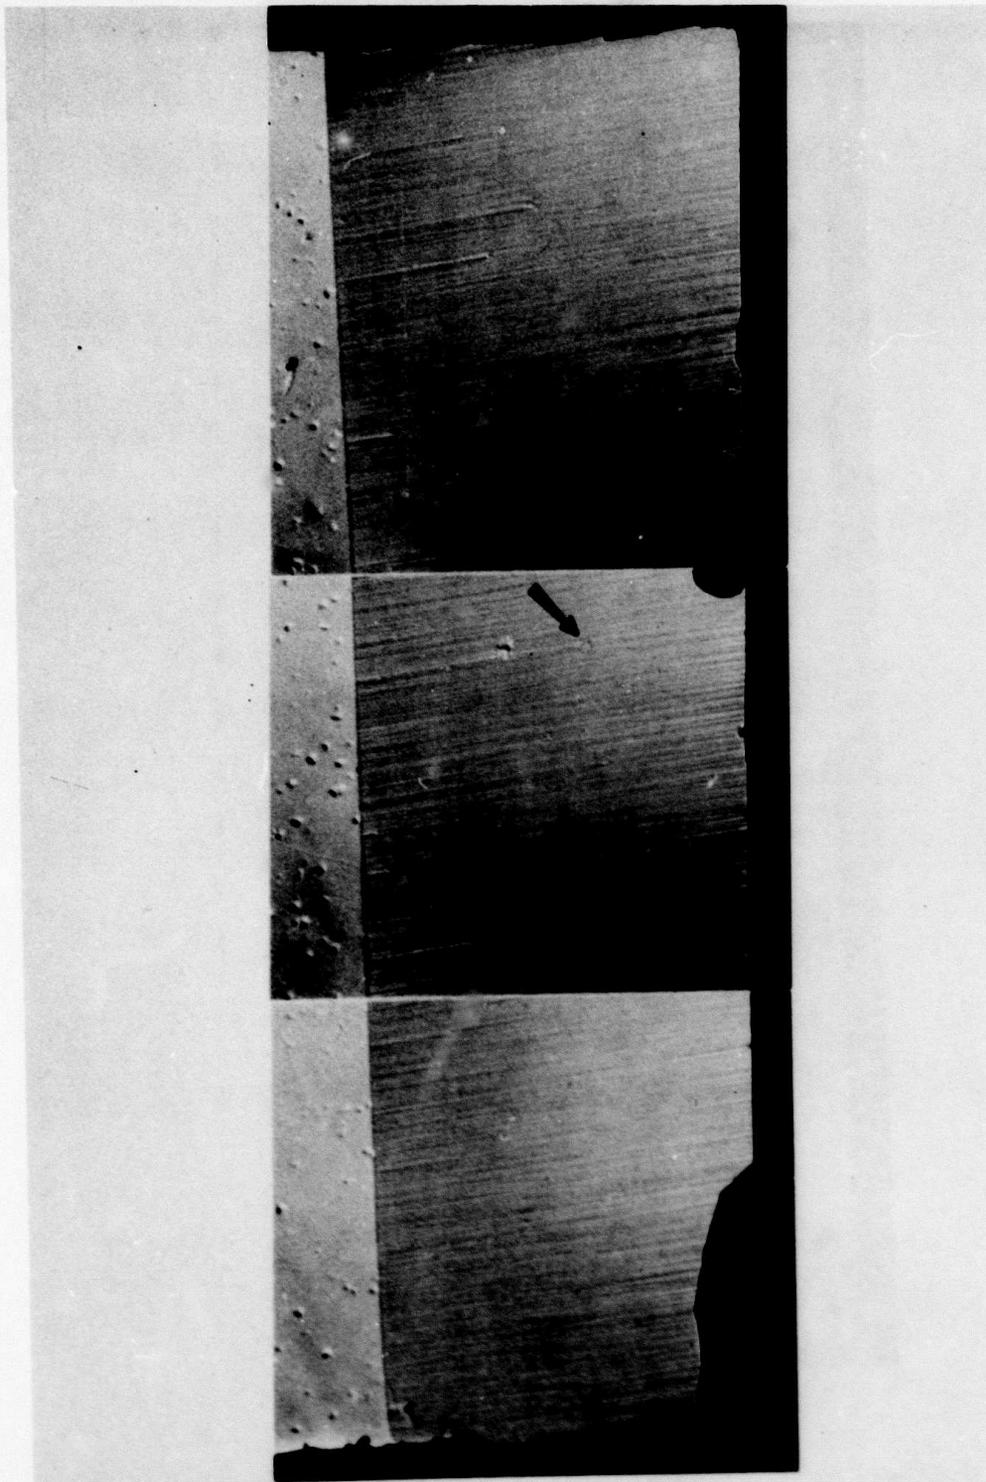
Fig. 2b. Same area as in Fig. 2a, bevelled at an angle of $1^{\circ} 19'$
46X magnification.

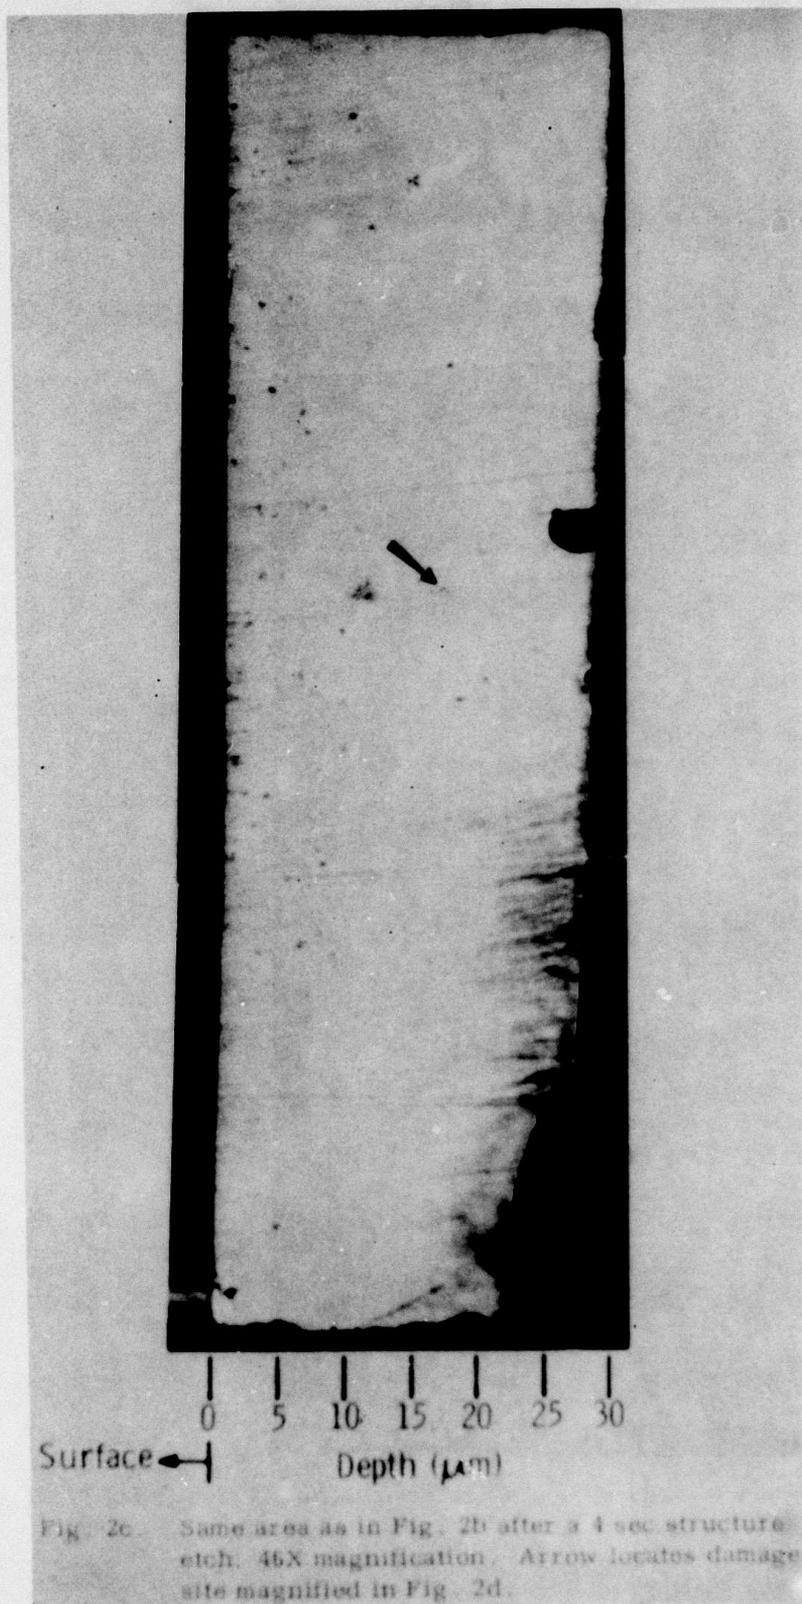
Fig. 2c Same area as in Fig. 2b after a 4 sec. structure etch. 46X magnification. Arrow locates damage site magnified in Fig. 2d.

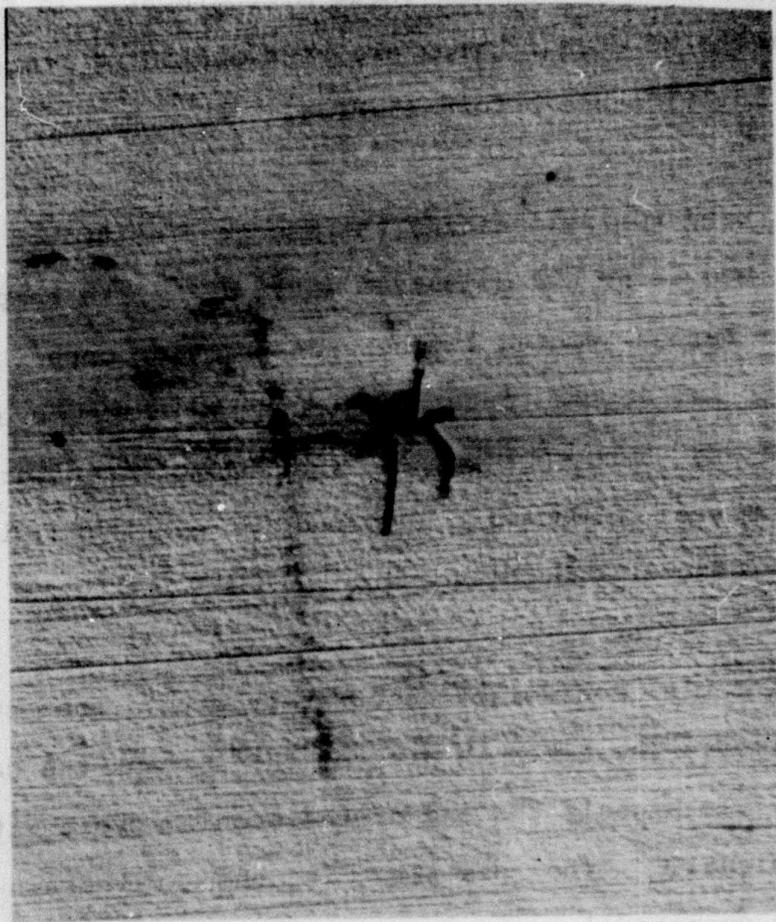
Fig. 2d. Closeup view (320X magnification) of etch figure indicated by arrow in Fig. 2c due to damage site located by arrows in Figs. 2a and 2b.

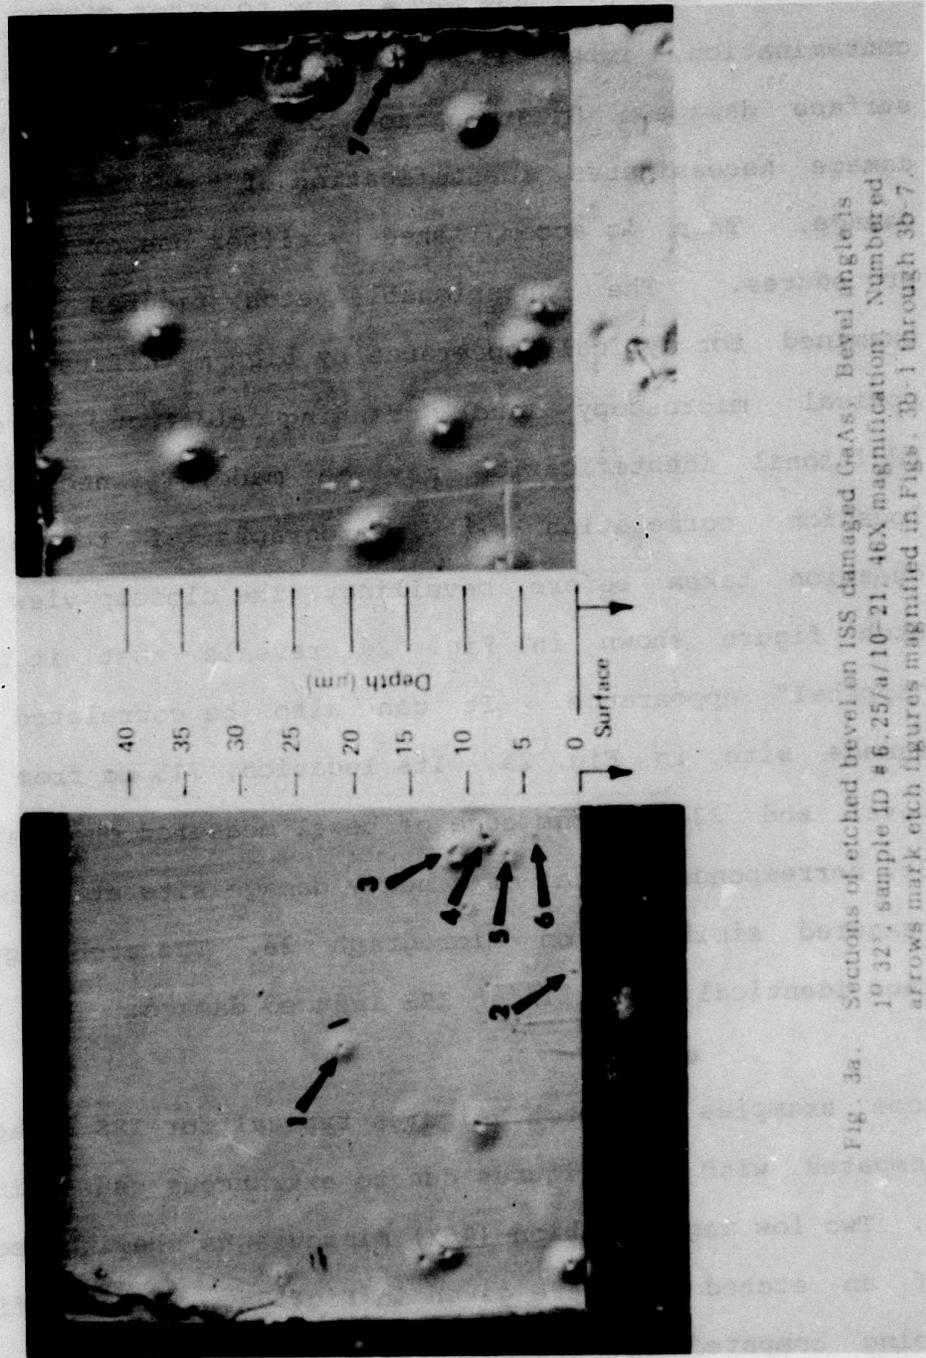
Fig. 3a. Sections of etched bevel on ISS damaged GaAs. Bevel angle is 10-32°, sample ID #6.25/a/10-21. 46X magnification. Numbered arrows mark etch figures magnified in Figs. 3b-1 through 3b-7.

Some examples of etch figures typical for ISS damage are compared with etch figures due to extraneous causes in Fig. 3. Two low magnification (46X) micrographs showing sections of an etched bevel are given in Fig. 3a. The etch figures being compared are indicated by numbered arrows. They are

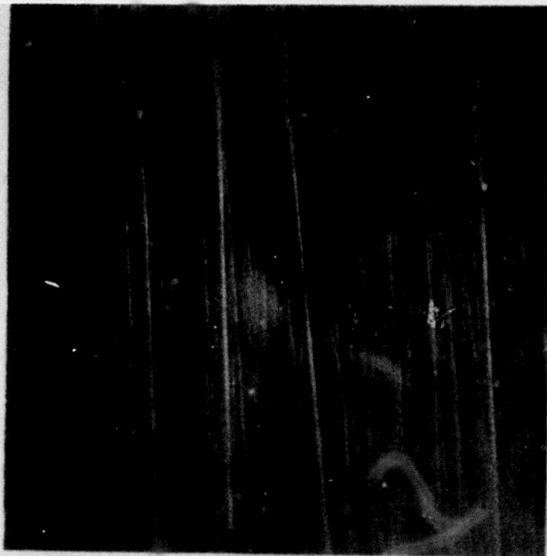
Fig. 3b-1. Etch figure not due to ISS damage.
855X magnification.

shown magnified in detail in Fig. 3b. Etch Figs. 1, 3, and 7 (Figs. 3b-1, 3b-3, and 3b-7) are not due to ISS induced damage. The remaining four etch figures are typical of etched ISS induced damage and are thus identified. The long etched out grooves are due to fractures and the short feathery ones are etched dislocation chains. Figures 3b-2, 3b-4, and 3b-6 are good examples. The two lower micrographs in Figs. 3b-4 are SEM recordings. The lower one gives a closeup view clearly showing the etched grooves. The lower micrograph in Figs. 3b-6 gives gives another such example. The upper edges of the fractures seen in the SEM micrograph of Figs. 3b-5 appear broken away. This may have occurred during bevelling.

Etch Fig. 1, at high magnification, is seen to be a shallow surface disturbance atypical of ISS damage. Etch Figs. 3 is identified in the SEM micrograph as a form protruding from the surface. It may be an imbedded aluminum oxide particle carried to its site in the abrasive slurry during bevelling. The SEM micrograph in the lower portion of Figs. 3b-7 shows that etch Fig. 7 has none of the typical etched grooves of ISS damage. It may be due to surface contamination.

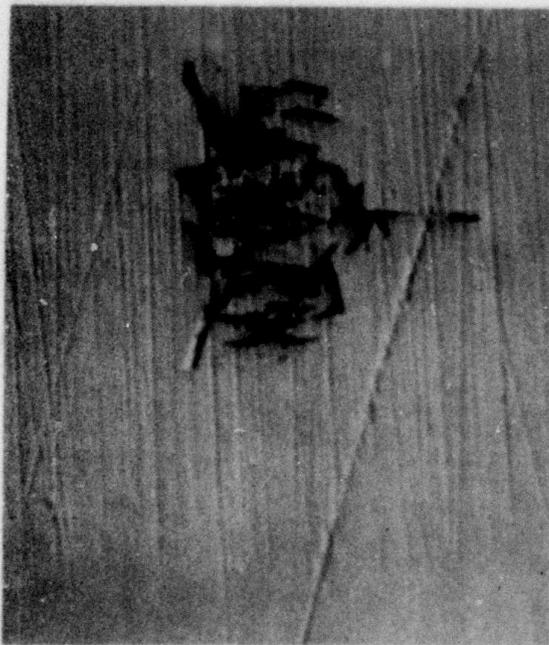
Fig. 3b-2. Etch figure due to ISS damage.
1390X magnification.

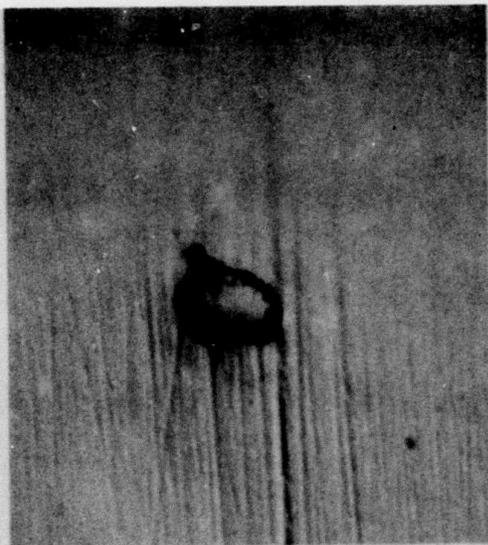
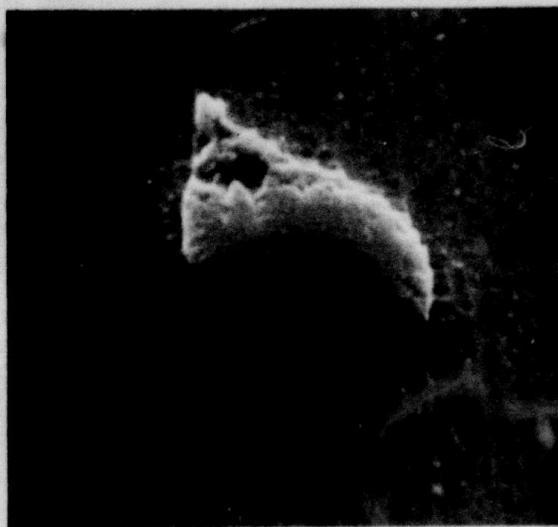
Light optical micrograph, 1390X magnification.

SEM micrograph, 4.7 KX magnification.

Fig. 3b-3. Particle on etched bevel.

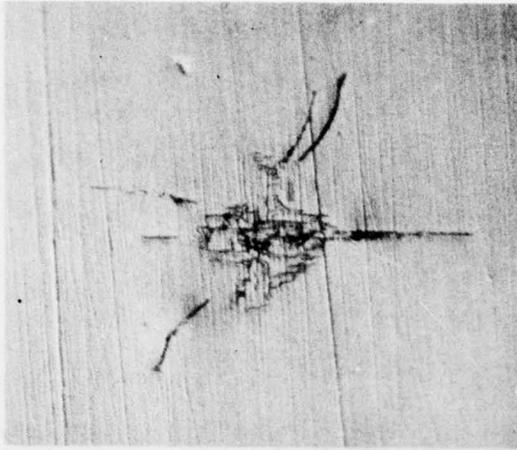
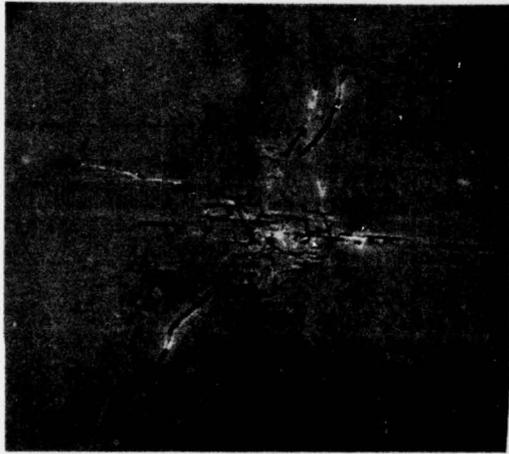
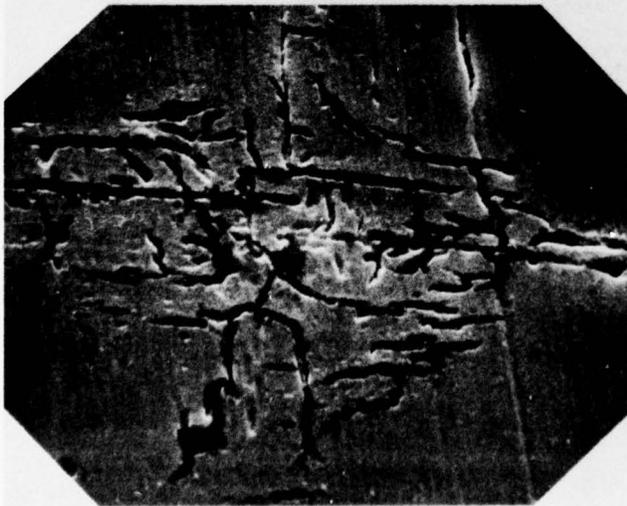
Light optical micrograph;
900X magnification.

SEM micrograph; 940X magnification.

Central view of etch figure
shown above;
3.2KX magnification.

Fig. 3b-4. Etch figure due to ISS damage.

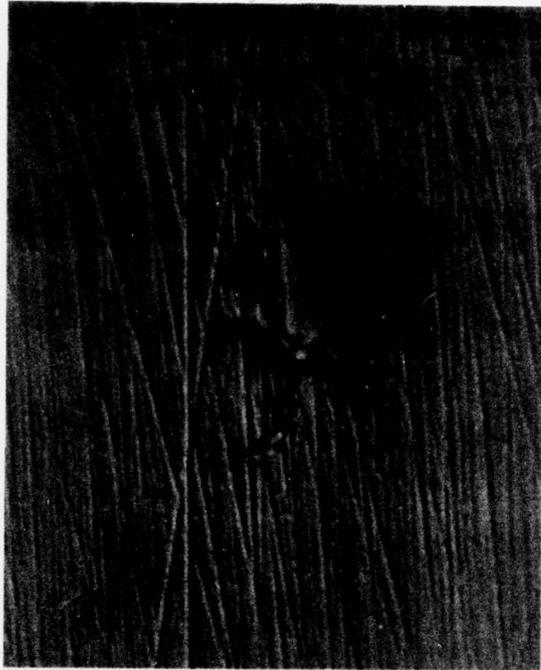
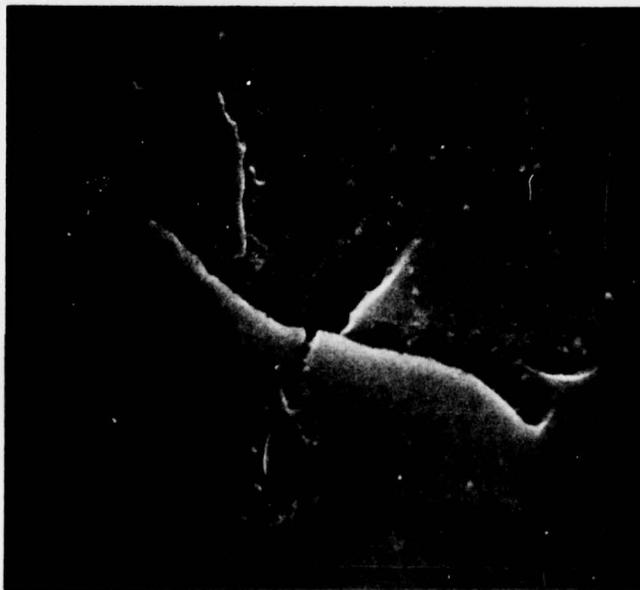
Light optical micrograph; 1390X magnification.

SEM micrograph showing broken edges on some grooves; 4.7KX magnification.

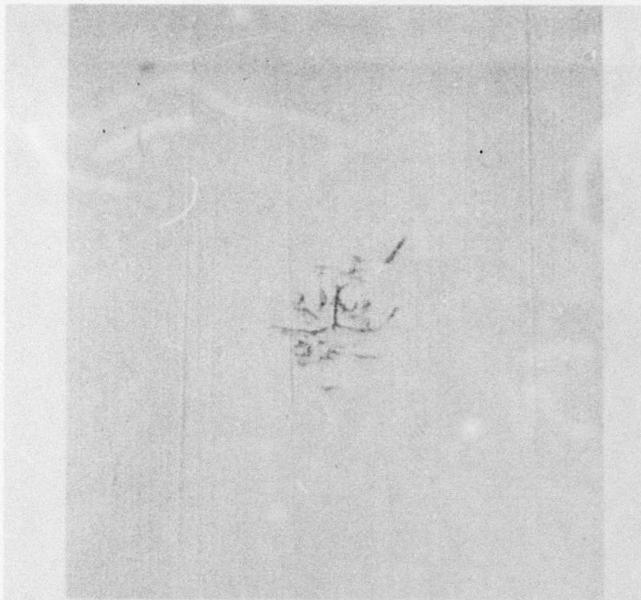
Light optical micrograph; 900X magnification.

SEM micrograph; 3.2 KX magnification.

Fig. 3b-6. Etch figure typical of ISS damage.
