DAMAGE PROFILES IN SILICON AND THEIR
IMPACT ON DEVICE RELIABILITY

G. H. Schwuttke, Principal Investigator, 914 - 897-3140

International Business Machines Corporation
East Fishkill Laboratories
Hopewell Junction, New York 12533

Final Report
April 1, 1978

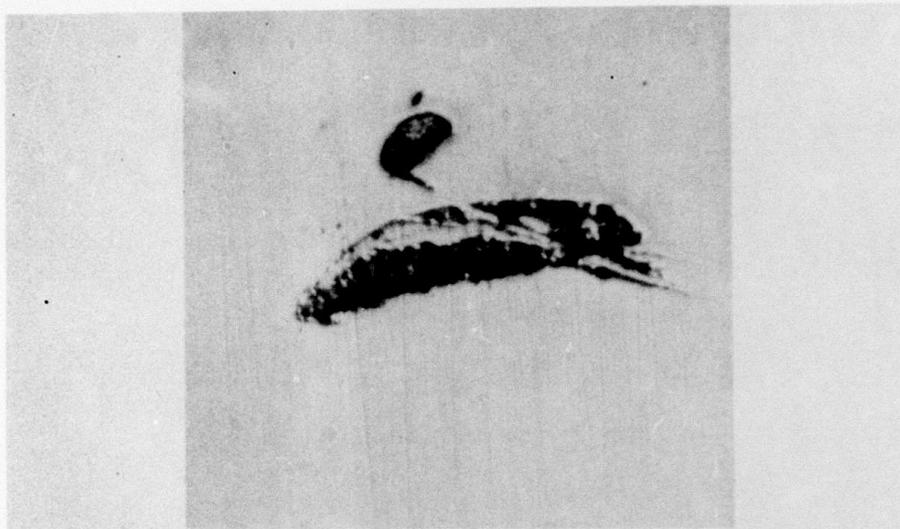
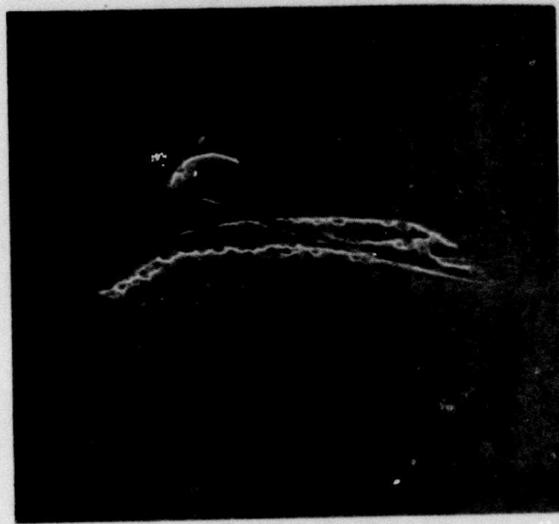
Light optical micrograph; 855X magnification.

SEM micrograph; 900X magnification.

Fig. 3b-7. Etch figure not due to ISS damage. Possibly caused by surface contamination.

Etch Fig. 1, at high magnification, is seen to be a shallow surface disturbance atypical of ISS damage. Etch Figs. 3 is identified in the SEM micrograph as a form protruding from the surface. It may be an imbedded aluminum oxide particle carried to its site in the abrasive slurry during bevelling. The SEM micrograph in the lower portion of Figs. 3b-7 shows that etch Fig. 7 has none of the typical etched grooves of ISS damage. It may be due to surface contamination.

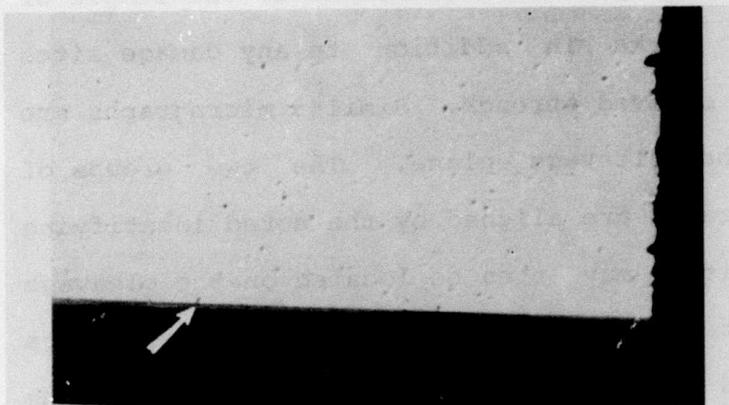
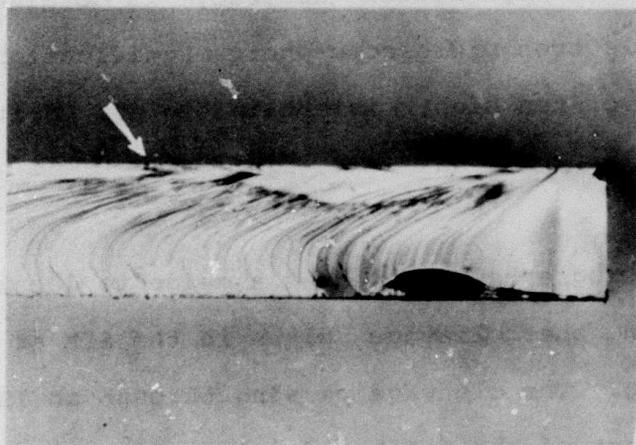
Surface; 46X magnification.

Cleavage plane; 46X magnification.

Fig. 4a. Cleaved, ISS damaged GaAs sample, sample ID # 6.25/1/10-21. Arrows indicate cleaved through damage site.

The light optical micrographs are used as a guide to locate the damage sites on the cleavage plane in the SEM at a similar magnification. The cleavage passing through an ISS damage site causes part of the fractured volume to collapse and fall out. This provides excellent contrast in the SEM and the sites are easily located for subsequent high magnification recording. The procedure is illustrated in Figs. 4.

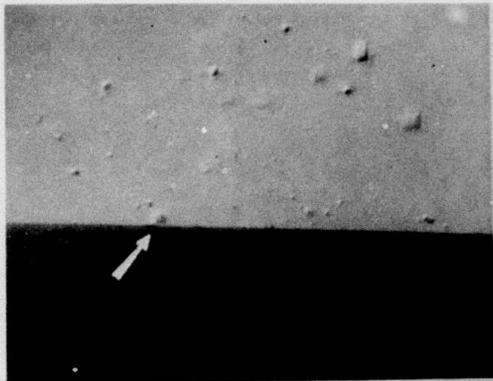
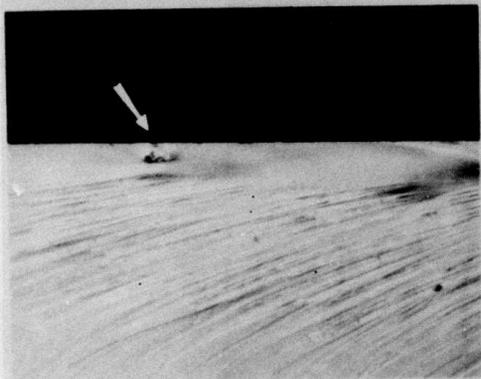
Light optical micrograph of surface:
167X magnification.

Light optical micrograph of cleavage plane:
167X magnification.

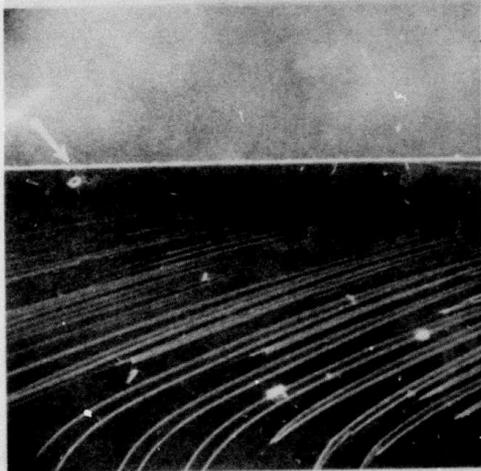
Fig. 4b. Magnified view of damage site shown in Fig. 4a for
location in SEM.

SEM micrograph of cleavage plane:
200X magnification.

Figure 4a shows the surface of a cleaved sample in the top micrograph. The arrow points to a damage site which has been cleaved through. An edge view of the same area is given below the surface micrograph, with the damage site identified on the cleavage plane. Magnified views of the area of the damage site are given in Fig. 4b.

The edge view at the center is used as a guide to locate the damage site in the scanning electron microscope. A slightly more magnified scanning electron micrograph of the same area is given below. This shows where the damage site has been identified on the cleavage plane. Figure 4c shows the final scanning electron micrograph of the damage site in the cleavage plane taken at 2000X magnification. The cleavage plane is placed perpendicular to the electron beam for recording. This avoids fore-shortening and allows direct depth measurements from the micrograph.

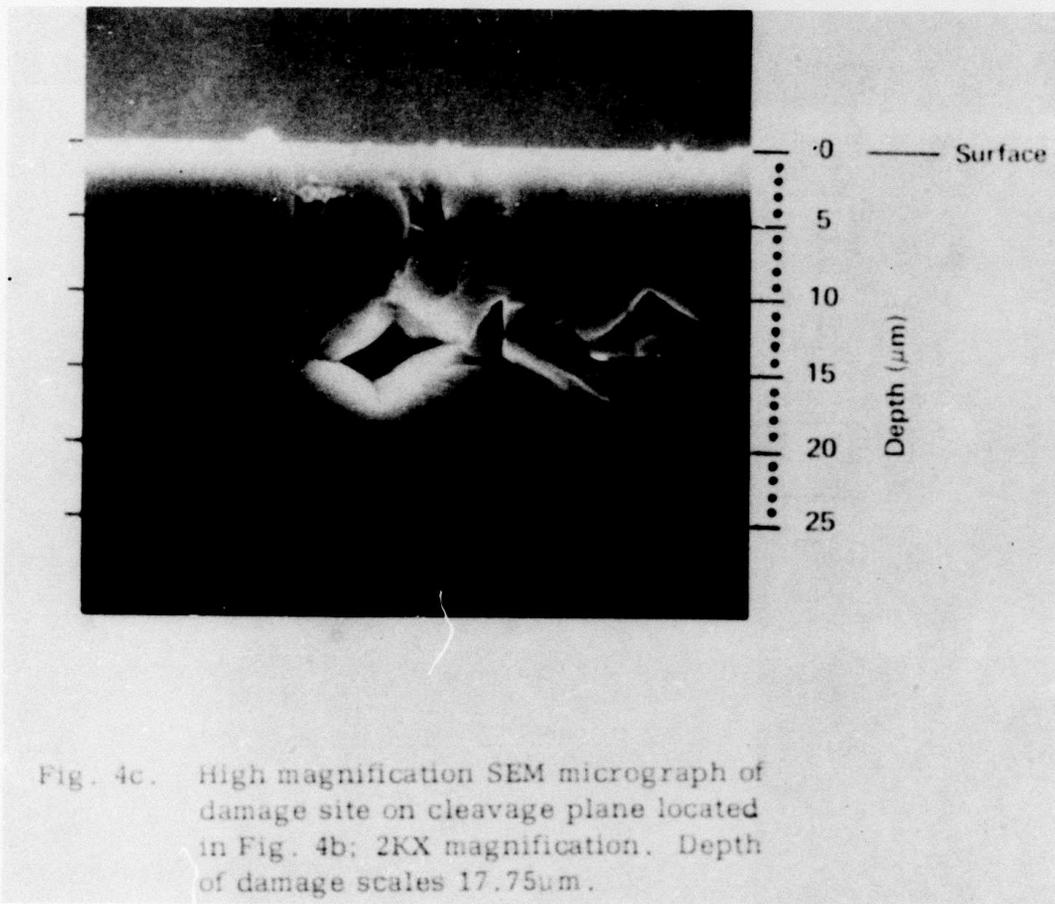
Fig. 4c. High magnification SEM micrograph of damage site on cleavage plane located in Fig. 4b; 2KX magnification. Depth of damage scales 17.75 μm .
