INVESTIGATION OF REJUVENATION OF FATIGUE
DAMAGE IN Ti-6Al-4V

BATTELLE- COLUMBUS LABORATORIES
505 King Avenue
Columbus, Ohio 43201

JULY 1977

TECHNICAL REPORT AFML-TR-77-107
INTERIM REPORT FOR PERIOD

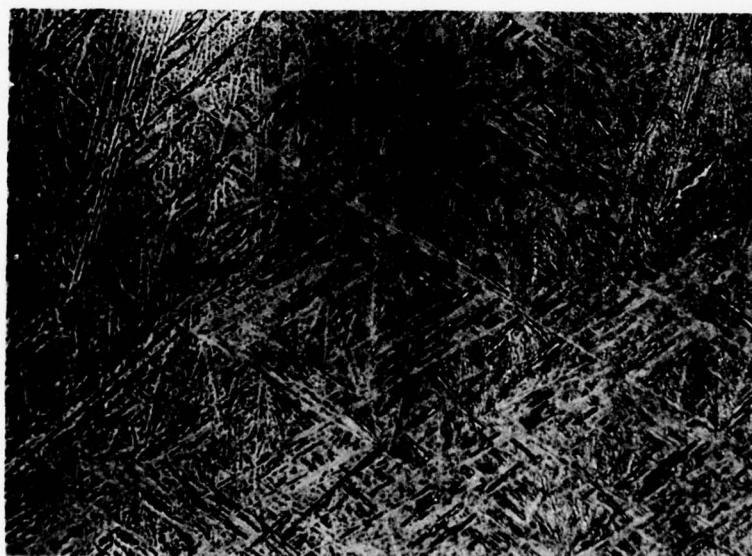
FIGURE 1. MICROSTRUCTURE OF Ti-6Al-4V IN THE β STOA CONDITION USED FOR THE FATIGUE EXPERIMENTS

* The microstructure of the specimens were the same for both lots as seen by optical metallography (Figure 1).
