CIVIL ENGINEERING LABORATORY  
Naval Construction Battalion Center  
Port Hueneme, California 93043

6 REDUCING VANDALISM IN NAVAL BACHELOR ENLISTED  
QUARTERS, VOLUME II: DEMONSTRATION PROGRAM &  
DESIGN GUIDELINES. (and)

BOSTI  
THE BUFFALO ORGANIZATION FOR SOCIAL &  
TECHNOLOGICAL INNOVATION  
Buffalo, New York

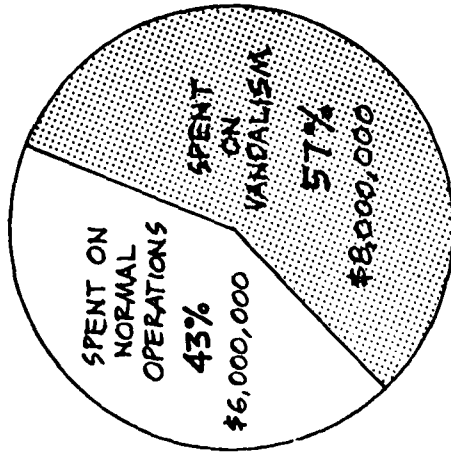
VANDALISM COST AS A PERCENTAGE OF TOTAL BEQ MAINTENANCE, REPAIR AND OPERATIONS BUDGET

For 1976, the estimated cost of these incidents to the Navy is almost \$8,000,000. The estimated 1976 budget for maintenance, repair and operations of stateside BEQs is almost \$14,000,000. Thus, as is shown in the diagram to the left, over half (57%) of the budget for BEQ operations during that period is believed to have been spent repairing property damage due to vandalism.

1. Well over half (57%) of the Navy-wide costs for BEQ maintenance and operations reported to us during 1976 have been spent repairing, reporting and investigating property damage due to vandalism.
2. At the current rate of vandalism, vandalism costs for FY 1978 and 1979 are equal to 48% of the total projected Navy Construction Program budget (excluding overseas and marine installations) for FY 1978 and FY 1979.

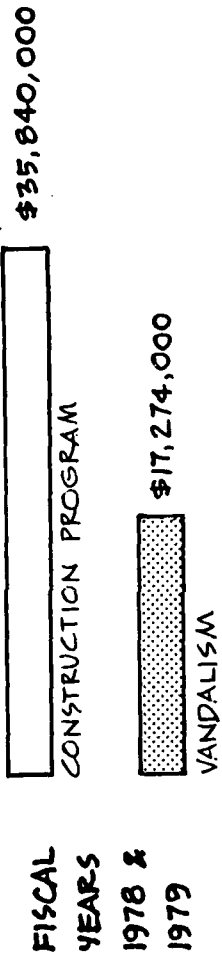
VANDALISM COST AS A PERCENTAGE OF BEQ CONSTRUCTION PROGRAM

The Navy BEQ Construction Program projected costs for FY 1978 and FY 1979 were examined. Construction for overseas bases and Marine Corps bases were excluded. If vandalism costs grow at their current rate, then vandalism costs will be 48% of the total Naval BEQ construction, modernization and rehabilitation budget for these two recent years.

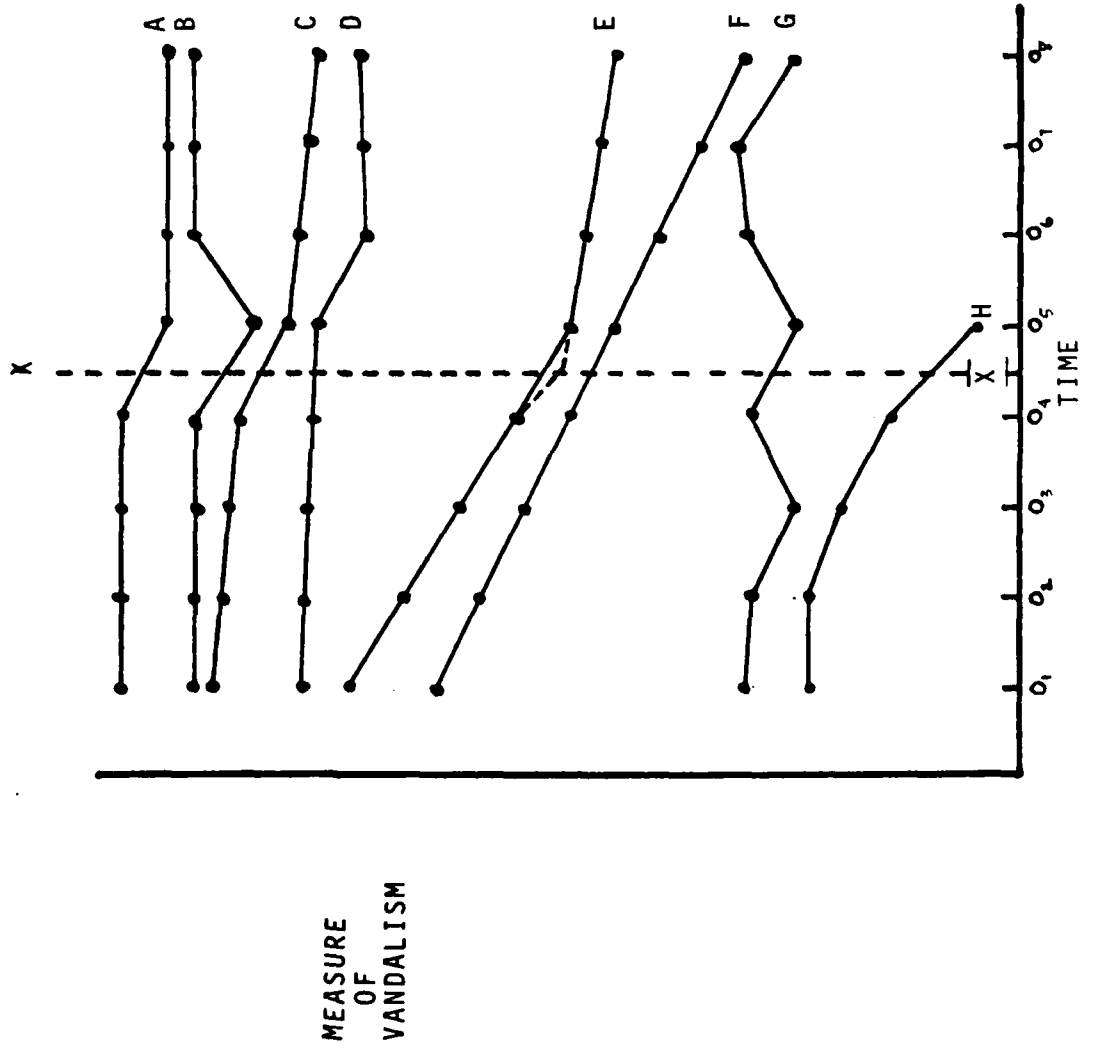
The figure below indicates some possible outcome patterns for a time-series which may occur after a design change has been introduced as indicated by the vertical line X.

(Diagram adapted from Campbell, D.T. and Stanley, J.C., *Experimental and Quasi-Experimental Designs for Research* 1963, p. 38.)
