6 TANK BARGE OIL POLLUTION STUDY.

Automation Industries, Inc.
Vitro Laboratories Division
14000 Georgia Avenue
Silver Spring, Maryland 20910

9 FINAL REPORT. Jul 77-Feb 78.

PREPARED FOR
DEPARTMENT OF TRANSPORTATION
UNITED STATES COAST GUARD
OFFICE OF MARINE ENVIRONMENT AND SYSTEMS
WASHINGTON, D. C. 20590

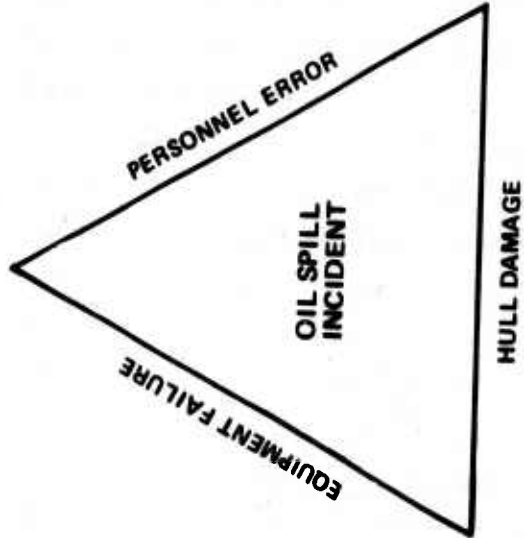
Figure 3-1. Nature and Extent of Tank Barge Oil Pollution

An overview of the tank barge oil pollution problem is illustrated on figure 3-1. This shows not only the broad technical considerations (causes and major parameters associated with tank barge oil spills), but also points out the interfaces and involvement with the industrial and public sectors.

Hull damage was a primary cause of pollution, especially from the viewpoint of oil volume spilled. However, as indicated on figure 3-1, interfaces between personnel, equipment, and hull design are an important aspect of the overall pollution prevention problem. Improvement in barge structure and design will not, by itself, prevent oil pollution; therefore, essential to any future pollution prevention efforts is consideration of all the underlying causes and their interfaces. This was the general approach taken in this study, which is reflected in the discussion of preventive measures which follows.
