FOREIGN TECHNOLOGY DIV WRIGHT-PATTERSON AFB OHIO
A COLLECTION OF STEEL METALLOGRAPHIES WITH ILLUSTRATION AND DES--ETC(U)
NOV 77

A COLLECTION OF STEEL METALLOGRAPHIES
WITH ILLUSTRATION AND DESCRIPTIONS

Source. Steel Metallography, 1975, pages 1-149.

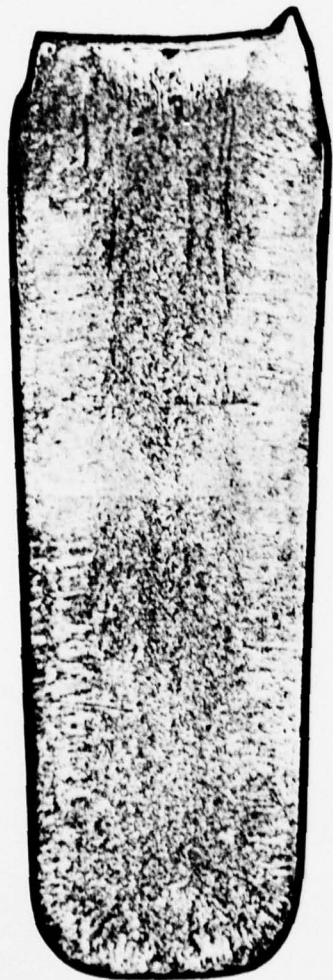
Picture No.	Title	Description
101	The crystal structure and defects of 30CrMnSiNi structural alloy steel ingot	<p>The weight of the ingot is 3 ton, and it is big-end-up with a hot top. The crystalization begins from the mould wall and gradually spreads to the center. From the longitudinal section of the ingot, three crystal zones can be seen. The extremely outside one is a very thin shell layer, which is formed by fine isometric crystals. Next is a rather thick columnar crystal zone and it is formed by coarse and long crystals which stand perpendicular to the mould wall. The one that is connected with the columnar crystal zone is the central zone and it is formed by large isometric grains.</p>

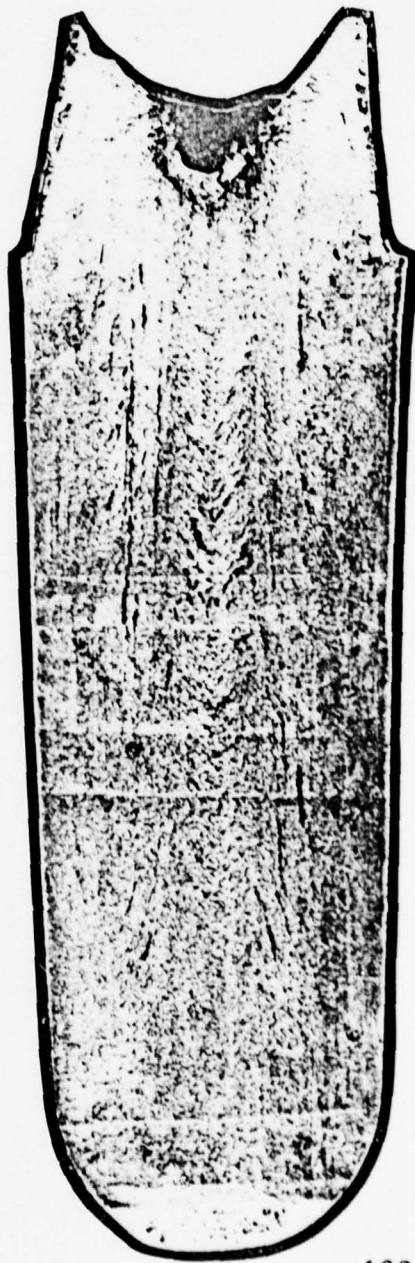
102

The sulphur print on the longitudinal cross-section of heavy rail steel ingot

The chemical composition of the steel is 0.64%C, 0.22%Si and 0.73%Mn. The weight of the ingot is 5.3 ton, and it is big-end-up with a hot top. As a result of having such sulphur prints, it proves that the sulphur content of the steel in the V-shaped and inverted V-shaped segregation parts is high.

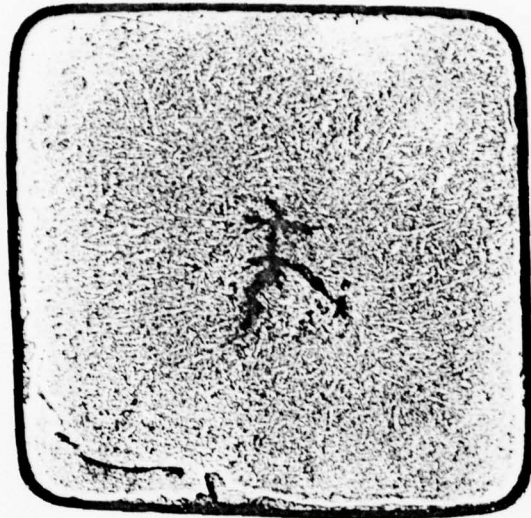
Picture No.	Title	Description
128	Shrinkage cavity remnant	<p data-bbox="678 457 1377 1352">Shrinkage cavity remnant in a steel billet of GCr15 bearing steel. There are overturned skin and other defects on the edge of the billet. The shrinkage cavity remnant at the central part of the hot acid etching transverse testing piece (perhaps because of the effect of hot working deformation, it moves close to the central part) appears to be wrinkle cracks, if the crop end of the billet is too few, they can even become macroscopic hollow. In the neighbouring areas of the shrinkage cavity remnant, there generally are aggregation of impurity inclusion, and unsolidness or segregation. This is the basis to differentiate shrinkage cavity remnant from internal cracks.</p>

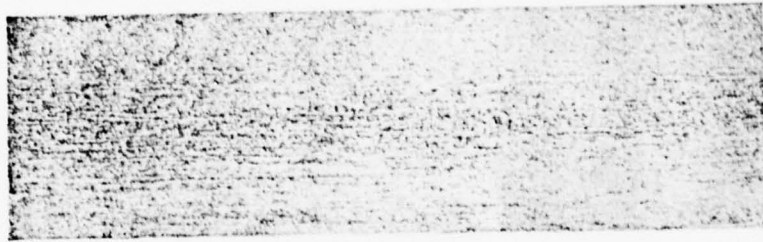
Picture No.	Title	Description
144	White spots	<p>White spots on the longitudinal section of a rail end, and the heavy rail does not have gradual cooling after rolling (picture above). There is no white spot on the longitudinal section of the rail end after gradual cooling (picture below).</p> <p>Etching agent: L:l hydrochloric acid water solution at at 60-70°C.</p> <p>Multiple: Approximately 1:1.3</p>

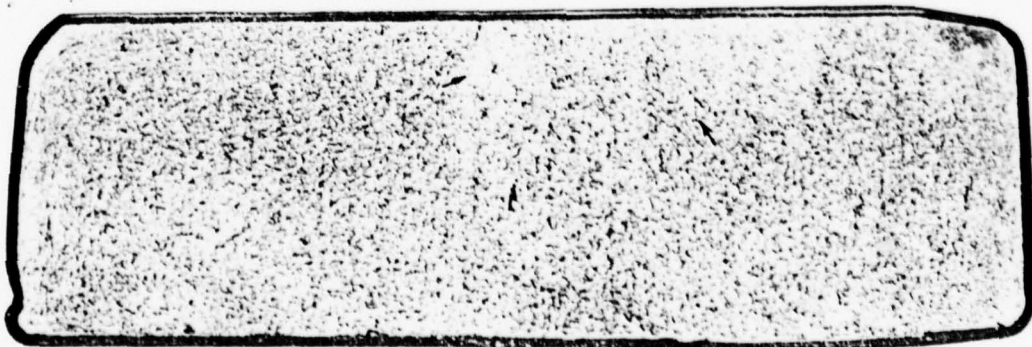
145	White spots	<p>Small white spots (as arrow pointing) on a billet of train wheel steel (corresponding to 65 steel).</p> <p>Etching agent: 1:1 hydrochloric acid water solution at 60-70°C.</p> <p>Multiple: 1:1</p>
-----	-------------	--

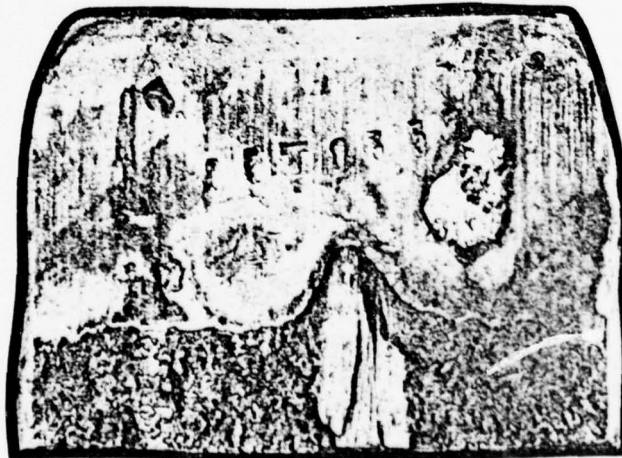
153

is defect in the billet. The experienced operators often use "tongue" as a means to do macroscopic examination. In this picture, the form of the "tongue" looks like an arc-shaped concave in the midmost part of the billet, and there are strips in the concave.

In the process of hot shearing of the billet, there are three continuous stages of change and each stage constitutes a different part of the billet. (1) the depressed part, this is the part where the shear presses the metal and the metal begins to shrink and curve; (2) ^{the} sheared part, this constitutes the most part of the end; and (3) the broken part. The "tongue" often appears between part (2) and part (3).

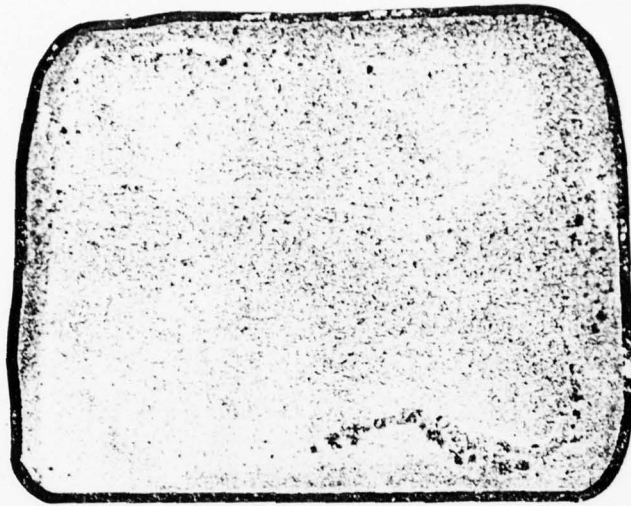
Picture No.	Title	Description
156	Overtuened skin	<p>The overturned skin in 45 steel. At the left upper corner, the overturned skin appears to be a white bright band, and around it there are pores, which were left after the impurity inclusion was eaten away by acid etching. At the right lower corner, the overturned skin is of the shape of black curved band. In the black band and its vicinity, there are some impurity inclusions. During ingot casting, there is an oxide film floating on the surface of steel liquid. In pouring, the film goes down into the liquid, and then it became an overturned skin in or on the cast ingot.</p> <p style="text-align: center;">Etching agent: 1:1 hydrochloric acid water solution at 60-70°C.</p>

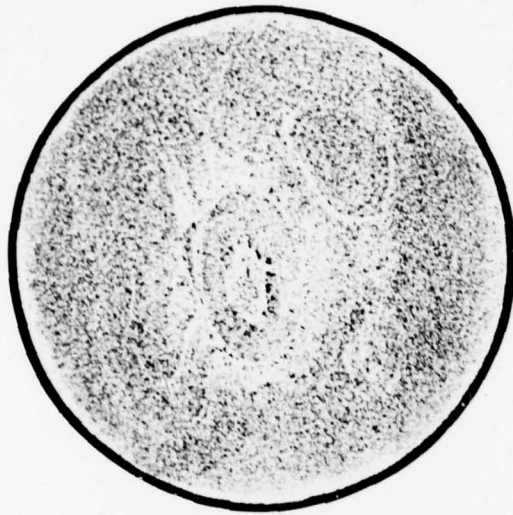
Picture No.	Title	Description
174	Negative segregation	<p>Negative segregation on the tail of an ingot of 30SiMnMoV structural alloy steel. On a hot acid etching transverse testing piece, negative segregation appears in the shape of either oval or irregular white or black band. The difference between negative segregation and overturned skin is that in the vicinity of the band there is no inclusion, and at the same time, the C and S contents are lower than that in the composition of ingot. The reason of producing this kind of defect is not yet known, nevertheless, it can be avoided by increase the steel liquid temperature, pouring faster, especially at the beginning of pouring or changing the shape of the die bottom.</p> <p>Etching agent: 1:1 hydrochloric acid water solution at 60-70°C.</p> <p>Multiple: 1:1</p>
.....		
175	Edge coarse crystal	DTI pure steel ingot. if the control of heating is not appropriate, there will

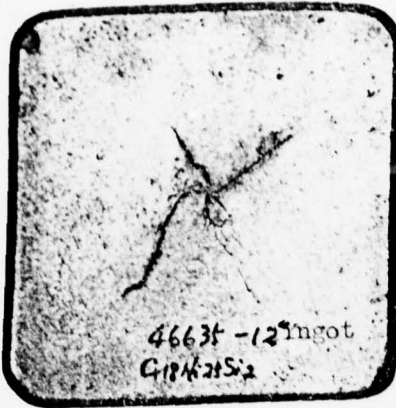
Picture No.	Title	Description
181	Forge crack	<p>Forge crack in a billet of Cr18Ni25Si2 heat resistant steel. Most of the crack appear at the axial part. When there is only one strand of crack, it always runs along a diagonal direction, when they are two, they make a cruciform and when they are more than two, they radiate out from the axis center.</p> <p>Etching agent: 1:1 hydrochloric acid water solution at 60-70°C.</p>

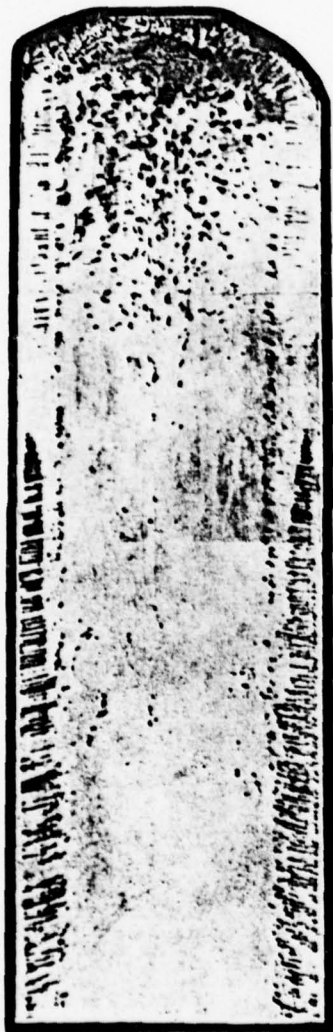
Picture No.	Title	Description
201	The structure and sulphur	The structure (picture 201) and sulphur
202	print of an open ingot of open steel	print (picture 202) of an open ingot of B3F steel. The structure of the longitudinal section of the ingot is of the following few layers: The outmost layer is a solid and hard shell, which contains no bubble. The thickness or thinness of this layer is determined by the condition of smelting and casting. Inside the hard shell, there is a layer of honeycomb bubbles. On this layer scatter many long strip-like bubbles, and the long axis of the bubble is perpendicular to the mould wall and stretches from the bottom of the ingot to its central part. Inside the honeycomb bubble layer, there is a layer of secondary bubbles.

Etching agent: 1:1 hydrochloric acid
water solution at
60-70°C.

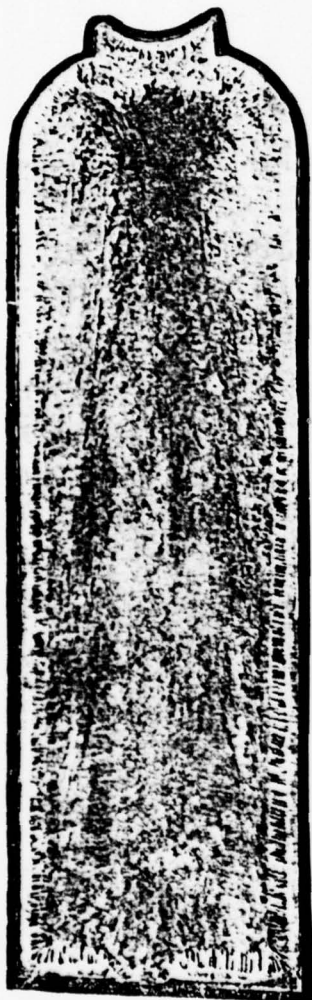
Picture No.	Title	Description
203	The structure and sulphur	The structure (picture 203) and sulphur print (picture 204) of a 7.26 ton bottle-shaped ingot of B3F steel. From the structure of the longitudinal cross-section of the ingot, it can be seen that the thickness of the ingot shell is 20-30 mm and thickness increases gradually from down up. The distribution of the honeycomb bubbles is different from that of the open steel ingot, the bubbles scatter over the whole length including the round arc part at the head, and their body is shorter than those on the open steel ingot. The latter is generally 70-100 mm while the former is about 25-45mm, and they gradually become short from down up. The secondary bubbles are not clear. The liquid extract concentrates in an area which constitutes 6-16% of the top.
204	print of a bottle-shaped ingot of open steel

Etching agent: 1:1 hydrochloric acid
water solution at
60-70°C.

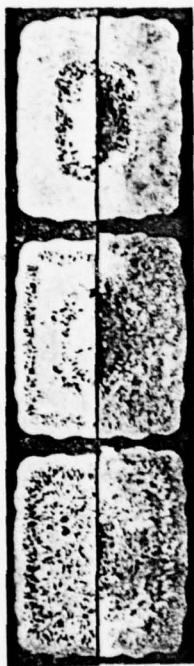
Picture No.	Title	Description
205	The structure and sulphur print of an open steel ingot	The structure seen on the longitudinal cross-section of an open ingot of open steel, which contains 0.09% C. From down up at a distance of 25%, 50% and 75% from the bottom, there are three not-acid--corroded testing pieces (left half) and sulphur prints (right half). The former illustrates the distribution of various kinds of bubbles and the latter illustrates the distribution of sulphide from surface to the center of the ingot.
206	Honeycomb bubbles	Honeycomb bubbles on the transverse cross-section of the middle and lower part of open steel. Etching agent: 1:1 hydrochloric acid water solution at 60-70°C.
207	Silicon segregation <i>g</i>	When B3F steel ingot has chemical sealing of its top by using silicon iron, some silicon enters into the honeycomb bubbles. Etching agent: 1:1 hydrochloric acid water solution at 60-70°C. Multiple: 1:2.5

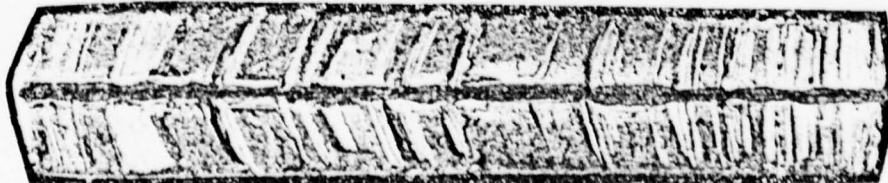
Picture No.	Title	Description
501	Terrace fracture	<p>In the picture from up down are terrace fractures with different degrees of 30CrNiMo steel. On the broken longitudinal fracture testing piece, under condition of modification, there are flat terraces of different size. The structure of the terrace is similar to that of the steel body but its color is lighter. Most of the terraces scatter in the areas of axis and segregation on the ingot. The less severe terrace fracture has only slight effect to the transverse plasticity of the steel, but the severe ones can reduce the transverse plasticity to a degree of being useless.</p> <p>.....,</p>
502	Tearing fracture	<p>In the picture from up down are tearing fractures with different degrees of 18CrNiW steel. On the broken longitudinal fracture testing piece, they are solid, shining grey strips. The joining point of the strips shows concavo-convex marks of tearing. The distribution of the strips is not regular.</p>

When they become severe, they can cover the whole fracture.

They are primarily regarded as products of remaining high aluminum content of the steel. The less severe tearing fracture has little effect to the mechanical property of the steel, but when they become severe, they can reduce the transverse plasticity and tenacity of the steel. According to their experiment in one plant, the effect of high-temperature annealing (1200°C, 5 hours) is not obvious.

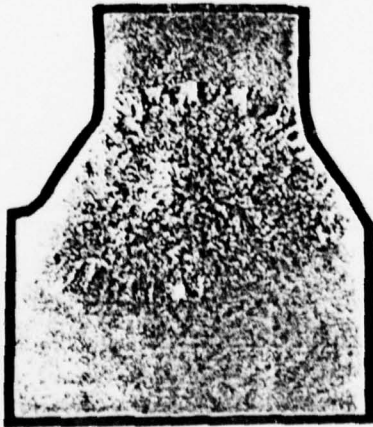
608

Picture on left-hand side is No.3 degasified steel plate and its thickness is 80mm. On it is the transverse section of Tee-joint of melting nozzle electro-slag welding.

Picture on right-hand side is the longitudinal section of melting nozzle electro-slag welding on No.3 degasified steel plate and its thickness is 80mm.

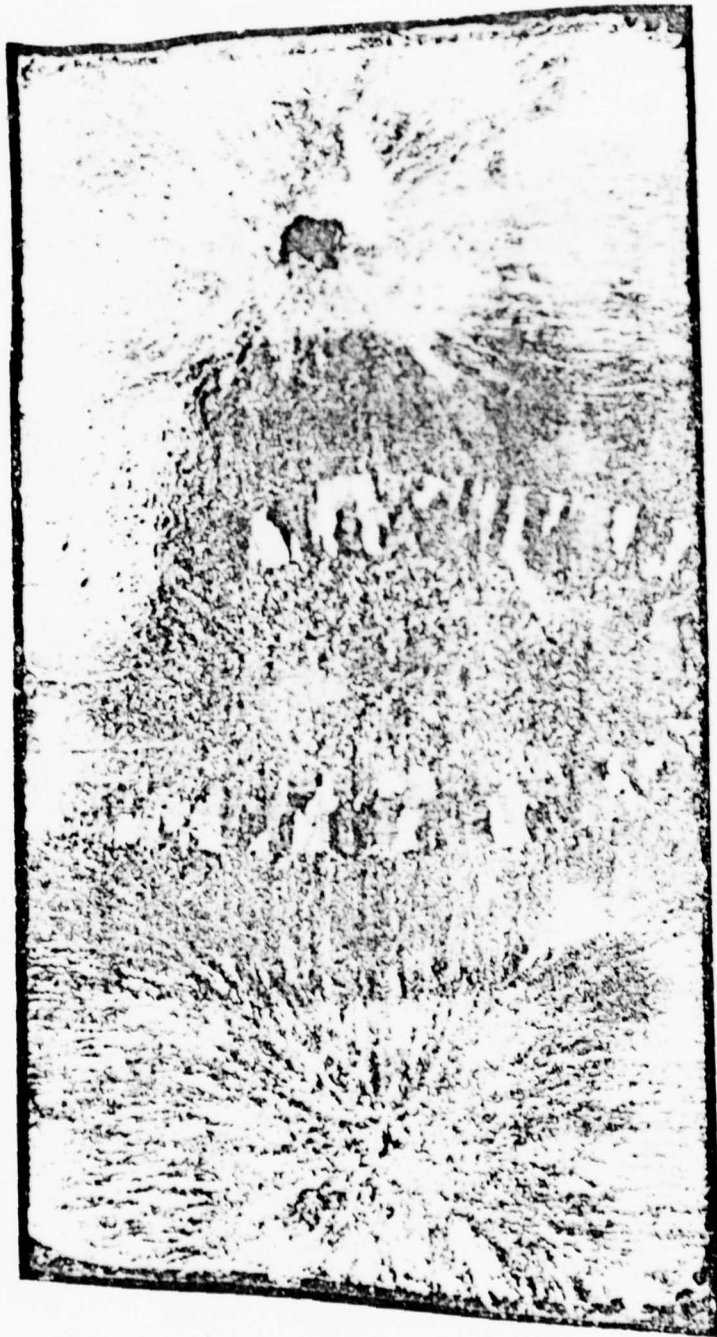
Picture No.	Title	Description
609	Casting steel electro- slag welding	The normal welded seams of electro-slag welding on the parts of a water press machine. Down and above are shrinkage cavities of the ingot, and in the middle are the seams of electro-slag welding.

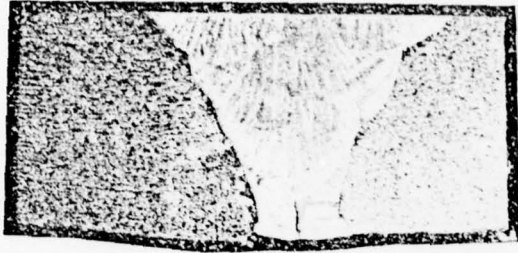
Picture No.	Title	Description
632	Crack of manual electro-arc welding	<p>Welding of No.20 furnace steel and Cr16Ni36 stainless steel.</p> <p>Crack at foot part of welding seam.</p> <p>Etching agent: Hydrochloric acid 50ml, nitric acid 5ml, potassium bichromate 2.5g, water 50ml, mix together and heating to 50°C, hot etching.</p> <p>.....</p>
633	Crack of automatic welding on thick plate	<p>115mm thick plate of 18MnMoNb steel, welding wire H08Mn2MoA, welding agent 250.</p> <p>Heating to 640°C after welding and temperature retention for 5 hours, then air cooling.</p> <p>.....</p>

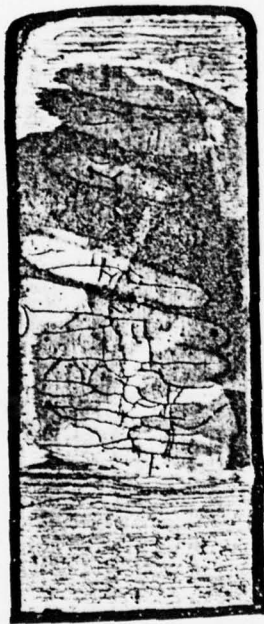
Picture No.	Title	Description
701	Cutting defects	Cracks and structural changes made at the time when a round billet of 60Si2 spring steel is cut with a sand-wheel-blade and partially overheated.
.....		
702	Cutting defects	Black circles made at the time when a round billet of GCr15 bearing steel is cut with a sand-wheel-blade and partially overheated. Etching agent: 1:1 hydrochloric acid water solution at 60-70°C. Multiple: 1:1.3
.....		
703	Cutting defects	Cracks made at the time when a round billet of GCr15 bearing steel is cut with a sand-wheel-blade and the cooling is not appropriate. Etching agent: 1:1 hydrochloric acid water solution at 60-70°C. Multiple: 1:1.4
