**DESTROYER ENGINEERED OPERATING CYCLE
(DDEOC)**

System Maintenance Analysis

FF-1052 CLASS

5-INCH 54-CALIBER MARK 42 MOD 9 GUN MOUNT

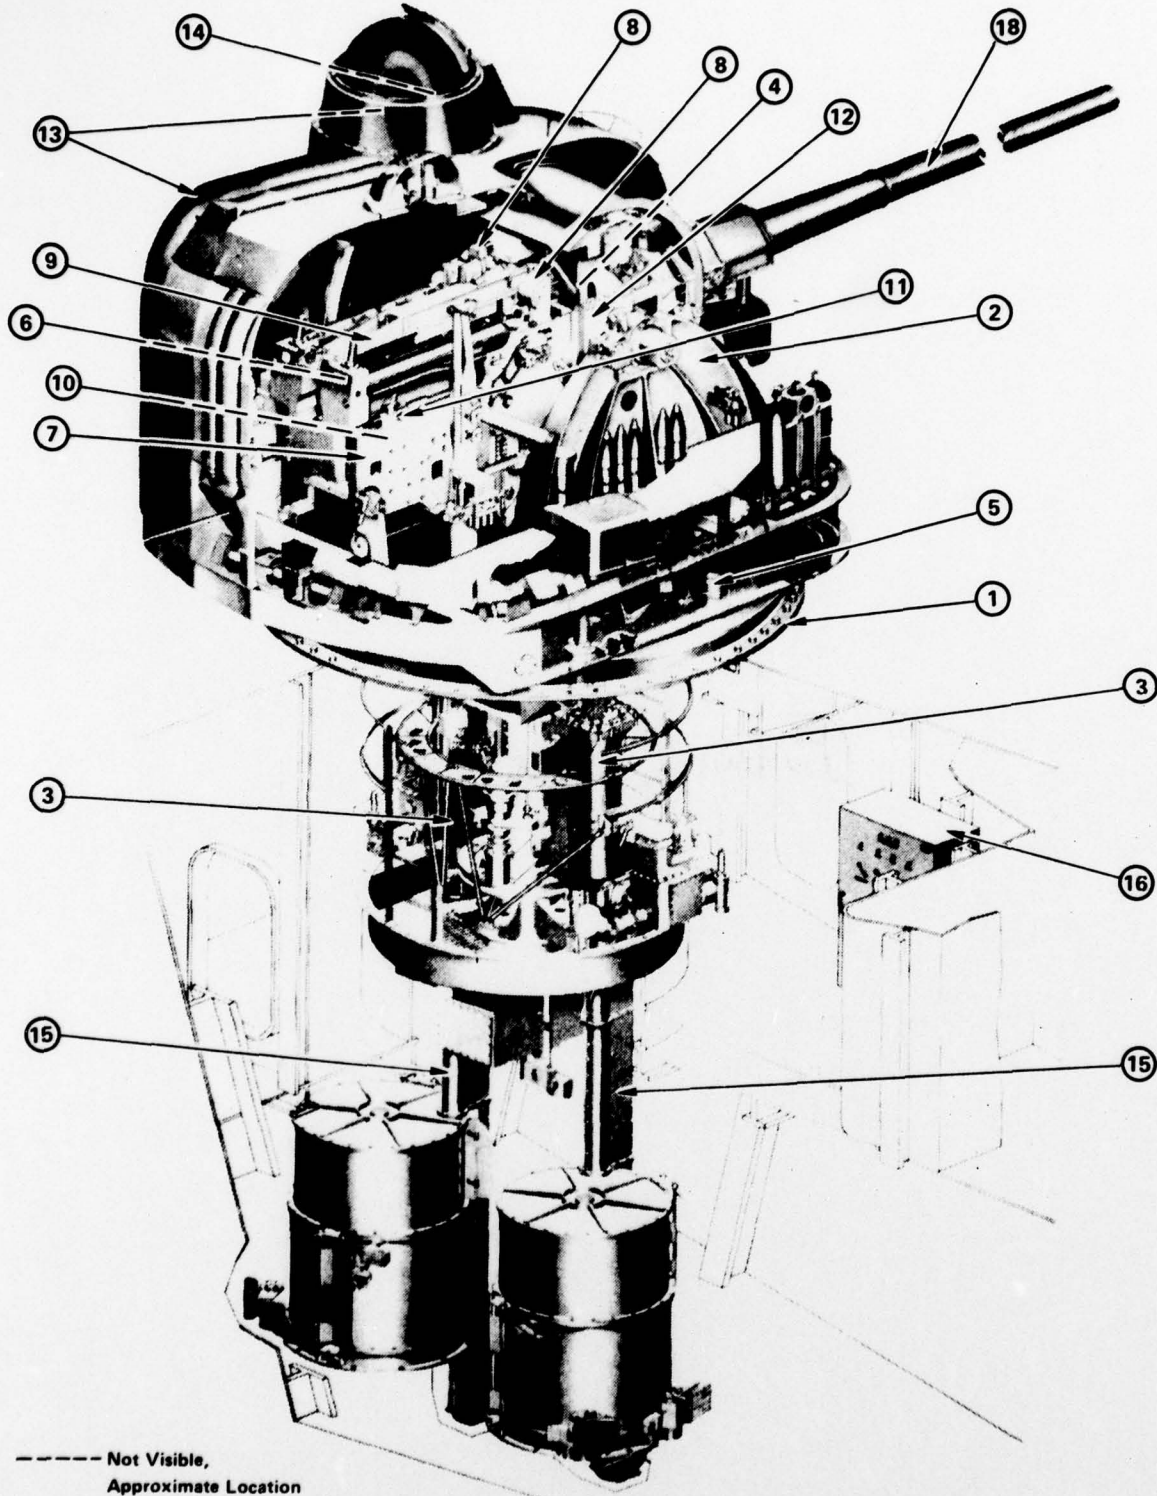
Figure 1-1. 5-INCH, 54-CALIBER SINGLE GUN MOUNT MARK 42 MOD 9 ASSEMBLY
(Reproduced from NAVORD OP 3851 IPB)

Figure 1-1 was extracted from Part 1 of the Illustrated Parts Breakdown (IPB) for the 5"/54 MK 42 MOD 9 Gun Mount Technical Manual, OP 3851, and illustrates the physical boundaries of the Gun Mount System. The original numbering was modified to refer to the components that make up the system as listed by APL/CID in Table 1-1.
