USARTL-TR-78-26

**DESIGN, TEST, AND ACCEPTANCE CRITERIA FOR  
HELICOPTER TRANSPARENT ENCLOSURES**

Bruce F. Kay  
Sikorsky Aircraft Division  
United Technologies Corp.  
Stratford, Conn. 06602

Final Report for Period 27 June 1974 - 26 July 1976

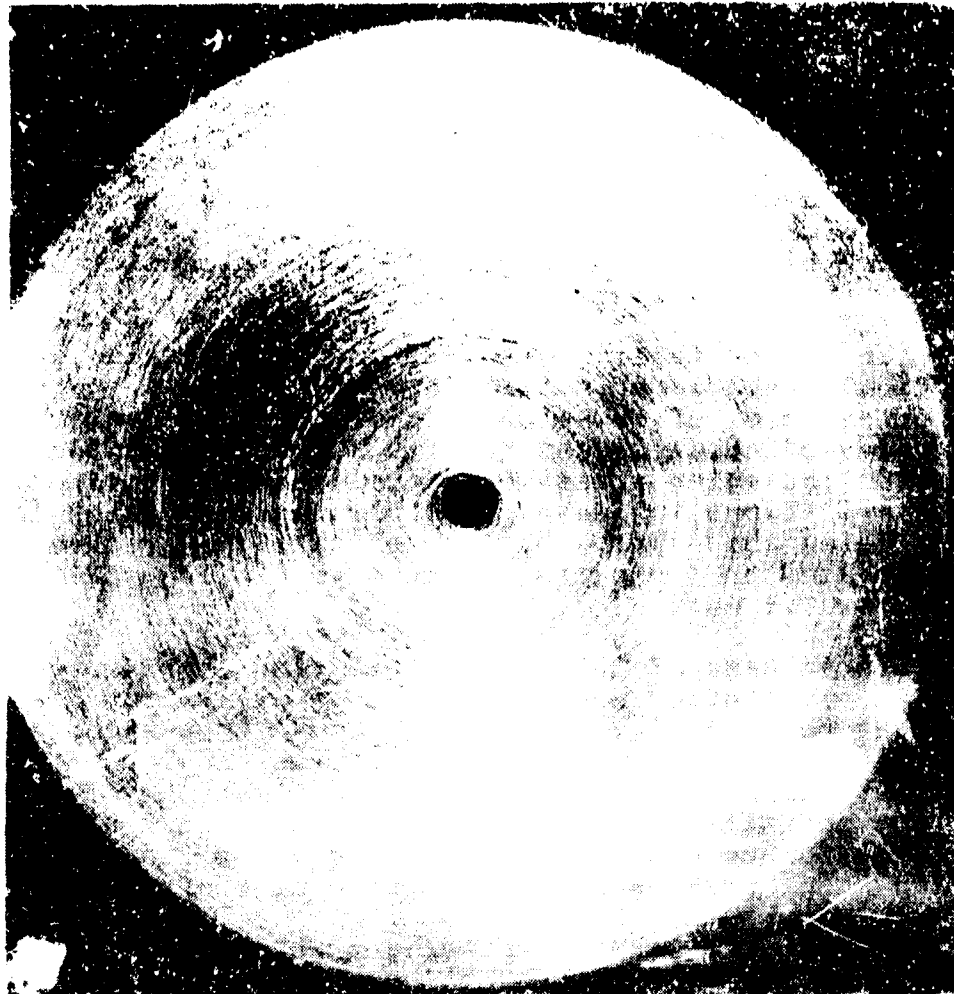
Figure 8. Specimen From Wet Rubbing Abrasion Test.

The characteristic abrasion marks produced by the test are illustrated in Figure 8.

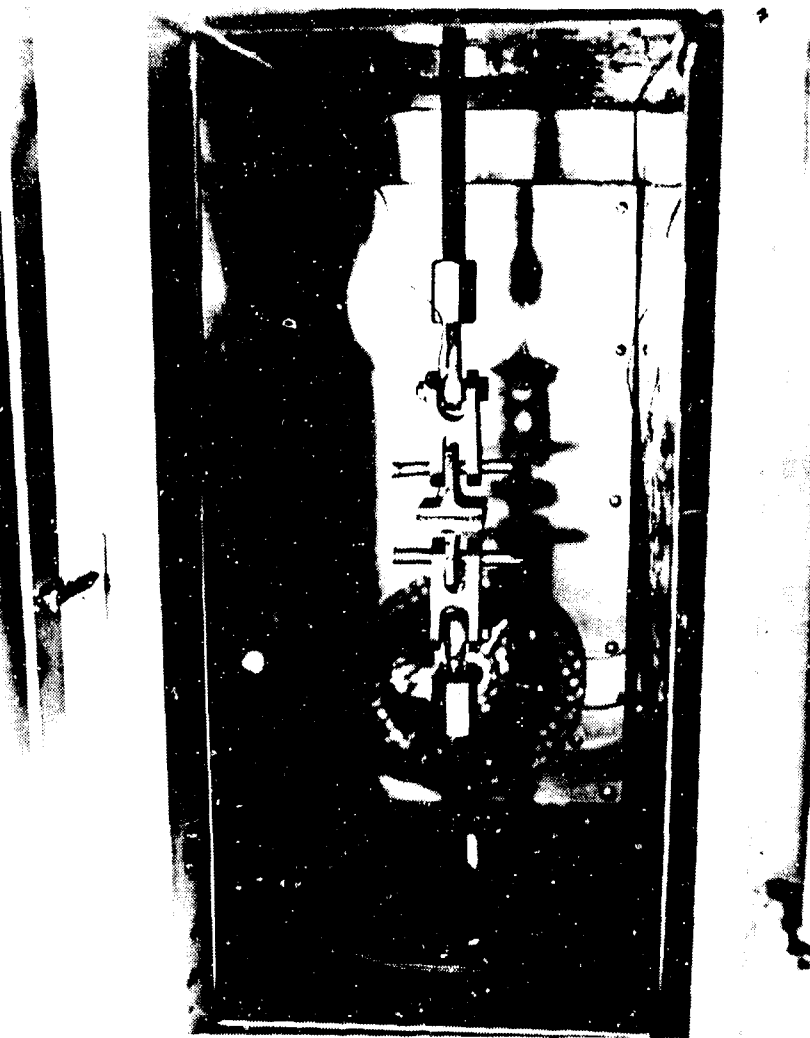
Figure 12. Bond Tensile Test Setup.

1. Three specimens of each configuration were tested at each temperature.
2. The specimens were each placed in the tensile testing machine with self-aligning holders, Figure 12, and loaded to failure at a rate of 0.2 inch/minute.
3. Step 1 was repeated at a temperature of  $-65^{\circ}\text{F} \pm 5^{\circ}\text{F}$ .
4. Step 1 was repeated at a temperature of  $+125^{\circ}\text{F} \pm 5^{\circ}\text{F}$ .

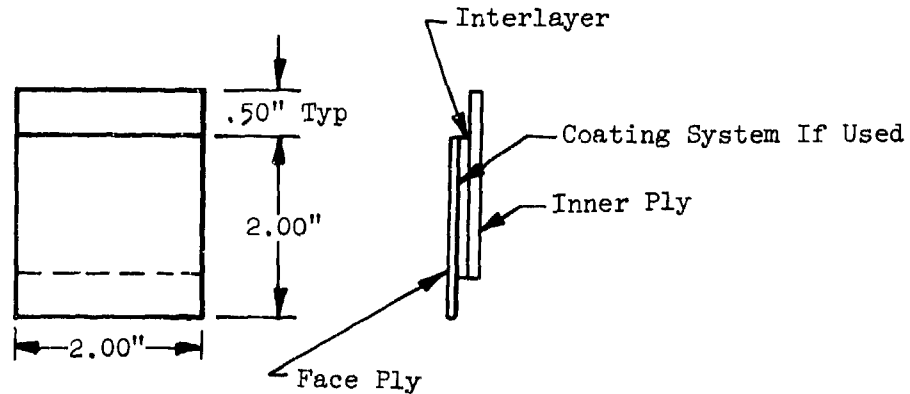
Figure 14. Bond Shear Test Specimen.

The coupon specimens for this test were fabricated as shown in Figure 14.

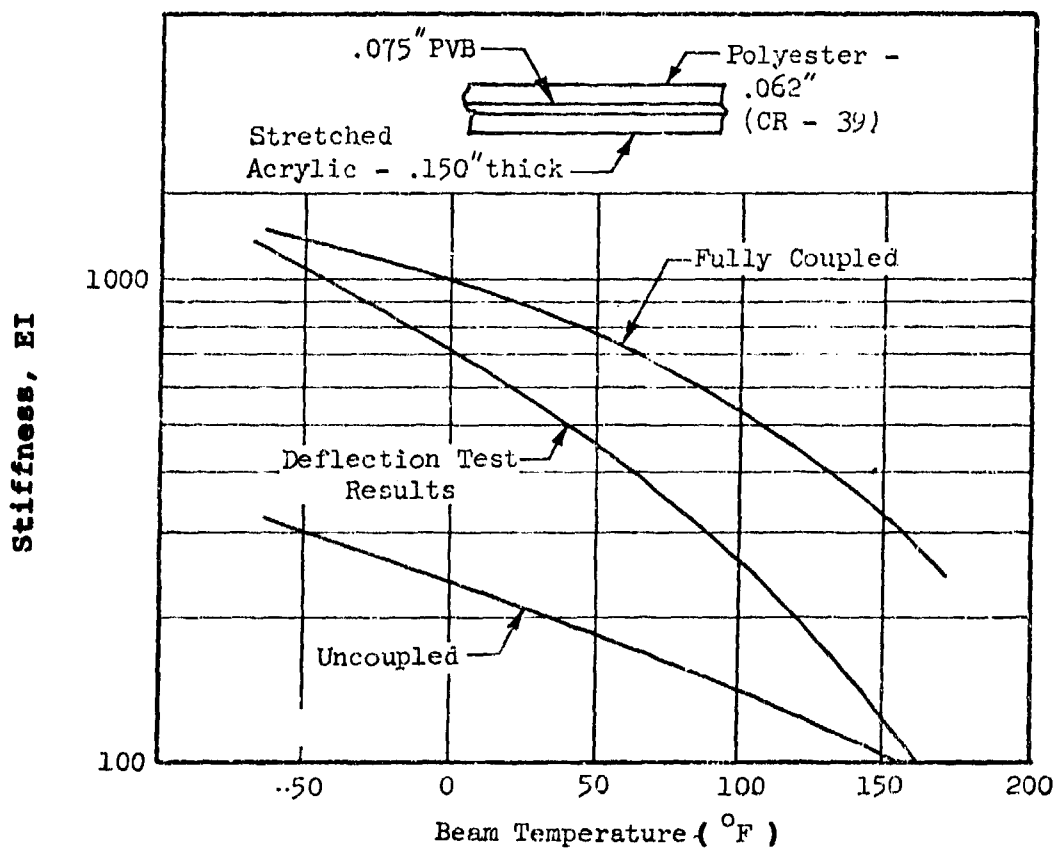
Figure 32. Variation in Stiffness With Temperature, Polyester-PVB-Stretched Acrylic.

Figures 32, 33 and 34 show curves of the expected stiffnesses for the ideal coupled and uncoupled beams as well as the equivalent stiffnesses derived from the load deflection curves. The glass-PVB-stretched acrylic specimens, with and without conductive coatings, are plotted on the same curve since the coatings do not affect stiffness. The calculations for the theoretical stiffnesses were obtained from Equations (3) and (4).

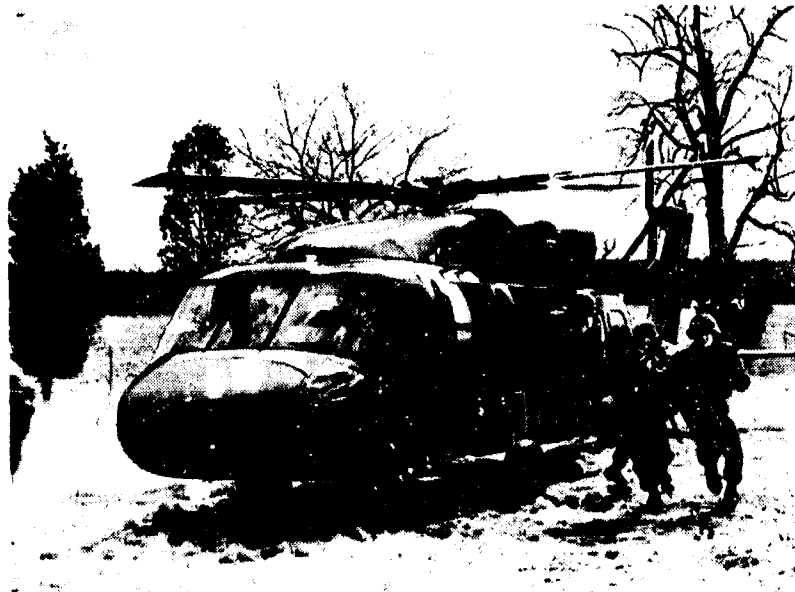
Figure 36. Sikorsky YUH-60A UTTAS.

The aircraft selected for this study was the Sikorsky YUH-60A Utility Tactical Transport Aircraft System (UTTAS). UTTAS represents the newest generation of Army helicopters, has relatively large windshields supported by slender posts (Figure 36), and is subjected to high aerodynamic pressure and maneuver loads.

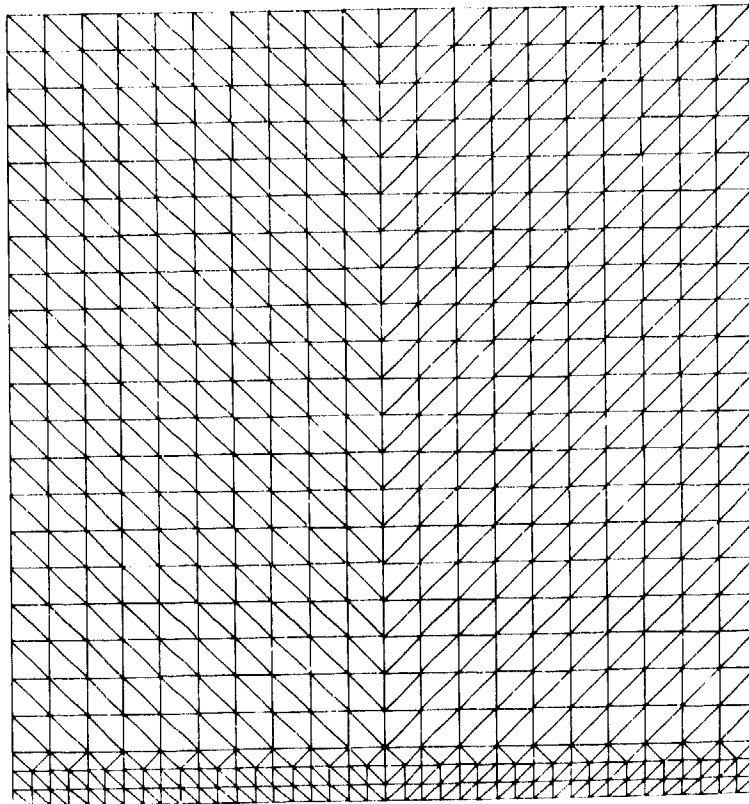
Figure 41. Refined Model Center Windshield.

The third model, shown in Figure 41, was a refined version of the center windshield and the surrounding portion of the upper and lower sills and butt line 10 posts. Restraint was provided by pin supports at the four corners. This model was used for correlating the NASTRAN results with those of instrumented tests performed on a section of the same structure represented by the model. The composite and plastic windshields, as well as the glass windshield, were analyzed with this model.

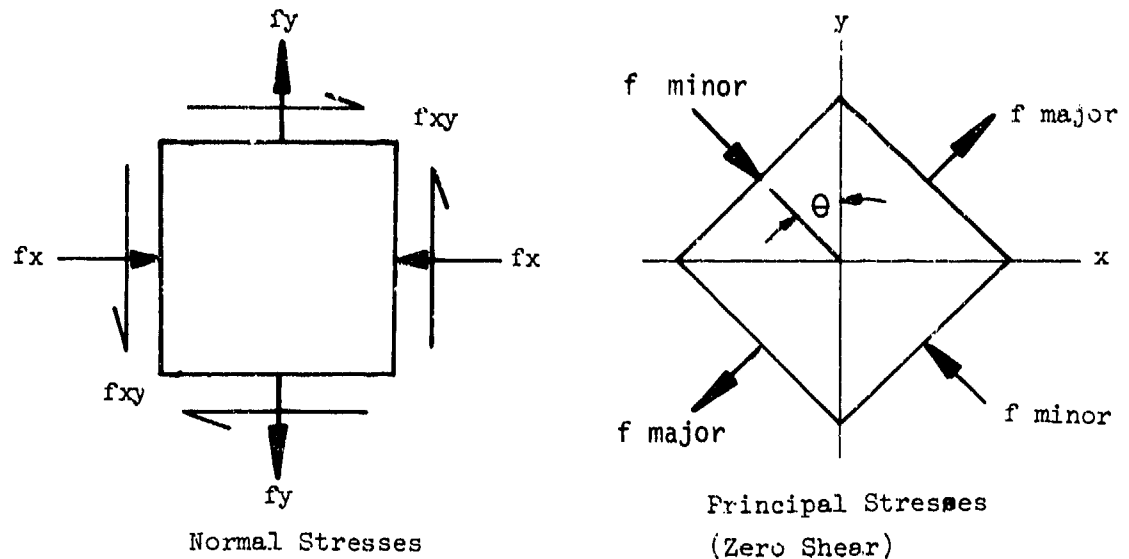
Figure 49. Distinction Between Normal and Principal Stresses.

In addition to normal and shear stresses, the major and minor principal stresses were tabulated for each element (see Figure 49). Strength analyses for glass windshields are based purely on material tensile strengths, whereas most other materials can be analyzed with combined shear and normal stress loadings. This anomaly occurs because the shear strength of glass is very difficult to measure, and is seldom used.

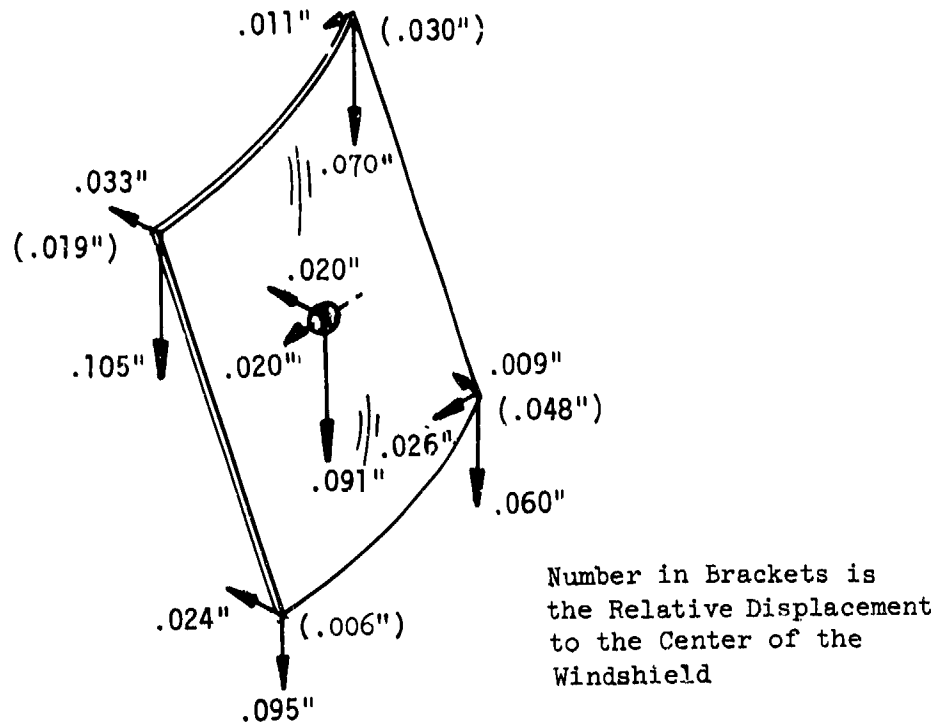
Figure 54. Windshield Deflections Under 0.3 psi Pressure, Outboard Glass/Glass Panel.

Figure 54 shows corner and center deflections for the outboard windshield. The relative displacement between the center of the windshield and each corner is also shown in the illustration. The maximum deflection measured relative to a corner (lower left) was 0.048 inch, which is less than half the panel thickness, and therefore within the limits of acceptability for thin plate stress analysis.

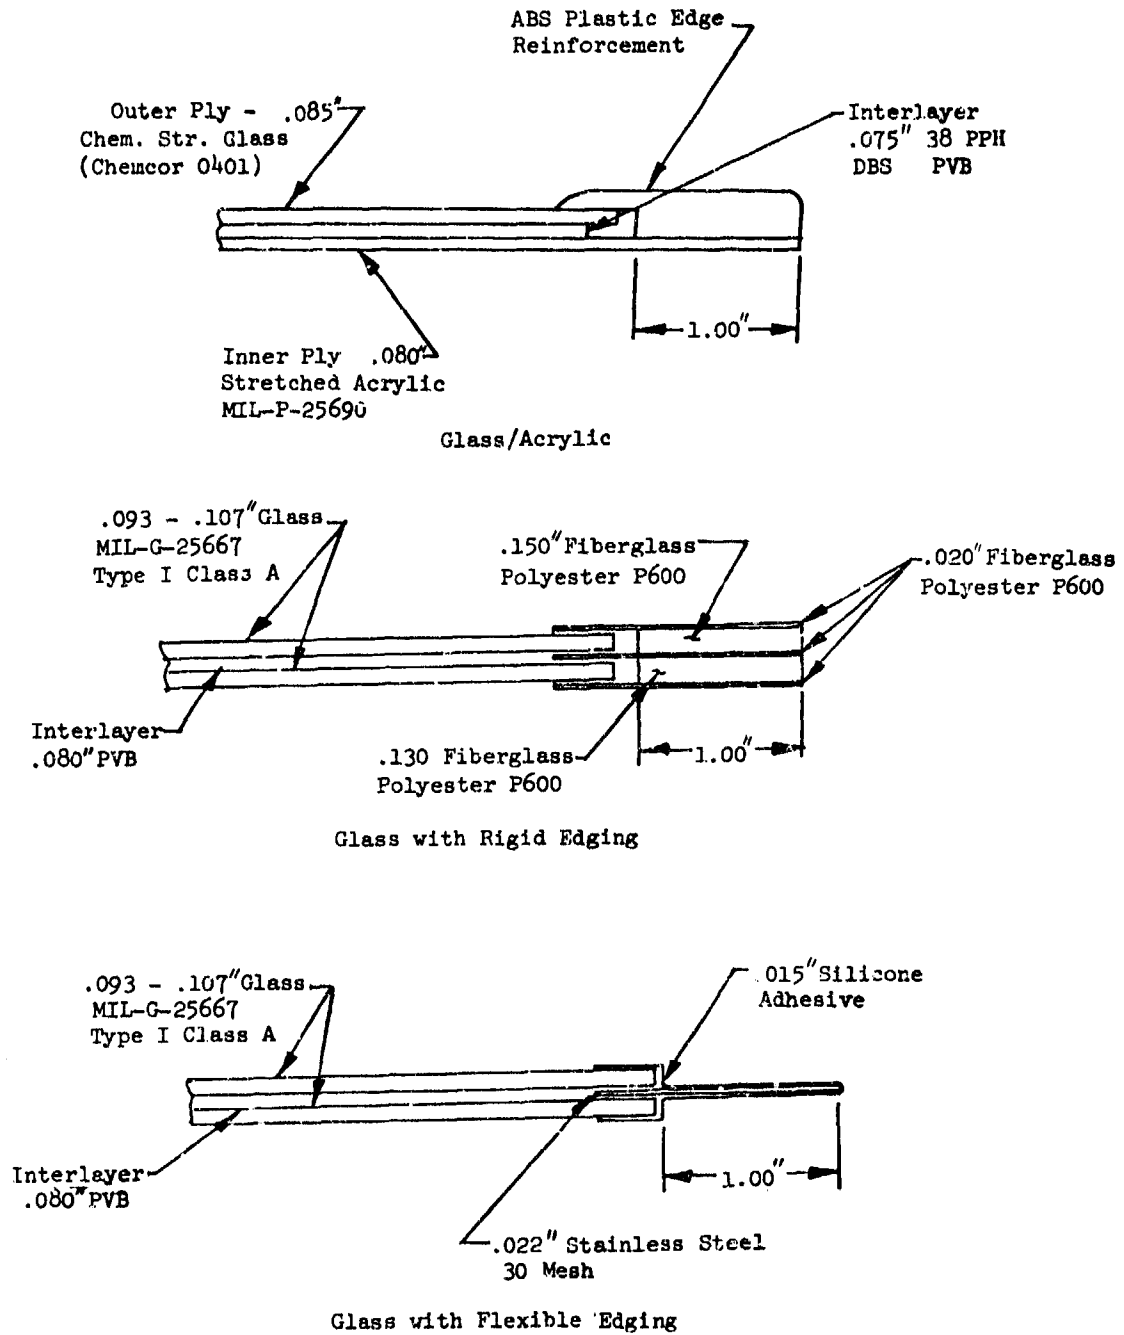
Figure 67. Laminated Test Specimen Edge Configurations.

Three different 24-inch-square laminated sample windshield configurations (Figure 67) were tested. The first configuration consisted of a glass outer surface, a polyvinyl butyral (PVB) interlayer, a plastic (stretched acrylic) inner surface, with a bonded Acrylonitrile Butadiene Styrene (ABS) edge reinforcement. The second configuration had glass inner and outer surfaces, a PVB interlayer and a bonded fiberglass edge reinforcement. The third configuration was the same as the second except for a bonded flexible impregnated fabric edge reinforcement.

The laminated glass with rigid fiberglass edge reinforcement, the second configuration in Figure 67, was found to be the stiffest design and exhibited a spring rate of approximately 233,000 lb/in. The composite glass/plastic design had a spring rate equal to 7700 lb/in. and the laminated glass panel with flexible edging had a spring rate of only 2100 lb/in. The spring rates are compared in Figure 69.

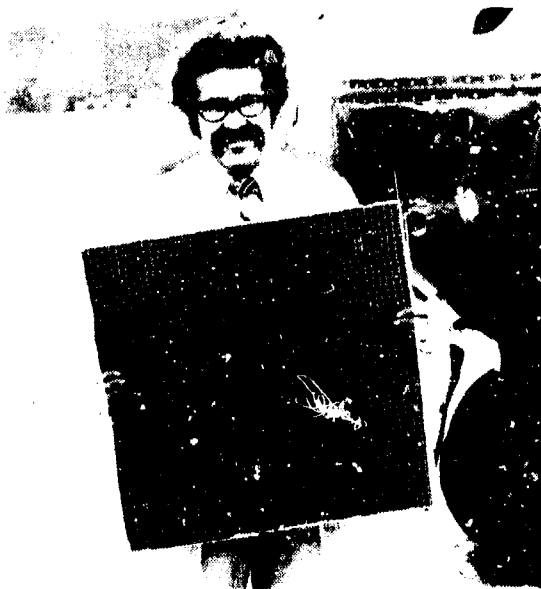
Figure 108. Test Grid Used to Measure Distortion.

A portable grid for evaluating optical distortion, shown in Figure 108, was used to locate and quantify optical distortion. Considerable experimentation was required to develop a technique for producing photographs with resolution adequate for measuring grid slope variation. The procedure finally adopted was to place the grid board approximately ten feet from the transparency with the camera at the pilot's eye position. A 4x telephoto lens was used to enable the grid to completely fill the picture. High-speed film with a shutter speed of 1/250th of a second was found to be necessary to prevent blurring lines due to motion of the grid or camera.

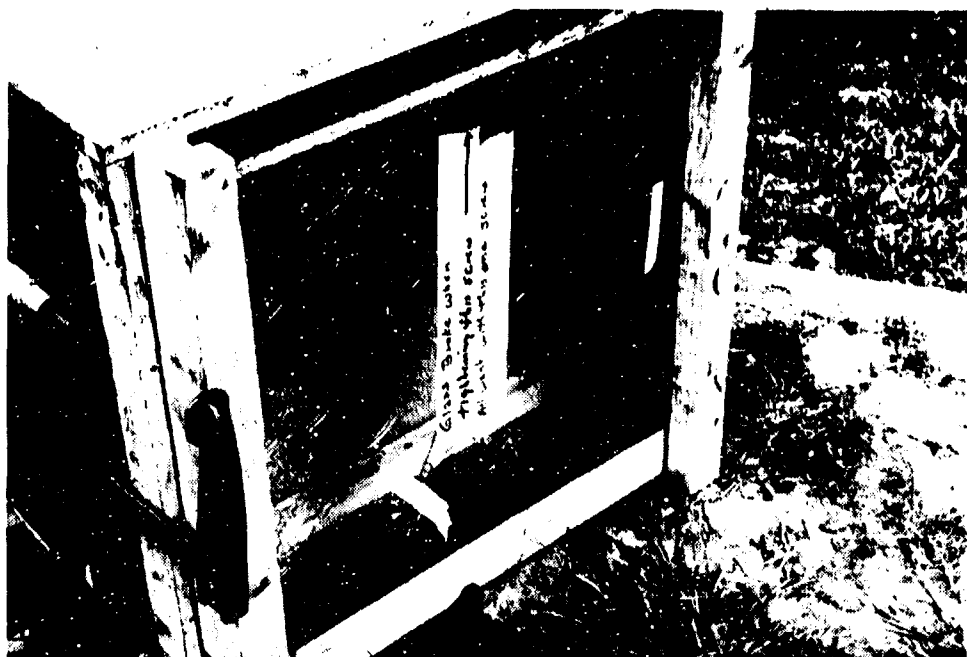
Figure 142. Damaged Ballistic Specimen.

Two glass/acrylic panels were cracked before testing during installation. The damage occurred because the flexibility of the edge reinforcement was sufficiently low to permit excessive bending to occur between fasteners when they were torqued. This created undue stresses which cracked the glass. However, the resultant cracks in the glass were widely spaced and did not interfere with the target area, which enabled the damaged panels to be successfully tested (Figures 142 and 143).

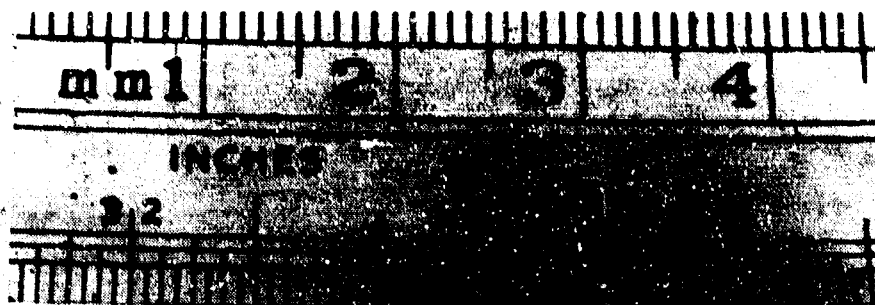
Figure 145. Ballistic Penetration of Polycarbonate.

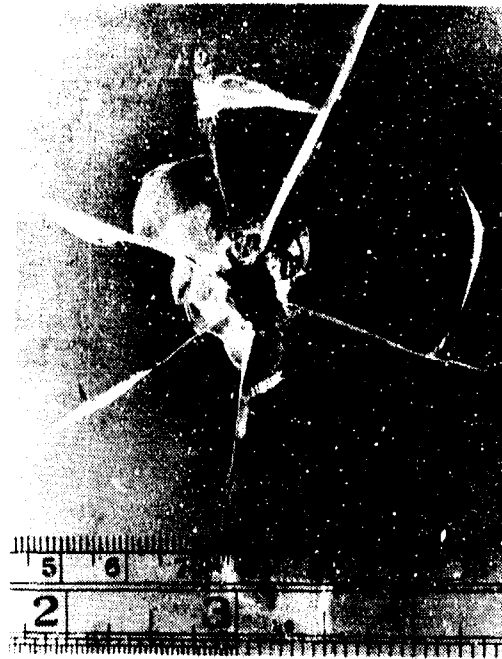
Figure 148. Ballistic Penetration of 0.187  
Inch Cast Acrylic.

The cast acrylic specimens suffered primarily localized damage. The entry holes were typically about one-inch across with some material being torn out by the round. Little damage was sustained beyond a 3-inch diameter for the 0.080-inch sheets (Figure 147). Cracking was somewhat more extensive for the 0.187-inch sheets, as shown in Figure 148.

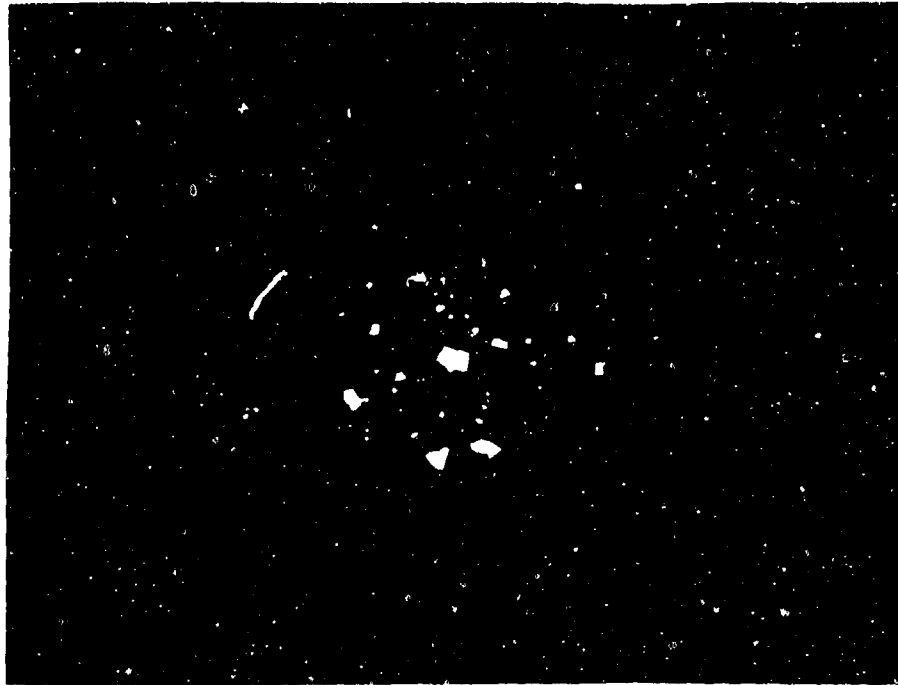
Figure 156. Typical Witness Sheet Penetration Pattern for Cast Acrylic.

The cast acrylic specimens caused several penetrations in a compact area. In general, ten or more particles penetrated the aluminum foil within 4 inches of the impact center. Also within that area was a number of dents roughly equal to the number of penetrations. The 0.187-inch specimen exhibited the same pattern but appeared to cause slightly larger penetrations. A typical witness sheet for the cast acrylic is shown in Figure 156.

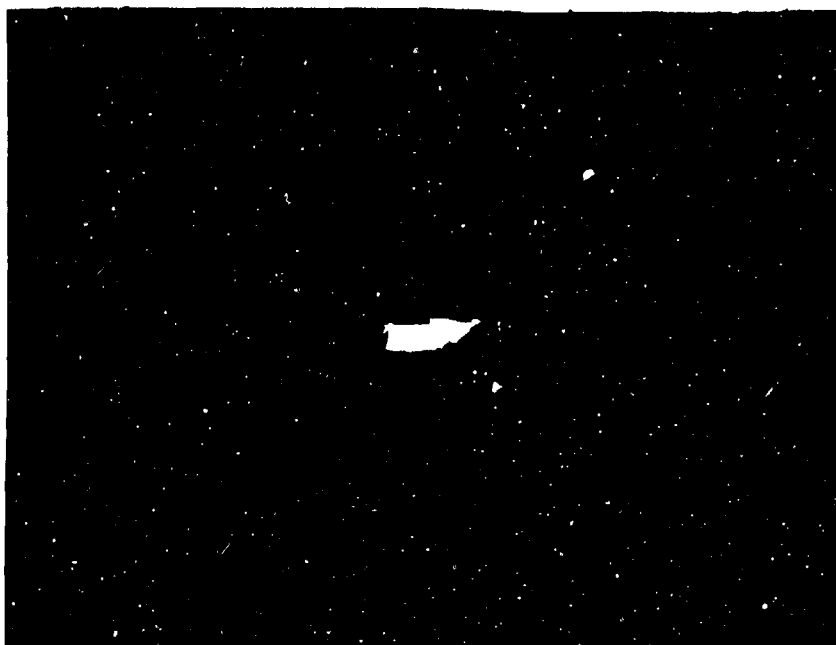
Figure 160. Witness Sheet Spall Penetration  
Pattern for Clamped All-Glass Laminate.

The witness sheets for the glass/glass laminates sustained serious damage. For every round, a large piece of the interlayer, weighing at least two grams and measuring at least an inch and a half across, was blown free from the specimen. This projectile caused severe rips in the foil. A large number of additional penetrations occurred within a 14-inch by 10-inch area, the most serious being in the neighborhood of ballistic impact. A typical witness sheet is shown in Figure 158. The penetration pattern for this sheet is shown in Figure 159. It should be noted that the amount and scatter of damage were much less for the clamped specimen, as reflected in Figure 160.

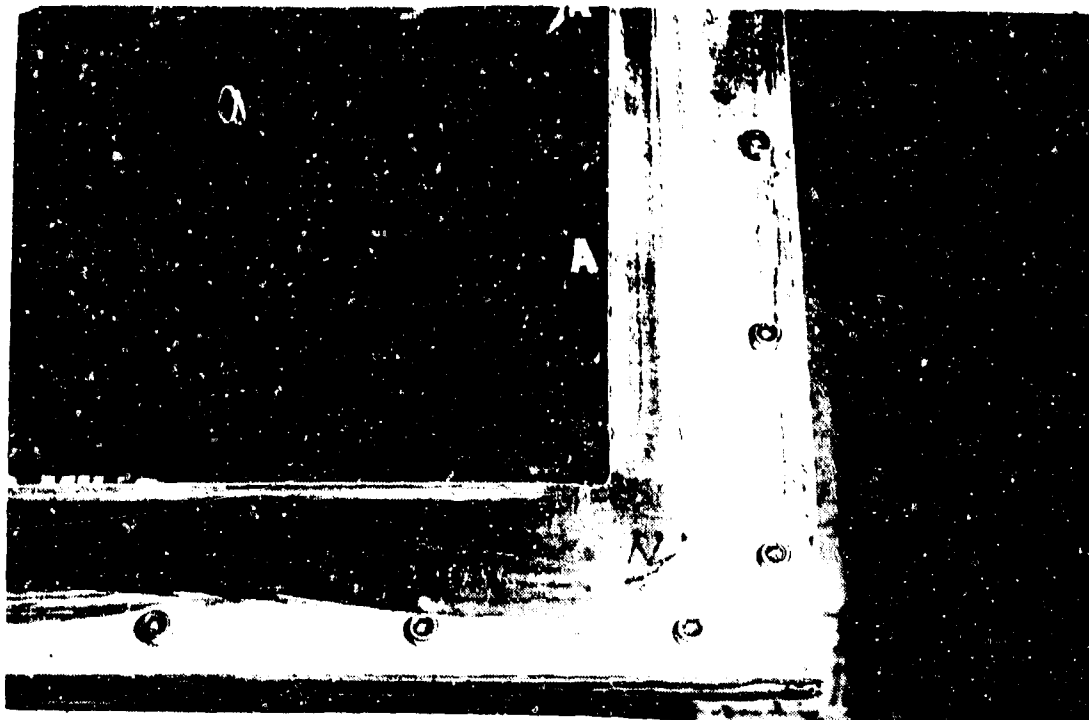
Figure 168. Bolted Attaching Arrangement.

The basic test setup for the impact tests is shown in Figure 166. The test specimens were secured to an aluminum box designed for ballistic and impact tests. The specimen was held rigidly in place by two different methods. In both cases, the specimen rested on a support frame rimmed by a rubber gasket. A metal retainer fit over the periphery of the specimen, leaving most of it exposed. In one configuration, this frame was secured to the test box by twelve spring clamps (Figure 167). In an alternative configuration, the metal retainer was bolted to the box by capscrews placed in drilled, tapped holes along the frame rim (Figure 168).

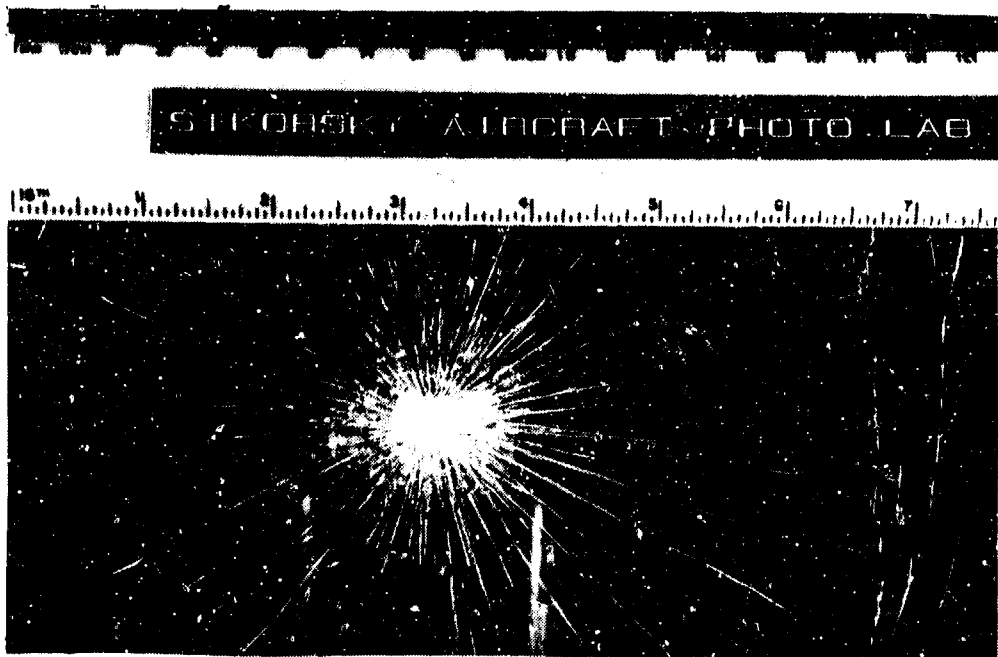
Figure 177. Close-up of Glass/Glass Laminate Impact Area.

Only the laminates sustained such damage, their glass layers being pulverized locally by the dart. Close-up shots of this damage are shown in Figures 176 and 177.

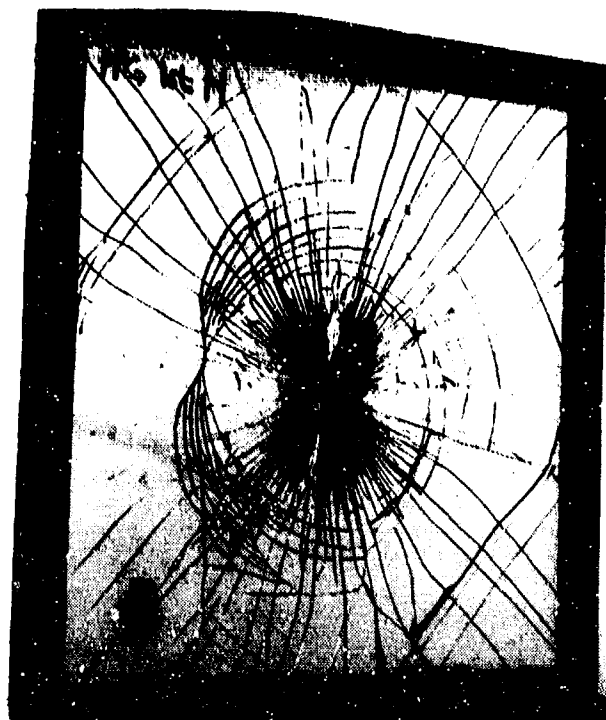
Figure 178. Glass/Glass Laminate, High-Temperature Impact Test.

Severe cracking occurred in the all-glass laminate at both temperature extremes. It extended typically two to three inches beyond the diced area as shown in Figure 178. Such damage was generally limited to the impact center and specimen edges in the glass/acrylic laminate at cold and ambient conditions. However, at high temperatures, the glass layer was severely shattered, badly impairing visibility as shown in Figure 179.

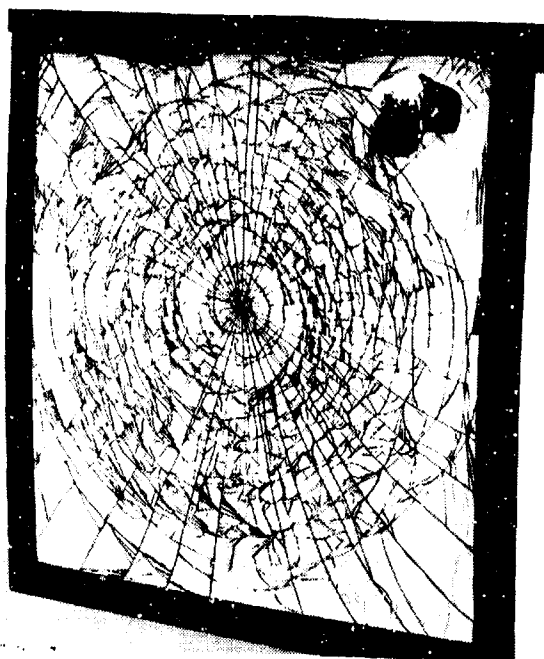
Figure 179. Glass/Acrylic Laminate, High-Temperature Impact Test.

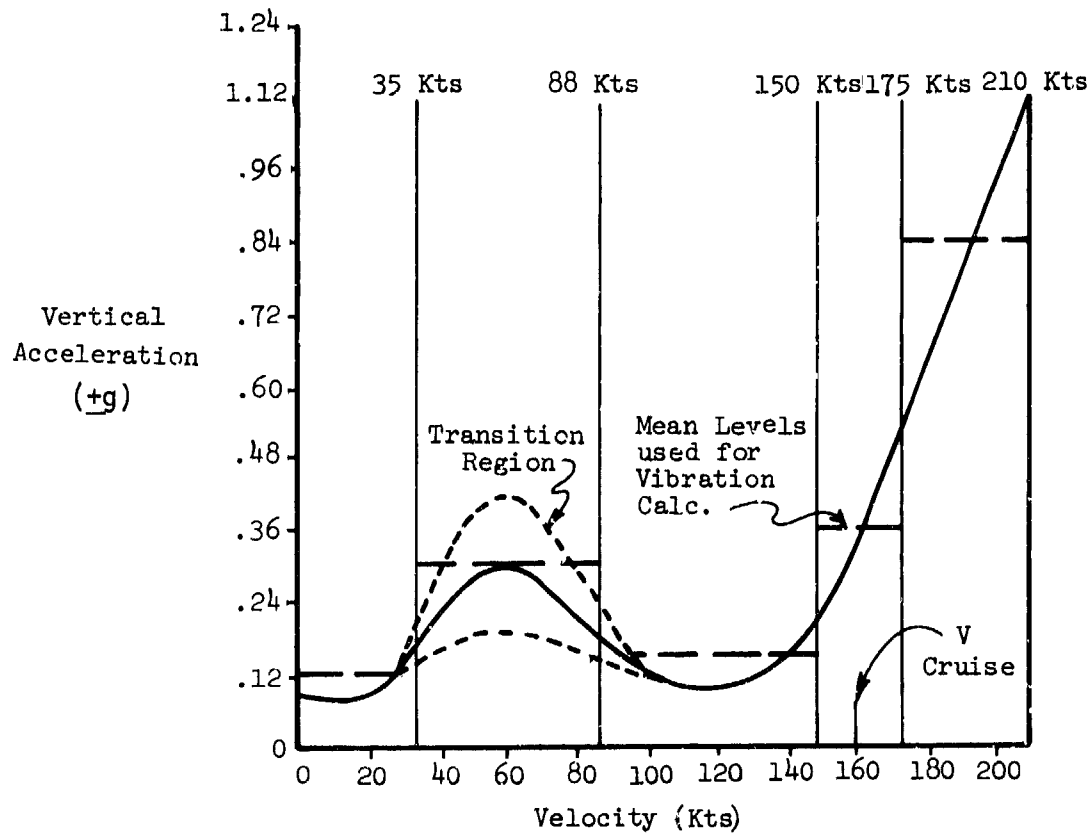
Figure 186. Windshield Vibration vs Aircraft Velocity, 1.0 g Level Flight.

Flight test data from the NH-3A<sup>17</sup> (high speeds) and the CH-53A<sup>18</sup> (low speeds) were used to generate a curve of windshield vibration level versus velocity as shown in Figure 186. The increment in vibration above the 1-g level as a function of load factor was also estimated from flight test data and is presented in Table 54. The dashed lines in the figure indicate the range of data for the condition. This increment was assumed to be zero for load factors equal to or less than 1.0 g.

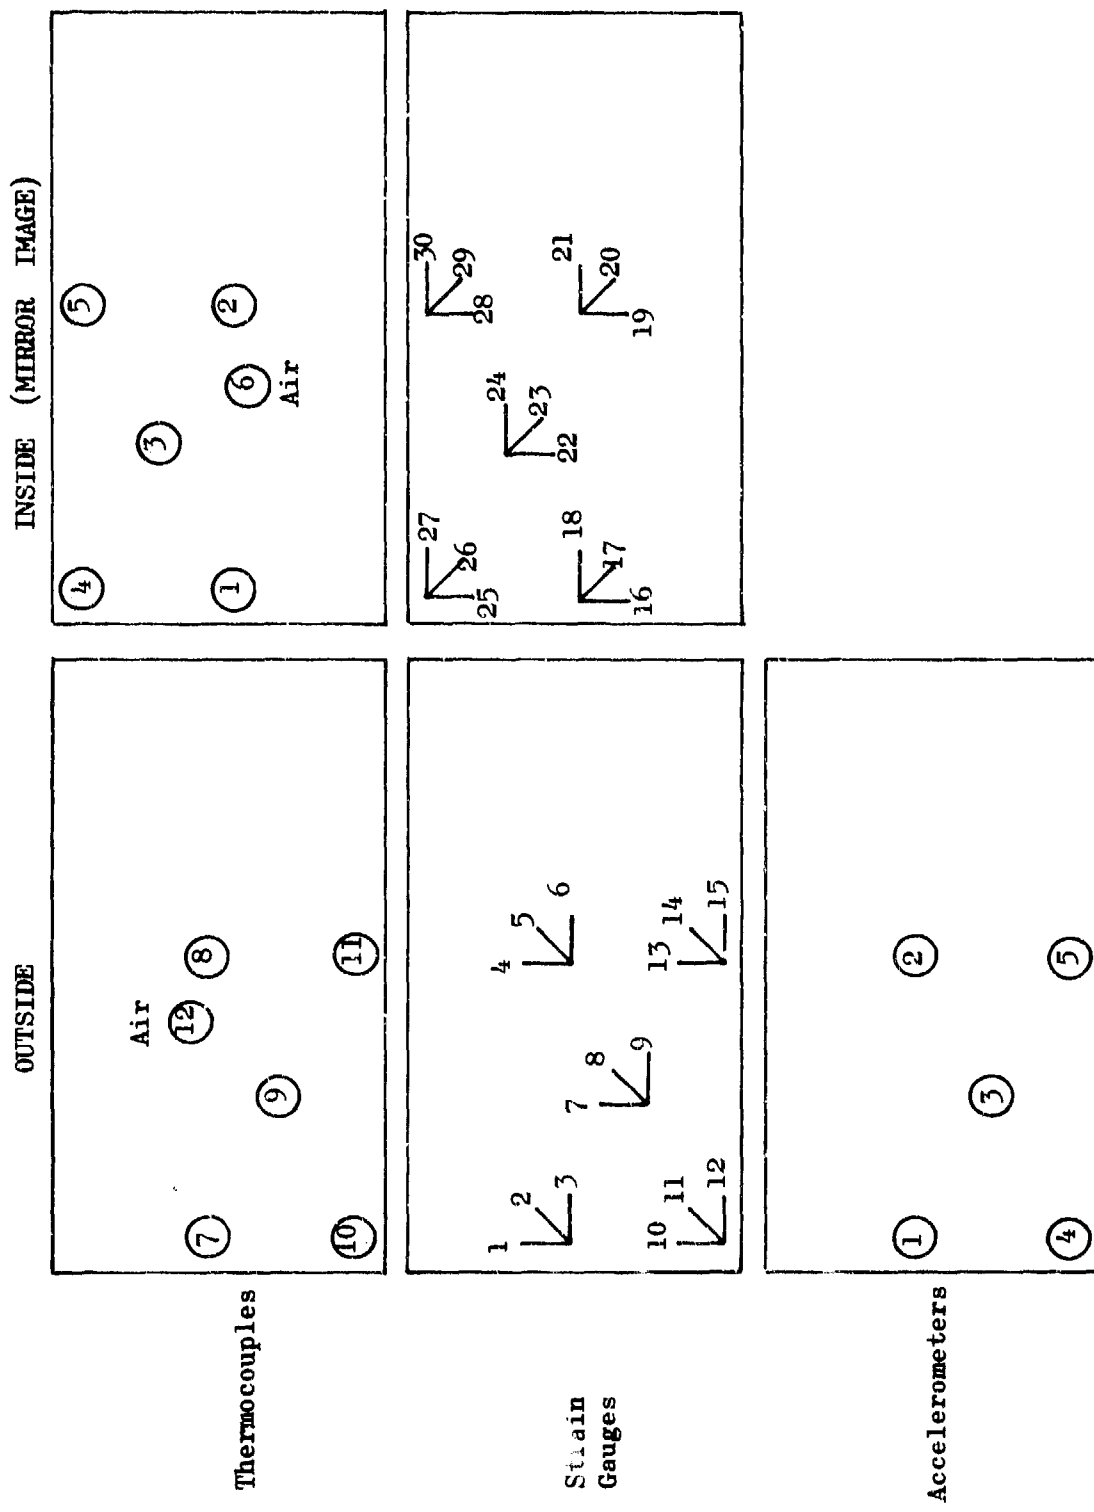
Figure 196. Location of Instrumentation.

Gauges were bonded to the surface using 'M' Bond AE10/15 adhesive (manufactured by Micro-Measurements Inc.) and the gauges were held in contact during adhesive curing by the use of a vacuum bag. A thin protective coating of silicone rubber was applied over the gauges. Gauges were positioned and orientated as shown in Figure 196.

Five accelerometers were bonded to the outside surface of the specimen in use at positions as close as possible to the strain gauge locations shown in Figure 196. As a control, a sixth accelerometer was installed on the floating support described in Figure 193, exactly in line with the vibratory input.

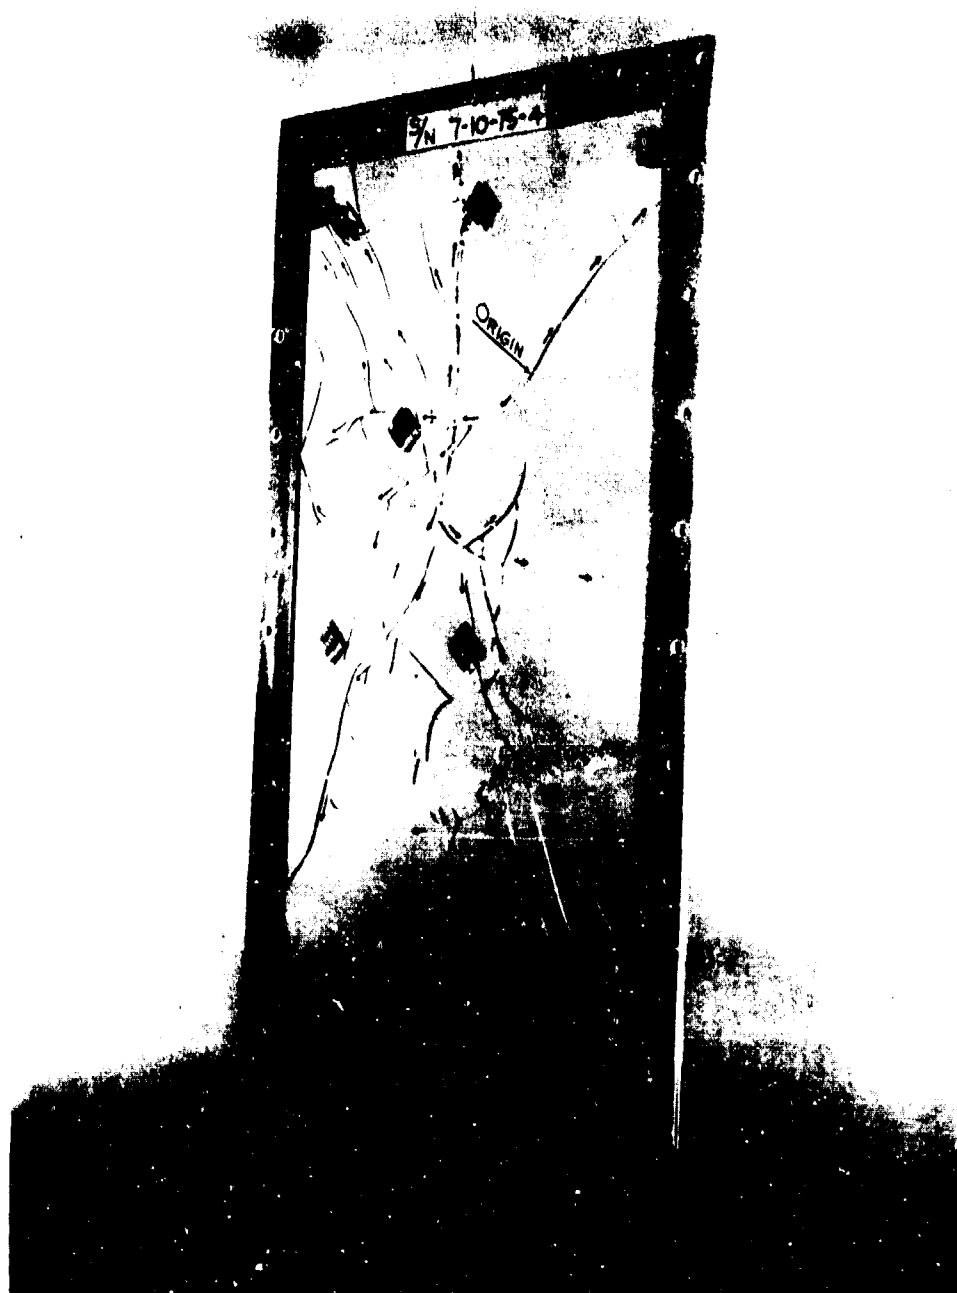
Figure 197. Failure of Glass/Glass (-101) Windshield,  
Serial No. 7-10-75-4, During Run 61, Case 21.

During application of Case 21 (cold shock and aerodynamic pressure), a failure of the facing ply occurred on windshield serial number 7-10-75-4. As shown by the overall view from outside in Figure 197, only the outboard glass ply was broken. Fracture started in the vision area 6-1/2 inches from the right edge and 8-1/2 inches from the top edge. Subsequent analysis revealed that the fracture origin was located on the outboard surface at a severe scratch 0.40 inch long. Fissures from this damage were about 0.017 inch deep, which almost completely penetrated the 0.020-inch compression layer. Because of this severe surface damage, very little mechanical or thermal load was required to cause fracture. This is supported by the fact that the origin fracture face revealed that the tension stress at failure was less than 1500 psi.

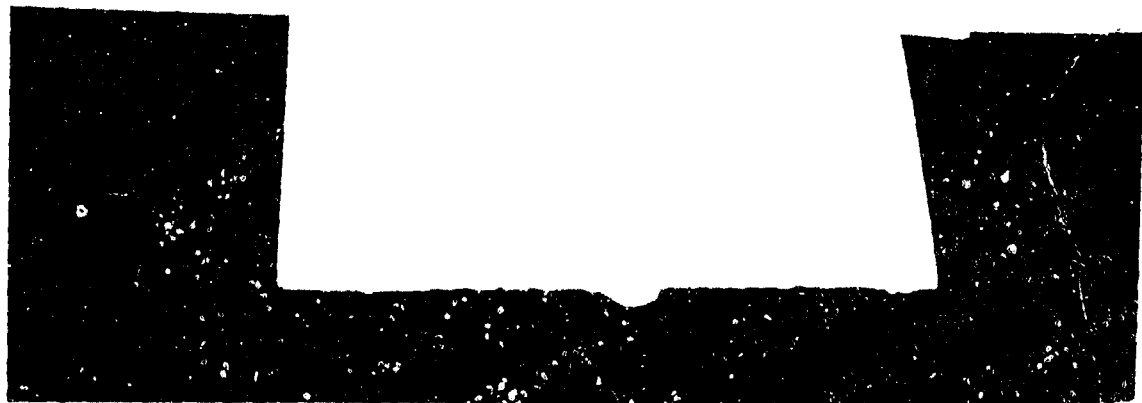
Figure 202. Failure of Polyester/Acrylic (-103)  
Windshield During Low-Temperature Test  
Spectrum, Also Showing Nib Seal Separation.

Damage to the windshield is recorded in Figures 201 and 202.
