AFML-TR-78-108

**DEFINITION AND NON-DESTRUCTIVE  
DETECTION OF CRITICAL ADHESIVE  
BOND-LINE FLAWS**

MCDONNELL AIRCRAFT COMPANY  
MCDONNELL DOUGLAS CORPORATION  
P.O. BOX 516  
ST. LOUIS, MISSOURI 63166

TECHNICAL REPORT AFML-TR-78-108  
FINAL REPORT FOR PERIOD  
27 JUNE 1975 - 31 JULY 1978

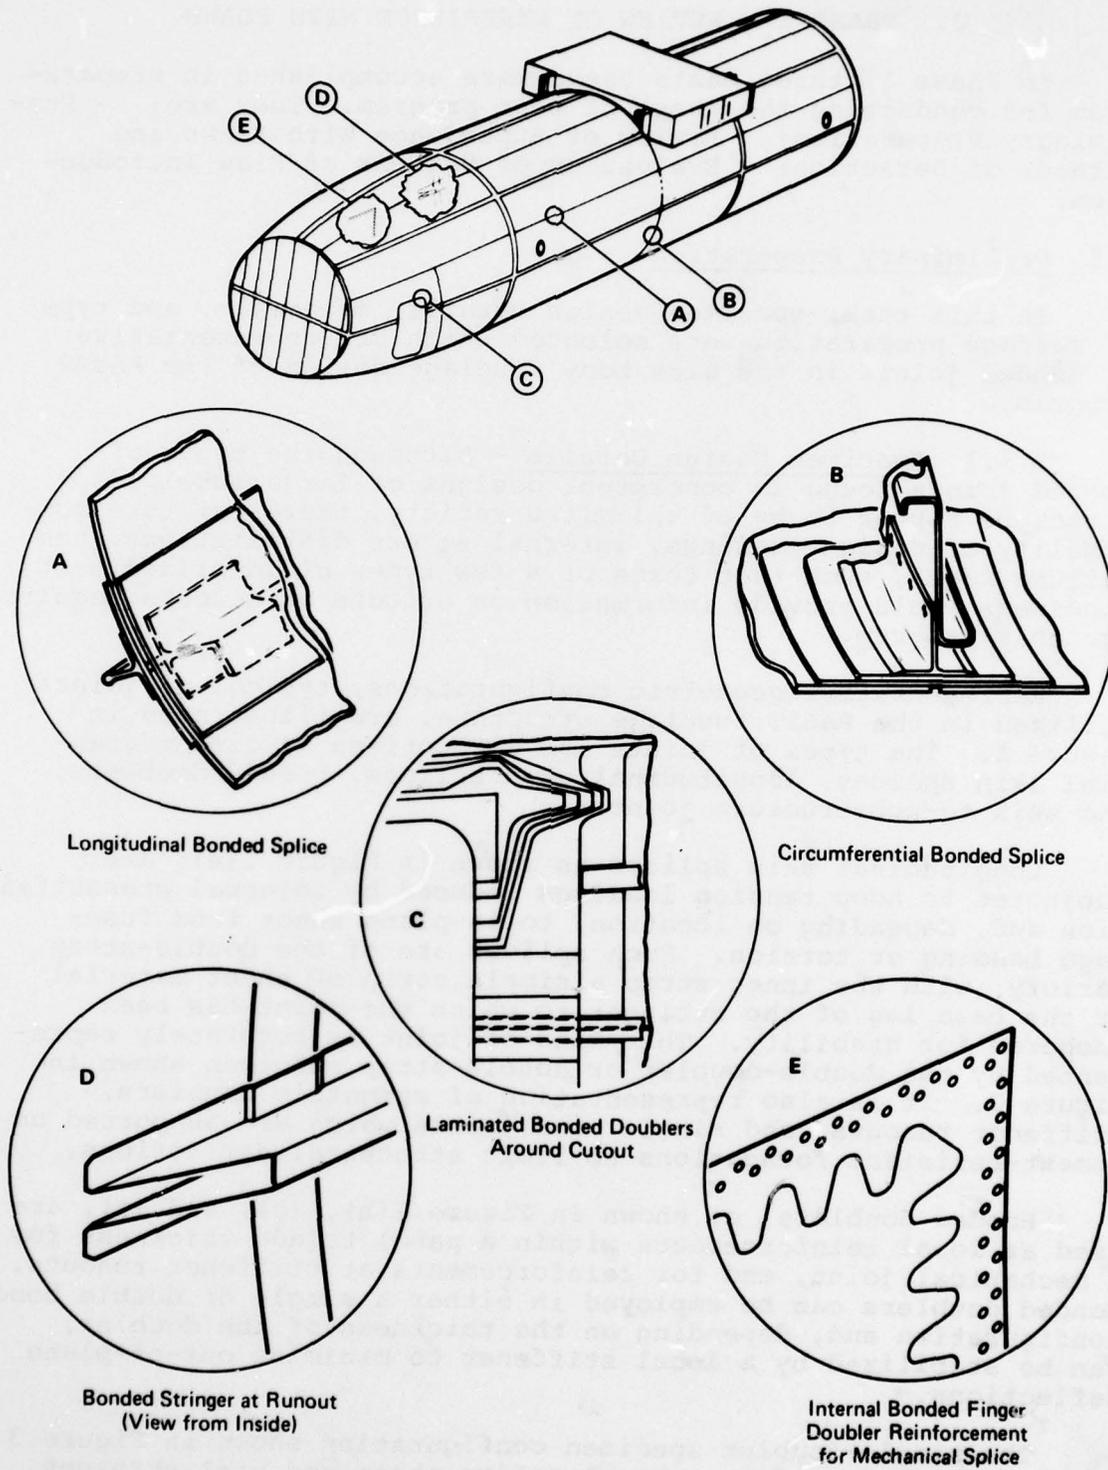
**FIGURE 1**  
**TYPICAL ADHESIVE BONDED JOINTS ON WIDE BODY FUSELAGE**

Representative geometric configurations, typical of joints utilized in the PABST fuselage structure, are illustrated in Figure 1. The types of joints are categorized as circumferential skin splices, longitudinal skin splices, bonded doublers, and skin-to-substructure joints.

Longitudinal skin splices as shown in Figure 1(a), are subjected to hoop tension loadings induced by internal pressurization and, depending on location, to in-plane shear from fuselage bending or torsion. Such splices are of the double-strap variety, with the inner strap a simple strip of sheet material or the base leg of the stringer to which the joint has been anchored for stability. This kind of joint is accurately represented by the double-doubler or double-strap specimen shown in Figure 2. It is also representative of symmetric doublers, stiffener runouts, and single bond joints which are supported on moment-resistant foundations to limit structural deflections.

Bonded doublers, as shown in Figure 1(b), (c), and (e), are used as local reinforcements within a panel to add thickness for a mechanical joint, and for reinforcements at stiffener runouts. Bonded doublers can be employed in either a single or double bond configuration and, depending on the thickness of the doubler, can be stabilized by a local stiffener to minimize out-of-plane deflections.

Circumferential skin splices (Figure 1(b)) are flush with the exterior surface to minimize aerodynamic drag and contain a single splice-strap on the inner surface of the skin. The joint is supported by a stiff member such as a frame or shear clip capable of reacting the eccentricity in load path. An unsupported splice specimen (Figure 4) was selected for testing in Phase II in order to subject the adhesive to peel loading conditions. In this unsupported form it is representative of a poorly designed bonded joint, having high induced peel stresses at the ends of the overlap and bending stresses in the splice. Taken as a set the three specimen configurations, double doubler, single doubler, and single-strap, cover the range of severity of stresses in bonded splice joints.

Skin-to-substructure joints as shown in Figure 1(a) and (b) include circumferential frame stiffeners-to-skins, longerons-to-skin and doublers, and frame shear tee-to-skin. These types of joints are characteristically subjected to tensile forces in the adhesive caused by fuselage pressurization or by shear buckling in the skin which forces the outer skin away from the internal supporting structure. The skin-to-substructure tee specimen shown in Figure 5 was designed to represent this type of bonded structure. Tension forces are induced in the bondline by loads applied to the upstanding leg of the tee and reacted by shear and tension loads in the skin.

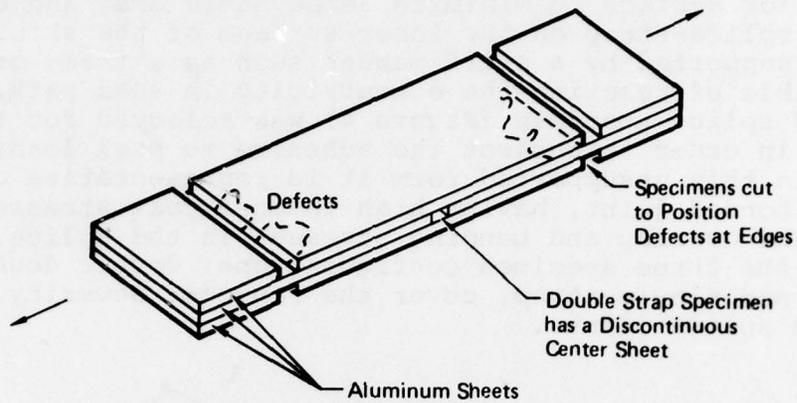
**FIGURE 2**  
**DOUBLE-DOUBLER AND DOUBLE STRAP TEST SPECIMENS**

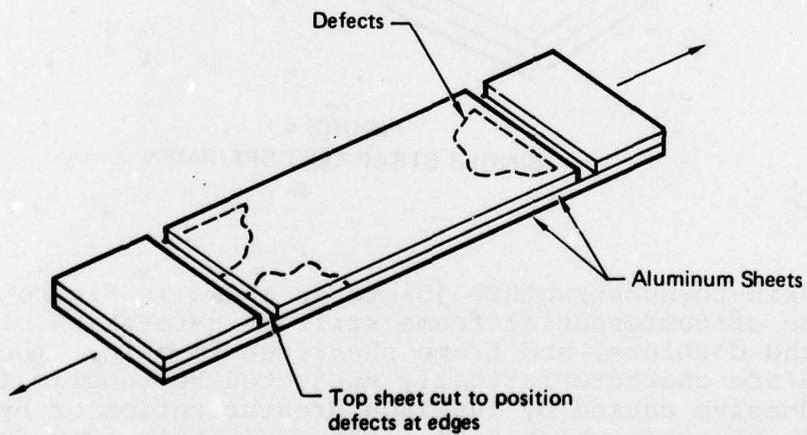
**FIGURE 3**  
**SINGLE-DOUBLER TEST SPECIMEN**

The single-doubler specimen configuration shown in Figure 3 was designed to produce representative shear and peel stresses found in an unsupported bonded doubler. In this configuration, without the parallel load path of double-bond joints, it experiences slightly higher peel stresses than the double-doubler specimen.

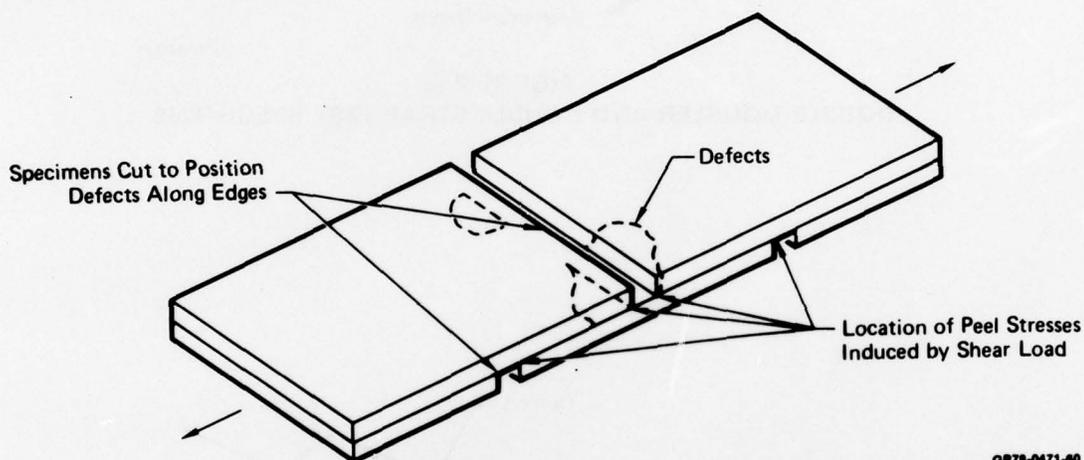
**FIGURE 4**  
**SINGLE-STRAP TEST SPECIMEN**

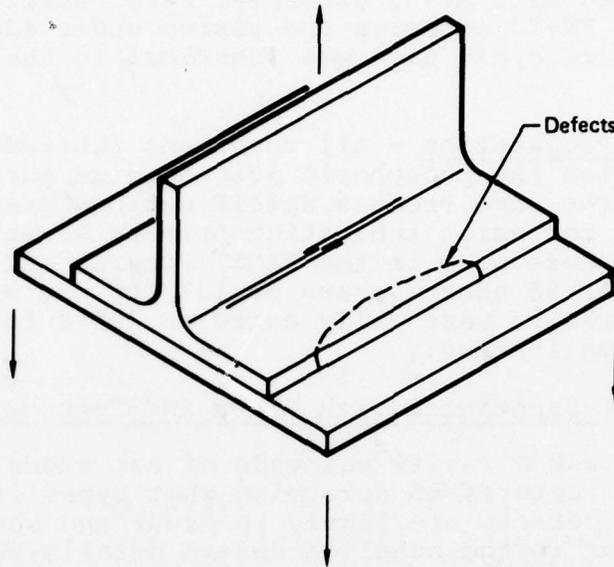
**FIGURE 5**  
**SKIN-TO-SUBSTRUCTURE TEE SPECIMEN**

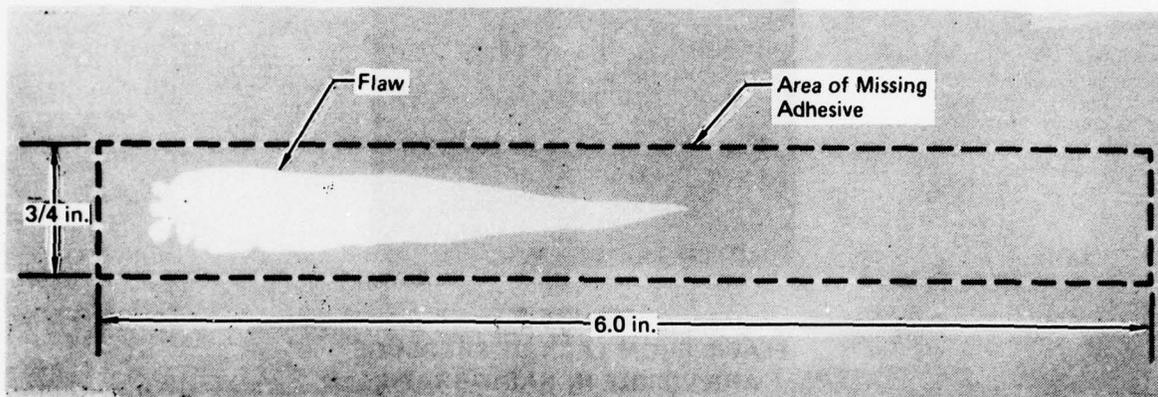
FIGURE 7  
FLAW PRODUCING MECHANISM - 3/4 IN. ADHESIVE GAP

2.3.1 Adhesive Cut-Out - In order to make crack-like (elongated) voids and circular voids representative of naturally occurring adhesive bondline voids, cutouts were made in the adhesive film prior to curing. Crack-like voids in the adhesive were formed by cutting out long rectangular shapes. As the adhesive cured under temperature, it partially filled the cut-out creating a cracklike void such as shown in Figure 7.

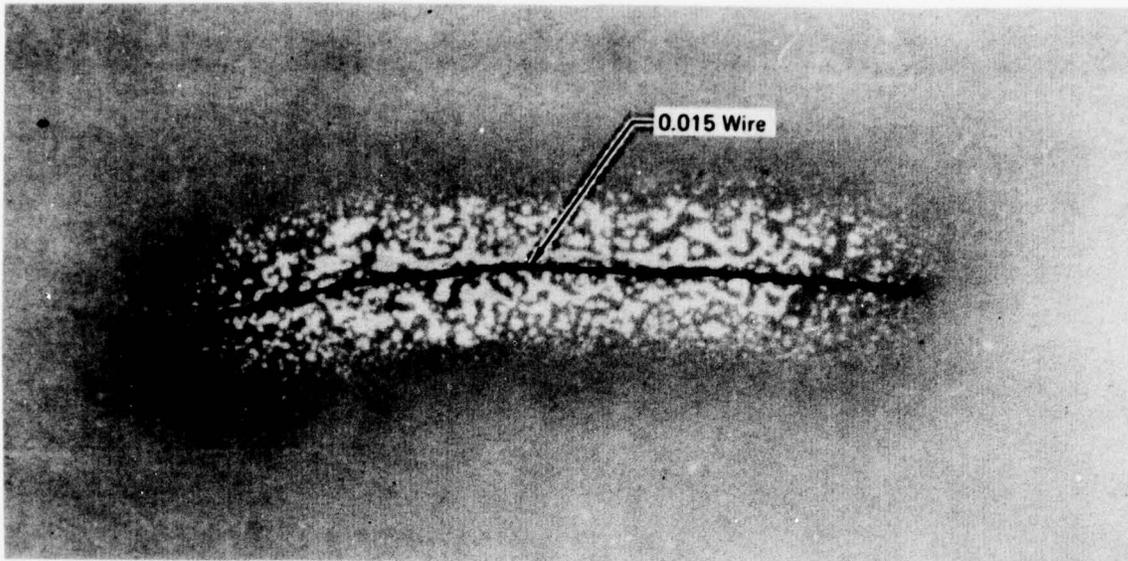
**FIGURE 8**  
**FLAW PRODUCING MECHANISM - 0.015 WIRE INSERTION**

2.3.2 Wire Insertion - Porosity can result from mismatched adherends, surface irregularities, and distortion in framing members. This type of flaw was reproduced by placing wires of specific diameters in the bondline prior to the cure cycle. The wires prevent proper bonding pressure between the adherends and cause porosity in the vicinity of the wire as shown in Figure 8. The wires are later removed during the machining process of the test specimens which then contain only the adjacent porosity. The wire insertion method is also used to produce thick-to-thin adhesives. In this case, wires are arranged such that specimens can be cut with the adhesive thickness variations in the desired direction.

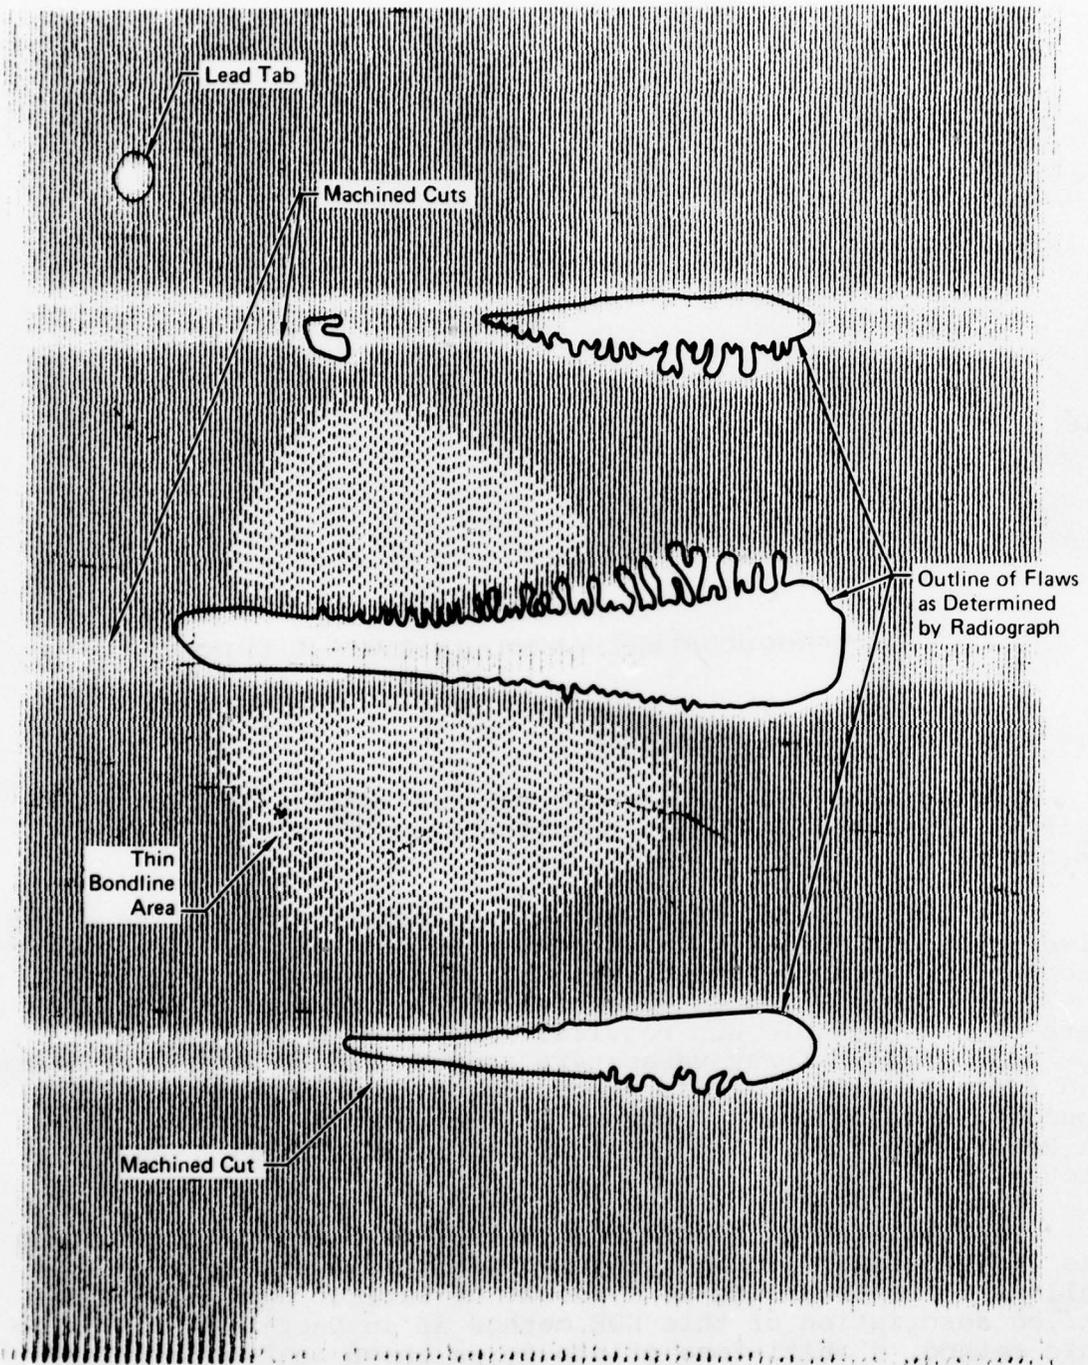
**FIGURE 9**  
**MULTI-TONE C-SCAN OF FLAWED SPECIMEN**

The thru-transmission reflector plate ultrasonic technique was used to find initially induced unbonds in the specimens as well as those occurring as a result of fatigue cycling. A detailed description of this NDE method is in Section 4.2. Using this method, a multi-tone printout, as shown in Figure 9, was obtained for each specimen showing flaw locations. Flaws are shown as solid white areas and bonded areas are printed out as multi-tone lines. The multi-tone printout is achieved through an electronic gating device which monitors the strength of the

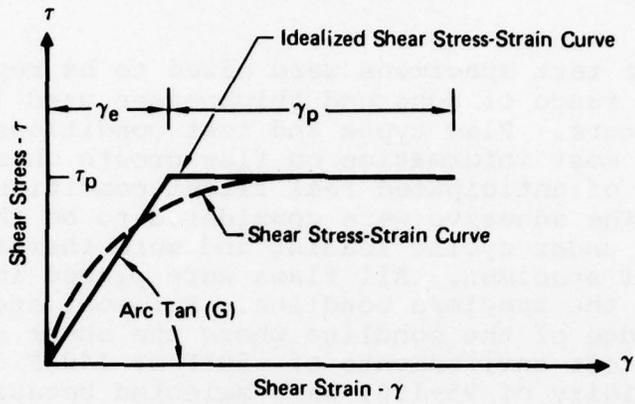
**FIGURE 10  
IDEALIZATION OF SHEAR STRESS-STRAIN CURVE**

All of the specimens were analyzed with the methods used in the PABST program. These are described in References 4 and 5. In these methods, an elastic-plastic idealization of the actual shear stress-strain curve, as shown in Figure 10, was used. The idealized curve is in the form of a trapezoid which encloses the same area (shear strain energy) as the real shear stress-strain curve. The ultimate values of shear stress ( $\tau_p$ ) and shear strain ( $\gamma_e + \gamma_p$ ) for the idealized curve are set at the maximum values developed on either torsion ring or thick adherend shear specimens. The elastic strain ( $\gamma_e$ ) is then set at that value for which the strain energy under the idealized curve is equal to that under the actual curve. The shear modulus is the slope of the elastic portion of the idealized curve. The adhesive properties used for all analysis in this program are summarized in Table 5.

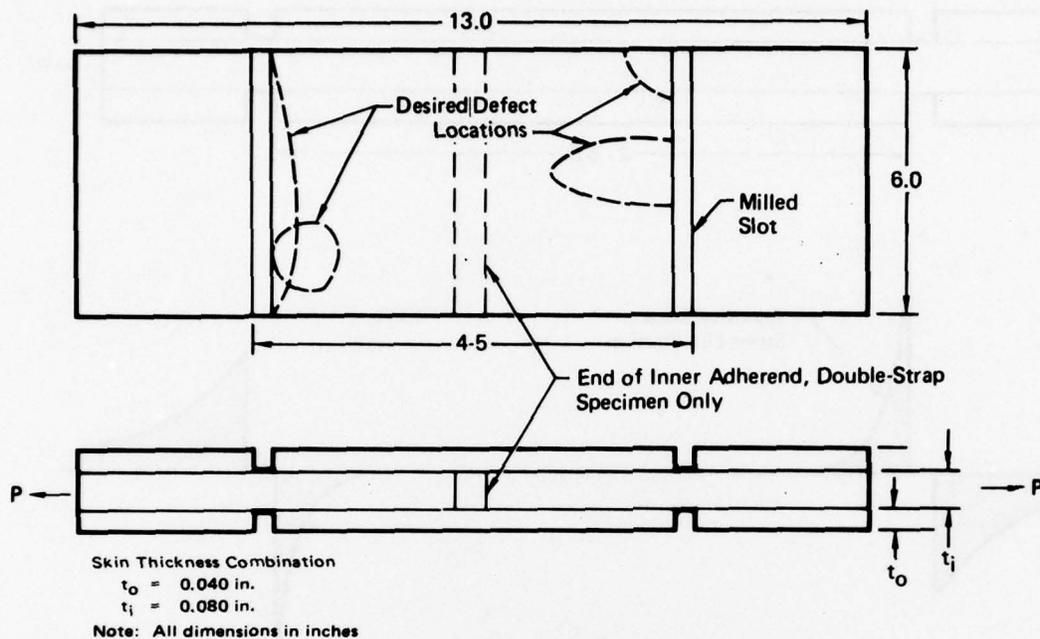
**FIGURE 11**  
**DOUBLE-DOUBLER OR DOUBLE STRAP SPECIMEN**

Double-Doubler and Double-Strap Specimen - Longitudinal bonded splices on the PABST fuselage, depicted in Figure 1(a) were simulated by the double-doubler and double-strap type specimen. Configuration details of both type specimens are shown in Figure 11.

This specimen consisted of a sandwich of three sheets of metal. All of the load was introduced into the middle sheet (skin) with some of that load transferred through the bond into

the outer sheets (doublers). The machined slots in the doublers were precisely located such that the bondline flaws were in the high shear stress region at the edge of the doublers. The depths of the slots were also precisely machined through the doublers down to the adhesive but not touching the inner adherend.

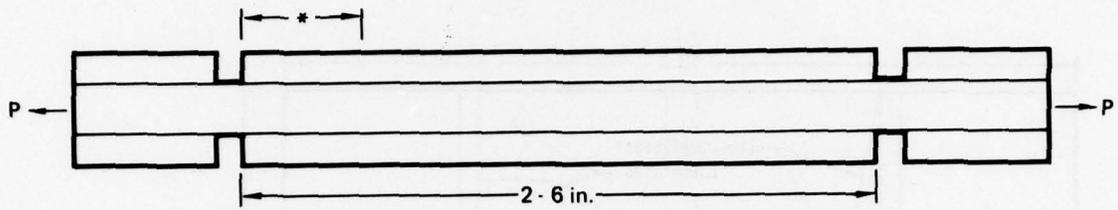
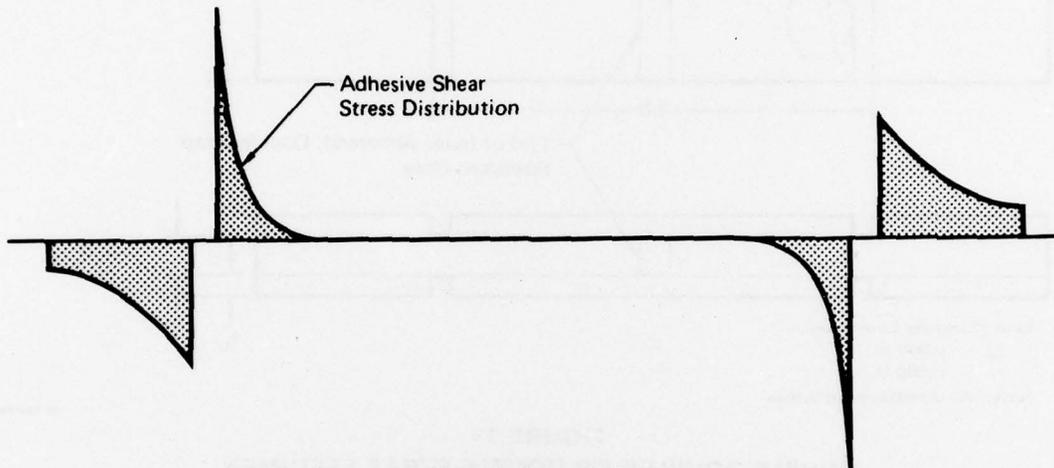
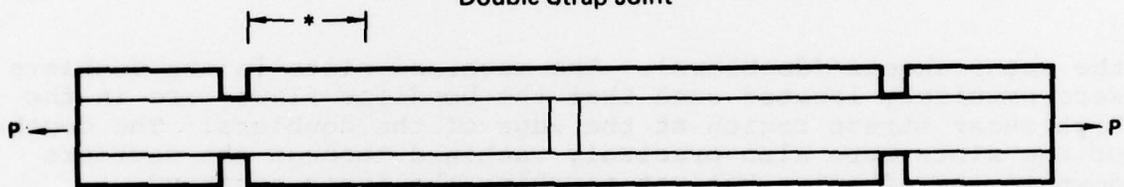
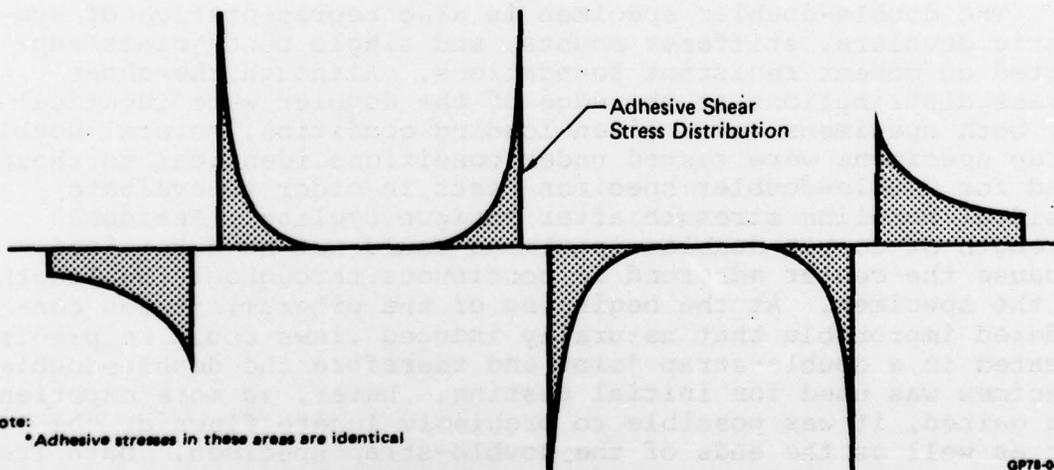
Double-Doubler Joint

Double-Strap Joint

Note:  
\*Adhesive stresses in these areas are identical

The double-doubler specimen is also representative of symmetric doublers, stiffener mounts, and single bond joints supported on moment resistant foundations. Although the shear stress distributions at the edge of the doubler were identical for both specimens for a given loading condition, several double-strap specimens were tested under conditions identical to those used for double-doubler specimen tests in order to evaluate residual bondline strength after fatigue cycling. Residual strength of double-doubler specimens could not be determined because the center adherend is continuous throughout the length of the specimen. At the beginning of the program, it was considered improbable that naturally induced flaws could be precisely located in a double-strap joint and therefore the double-doubler specimen was used for initial testing. Later, as more experience was gained, it was possible to precisely locate flaws at the center as well as the ends of the double-strap specimen. Data from both types of specimens are directly comparable because of equivalence in shear stress distributions as illustrated in Figure 12.

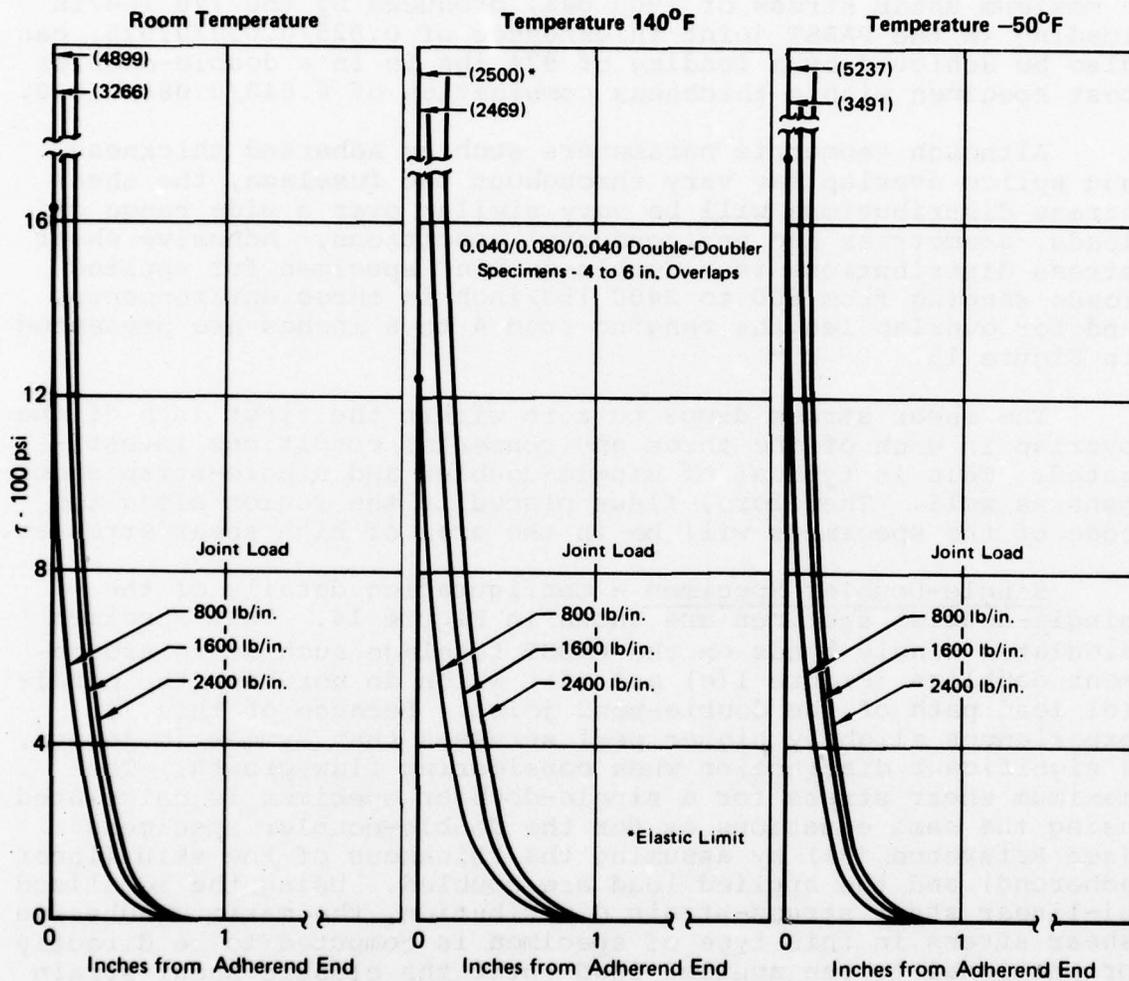
**FIGURE 13**  
**SHEAR STRESS DISTRIBUTIONS ARE SIMILAR OVER A WIDE RANGE OF LOADS**

Although geometric parameters such as adherend thickness and splice overlap may vary throughout the fuselage, the shear stress distributions will be very similar over a wide range of loads, geometries and environmental conditions. Adhesive shear stress distributions in a double-doubler specimen for applied loads ranging from 800 to 2400 lbs/inch in three environments, and for overlap lengths ranging from 4 to 6 inches are presented in Figure 13.

The shear stress drops to zero within the first inch of the overlap in each of the three environmental conditions investigated. This is typical of single-doubler and single-strap specimens as well. Therefore, flaws placed in the region along the edge of the specimens will be in the area of high shear stresses.

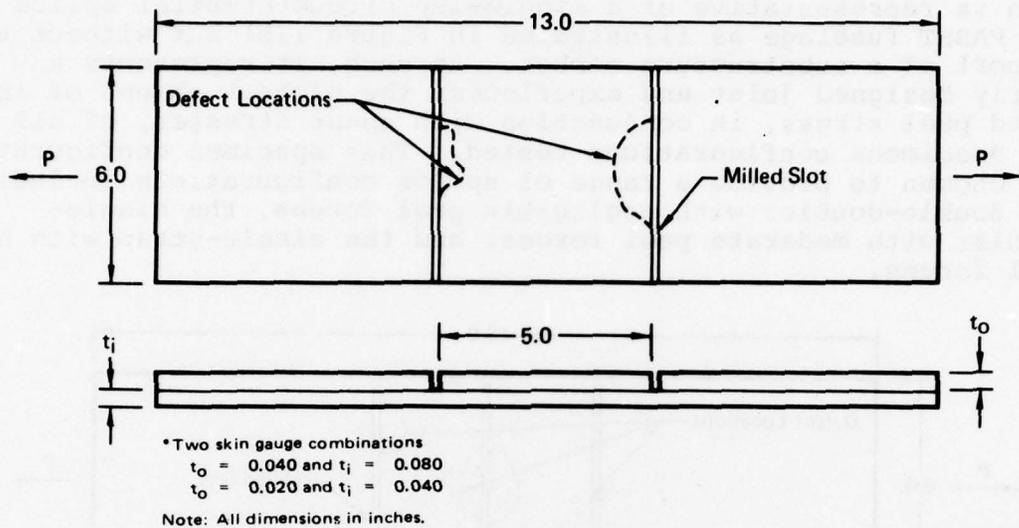
**FIGURE 14**  
**SINGLE-DOUBLER SPECIMEN**

Single-Doubler Specimen - Configuration details of the single-doubler specimen are shown in Figure 14. This specimen simulates single bonds on the PABST fuselage such as reinforcement doublers (Figure 1(c) and (e)) which do not have the parallel load path of the double-bond joint. Because of this, it experiences slightly higher peel stresses than symmetric joints, a significant distinction when considering flaw growth. The maximum shear stress for a single-doubler specimen is calculated using the same equations as for the double-doubler specimens (see Reference (3)) by assuming the thickness of the skin (inner adherend) and the applied load are doubled. Using the idealized bi-linear shear stress-strain distribution, the maximum adhesive shear stress in this type of specimen is computed to be directly proportional to the applied load until the elastic shear strain of the adhesive is reached. The test loads for the single-doubler specimens, shown in Table 6, were calculated to exactly duplicate maximum shear stresses in the .080 skin/.040 doubler and the .040 skin/.020 doubler combinations used on the PABST fuselage and are the peak shear stresses within the general range of peak shear stresses for the other skin/doubler combinations used on the PABST fuselage.

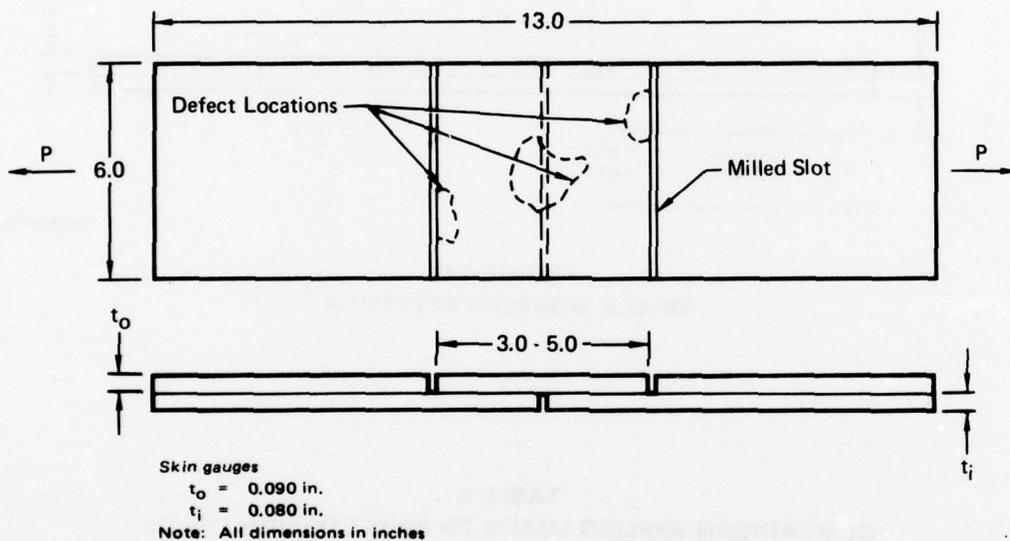
**FIGURE 15**  
**SINGLE-STRAP JOINT SPECIMEN**

Single-Strap Specimen - Configuration details for the single-strap specimen are shown in Figure 15. This specimen configuration is representative of a single-lap circumferential splice on the PABST fuselage as illustrated in Figure 1(b) but without the support of a substructure member. As such, it represents a poorly designed joint and experiences the highest amount of induced peel stress, in conjunction with shear stresses, of all the specimens configurations tested. This specimen configuration was chosen to provide a range of splice configurations including the double-doubler with negligible peel forces, the single-doubler with moderate peel forces, and the single-strap with high peel forces.

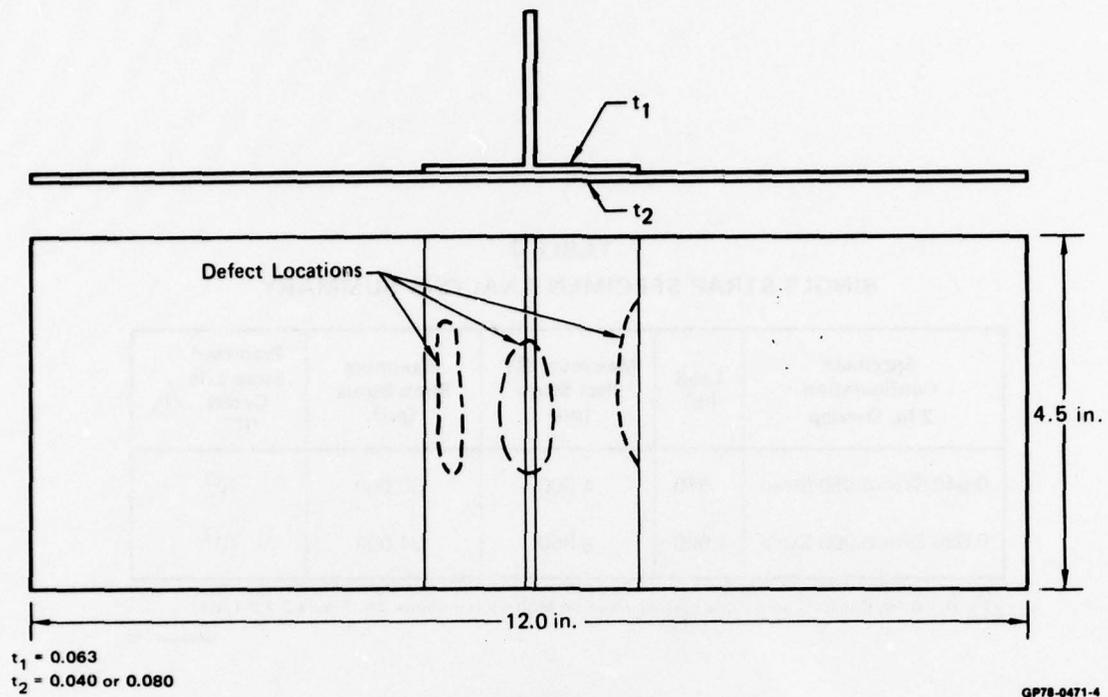
FIGURE 16  
SKIN-TO-SUBSTRUCTURE SPECIMEN

Skin-to-Substructure Specimen - Configuration details for skin-to-substructure tee specimens are shown in Figure 16. This specimen type simulates circumferential and longitudinal frame stiffeners bonded to the fuselage skin. Loadings for two types of failure modes were considered for this type specimen in order to determine an appropriate load for fatigue cycling tests. One failure mode results from tension forces between the skin and stiffener caused by internal fuselage pressure. In this case, the stiffener may prevent the skin from deflecting enough to carry the loads entirely as hoop tension, thus causing tension forces between the skin and stiffener. A second failure mode occurs at the onset of shear buckling in the skin, also creating tension forces between the skin and stiffener. Loadings for these two failure modes, which were derived in the PABST Program for the full range of expected thicknesses for wide body fuselages, are shown in Figure 17. Test loads were based on this data. The maximum test load for a tee specimen with 0.040 skins was 100 pounds per inch. For tee specimens with 0.080 skins, the maximum test load was increased slightly over that shown in the figure to 80 pounds per inch.

Most flaw types investigated were located along the edge of the tee where maximum shear and peel forces occur. For comparison purposes, several specimens had flaws located in the middle of the tee base.

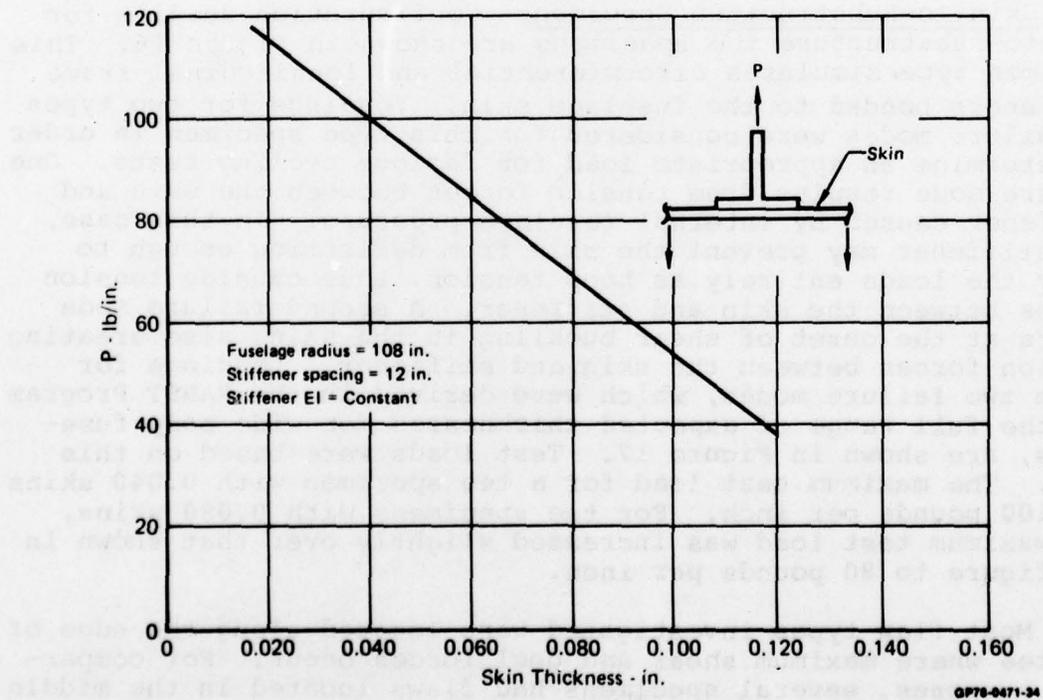
FIGURE 17  
TEST LOADS FOR SKIN-TO-SUBSTRUCTURE SPECIMENS

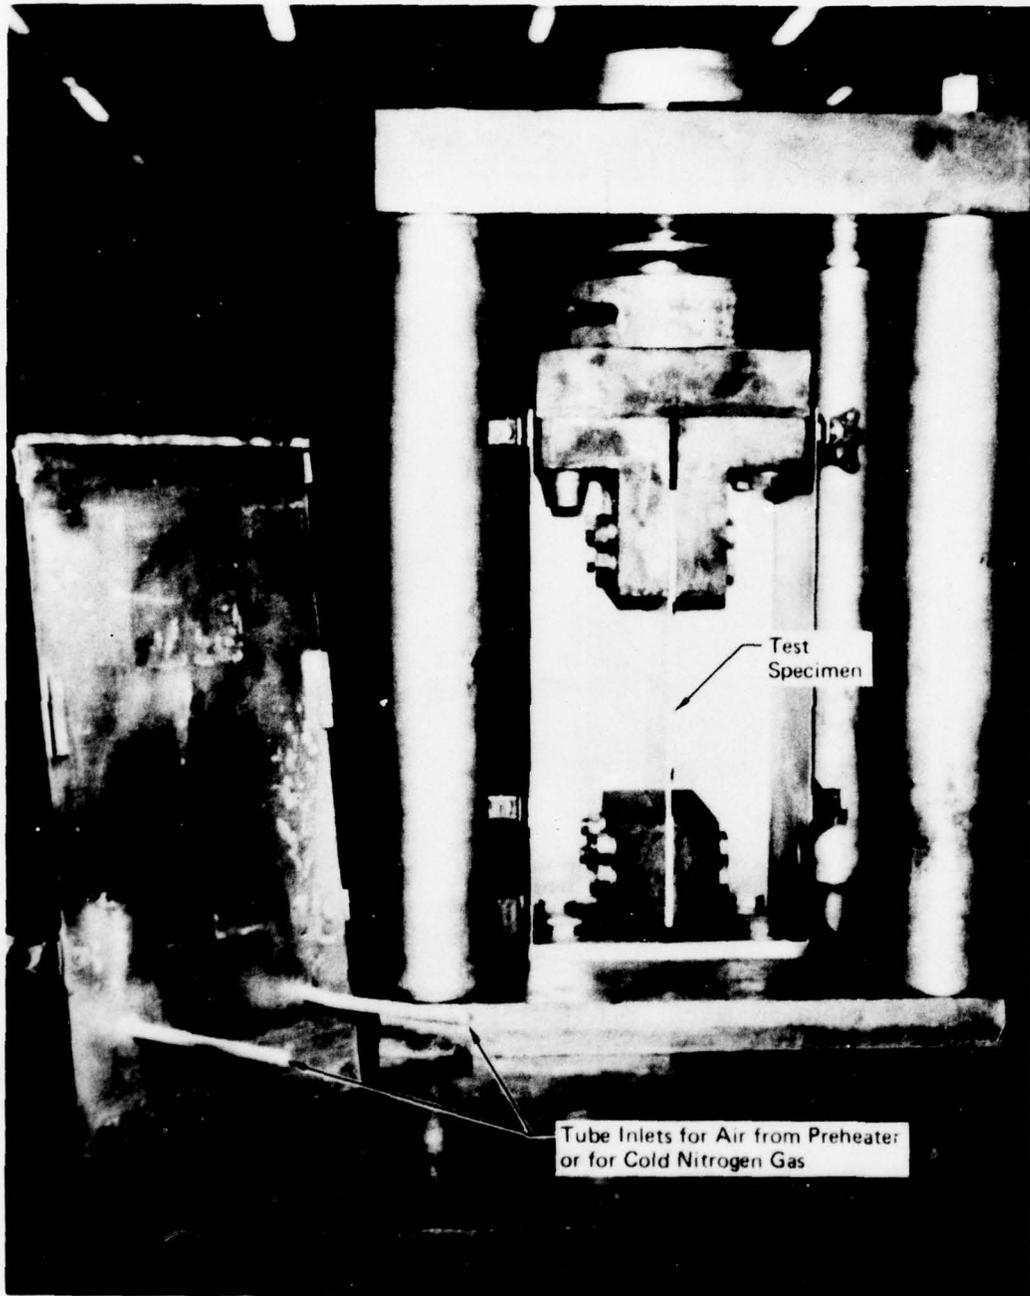
**FIGURE 19**  
**FAST CYCLE FATIGUE TEST SETUP FOR METAL LAP SPECIMENS**

Sonntag universal testing machines were used for all fast cycle (30 Hz) fatigue tests. Environmental conditions were controlled by using small insulated chambers around the specimen into which moist pre-heated air or nitrogen gas was pumped. A typical fast-cycle fatigue test setup for the tee specimen and for the all metal lap specimens is shown in Figures 18 and 19, respectively. The eight specimens which were tested in a preliminary evaluation of the effect of cycle rate utilized an MTS machine. A typical test setup for these tests is shown in Figure 20.

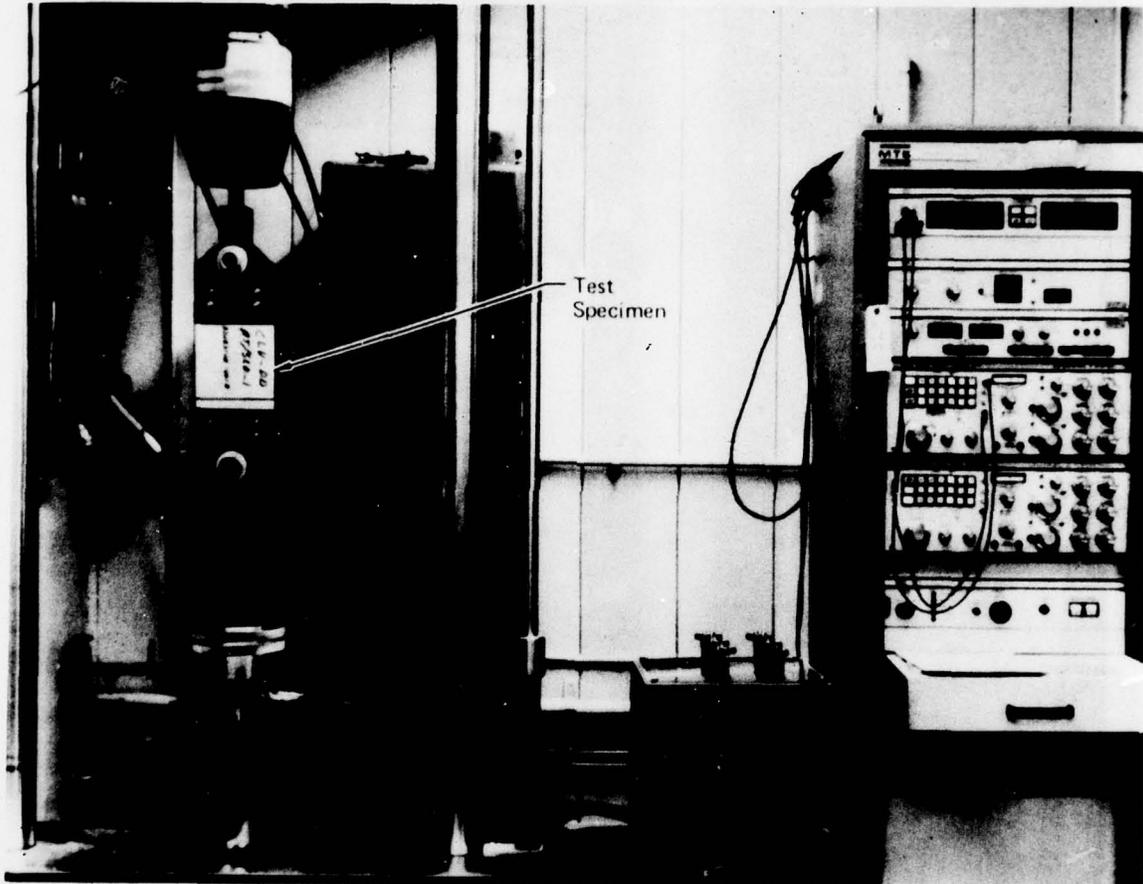
**FIGURE 20**  
**TEST SETUP FOR PRELIMINARY TESTS ON EFFECT OF CYCLE RATE**

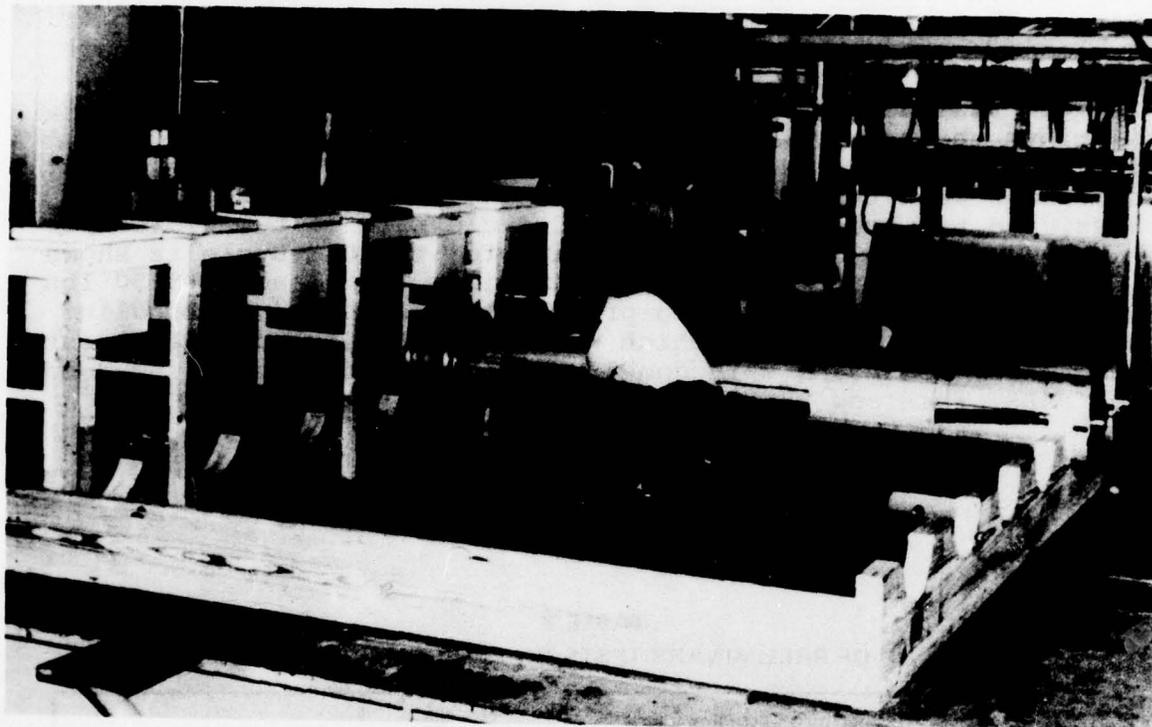
FIGURE 21  
SLOW-CYCLE TEST FIXTURES

Six special loading fixtures were fabricated for cycling specimens at the DAC cycle rate in the specified environments. Two of the fixtures are shown in Figure 21. Each loading fixture consists of a pneumatic piston and housing mounted to a 14 inch diameter by 8-foot long stainless steel cylinder. Load is applied to a string of six specimens by the piston and reacted by a clevis attached to the opposite end of the cylinder. Doors in the sides of the cylinder provide access to the specimens. Sagging of the string of specimens was prevented by intermittent supports. Each fixture is equipped with individual load and temperature controls and serves as an independent environmental chamber. Water placed inside the horizontal fixtures was heated to 140°F by the use of blankets attached to the outer surface of the cylinder. Relative humidity within the chambers ranged from 95 to 100% of saturation. To provide the low temperature (-50°F) environment, boil-off from liquid nitrogen was pumped into the chambers through a solenoid valve actuated by a temperature controller.

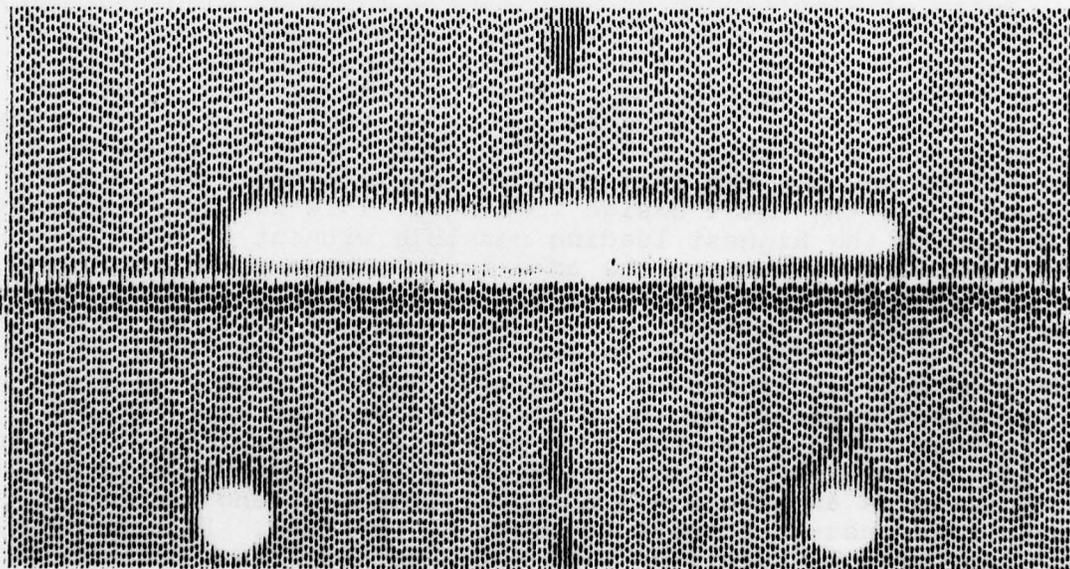
(a) C-Scan Before Cycling

(b) C-Scan After 10<sup>6</sup> Cycles

Crack-like voids in the adhesive bondline were located at the edges of the 0.040 doubler similar to that shown in the full-scale radiograph of Specimen No. 1 in Figure 22. Ultrasonic c-scans of the specimens made before, during, and after cycling, were used to determine whether or not flaw growth occurred. The initial and final c-scans of one end of Specimen No. 1 are shown in Figure 23. The flaw, as indicated by the white area located parallel to the edge of the 0.040 doublers, did not change in size or shape during the time of fatigue cycling. This lack of flaw growth was verified by tracing the flaw outline from the original radiograph and c-scan and over-laying it on the corresponding flaw indication of the c-scan made after the test was completed. Inspection of the c-scans in this manner revealed no evidence of flaw growth after  $10^6$  cycles for specimens cycled at 30 Hz, 8 Hz, and after 129 cycles for those cycled at the DAC cycle rate. Because no flaw growth occurred in these preliminary "quick look" tests, the original program test plan and test matrix was revised. The revised program plan was to use higher loadings in the fast cycle testing than originally planned as well as larger than anticipated flaws in order to test flawed bondlines under extremely severe conditions. The program plan for slow (DAC) cycle fatigue testing was to use realistic flaw sizes, and actual loading intensities derived from the PABST Program. Testing would be accomplished only under the extreme hot or cold environmental conditions, eliminating tests planned at room temperature.

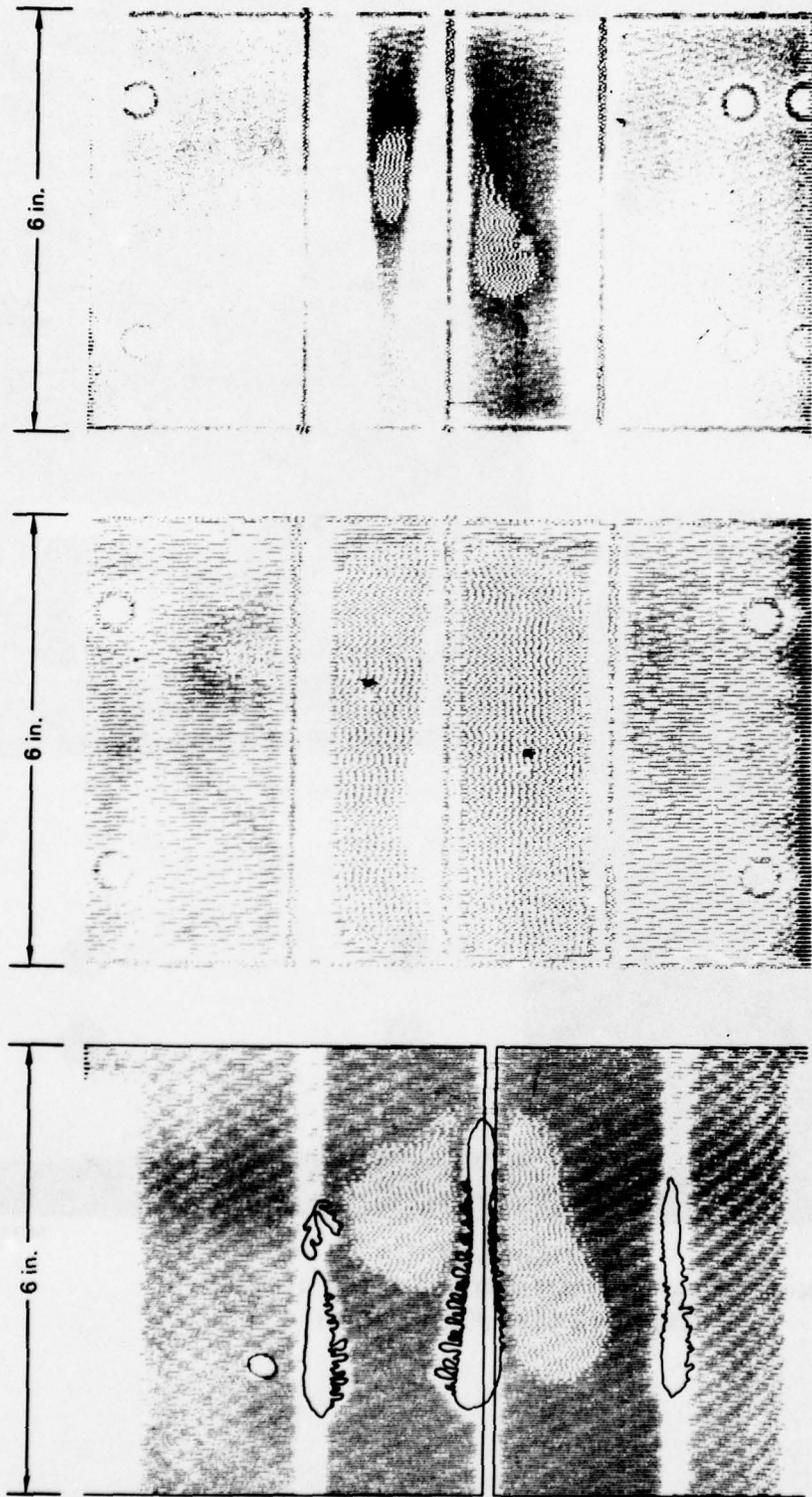
c) After 10<sup>6</sup> Cycles  
 GFR-3471-51

b) After 500,000 Cycles

**FIGURE 24**  
**C-SCANS OF SINGLE-STRAP SPECIMEN NO. 5**

a) Before Cycling

Flaw growth in the adhesive was easily detectable using the optimized c-scan method described in Section 2.4. A typical example of flaw growth is illustrated in Figure 24. Outlines of the crack-like adhesive voids, as indicated by a radiograph of the specimen have been superimposed on the c-scans to show their exact size and location prior to testing. After one-half million cycles, flaw growth had occurred all across the width of the specimens at one end of the splice and part way across the width at the opposite end and in the middle of the splice. After one million cycles, the unbonded area completely engulfed the original flaws in one splice over-lap, leaving only a thin strip of area still bonded. In most cases, flaw growth was more rapid along the sides of the initial flaws creating a filleted area of unbond as shown in Figure 25. Also, in this figure, the boundaries of the original adhesive cut-outs as well as the resulting voids are clearly visible in the figure because the mode of bondline failure in this area changed from cohesive to adhesive. Cohesive failure occurred over the other portions of the splice.
