AFML-TR-78-108

**DEFINITION AND NON-DESTRUCTIVE  
DETECTION OF CRITICAL ADHESIVE  
BOND-LINE FLAWS**

MCDONNELL AIRCRAFT COMPANY  
MCDONNELL DOUGLAS CORPORATION  
P.O. BOX 516  
ST. LOUIS, MISSOURI 63166

TECHNICAL REPORT AFML-TR-78-108  
FINAL REPORT FOR PERIOD  
27 JUNE 1975 - 31 JULY 1978

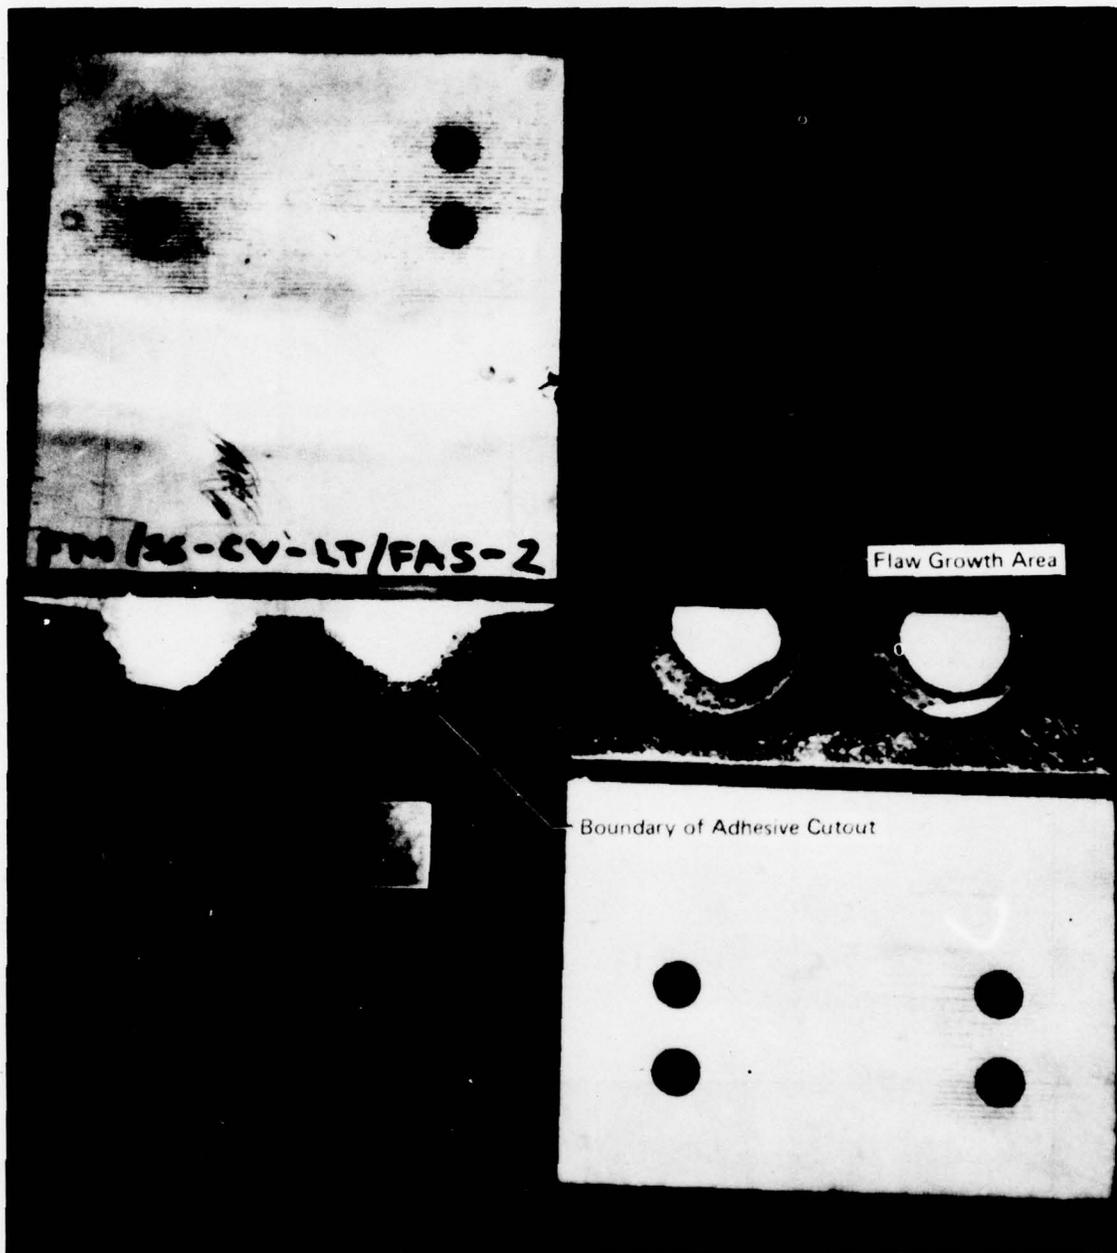
**FIGURE 25**  
**SINGLE-STRAP SPECIMEN NO. 32 AFTER RESIDUAL**  
**STRENGTH TEST (FAST CYCLE)**

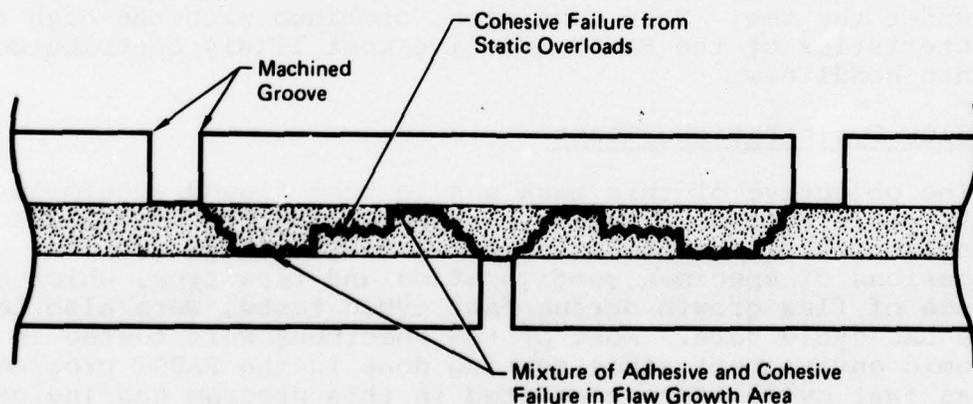
**FIGURE 26**  
**FLAW GROWTH CHARACTERISTICS OF SINGLE-STRAP SPECIMENS**

Visual inspection of specimens after residual strength tests, using a 10-30X variable power viewer, revealed that flaw growth always initiated on the surface of the terminating adherend at the edges of the machined grooves as shown in Figure 26. It then propagated to and along the adhesive-primer interface of the continuing adherend. This failed surface is described as a combined adhesive-cohesive failure because small pieces of adhesive (visible only with the viewer) remained bonded to the primer. Static overloads after cycling caused the remaining adhesive to fail cohesively, i.e., totally within the adhesive.

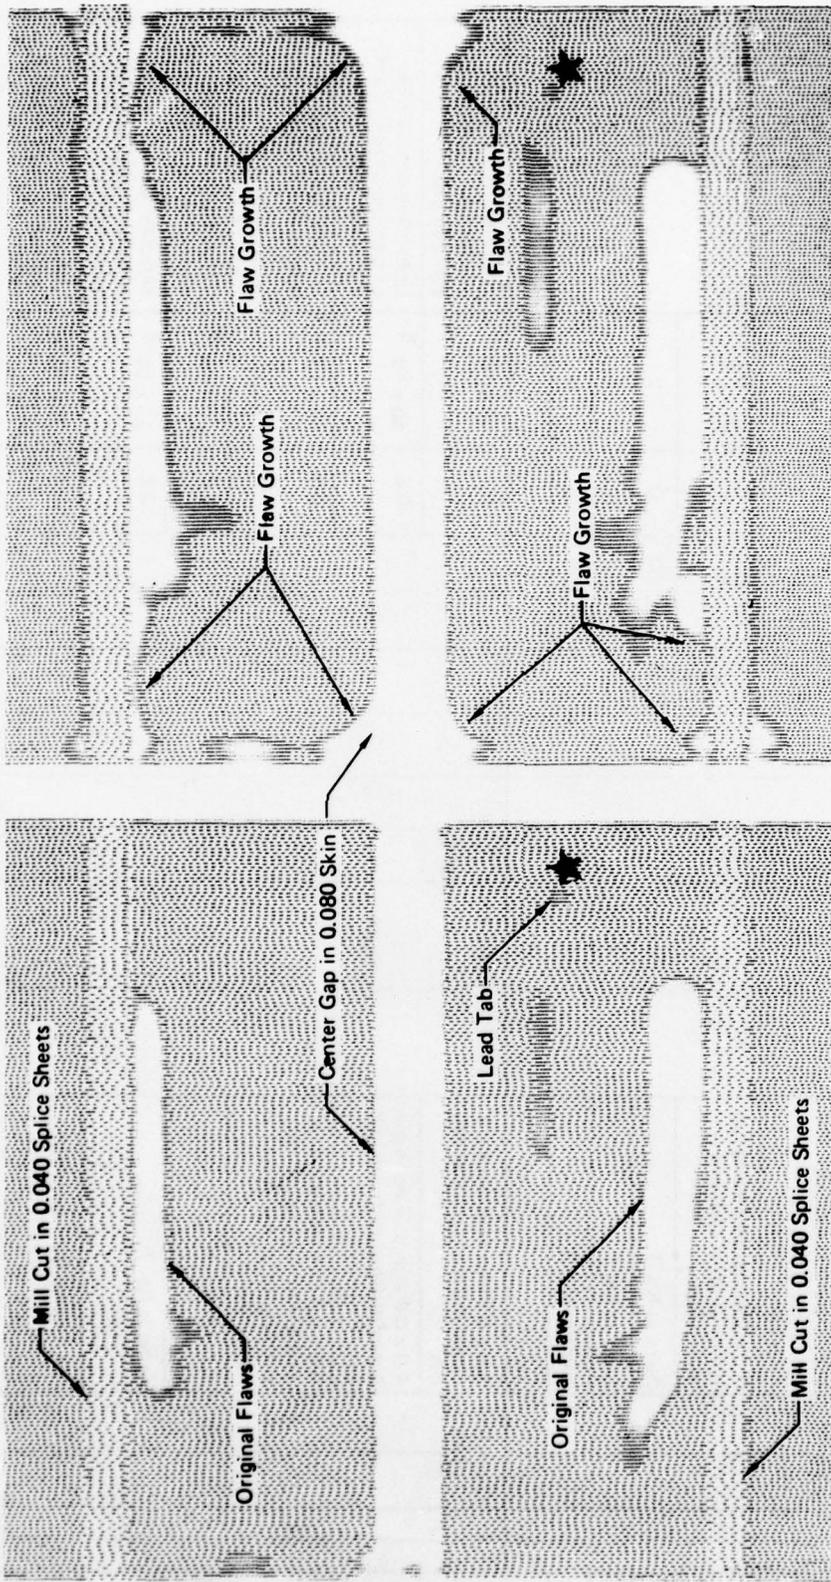
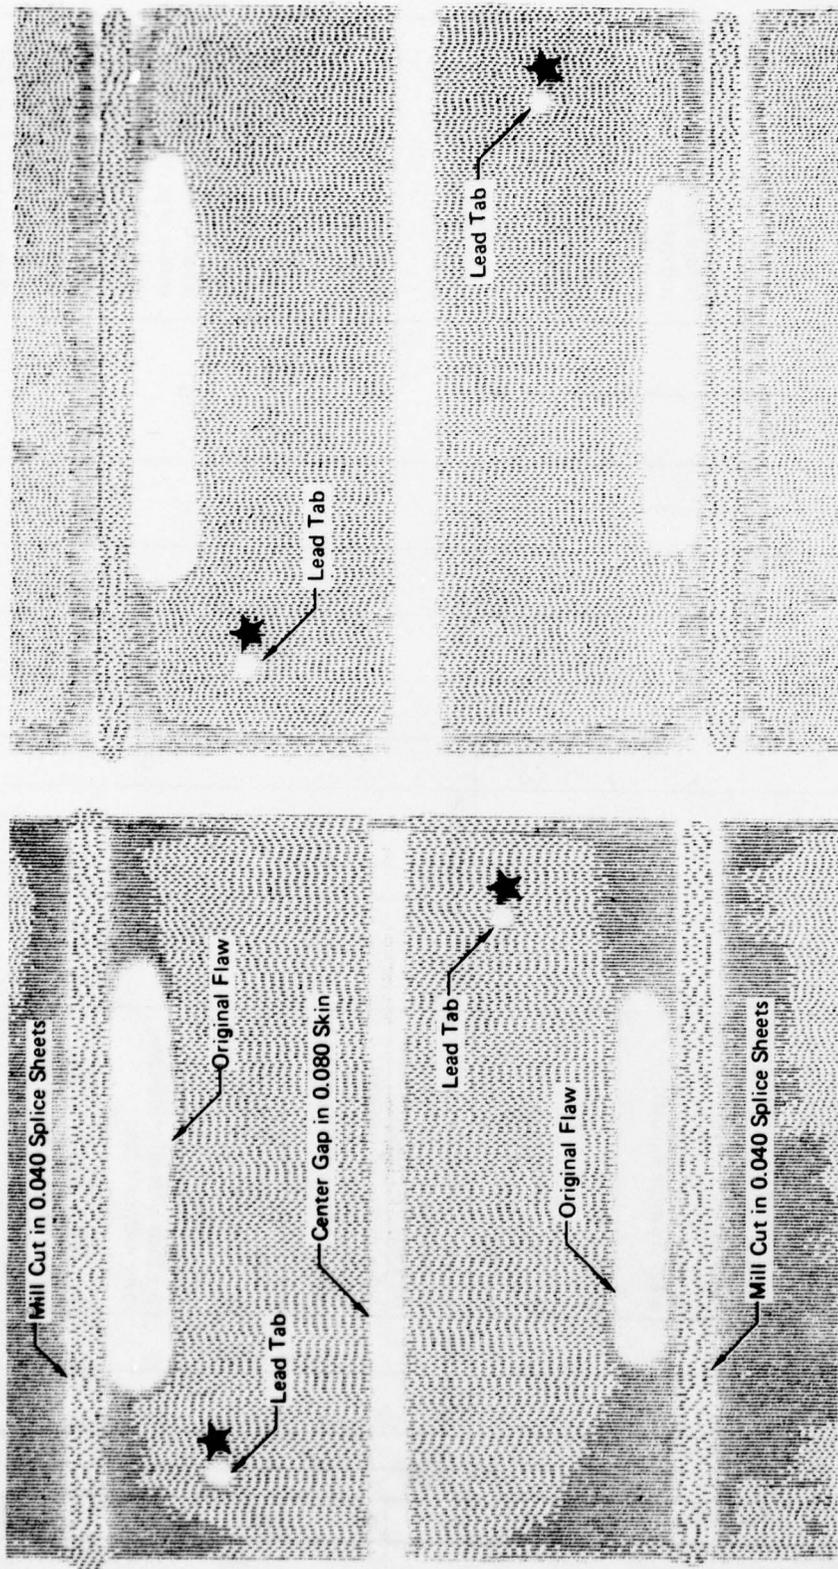
**FIGURE 27**

Before Cycling After 4000 DAC Cycles

**C-SCANS OF DOUBLE-STRAP SPECIMEN NO. 7 BEFORE AND AFTER CYCLING**

After 4000 DAC Cycles

This series of tests provided a comparison between the flaw growth characteristics of AF-55 and FM-73 adhesive. At the end of 4000 cycles, the specimens bonded with FM-73 adhesive had exhibited unbonding in the splice region, particularly along the sides of the specimen whereas the AF-55 specimens showed no change in bondline. The FM-73 specimens have been returned to the test environment and are continuing to cycle at the same DAC cycle rate. An example of the type of unbonding occurring in the FM-73 specimens is shown in c-scans of specimen No. 7 before and after cycling (Figure 27). For comparison, c-scans before and after cycling of specimen No. 2, an AF-55 specimen, are shown in Figure 28. Similar results were obtained in the fast cycle tests for both adhesives. In the fast cycle tests, specimens bonded with FM-73 and tested in the hot/humid environment exhibited a small amount of flaw growth before failure occurred in the aluminum, whereas specimens bonded with AF-55 adhesive, and tested under identical conditions, did not exhibit flaw growth. Results of the FM-73 specimens currently being cycled at the DAC cycle rate will be reported to the Air Force at the conclusion of testing.

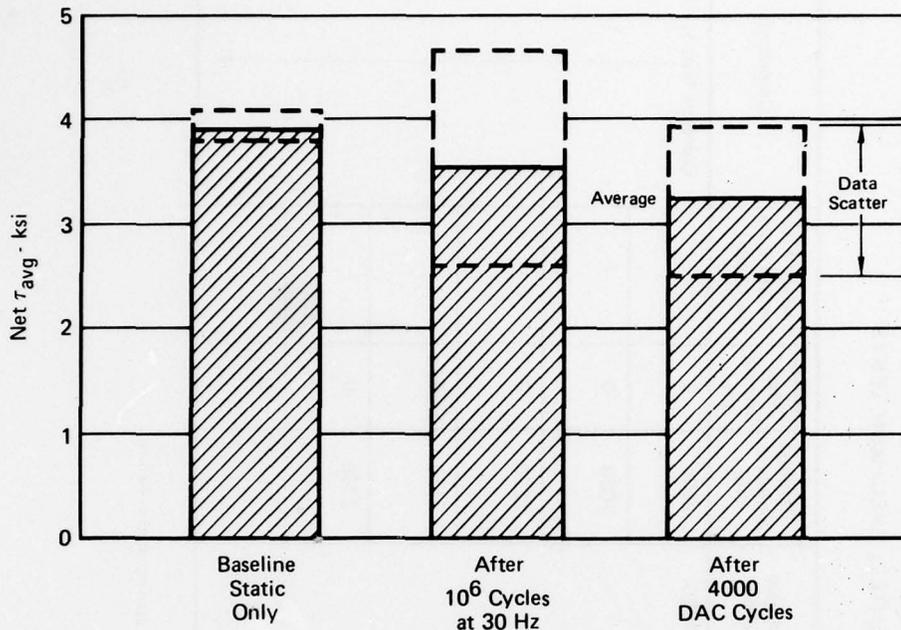
**FIGURE 29  
RESIDUAL STRENGTH TESTS OF  
SINGLE-STRAP SPECIMENS**

Residual strength tests were conducted on sixteen single-strap specimens which survived the fast cycle fatigue tests and on twenty-seven specimens which survived the DAC cycle fatigue tests. Two specimens which had not been exposed to either type of fatigue cycle were static tested to failure for comparison purposes. Eleven of the sixteen specimens surviving the fast cycle tests had residual net shear strengths below that of the uncycled specimens. Net shear strength was based on the actual bonded area after fatigue testing. Residual net shear strength of twenty-six of the twenty-seven specimens surviving the DAC cycle tests were below that of the uncycled specimens. A bar chart depicting these results as well as the scatter in data is presented in Figure 29. The lowest average residual net shear strength, for specimens cycled at either cycle rate, was recorded for specimens with variable adhesive thickness or mechanical damage. Specimens with crack-like voids exhibited the highest residual net shear strength of specimens cycled at either cycle rate. Residual net shear strengths of fast cycle specimens with crack-like and circular voids, and bonded with AF-55 adhesive were higher than similarly flawed specimens bonded with FM-73 adhesive. One specimen with porous bondline flaws and bonded with AF-55 had a slightly lower residual net shear strength than a similarly flawed FM-73 specimen.

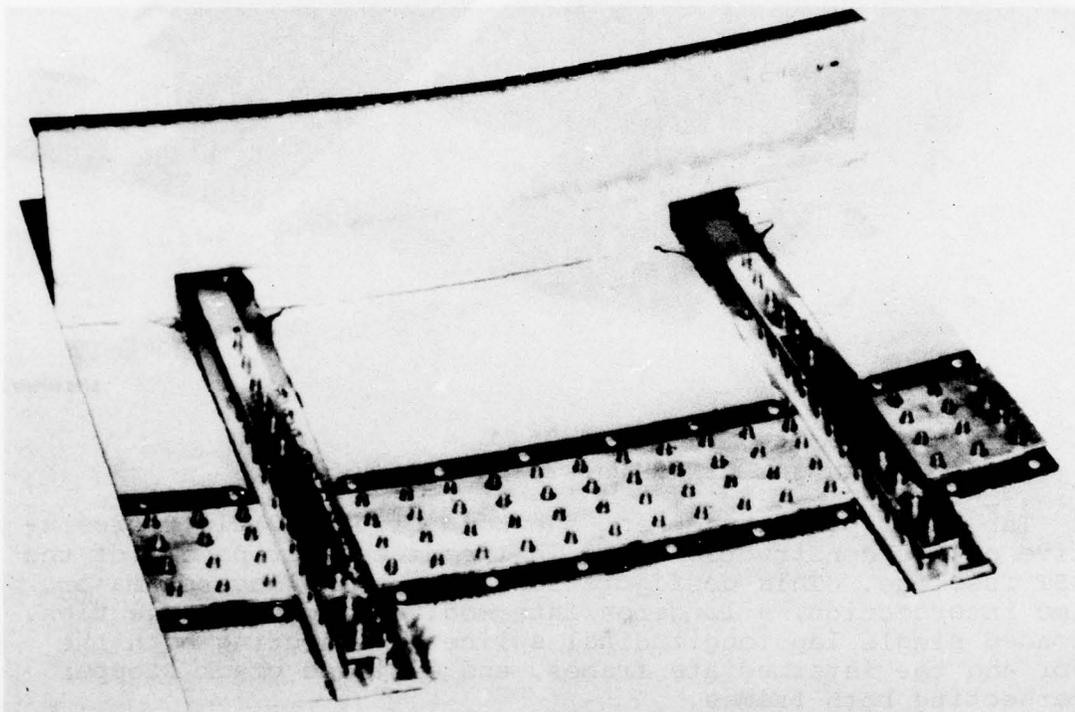
The internal longeron specimen, shown in Figure 30, is representative of the upper portion of the fuselage where longerons are located on the inner moldline of the fuselage cover skins. This specimen includes a frame longeron intersection, a longeron splice, a circumferential splice, and a bonded crack stopper under the longeron.

**FIGURE 30**  
**COMPLEX SPECIMEN - INTERNAL LONGERON**

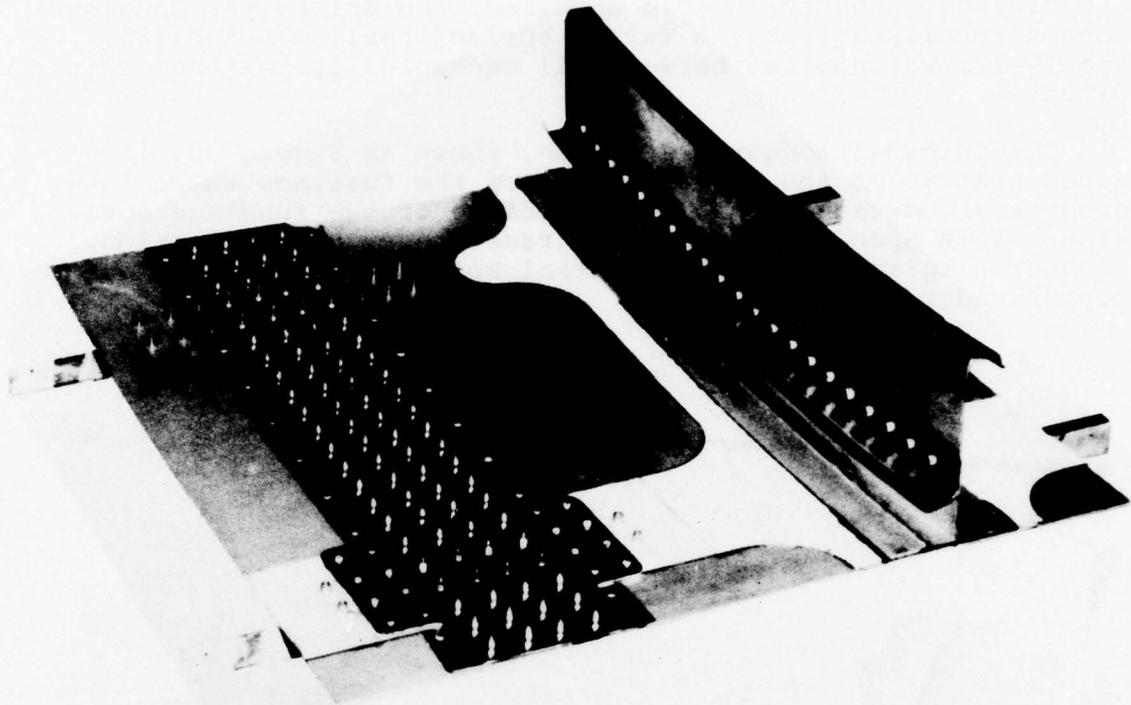
The external longeron specimen, shown in Figure 31, is representative of the lower portion of the PABST fuselage where longerons are located on the outer moldline of the fuselage cover skins. This specimen includes a frame/longeron intersection, a longeron splice, and a bonded double-lap longitudinal splice intersecting a mechanically fastened circumferential splice, and a bonded double-lap longitudinal splice intersecting a mechanically fastened circumferential splice as well as a bonded circumferential splice.

**FIGURE 31**  
**COMPLEX SPECIMEN - EXTERNAL LONGERON**

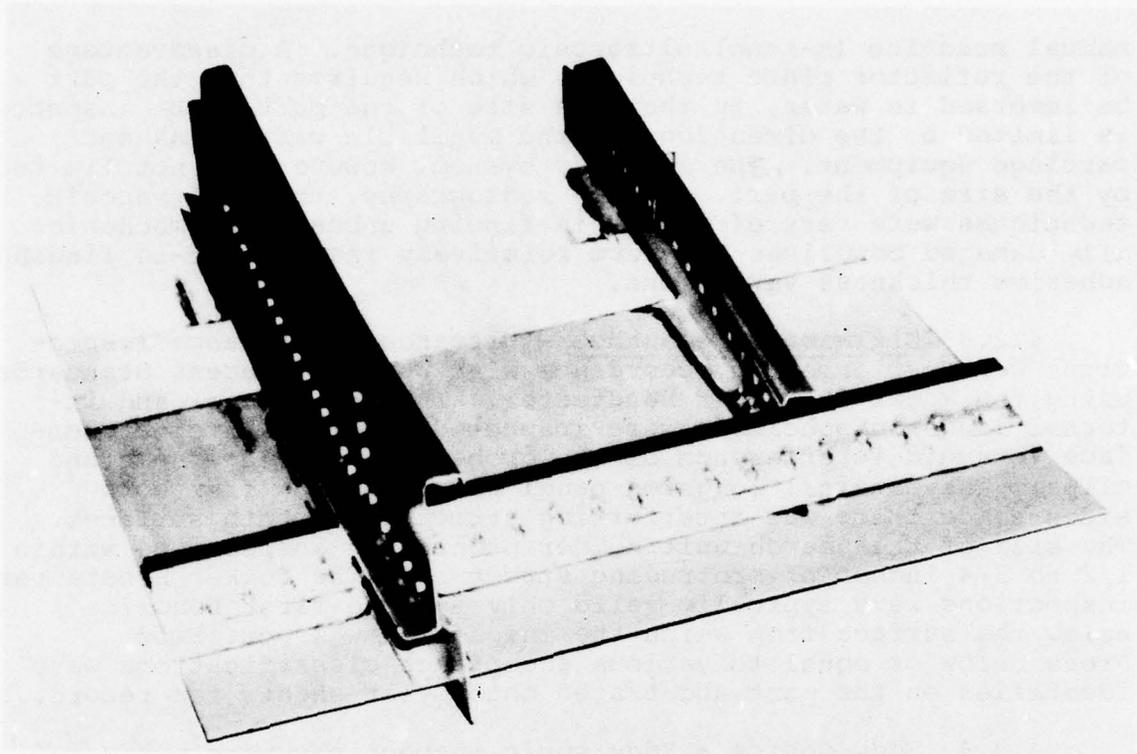
The shear panel specimen, shown in Figure 32, is representative of the construction used in the side shear panels of the PABST fuselage. This configuration includes a longeron/major frame intersection, a longeron/intermediate frame intersection, a bonded single lap longitudinal splice intersecting both the major and the intermediate frames, and a bonded crack stopper intersecting both frames.

**FIGURE 32**  
**COMPLEX SPECIMEN - SHEAR PANEL**
