INTERIM REPORT
TO CONGRESS

THE STREAMBANK EROSION CONTROL
EVALUATION AND DEMONSTRATION ACT OF 1974

September 1978

U. S. ARMY
CORPS OF ENGINEERS

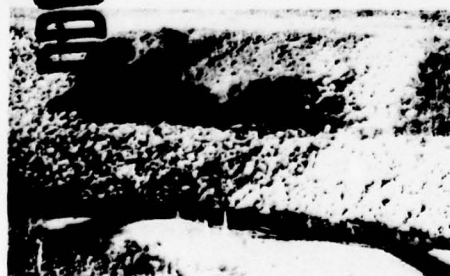
Rock Toe With Tie-Backs

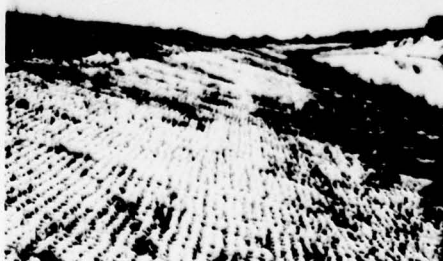
Precast Block Paving

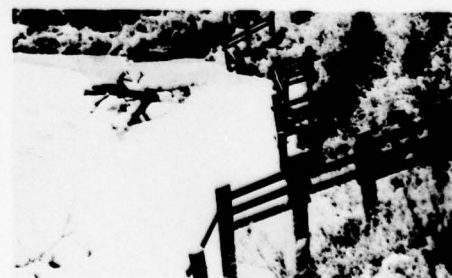
Board Fence Dikes

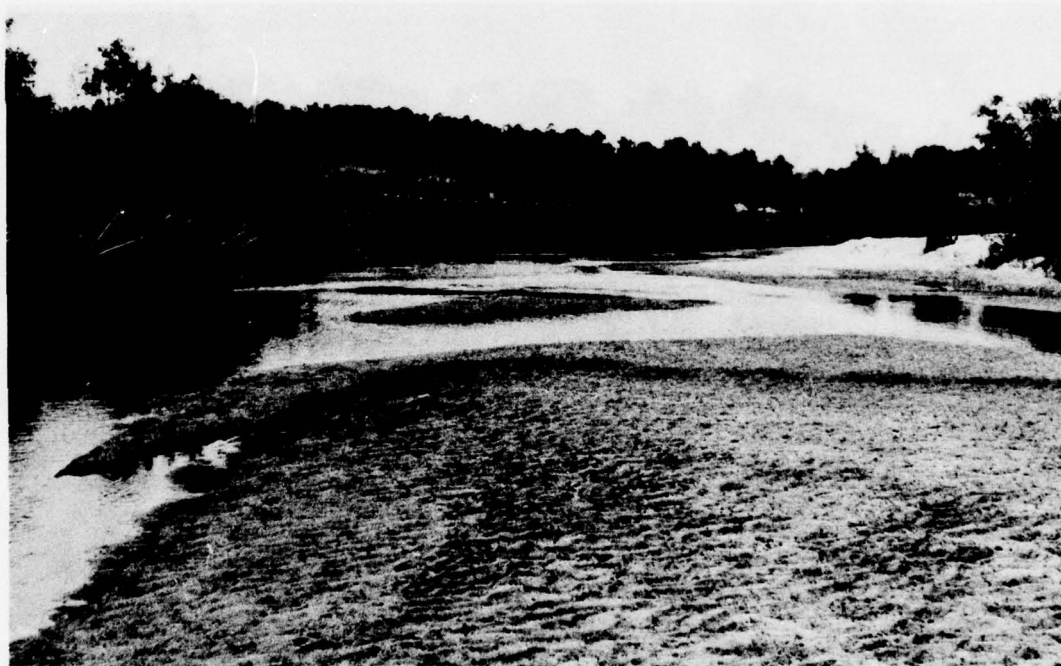
Photo 2. Board fencing with concrete jacks upstream and downstream

4. The first protection method observed on Big Sand Creek was a system of board fencing parallel to the streambank on the outside bank of a channel bend with concrete jacks upstream and downstream of the fencing (Photos 2 and 3). Fencing and jacks have been used in several locations on the Big Sand Creek and have worked well for the 10 years they have been in place. The next area observed on the Big Sand was where kudzu had been planted to stabilize the bank (Photo 4). The kudzu was not doing an adequate job of stabilizing the bank and had taken over the overbank vegetation.

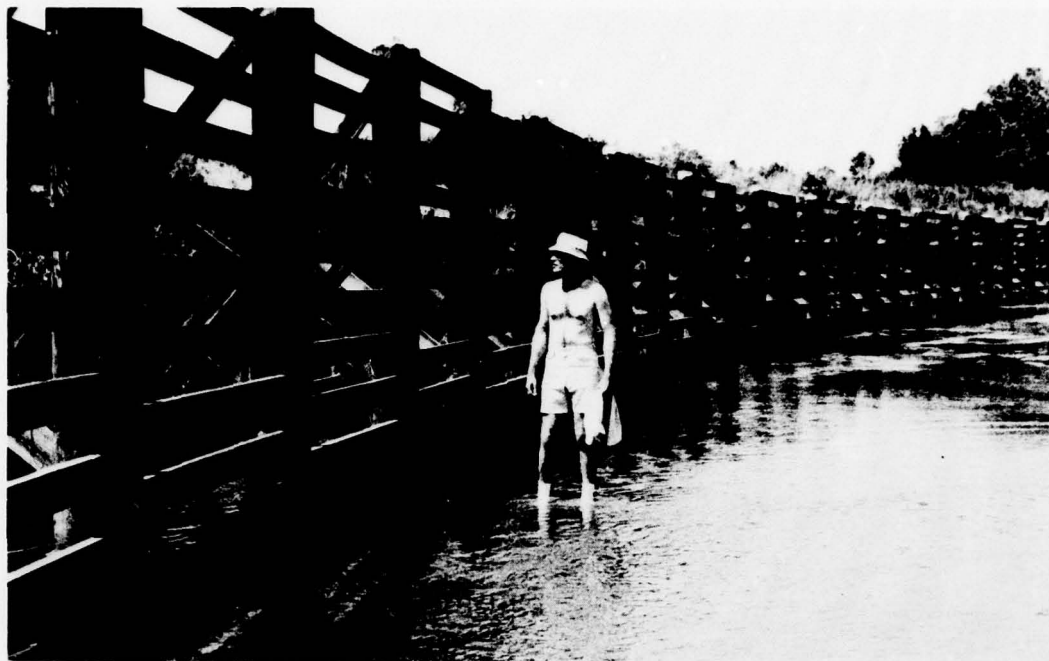
Photo 3. Board fencing

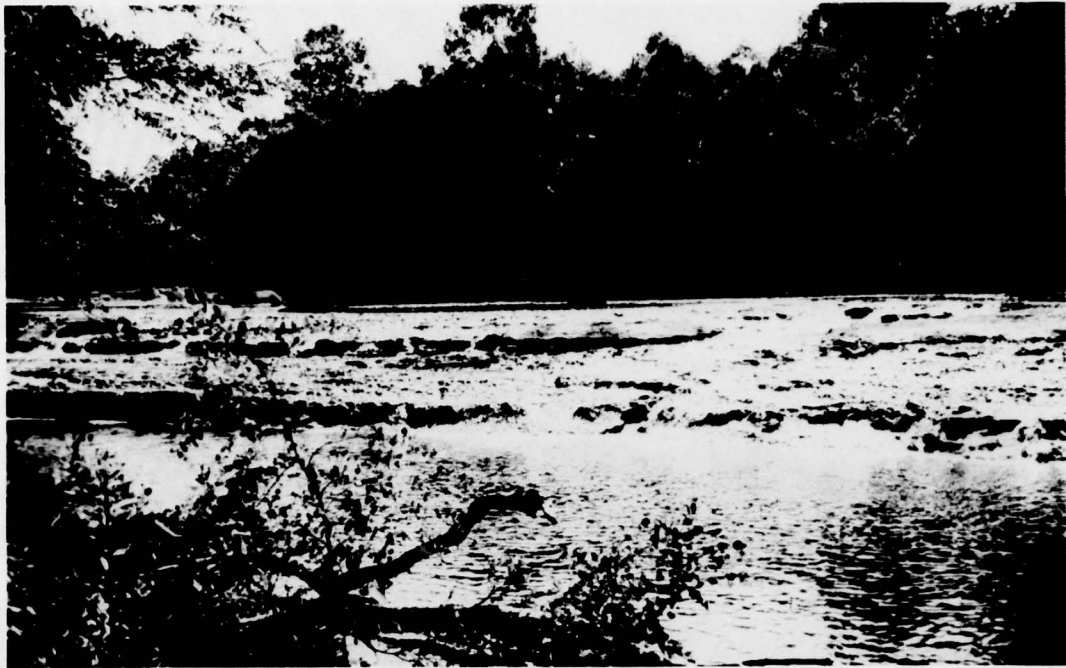
Photo 5. Natural grade control

5. In the upper reaches of the Big Sand Creek, an outcropping of a clay-sand mixture forms a natural grade control structure (Photo 5). If the Big Sand were to cut through this natural control, additional degradation and subsequent bank erosion would most likely occur upstream of the outcropping.

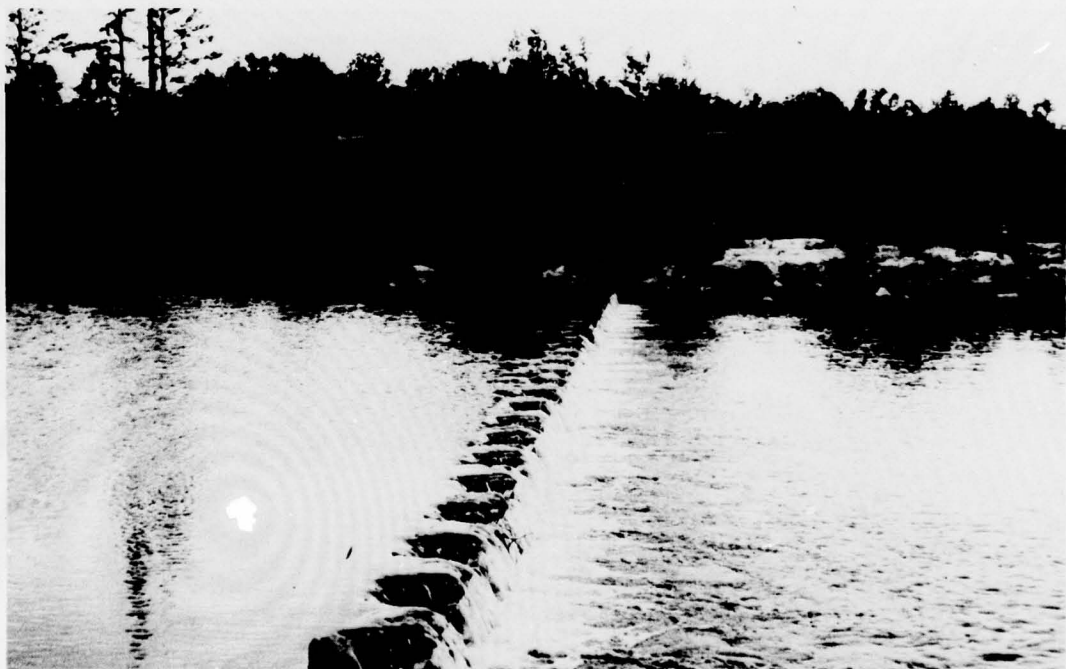
Photo 6. Low-head sheet pile grade control structure

the flow. A series of low-head sheet pile (Photo 6) and concrete drop structures (Photo 7) were built to control the grade and act as sediment basins. The channel upstream and downstream of the concrete structure is completely filled with sediment.

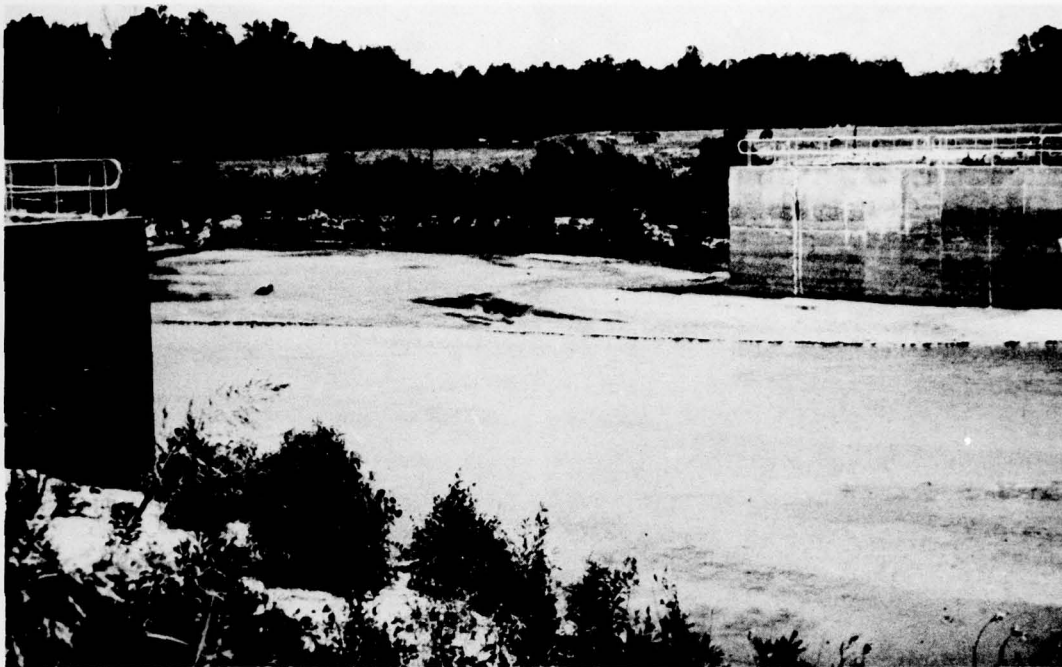
Photo 7. Concrete grade control structure
silted in both upstream and downstream

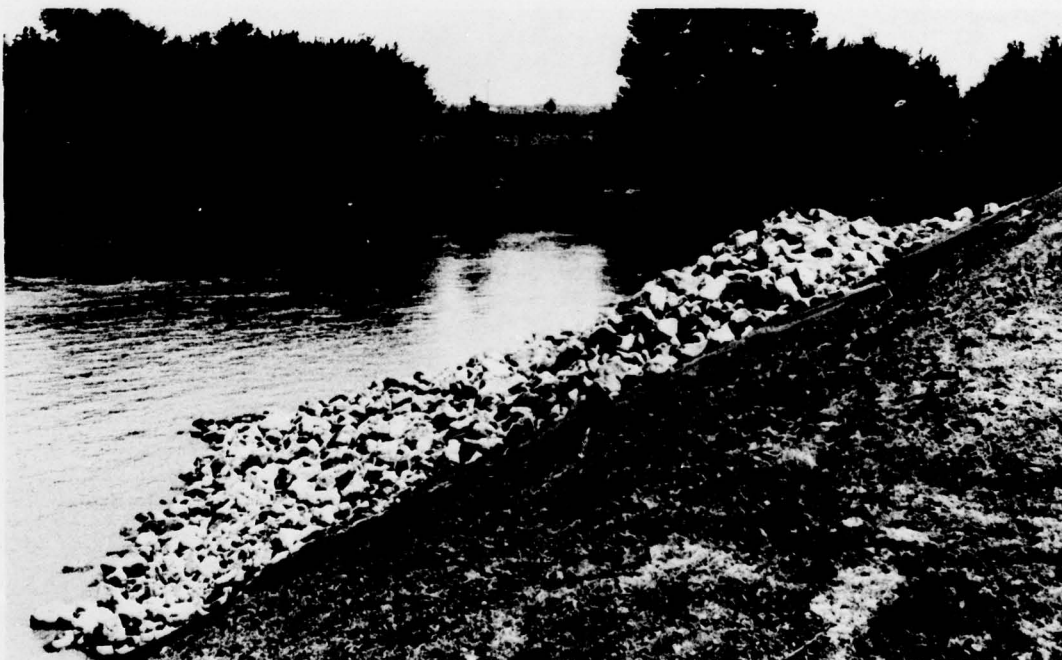
Photo 8. Riprap placement on black plastic filter material

7. Next, riprap revetment was observed at the junction of the Greenwood diversion canal and the Tallahatchie River (Photo 8). The riprap was being placed on a 1V-on-2H slope on a black plastic filter cloth. Toe protection for the revetment was being extended well out into the river.

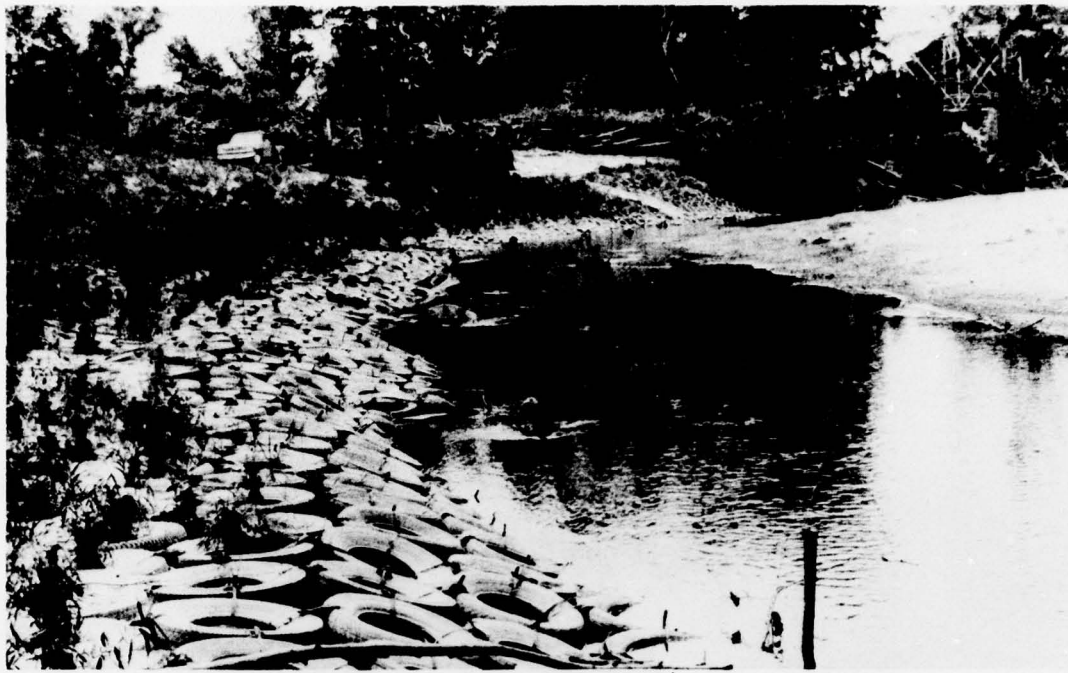
Photo 9. Tire mattress

8. The inspection continued to Tillatoba Creek near Charleston, Mississippi, where the Vicksburg District has a very active bank protection program under way. Many of the Section 32 demonstration sites are located on Tillatoba Creek. The first area observed was a mattress of tires connected together with steel bands around the periphery and anchored with cables attached to guy wire anchors (Photos 9 and 10). Willow shoots were planted in the tires and about 50 percent were growing.

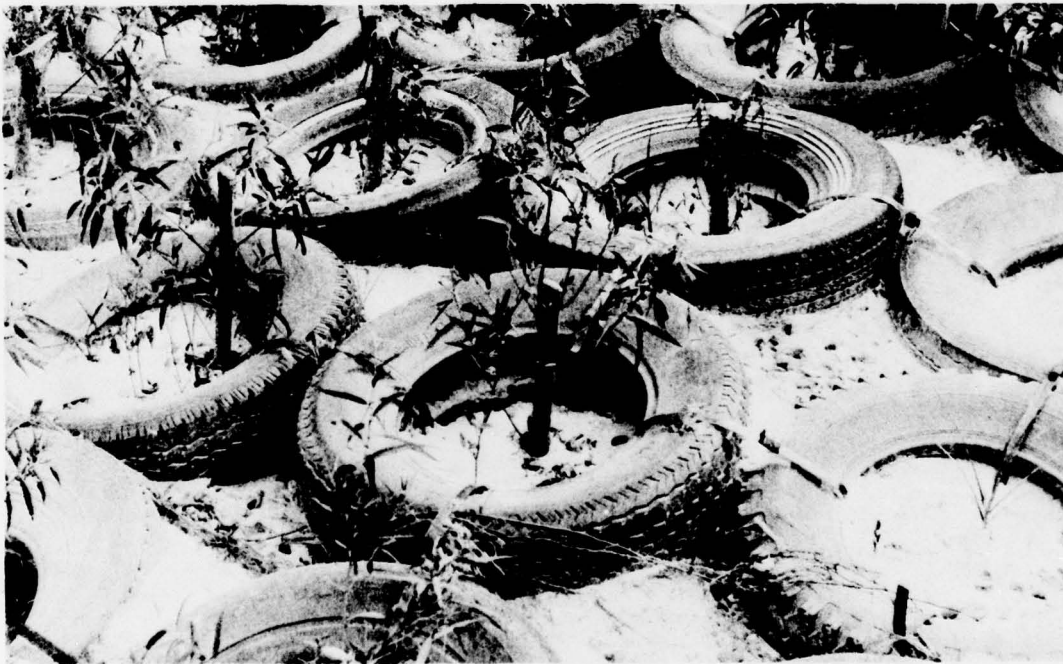
Photo 10. Tire mattress with willow shoots
planted to increase stability

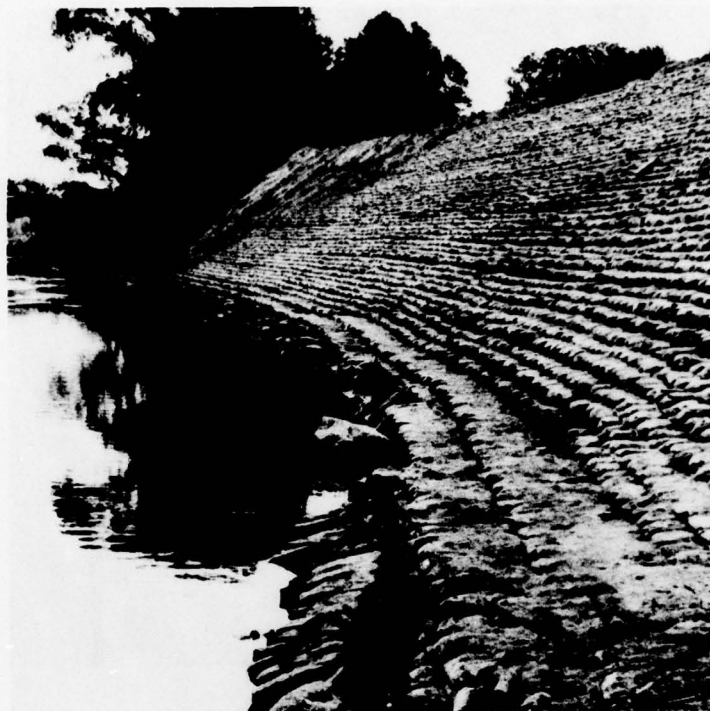
Photo 11. Sand-cement bags with toe launching

9. Another Section 32 demonstration site was observed consisting of sand-cement bag protection (Photo 11). These bags were placed on a steep slope (1V on 1.5H) and some evidence of toe launching was observed. The next protection method observed on Tillatoba Creek was a site under construction using a double row of wire fencing parallel to the stream (Photos 12 and 13). The space between the double fence will be filled with old tires. Farther upstream a double-row wire fence will be constructed and filled with hay bales.

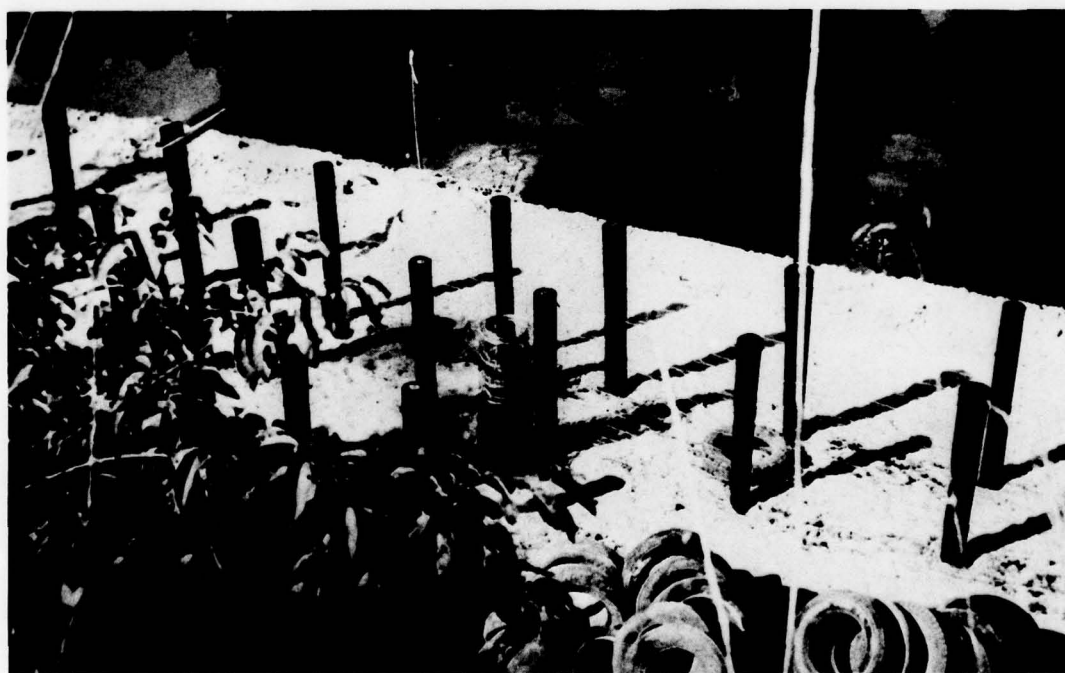
Photo 12. Double-row wire fence (to be filled with tires)

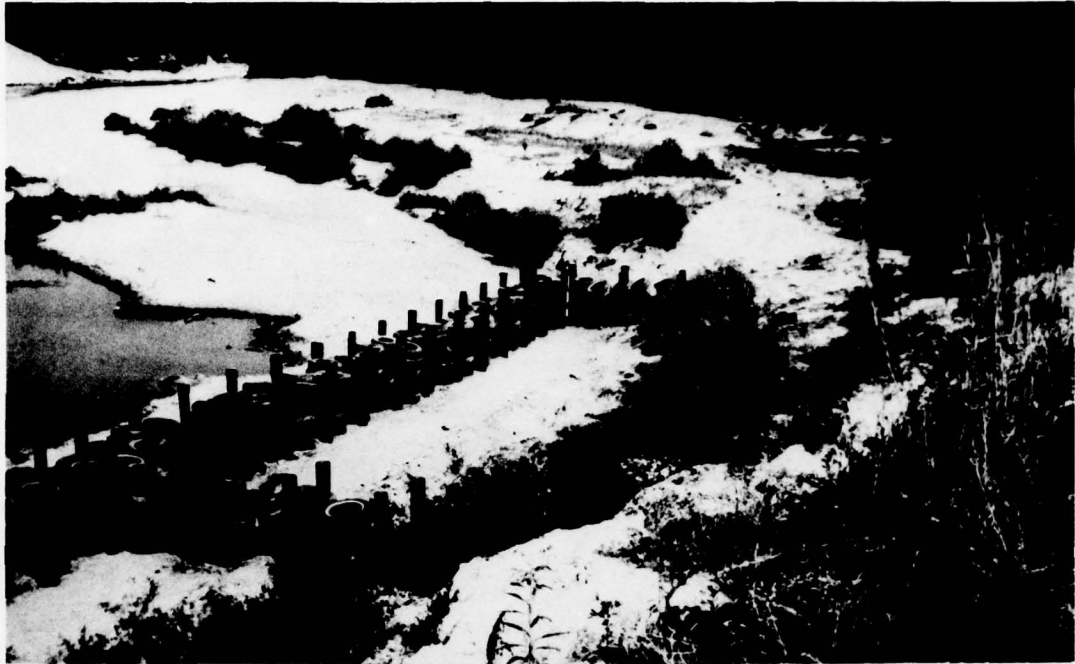
Photo 13. Double-row wire fence with tiebacks

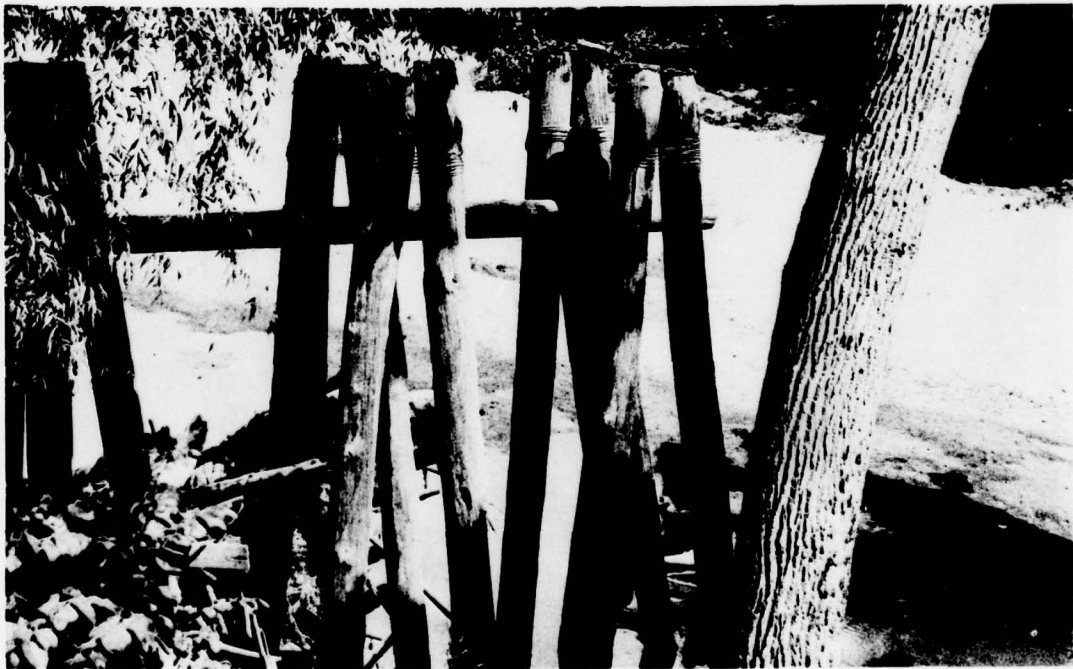
Photo 14. Timber pile groins

10. Timber pile groins that had been in place many years were observed in a bend upstream of the highway bridge (Photo 14). These groins had trapped debris and appeared effective in halting the erosion of the outside bank of the bend. Riprap hard points were observed at two locations on Tillatoba Creek (Photos 15 and 16). Kudzu was well established between the riprap hard points at one location.

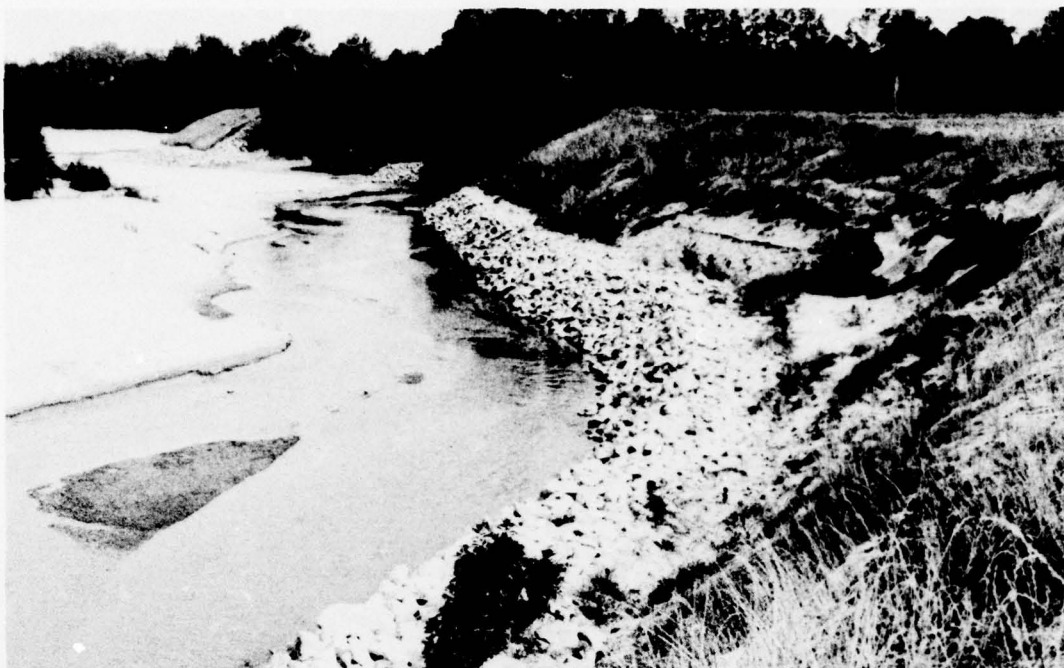
Photo 17. Riprap toe protection

11. The last protection type observed on the trip was riprap toe protection (Photos 17 and 18). This type of protection consists of a large section of rock placed at the toe of the slope extending up the bank as high as one half of the total bank height. The bank is usually graded to a 1V-on-2H slope before rock placement and the upper bank is vegetated after the rock is in place. The Vicksburg District has constructed several Section 32 demonstration sites using this scheme and all are performing satisfactorily.

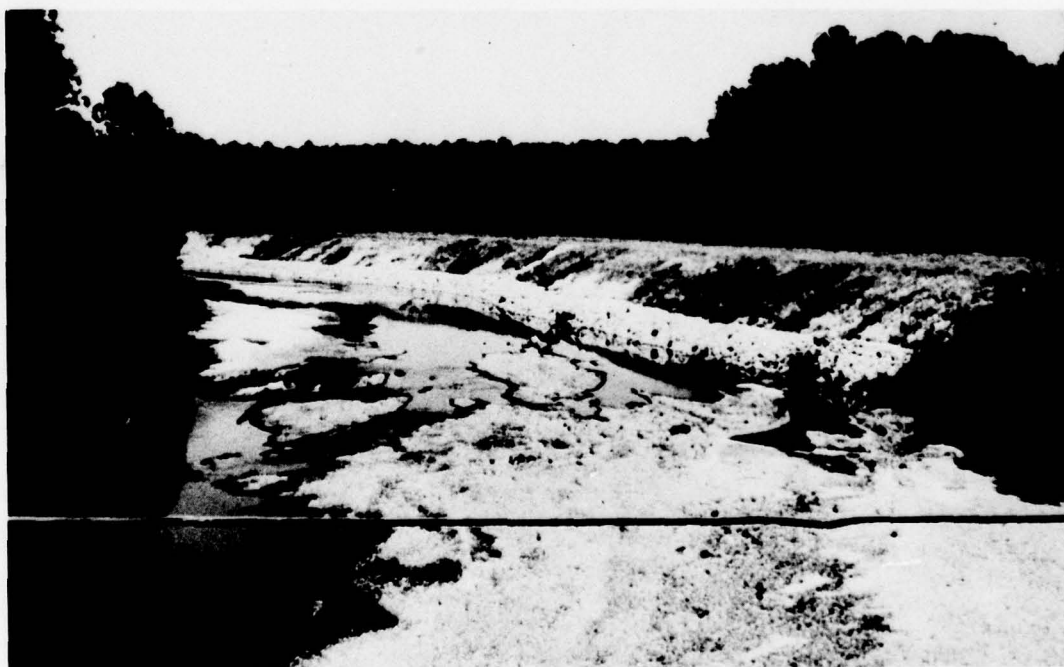
Photo 18. Riprap toe protection

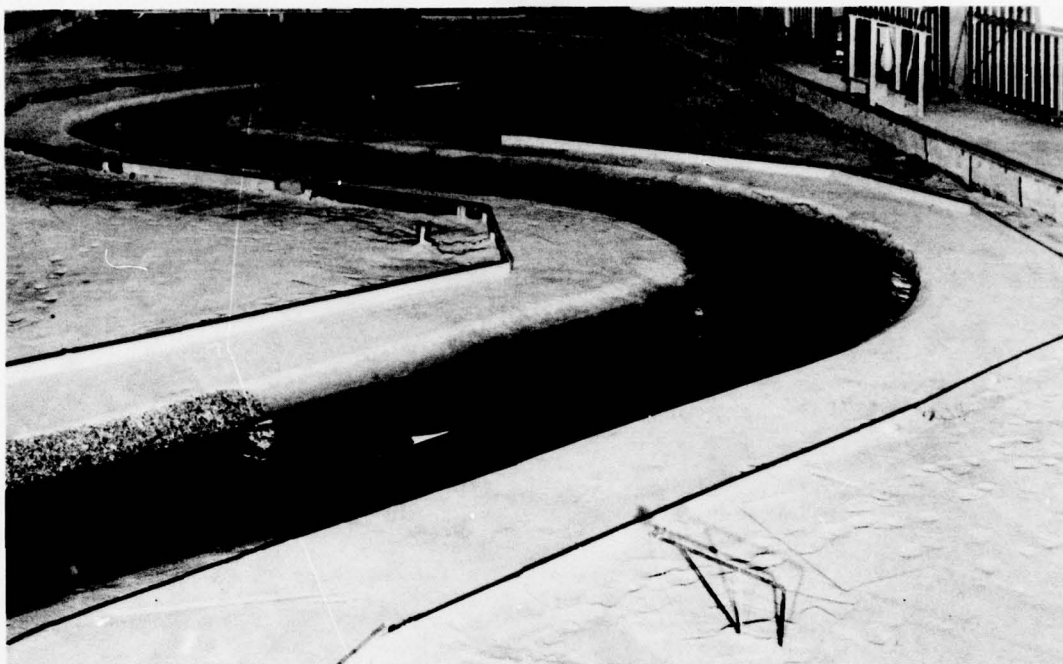
Figure C1. Multicurved channel flow facility

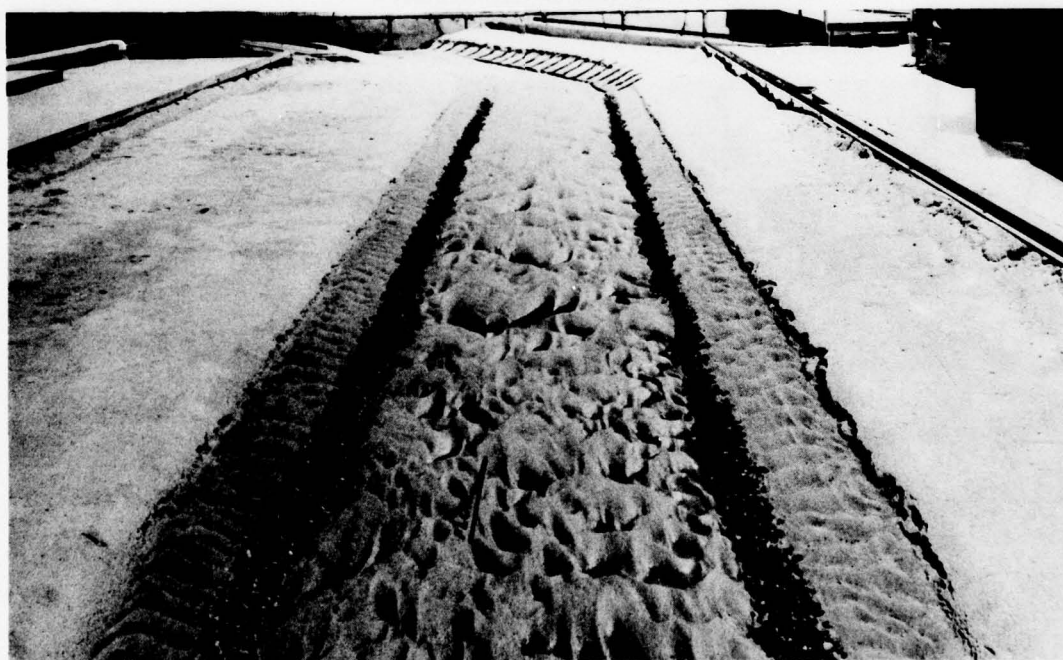
Figure C2. Straight and single-curved channel facility

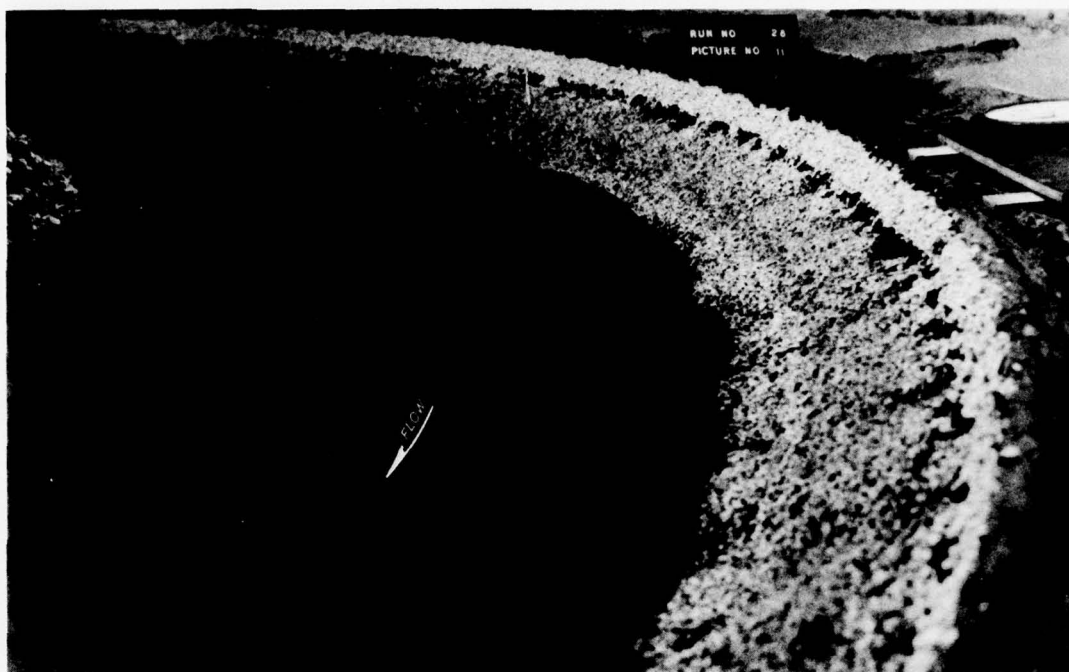
Figure C3. Windrow revetment study

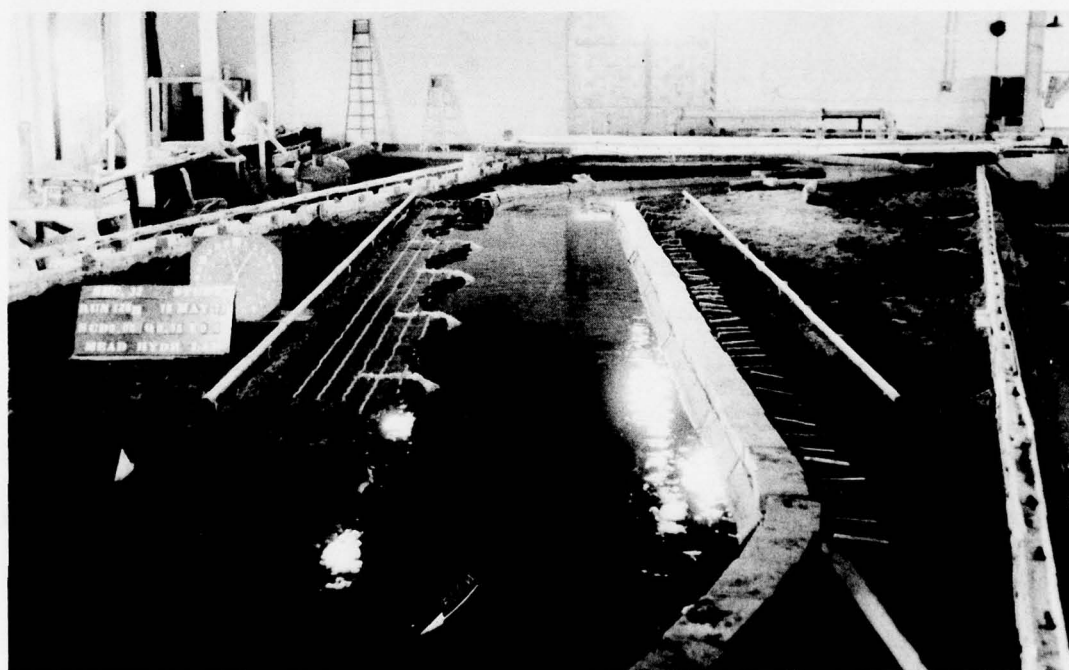
Figure C4. Intermittent hard-point study

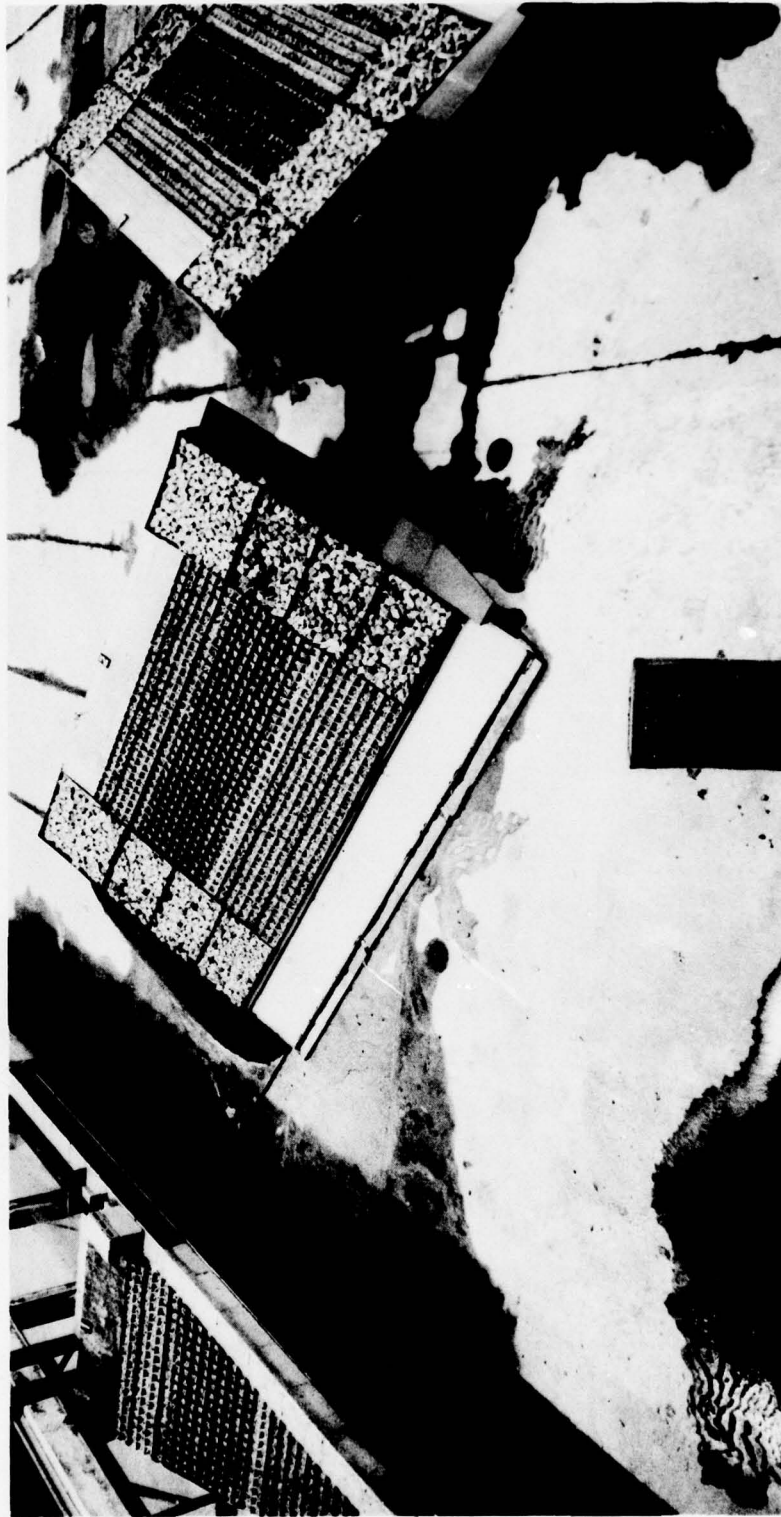
Figure C5. Wave test facility (two-dimensional installation at left; three-dimensional installation at center and right)

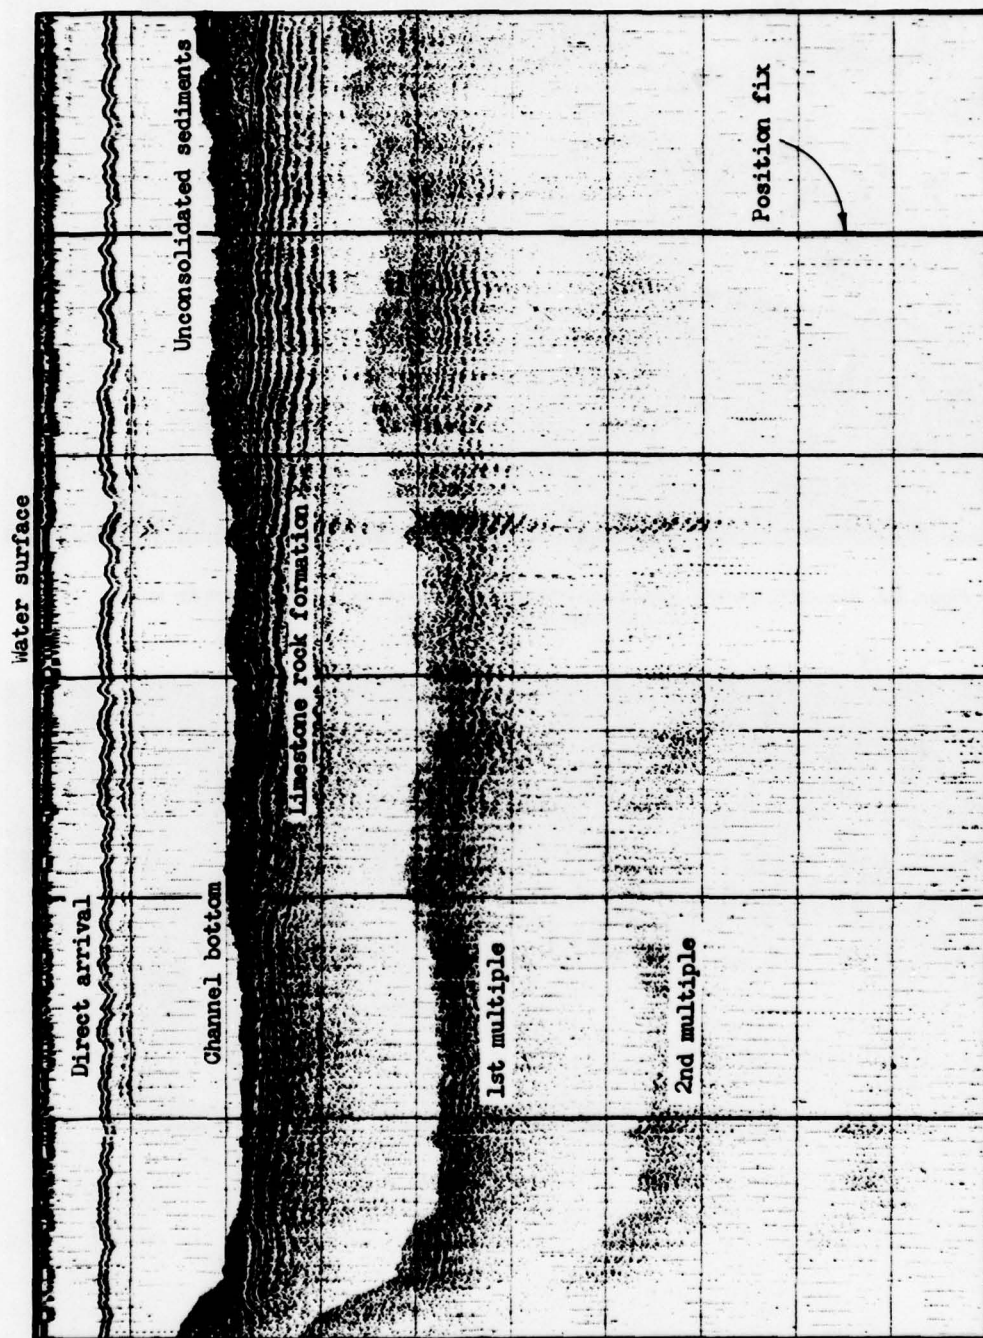
Figure D1. Example acoustical subbottom profile across a river channel. ("Direct arrival" and "multiple" traces are from false signals inherent in the sounding techniques.)

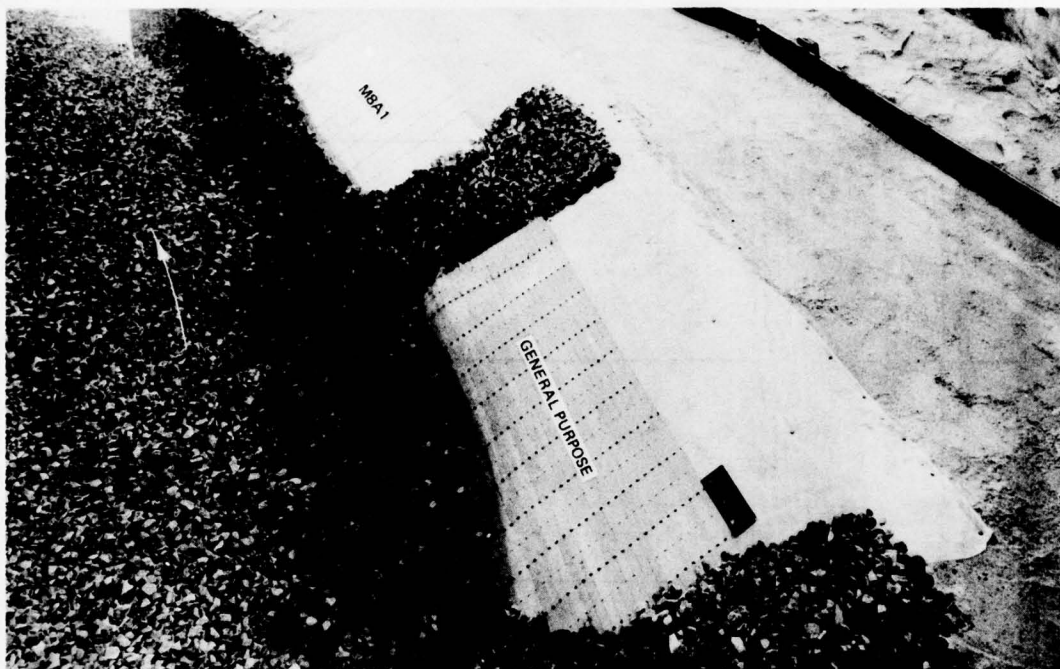
Figure D2. Simulated general purpose and M8A1 metal panels laid on filter cloth for testing in 1:25-scale model river bend

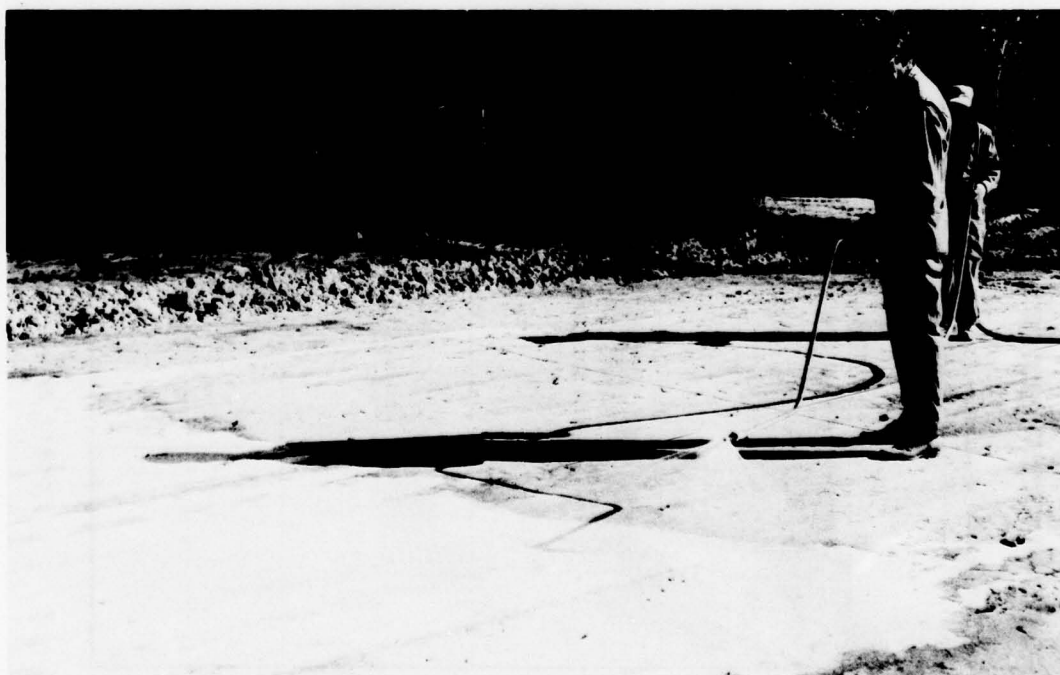
Figure D3. Applying spray-on chemical, soil-surface stabilizer to test section

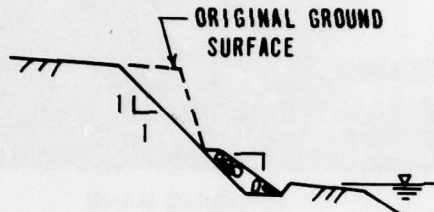
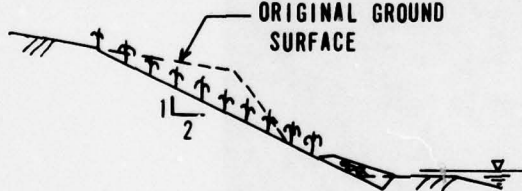
PLATE E1

18-in.-THICK GRADED STEEL FURNACE
SLAG BLANKET FROM EL 623.0 TO EL 627.0

SCHEME 1

SEEDING AND MULCHED FROM EL 627.0 TO
TOP OF CUT SLOPE. GRADED STEEL FURNACE
SLAG WEDGE FROM EL 622.0 TO EL 627.0

SCHEME 3

PLANT SHOOTS WITH MAT COVER FROM EL
625.0 TO TOP OF CUT SLOPE. GRADED
STEEL FURNACE SLAG WEDGE FROM EL
621.0 TO EL 625.0

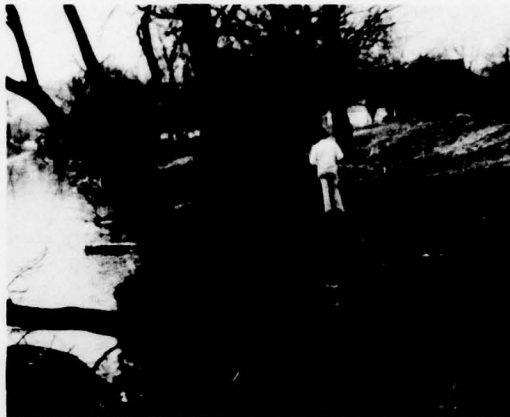
ERODING BANK
13 DECEMBER 1977

ERODING BANK
21 JUNE 1977

EROSION AT
MOUNDSVILLE, W. VA. SITE
GRAVE CREEK SITE
OHIO RIVER

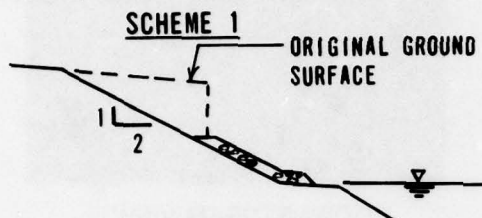
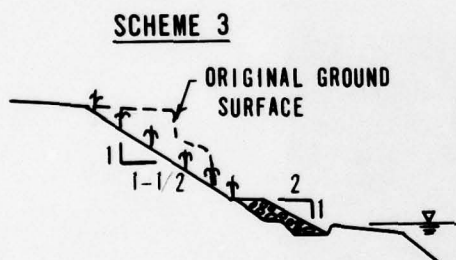
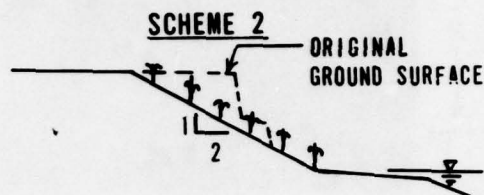
SEEDING AND MULCHING FROM EL 628.0 TO TOP OF CUT SLOPE. 12-in.-THICK GRADED STEEL FURNACE SLAG BLANKET ATOP FILTER CLOTH FROM EL 623.0 TO EL 628.0

PLANT SHOOTS WITH MAT COVER FROM EL 626.0 TO TOP OF CUT SLOPE. 18-in.-THICK GRADED STEEL FURNACE SLAG WEDGE FROM EL 622.0 TO EL 626.0

SCHEME 5

SEEDING AND MULCHING FROM EL 628.0 TO TOP OF CUT SLOPE. 8-in.-THICK GRADED STEEL FURNACE SLAG BLANKET ATOP FILTER CLOTH FROM EL 623.0 TO EL 628.0

PLANT SHOOTS WITH MAT COVER FROM EL 628.0 TO TOP OF CUT SLOPE. PLANT SHOOTS WITH FILTER CLOTH COVER FROM EL 623.0 TO EL 628.0

SCHEME 4

Status. Construction of the project was completed in May 1977. Moderately high flows have occurred several times since completion. Significant deterioration has been observed in Scheme 4 where recently planted vegetal cover was lost during high water. Restoration of this area will be done during the summer of 1978.

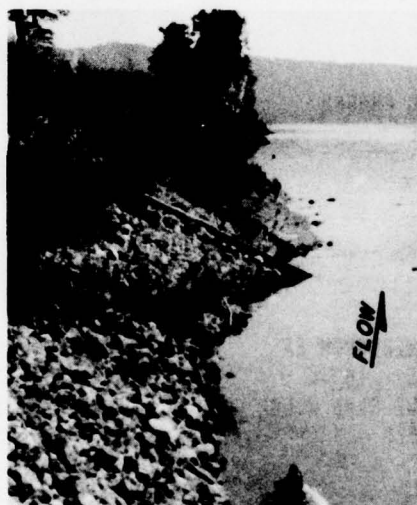
PLATE E5

DOWNSTREAM VIEW
FROM SCHEME 3
BEFORE CONSTRUCTION
17 NOVEMBER 1976

DOWNSTREAM VIEW
FROM SCHEME 3
6 JUNE 1977

DOWNSTREAM VIEW
FROM SCHEME 3
1 SEPTEMBER 1977

EROSION AT
MOUNDSVILLE, W. VA.
OHIO RIVER

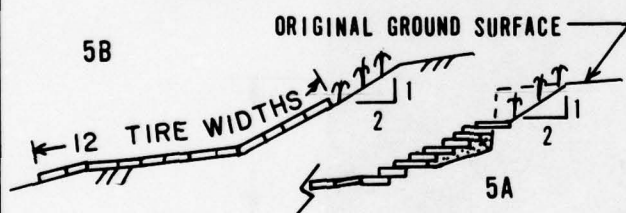
PLANT SHOOTS WITH MAT COVER FROM EL
628.0 TO TOP OF CUT SLOPE. SCHEME 5A
IS STACKED RUBBER TIRE WALL FROM EL
623.5 TO EL 628.0 WITH GRAVEL-FILLED
TIED TIRE BLANKET 6 TIRE WIDTHS BELOW
EL 623.5. SCHEME 5B IS GRAVEL-FILLED
TIED TIRE BLANKET 12 TIRE WIDTHS BELOW
EL 628.0

SCHEMES 5A & 5B

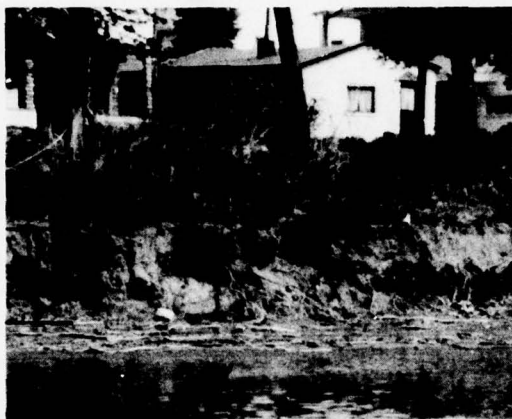
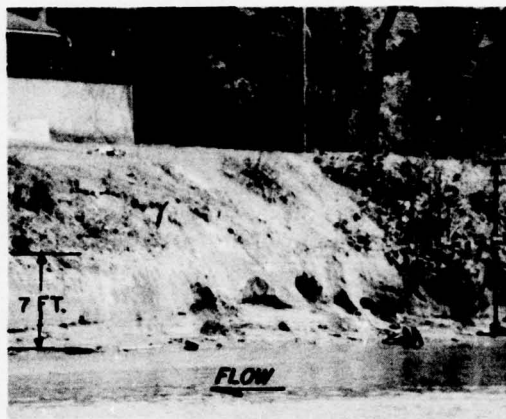
ERODING BANK
5 MAY 1977

ERODING BANK
8 MARCH 1977

EROSION AT
POWHATAN POINT, OHIO SITE
OHIO RIVER

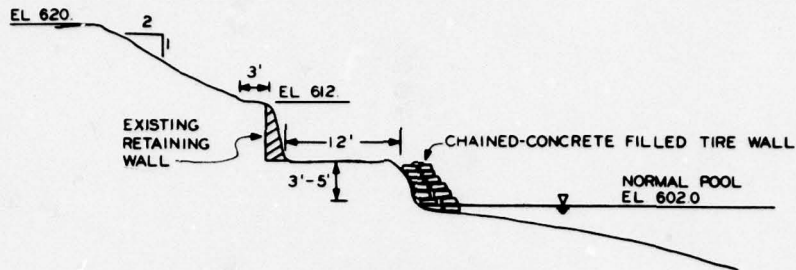
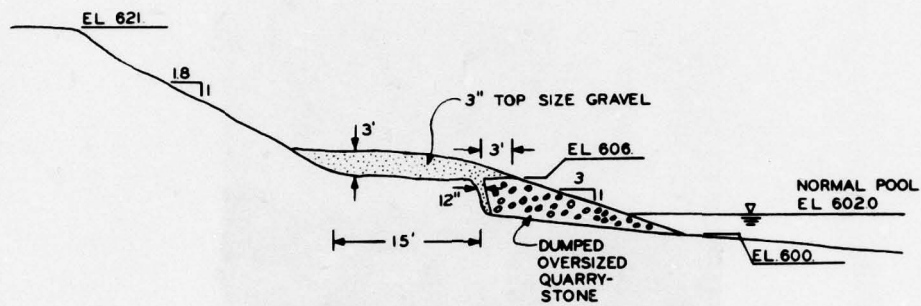
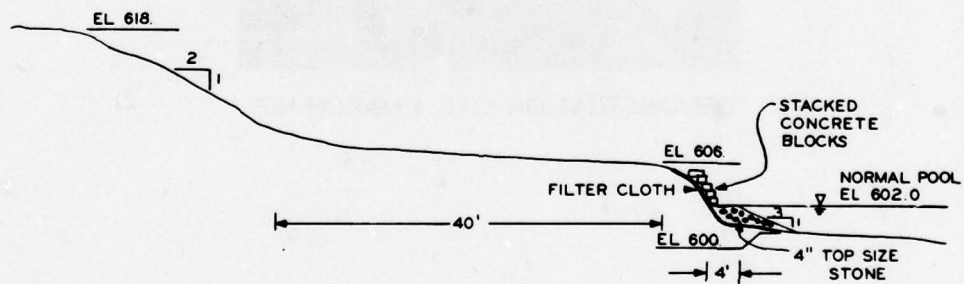
SCHEME A

SCHEME B

SCHEME C

PROTECTION SCHEMES A-C
OHIO RIVER
ST. MARYS, W. VA.

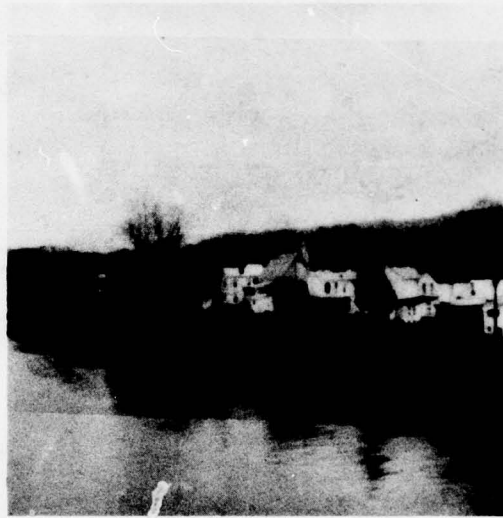
DEMONSTRATION SITE, 4 MARCH 1977

DEMONSTRATION SITE
OHIO RIVER AT
ST. MARYS, WEST VIRGINIA

Problem. The lower bank within the project area has failed as a result of drawdown-related slumping. Cracking and vertical displacement of soil within the upper bank reach have been observed during the last two years. These indicators of bank and slope failure are close to several residential properties, a church, commercial building, and street. The site as shown in Plates E10 and E12 is within a back channel area associated with the downstream end of Middle Island.

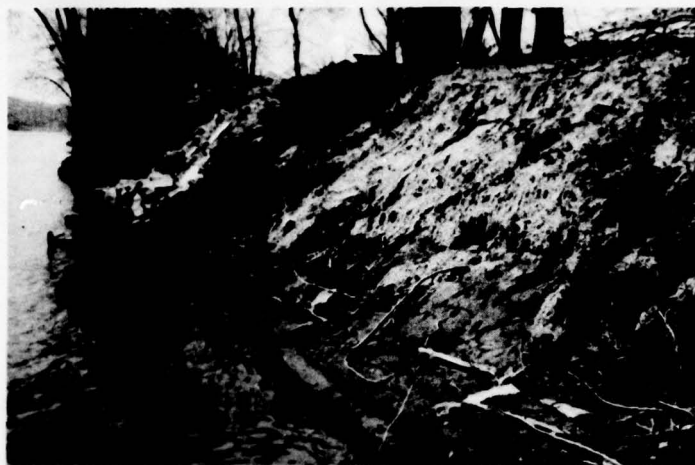
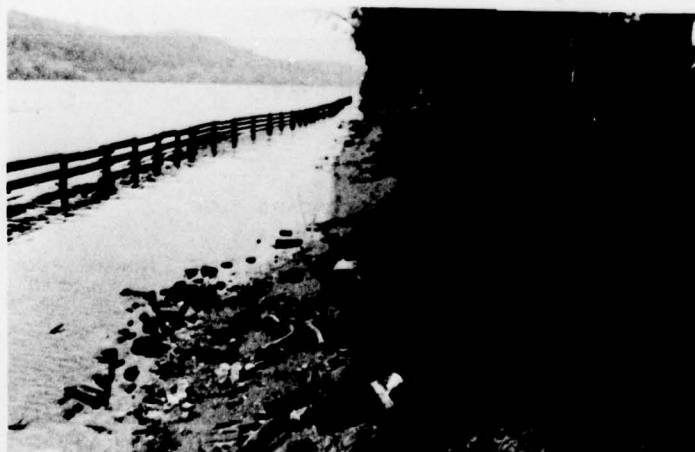
BEFORE CONSTRUCTION
APRIL 1974

DURING CONSTRUCTION
15 JULY 1977

POSTCONSTRUCTION
AUGUST 1977

UPSTREAM VIEW OF
RAVENSWOOD, W. VA.
DEMONSTRATION SITE

Status. Construction of the major components of the protection works was completed in late summer 1977. Observations to date indicate that overland flow from the bank is causing gullyng within upper bank areas. The elevation of the breakwater fence is not high enough and wave washing at frequently encountered pools is causing problems (Plate E15). Additionally, the protection of the Longard tube with an acceptable epoxy coating is an outstanding work item.

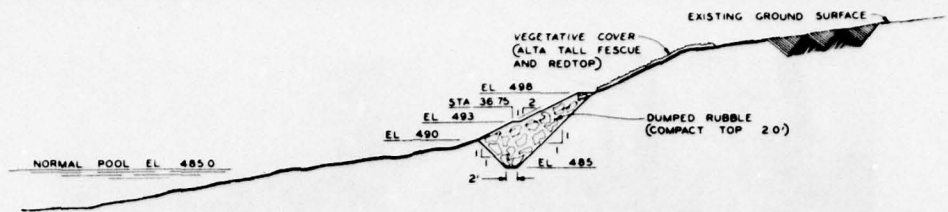
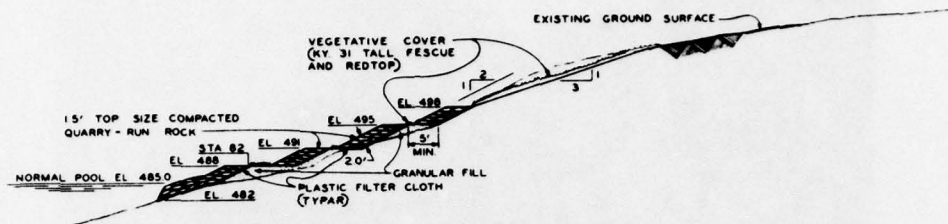
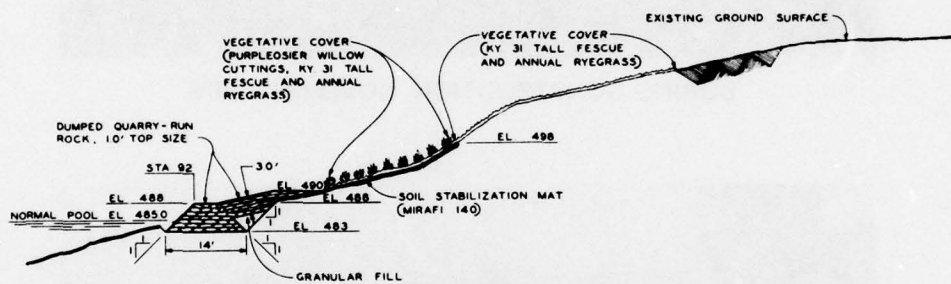
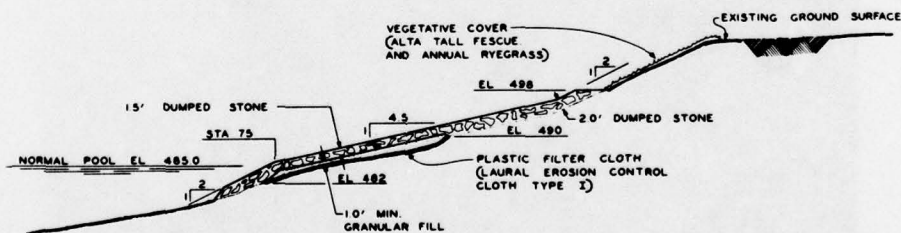
PLATE E17

SCHEME A

SCHEME B

SCHEME C

SCHEME D

PROTECTION SCHEMES A-D
OHIO RIVER
PORTSMOUTH, OHIO
