INTERIM REPORT
TO CONGRESS

THE STREAMBANK EROSION CONTROL
EVALUATION AND DEMONSTRATION ACT OF 1974

September 1978

U. S. ARMY
CORPS OF ENGINEERS

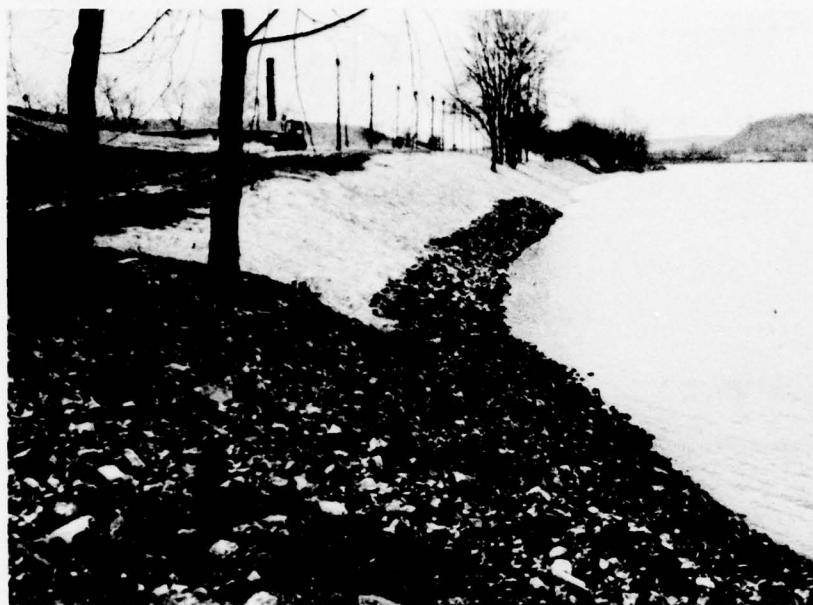
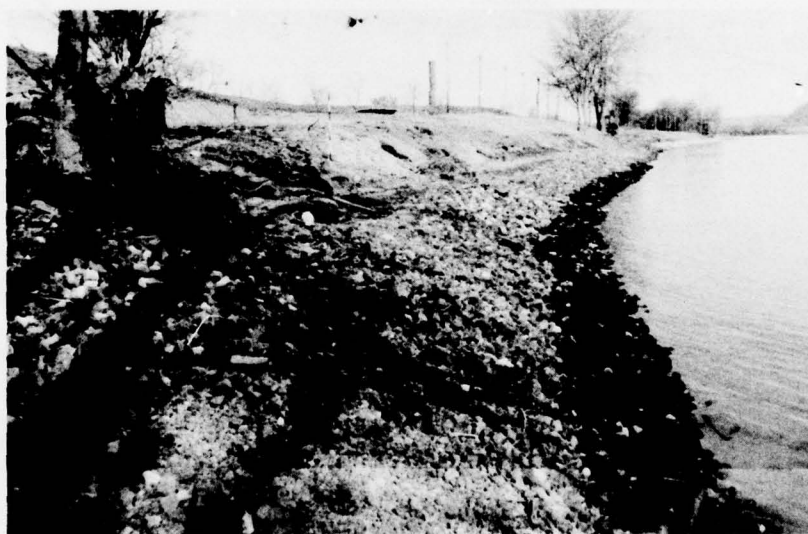
DURING CONSTRUCTION, NOVEMBER 1976

POSTCONSTRUCTION, APRIL 1977

DEMONSTRATION SITE,
LOOKING UPSTREAM
PORTSMOUTH, OHIO

Status. The basic construction was completed in January 1977 with remedial planting of vegetative cover scheduled for the spring and summer of 1977. At present, the project has remedial work to be completed in the summer of 1978 (Plate E18). The scheduling problems which precluded the planting of vegetative cover on the slopes and drainage-related seepages existing back of bank have caused deterioration of the protective measures. Remedial work scheduled for this summer will address these problems.

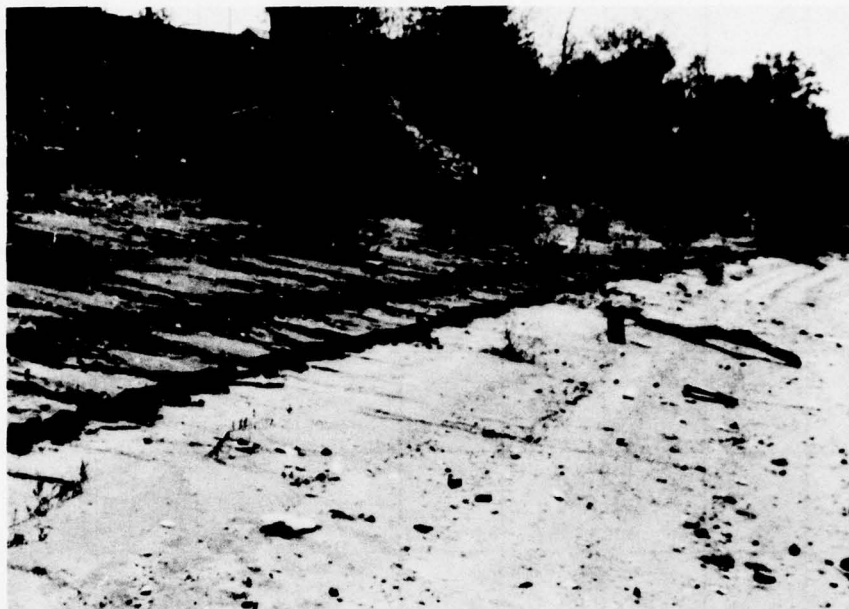
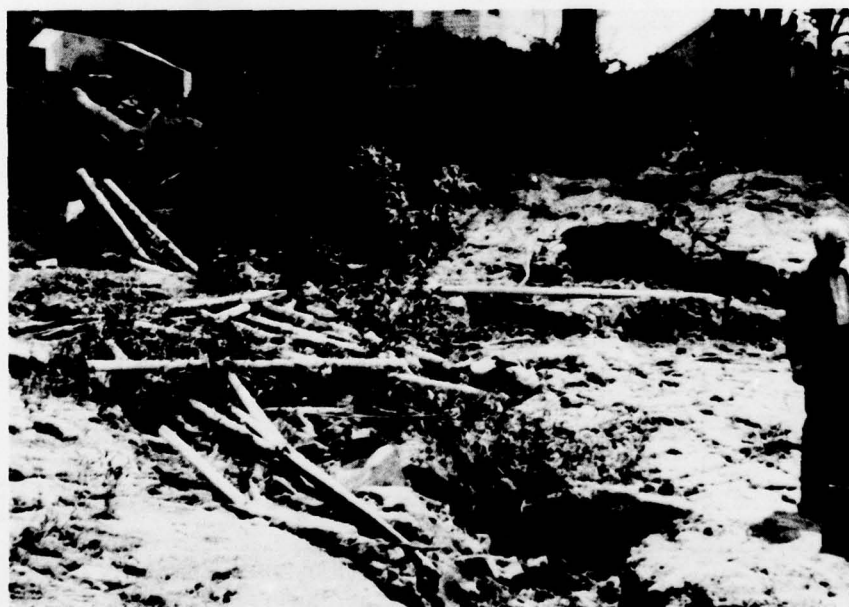
EXISTING BANK NEAR UPSTREAM LIMIT OF PROJECT. VIEW IS FROM DOWNSTREAM. BANK IS ABOUT 36 FT HIGH AND CHANNEL IS ABOUT 1500 FT WIDE AT THIS POINT. JUNE 1976

ERODED AREA AT DOWNSTREAM LIMIT OF PROJECT. VIEW IS FROM DOWNSTREAM. JUNE 1976

DEMONSTRATION SITE
MOSCOW, OHIO

Status. Plans and specifications are in preparation. The Village has not secured all rights-of-way needed for construction and still needs a permit from the State of Ohio to open an off-site borrow area. The public notice has been issued and no public meeting was requested. Construction is planned for the summer of 1979. A report on the effectiveness of measures employed will be prepared by the end of 1982. Photographs of existing conditions are shown in Plate E21.

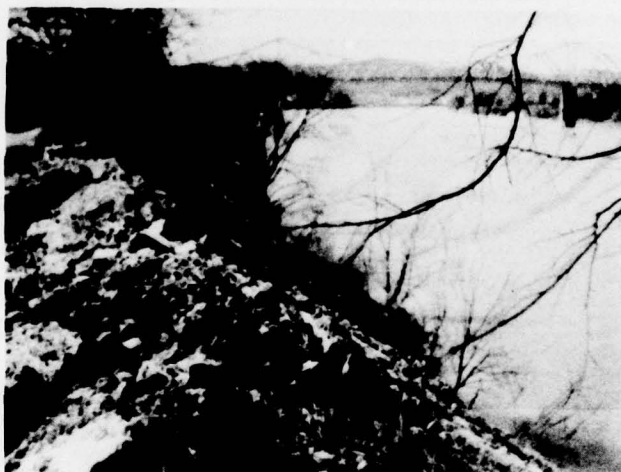
PLATE E26

DEMONSTRATION SITE, 23 MARCH 1977

DEMONSTRATION SITE
LOOKING DOWNSTREAM
KANAWHA RIVER,
SOUTH CHARLESTON, WEST VIRGINIA

- a. The upstream scheme consists of toe protection comprised of a mat of used tires connected with welded chain placed on filter cloth. The chain and connectors include corrosion protection. The slopes will be selectively graded to 1V on 2H and vegetation reestablished (Plate E26, Scheme A). The length of the scheme is 480 ft.

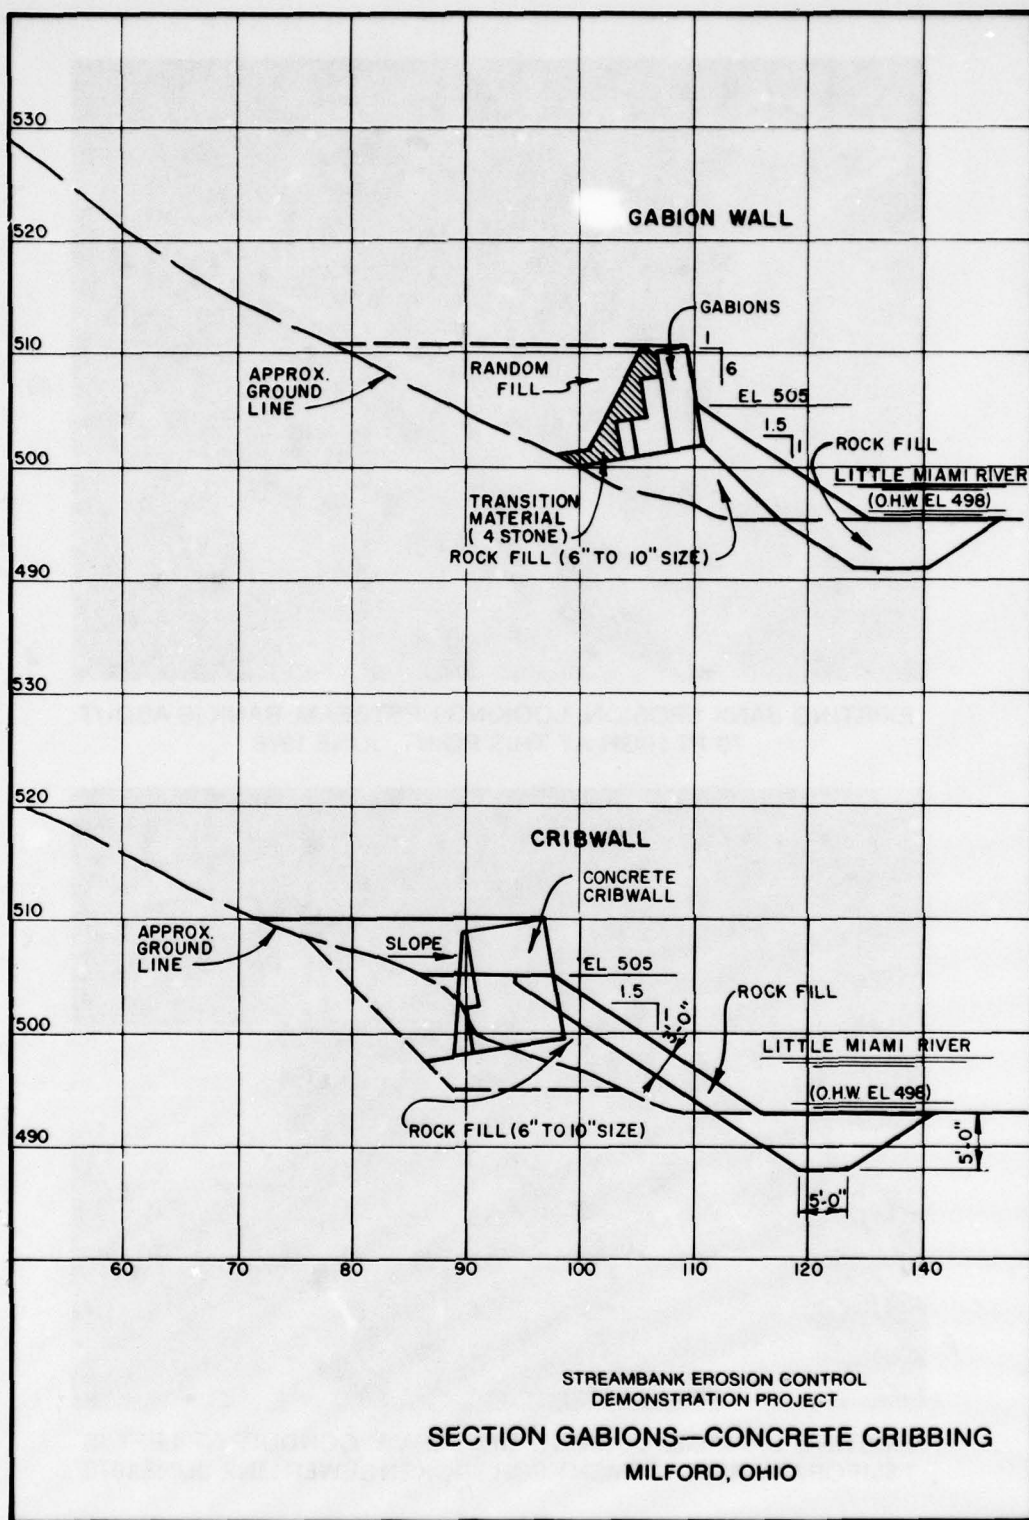
PLATE E29

STREAMBANK EROSION CONTROL
DEMONSTRATION PROJECT
SECTION GABIONS—CONCRETE CRIBBING
MILFORD, OHIO

Protection. The proposed work is to be accomplished in three sections. Two types of revetment, gabions and concrete cribbing, would be placed on a riprap dike which will provide a foundation. The riprap dike would be about 8 ft high and extend the length of the project. Its top surface would be above ordinary high water. Beginning at the upstream limit of the project, a riprap bank 10 ft high will extend for about 200 ft. About 500 ft of concrete cribwall, 10 ft high, would follow. As shown on the plans, the top of cribwall is at el 510, the 5-year flood level. Following the concrete cribwall segment would be 300 ft of gabion walls extending to the downstream limit of the project. The selection of gabions and cribwall was meant to present a rustic appearance consistent with Ohio's scenic river designation for this portion of the Little Miami River. Plan and cross sections are shown in Plates E28 and E29. Fill is to be placed behind the revetment by the Village to provide a uniform slope to the top of bank.

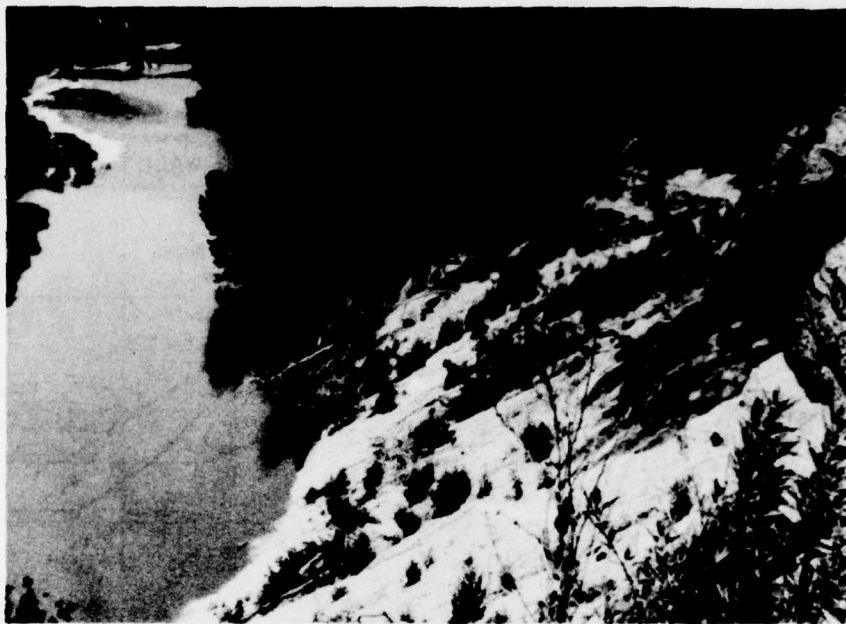
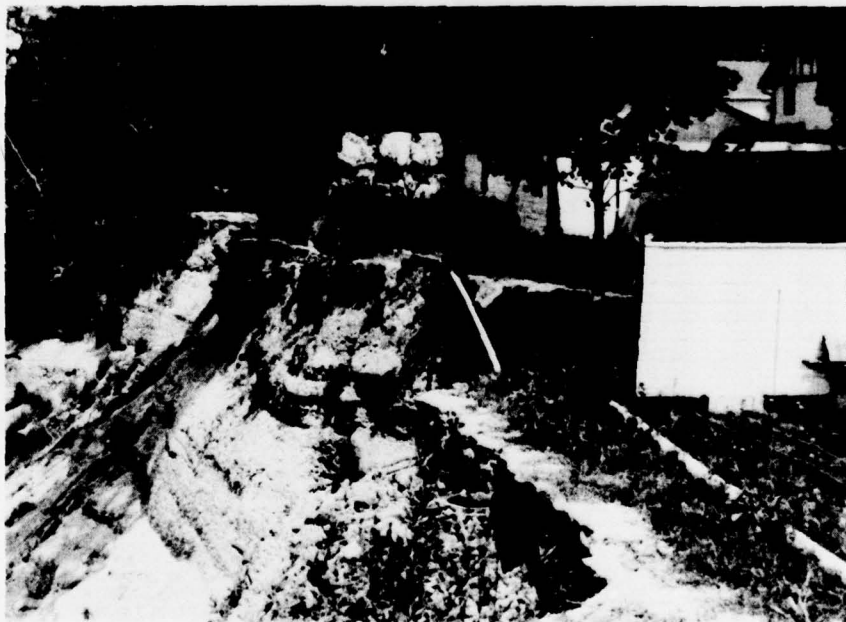
EXISTING BANK EROSION, LOOKING UPSTREAM. BANK IS ABOUT
70 FT HIGH AT THIS POINT. JUNE 1976

EXISTING DAMAGE, LOOKING UPSTREAM. CONDUIT AT LEFT IS
TEMPORARY REPLACEMENT FOR BROKEN SEWER LINE. JUNE 1976

DEMONSTRATION SITE
MILFORD, OHIO

Status. Plans and specifications are in preparation. All necessary rights-of-way have been obtained. Construction is planned for the fall of 1978. A report on the effectiveness of measures employed will be prepared by the end of 1981. Photographs of existing conditions are shown in Plate E30.

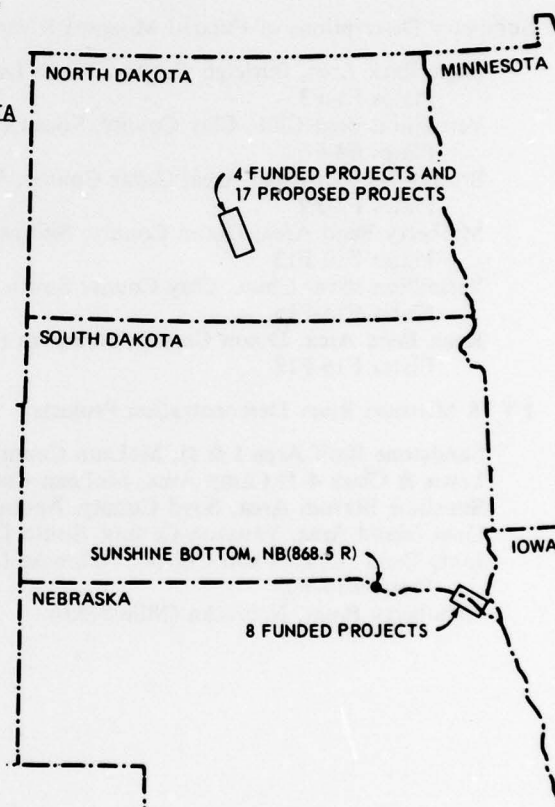
Figure F1. Locations of Missouri River Demonstration Projects (Work Unit 6)

* RIVER MILE AND BANK LOCATION (EITHER LEFT OR RIGHT BANK LOOKING DOWNSTREAM) ARE SHOWN IN PARENTHESES.

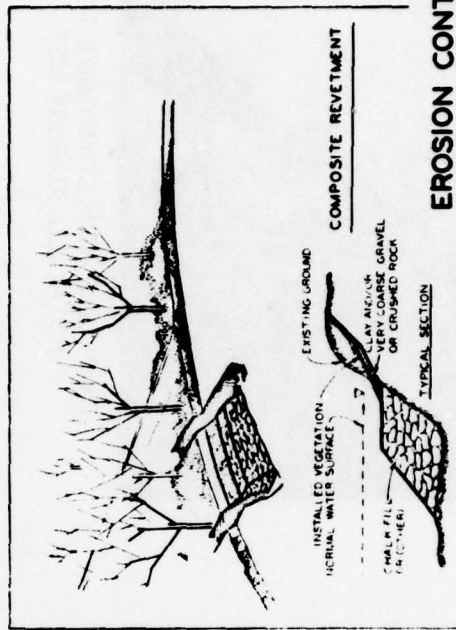
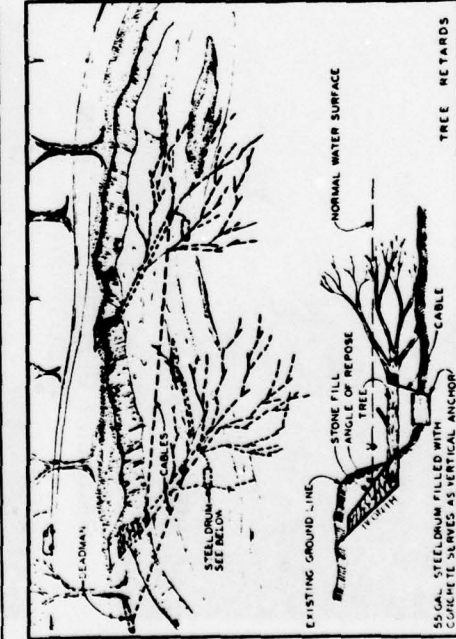
**EROSION CONTROL
DEMONSTRATION PROJECT
EAGLE PARK AREA
BURLEIGH COUNTY, NORTH DAKOTA**

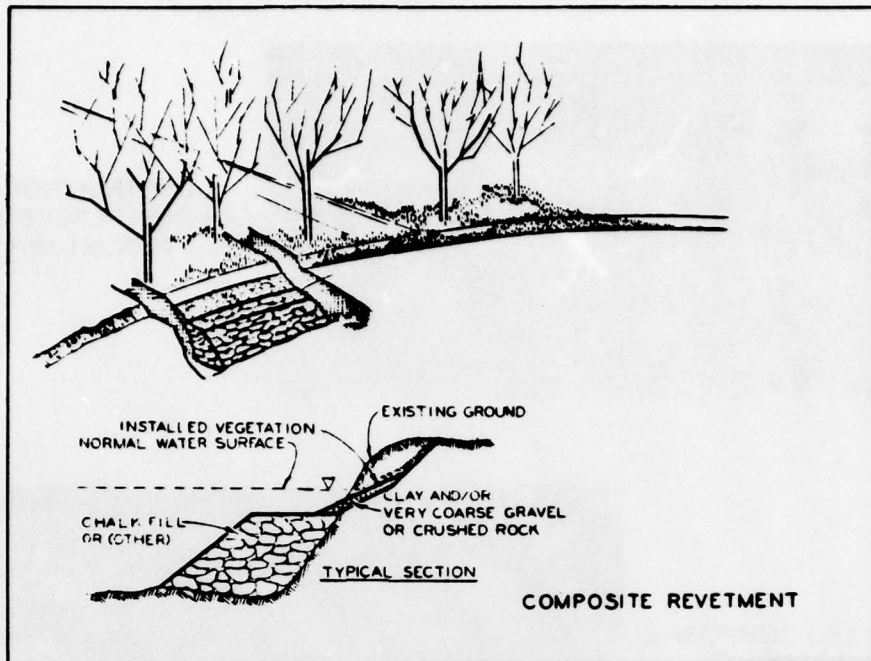
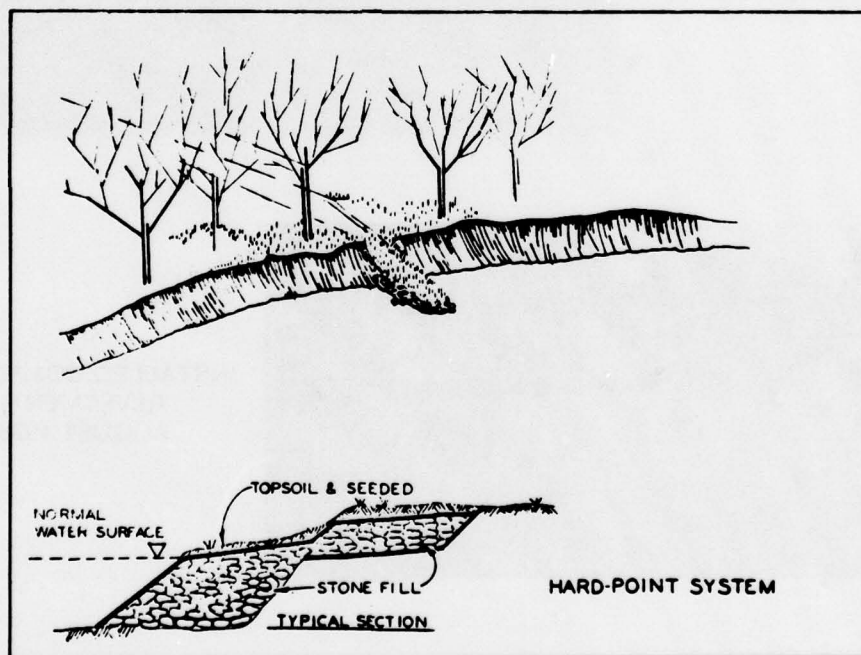
PLATE F5

EROSION CONTROL
VERMILLION BOAT CLUB
CLAY COUNTY, SOUTH DAKOTA

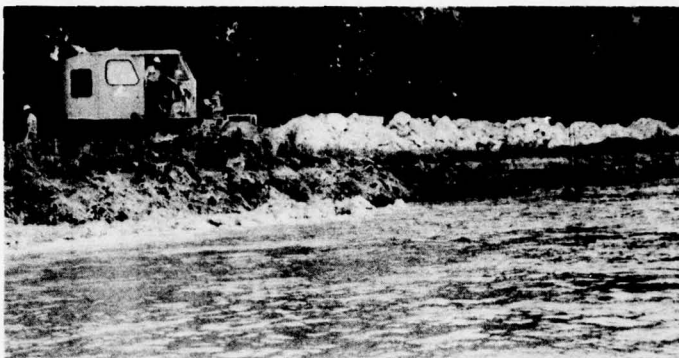
CONSTRUCTION OF
COMPOSITE REVETMENT,
AUGUST 1978

Monitoring Program. The monitoring program is divided into five major subprograms: **PHYSICAL FEATURES**—channel cross sections, bank-line surveys, and velocity measurements; **MATERIAL TESTING**—bank, streambed, and construction materials; **PHOTOGRAPHY**—aerial oblique and controlled vertical, ground-level and videotape; **BIOLOGICAL**—evaluation of project effects on riparian and aquatic habitat; **REVIEW**—field inspections, data analyses, and reports. Plate F6 shows photographs of the site.

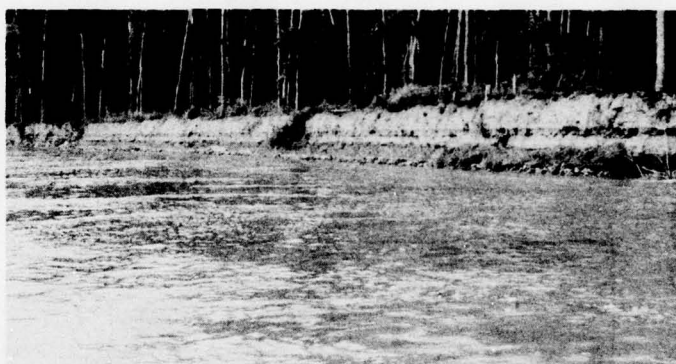
INSTALLED COMPOSITE
REVETMENT,
AUGUST 1978

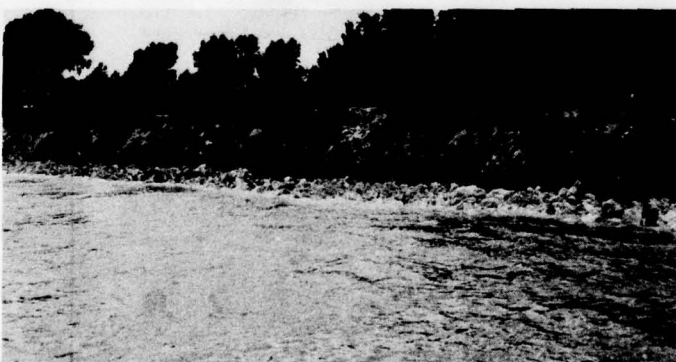
INSTALLED COMPOSITE
REVETMENT,
AUGUST 1978

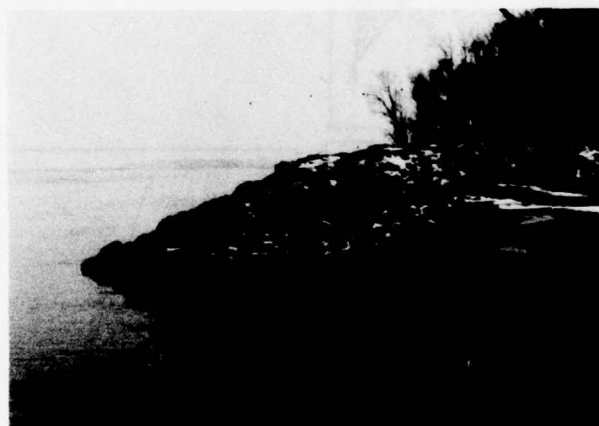
**BANK LINE WITH HARD POINT
INSTALLED, DECEMBER 1977**

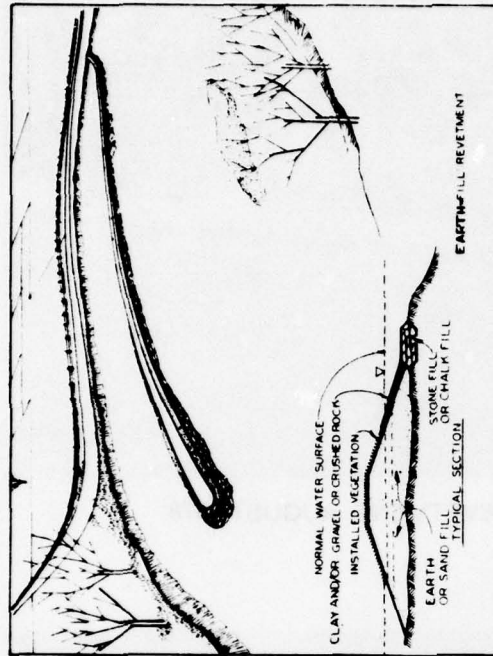
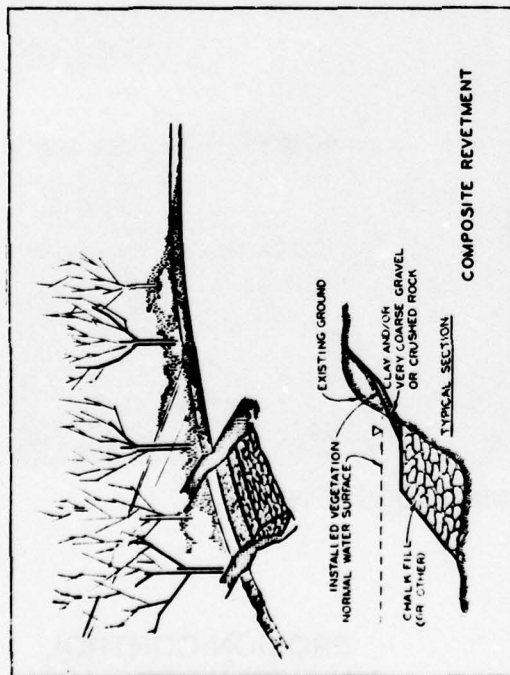
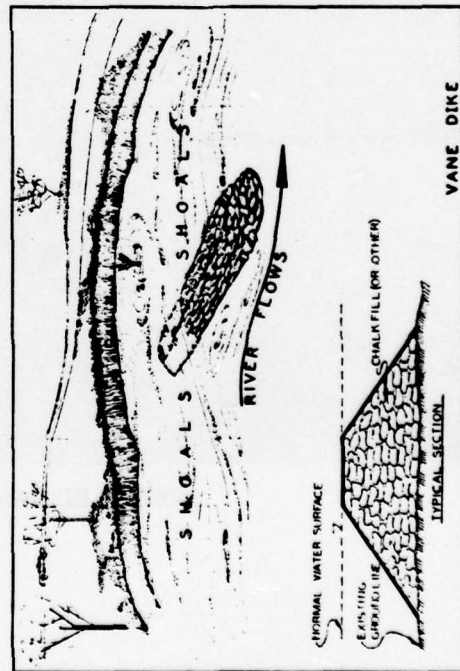
EROSION CONTROL
DEMONSTRATION PROJECT
MULBERRY BEND AREA
DIXON COUNTY, NEBRASKA

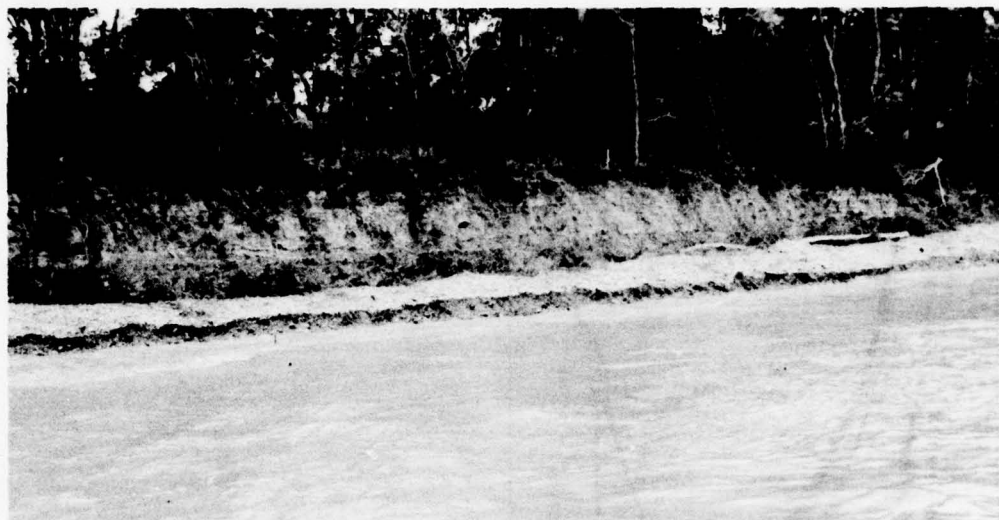
INSTALLED COMPOSITE REVETMENT, AUGUST 1978

Monitoring Program. The monitoring program is divided into five major subprograms: PHYSICAL FEATURES—channel cross sections, bank-line surveys, and velocity measurements; MATERIAL TESTING—bank, streambed, and construction materials; PHOTOGRAPHY—aerial oblique and controlled vertical, ground-level and videotape; BIOLOGICAL—evaluation of project effects on riparian and aquatic habitat; REVIEW—field inspections, data analyses, and reports. Plate F12 shows photographs of the site.

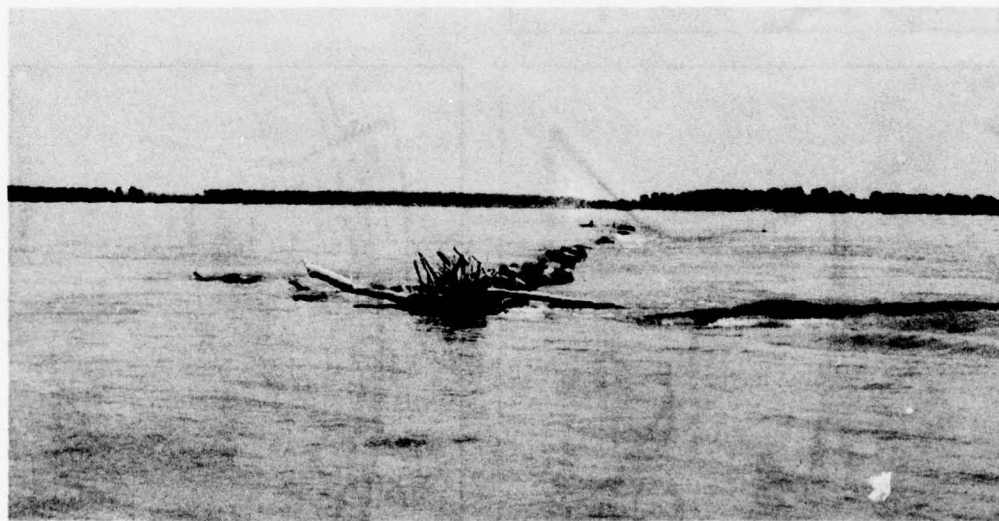
INSTALLED VANE DIKE, AUGUST 1978

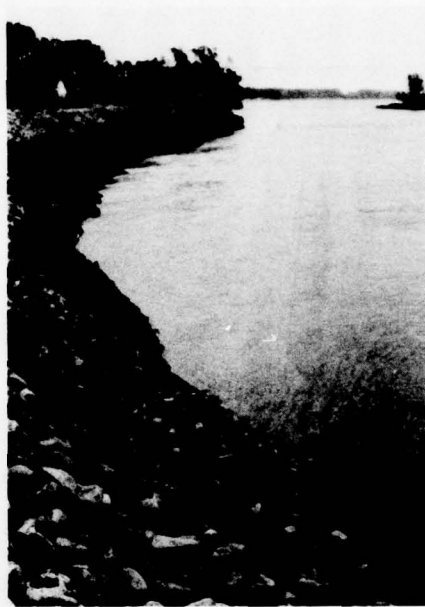
**BANK LINE AFTER INSTALLATION
OF WINDROW REVETMENT,
MAY 1977**

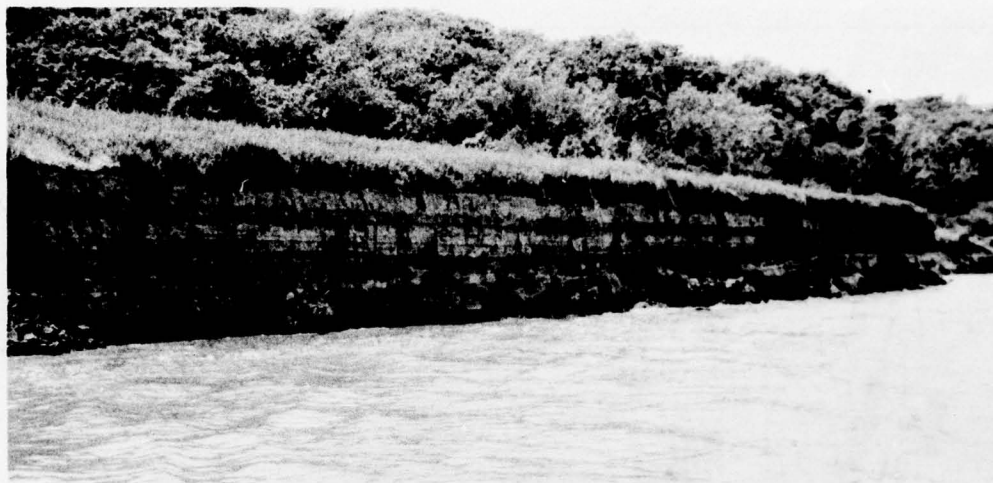
BANK LINE BEFORE CONSTRUCTION, JULY 1978

Monitoring Program. The monitoring program is divided into five major subprograms: PHYSICAL FEATURES—channel cross sections, bank-line surveys, and velocity measurements; MATERIAL TESTING—bank, streambed, and construction materials; PHOTOGRAPHY—aerial oblique and controlled vertical, ground-level and videotape; BIOLOGICAL—evaluation of project effects on riparian and aquatic habitat; REVIEW—field inspections, data analyses, and reports. Plate F18 shows photographs of the site.

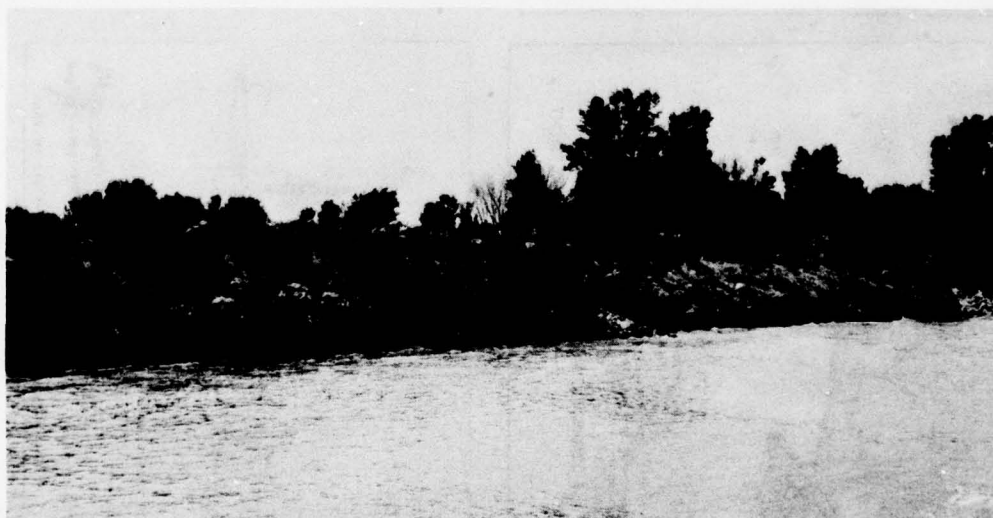
INSTALLED REINFORCED REVETMENT, AUGUST 1978

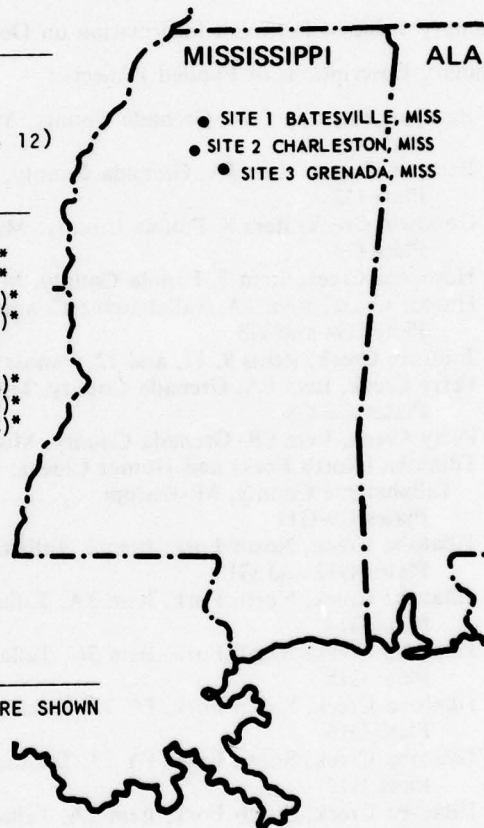
Figure G1. Location of Yazoo River Basin Demonstration Projects (Work Unit 7)

NOTE: PROJECT IDENTIFICATION NUMBERS ARE SHOWN
IN PARENTHESES.
* FUNDED PROJECTS.

The objectives of Work Unit 7 are to construct and evaluate various bank protection and stabilization and grade-control structures for demonstration throughout the Yazoo River Basin (Figure G1). The streams draining into the Yazoo Basin have been a source of problems for many decades. Their instability results in many costly responses, both in the hills and in the delta. Hill streams are generally degrading, resulting in land loss, bank caving, and damage to highway bridges. The resulting aggradation in the delta streams causes losses of navigation and flood control. This work unit is directed toward determining the causes of stream instability and how to best work with natural controls and to develop the least expensive construction to aid in reestablishing a drainage basin stability factor. A wide variety of bed and bank stability measures are being tested to determine the most economical and effective means of providing the needed protection.

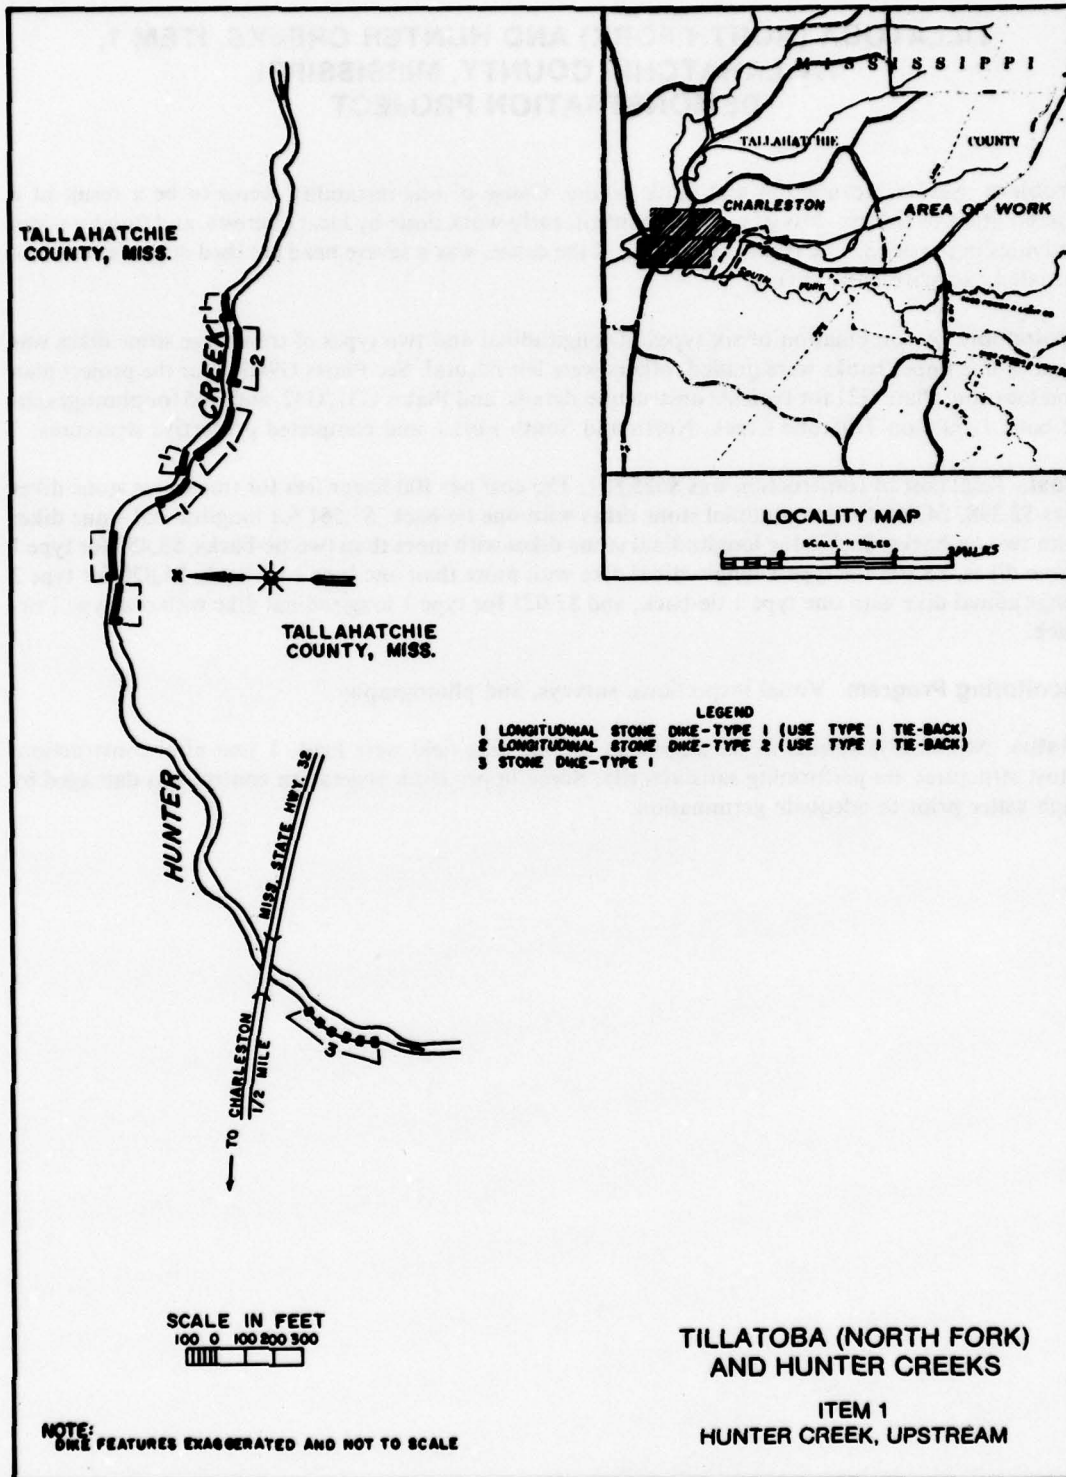
PLATE G9

PLATE G10

PLATE G11

Protection. A combination of six types of longitudinal and two types of transverse stone dikes was used. Some upper banks were graded, others were left natural. See Plates G9-G11 for the project plan and location; Plate G21 for typical construction details; and Plates G31, G32, and G35 for photographs of bank failure on Tillatoba Creek, North and South Forks, and completed protective structures.

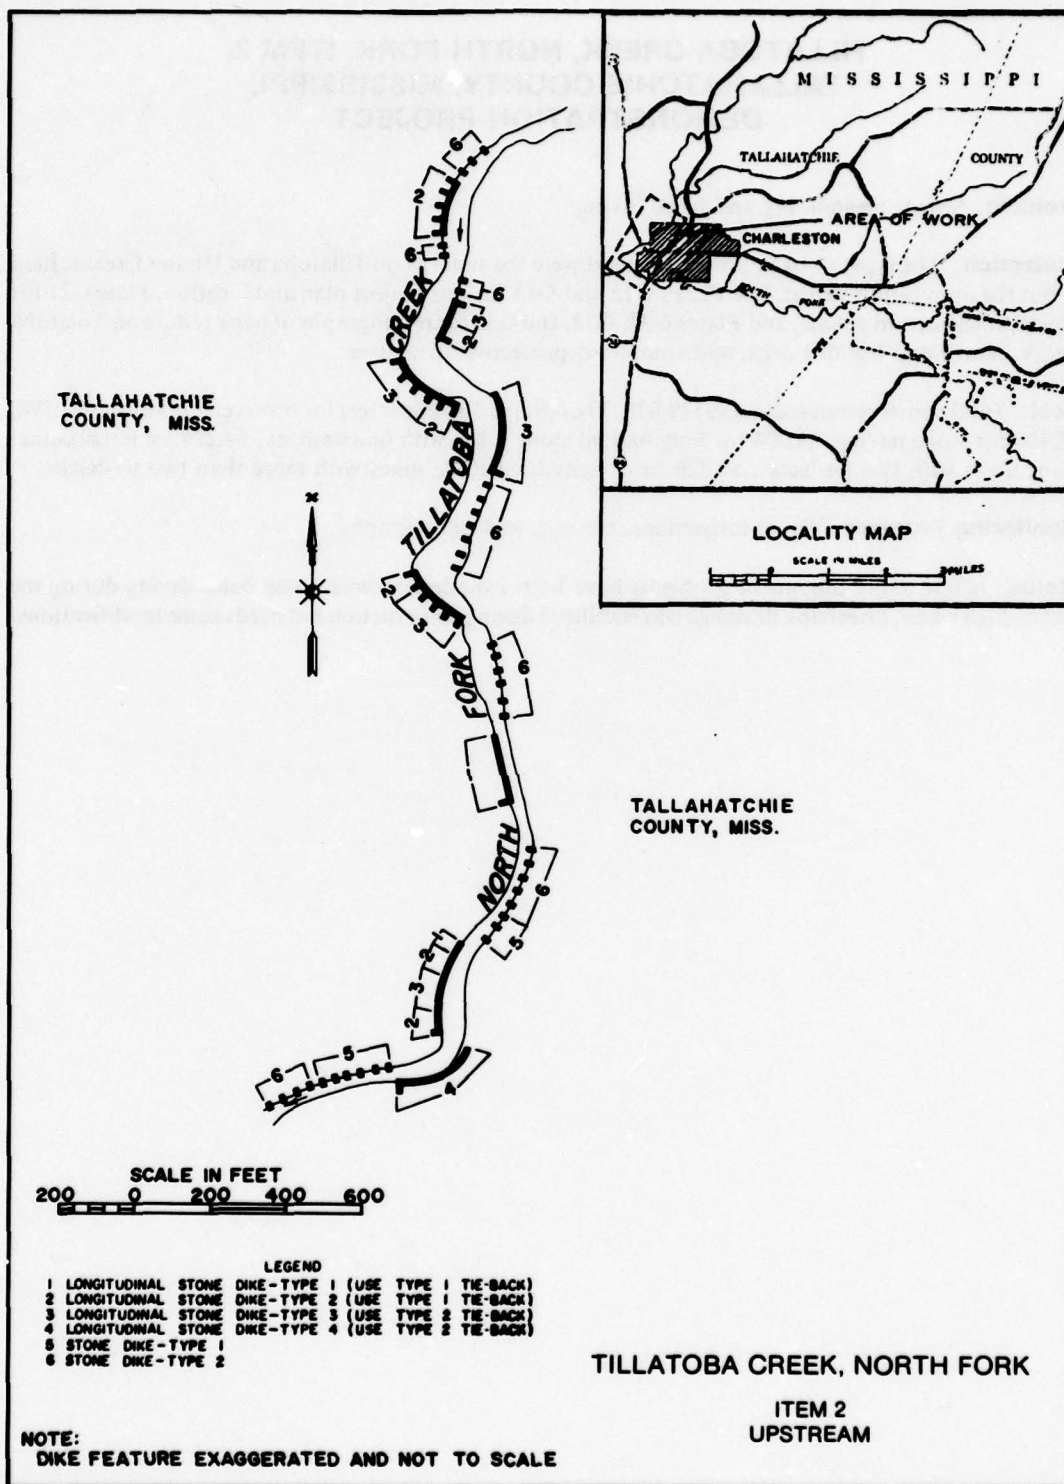
PLATE G 12

PLATE G 13

Protection. The types of bank protection used were the same as on Tillatoba and Hunter Creeks, Item 1, but the application varied. See Plates G12 and G13 for the project plan and location, Plate G21 for typical construction details, and Plates G31, G32, and G35 for photographs of bank failure on Tillatoba Creek, North and South Forks, and completed protective structures.

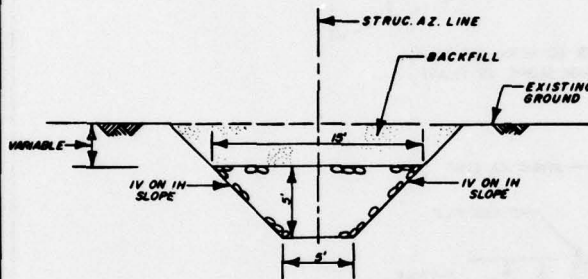
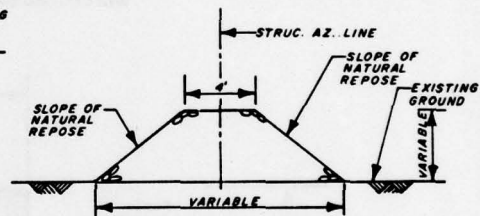
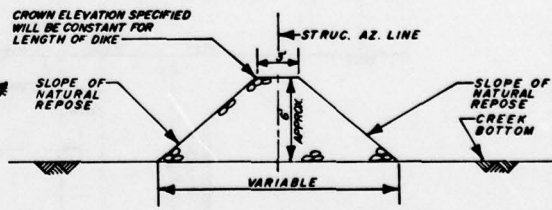
PLATE G21

TYPICAL PROFILE

SECTION A-A

SECTION C-C

SECTION
LONGITUDINAL DIKE
(BETWEEN DIKES 2-7 APPROX. 610 L.F.)

SECTION
LONGITUDINAL DIKE
(BETWEEN DIKES 37-39, APPROX. 300 L.F.)

TYPICAL TRANSVERSE AND LONGITUDINAL STONE DIKES

Protection. Longitudinal stone dikes with vegetation and modified used-tire revetment with vegetation. See Plate G20 for the project plan and location, Plates G21 and G24 for typical construction details, and Plates G32, G35, and G36 for photographs of typical eroding and failing bank and completed protective structures at other locations.

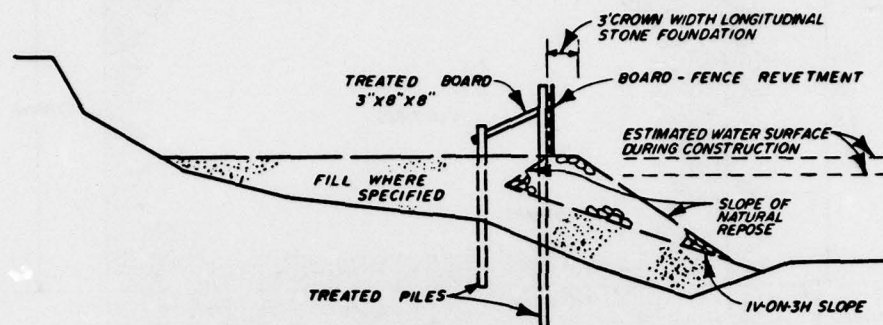
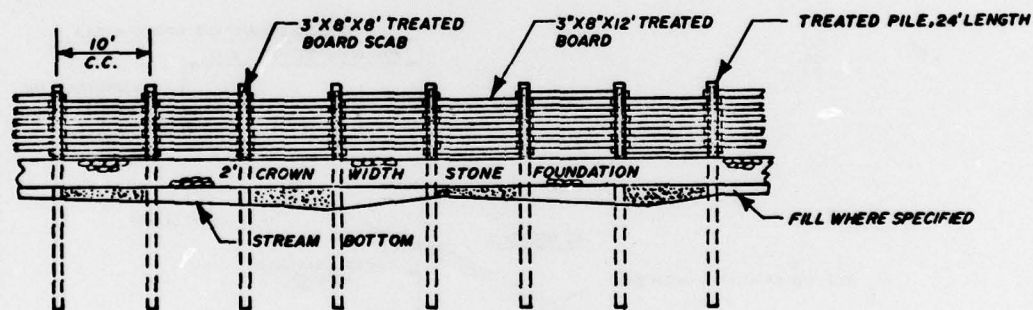
PLATE G23

PROFILE

REVTMENT BETWEEN TIE-BACKS

FRONT VIEW

TYPICAL BOARD-FENCE
LONGITUDINAL REVTMENT

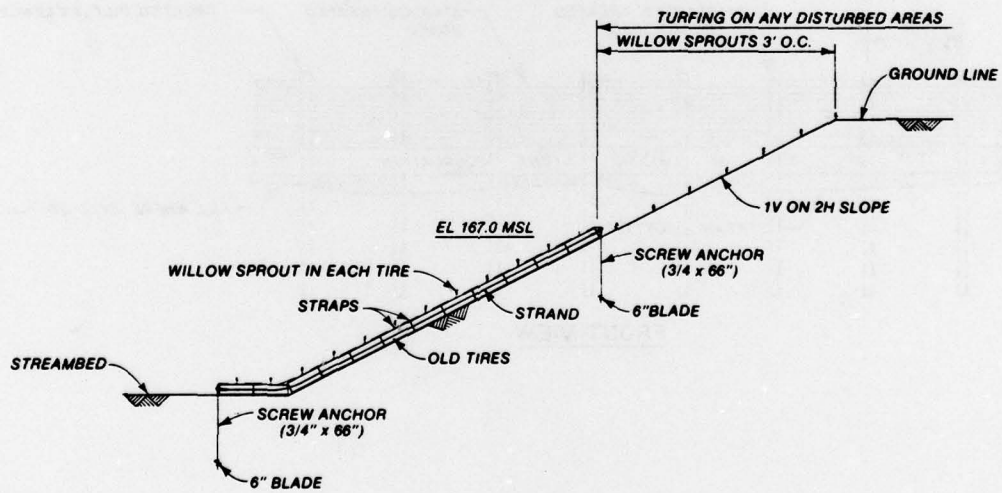
PLAN

SECTION A-A

**TYPICAL
RUBBER-TIRE REVETMENT**

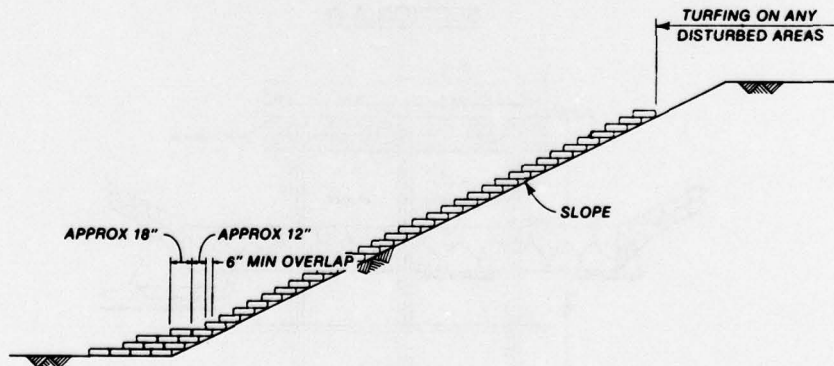
PLATE G25

NOTE: LAP UNFILLED PORTION OF BAG UNDER NEXT BAG. TIEING OR SEWING BAG IS NOT NECESSARY. CLOSE ALL SPACE BY TAMPING EACH BAG AS LAID.

PLAN

SECTION A-A

**TYPICAL
SAND-CEMENT BAG REVETMENT**

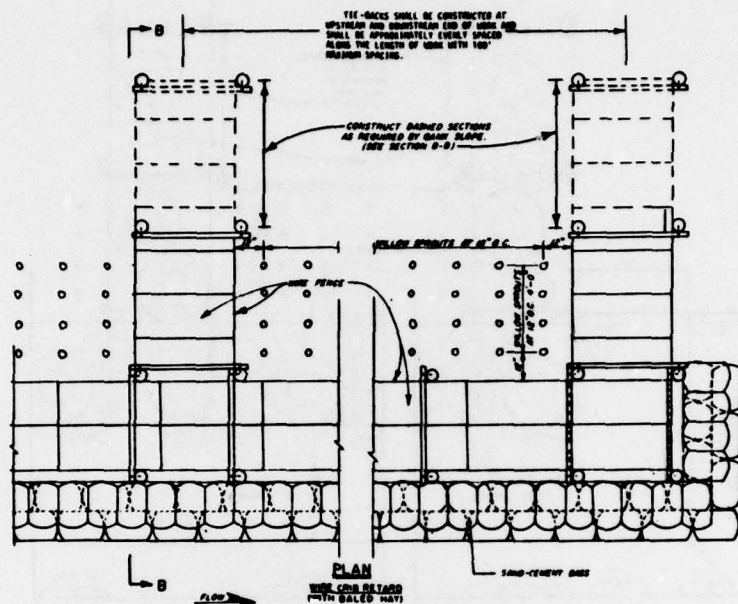
PLATE G27

TYPICAL WIRE CRIB RETARDS
BALED-HAY-FILLED

Protection. Two methods using local material were used on this item. Cribs were constructed with treated piles driven 7 ft into the ground and fenced as shown in Plates G27 and G28. The cribs were filled with either baled hay or used tires. The existing bank was left untreated and in a natural condition, where possible; however, construction techniques required clearing in some locations. See Plate G19 for project plan and location, and Plates G42 and G43 for photographs of typical eroding and failing banks and completed protective structures.

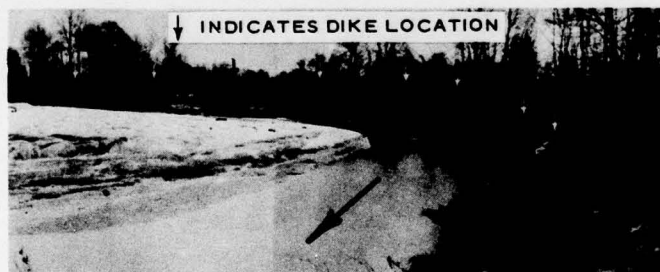
PHOTO 1
BEFORE CONSTRUCTION
11 MAY 1971

PHOTO 2
AFTER CONSTRUCTION
1 MAY 1972

PHOTO 3
14 FEBRUARY 1974

TILLATOBA CREEK, SOUTH FORK
TRANSVERSE STONE DIKES

18-FT-HIGH BANK

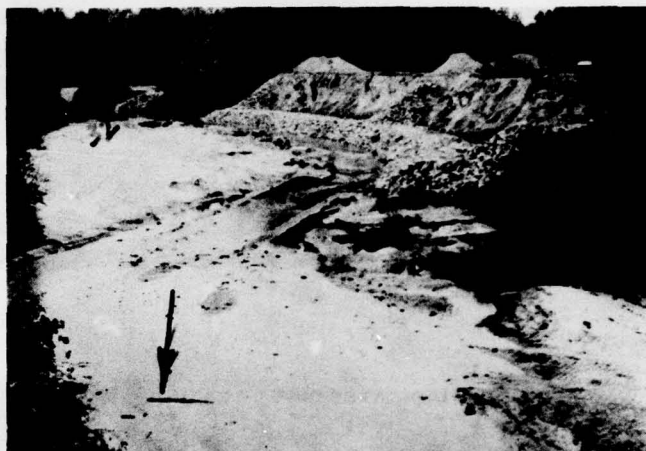
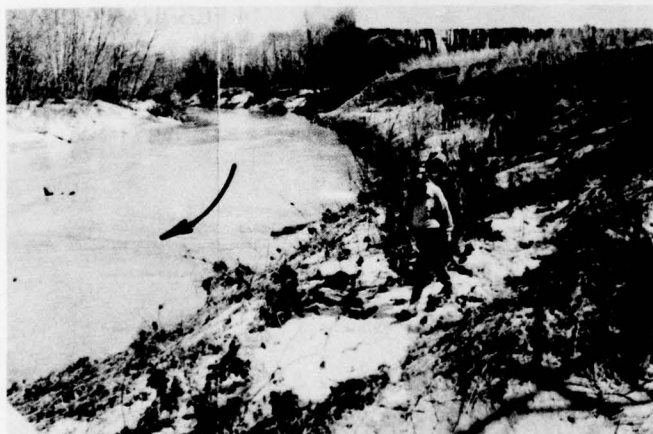
PHOTO 1
BEFORE CONSTRUCTION
10 MAY 1971

PHOTO 2
AFTER CONSTRUCTION
20 OCTOBER 1971

PHOTO 3
19 MARCH 1975

TILLATOBA CREEK, SOUTH FORK
LONGITUDINAL DIKE WITH TIE-BACKS
15-FT-HIGH BANK

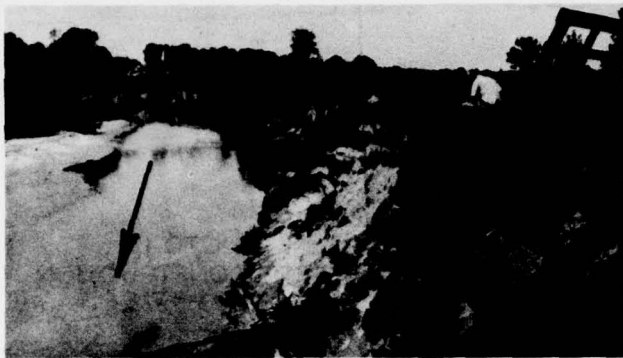
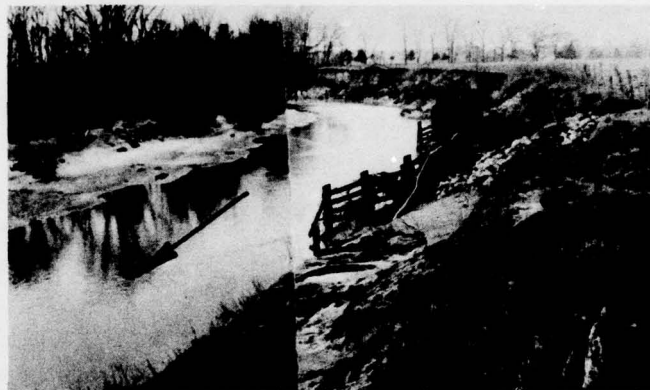
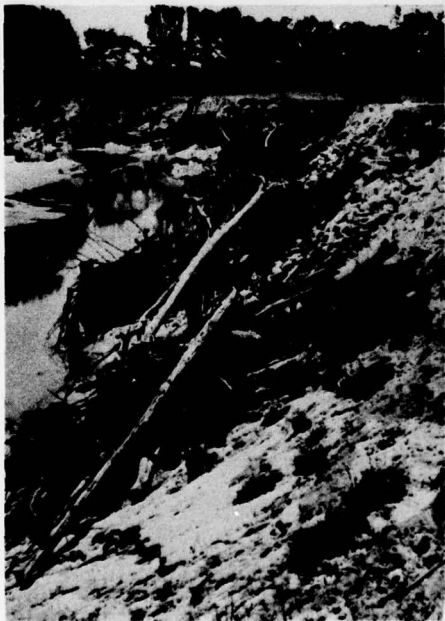
PHOTO 1
BEFORE CONSTRUCTION
8 MAY 1972

PHOTO 2
AFTER CONSTRUCTION
30 MAY 1973

PHOTO 3
19 MARCH 1975

TILLATOBA CREEK, SOUTH FORK
TRANSVERSE BOARD-FENCE DIKES

16-FT-HIGH BANK

Protection. Four types of bank protection were used: (a) longitudinal stone dike toe protection, (b) transverse stone dikes, (c) board-fence dikes, and (d) cable-fence dikes. This work began at the upper end of FY 72 work and extended 1-1/4 miles upstream for 10 bendways. See Plate G17 for the project plan and location; Plates G21, G22, and G30 for typical construction details; and Plates G31-G33, G35, and G45 for photographs of typical eroding and failing banks and completed protective structures.

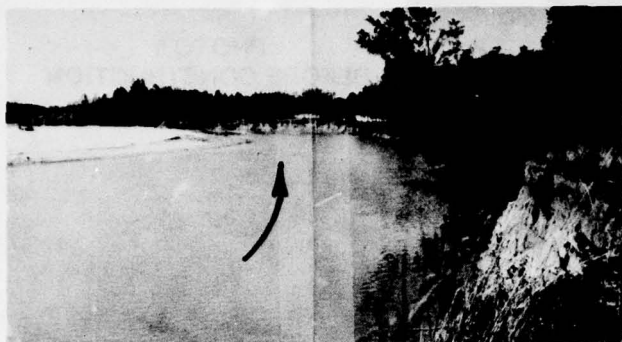
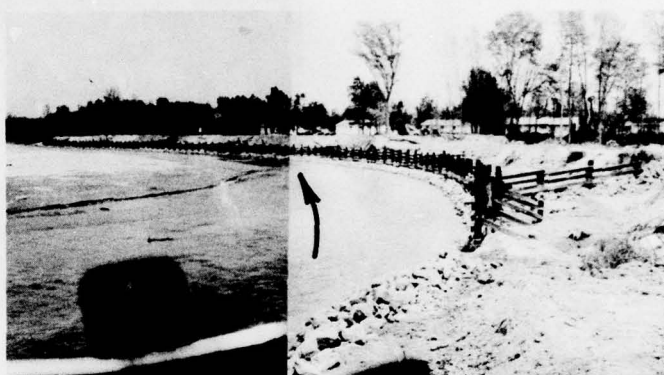
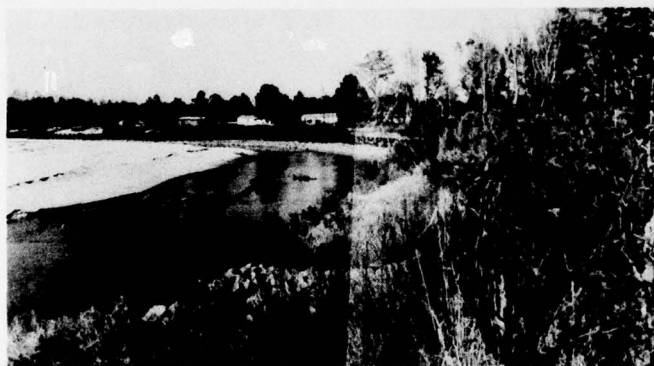
PHOTO 1
BEFORE CONSTRUCTION
5 MAY 1973

PHOTO 2
AFTER CONSTRUCTION
11 APRIL 1974

PHOTO 3
17 NOVEMBER 1975

BATUPAN BOGUE
BOARD-FENCE REVETMENT
12-FT-HIGH BANK
