INTERIM REPORT
TO CONGRESS

THE STREAMBANK EROSION CONTROL
EVALUATION AND DEMONSTRATION ACT OF 1974

September 1978

U. S. ARMY
CORPS OF ENGINEERS

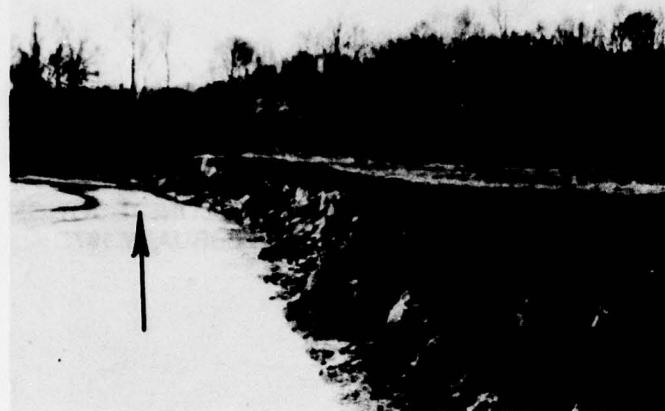
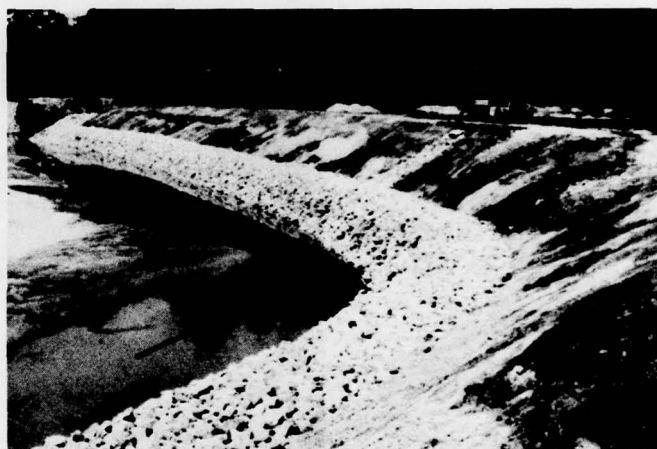
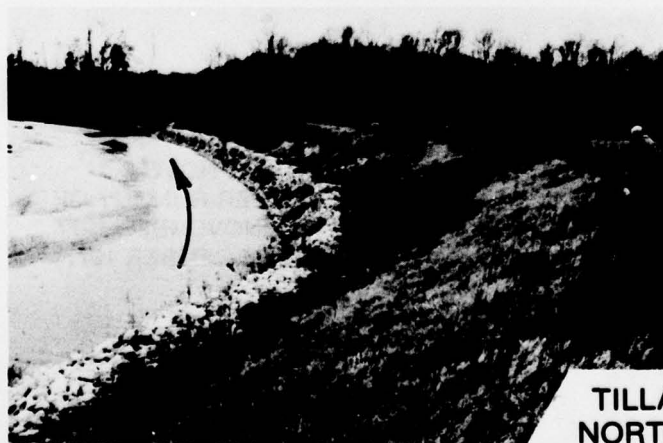
PHOTO 1
BEFORE CONSTRUCTION
18 MARCH 1975

PHOTO 2
AFTER CONSTRUCTION
22 JUNE 1976

PHOTO 3
AFTER RUNOUT OF
21 NOVEMBER 1977
(8 DECEMBER 1977)

TILLATOBA CREEK,
NORTH FORK, ITEM 1
LONGITUDINAL DIKE WITH
BANK GRADING AND VEGETATION
18-FT-HIGH BANK

Protection. The types of bank protection used were the same as on Tillatoba and Hunter Creeks, Item 1, but the application varied. See Plates G12 and G13 for the project plan and location, Plate G21 for typical construction details, and Plates G31, G32, and G35 for photographs of bank failure on Tillatoba Creek, North and South Forks, and completed protective structures.

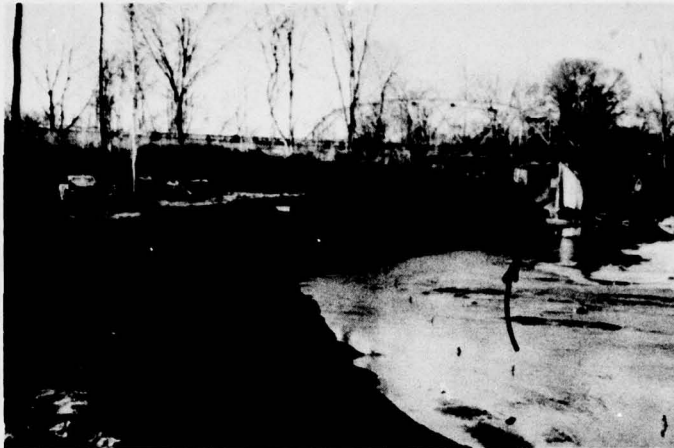
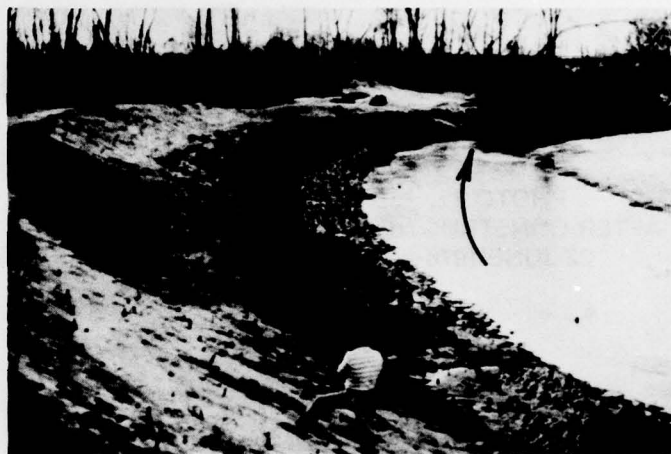
PHOTO 1
DURING CONSTRUCTION
9 FEBRUARY 1977

PHOTO 2
AFTER CONSTRUCTION
11 MARCH 1977

PHOTO 3
AFTER RUNOUT OF
21 NOVEMBER 1977
(7 DECEMBER 1977)

TILLATOBA CREEK,
SOUTH FORK, ITEM 5A
TIRE REVETMENT WITH
WILLOW CUTTINGS

16-FT-HIGH BANK

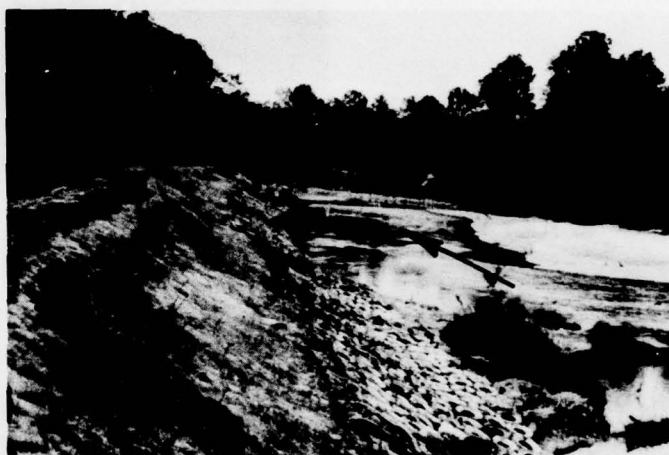
PLATE G37

PHOTO 1
BEFORE CONSTRUCTION
13 APRIL 1977

PHOTO 2
AFTER CONSTRUCTION
11 OCTOBER 1977

BATUPAN BOGUE, ITEM 4A
TIRE REVETMENT (FAILURE)

16-FT-HIGH BANK

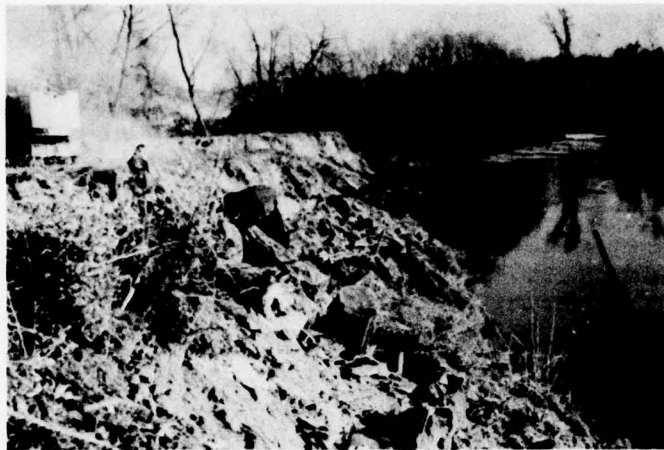
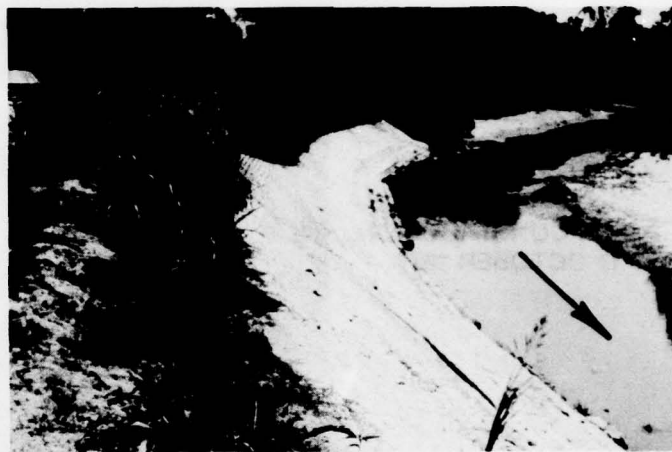
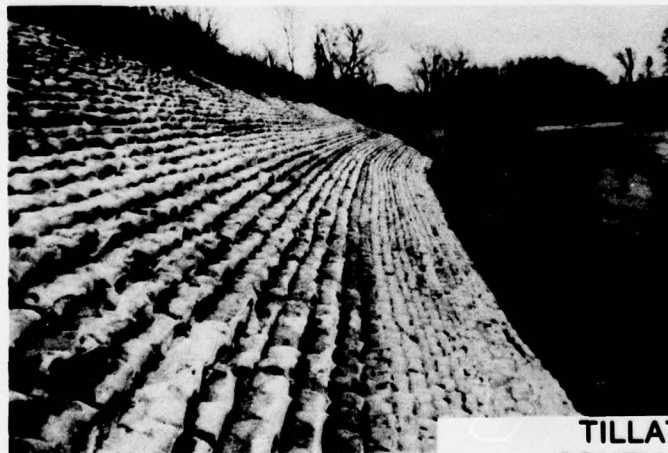
PHOTO 1
BEFORE CONSTRUCTION
9 FEBRUARY 1977

PHOTO 2
AFTER CONSTRUCTION
15 JULY 1977

PHOTO 3
AFTER RUNOUT OF
21 NOVEMBER 1977
(7 DECEMBER 1977)

TILLATOBA CREEK,
SOUTH FORK, ITEM 5A
SACKED SAND-CEMENT REVETMENT

19-FT-HIGH BANK

Protection. Two methods of utilizing local material and hired labor were used on this project: (a) bagged sand-cement placed and backfilled on a graded bank over a city dump with additional bags used as toe protection; and (b) rubber tire revetment on a graded bank with willow cuttings. See Plates G18 and G19 for the project plan and location, Plates G24 and G25 for typical construction details, and Plates G36 and G38 for photographs of typical eroding and failing banks and completed protective structures.

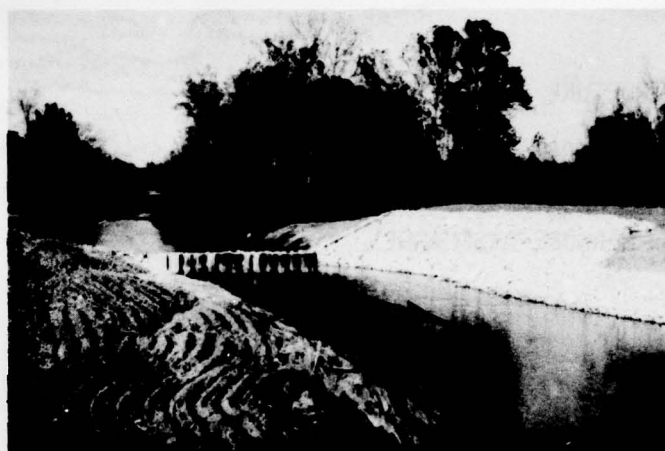
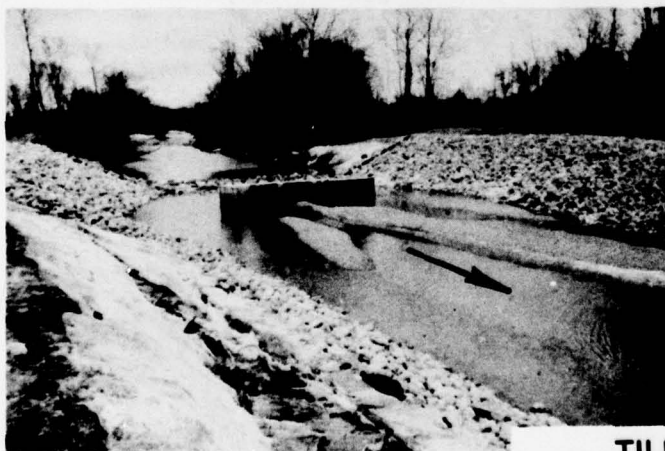
**PHOTO 1
BEFORE CONSTRUCTION
14 JULY 1977**

**PHOTO 2
AFTER CONSTRUCTION
15 NOVEMBER 1977**

**PHOTO 3
AFTER RUNOUT OF
21 NOVEMBER 1977
(7 DECEMBER 1977)**

**TILLATOBA CREEK,
NORTH FORK, ITEM 3A
GRADE-CONTROL STRUCTURE**

15-FT-HIGH BANK

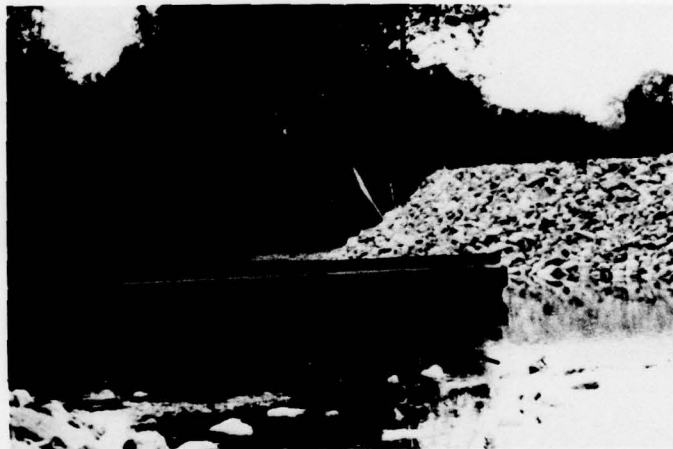
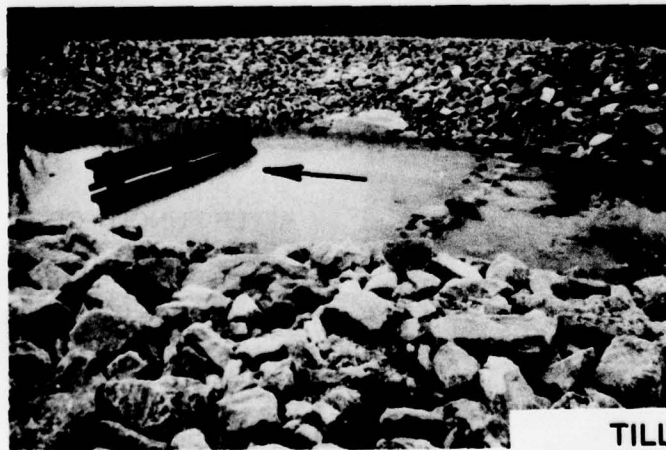
PLATE G41

PHOTO 1
BEFORE CONSTRUCTION
14 JULY 1977

PHOTO 2
AFTER CONSTRUCTION
25 AUGUST 1977

PHOTO 3
AFTER RUNOUT OF
21 NOVEMBER 1977
(7 DECEMBER 1977)

TILLATOBA CREEK,
NORTH FORK, ITEM 3C
GRADE-CONTROL STRUCTURE
12-FT-HIGH BANK

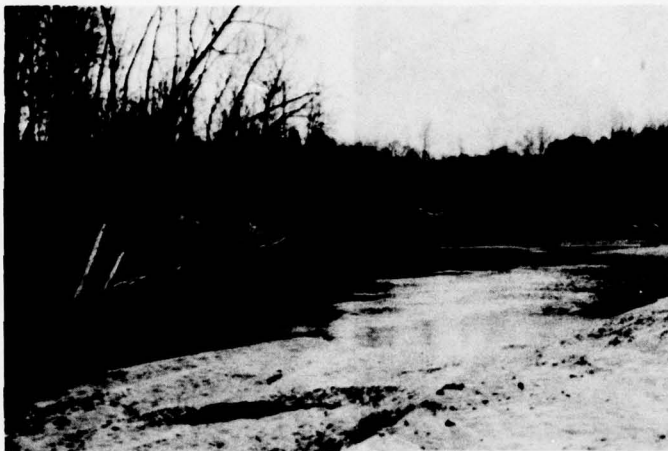
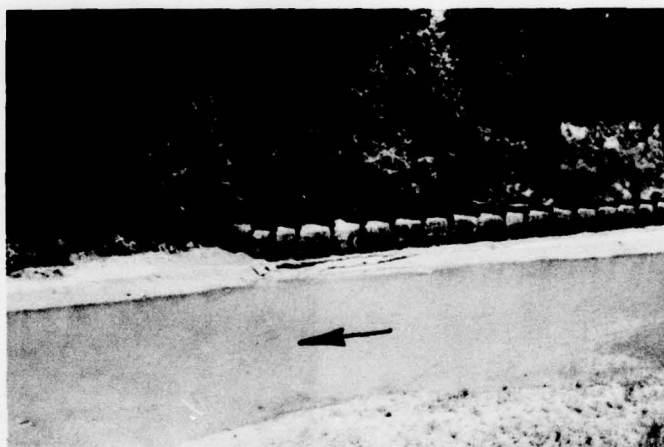
PHOTO 1
BEFORE CONSTRUCTION
7 MARCH 1977

PHOTO 2
AFTER CONSTRUCTION
14 JULY 1977

PHOTO 3
AFTER RUNOUT OF
21 NOVEMBER 1977
(7 DECEMBER 1977)

TILLATOBA CREEK,
SOUTH FORK, ITEM 5B
WIRE CRIB RETARD, HAY-FILLED
18-FT-HIGH BANK

Protection. Two methods using local material were used on this item. Cribs were constructed with treated piles driven 7 ft into the ground and fenced as shown in Plates G27 and G28. The cribs were filled with either baled hay or used tires. The existing bank was left untreated and in a natural condition, where possible; however, construction techniques required clearing in some locations. See Plate G19 for project plan and location, and Plates G42 and G43 for photographs of typical eroding and failing banks and completed protective structures.

Status. These structures were subjected to four or five high-water conditions during the first year of operation. Several problems are currently apparent: (a) streambed scour, occurring between surveys and construction, was backfilled with local material; this did not stay, even during moderately low flows; (b) alignment was not always compatible with high flows because of above changes between survey and construction; (c) bags filled with sand-cement used for toe protection were inadequate, leaving portions of structure unprotected when above scour reoccurred; and (d) when scour, possibly 4 to 7 ft, occurred during high water, the tires and hay bales were removed under the wire crib which rested on natural or man-made fill. Some structures were scoured to the point that cribs were emptied, the outside piles scoured below maximum penetration, and then the entire structure swung up and over the rear piles.

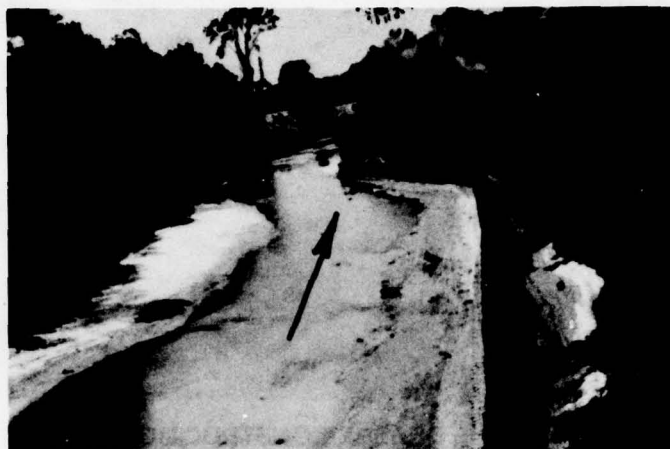
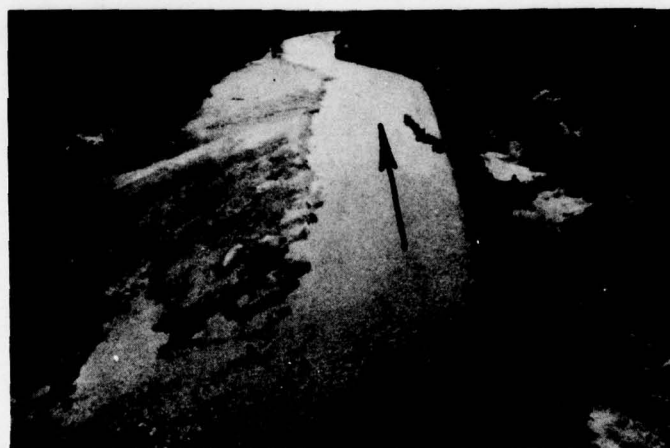
PLATE G 43

PHOTO 1 AFTER CONSTRUCTION
14 JULY 1977

PHOTO 2 AFTER RUNOUT OF
21 NOVEMBER 1977
(7 DECEMBER 1977)

TILLATOBA CREEK,
SOUTH FORK, ITEM 5B
WIRE CRIB RETARD, TIRE-FILLED
15-FT-HIGH BANK

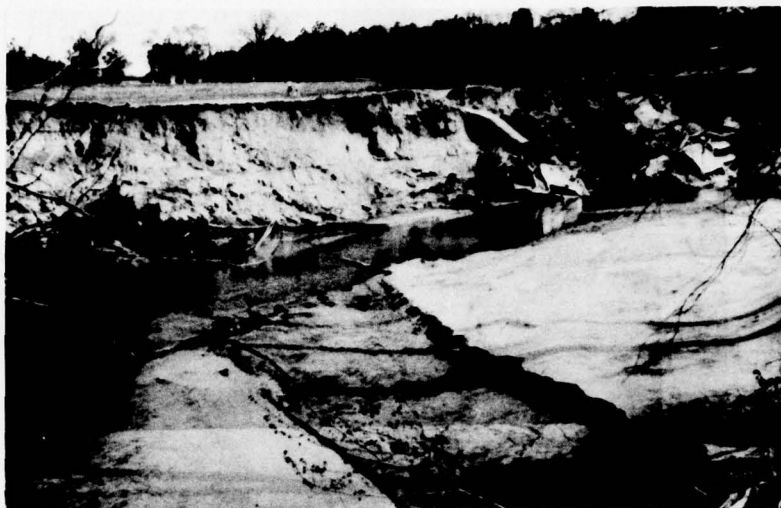
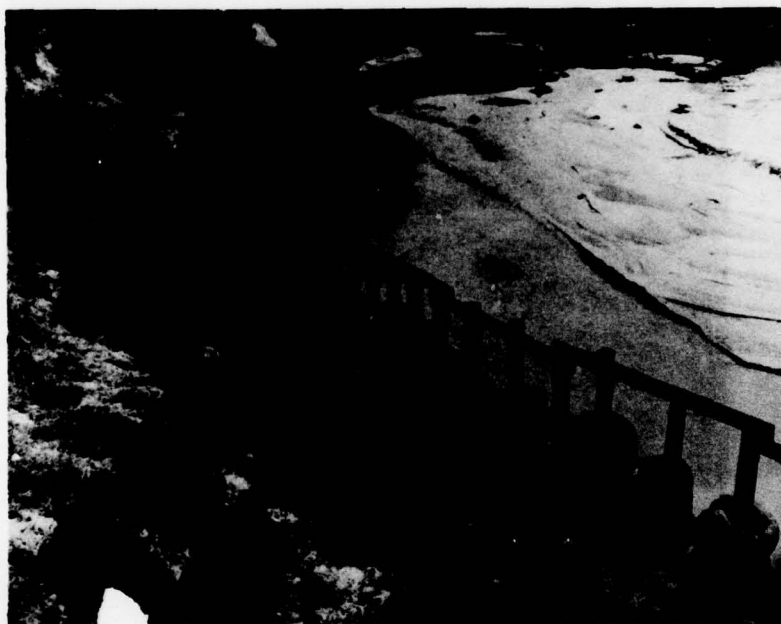
PHOTO 1 BEFORE CONSTRUCTION
30 MARCH 78

PHOTO 2 AFTER CONSTRUCTION
13 JUNE 78

PERRY CREEK ITEM 6A
TIRE-POST RETARDS

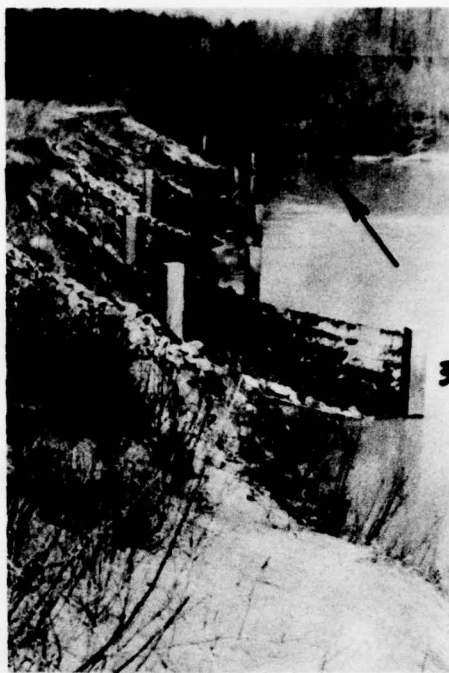
PHOTO 1
BEFORE CONSTRUCTION
8 MAY 1972

PHOTO 2
AFTER CONSTRUCTION
16 JANUARY 1973

PHOTO 3
19 MARCH 1975

TILLATOBA CREEK, SOUTH FORK
CABLE-FENCE DIKES
15-FT-HIGH BANK

Protection. Four types of bank protection were used: (a) longitudinal stone dike toe protection, (b) transverse stone dikes, (c) board-fence dikes, and (d) cable-fence dikes. This work began at the upper end of FY 72 work and extended 1-1/4 miles upstream for 10 bendways. See Plate G17 for the project plan and location; Plates G21, G22, and G30 for typical construction details; and Plates G31-G33, G35, and G45 for photographs of typical eroding and failing banks and completed protective structures.

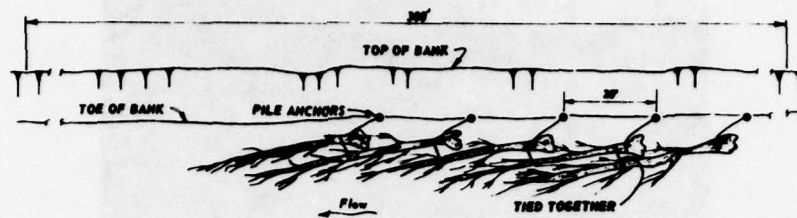
PLAN

TREE PENDANTS

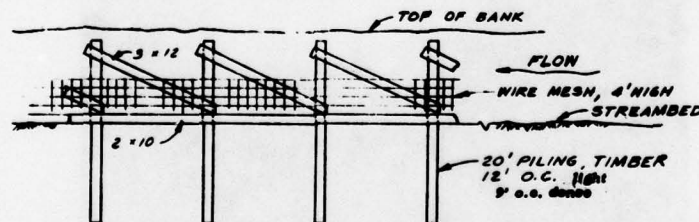
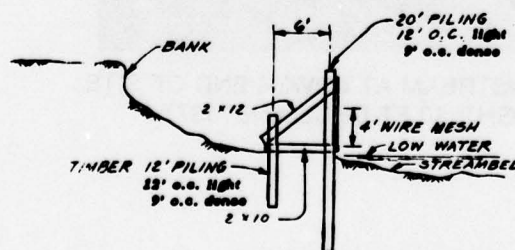
PLAN

FRONT ELEVATION

SECTION

PILE FENCE

VAN DUZEN RIVER
HUMBOLDT COUNTY, CALIFORNIA
TREE PENDANTS AND
PILE-FENCE PROTECTION

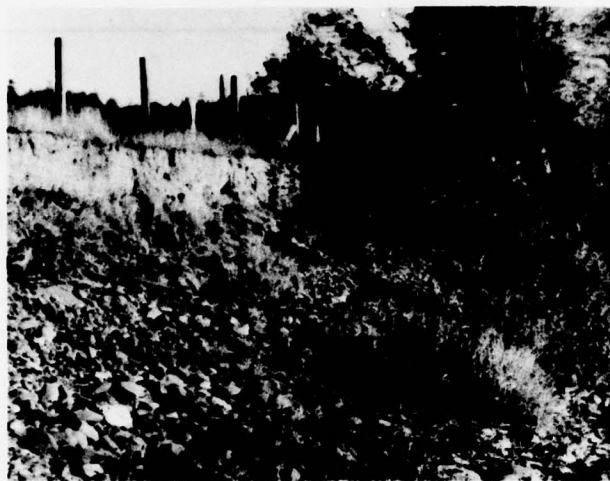
LOOKING UPSTREAM AT DENSE PILE FENCE SITE
BANK HEIGHT 10 FT, DECEMBER 1976

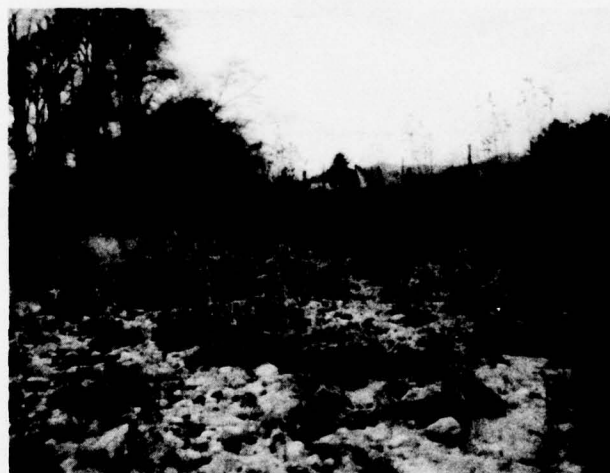
LOOKING DOWNSTREAM AT LOWER END OF SITE
BANK HEIGHT, 10 FT, DECEMBER 1977

VAN DUZEN RIVER
HUMBOLDT COUNTY, CALIFORNIA
BEFORE CONSTRUCTION

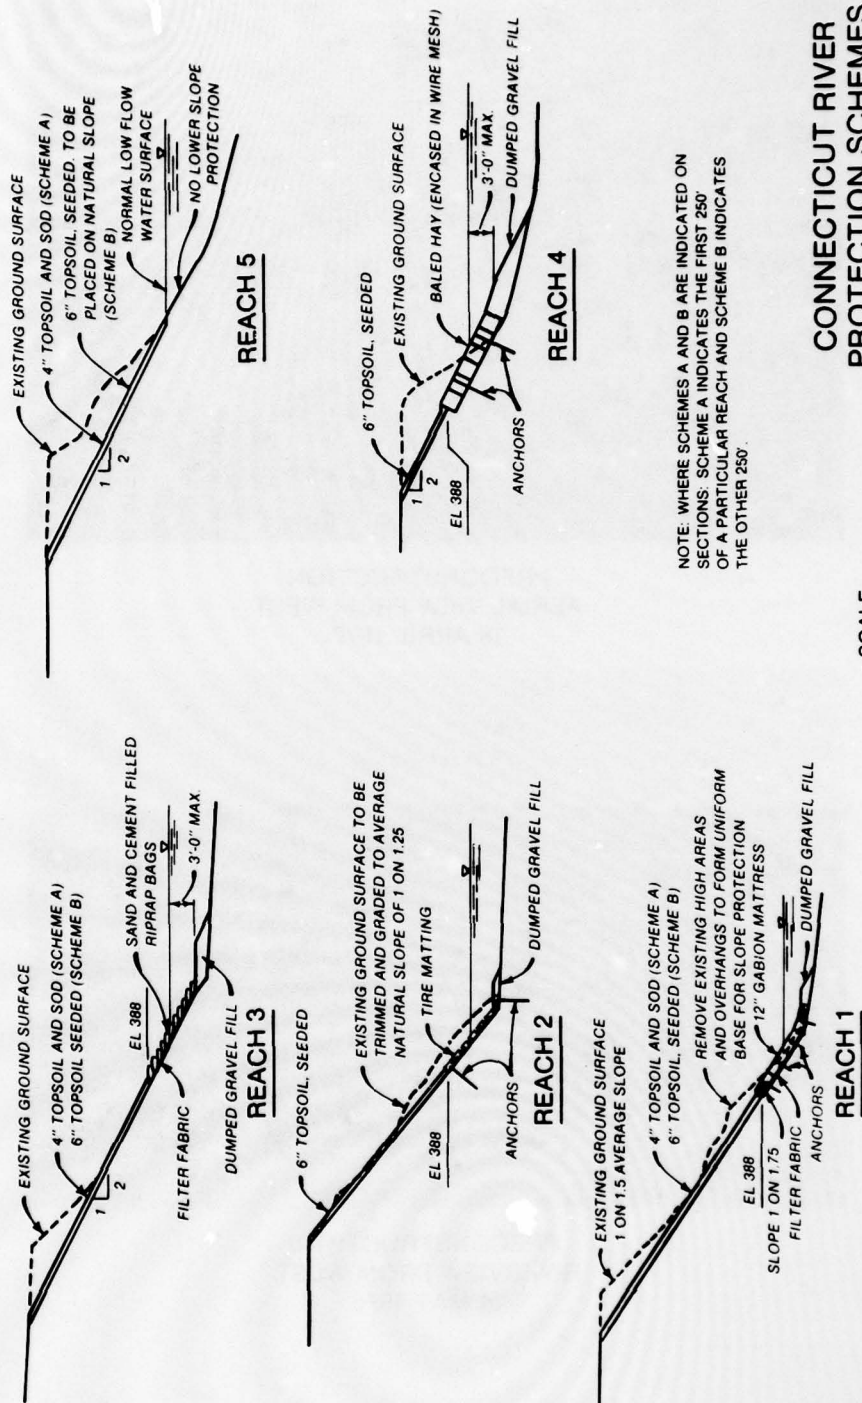
CONNECTICUT RIVER PROTECTION SCHEMES HAVERHILL, NEW HAMPSHIRE

TYPICAL SCHEMES

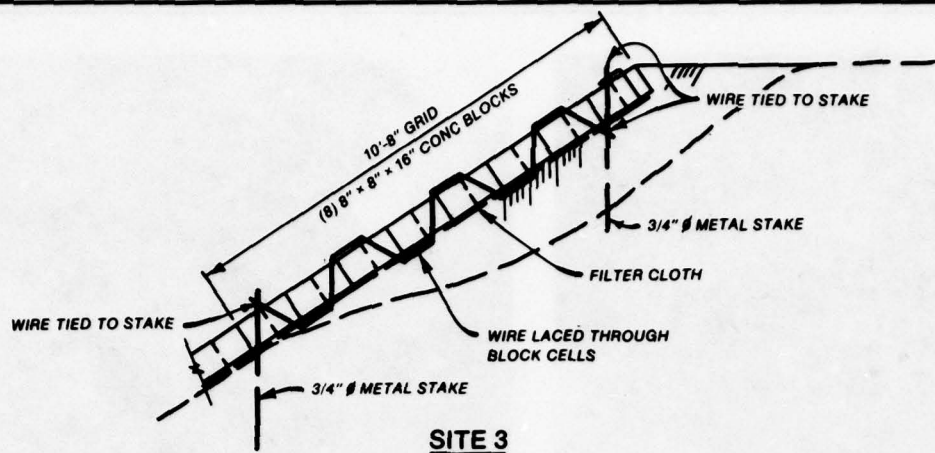
SITE 3

PEARL RIVER
MONTICELLO, MISS.
TYPICAL PROTECTION SCHEMES

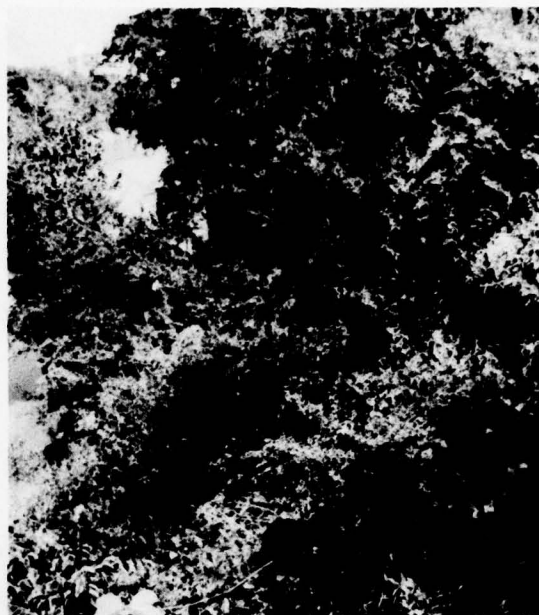
SITE 2
RIGHT BANK HEIGHT 30 FT ±
BEFORE CONSTRUCTION
APRIL 1978

Monitoring Program. The preconstruction observations for each site include visual inspections, cross-section surveys, and photography (Plate H9). Velocity, stage frequency, and rating curves were furnished in a previous report to the Steering Committee.

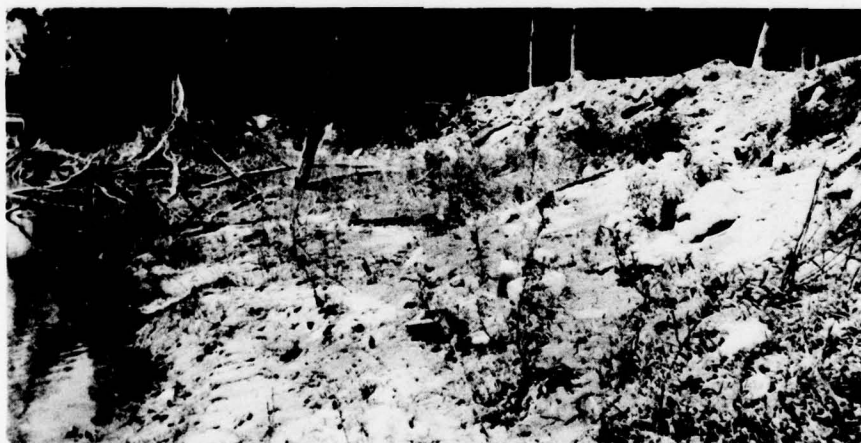
SITE 3
LEFT BANK HEIGHT 15 FT ±
BEFORE CONSTRUCTION
APRIL 1978

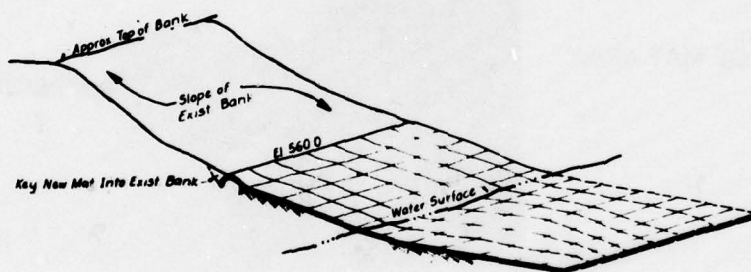
CONCRETE-FILLED MAT DETAILS
 (NO SCALE)

**IOWA RIVER
 WAPELLO, IOWA
 PROTECTION PLAN DETAILS**

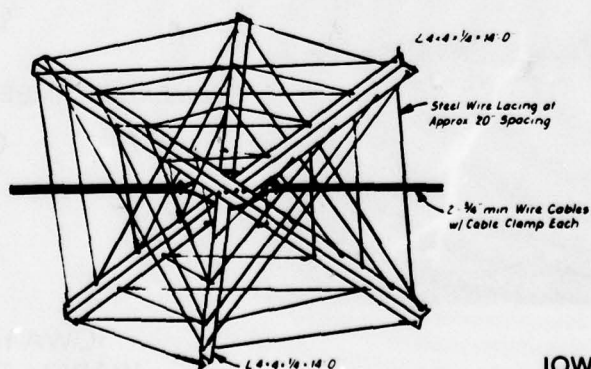
STEEL JACK UNIT
 (NO SCALE)

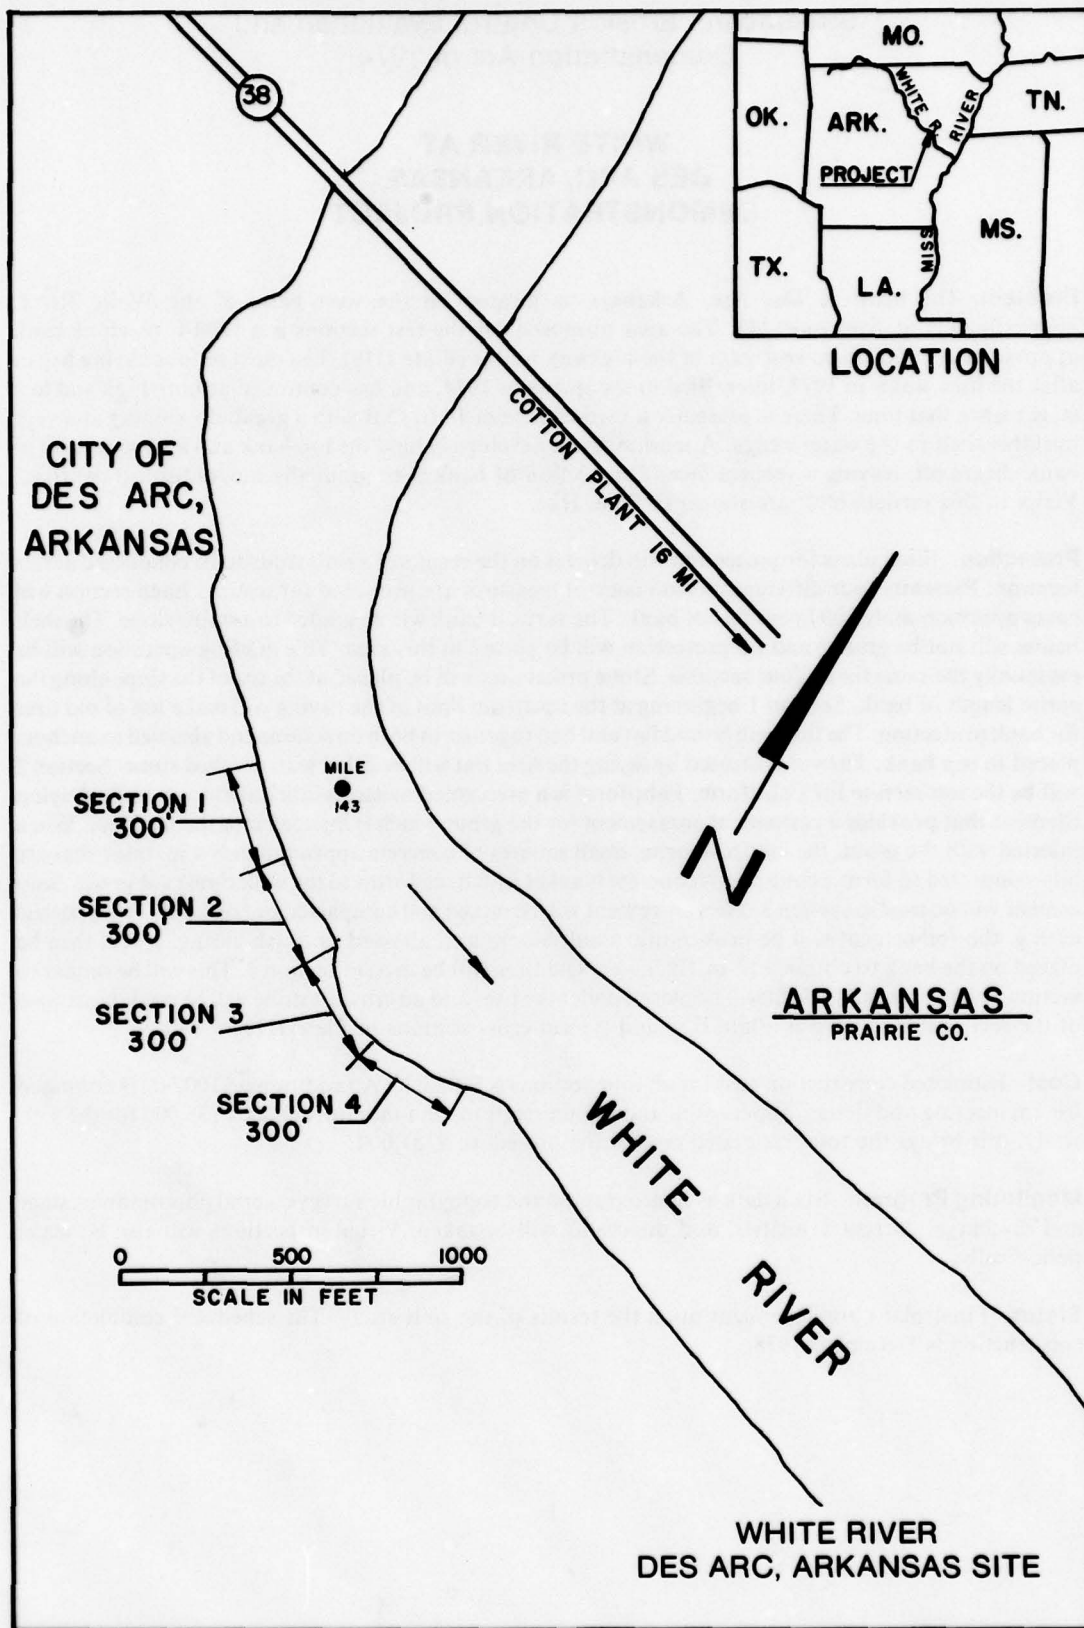
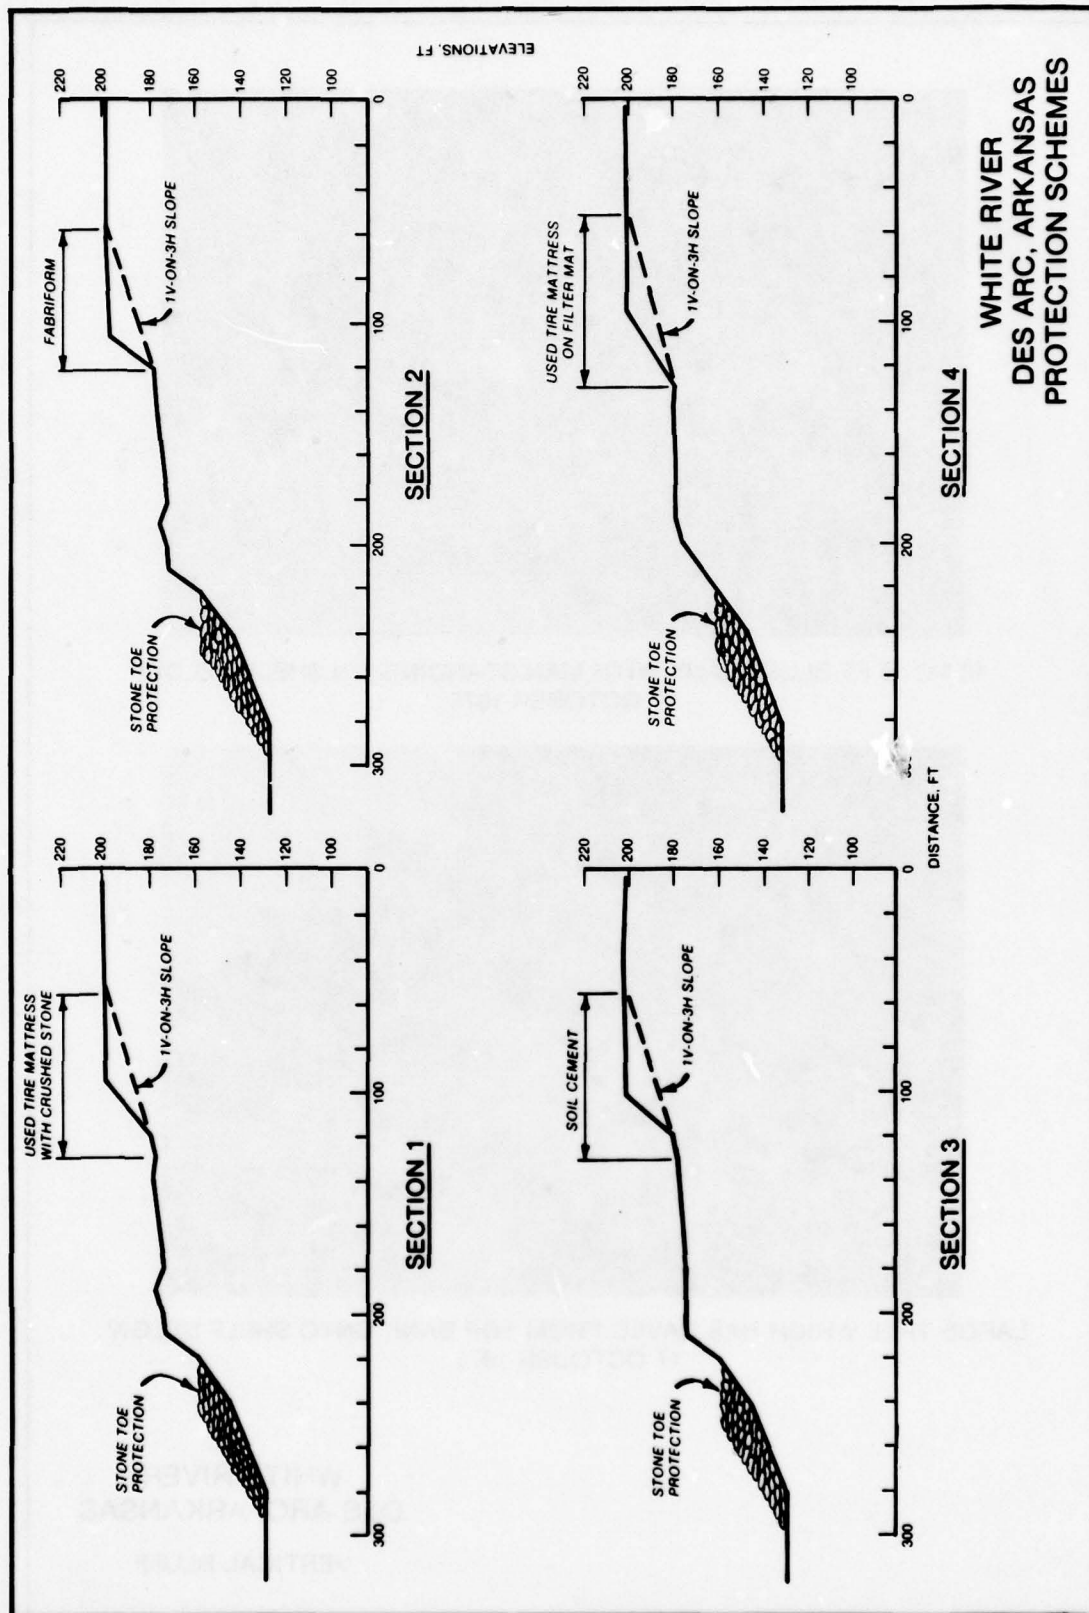
WHITE RIVER
DES ARC, ARKANSAS
PROTECTION SCHEMES

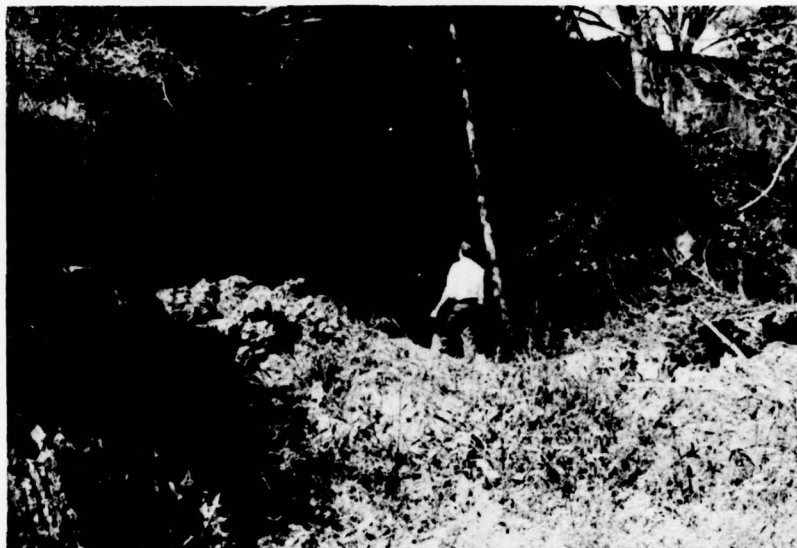
10 TO 15 FT BLUFF BANK WITH MAN STANDING ON SHELF BELOW
17 OCTOBER 1975

WHITE RIVER
DES ARC, ARKANSAS
VERTICAL BLUFF

Problem. The town of Des Arc, Arkansas, is located on the west bank of the White River, approximately at river mile 143. The area proposed for the test sections is a 1200-ft reach of bank approximately 2000 ft downstream of the highway bridge (Plate H19). The most serious caving began after the high water in 1973, intensified in the spring of 1974, and has continued at both high and low stages since that time. There is presently a vertical face of 10 to 15 ft with a gradually sloping and very unstable shelf to the water's edge. A tension crack develops behind the top bank and a large section of bank shears off, leaving a vertical face. This section of bank then gradually moves toward the river. Views of this vertical bluff are shown in Plate H21.

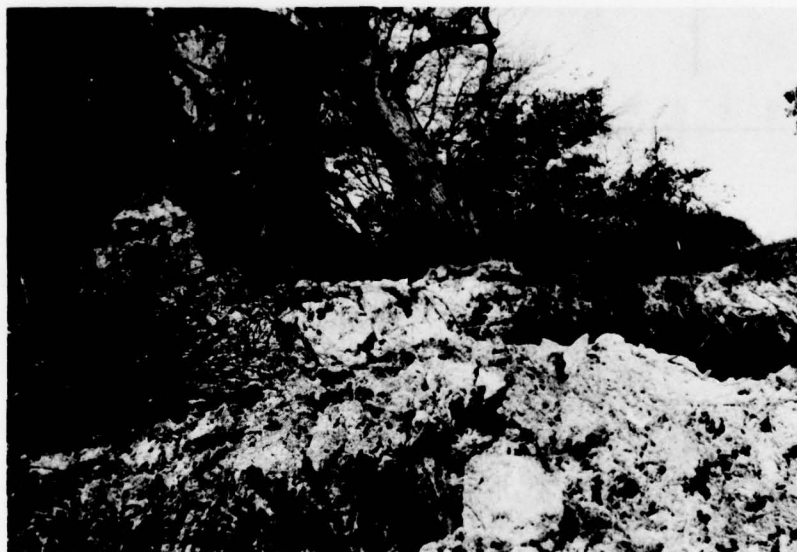
LARGE TREE WHICH HAS CAVED FROM TOP BANK ONTO SHELF BELOW
17 OCTOBER 1975
