MISSOURI RIVER

GAVINS POINT DAM - LEWIS AND CLARK LAKE NEBRASKA AND SOUTH DAKOTA

EMBANKMENT CRITERIA AND PERFORMANCE REPORT

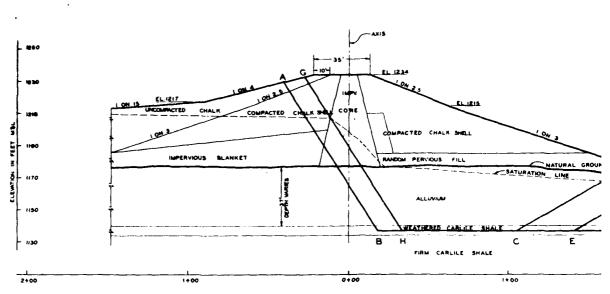
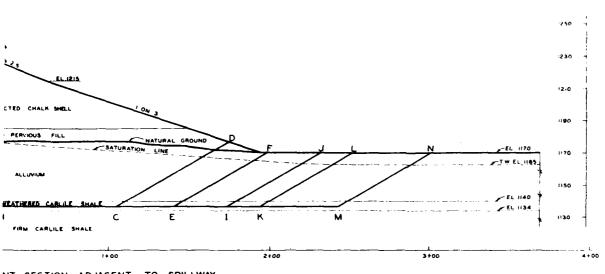
EMBANKMENT SECTION ADJACENT TO SPILLM

SHOWING SLIDE PLANES ANALYZED

- 2. THIS ANALYSIS IS FOR A CONDITION AFTER THE COMPLETION OF THE DAM, WITH STEADY SEEPAGE FLOW ESTABLISHED FROM A MAXIMUM NORMAL OPERATING POOL ELEVATION OF 1210.
- 3. THE EVALUATION OF PORE WATER PRESSURE IN THE EMBANKMENT AND FOUNDATION IS BASED ON THE ASSUMPTION OF MYDROSTATIC PRESSURES BELOW THE ESTIMATED SATURATION LINE.
- 4 THE ANGLES OF THE SLIDE PLANES FOR THE ACTIVE AND PASSIVE WEGGES WERE BASED ON RAMKINES' THEORY, USING WEIGHTED TANGENT & WALKES.

NT SECTION ADJACENT TO SPILLWAY

ING SLIDE PLANES ANALYZED

- 10.1 Original Stability Analysis. The design stability analysis on the critical embankment section is presented on Plate A-25. Assumed water and seepage conditions for the steady seepage condition and adopted embankment and foundation shear strengths are indicated on the plate. The analysis showed a minimum factor of safety of 1.59.

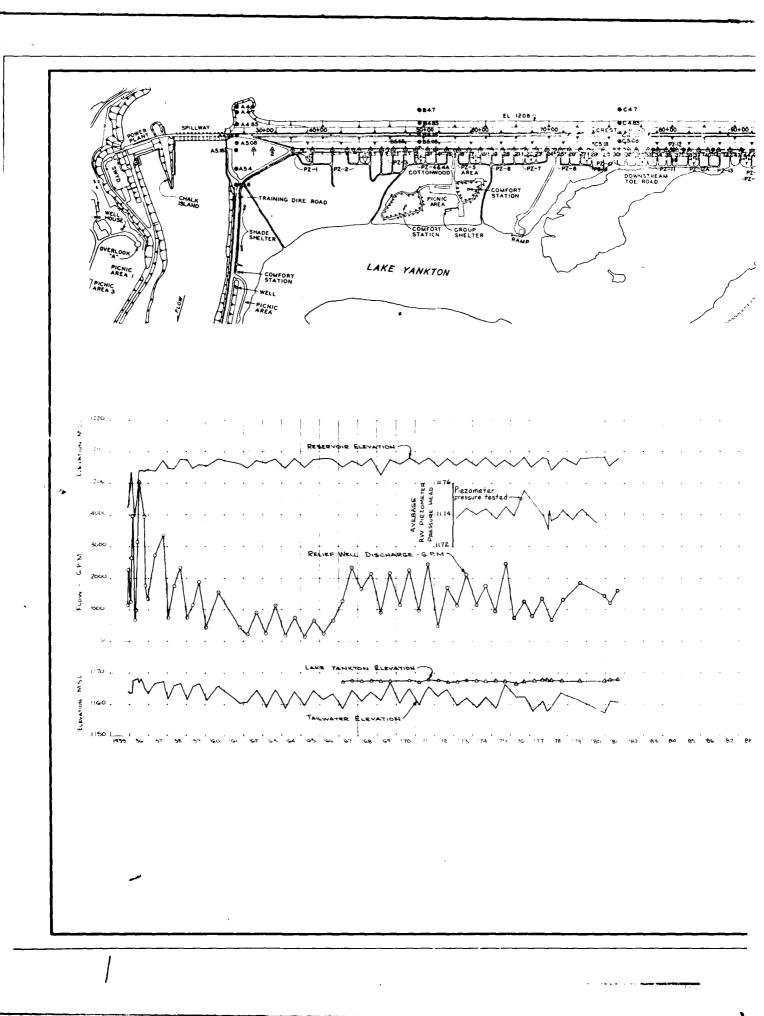
THIS DRAWING HAS BEEN REBUCED TO INNEE-EIGHTMS THE ORIGINAL SCALE. REVISIONS U. S. ARMY ENGINEER DISTRICT, DMAKA CORPS OF ENGINEERS CMAHA, NESRASKA MISSOURI RIVER EMBANKMENT RELIEF WE L OBSERVATIONS
TOTAL FLOW PLATE A-32 EMBANKMENT CRITERIA AND PERFORMANCE REPORT

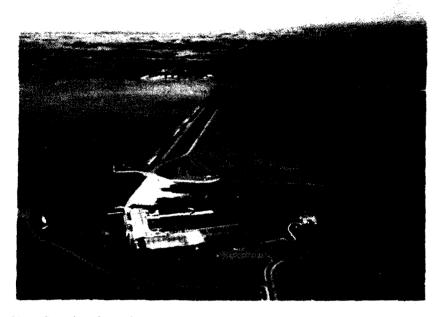
Photo No. 1 - Aerial view of Gavins Point Dam, looking north. Sept 1978.

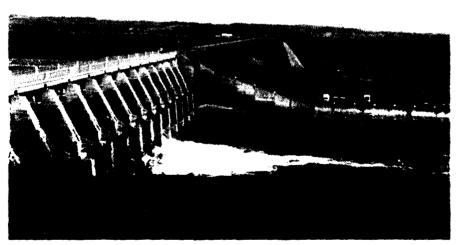
Photo No. 2 - Spillway and embankment, looking north. May 1979.

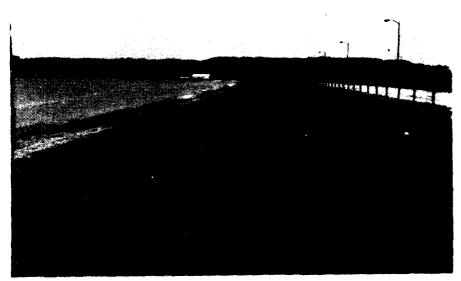
Photo No. 3 - Upstream slope of embankment, looking north. May 1979.

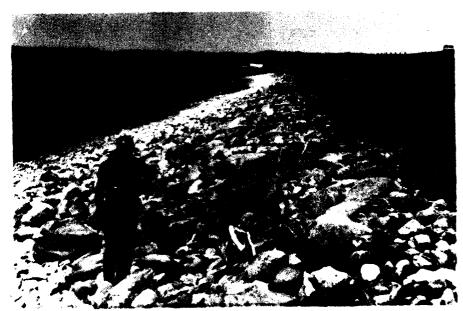
Photo No. 4 - Field boulder upstream slope protection. May 1979.

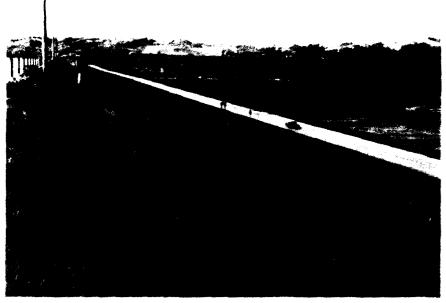
Photo No. 5 - Embankment downstream slope, toe road, and downstream area. May 1979.

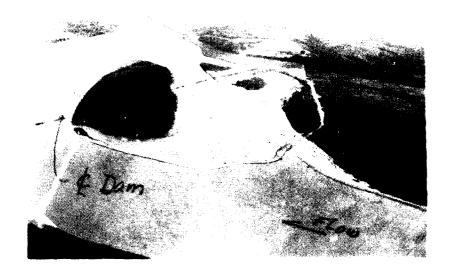
Photo No. 7 - Aerial view of dam site during Earthwork, Stage I construction, showing dike across river chute, looking southeast. Sept 1952.

- 3. <u>CONSTRUCTION STAGES</u>. The embankment was constructed in two stages under separate contracts. These are briefly summarized below.
- Earthwork Stage I. The first earthwork contract included partial construction of the embankment, primarily the upstream impervious blanket, from approximately Station 27+65 near the spillway to about Station 70+65 near the north side of the island. This included filling of a 200-foot wide river chute just north of the spillway and a wider 1,100-100t chute that cut through the island. Earthwork Stage I also involved initial excavation in the spillway to about El. 1170 and in the powerhouse area to about El. 1210. Chalk and overburden material from the structure excavation and overburden material from the structure excavation and from the borrow area south of the powerhouse were used as fill for the embankment. Approximately 1,080,000 cubic yards of chalk and 850,000 cubic yards of overburden were excavated and placed in the embankment section. Profiles and sections of the Stage I embankment are shown and noted as "placed by prior contract" on the Stage II drawings, Plates A-18 through A-21. Photos No. 7 and 8 show the dike constructed across the upstream portion of the central river chutes.

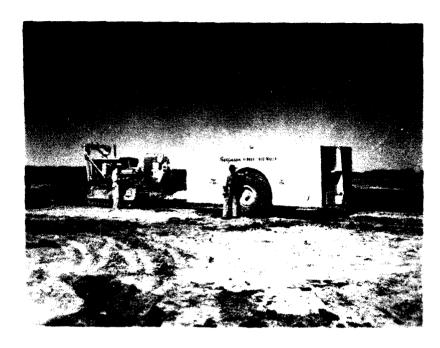
Photo No. 9 - Ferguson 50-ton rubber-tired roller used to compact embankment, Earthwork Stage I. Aug 1952.

- 6.2 Compacted Random Fill. Compacted random fill consisted of the same type of materials as uncompacted random fill. It was placed beneath the impervious core, upstream compacted chalk blanket, impervious upstream blanket, and downstream compacted chalk fill. In Earthwork Stage I, this material was placed beneath the upstream embankment section from El. 1170 to about El. 1177, sandwiched between the underlying uncompacted random fill or prepared foundation and the overlying compacted chalk and impervious fill blankets. In Earthwork Stage II, it was placed from the original ground line to El. 1177 beneath the upstream embankment, impervious core, and filter sections and to El. 1185 beneath the downstream compacted chalk section. The material above water was placed in 18-inch loose lifts and was compacted by at least three complete passes of a 50-ton rubber-tired roller (Photo No. 9). Underwater placement was by hydraulic dredging of pervious alluvial material. (Photo No. 18).

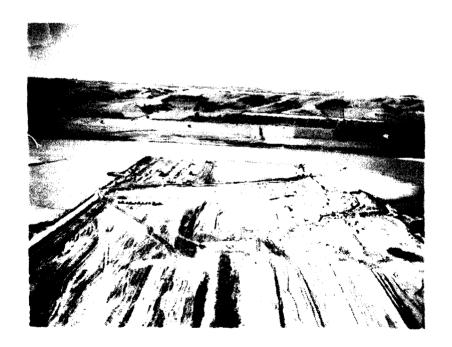
Photo No. 10 - Aerial view of embankment construction, Earthwork Stage II, looking north towards closure area and left abutment. Aug 1953.

and shale, about 2,800,000 cubic yards of valley alluvium, and 1,200,000 cubic yards of left and right bank overburden were excavated under this contract. These were mostly used for construction of the embankment. Pertinent drawings showing the Earthwork Stage II construction work are presented on Plates A-18 through A-22. Photos No. 10 through No. 22 were taken during this phase of construction.

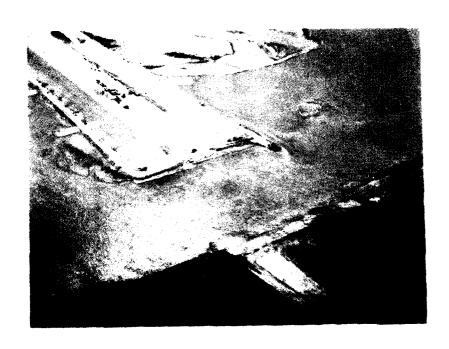
Photo No. 14 - Aerial view of embankment closure area at beginning of closure operations. 29 Jun 1955.

6. DIVERSION AND CLOSURE. During the embankment closure operations, the Missouri River was diverted through the powerhouse draft tubes and over the spillway weir. Prior to the closure, the upstream dike was opened to allow the river to flow through the diversion channel to the powerhouse and spillway structures. Fill placement for the closure section was started in June 1955 and initial closure was accomplished at about 4:00 a.m. on 31 July 1955. Closure was made by constructing a chalk diversion dam across the river along the upstream end of the impervious blanket. Photos No. 14 through No. 20 were taken during construction of the closure section. Plans, sections, and details of the closure section are shown on Plate A-22.

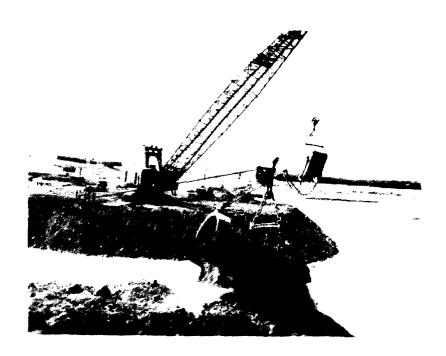
Photo No. 15 - Closure operations, looking south. In foreground is 3.5 C. Y. bucket from 111-M dragline. Opposite bank shows 191-M dragline with 8 C. Y. bucket. 30 Jul 1955.

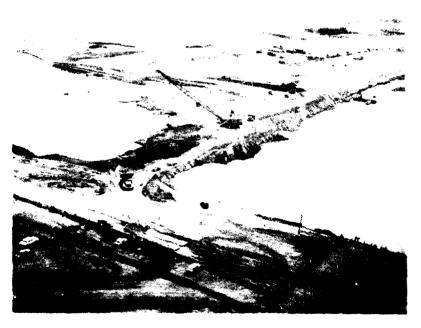
Photo No. 18 - Aerial view of closure section, approximately 6 hours after initial closure was made at about 4:00 a.m., 31 Jul 1955.

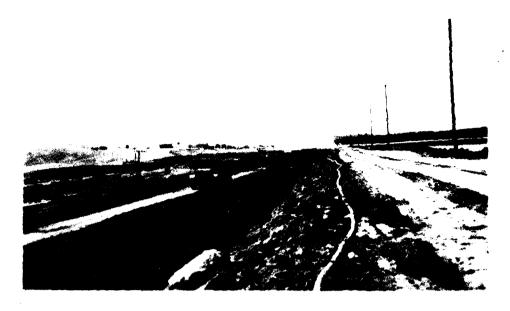
Photo No. 19 - Placement of impervious blanket in closure section, looking south. 5 Aug 1955.

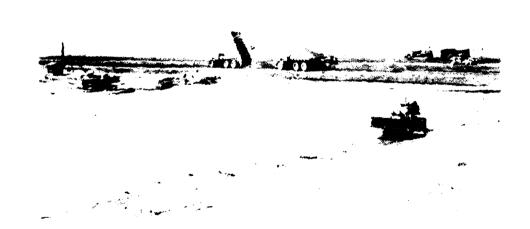
Photo No. 20 - Placement of impervious blanket in closure section, looking southwest. 5 Aug 1955.

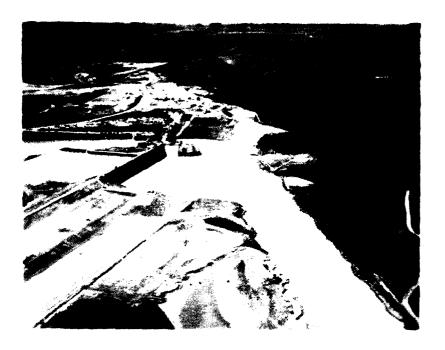
Photo No. 21 - Aerial view of south abutment area, showing powerhouse and spillway structures, the south portion of embankment, and the diversion channel. Aug 1955 (est.)

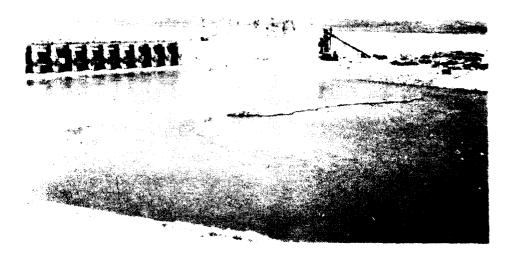
Photo No. 22 - View of the spillway, discharge channel and embankment. Concrete batch plant and contractor's work area shown downstream of the embankment. Aug 1955.

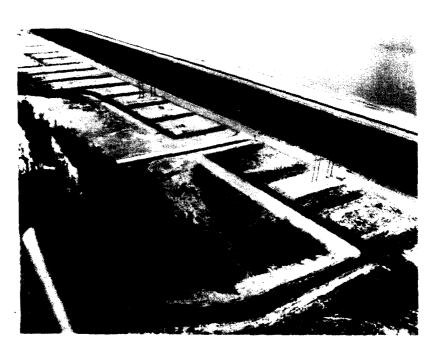
Photo No. 24 - Aerial view showing relief well discharge and collector ditches. Discharge ditch for relief well No. 19 is pictured in extreme right of photo. 8 May 1957.

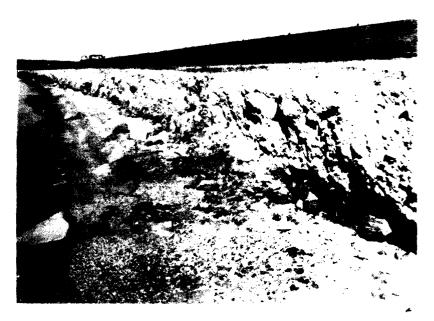
Photo No. 25 - Wave erosion scarp along embankment upstream chalk berm. Oct 1966.

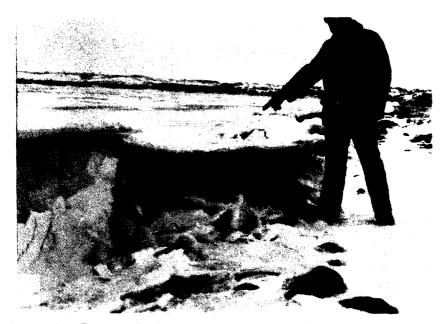
Photo No. 26 - Reservoir ice thrust against riprap along embankment upstream berm. Mar 1976.
