PULSED LASER DEVICE DEVELOPMENT PROGRAM

MIRROR DEVELOPMENT FOR PULSED LASERS

**AVCO EVERETT RESEARCH LABORATORY, INC.
a Subsidiary of Avco Corporation
2385 Revere Beach Parkway
Everett, Massachusetts 02149**

Test Report

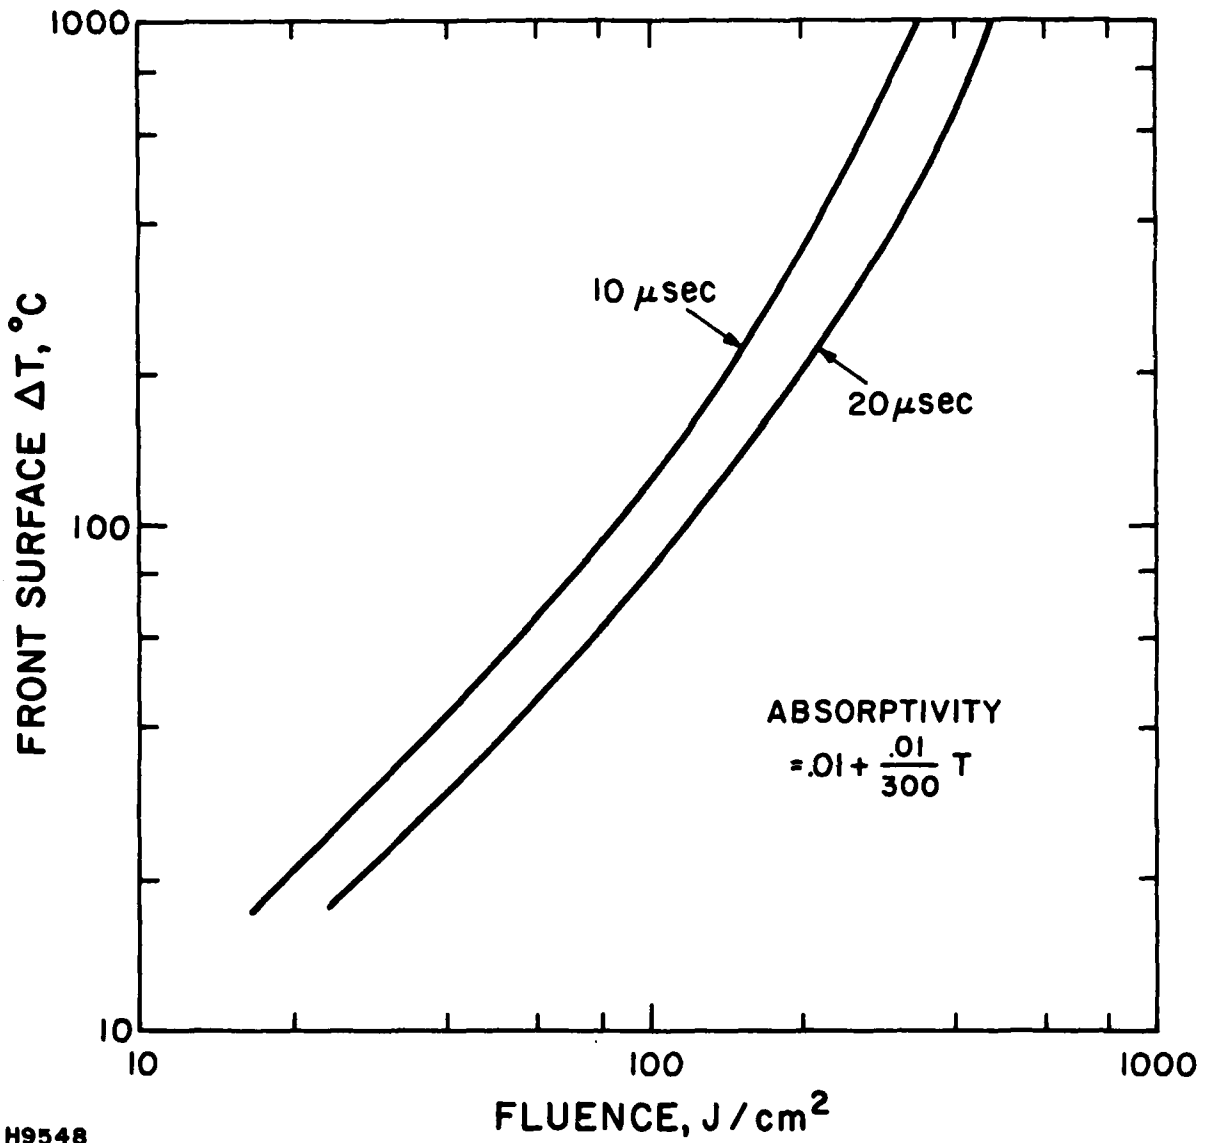
H9548

Figure 2. Copper Mirror Single Pulse ΔT

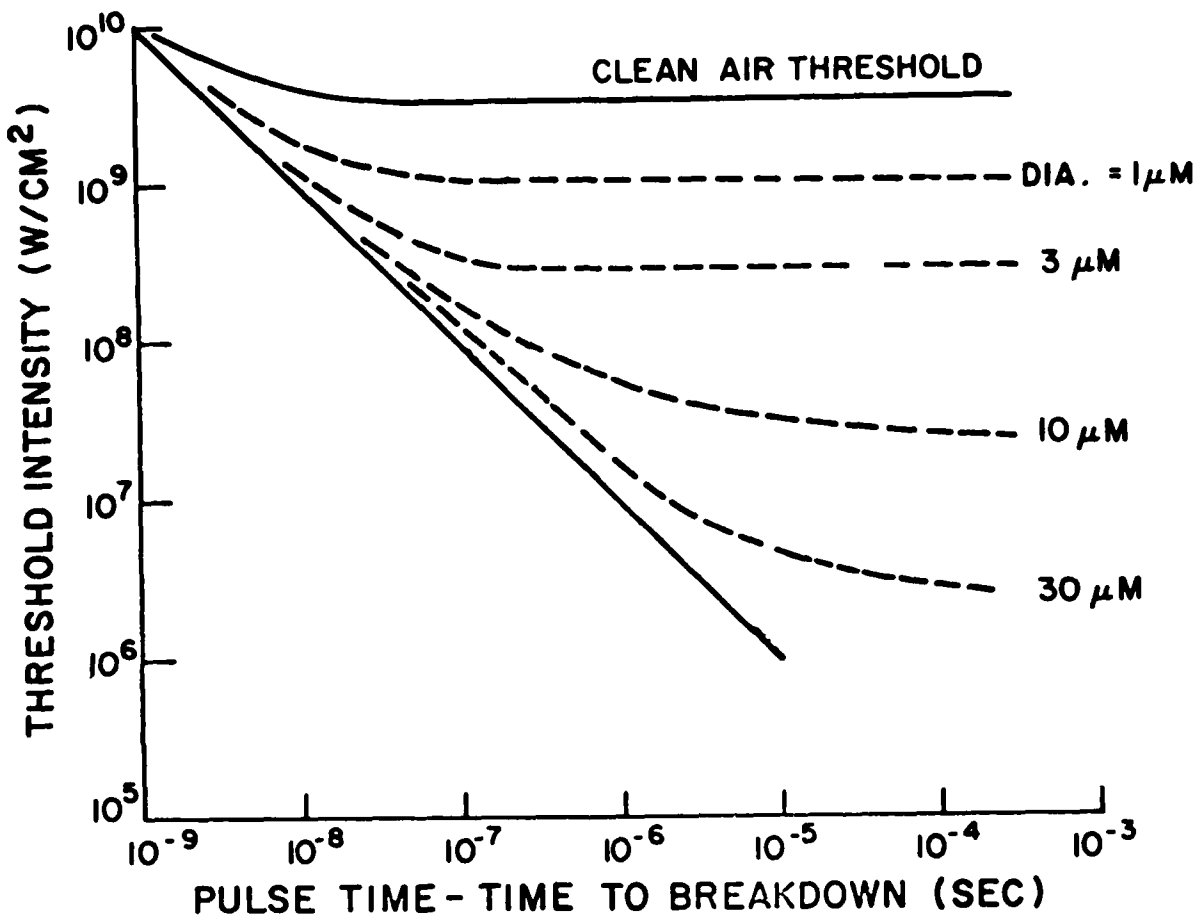
D7158

Figure 3. Dusty Air Breakdown

Lencioni⁽⁵⁾ has shown (Figure 3) that dust in the air lowers the plasma initiation threshold considerably. The dusty mirror limit shown on Figure 1 presumes 20 μm dust; dust of this size is routinely present on optical components prepared and handled in typical room environments. Straight-forward preparation and handling techniques have been shown to limit surface dust breakdown to the extent that it is not, in general, the limiting failure mode.
