AFWAL-TR-82-2121
Volume II

STRUCTURAL ELEMENT TESTING AND REAL BLADE IMPACT TESTING

ROBERT S. BERTKE

UNIVERSITY OF DAYTON RESEARCH INSTITUTE
300 COLLEGE PARK AVENUE
DAYTON, OHIO 45469

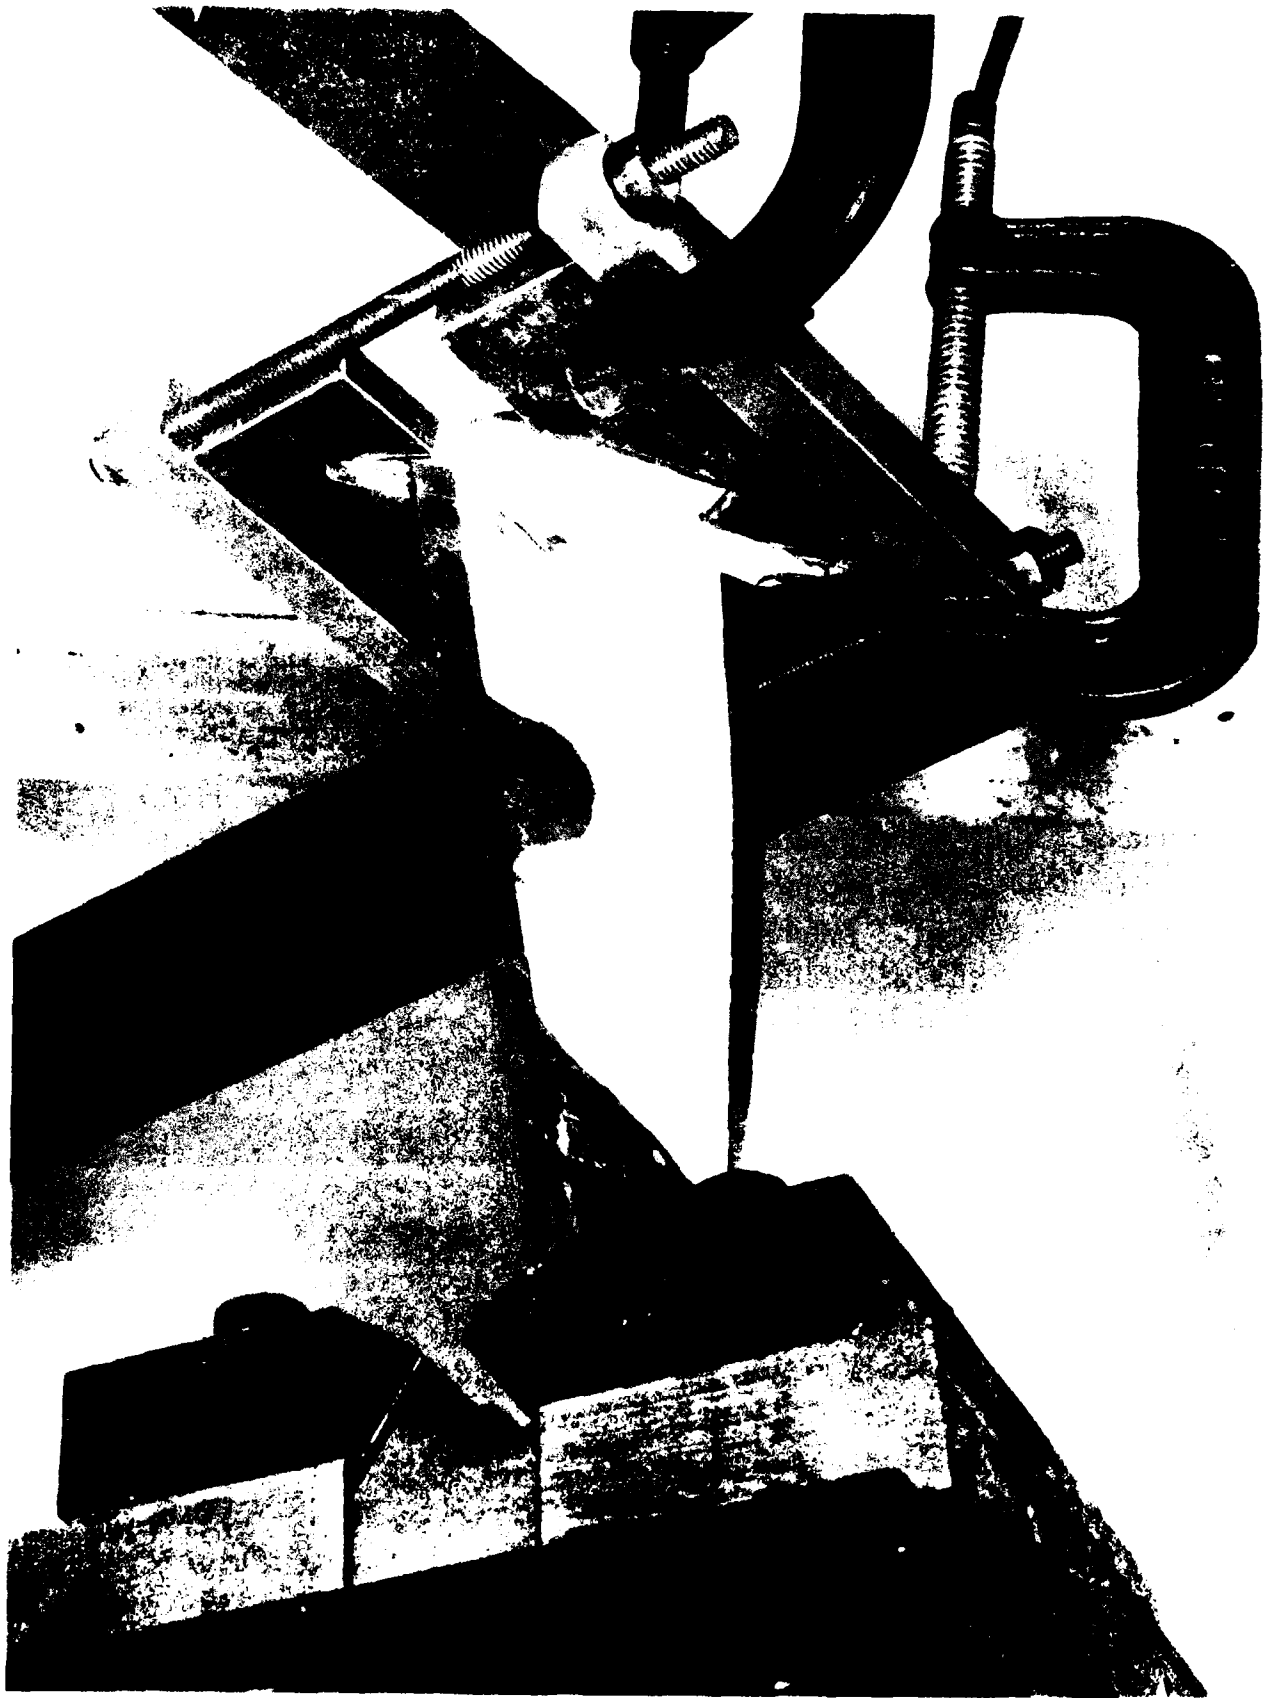
Figure 4. Photograph of Technique Utilized to Restrain F101 Blade Tips.

In the case of the F101 blades, the tips were also restrained to simulate the tip shrouds in the actual engine. Figure 4 shows the system utilized to restrain the tip of the F101 blades.
