AFWAL-TR-83-4039

RAIN EROSION MECHANISMS OF
FLUROELASTOMER AND POLYURETHANE
COATINGS ON SELECTED COMPOSITE
SUBSTRATES

Special Interim Report for the Period July 1980 - February 1983

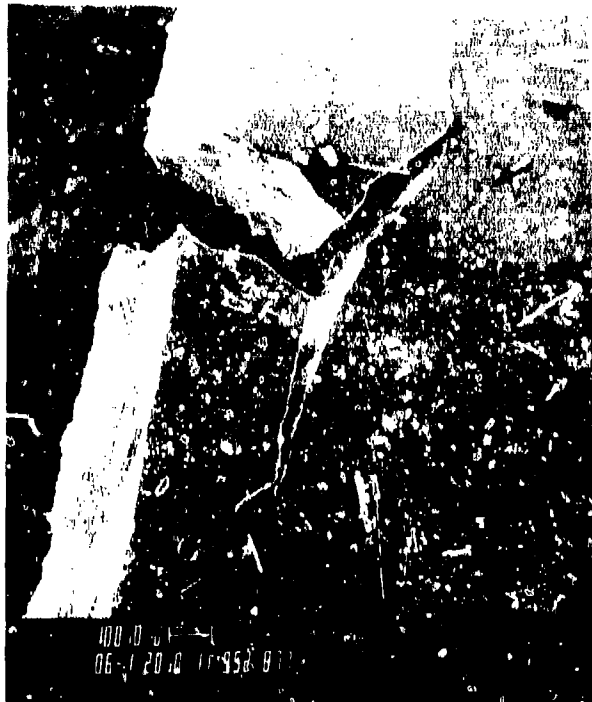
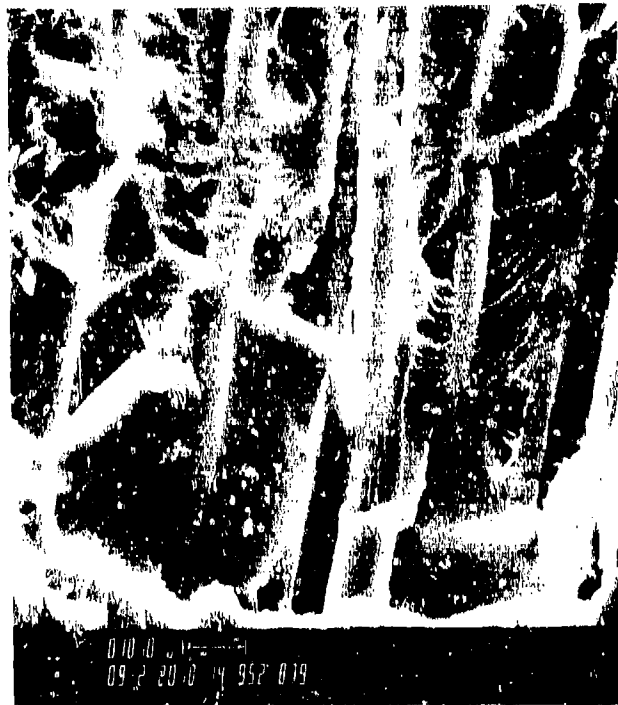
A 30.0 min Rainfield Exposure
60X

B 30.0 min Rainfield Exposure
900X

Figure 15. Fluoroelastomer Coated Glass Epoxy Composite,
90° Impact Angle.

(Figures 14A and 14B), microcracks (Figure 14D) leading to coating delamination and removal (Figure 15A) and subsequently to substrate erosion damage as shown in Figure 15B. It should be noted that these processes were associated with the presence of elongated striations found in the fluoroelastomer coating before exposure to rainfield conditions as shown in Figure 12B.

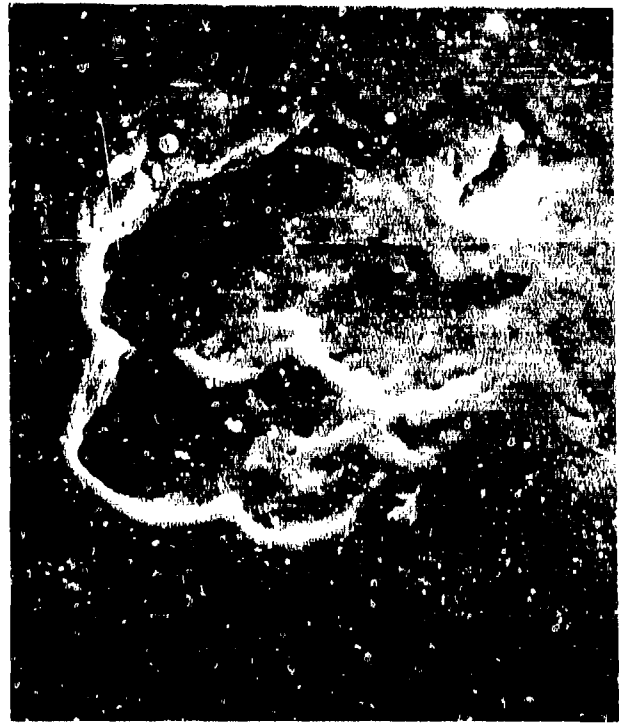
A 15.0 min Rainfield Exposure
500X

B 15.0 min Rainfield Exposure
1000X

C 30.0 min Rainfield Exposure
3000X

D 30.0 min Rainfield Exposure
8000X

Figure 20. Fluoroelastomer Coated Quartz Polyimide Composite,
90° Impact Angle.

Figures 19 and 20 exhibit the erosion damage at a 90° impact angle on the fluoroelastomer coating surface after:

exposure to rainfield conditions up to 30 minutes in duration. The damage illustrated was characterized by formation of localized erosion sites in the 10 micron size range after five minutes (Figure 19A and 19B) and 10 minutes (Figure 19C and 19D) of rainfield exposure. Rainfall exposure intervals of 15 minutes to 30 minutes resulted in the formation of clusters of single erosion sites as shown in Figure 20. Furthermore, the erosion damage after 30 minutes of rainfield exposure at a 90° impact angle resulted in coating cracking and delamination (Figure 21A) followed by severe erosion damage incurred in the quartz polyimide substrate (Figure 21B and 21C). Erosion damage in the quartz polyimide substrate material was characterized by broken quartz fibers (Figure 21B) as well as by polyimide resin removal (Figure 21C).

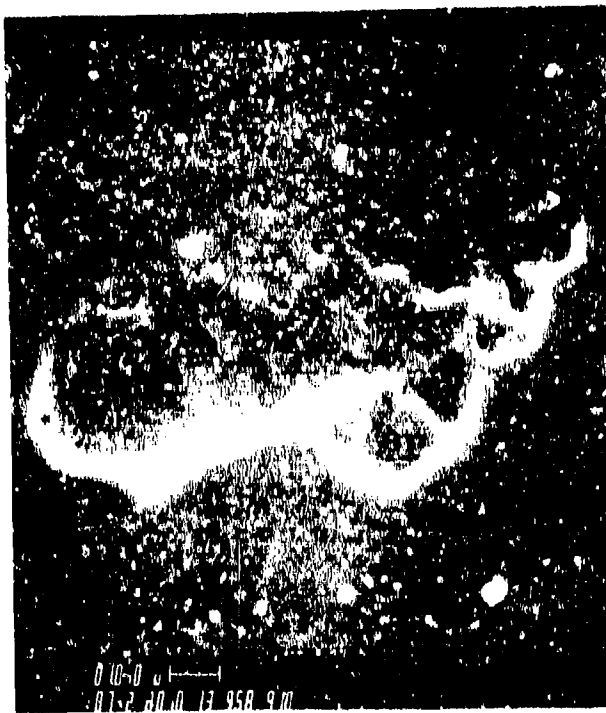
Figure 26. Polyurethane Coated Glass Epoxy Composite,
90° Impact Angle.

A 5.0 min Rainfield Exposure
100X

B 5.0 min Rainfield Exposure
1000X

C 20.0 min Rainfield Exposure
700X

D 40.0 min Rainfield Exposure
1000X

E 40.0 min Rainfield Exposure
1000X

Figure 26 (Cont'd). Polyurethane Coated Glass Epoxy Composite,
90° Impact Angle.

Surface structure and morphology of the polyurethane coated glass epoxy composite substrates after exposure to rainfield conditions at a 90° impact angle for intervals of five minutes to 40 minutes are shown in Figure 26. The erosion damage was associated with localized material removal from the coating surface resulting in single craters or clusters of craters as shown in Figure 26C and 26E. The presence of the grain-type structures as well as the titanium dioxide pigments were not directly associated with local erosion processes as clearly shown in Figures 26A, 26D, and 26B, respectively.

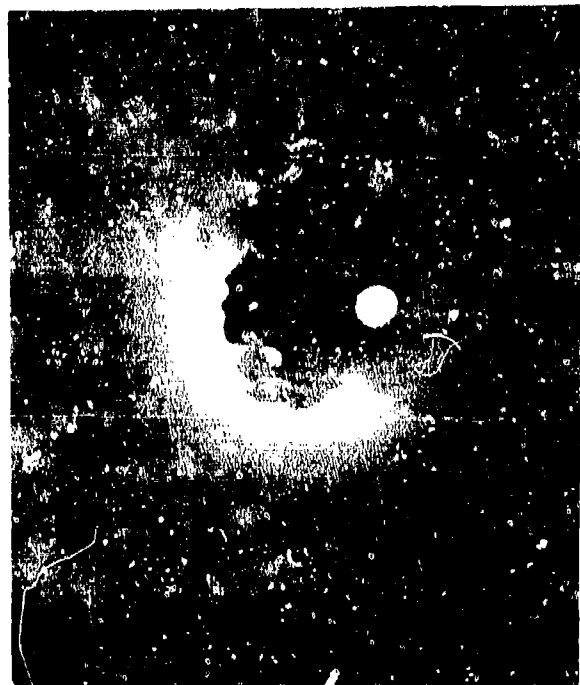
Figure 28. Polyurethane Coated Graphite Epoxy Composite,
90° Impact Angle.

A 5.0 min Rainfield Exposure
1000X

B 5.0 min Rainfield Exposure
3000X

C 10.0 min Rainfield Exposure
2000X

Erosion damage was introduced into the polyurethane coating surface on the graphite epoxy composite materials during rainfield exposure at a 90° impact angle. Five-minute exposures to rainfield conditions resulted in single craters or clusters of craters as illustrated in Figures 28A and 28B. An exposure to rainfield conditions of 10 minutes duration exhibited extensive microcracking in the polyurethane coating surface and is shown in Figure 28C.

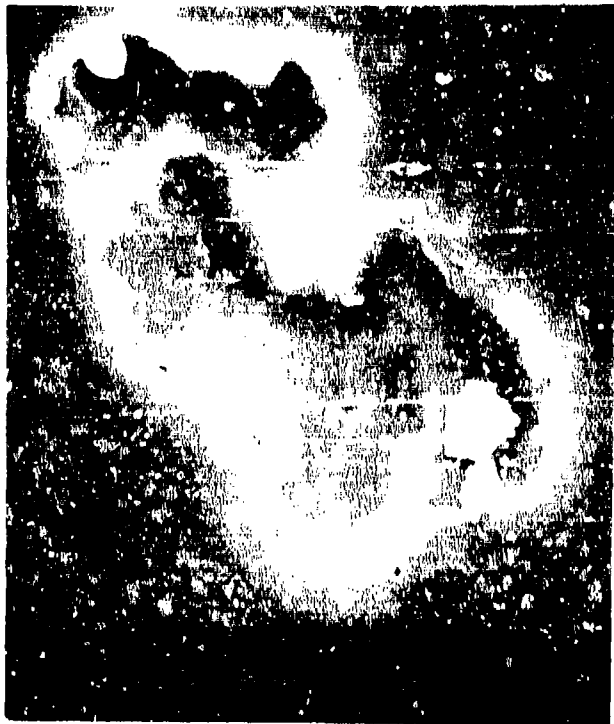
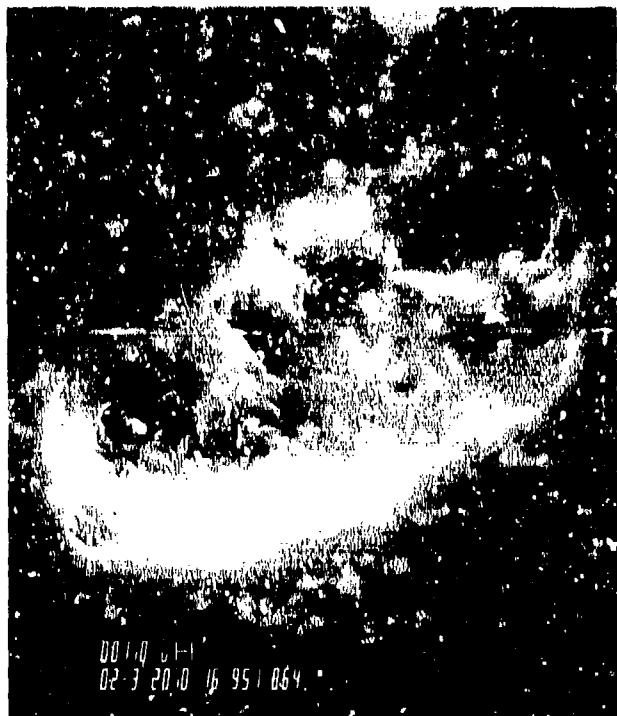
Figure 30. Polyurethane Coated Quartz Polyimide Composite,
90° Impact Angle.

A 5.0 min Rainfield Exposure
2000X

B 5.0 min Rainfield Exposure
2000X

C 10.0 min Rainfield Exposure
2000X

D 10.0 min Rainfield Exposure
4600X

Figures 30 and 31 exhibit the erosion damage at a 90° impact angle on the polyurethane coated quartz polyimide composite substrates after exposure to rainfield conditions up to 20 minutes in duration. Localized surface erosion in the form of craters and microcracking of the polyurethane coating was exhibited after five minutes and 10 minutes of rainfield exposure as shown in Figures 30A, 30B, 30C, and 30D. Some minor coating tearing along the path of the microcracks was noted as in Figure 30B. Surface characterization after 20 minutes duration indicated continued localized crater production and increased microcracking. The microcracks observed did not appear to be associated with crater formation as shown in Figure 31.

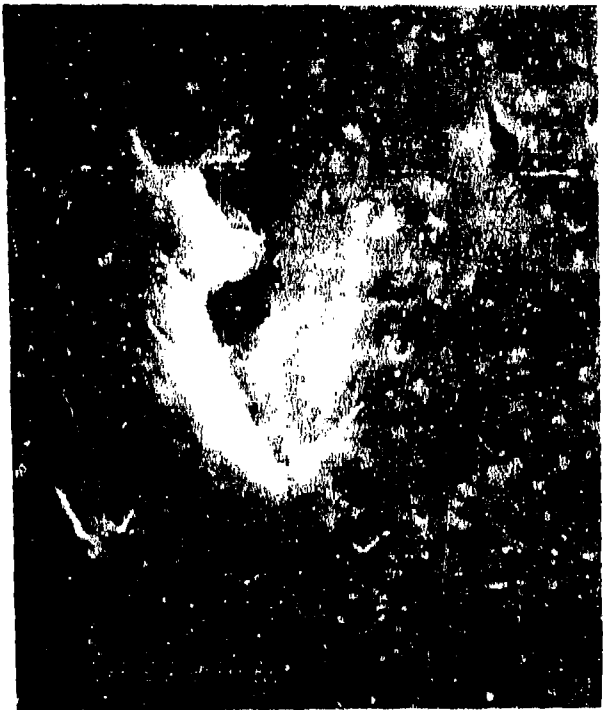
Figure 31. Polyurethane Coated Quartz Polyimide Composite,
90° Impact Angle.

A 20.0 min Rainfield Exposure
2000X

B 20.0 min Rainfield Exposure
2000X

C 20.0 min Rainfield Exposure
4000X
