1 1
TECHNICAL REPORT NO. 186-1

**HYDRAULIC MODEL
INVESTIGATION**

**Placer Creek High-Velocity Channel
and Debris Basin at Wallace, Idaho**

**SPONSORED BY
U. S. ARMY CORPS OF ENGINEERS
SEATTLE DISTRICT**

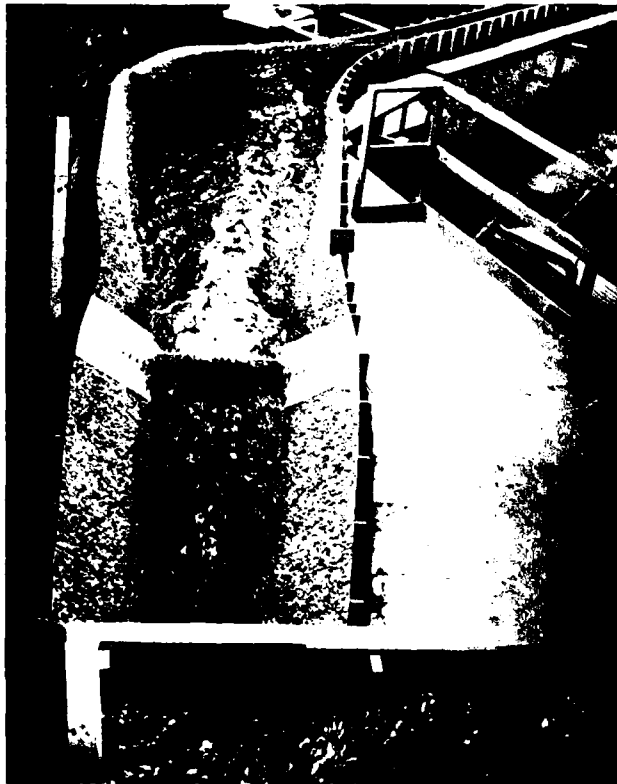
Photograph 2. Flow through trash barriers;
discharge 4,600 cfs

Original-Design Debris basin

12. Details of the original design are shown on plate 2. The debris basin consisted of a trapezoidal channel with improved bank protected by riprap with two debris barriers (plate 2 and photograph 1). Tests were conducted with discharges of 2,400 cfs, 3,300 cfs, and 4,600 cfs (design flow). Photograph 2 shows the design flow condition through the debris basin. The debris basin was ineffective, as all three discharges passed through the basin as a narrow, high-velocity stream with eddies on both sides of the basin between the debris barriers. At 4,600 cfs, impact on the upstream debris barrier was localized in the center where flow ride-up on the vertical beams overtopped the barriers (photograph 3). The entire downstream barrier was submerged, and the wall near station 40+00 (upstream of "V" bottom channel) was occasionally overtopped by the concentration of flow on the left bank (photograph 4).

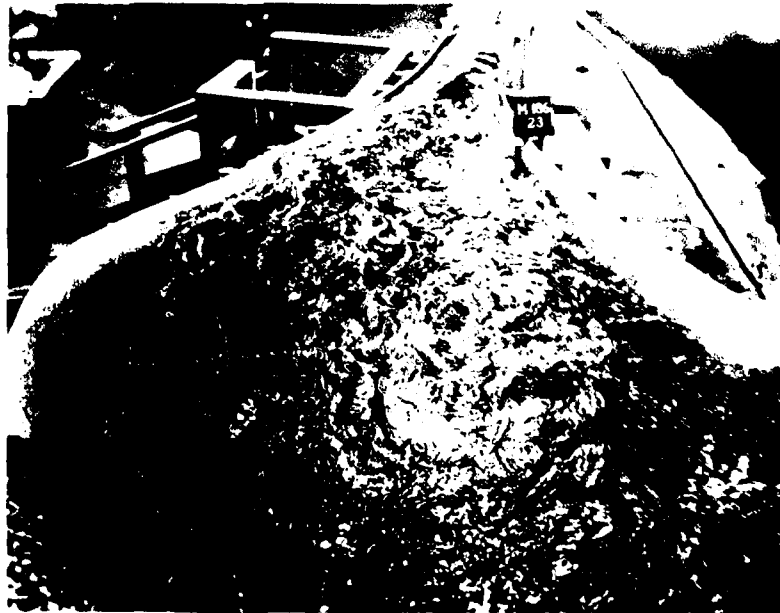
Photograph 4. Overbank flow downstream from submerged downstream trash barriers

Original-Design Debris Basin

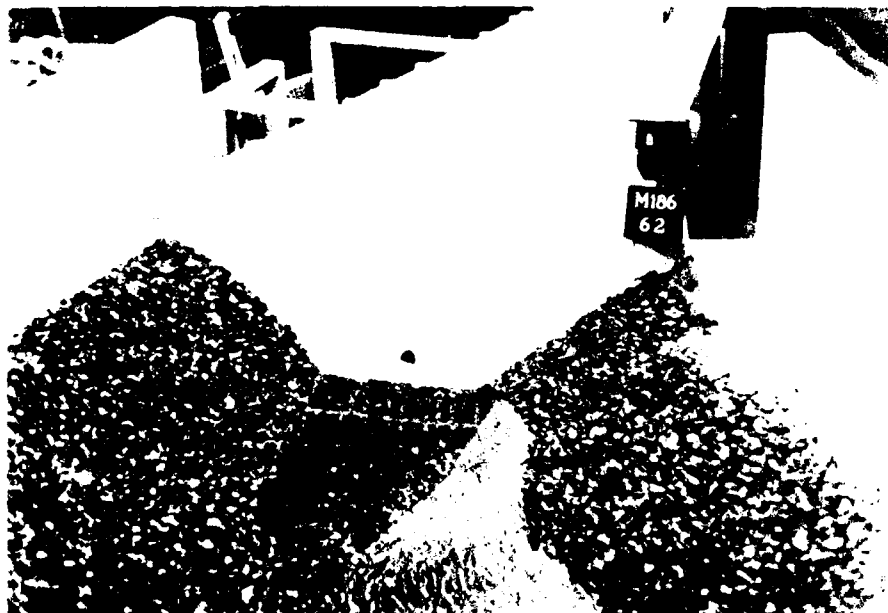
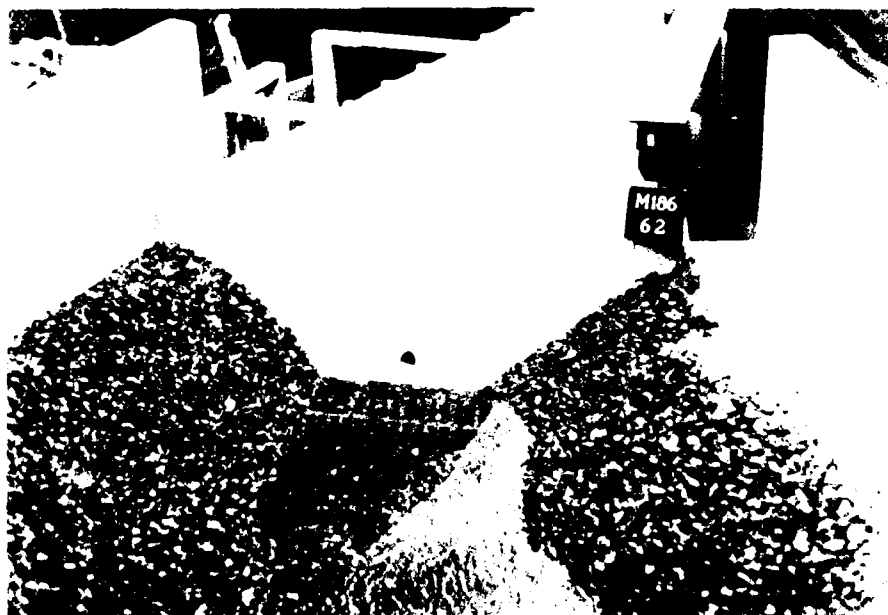
Photograph 10. Upstream view of trash barrier

Plan C Debris Basin and Drop Structure

14. The Plan C basin consisted of a deeper, shorter basin with a 23-foot-high drop structure at the upstream end (photograph 9) with a vertical training wall on the left bank and a single debris barrier at the downstream end near the channel entrance (photograph 10). The drop structure was provided to dissipate the energy of the incoming flow and to allow debris and bed material to settle out within the debris basin. Velocities in the Plan C basin, listed in table B, indicated that acceptable hydraulic conditions would be achieved using this scheme.

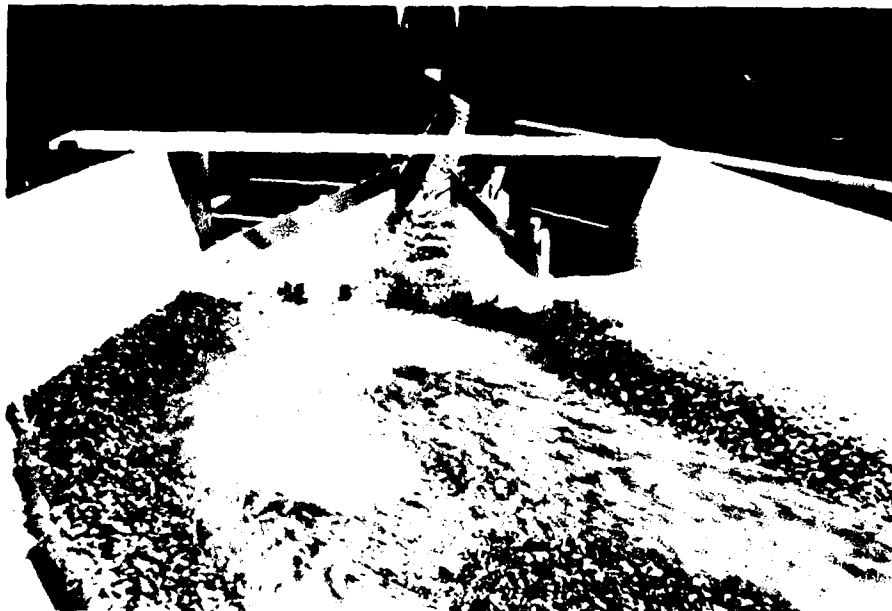
Photograph 19. Buildup at trash barrier

Final-Design Debris Basin
200-Year Thunderstorm Flood Hydrograph
3rd Hour; Discharge 2,530 cfs

Creek channel. Initial fallout in the basin occurred between stations 42+50 and 43+00. As the velocities and volume of bed material increased, the deposition moved downstream. After the peak had passed, the material still moving was depositing more in the area of stations 43+00 to 44+00. Eventually the bed material filled the debris basin from bank to bank and from the drop structure to the trash barrier by slow continuous movement of material downstream. Trash formed a porous barrier on the racks, and bed material was deposited against it. Rock stopped moving at approximately 700 cfs. At the end of the flood, the top of the drop structure was under 4.2 feet of debris and the material had backed upstream as far as station 45+20. Velocities along the riprapped banks of the basin during the flood were 12 to 14 fps on the left bank and 17 fps on the right bank. Photographs 19 to 27 show the sequence of the test. A centerline profile of the deposited material is listed in table D.

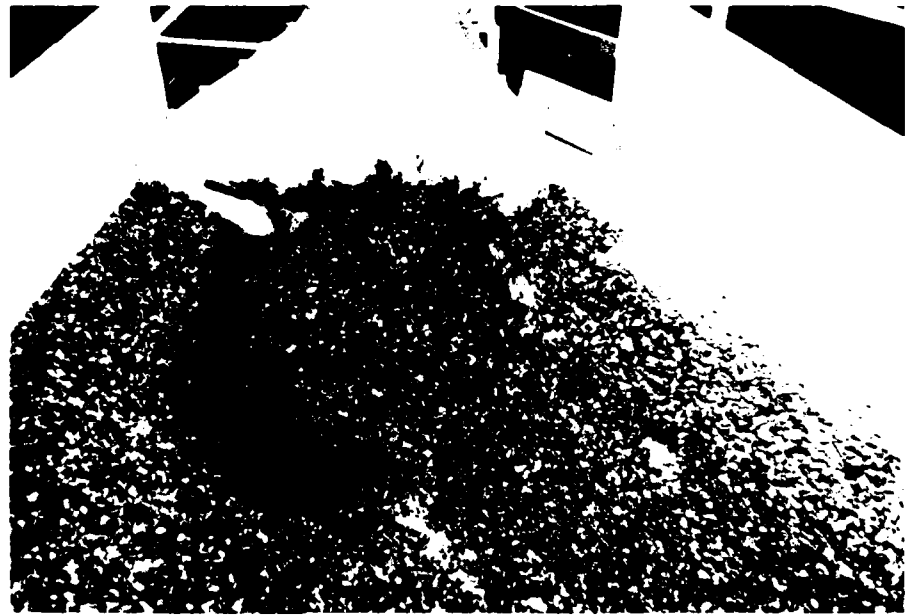
Photograph 26. Looking downstream at debris buildup on trash barrier

Conclusion of 200-Year Thunderstorm Flood Hydrograph
16,000 Cubic Yards of Debris

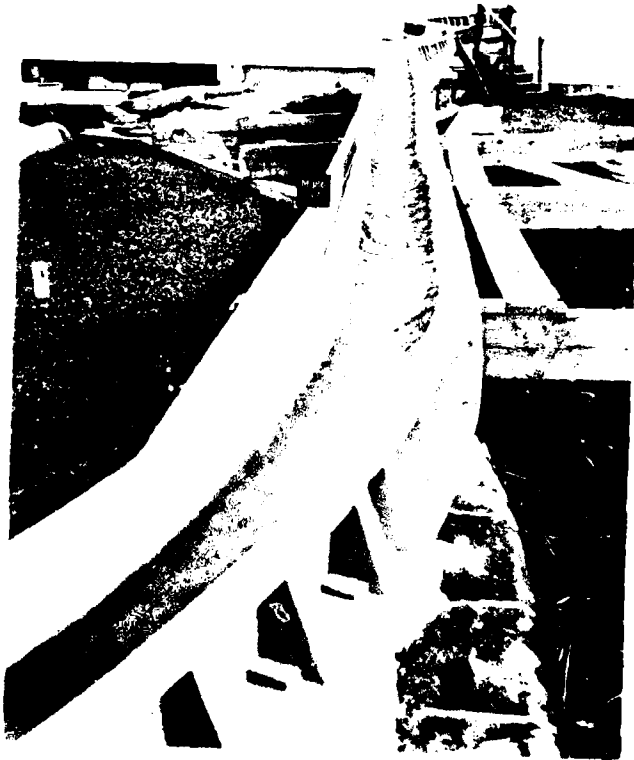
Photograph 45. Looking upstream from Curve No. 3
(Station 15+00) at standing waves
created by Curves No. 4 and 5;
discharge 4,600 cfs

The original channel design proved to be satisfactory except in one area where two short reverse curves caused unacceptable waves in the channel. This condition was remedied by realining the channel using a straight-line transition between the PC of one curve and the ST of the other curve.

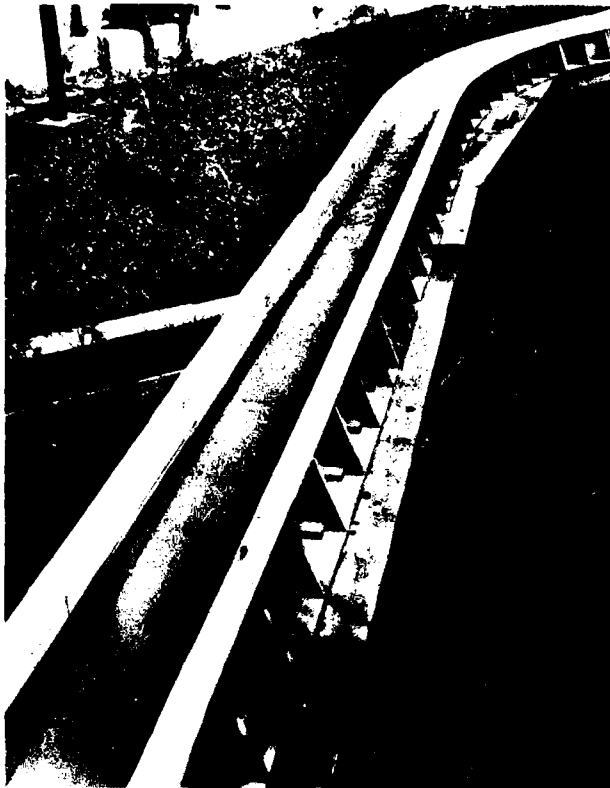
Photograph 51. Hydraulic jump at Station 7+00;
Placer Creek discharge 565 cfs

and pushed the hydraulic jump downstream another 150 feet. Walls were still overtopped at the upstream end of the culvert. No movement of bed material in the South Fork Coeur d'Alene River was observed. At the 28th hour when the flood peaked, the existing small scour hole in the river at the exit of Placer Creek was enlarged. The high flow in the river moved the scoured material downstream. An upwelling along the left bank wall deposited some of the smaller rock on top of the wall. The jump in Placer Creek was only 50 feet upstream from the highway culvert and caused a high impact on the culvert and significant overtopping of the walls (photographs 51 to 55).

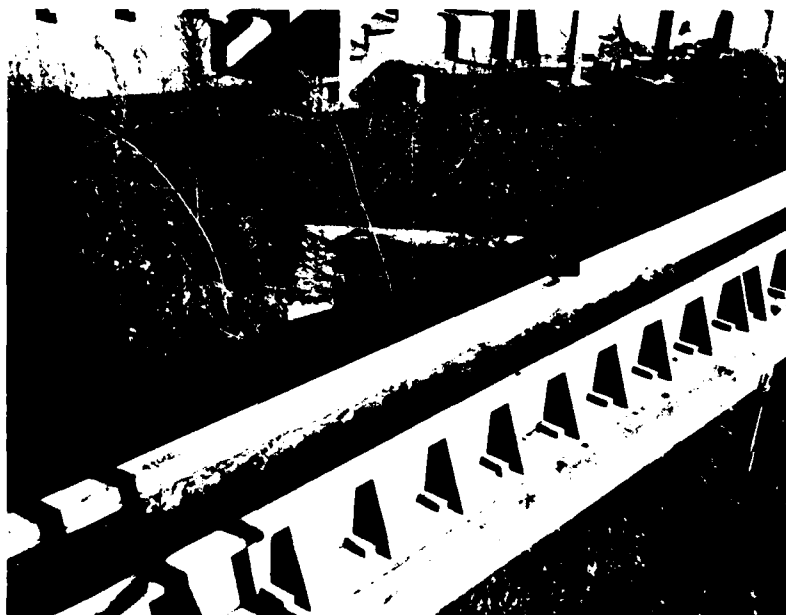
Photograph 52. Hydraulic jump at Station 5+50;
Placer Creek discharge 1,175 cfs

Winter Rainflood Hydrograph

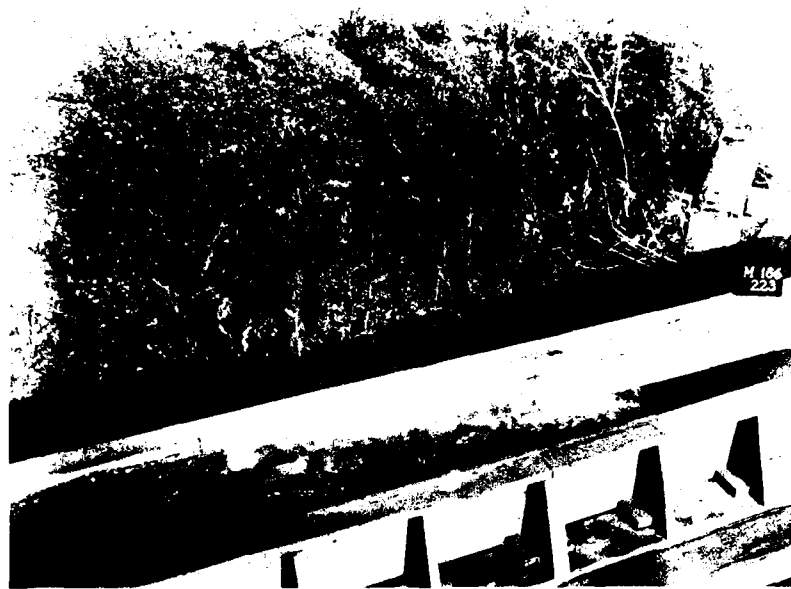
Photograph 53. Hydraulic jump at Station 4+00;
Placer Creek discharge 2,000 cfs

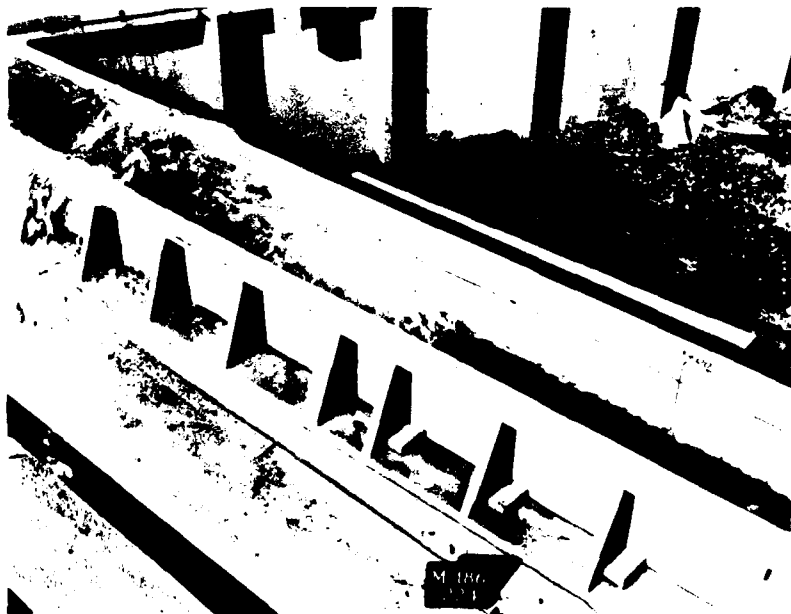
Photograph 54. Hydraulic jump at Station 2+50;
Placer Creek discharge 3,050 cfs

Winter Rainflood Hydrograph

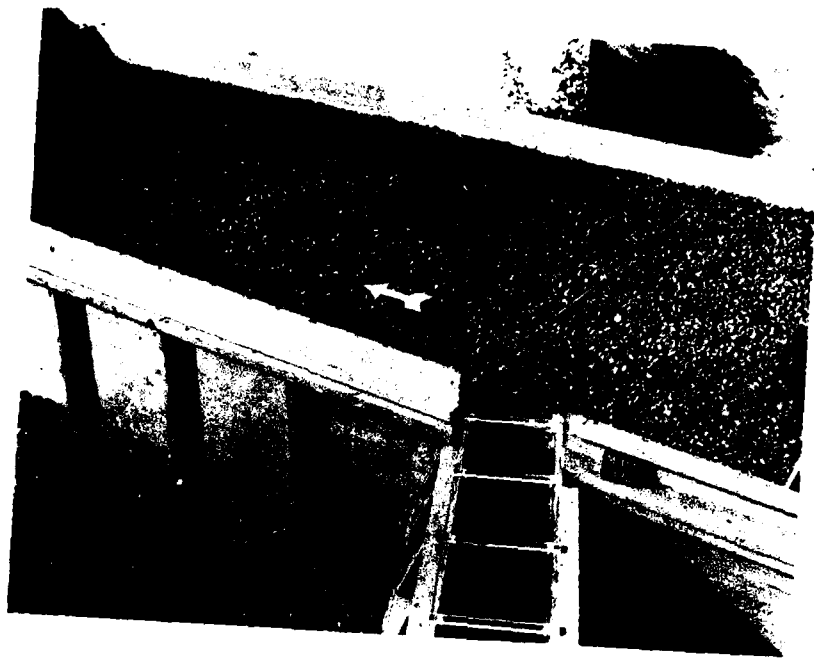
Photograph 58. View from Placer Creek

Photograph 59. View from South Fork Coeur d'Alene River

Movable-Bed Original Conditions
in South Fork Coeur d'Alene River

31. The simulated hydrological conditions for this observation were the project design 200-year thunderstorm flood (table D). Flow in the South Fork Coeur d'Alene River was constant at 400 cfs, while flow in Placer Creek increased from 14 cfs during the 3rd hour of the storm to a maximum of 4,600 cfs shortly after the 4th hour and receded to constant at 400 cfs by the 9th hour. The movable bed section of the model reproduced 350 feet of the river invert and right bank (plate 15, photographs 58 and 59).

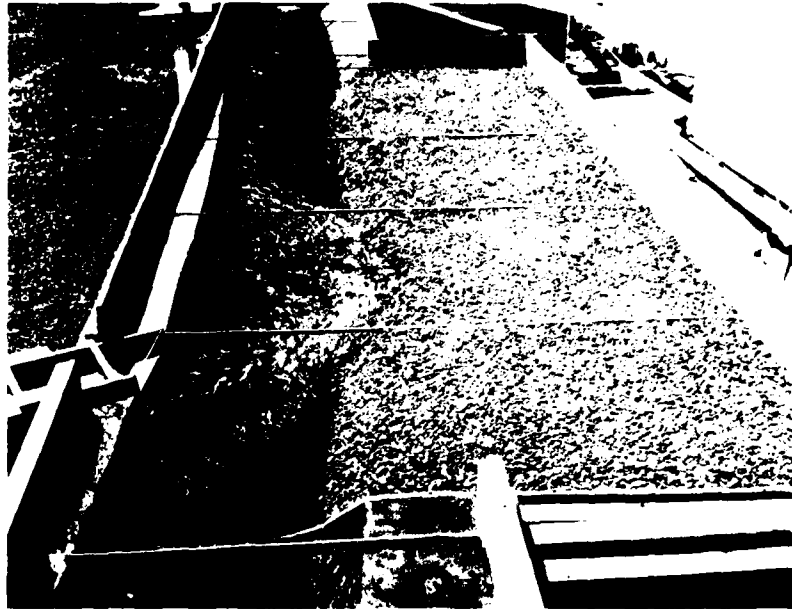
Photograph 60. View from South Fork Coeur d'Alene River

Thunderstorm Flood Hydrograph
Placer Creek Discharge 500 cfs
South Fork Coeur d'Alene River Discharge 400 cfs

32. The test began at the 3rd hour of the storm when Placer Creek flow was increased from 14 to 500 cfs (3 hours and 15 minutes into the storm) and quickly scoured the right bank of the South Fork Coeur d'Alene River (photograph 60). By 3 hours and 30 minutes of the storm, the flow increased to 2,350 cfs and extensive scouring was occurring. The right

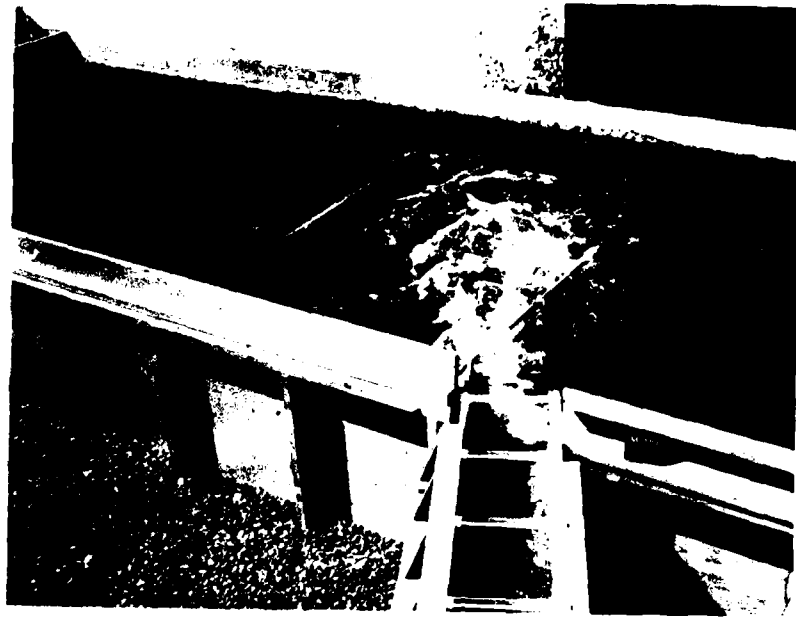
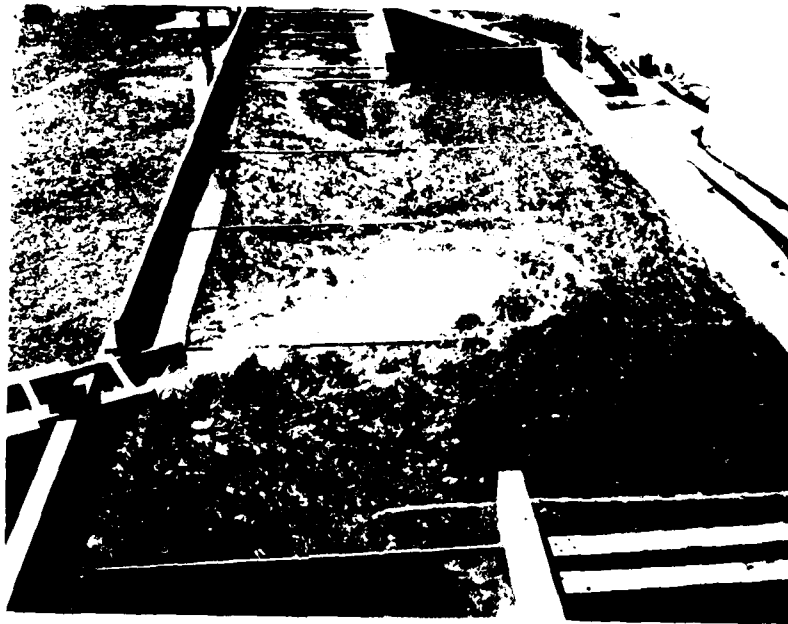
Photograph 61. View from Placer Creek

Photograph 62. View from South Fork Coeur d'Alene River

Thunderstorm Flood Hydrograph
Placer Creek Discharge 4,600 cfs
South Fork Coeur d'Alene River Discharge 400 cfs

33. The maximum flow of 4,600 cfs was reached shortly after the 4th hour of the storm (photographs 61 and 62). The volume of scouring increased with the bulk of the rock forming a berm beyond and downstream from the expanded scour area. Flow was still over the top of the South Fork Coeur d'Alene River bank. Scouring reduced sharply when flow dropped to 4,100 cfs after 4 hours and 30 minutes of the storm. The shooting flow was reduced, and the top of the newly formed berm of aggraded rock was exposed.

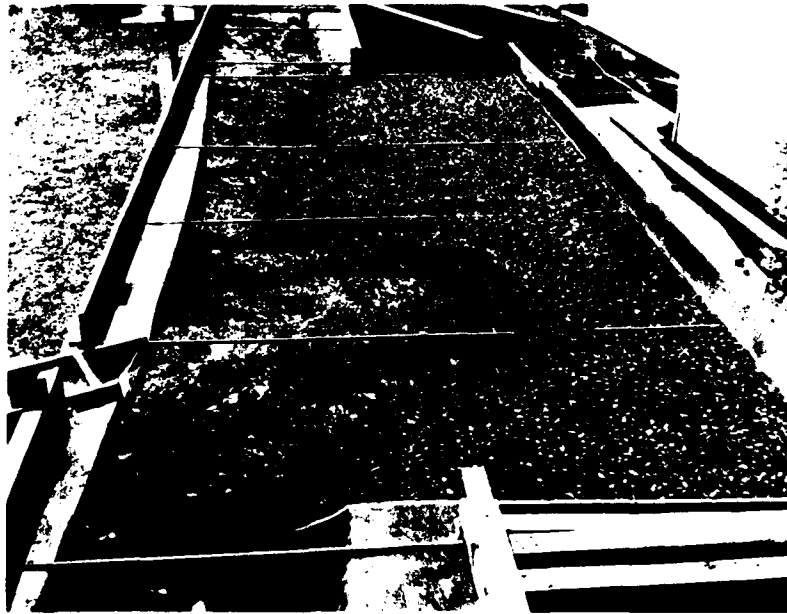
Photograph 63. Placer Creek discharge 2,500 cfs

Photograph 64. Placer Creek discharge 1,000 cfs

Views From South Fork Coeur d'Alene River

Thunderstorm Flood Hydrograph
South Fork Coeur d'Alene River Discharge 400 cfs

34. Only drifting and readjusting of bed material occurred at a flow of 3,500 cfs during the 5th hour of the storm. After 5 hours and 30 minutes flow receded to 3,000 cfs and most of the right bank was exposed again. Some rock still moved along the river bottom as flow settled back into the main channel. Photograph 63 shows how the 2,500 cfs discharge (6th hour) flowed against the left bank (wall). The flow moved some loose material but did not scour the existing invert.

35. At 2,000 cfs, after 6 hours and 30 minutes of the storm, shooting flow from Placer Creek was further reduced. Loose rock still moved along the invert but major scouring had ceased. Flow from Placer Creek started to turn downstream within the river during the 7th hour of the storm when the discharge was 1,500 cfs. All material had stopped moving, and the riverflow was confined to the left half of the channel by the deposited material. Flow was entirely downstream with a flow of 1,000 cfs (photograph 64). Riverflow was confined to a 25-foot-wide channel on the left. Just before the test was concluded with a minimum

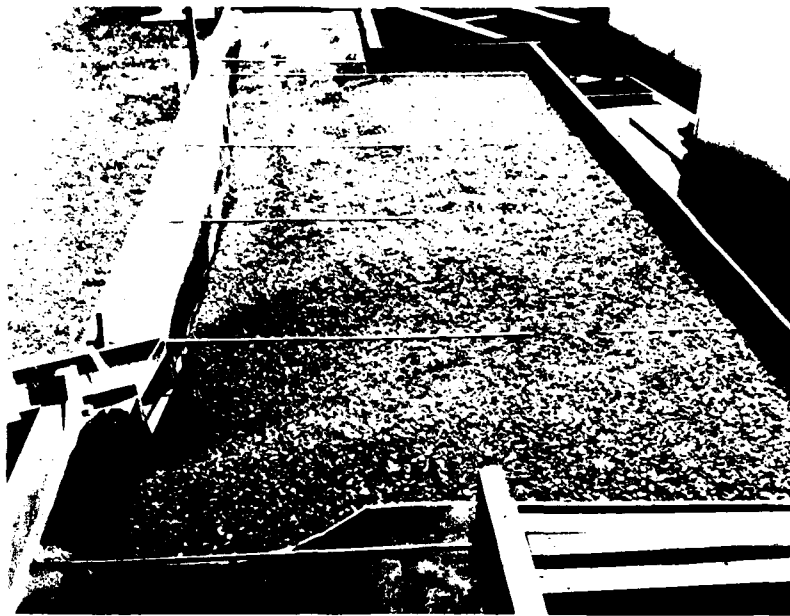
Photograph 65. View from upstream

Photograph 66. View from downstream

Thunderstorm Flood Hydrograph
Eroded Condition at End of Flood

flow of 500 cfs (after 8 hours and 30 minutes of the storm), bed material was observed to be deposited as far as 250 feet downstream from the movable bed section. Scour and deposition at the end of the flood are shown on plate 15 and in photographs 65 and 66. Flow through the highway culvert at the mouth of Placer Creek was open-channel flow at all times during the 200-year thunderstorm design flood.

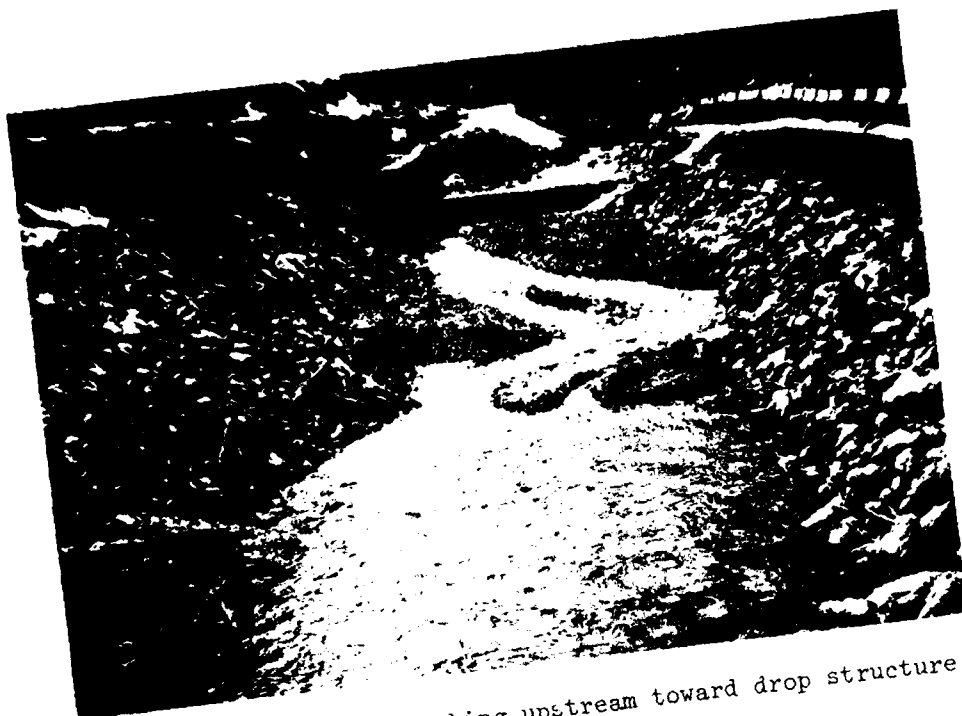
Photograph 68. View looking upstream toward drop structure

Photograph 69. Upstream face of trash barrier

Prototype Debris Basin Following February 1982 Flood
