Aerial View of Libby Dam

LIBBY DAM, KOOTENAI RIVER, MONTANA
Hydraulic Model Investigations
PART I: INTRODUCTION

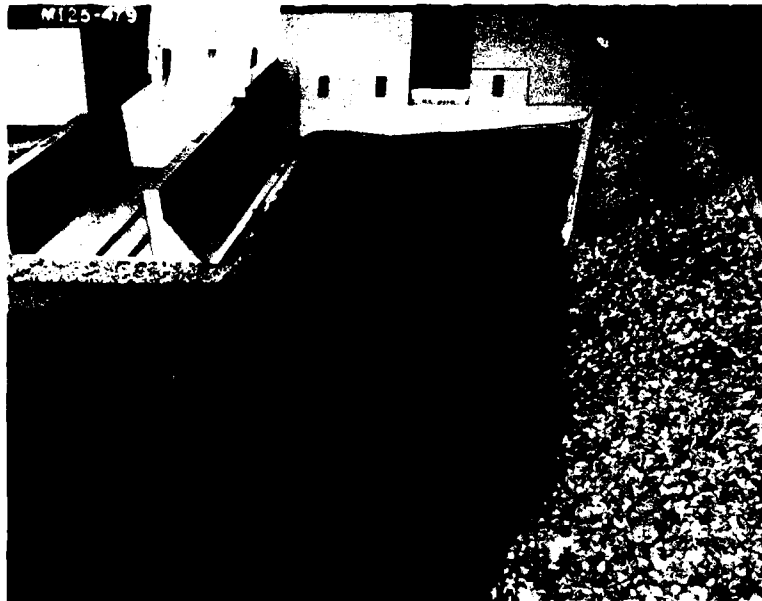
Second-step, second-stage diversion

Third-stage diversion

Photograph 15. Diversion structures and downstream channel (before scour tests).

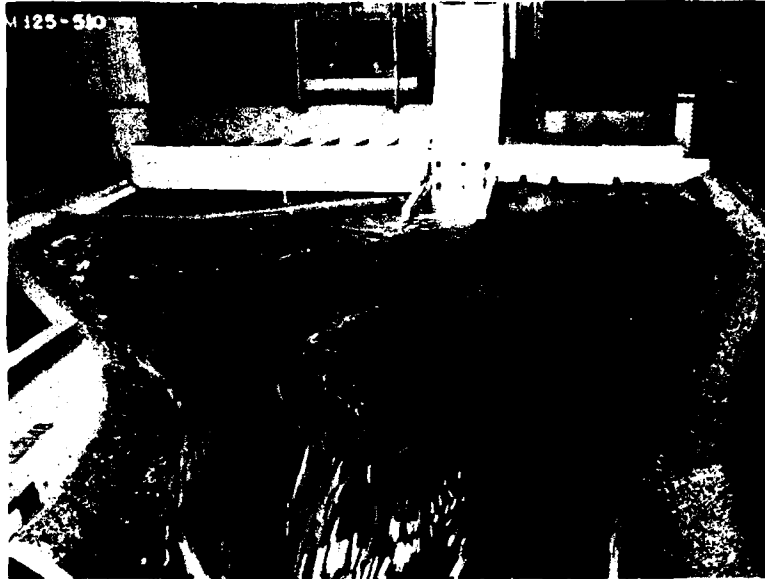
Flow conditions

Scour and deposition after 10 hours

Photograph 23. Third-stage diversion. Discharge 30,000

53. Bank velocities were low (plates 56 and 57), and only minor erosion occurred during the low flows of third-stage diversion (photographs 22 and 23). Almost all movement was along the right side. Material deposited downstream from Monolith 31 was moved into the scoured area downstream from the stilling basin by flows of 10,000 to 20,000 cfs and on downstream by 30,000 cfs (photograph 23).

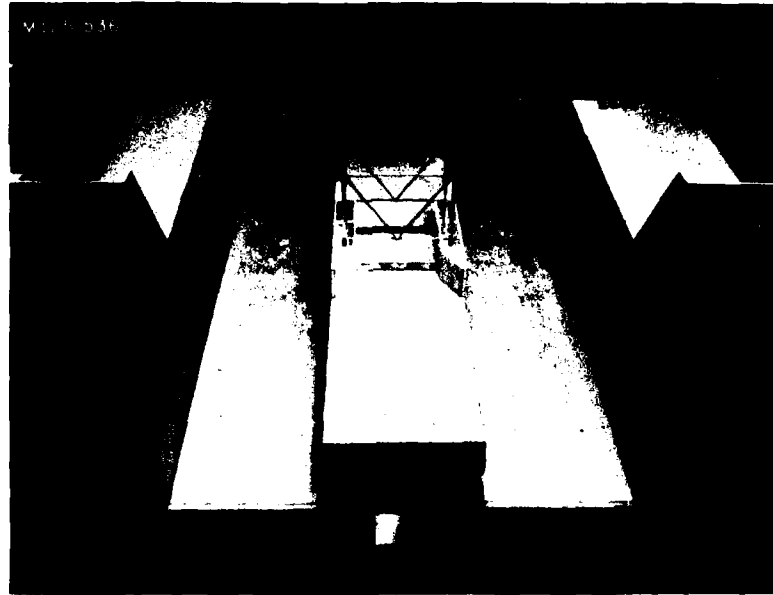
View from upstream

Discharge 109,000 cfs

Discharge 130,000 cfs

Debris caught on deflector piers and tower

Photograph 24. Low monoliths 33 to 35 and contractor's debris deflectors and tower, first-step, second-stage diversion.

57. The adopted plan included two 15-foot-high concrete piers that encased the tower legs (photograph 24 and plate 60). Each pier served as a deflector and would become part of the mass concrete of the monolith. Debris that caught on the long pier noses could be dislodged or removed by means of overhead cranes. Flow around the piers was satisfactory. Debris caught on a pier nose and on a cross

member of the model tower is shown in photograph 24. The piers had no significant effect on the forebay elevation during a riverflow of 109,000 cfs. Maximum rideup of waves on the piers was 14 feet.

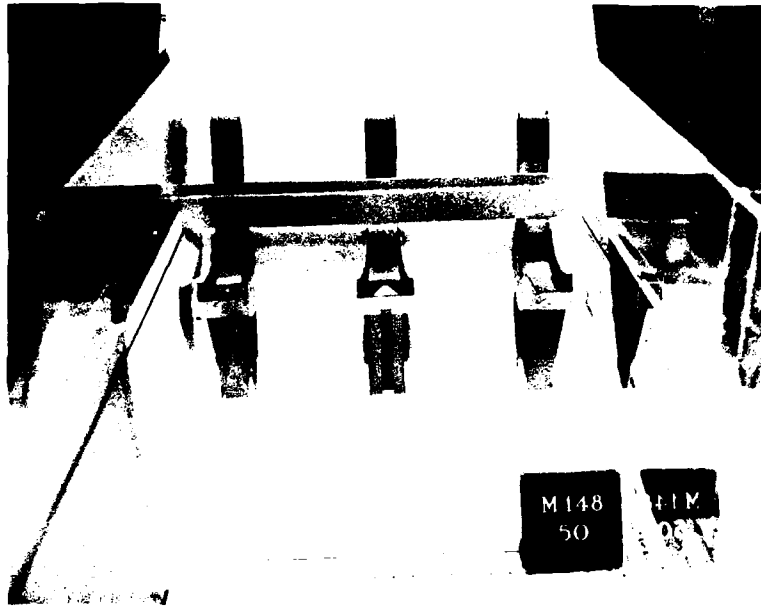
View from downstream

Side view

Photograph A-4. Plan E, 30-degree flip bucket at sluice outlets.

5. Flip buckets that would project the sluice flow over the stilling basin into relatively shallow water on the runout slope and reduce the amount of nitrogen that would be absorbed were tested (photograph A-4). With normal pool elevation 2459 and a 30-degree flip bucket with lip at elevation 2127.7, zones of impact were on the stilling basin runout slope (photographs A-5 to A-7). With minimum pool elevation 2287, impact was in the basin and entrained air was carried to the basin floor at the end sill. After several combinations of deflectors and flip buckets were tested, flip buckets were abandoned because potential damage to the runout slope and waves in the exit channel were considered to be too severe.
