JETTY STABILITY STUDY OREGON INLET NORTH CAROLINA
HYDRAULIC MODEL INVESTIGATION(U) COASTAL ENGINEERING
RESEARCH CENTER VICKSBURG MS R D CARVER ET AL. SEP 83
CERC-TR-83-3

TECHNICAL REPORT CERC-83-3

JETTY STABILITY STUDY, OREGON INLET, NORTH CAROLINA

Hydraulic Model Investigation

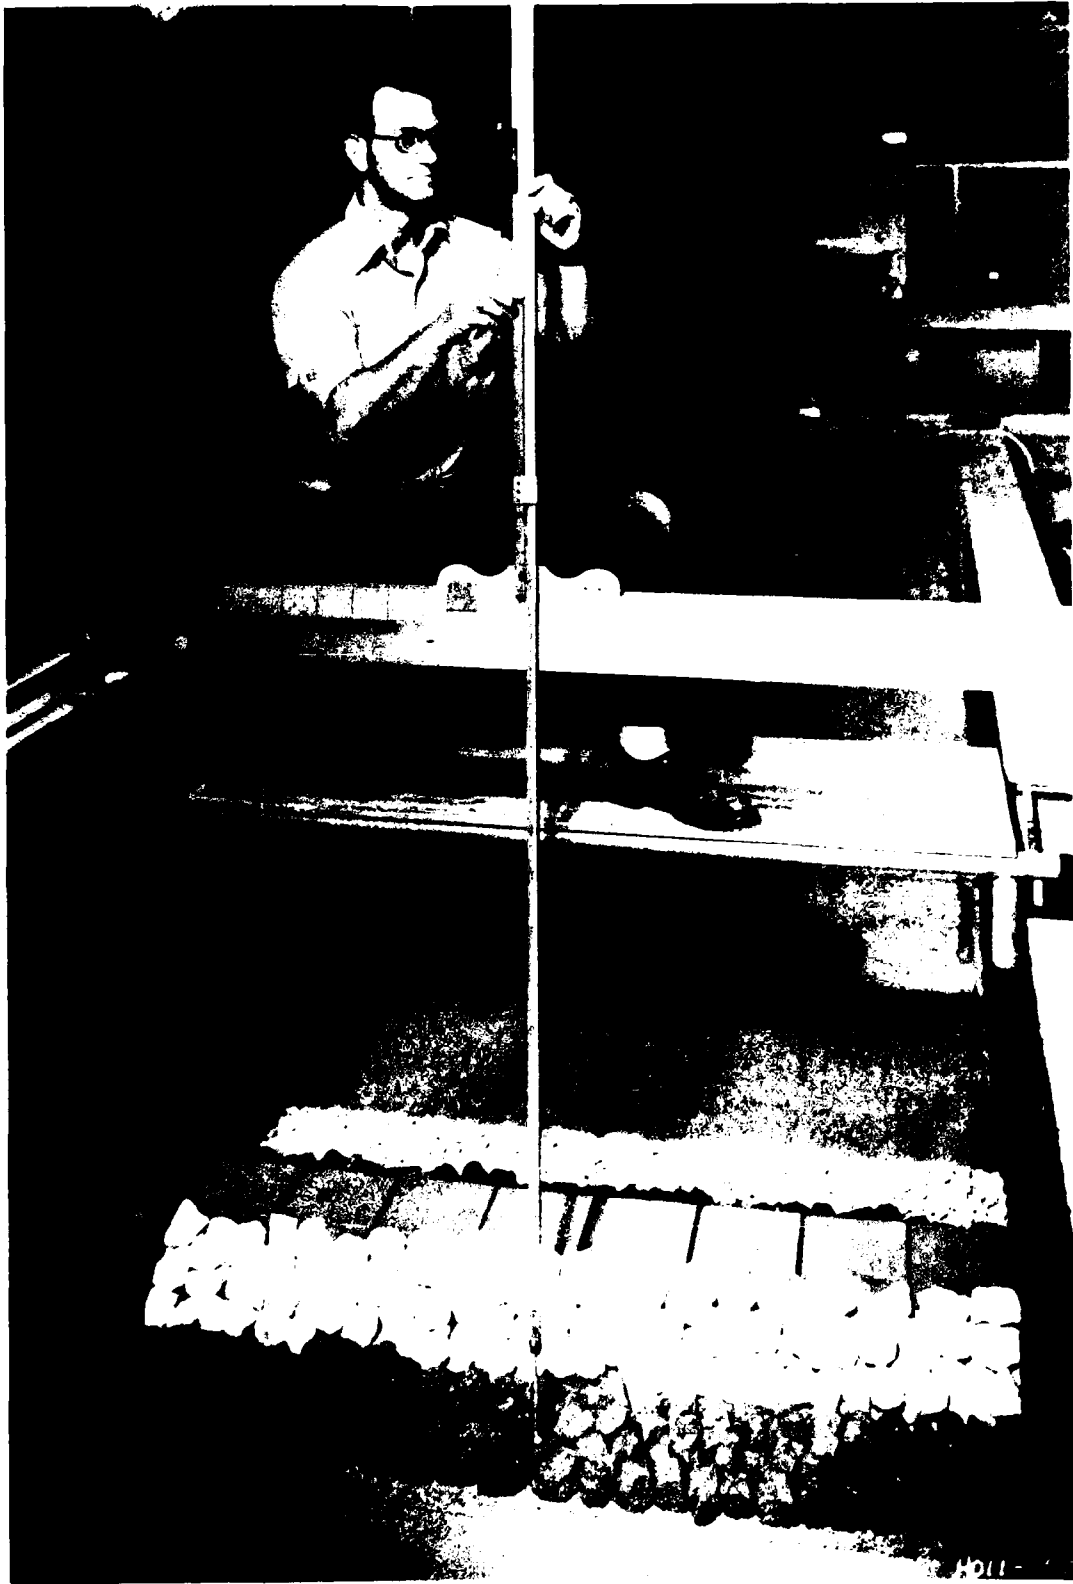
Figure 4. Sounding jetty before wave attack

23. Sounding data for each test section were obtained as follows. After the core material and first underlayer were in place, soundings were taken along rows beginning at and parallel to the center line of the structure and extending in 0.20-ft increments to the seaward and channelward edges of the armor (the spacing between some rows was slightly more or less than 0.20 ft to provide better resolution in the vicinity of slope changes or armor material size interfaces). On each parallel row, 16 or 24 sounding points, spaced at 0.20-ft increments, were measured. This distance represented the middle

3 and 4.6 ft of the 5- and 6.6-ft-wide test sections; the 1 ft of the structure next to each wall was not considered because of possible discontinuity effects. Soundings were taken at the identical points once the armor was in place and again after the structure had been subjected to wave attack.

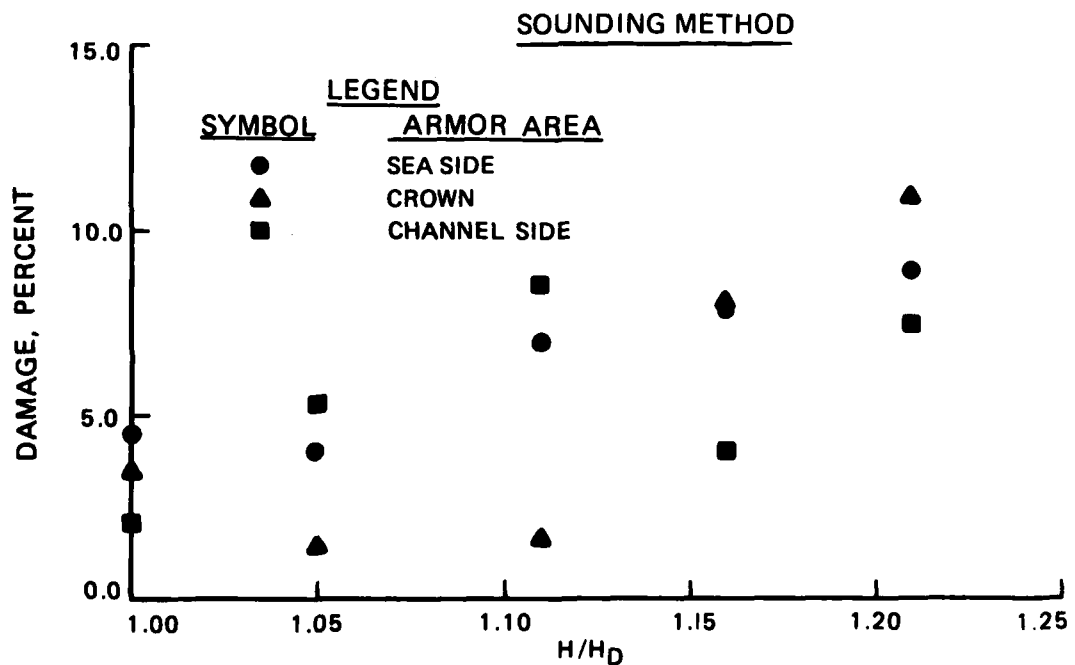
Figure 10. Damage as a function of H/H_D for Plan 4D

46. As reported in paragraphs 39 through 41, it was determined that a sea-side stone weight of 22 tons (Plan 4D) and a sea-side dolos weight of 9.25

tons (Plan 10) would be stable for a design-wave height of 15.5 ft at an swl of +7.5 ft. Using these test results ($K_D = 2.3$ and 8.3 for plan 4D and Plan 10, respectively) in conjunction with the HSE, predicted stable armor weights for a design-wave height of 17.2 ft at the +9.5 ft swl are 30.5 and 12.5 tons for the stone and dolosse, respectively. Therefore, initial stability tests were conducted with 30.5-ton stone and 12.5-ton dolosse.

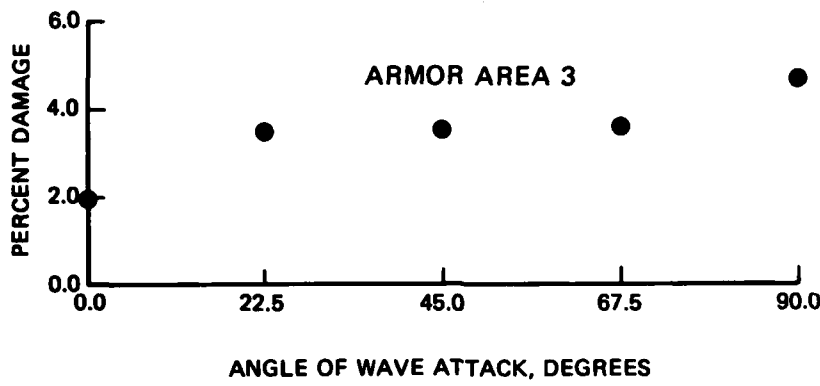
Figure 20. Percent damage as a function of angle of wave attack for Plan 3D-2C; +1 ft swl followed by +8 ft swl

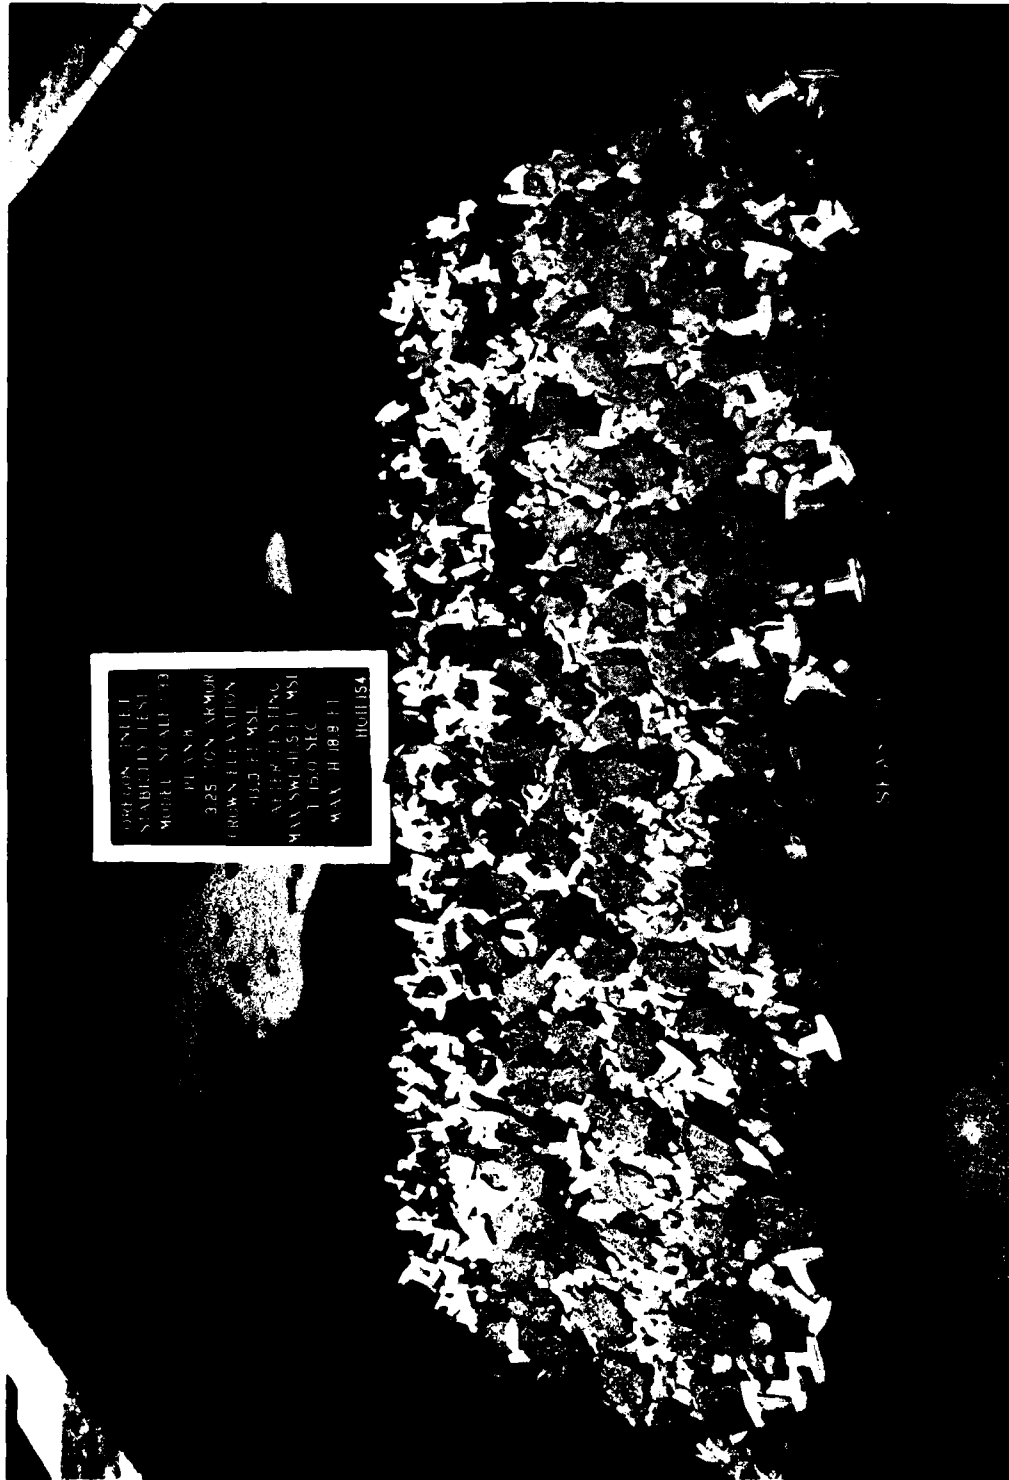
Photo 64. End view of Plan 4B after testing step 13 of the +11.5 ft NGVD hydrograph

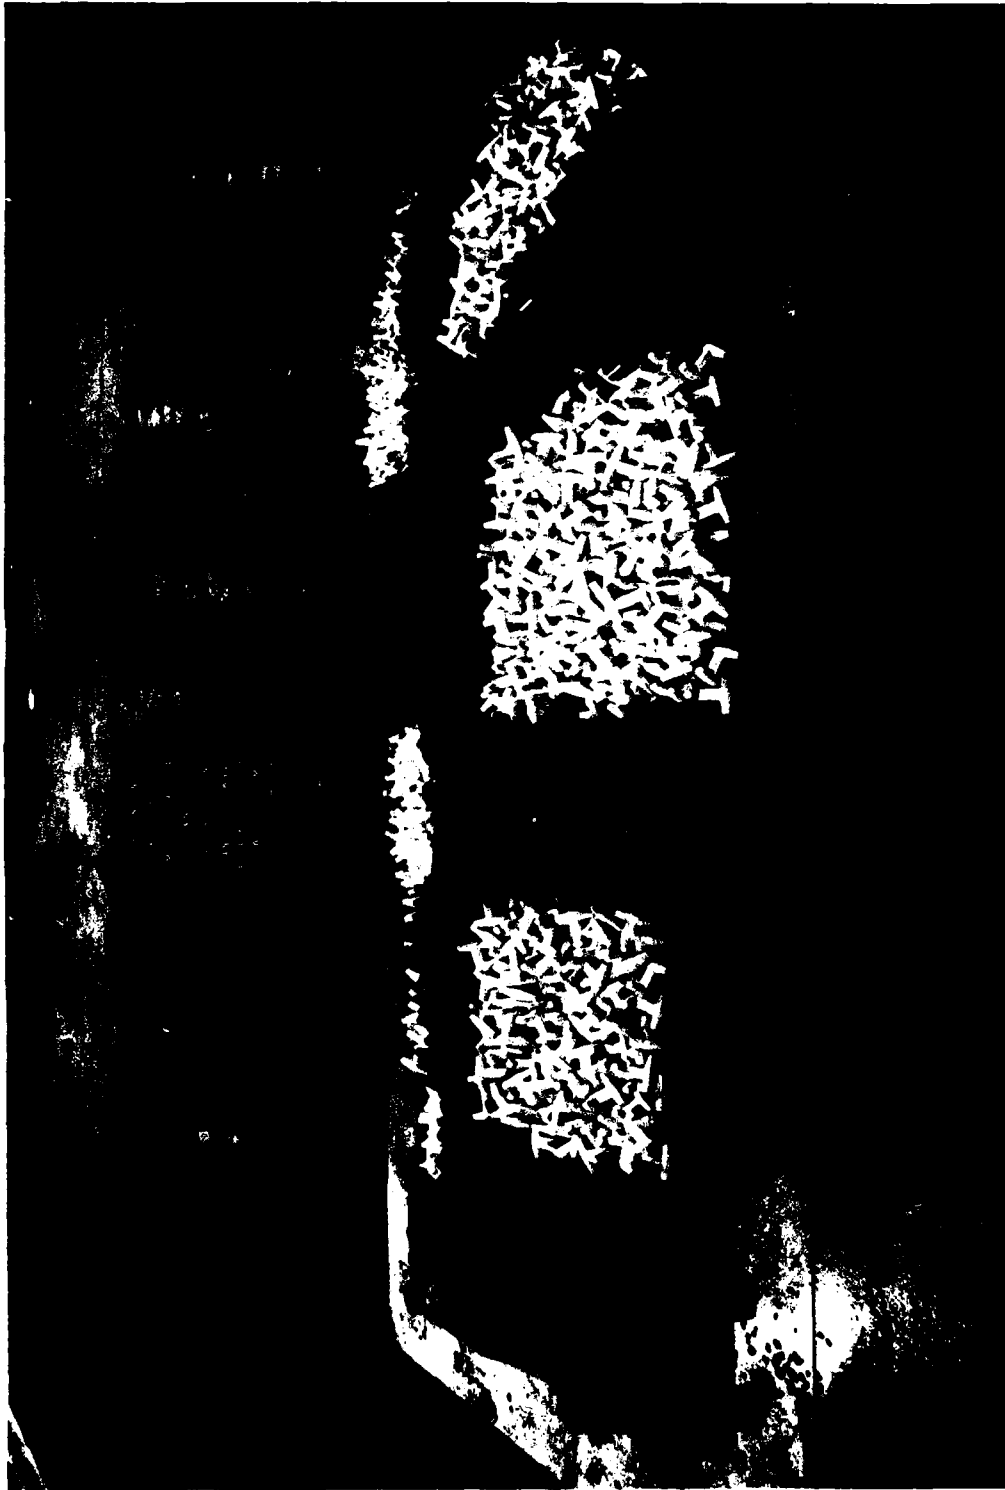
Photo 144. Repeat test of Plan 3D-1; end view after attack of 15-sec, 17.6-ft nonbreaking waves at an swl of +8 ft NGVD followed by 15-sec, 17.6-ft breaking waves at an swl of +1 ft NGVD; angle of wave attack = 90 deg

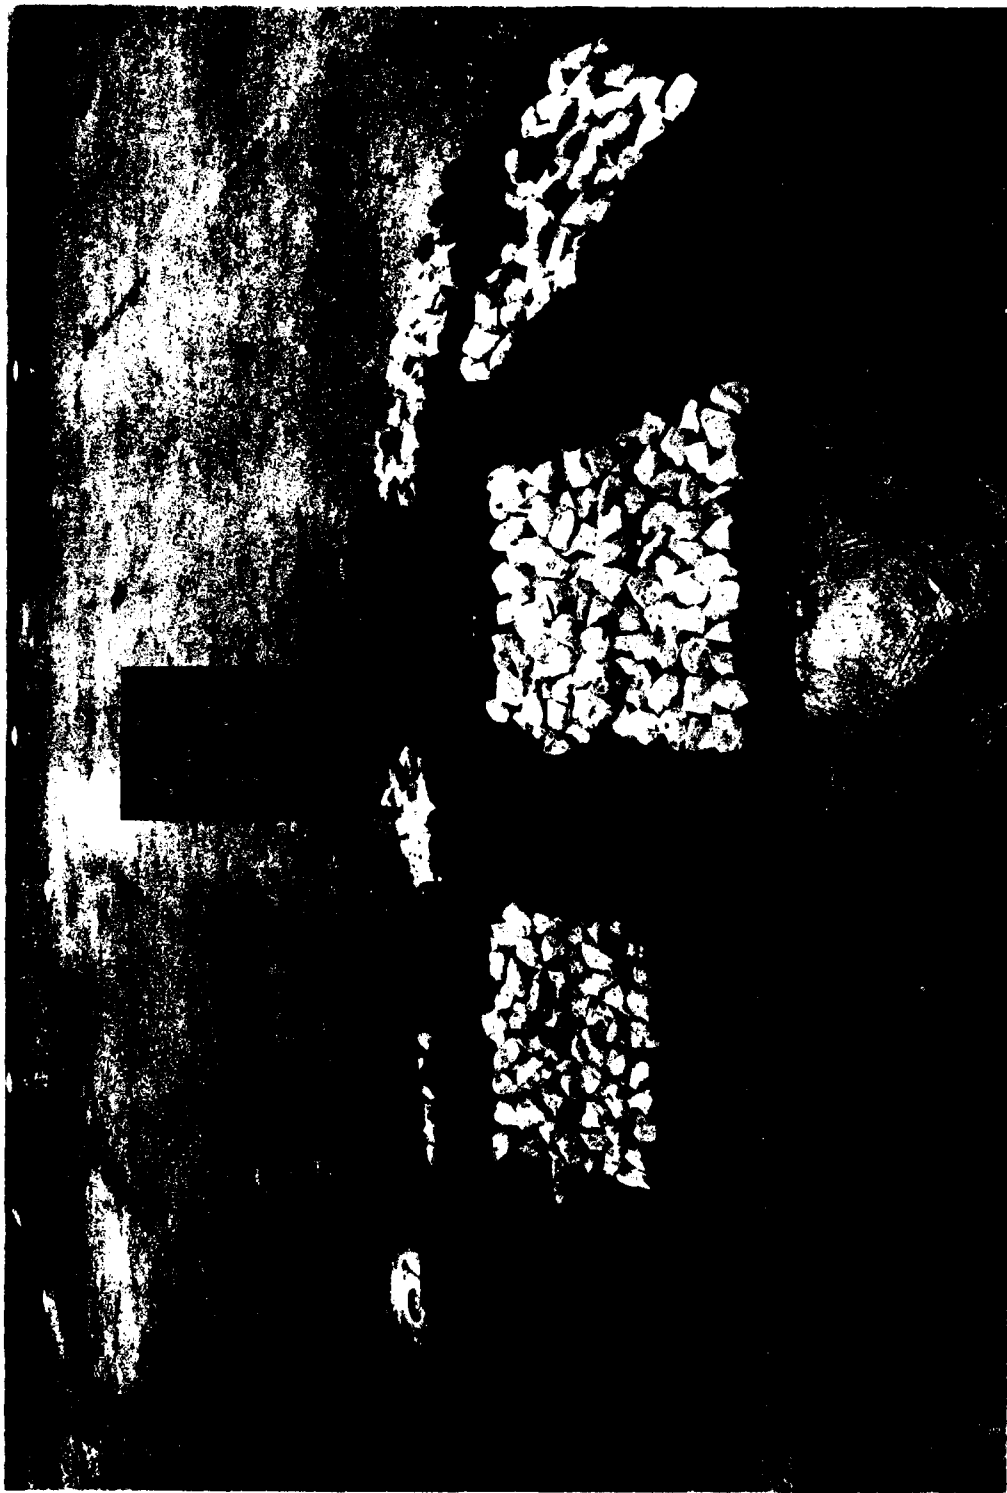
Photo 147. Repeat test of Plan 3D-2; end view after attack of 15-sec, 17.6-ft nonbreaking waves at an swl of +8 ft NGVD followed by 15-sec, 17.6-ft breaking waves at an swl of +1 ft NGVD; angle of wave attack = 90 deg

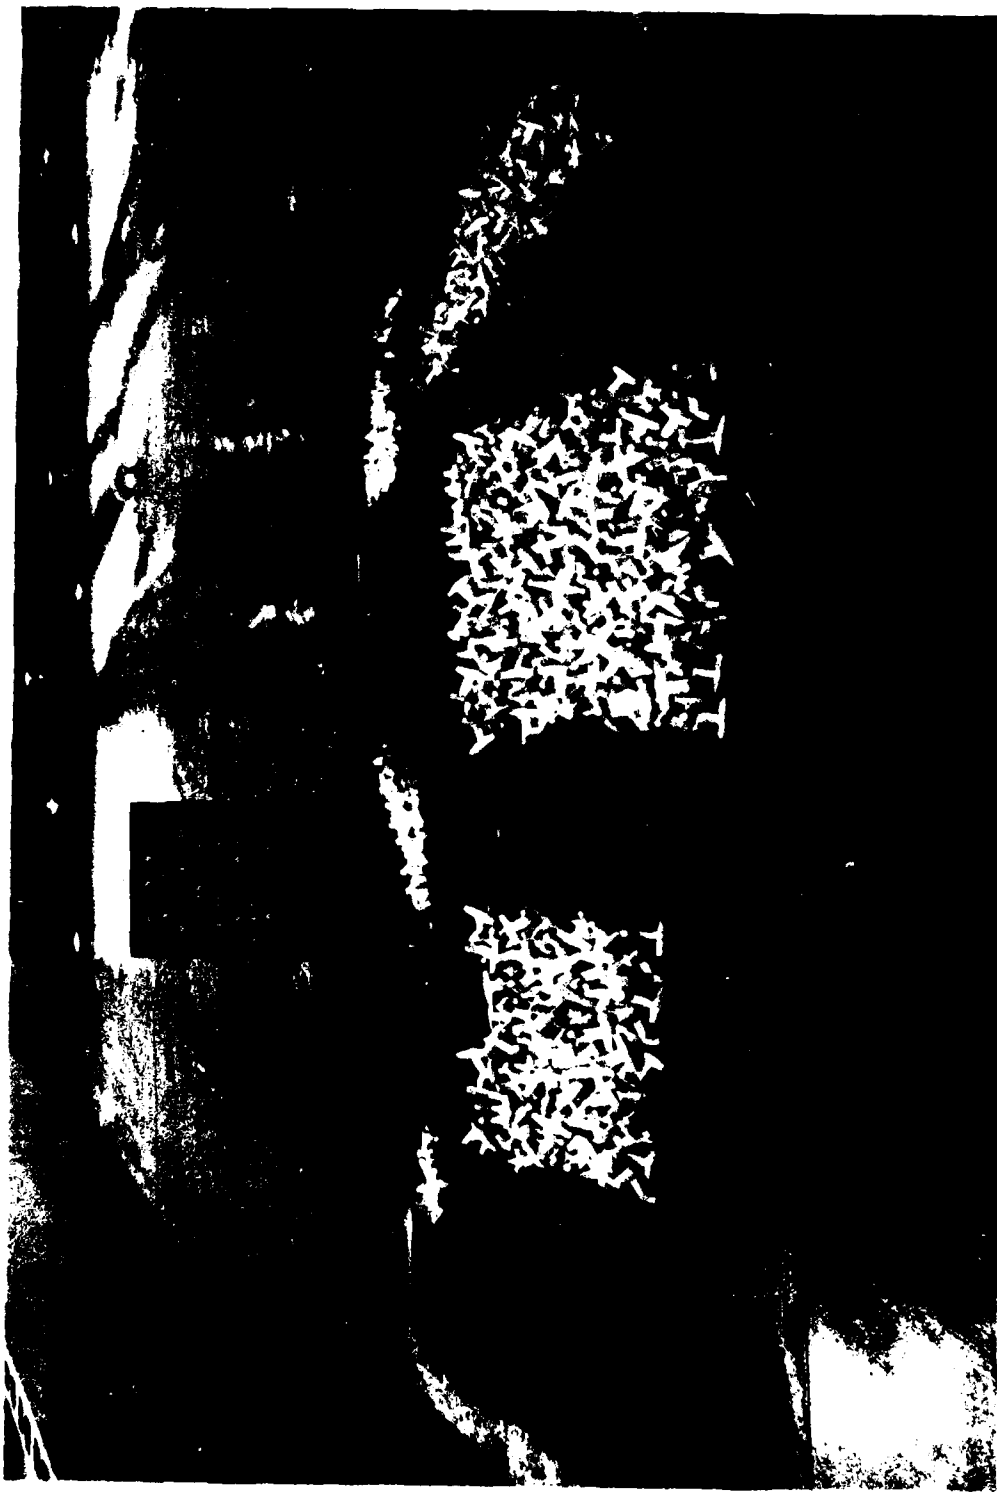
Photo 150. End view of Plan 3D-1A after attack of 15-sec, 17.6-ft breaking waves at an swl of +1 ft NGVD followed by 15-sec, 17.6-ft nonbreaking waves at an swl of +8 ft NGVD; angle of wave attack = 90 deg

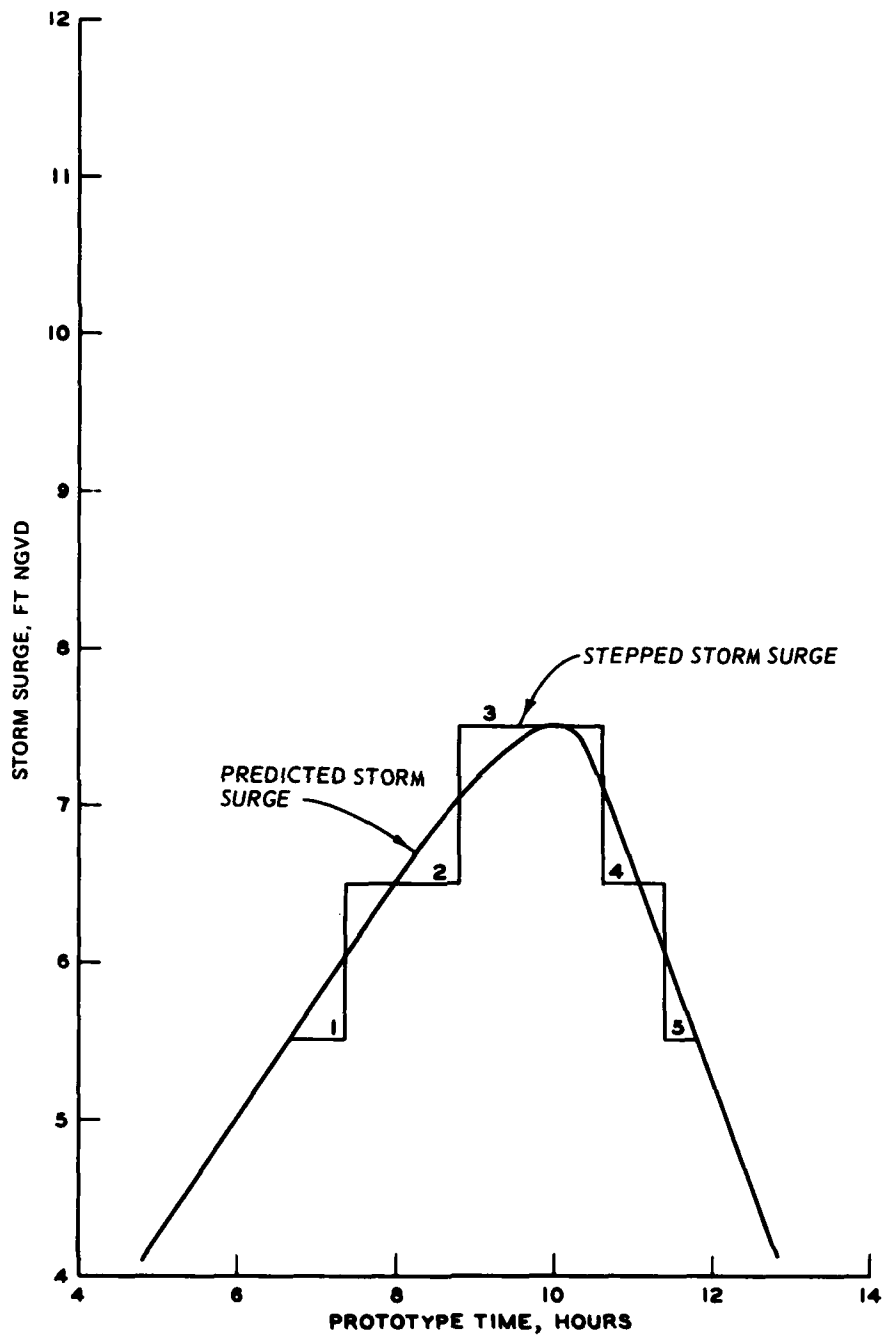
NOTE:
 NUMBERS INDICATE HYDROGRAPH
 STEP NUMBER.
 TEST CONDITIONS FOR EACH
 STEP ARE GIVEN IN TABLE 2.

STORM-SURGE HYDROGRAPH
 MAXIMUM SURGE 7.5 FT NGVD
 DESIGN SWL 5.5 FT NGVD

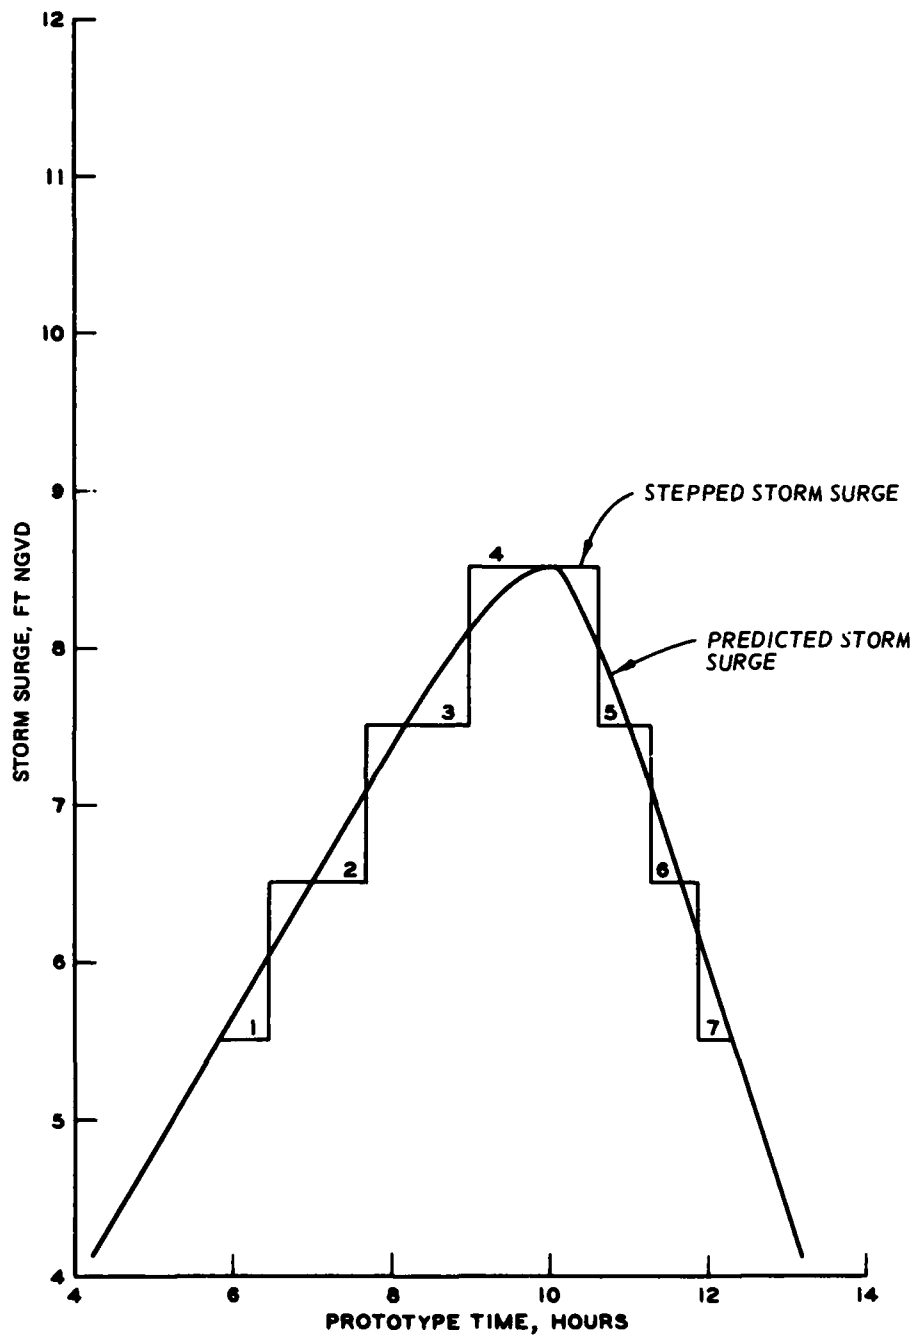
NOTE:
 NUMBERS INDICATE HYDROGRAPH
 STEP NUMBER.
 TEST CONDITIONS FOR EACH
 STEP ARE GIVEN IN TABLE 2.

STORM-SURGE HYDROGRAPH
 MAXIMUM SURGE 8.5 FT NGVD
 DESIGN SWL 5.5 FT NGVD
