AD-R139 855 UNCLASSIFIED	STREAM LOCAL STATIO OCT 83	BANK PROTECT GOVERNMENTS N VICKSBURG	TION GUIDE (U) ARMY E MS ENVIRO	LINES FOR Ngineer Wa Nmental La	LANDON TERWAY B M P	NERS A 5 Expe Keown F/g 8	ND RIMENT /8	. 1/1 NL	
					ни.		÷	R	
	2				MELS				
		1 12 12 1							
				-					
k	_

Prepared by: U.S. Army Engineer Waterways Experiment Station, Vicksburg, Mississippi 39180 Written by: Malcolm P. Keown,

October 1983

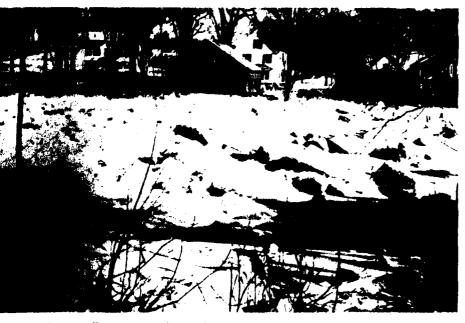
Debris can cause streambank erosion due to abrasion or impact.

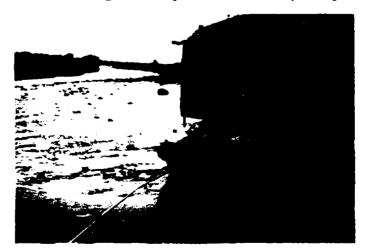
Clearing of a greenbelt adjacent to the top of a streambank often leads to severe erosion.Note natural greenbelt in background.

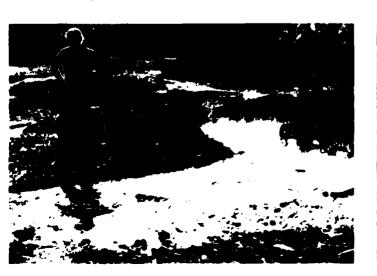
Pilot channel eroding point bar (left). Concrete check dam (right).

If later observations indicate that the shrubs are preventing the bar from eroding, then they will have to be removed. Next, dig one or more pilot channels through the bar. The pilot channels can be dug with hand tools if trenching equipment is not available or if the bar is not accessible to machinery. Locate the channels at such an angle that a rapid current is diverted into the trench. This rapid current is needed to erode the bar. If the bar is large, several pilot channels may have to be dug. Any large stones or leaf debris should be raked off the sides of the bar. This will increase the current flow along the edges of the bar and promote erosion. If the bar is not removed by flow through the pilot channels, a current deflector can be used. The deflector consists of a brush pile or fallen tree secured at a point upstream from the bar. The current deflector should be positioned to divert the

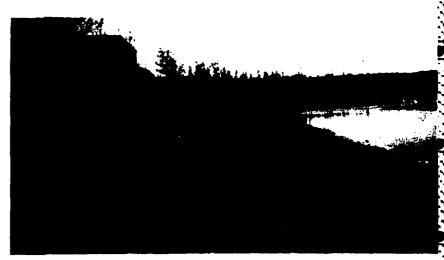
Rock and wire mattress made from prefabricated baskets.

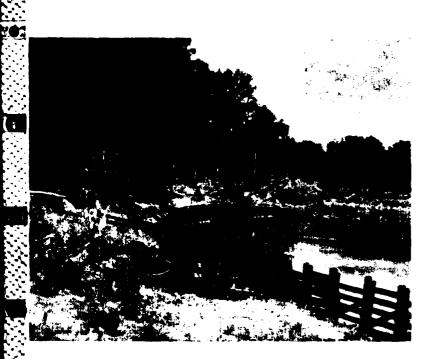
Wooden fence constructed along eroding streambanks. Note sediment deposition behind the fenceline and the tie-back fences between the fence and bank. If the fence is long, tie backs are needed to minimize flow between the fenceline and bank (left). Double row fence (right). Fences are most successful as a bank protection method on streams with heavy sediment loads.

- b. The ends of the fence should be tied into the bank at the upstream and downstream ends of the fenceline to minimize flow between the fenceline and the bank that could cause erosion. If the fence is long, tiebacks are needed at regular intervals between the fenceline and bank.

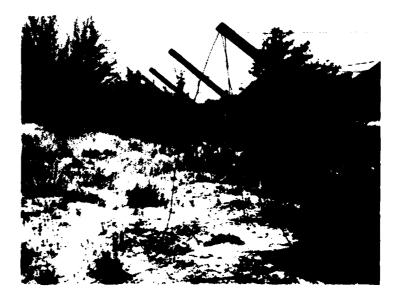
Kellner jacks assembled from angle iron.

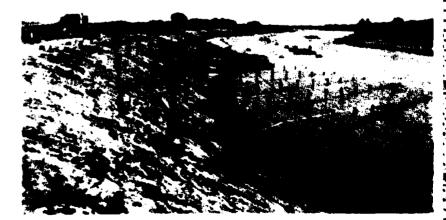
BELOW: Wire fence dike field. Note that the top of each fence post is guyed to the bottom of the fence post immediately upstream and that each fence line is tied into the bank.
