AGARD REPORT No. 716

Composite Structure Repair

Larry G.Kelly
AFWAL/FIBC
Wright Patterson AFB
OH 45433
USA

Paper presented at the 57th Meeting of the Structures and Materials Panel in
Vimeiro, Portugal on 9-14 October 1983.

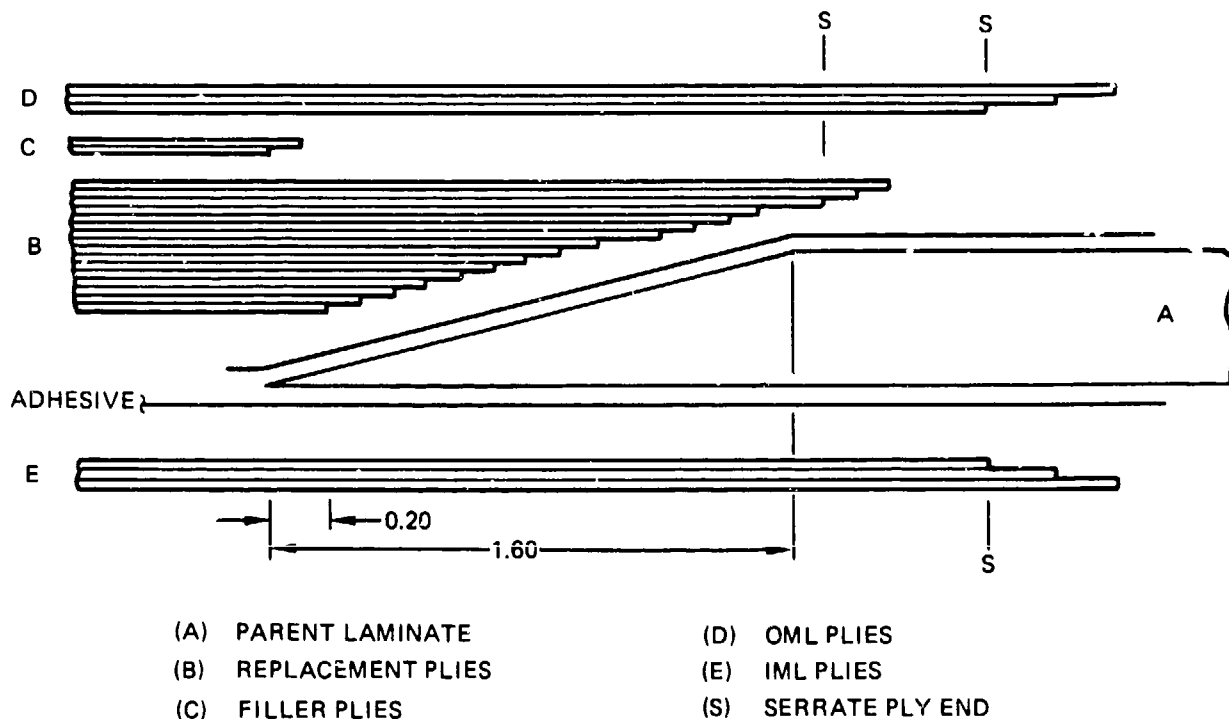
Figure 10. Basic Cured 16-Ply Scarf Joint

This basic scarf joint employs an 18:1 taper ratio since a .10 inch step is 18 times the nominal ply thickness of (.0055 inch). The scarfing is accomplished quite readily with the use of a portable router to cut .10 inch concentric steps, each successively larger, followed by a portable power driven sander to provide a finished scarf. A good scarf patch design practice is to extend the outermost plies over the ends of all the other plies and to serrate these plies to minimize ply end peeling. This can easily be done to the edge normal to the fiber direction with a pair of standard 1/8 inch V-notch pinking shears. It is also good practice to avoid placing unidirectional material as the outer most ply. An outside cover of woven material or for balanced

Precured bonded composite doublers, discussed previously, metal sheets and plates and metal foils of 8, 12 and 16 mil thickness have all been utilized satisfactorily as patch materials for low load levels and relatively flat surfaces. For curved or irregular surfaces and intermediate to high load levels the most versatile repair concept is the cured in place flush scarf repair. Accomplishing the scarf may appear difficult at first but was found to be relatively easy with simple portable tools. As a general rule when making a large area repair a flush scarfed repair is preferred since a significantly higher percent of the strength of the parent laminate can be restored. This is especially true for compressive loading where eccentricity of the patch can increase bending forces. Practical size limitations will probably restrict this repair approach to laminate thicknesses less than 1/2 inch because of the amount of material that has to be removed to achieve the required taper for proper scarf angle ($L = 18$ to 40 times the thickness). Figure 10 illustrates a typical scarf joint using a 16 ply laminate to be repaired.
