US Army Corps  
of Engineers  
Construction Engineering  
Research Laboratory

TECHNICAL REPORT P-85/13  
June 1985

# Design Criteria Upgrade for U.S. Army Type II Air Traffic Control Towers

This report documents research conducted to identify problem areas in the design of existing Type II Air Traffic Control Tower (ATCT) installations and to develop standard design criteria to avoid these problems in future installations. Many design problem areas were identified in the ATCT structure's architectural design, substructure, superstructure, roof systems, exterior walls, interior construction, mechanical systems, electrical systems, and air traffic control interfaces. For each of these areas, specific solutions to the problems were recommended. However, incorporation of these solutions must consider a specific site's location and environmental conditions.

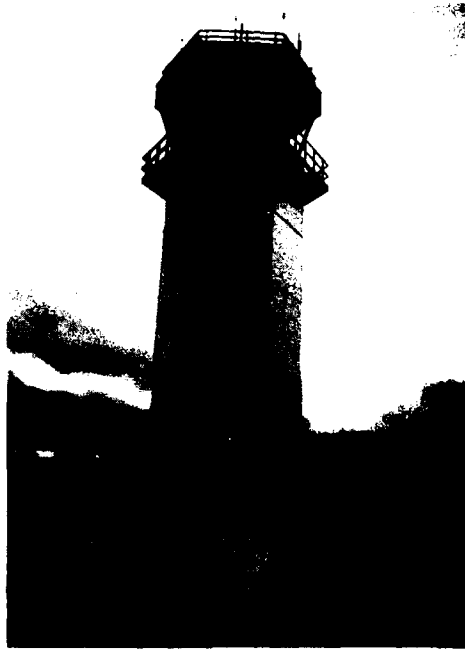
**Figure 1.** Type II ATCT exterior view (runway side).

The Type II ATCT at Fort Huachuca, AZ (Figures 1 through 7) was examined and problem areas were recorded based on observations and discussions with ATCA and tower personnel. Problem areas in other Type II ATCT installations were also compiled. Construction documents for towers at Fort Huachuca, Fort Wainwright, and other Type II ATCT installations were examined, and problem areas identified. Areas for which design and construction upgrades would be appropriate were then determined and upgrade tasks defined. Finally, design and construction criteria were developed that addressed the identified problem areas and provided guidance for avoiding them in future Type II installations.

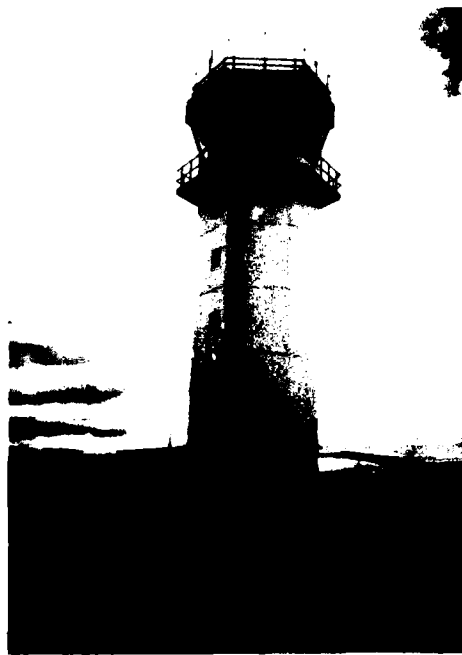
**Figure 2.** Type II ATCT exterior view (back side).

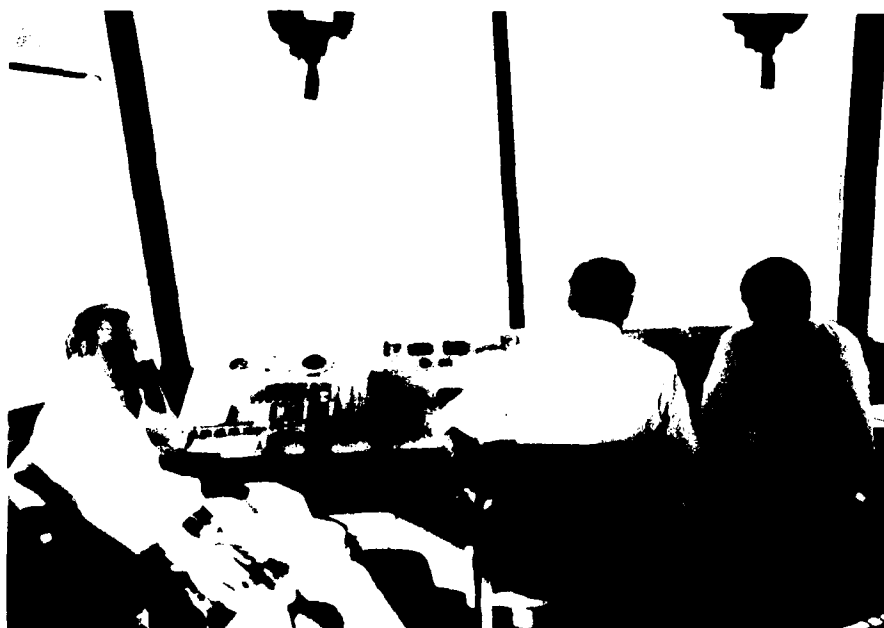
**Figure 4.** Interior view of control cab.

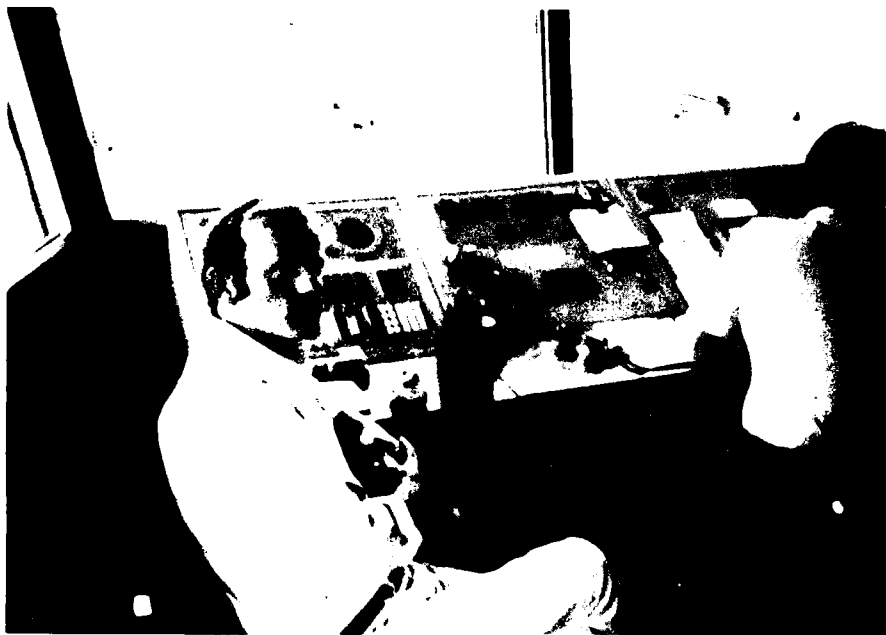
**Figure 5.** Controller station and console.

Placement/Location. Controller consoles are in the proper position but are not flush with the front wall of the cab because cables exit the cabinet at the back. Inserts through the cab floor are located at the base of the wall and protrude above the finish floor, preventing placement of the console against the wall. Radio/amp equipment, recorder, and radar equipment are crowded into available space in the tower shaft. Locating this equipment in the tower shaft is a problem for accessibility and repair, but may be preferable for electronic reasons.
