TECHNICAL REPORT CERC-85-8

# BREAKWATER REHABILITATION STUDY, CRESCENT CITY HARBOR, CALIFORNIA

## Coastal Model Investigation

November 1985

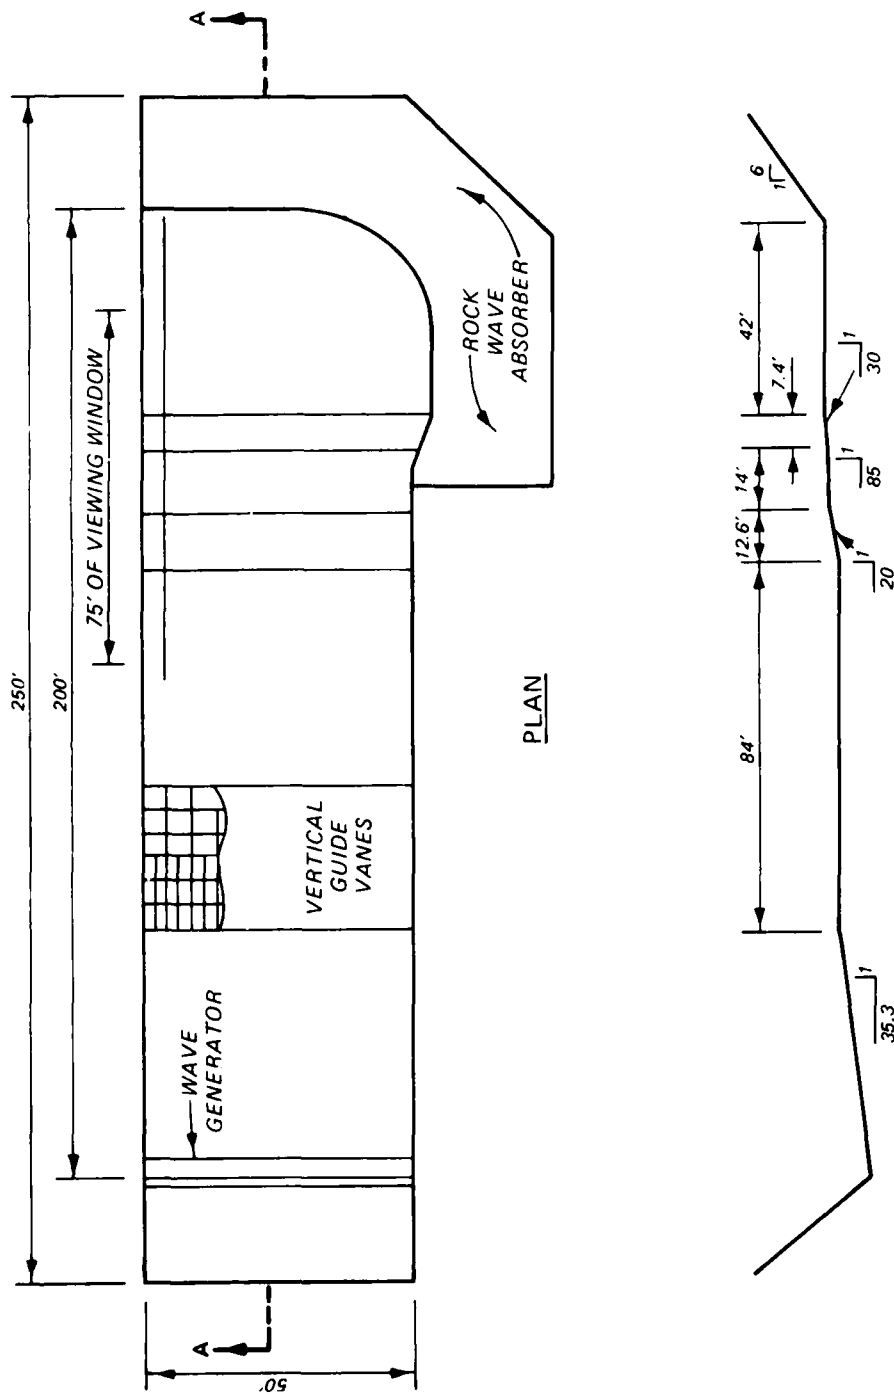
Figure 2. Wave basin geometry

24. All tests were conducted in an L-shaped wave basin which is 250 ft long, 50 and 80 ft wide at the top and bottom of the L, respectively, and 4.5 ft deep (Figure 2). The test facility was equipped with a flap-type generator which is capable of producing monochromatic waves of various periods and heights.

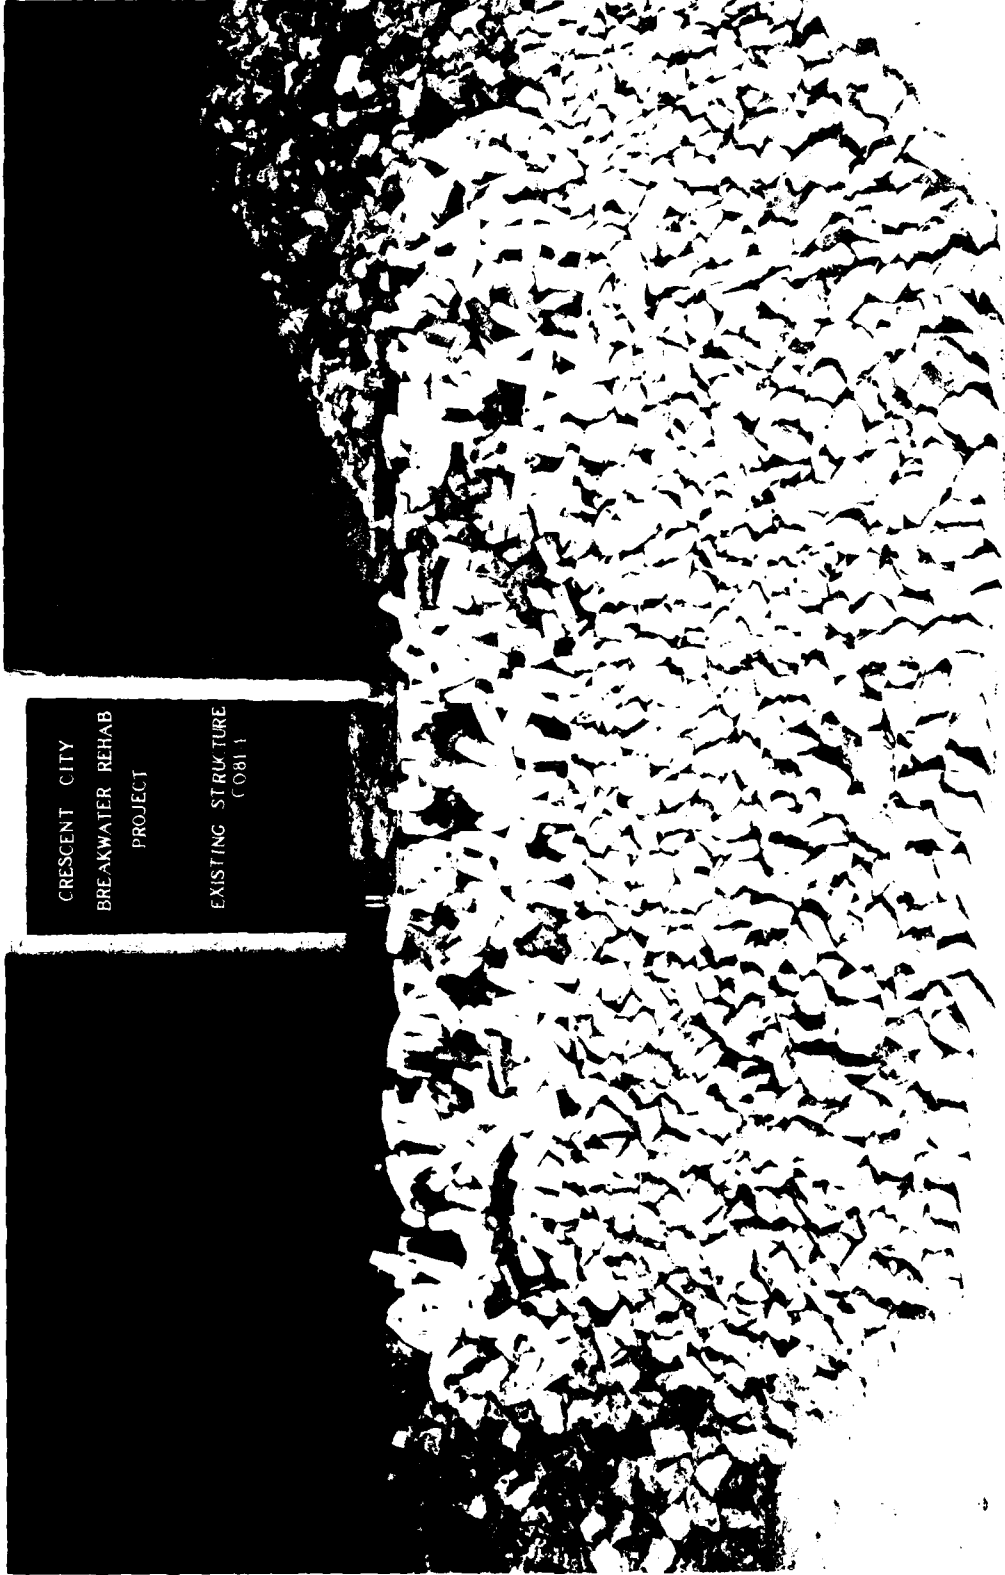
Photo 1. Sea-side view of existing structure

12. Plates 4 and 5 and Photos 1-6 show the existing structure as represented in the model. The breakwater was reproduced from sta 31+25 to 40+00, with dolos coverage from just below mllw up to the crest of the breakwater between sta 34+70 and 37+00. Dolos used in the model represented 42-ton units in the prototype. Several different configurations, or plans, were tested in an attempt to arrive at a feasible design for the dolos rehabilitation area. These plans are described in Part III.

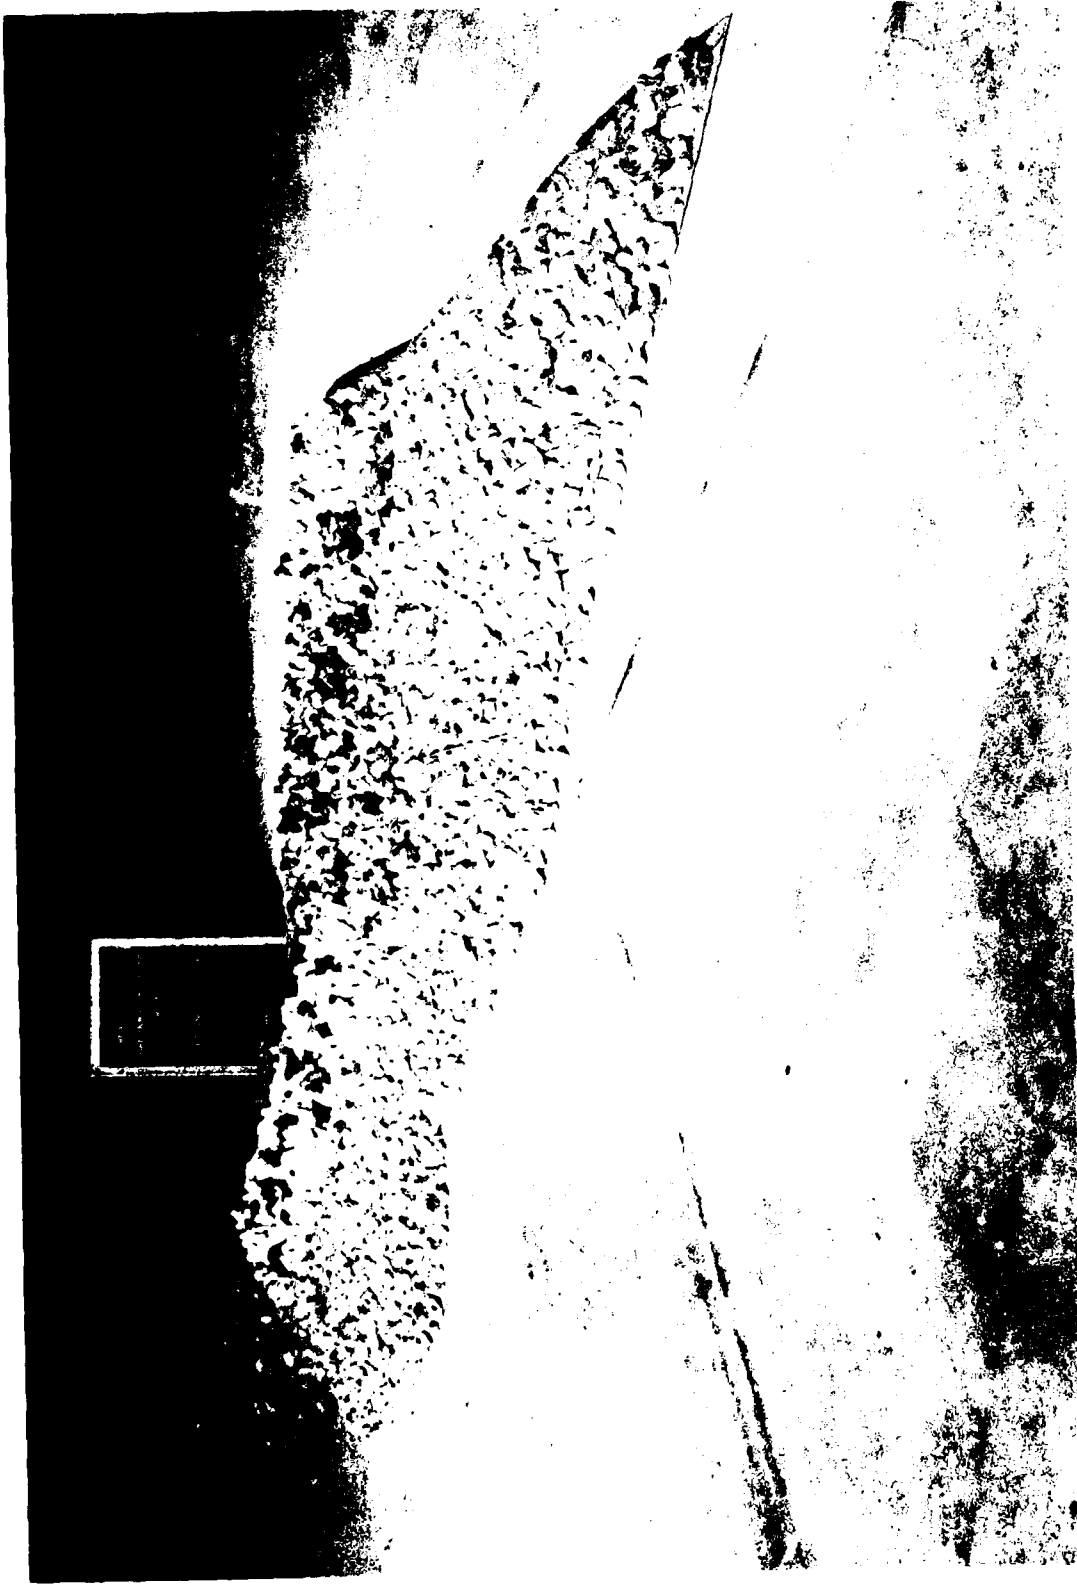
Photo 2. Seaward oblique view of existing structure

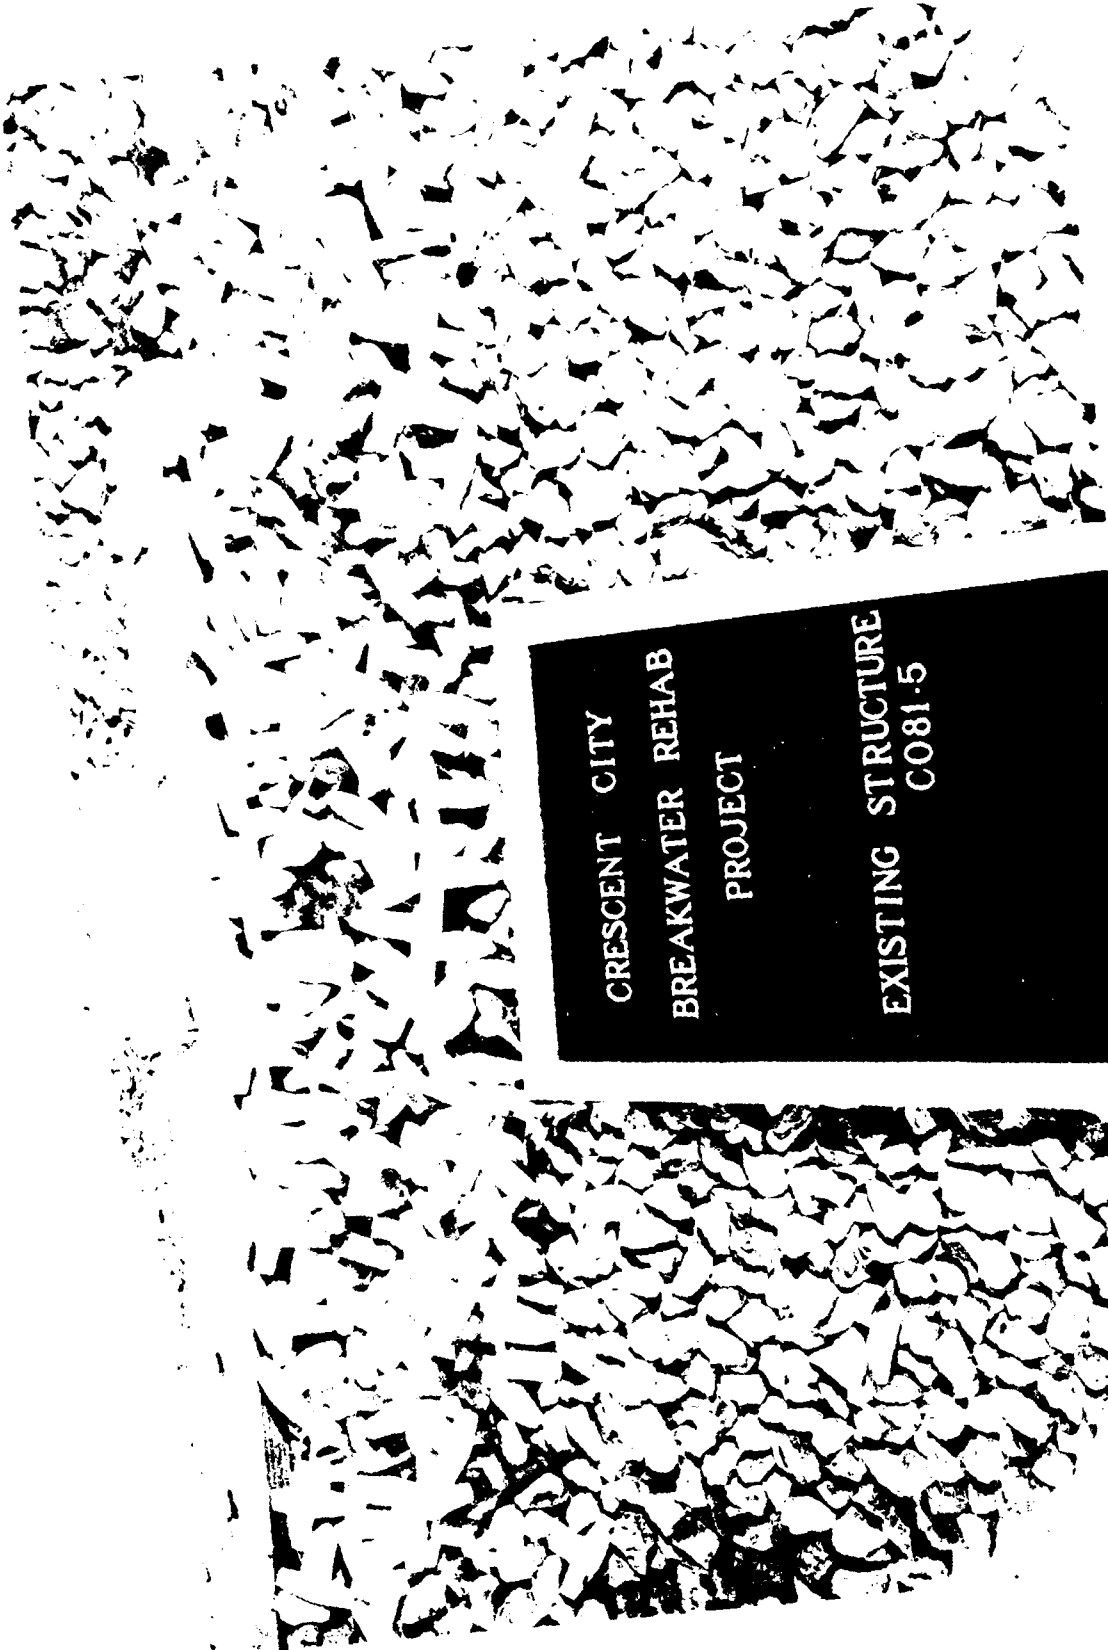
Photo 5. Shoreward end view of existing structure

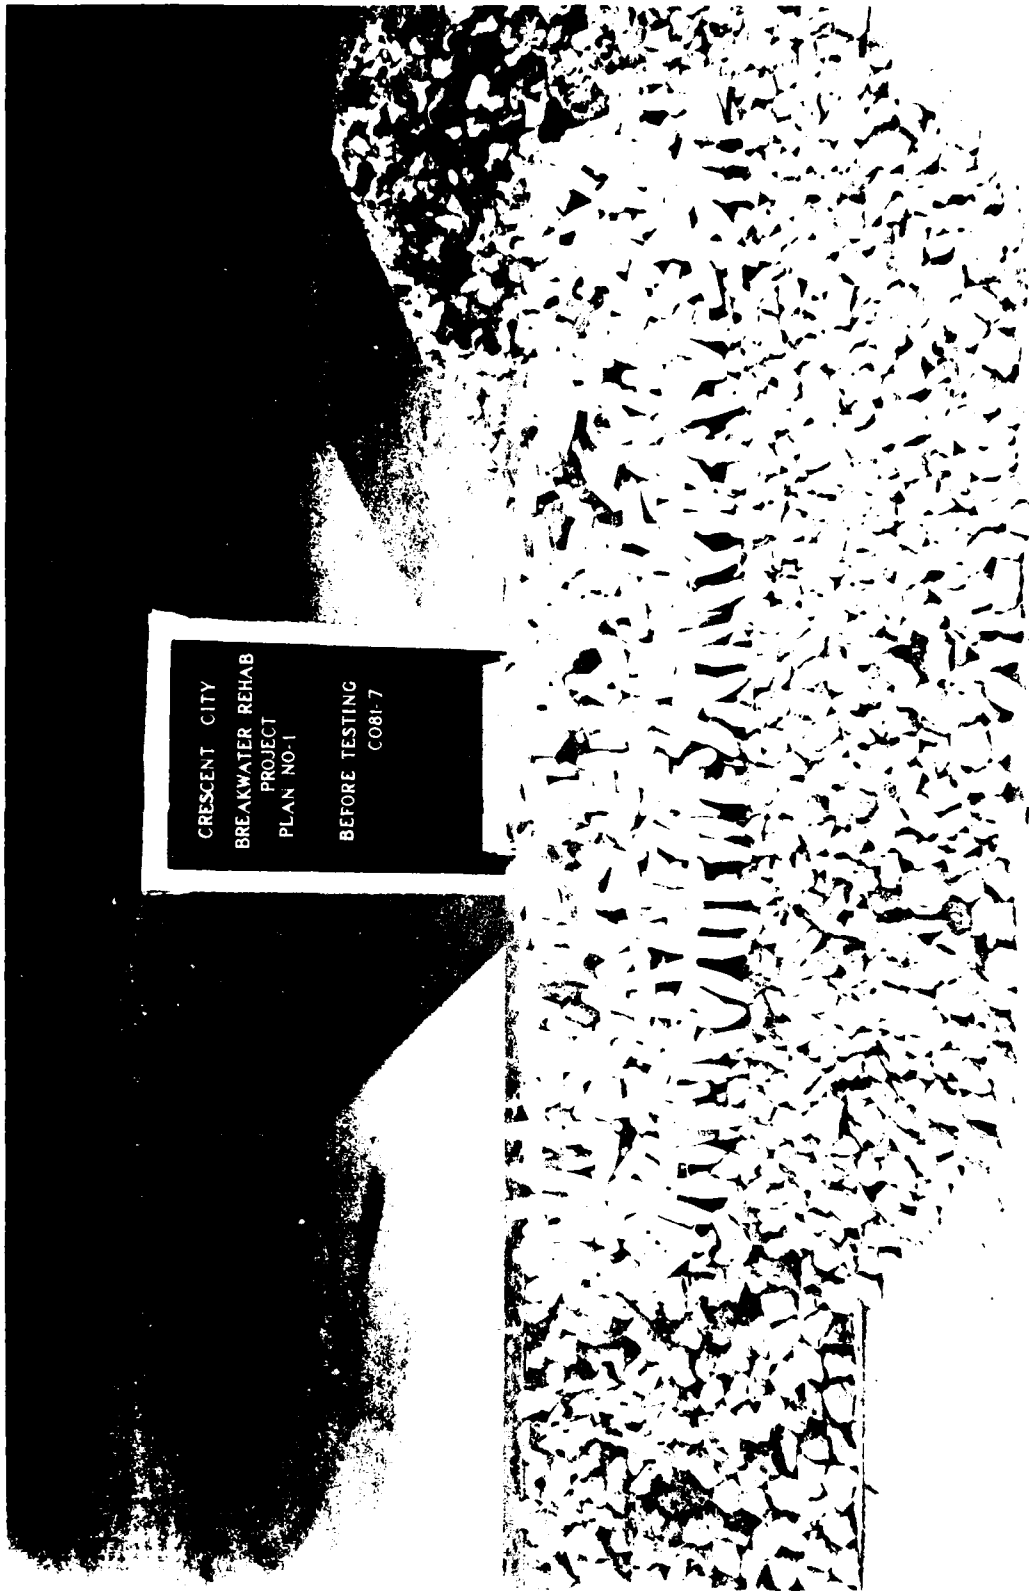
Photo 7. Sea-side view of Plan 1 before wave attack

28. Plan 1 (Plate 6 and Photos 7-10) was constructed with the toe of the rehabilitation dolos 98 ft from the outer edge of the cap. A total of 177 dolosse were used. Damage to the structure was severe, and the entire toe area was displaced. Damage originated at the toe, and as the toe units were displaced the units upslope unraveled. The dolosse flukes extended above the still water level (swl) at the toe of the rehabilitation area for all water depths. Therefore, it was decided that the toe of the dolos would have to be placed in deeper water to remove it from the high wave energy region around the swl. Photos 11-14 show the structure after testing.

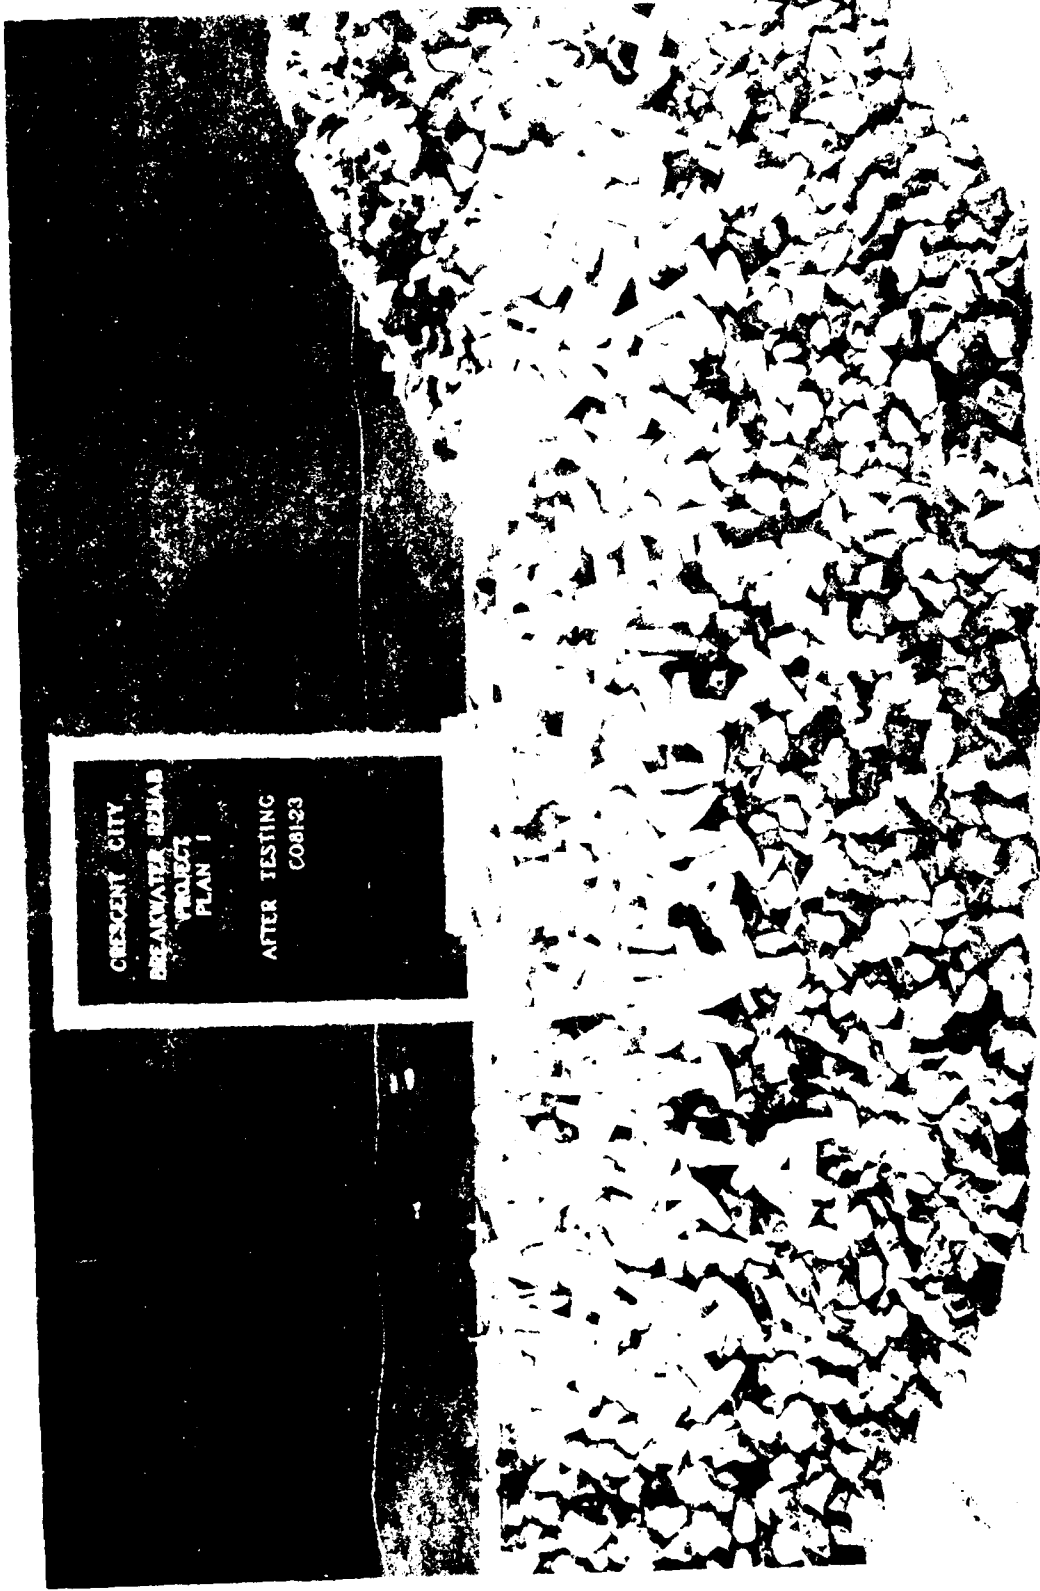
Photo 11. Sea-side view of Plan 1 after completion of abbreviated hydrograph

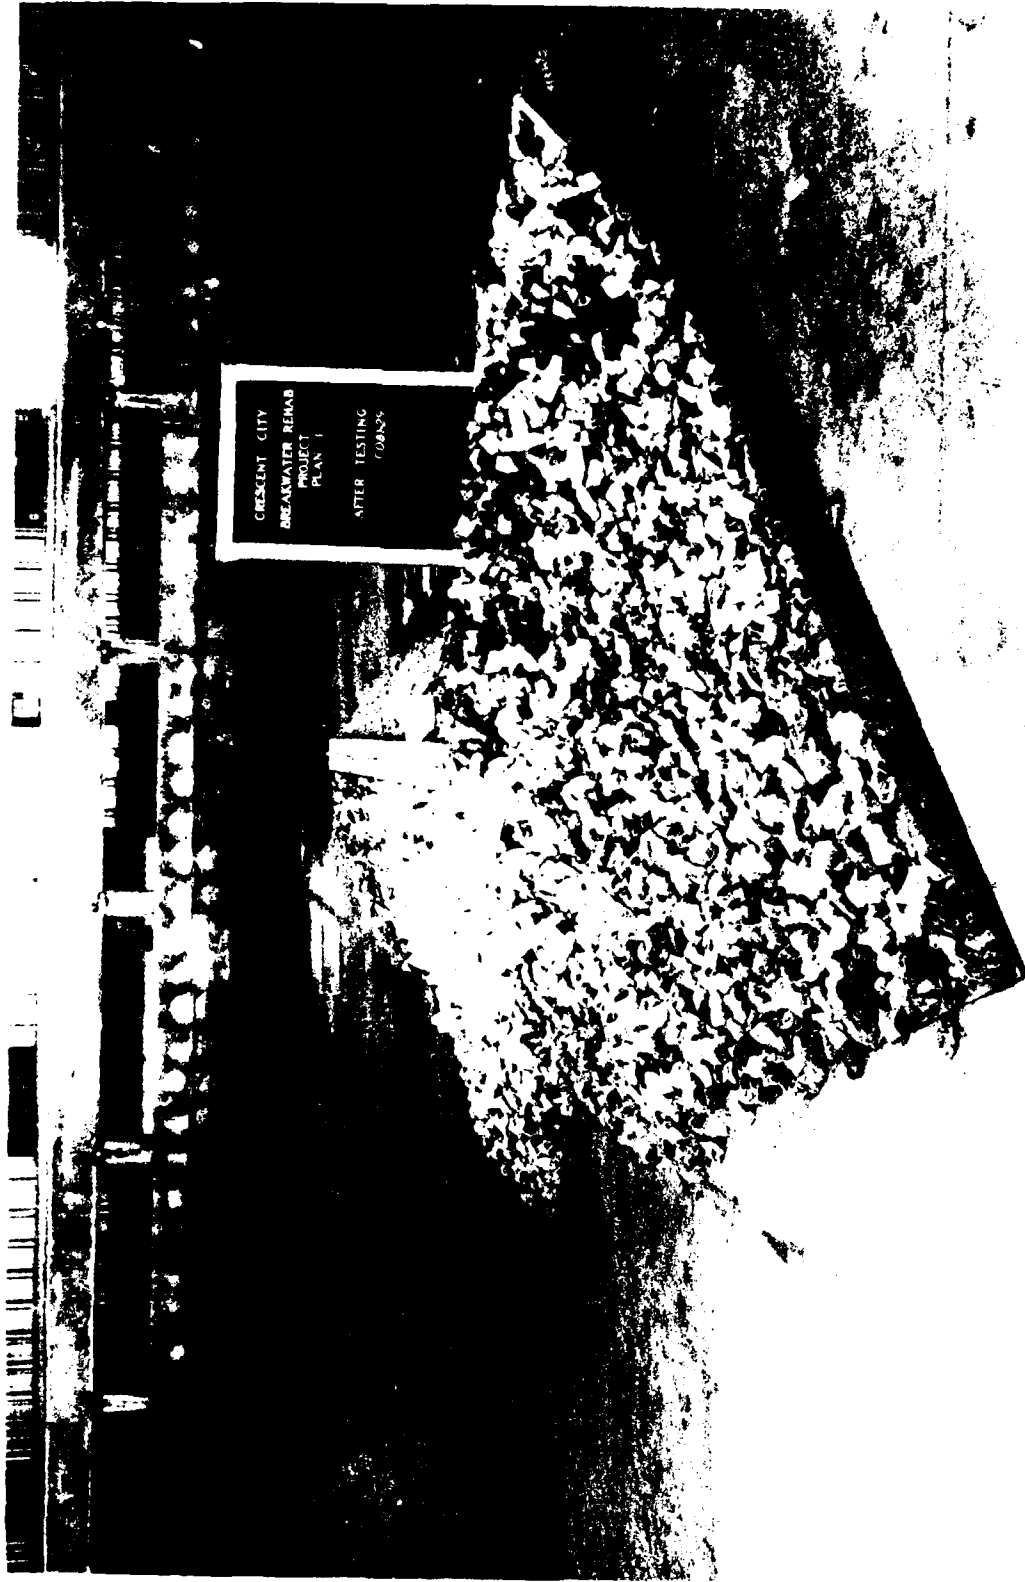
Photo 13. Seaward end view of Plan 1 after completion of abbreviated hydrograph

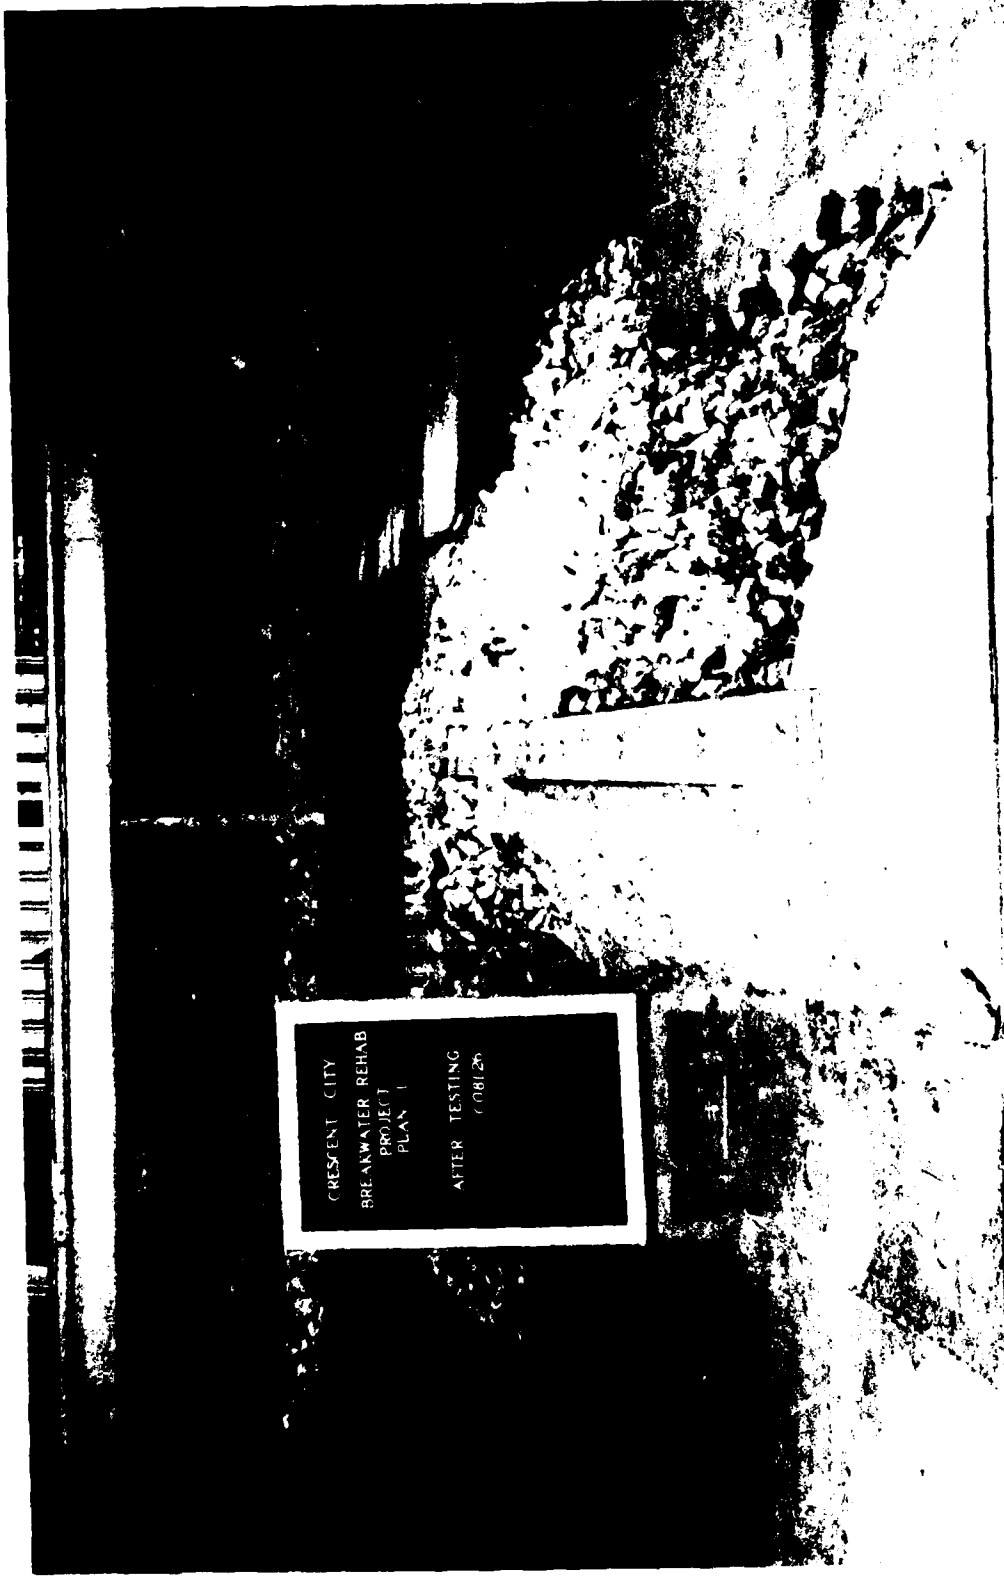
Photo 14. Shoreward end view of Plan 1 after completion of abbreviated hydrograph

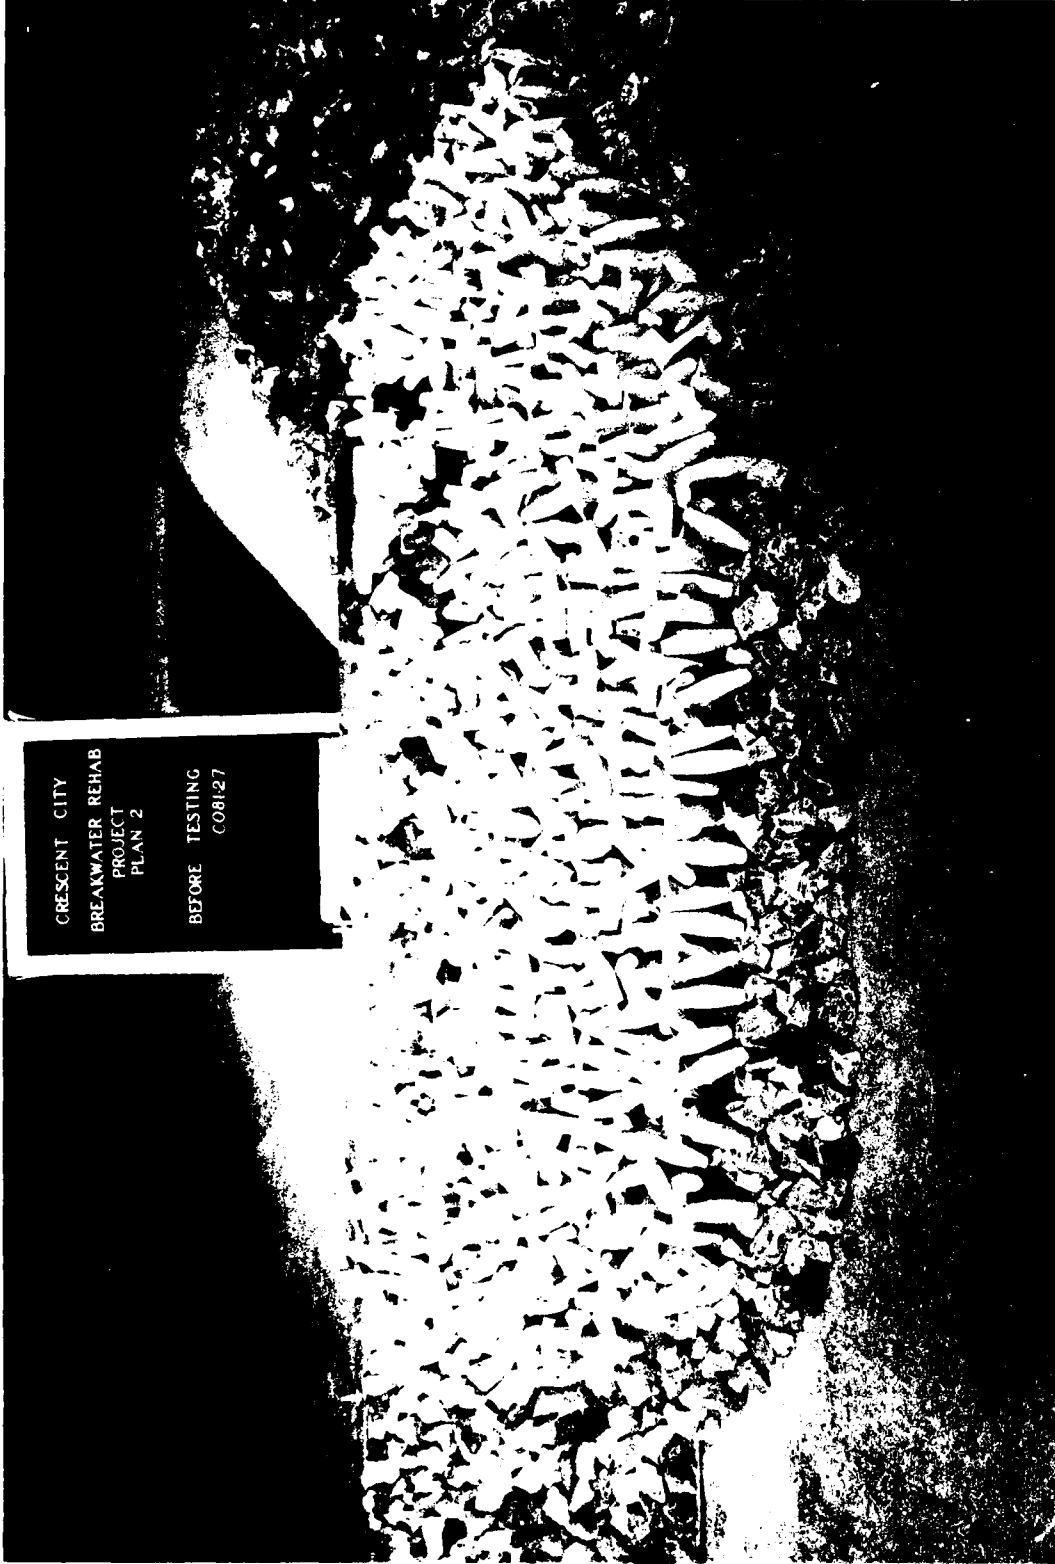
Photo 15. Sea-side view of Plan 2 before wave attack

29. Plan 2 (Plate 7 and Photos 15-18) was constructed with the toe of the rehabilitation dolos 160 ft from the outer edge of the cap. A total of 381 dolosse were used. The toe units in the left (shoreward) transition and central areas were stable; however, there was severe damage to the toe units in the right (seaward) transition area. The damage was occurring at the swl, and as the water depth was increased the damaged area moved upslope. Because of the geometry of the breakwater (i.e., the dogleg), wave energy is concentrated in this area and problems were expected in this region. Photos 19-21 show the structure after testing.

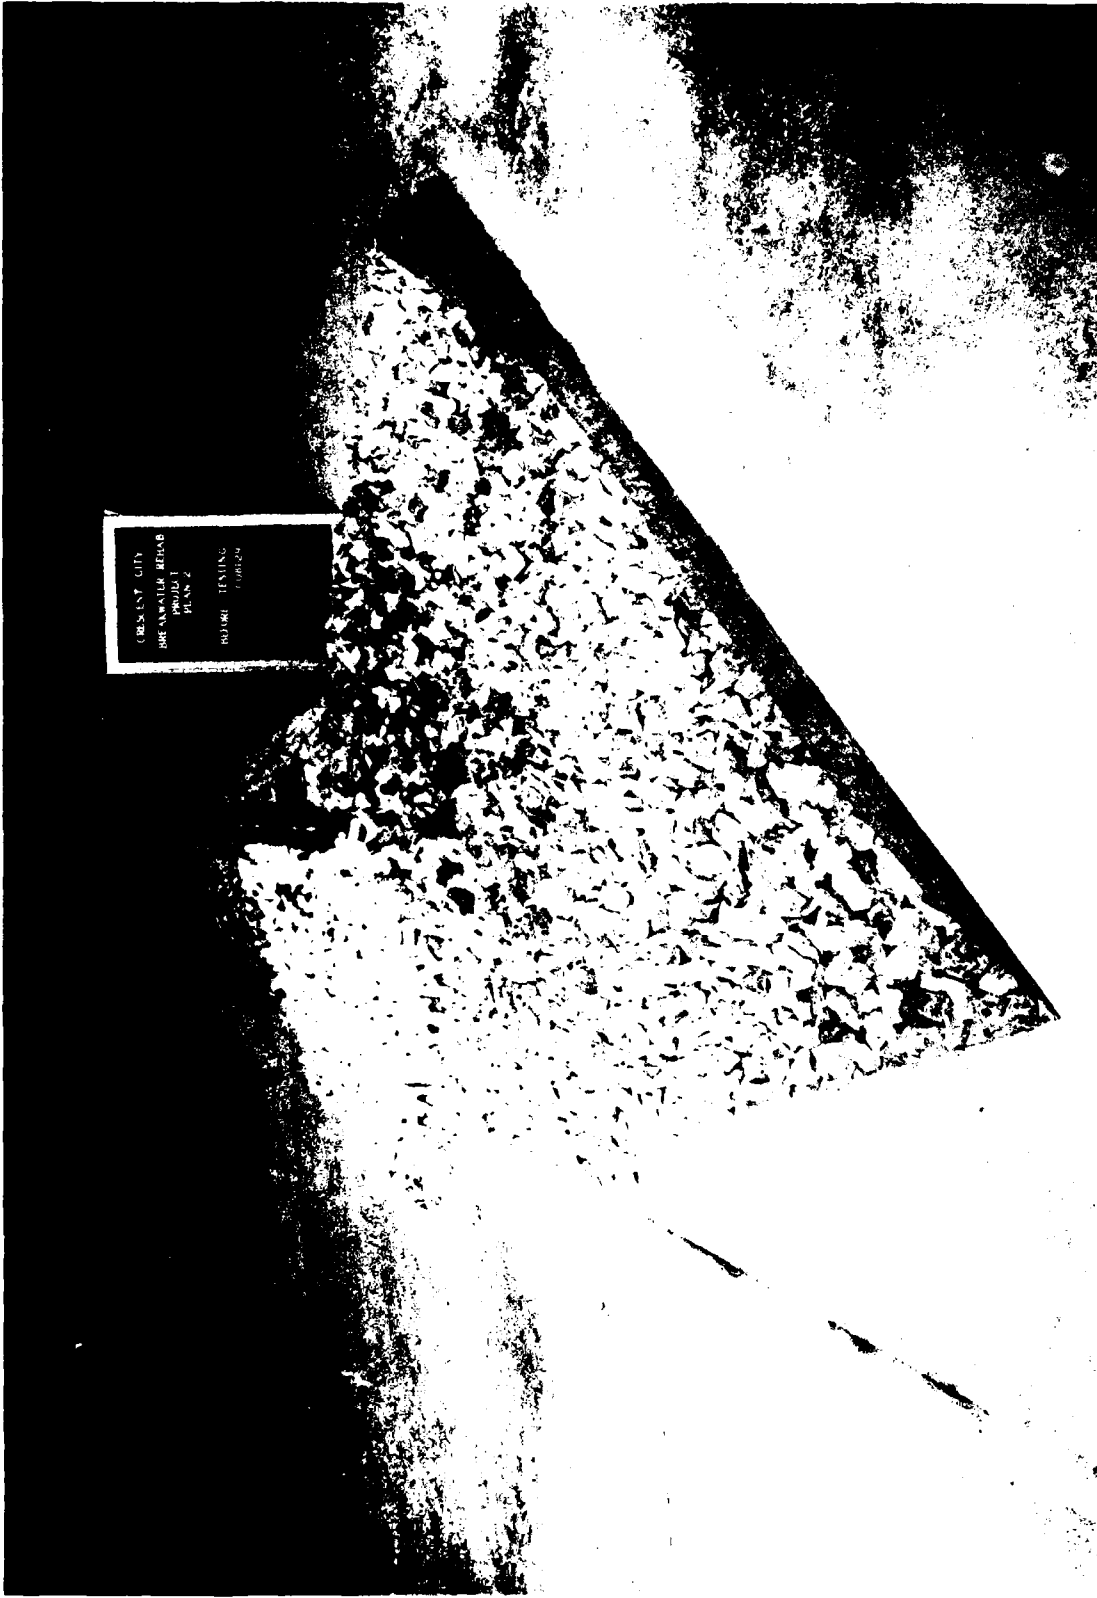
Photo 17. Seaward end view of Plan 2 before wave attack

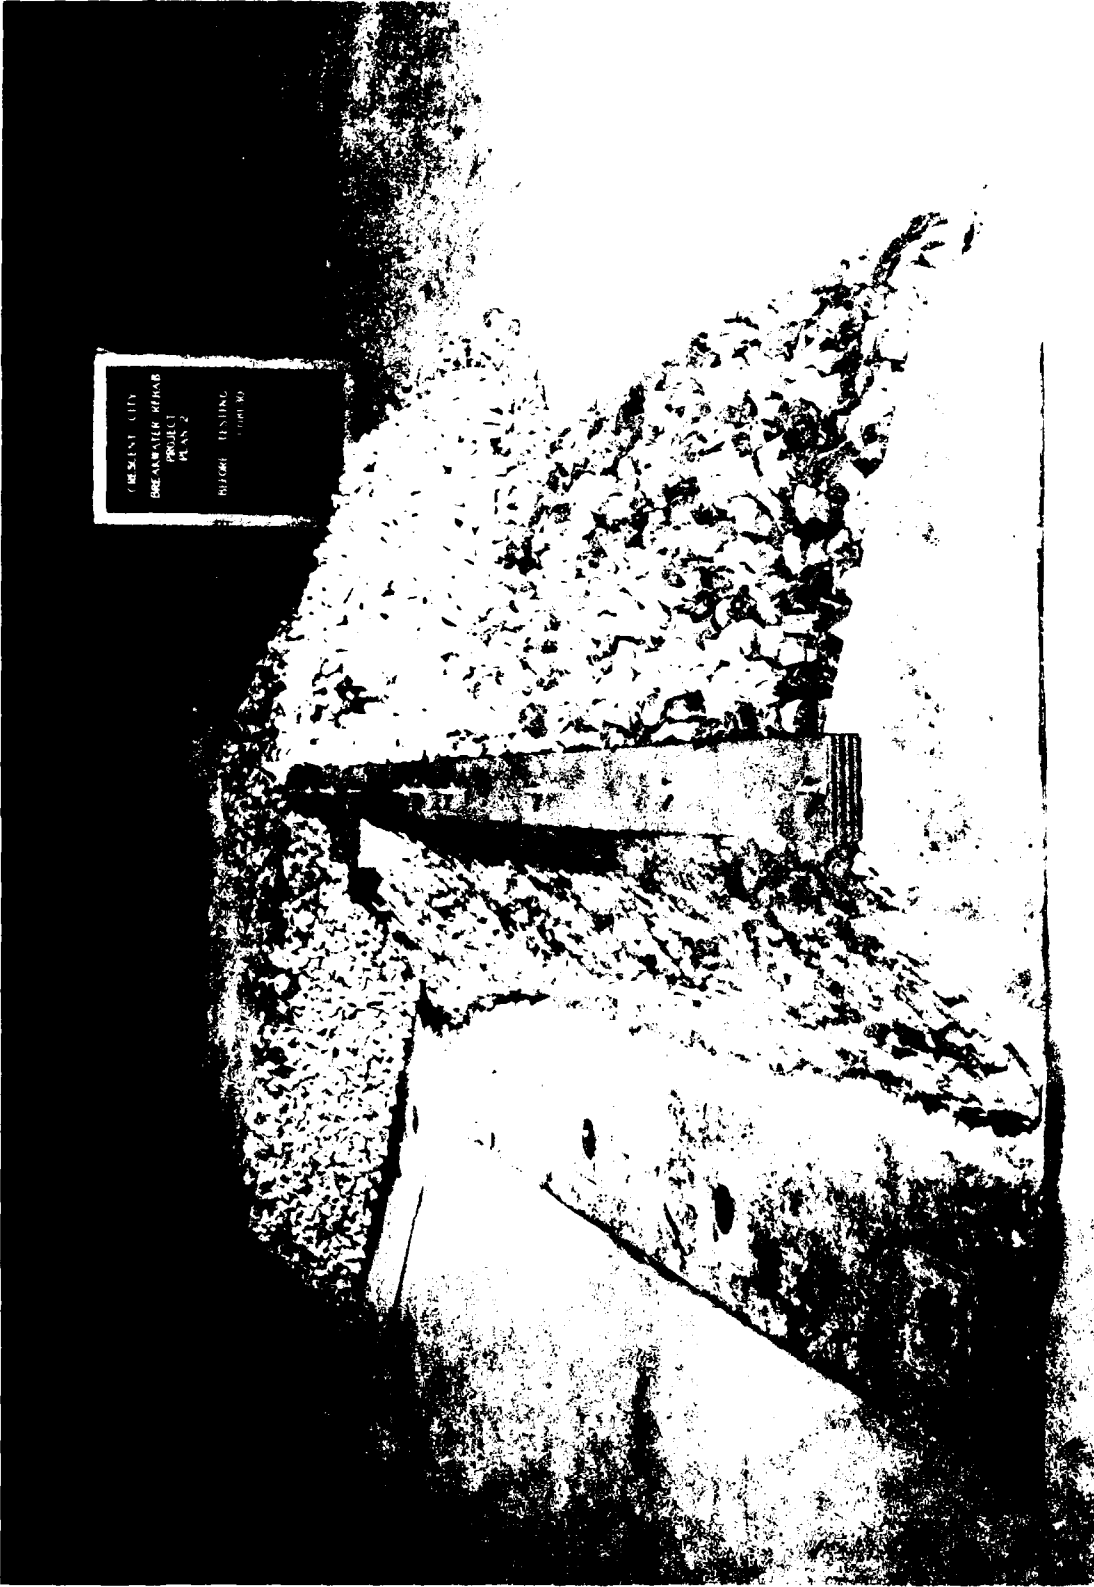
Photo 18. Shoreward end view of Plan 2 before wave attack

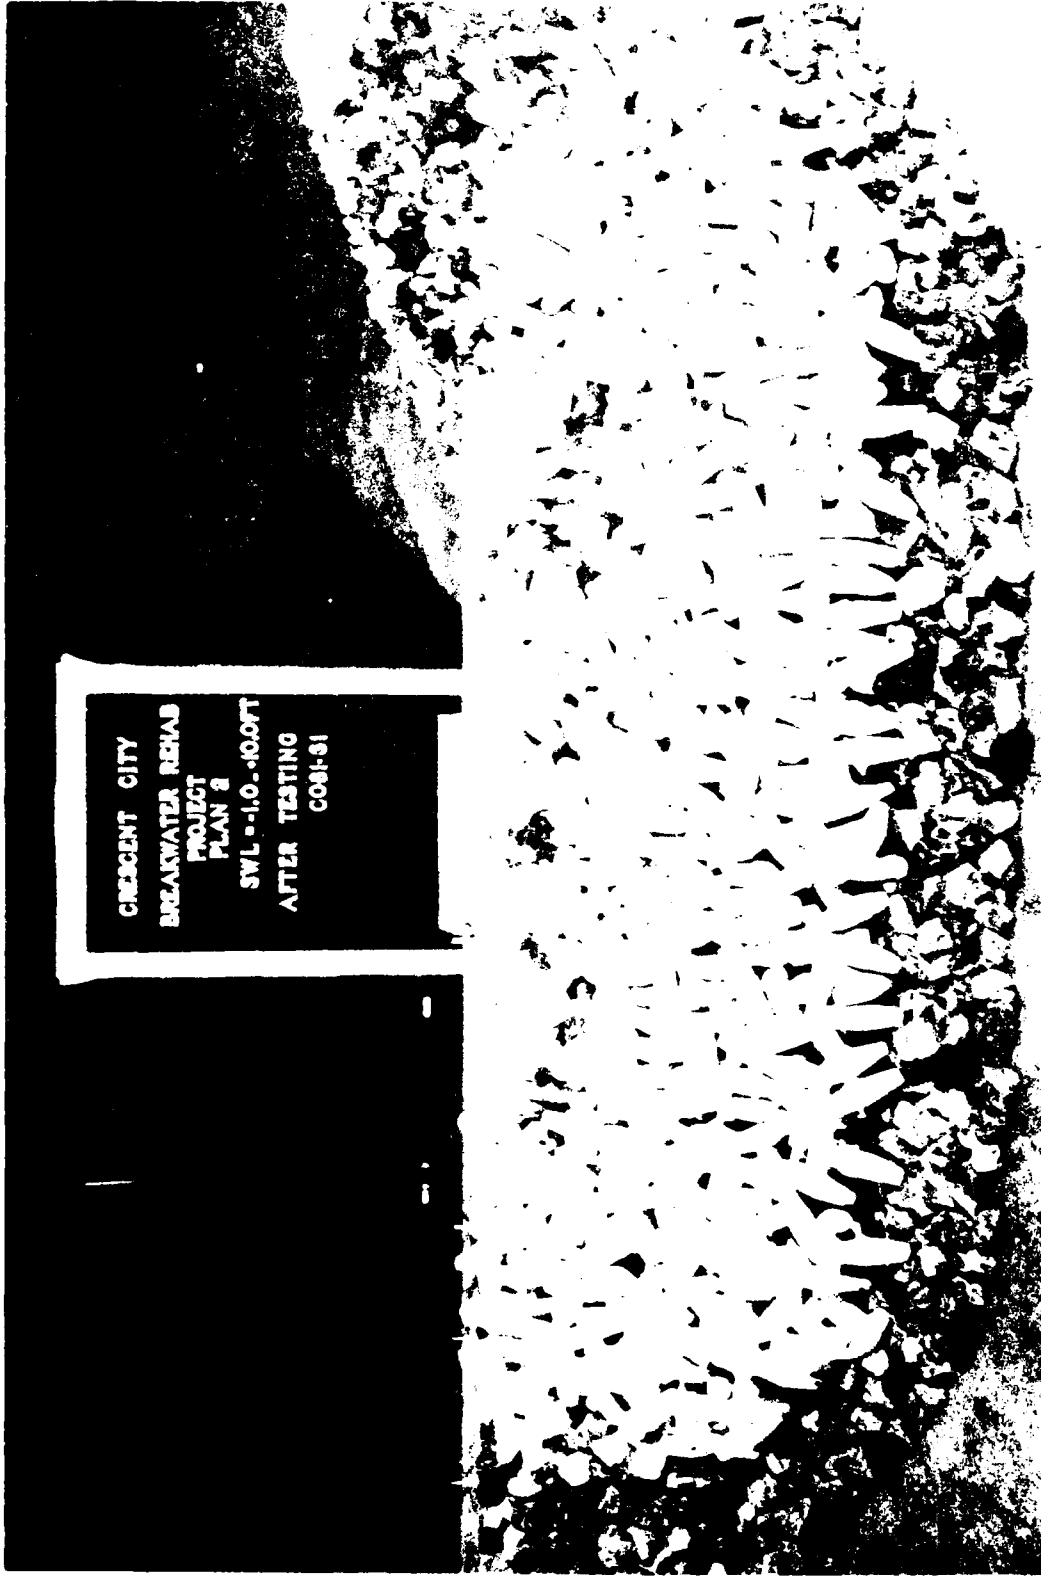
Photo 19. Sea-side view of Plan 2 after completion of abbreviated hydrograph

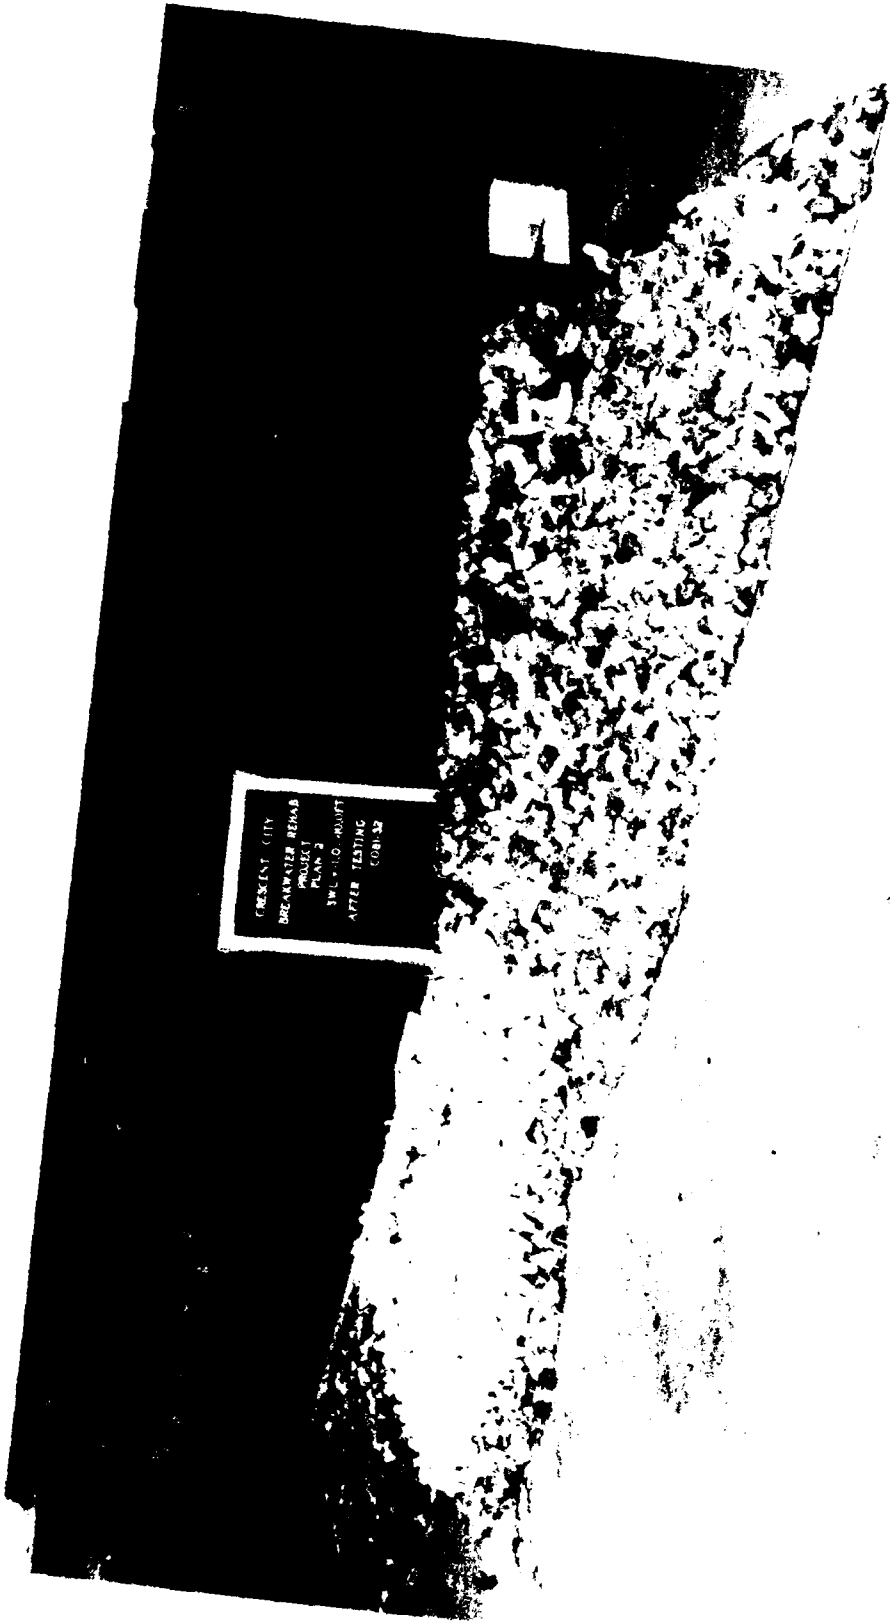
Photo 20. Seaward oblique view of Plan 2 after completion of abbreviated hydrograph
