TECHNICAL REPORT CERC-85-8

# BREAKWATER REHABILITATION STUDY, CRESCENT CITY HARBOR, CALIFORNIA

## Coastal Model Investigation

November 1985

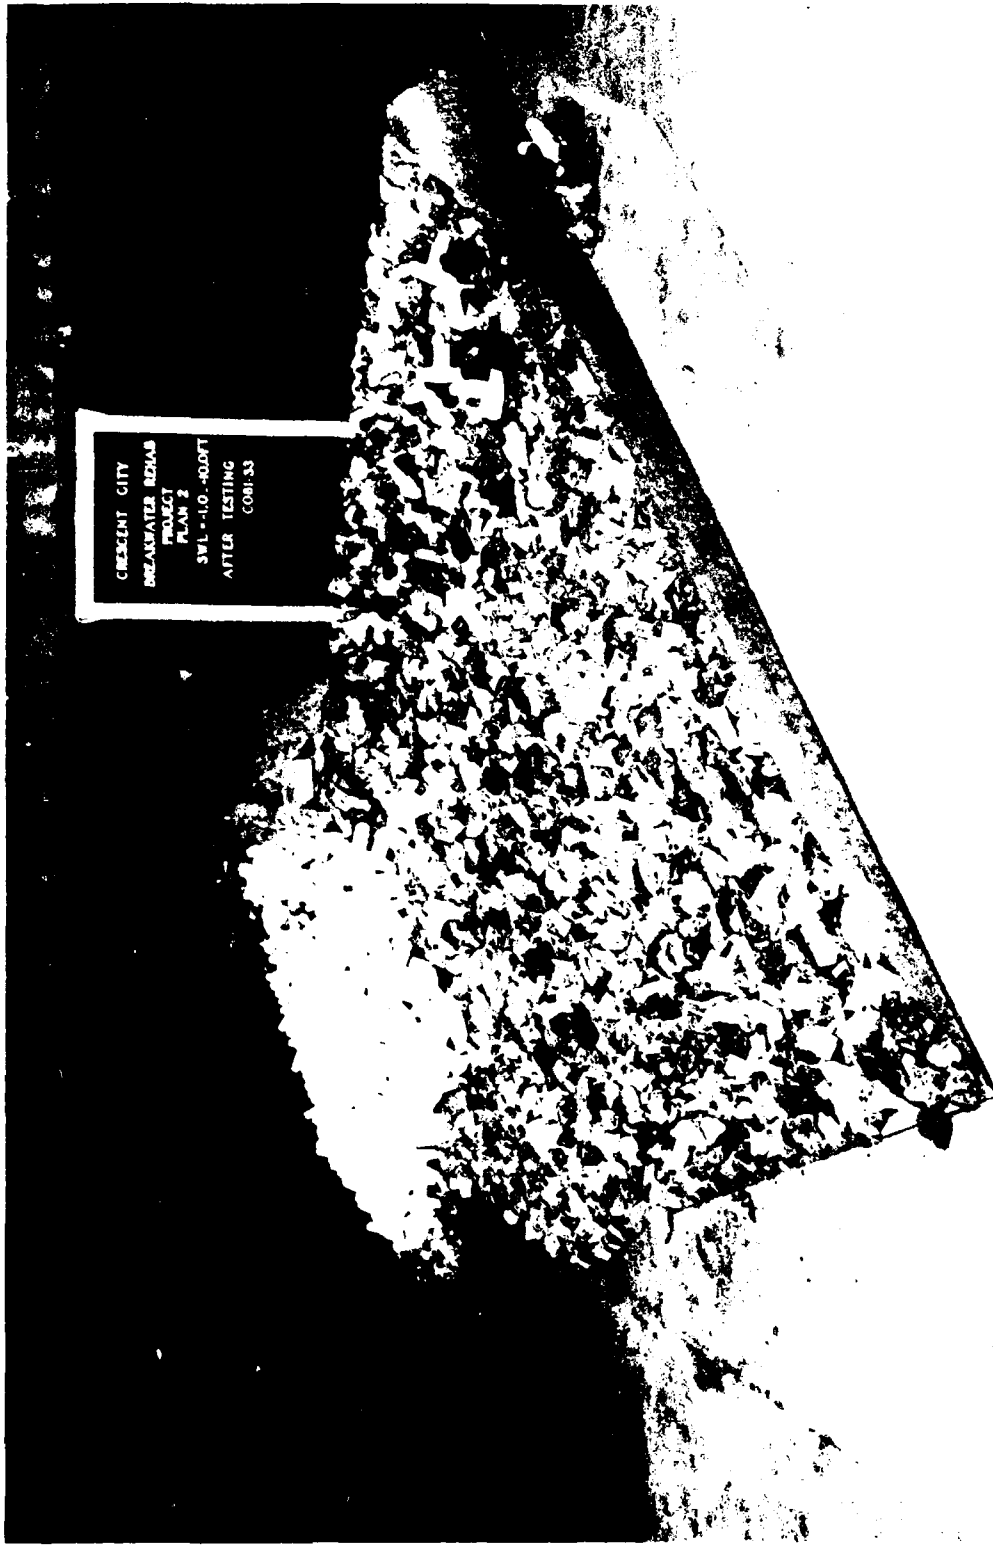
Photo 21. Seaward end view of Plan 2 after completion of abbreviated hydrograph

29. Plan 2 (Plate 7 and Photos 15-18) was constructed with the toe of the rehabilitation dolos 160 ft from the outer edge of the cap. A total of 381 dolosse were used. The toe units in the left (shoreward) transition and central areas were stable; however, there was severe damage to the toe units in the right (seaward) transition area. The damage was occurring at the swl, and as the water depth was increased the damaged area moved upslope. Because of the geometry of the breakwater (i.e., the dogleg), wave energy is concentrated in this area and problems were expected in this region. Photos 19-21 show the structure after testing.

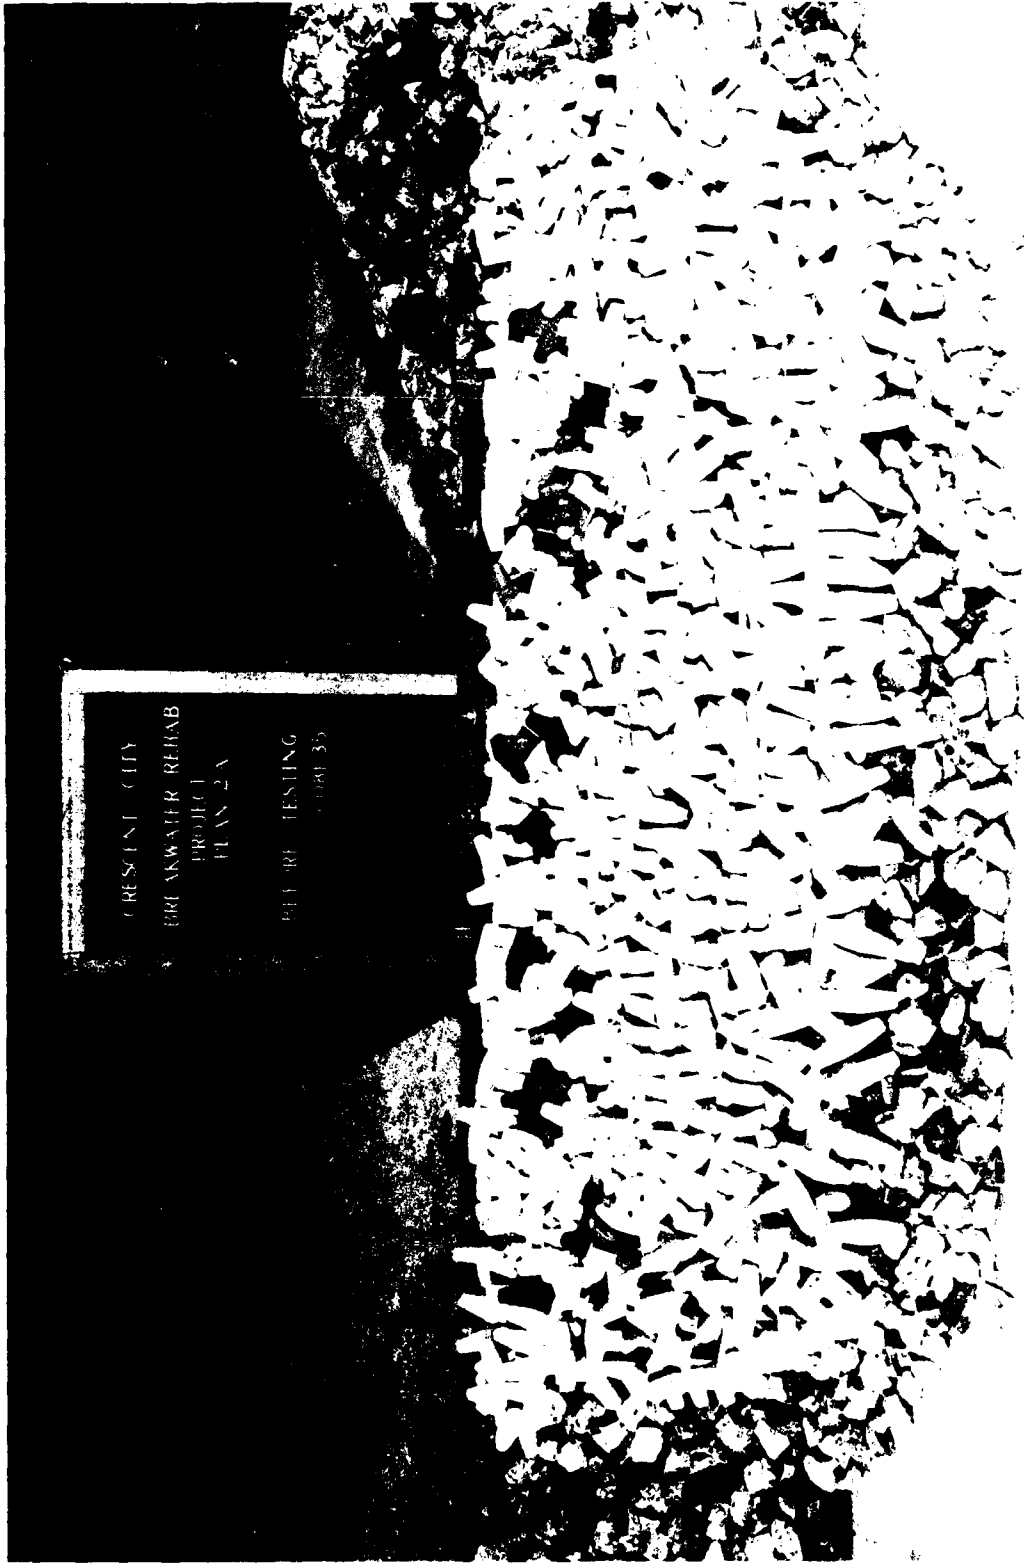
Photo 22. Sea-side view of Plan 2A before wave attack

30. Plan 2A (Plate 7 and Photos 22-23) was the same as Plan 2, except that the toe units in the seaward transition area were placed with their

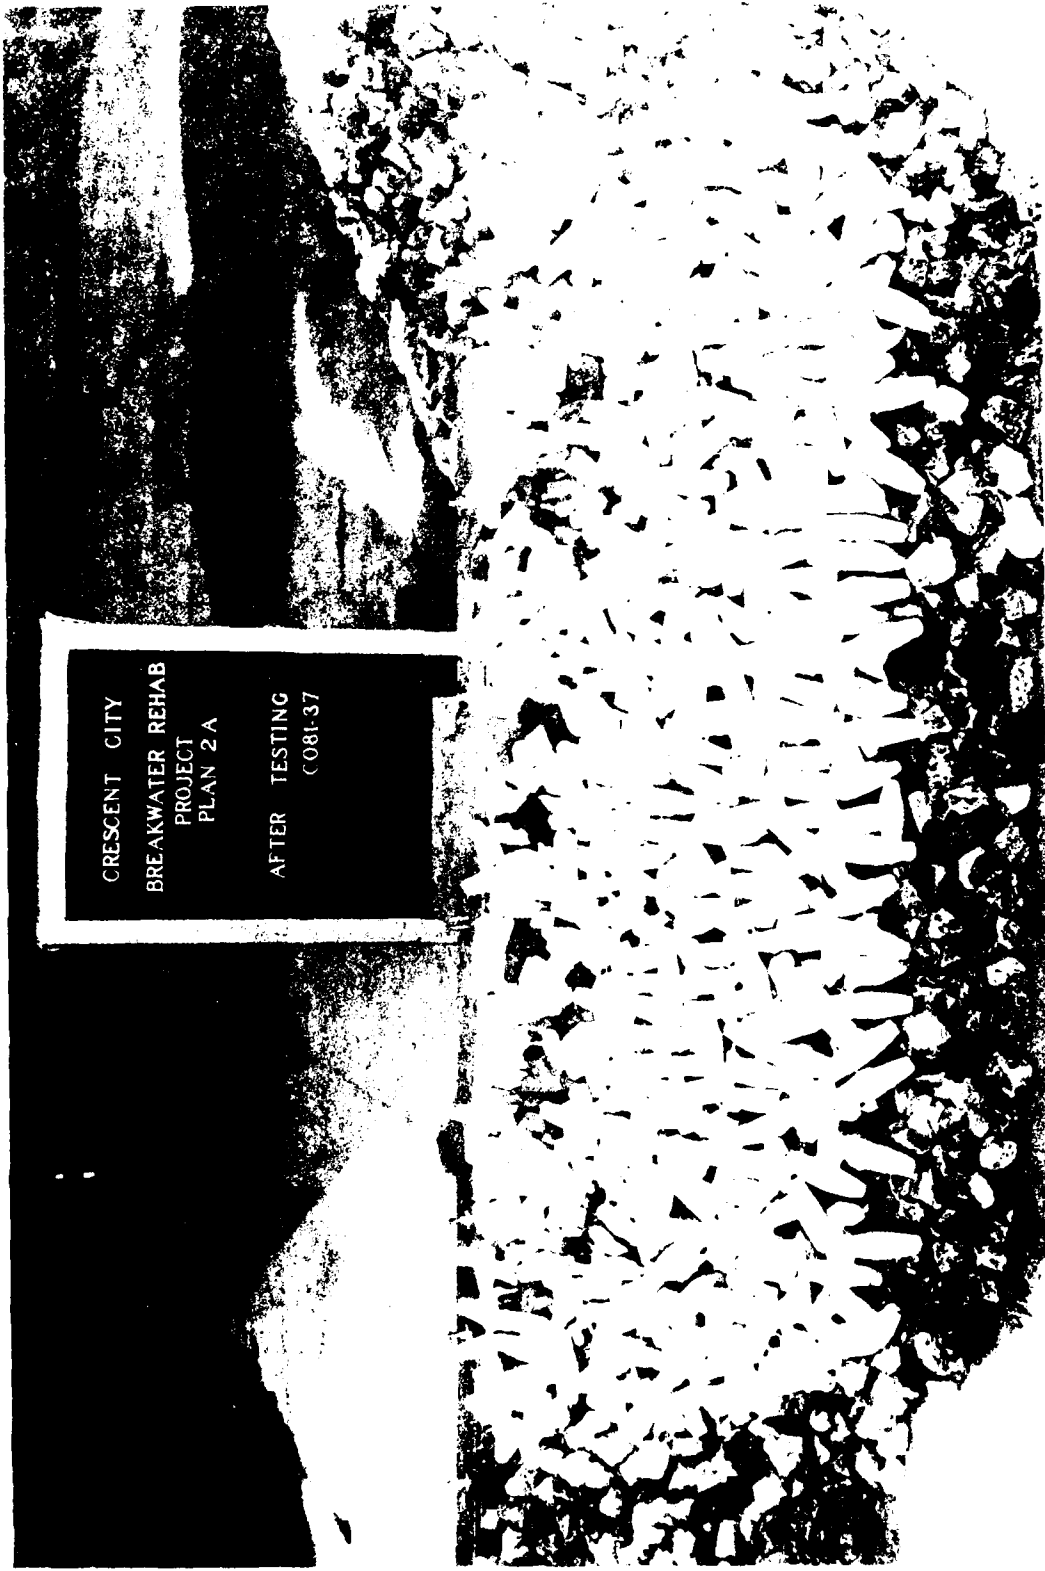
Photo 24. Sea-side view of Plan 2A after completion of abbreviated hydrograph

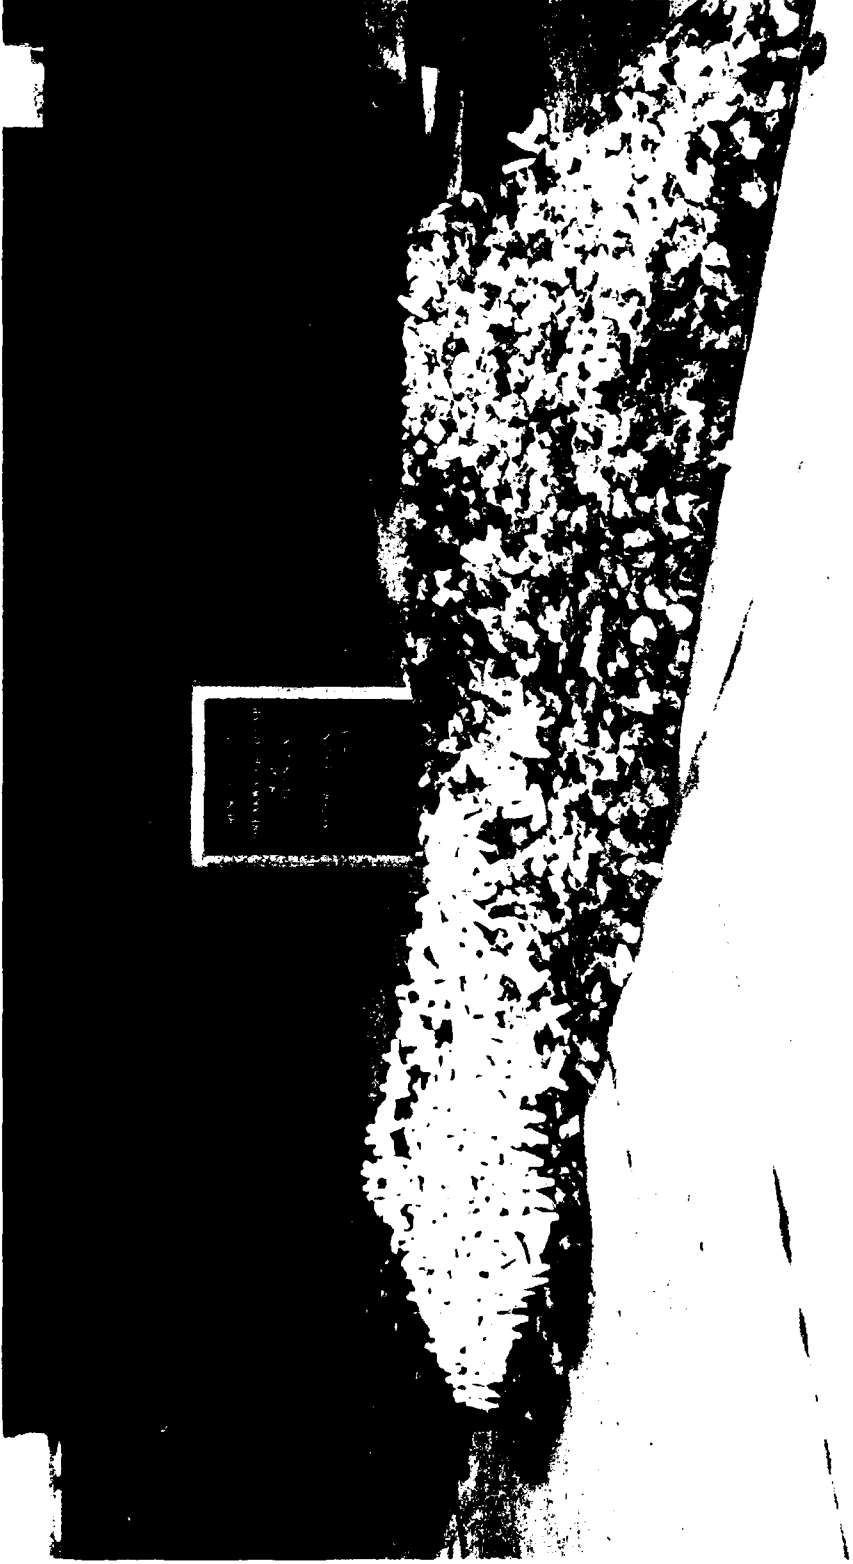
Photo 25. Seaward oblique view of Plan 2A after completion of abbreviated hydrograph

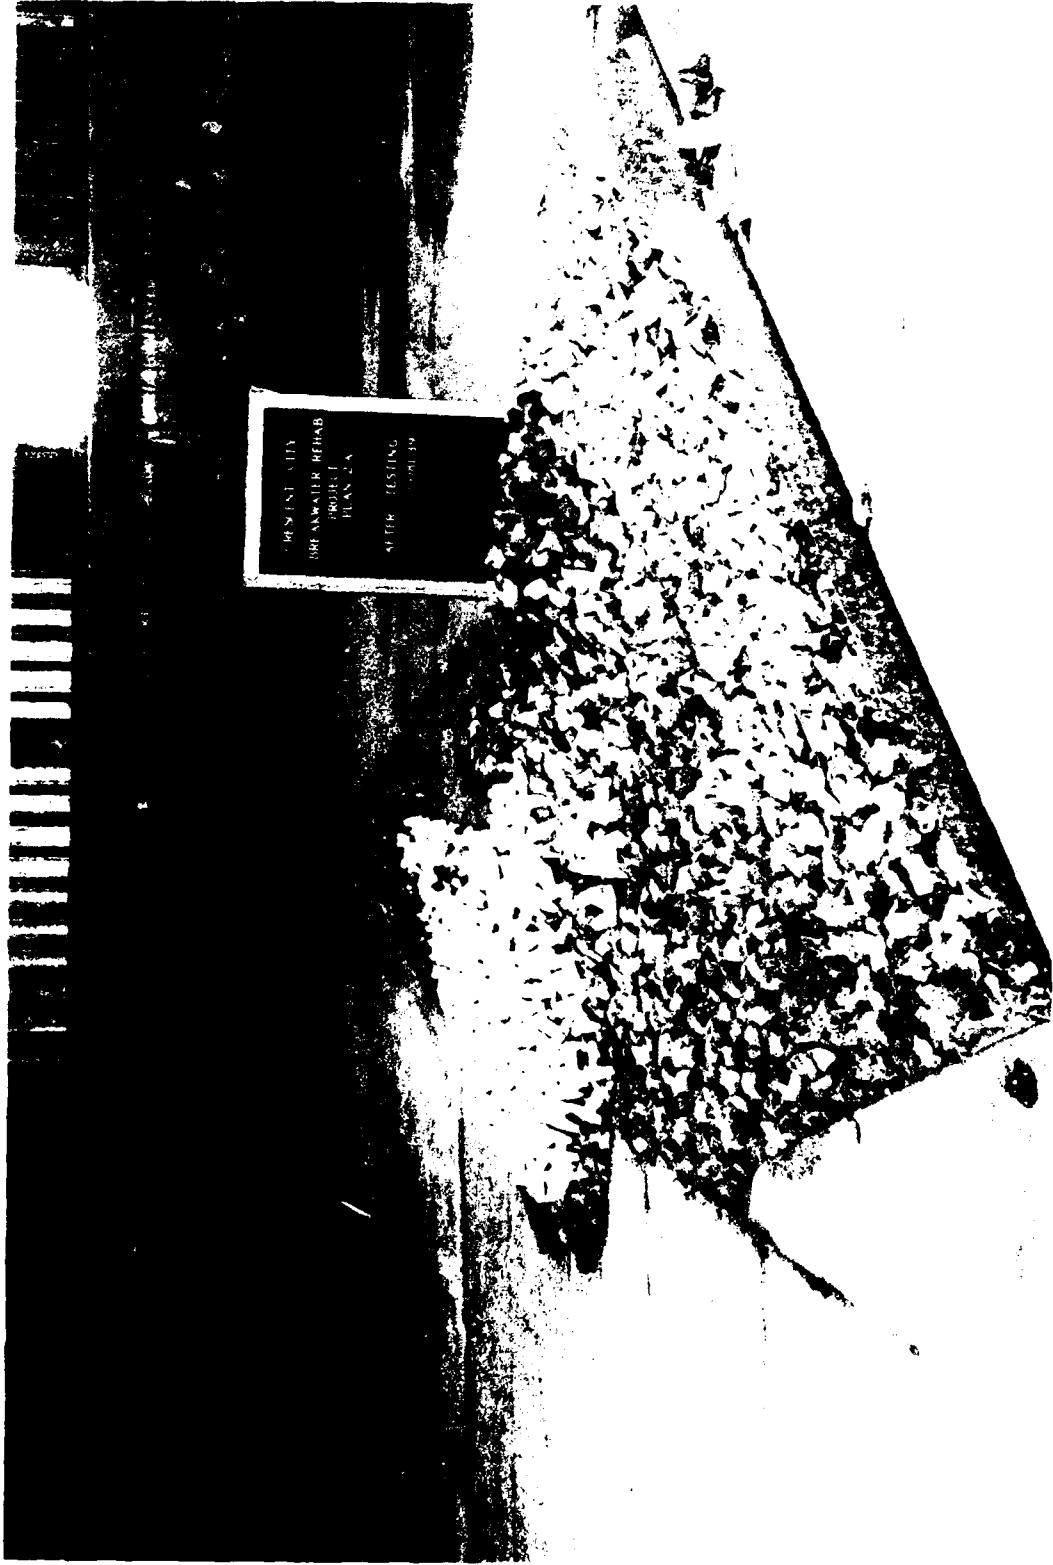
Photo 26. Seaward end view of Plan 2A after completion of abbreviated hydrograph

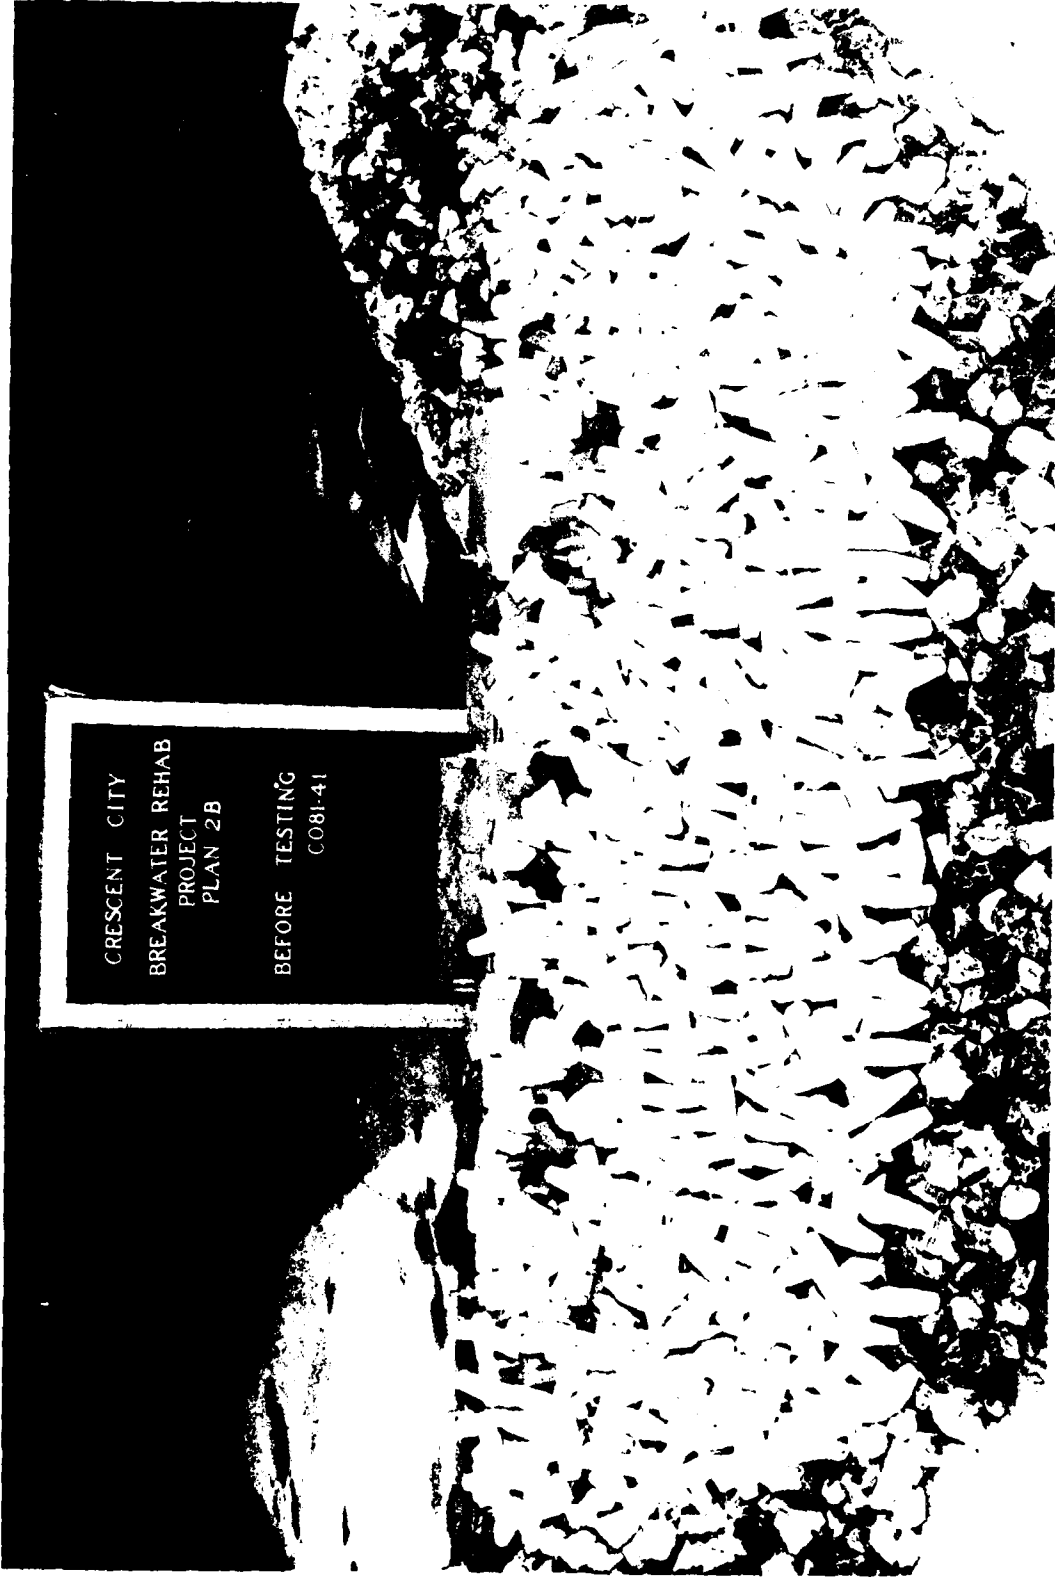
Photo 27. Sea-side view of Plan 2B before wave attack

31. Plan 2B (Plate 7 and Photos 27-28) was the same as Plan 2A, except that special placement was used for the toe units in the seaward transition area, i.e., the toe units in the second layer were placed to ensure double locking with the toe units in the bottom layer (see Photo 29). This plan performed less satisfactorily than Plan 2A in that failure was not gradual; the entire toe area failed as one unit. Tests conducted to date indicated that additional dolosse would be required to move the seaward transition further out the extension into a region where the wave action would probably be less severe. Photos 30-32 show the structure after testing.

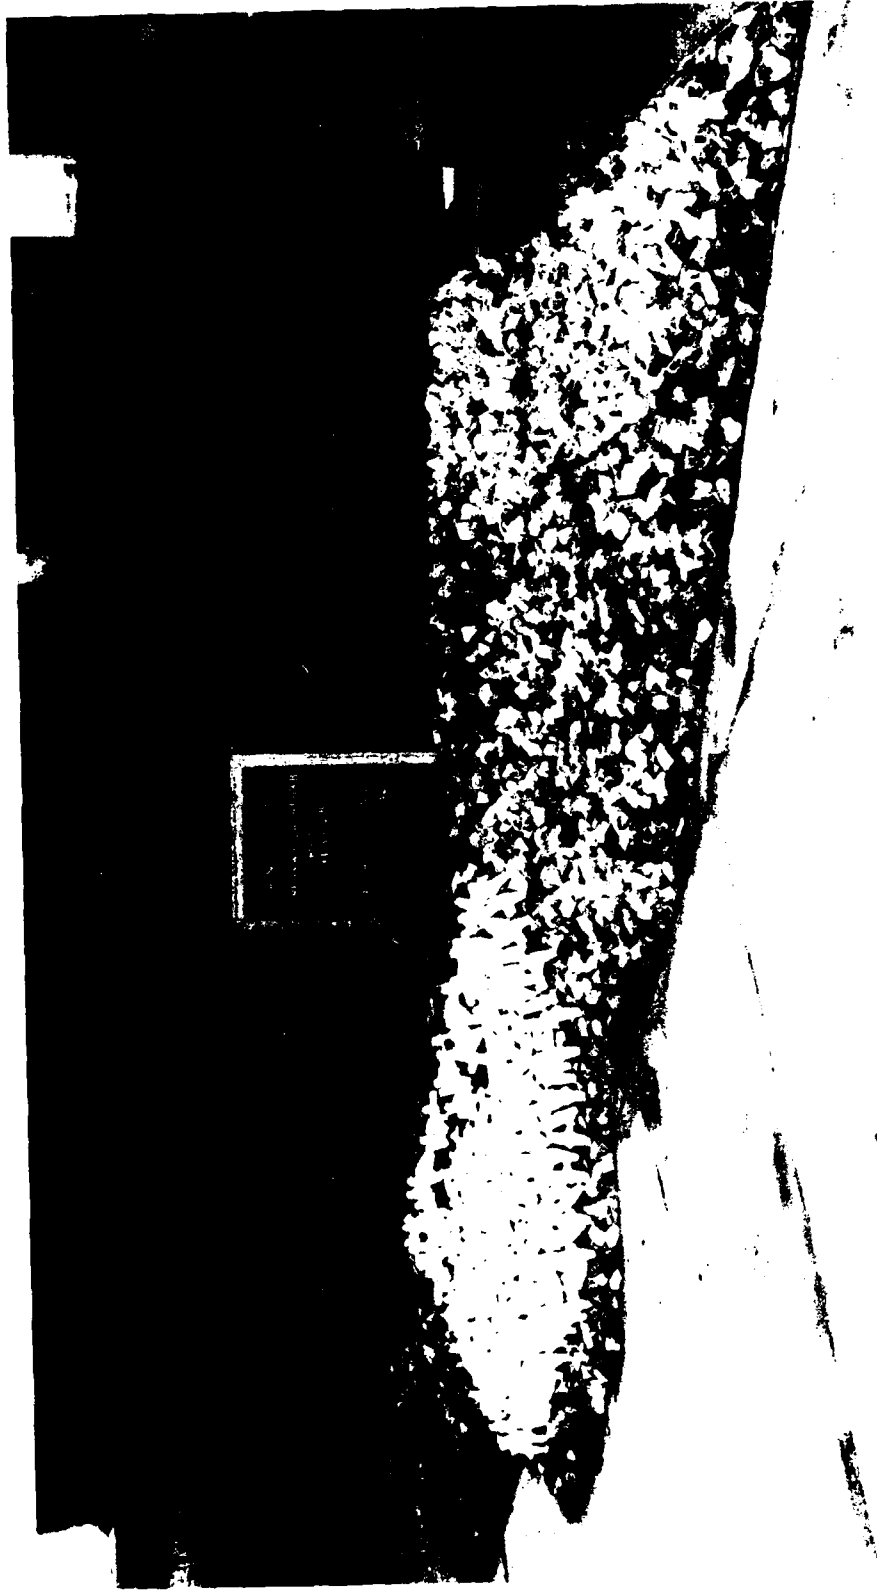
Photo 28. Seaward oblique view of Plan 2B before wave attack

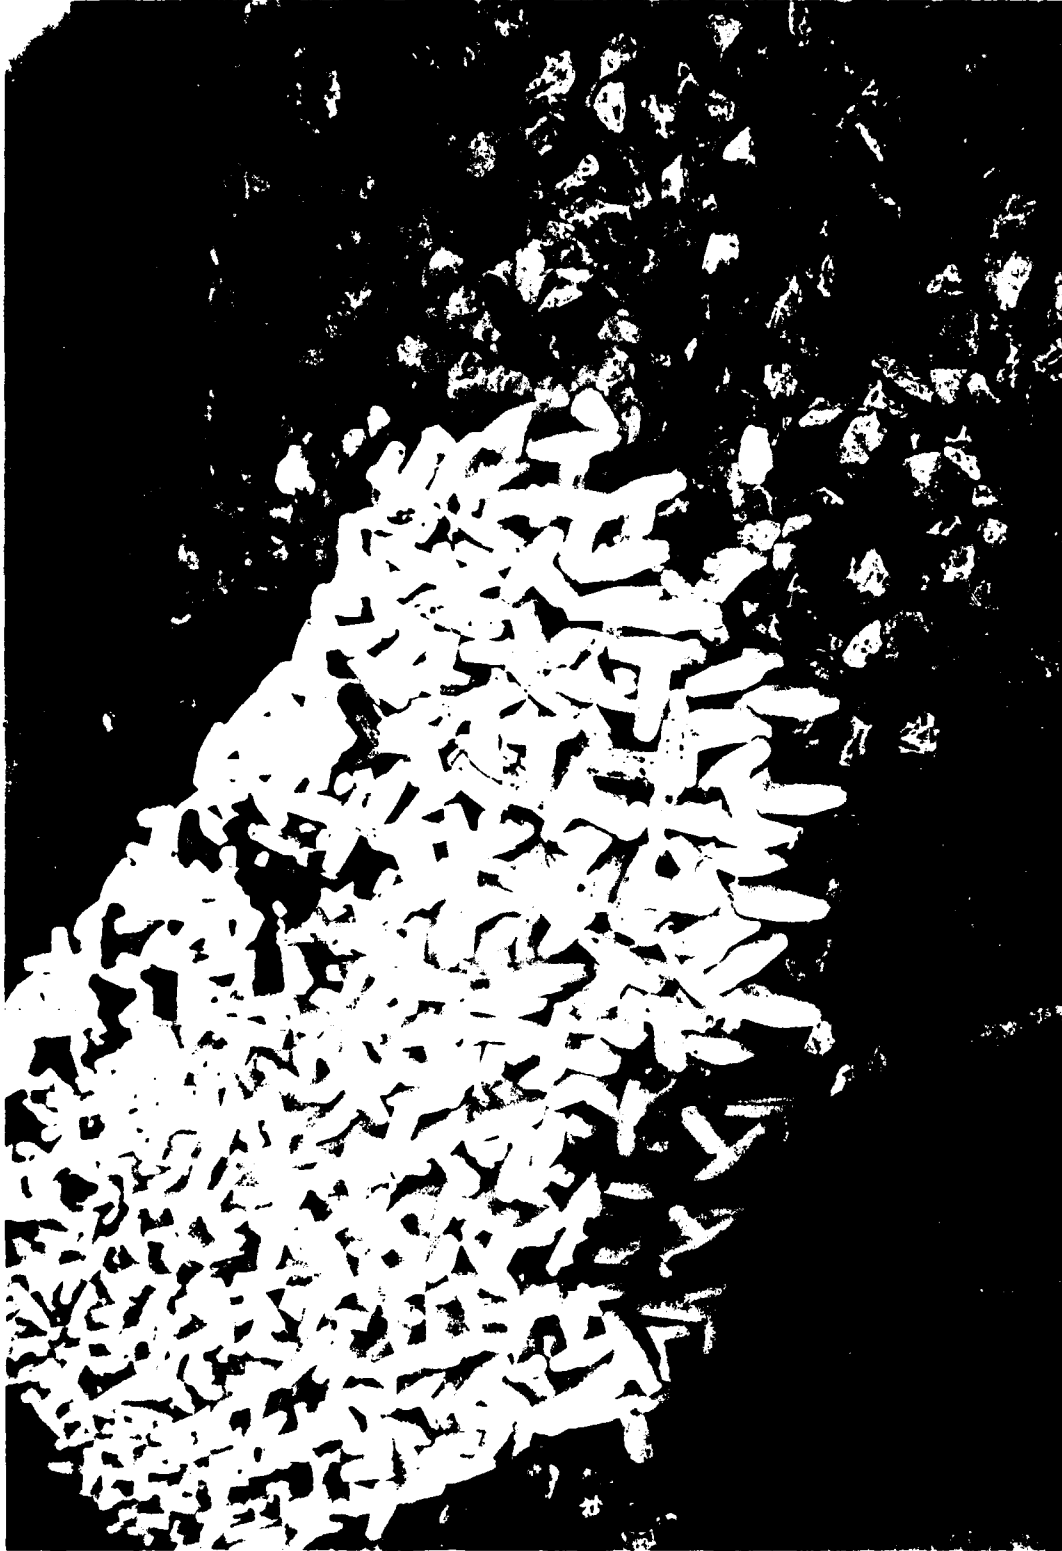
Photo 29. Special toe placement used for seaward transition of Plan 2B

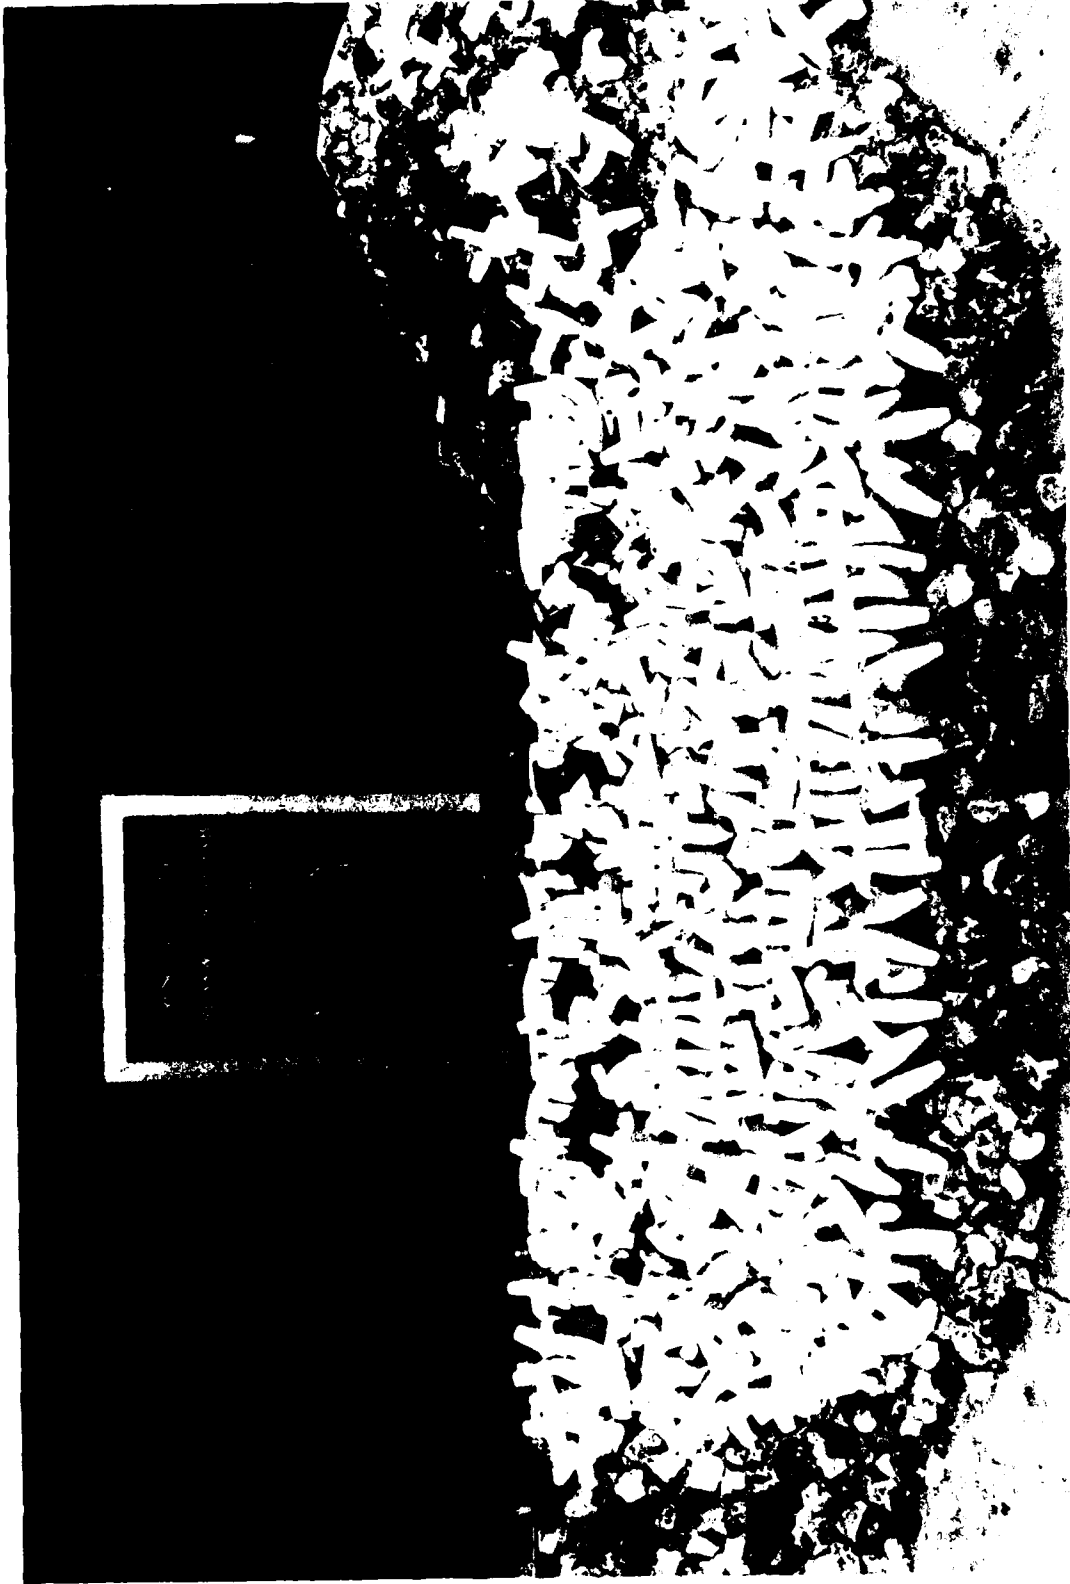
Photo 30. Sea-side view of Plan 2B after completion of abbreviated hydrograph

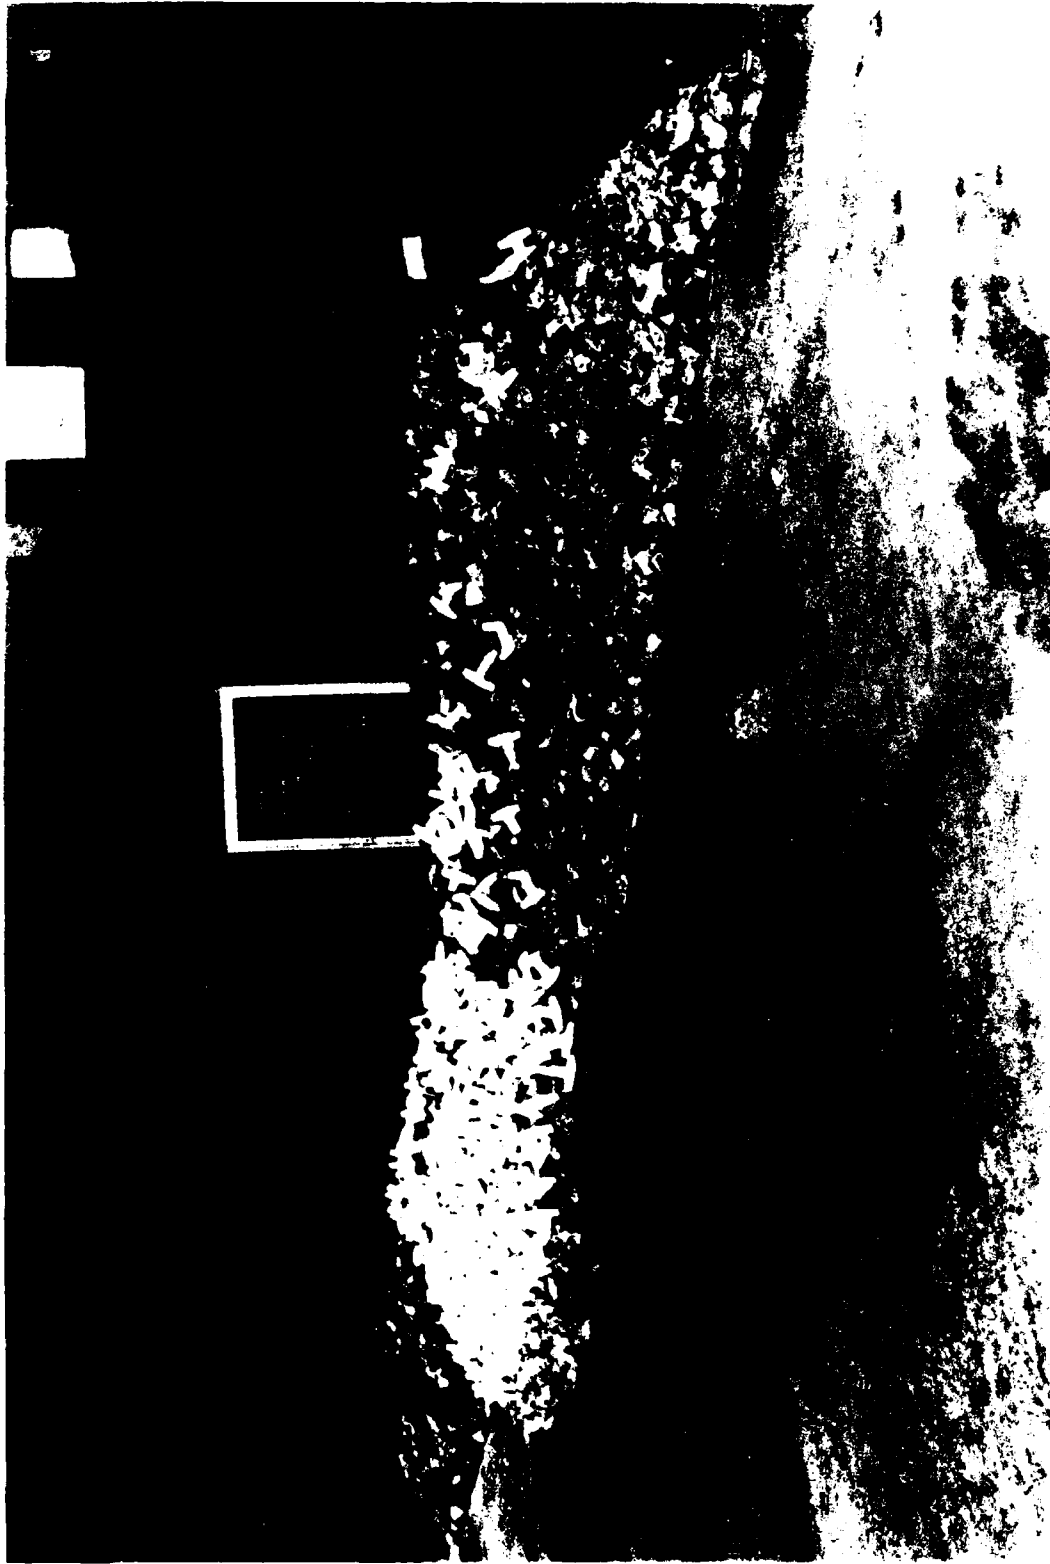
Photo 31. Seaward oblique view of Plan 2B after completion of abbreviated hydrograph

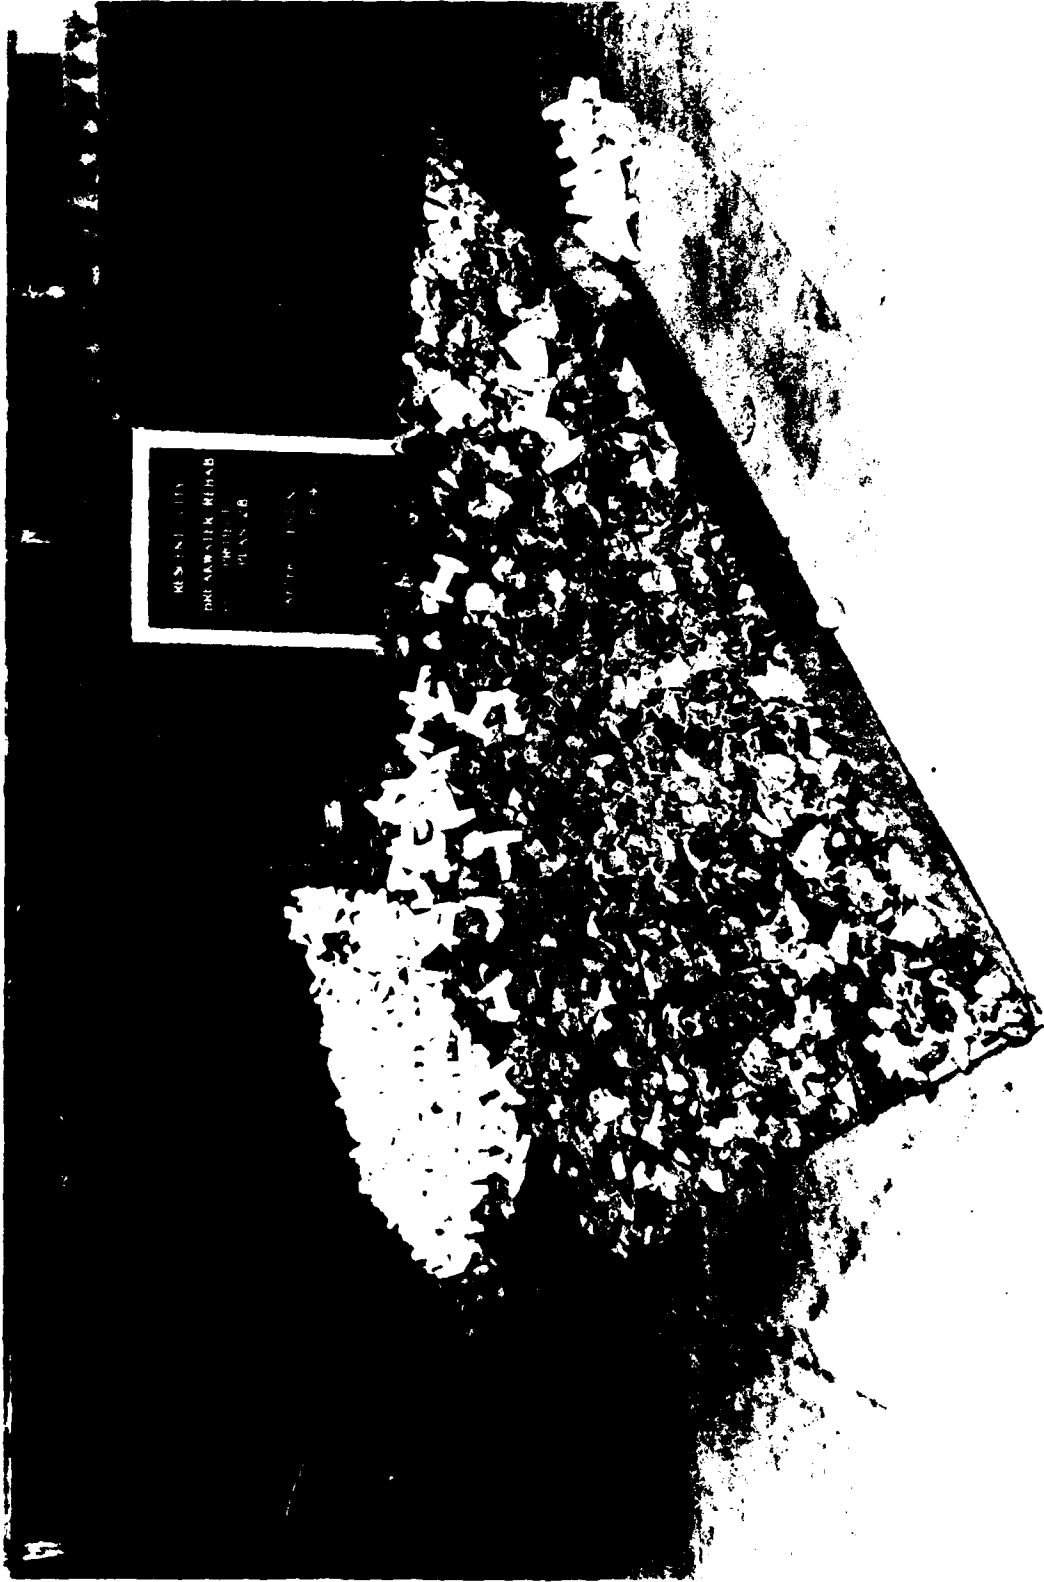
Photo 32. Seaward end view of Plan 2B after completion of abbreviated hydrograph

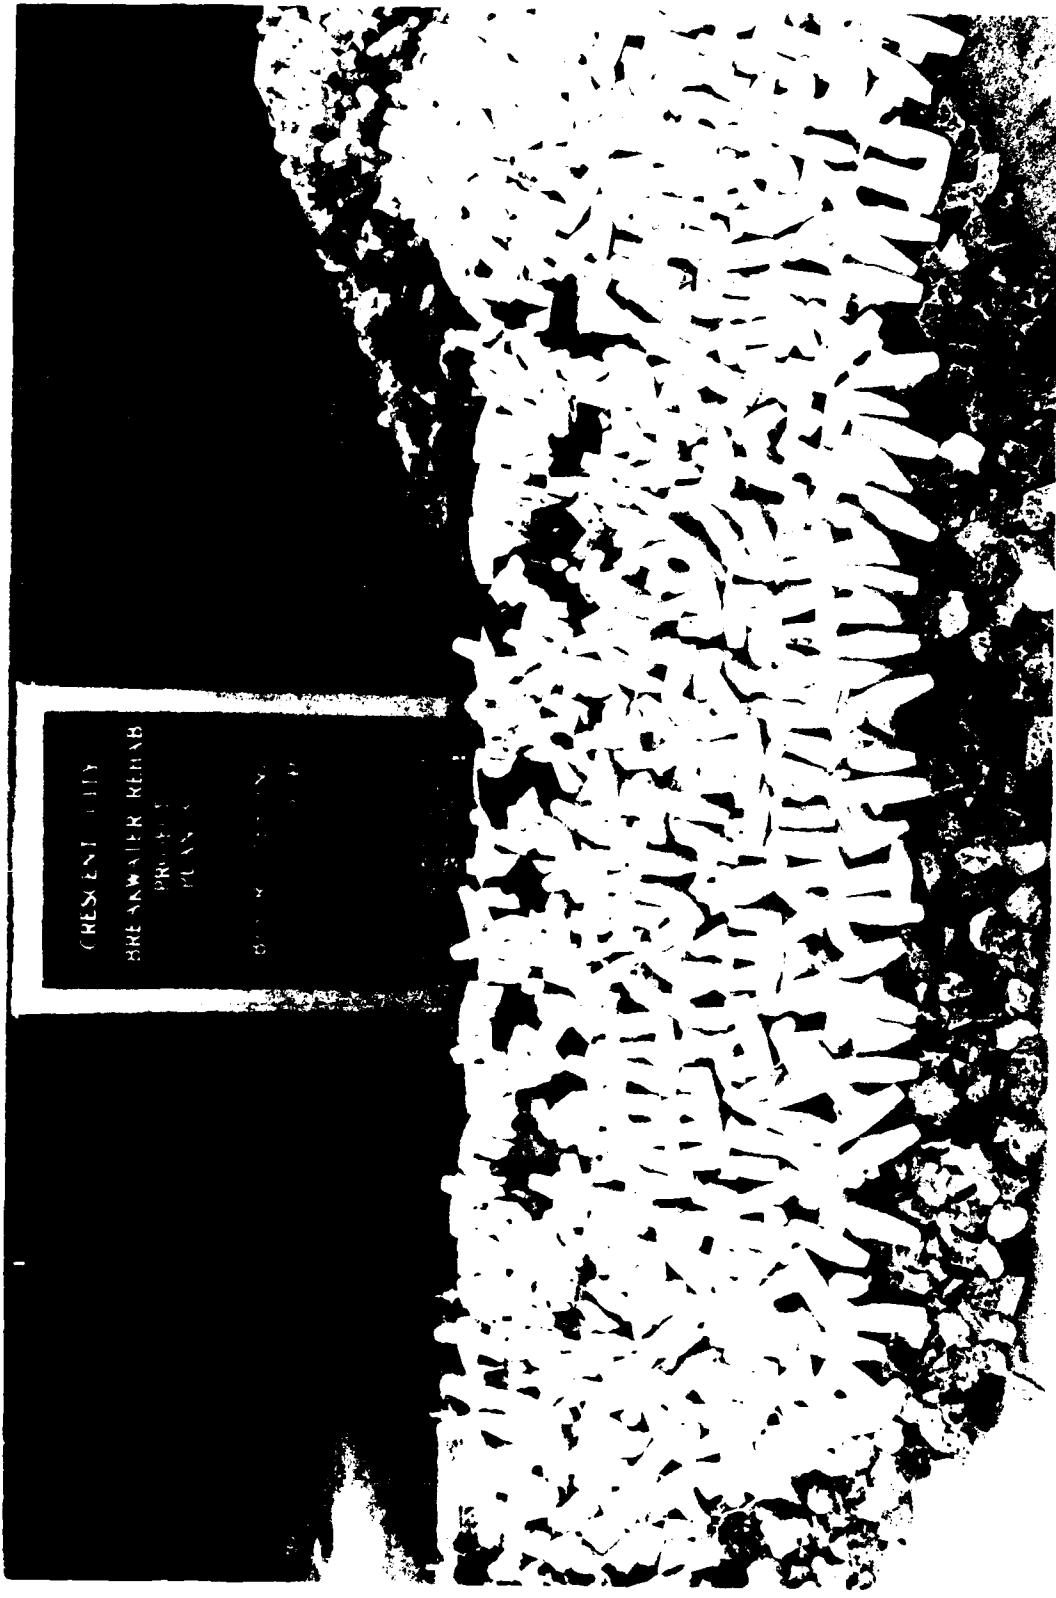
Photo 33. Sea-side view of Plan 3 before wave attack

32. Plan 3 (Plate 8 and Photos 33-35) was constructed with the toe of the dolos rehabilitation units still 160 ft from the outside edge of the cap; however, for this plan the dolos extended further out the eastern extension to sta 38+00. A total of 576 dolosse were used in the rehabilitation area. The lower corner of the seaward transition area now rested on material in the shoal area, and the flukes of these toe units were exposed for swl's of -1 and +4 ft. Damage originated in this location for these water levels and became severe for the +7-ft swl. Although there was less damage than for previous plans, the damage was still too excessive for the plan to be acceptable. Photos 36-38 show the structure after testing.

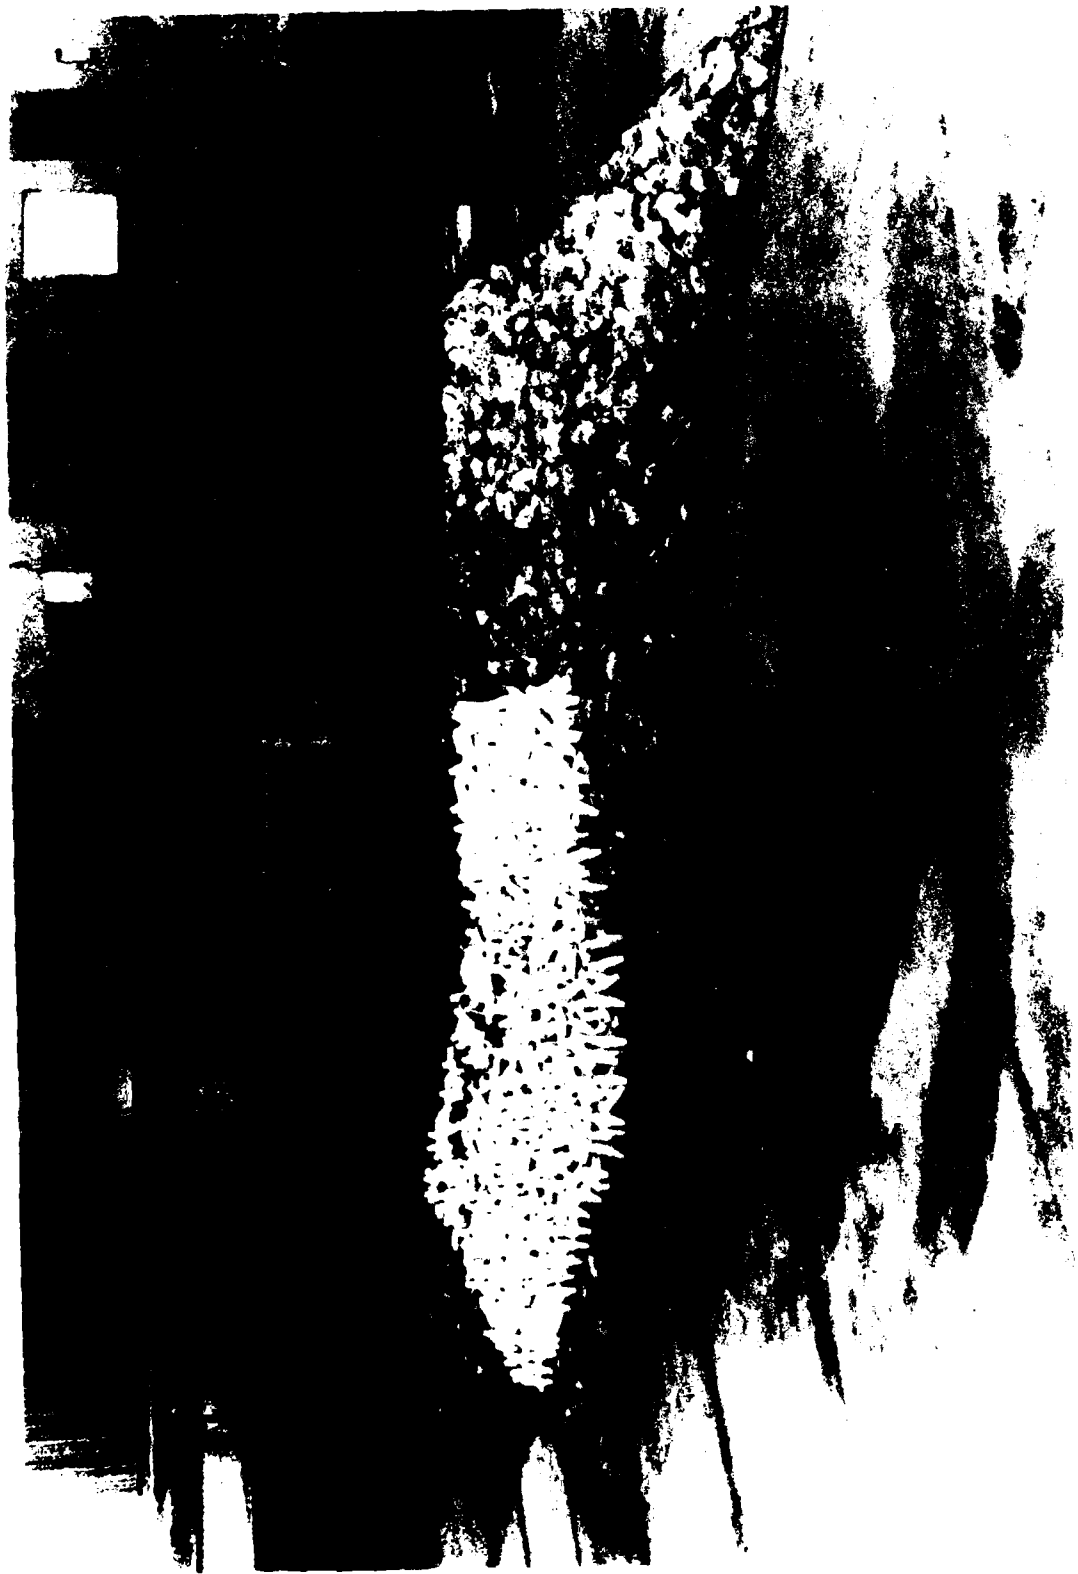
Photo 34. Seaward oblique view of Plan 3 before wave attack
