TECHNICAL REPORT CERC-85-8

# BREAKWATER REHABILITATION STUDY, CRESCENT CITY HARBOR, CALIFORNIA

## Coastal Model Investigation

November 1985

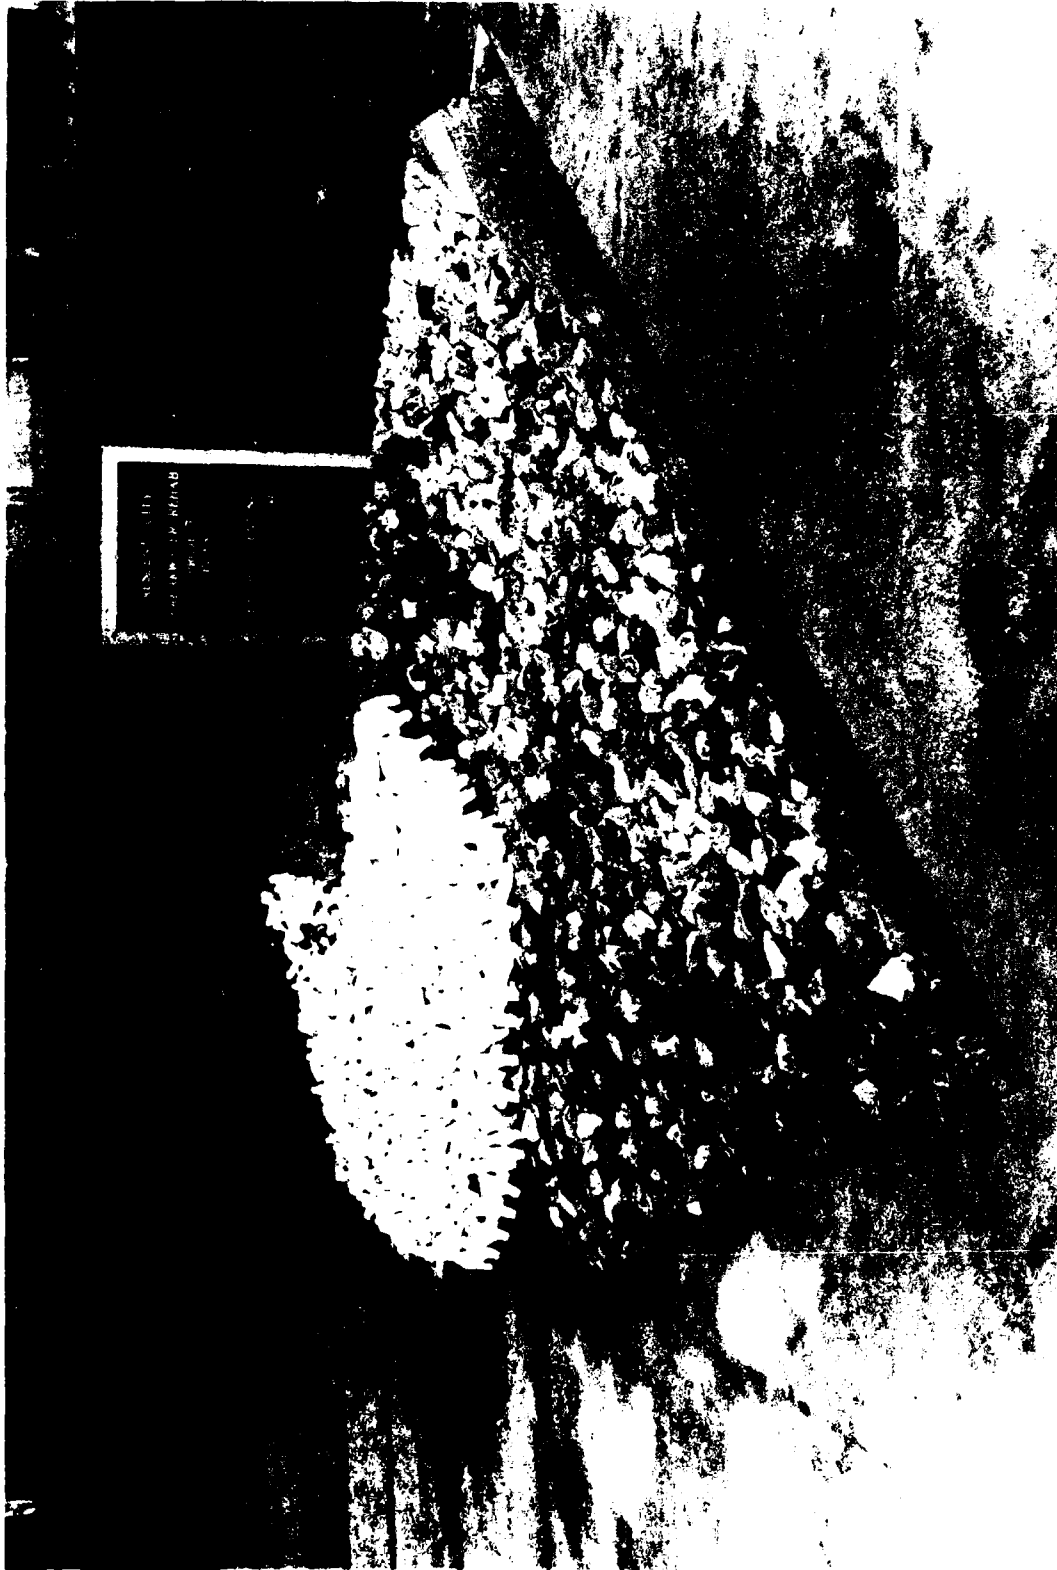
Photo 35. Seaward end view of Plan 3 before wave attack

32. Plan 3 (Plate 8 and Photos 33-35) was constructed with the toe of the dolos rehabilitation units still 160 ft from the outside edge of the cap; however, for this plan the dolos extended further out the eastern extension to sta 38+00. A total of 576 dolosse were used in the rehabilitation area. The lower corner of the seaward transition area now rested on material in the shoal area, and the flukes of these toe units were exposed for swl's of -1 and +4 ft. Damage originated in this location for these water levels and became severe for the +7-ft swl. Although there was less damage than for previous plans, the damage was still too excessive for the plan to be acceptable. Photos 36-38 show the structure after testing.

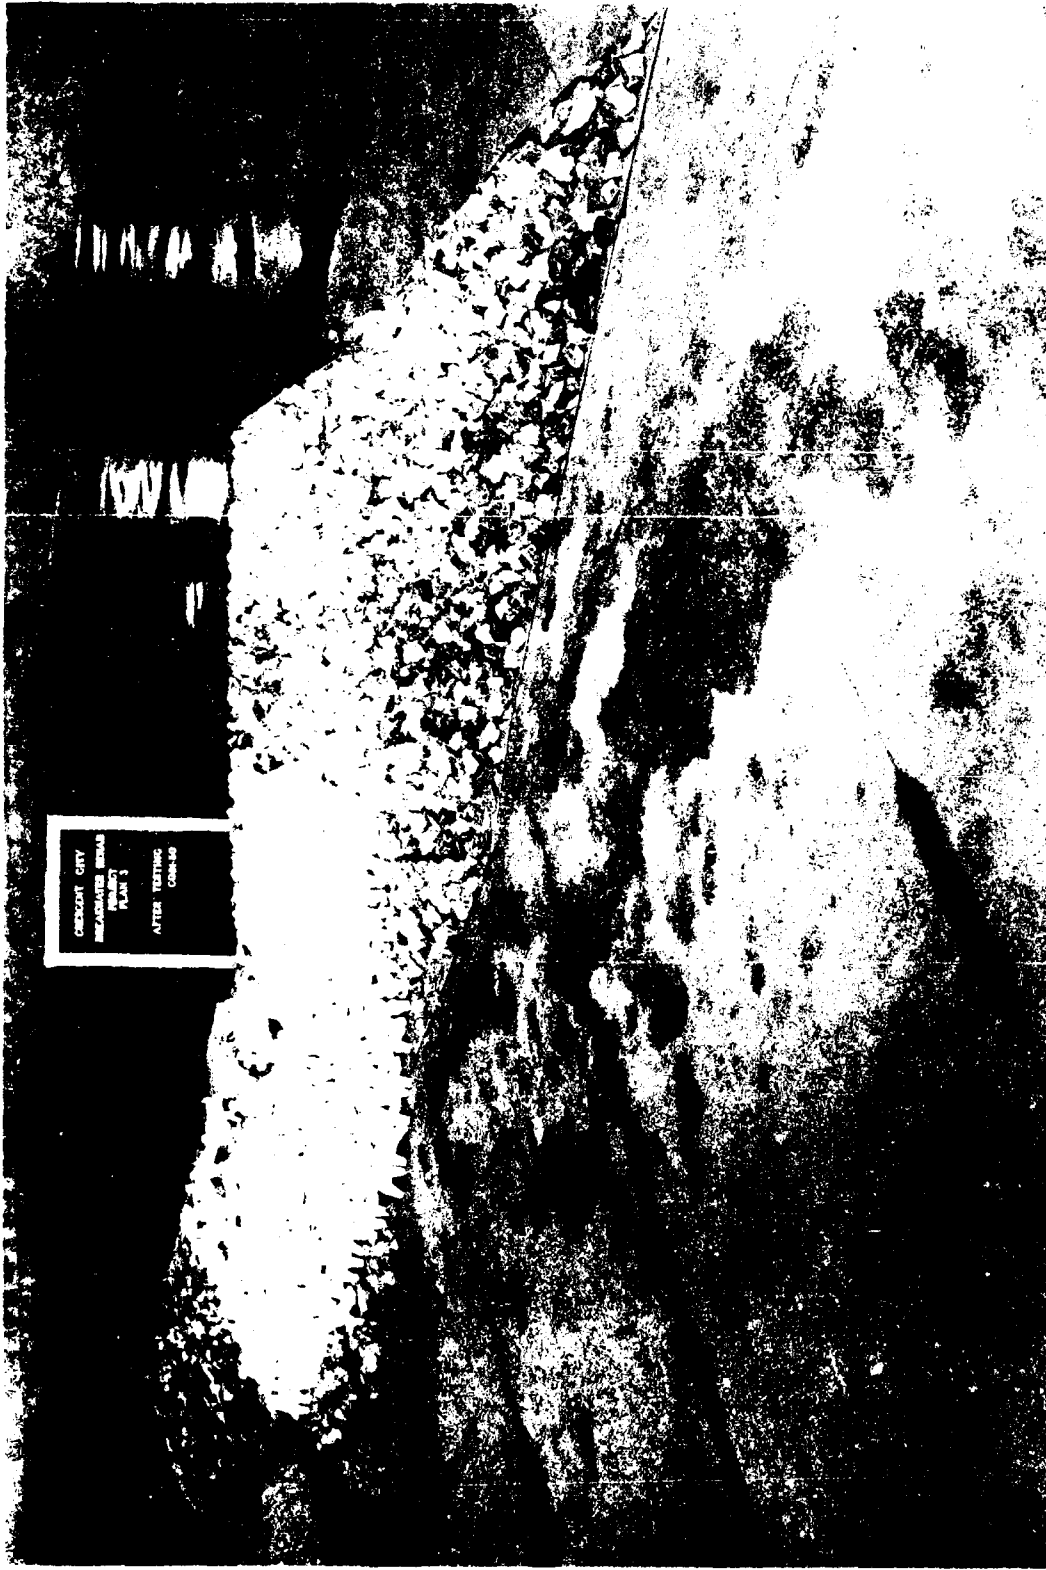
Photo 36. Sea-side view of Plan 3 after completion of abbreviated hypersaturation

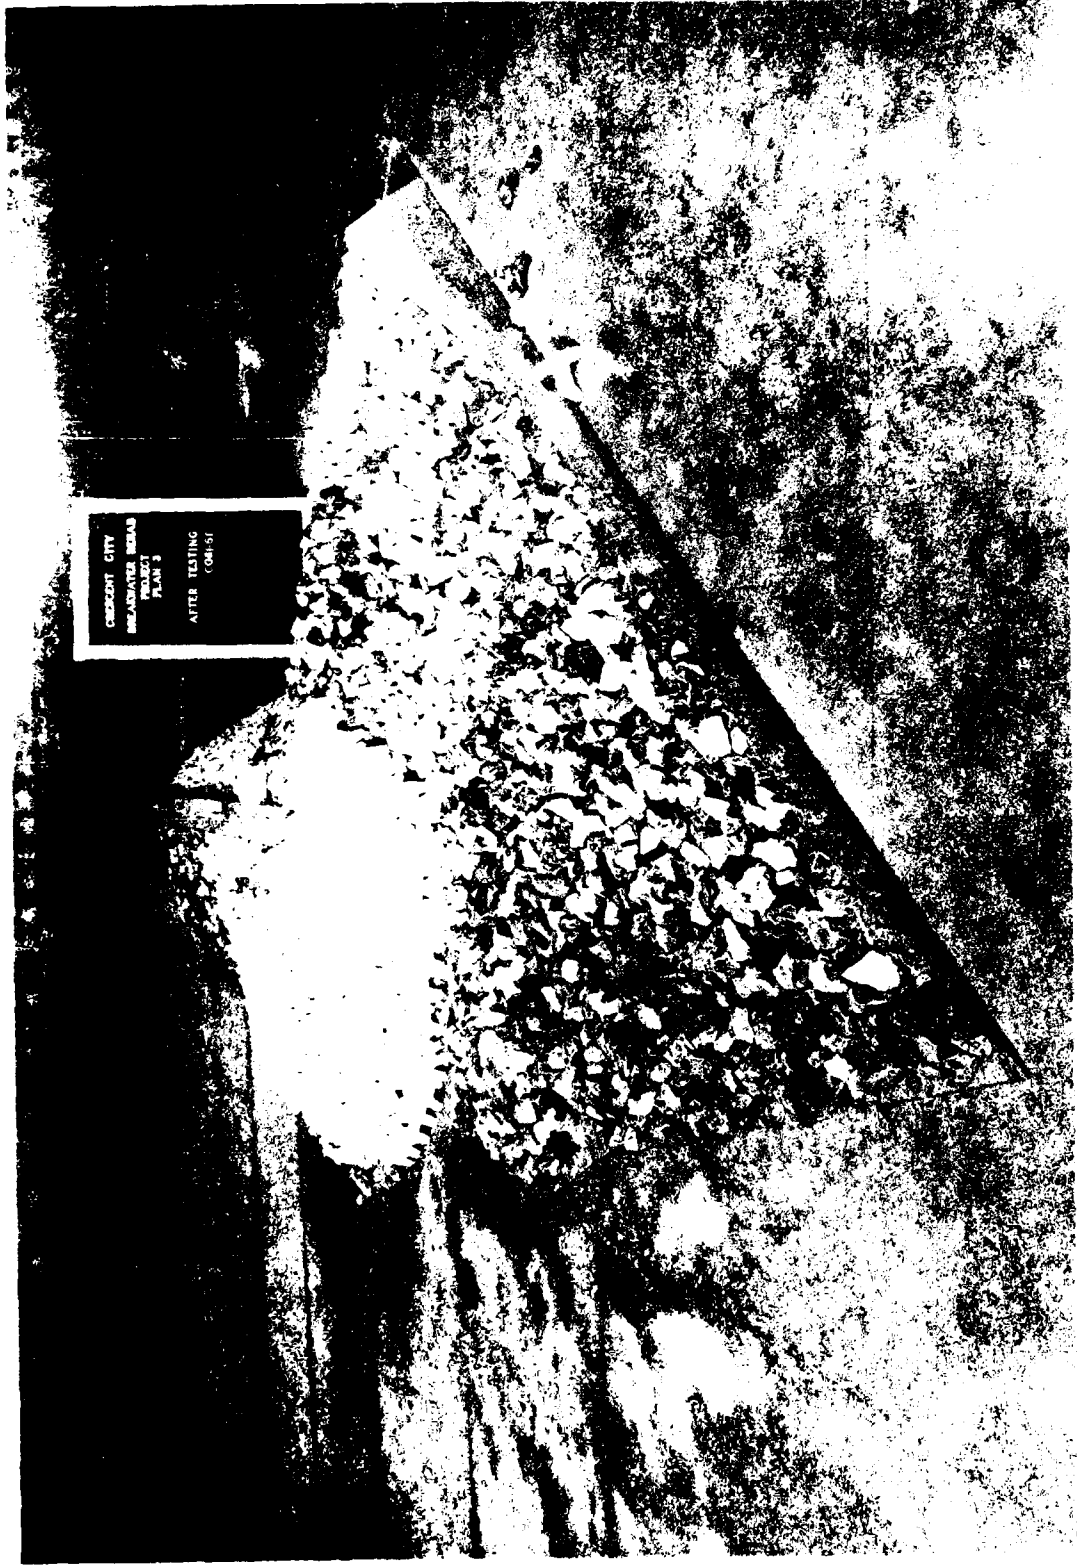
Photo 37. Seaward oblique view of Plan 3 after completion of abbreviated hydrograph

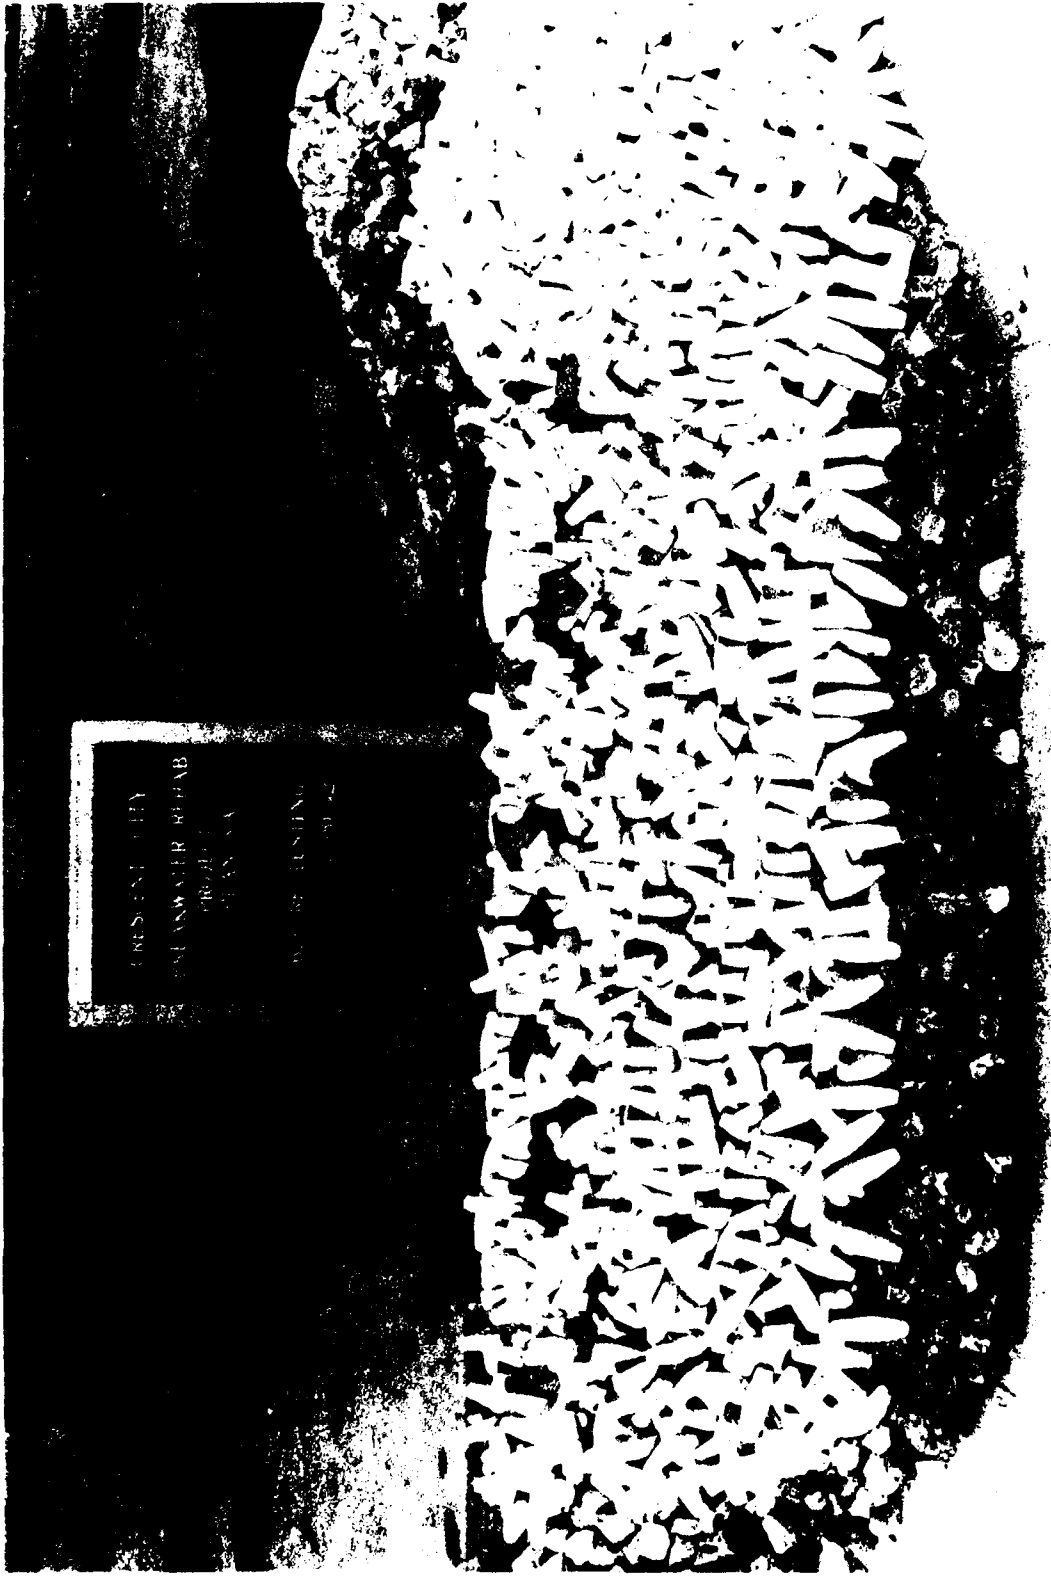
Photo 38. Seaward end view of Plan 3 after completion of abbreviated hydrograph

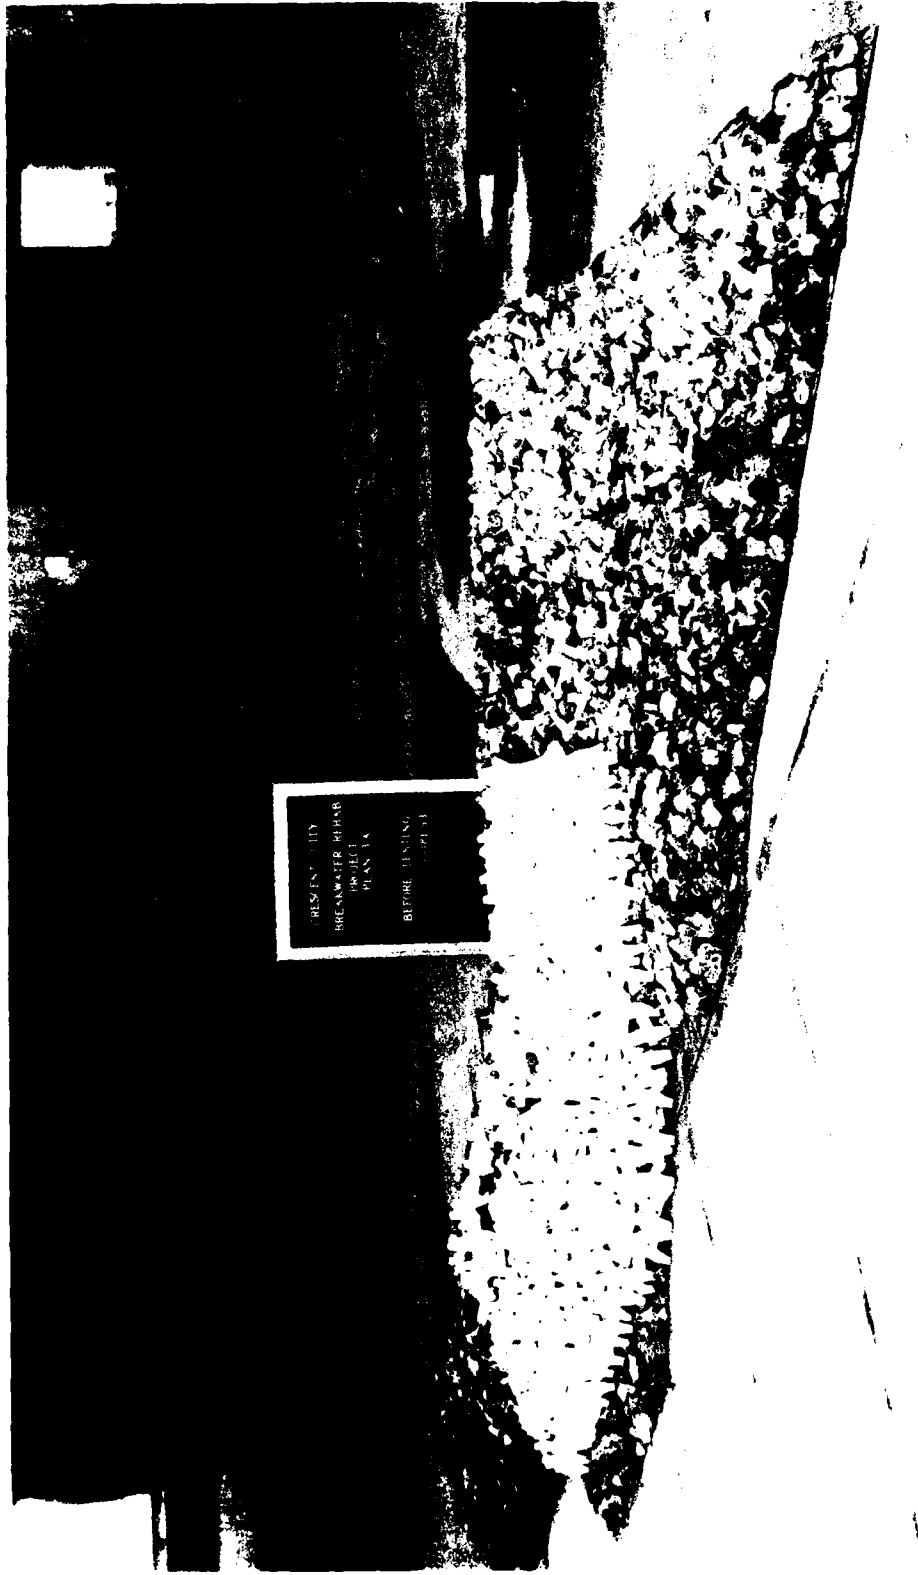
Photo 39. Sea-side view of Plan 3A before wave attack

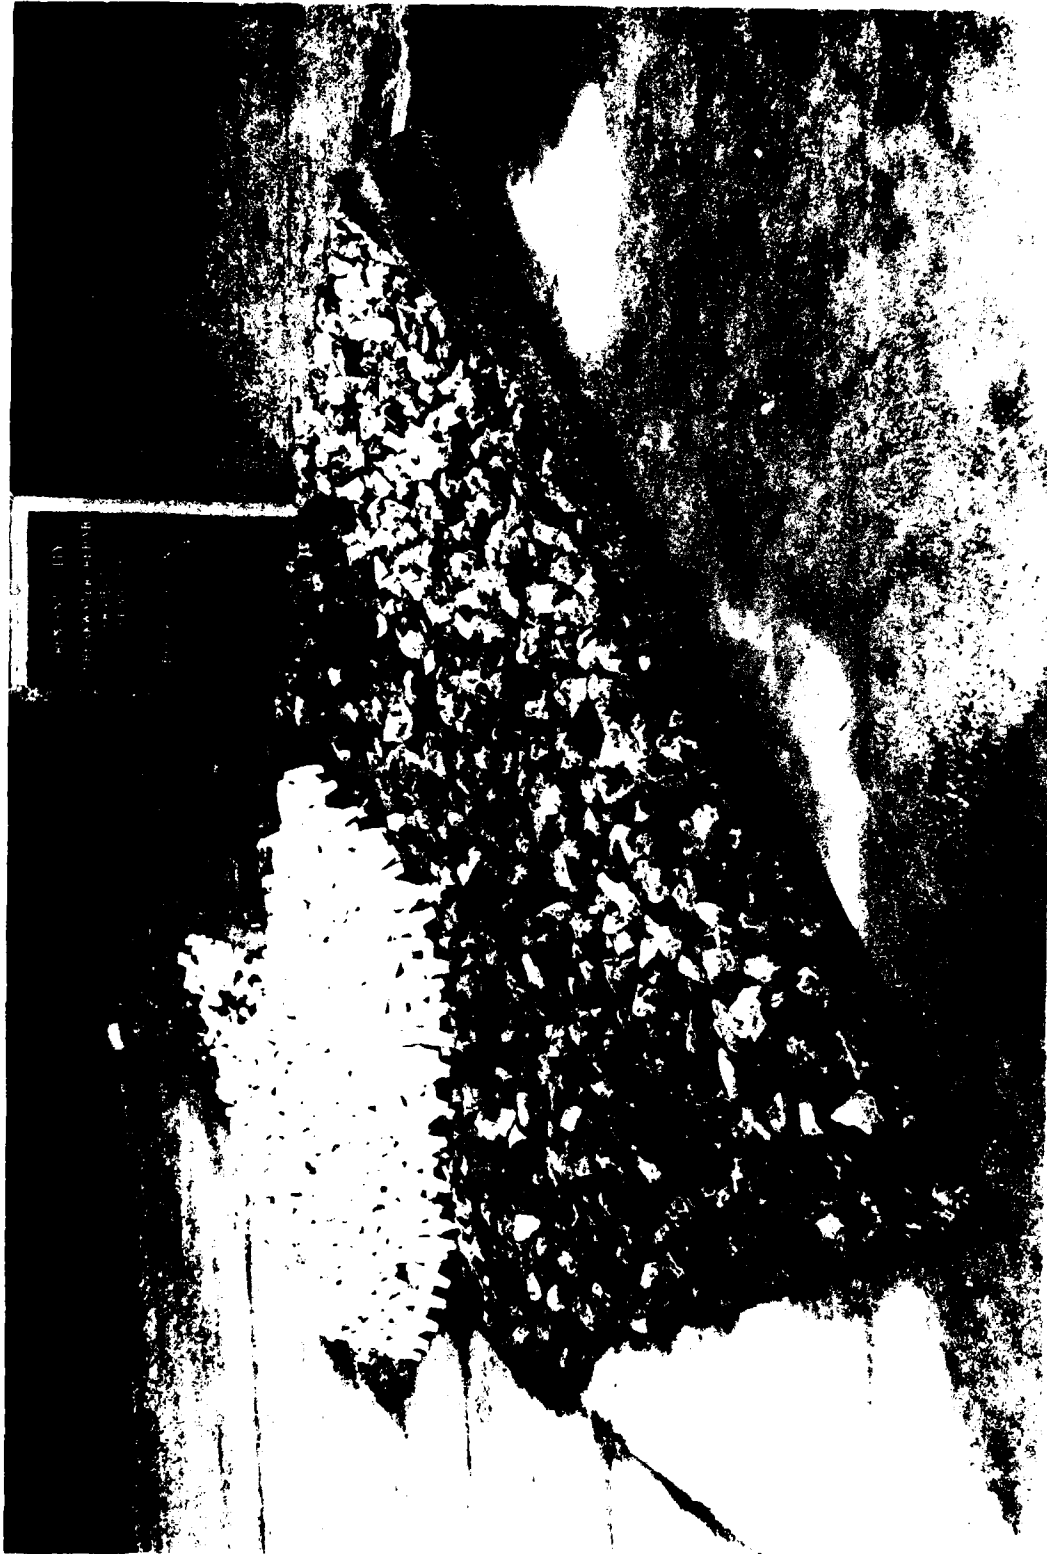
Photo 40. Seaward oblique view of Plan 3A before wave attack

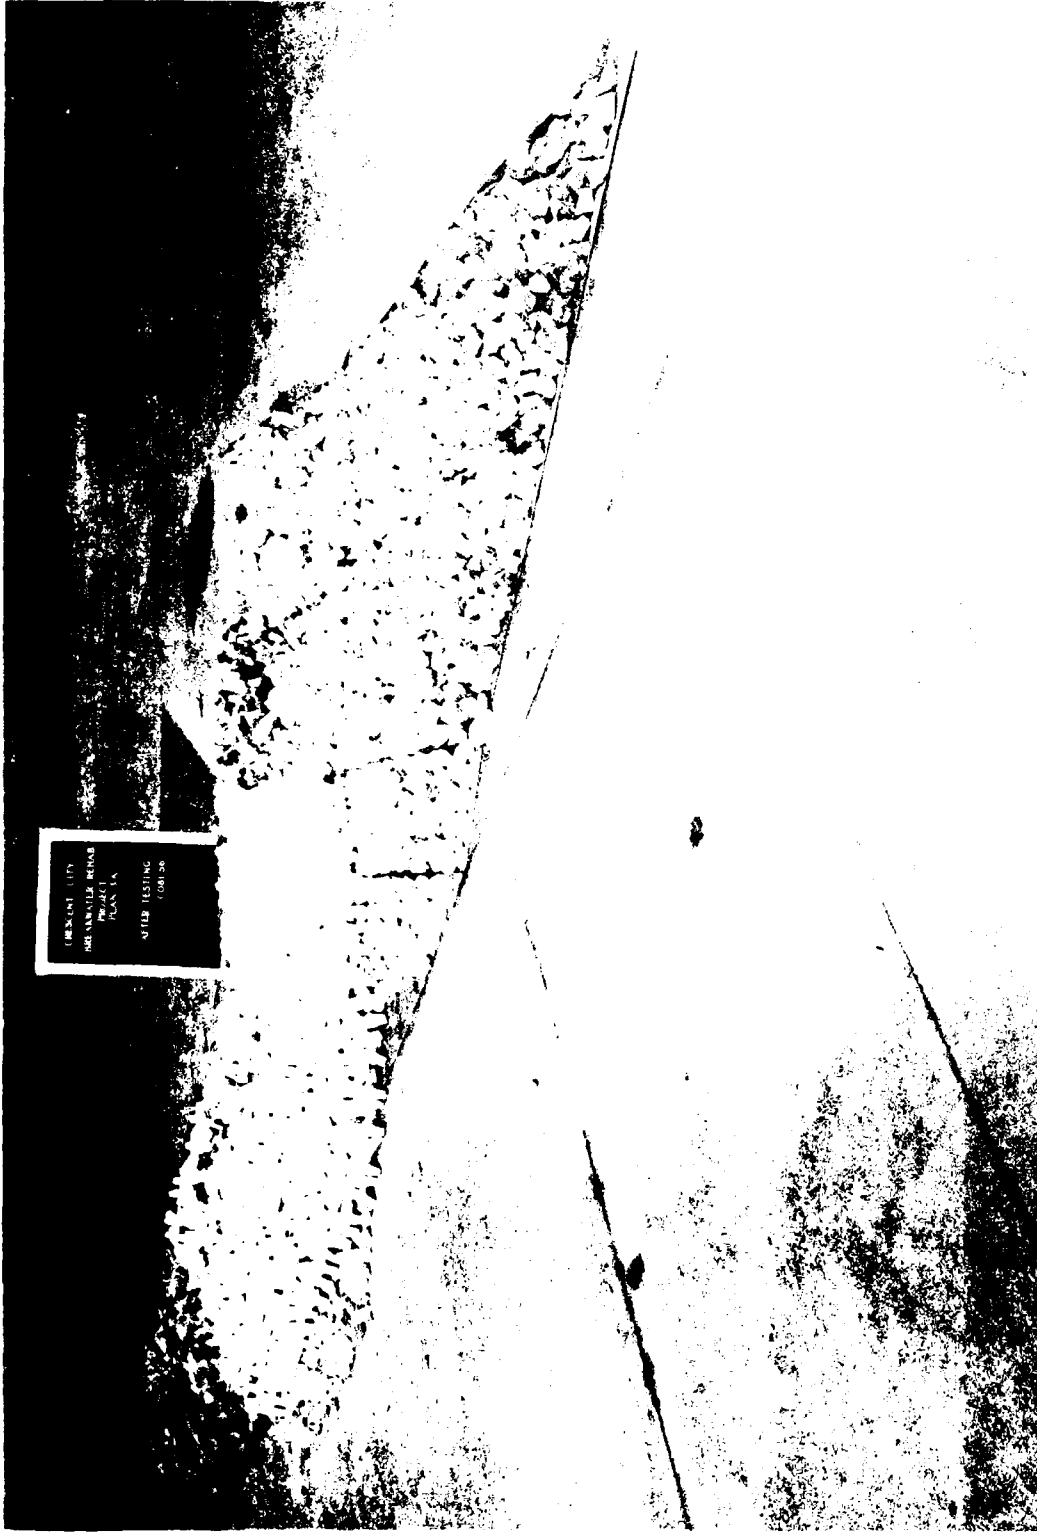
Photo 42. Sea-side view of Plan 3A after completion of abbreviated hydrograph

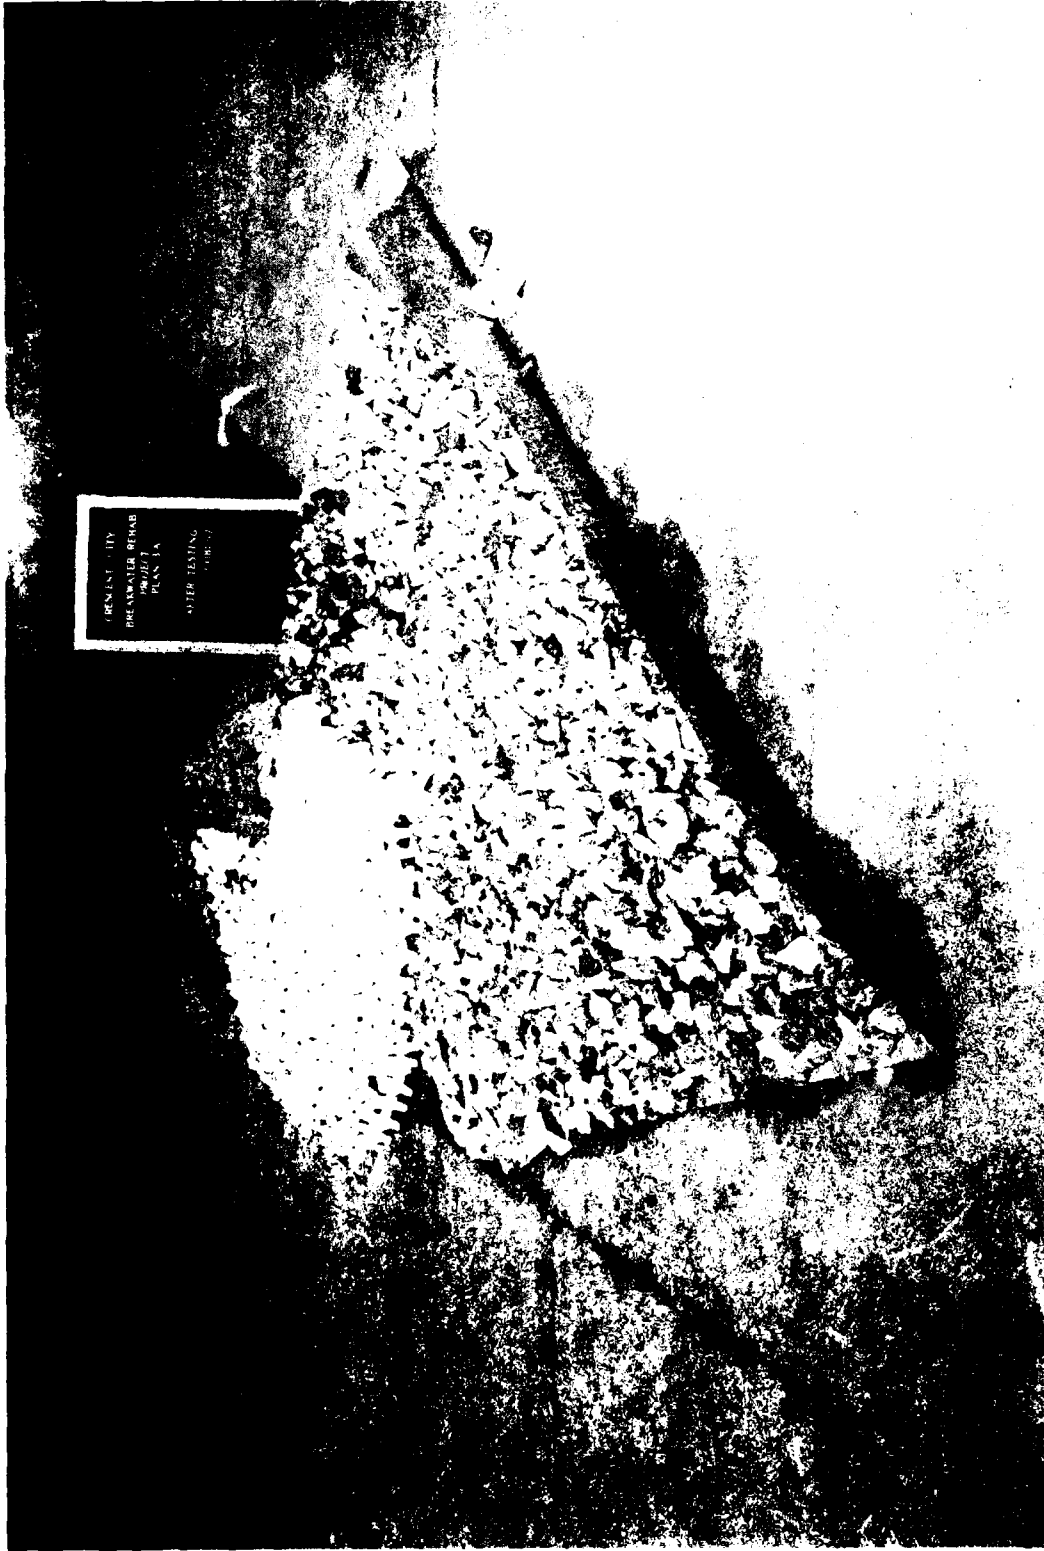
Photo 43. Seaward oblique view of Plan 3A after completion of abbreviated hydrograph

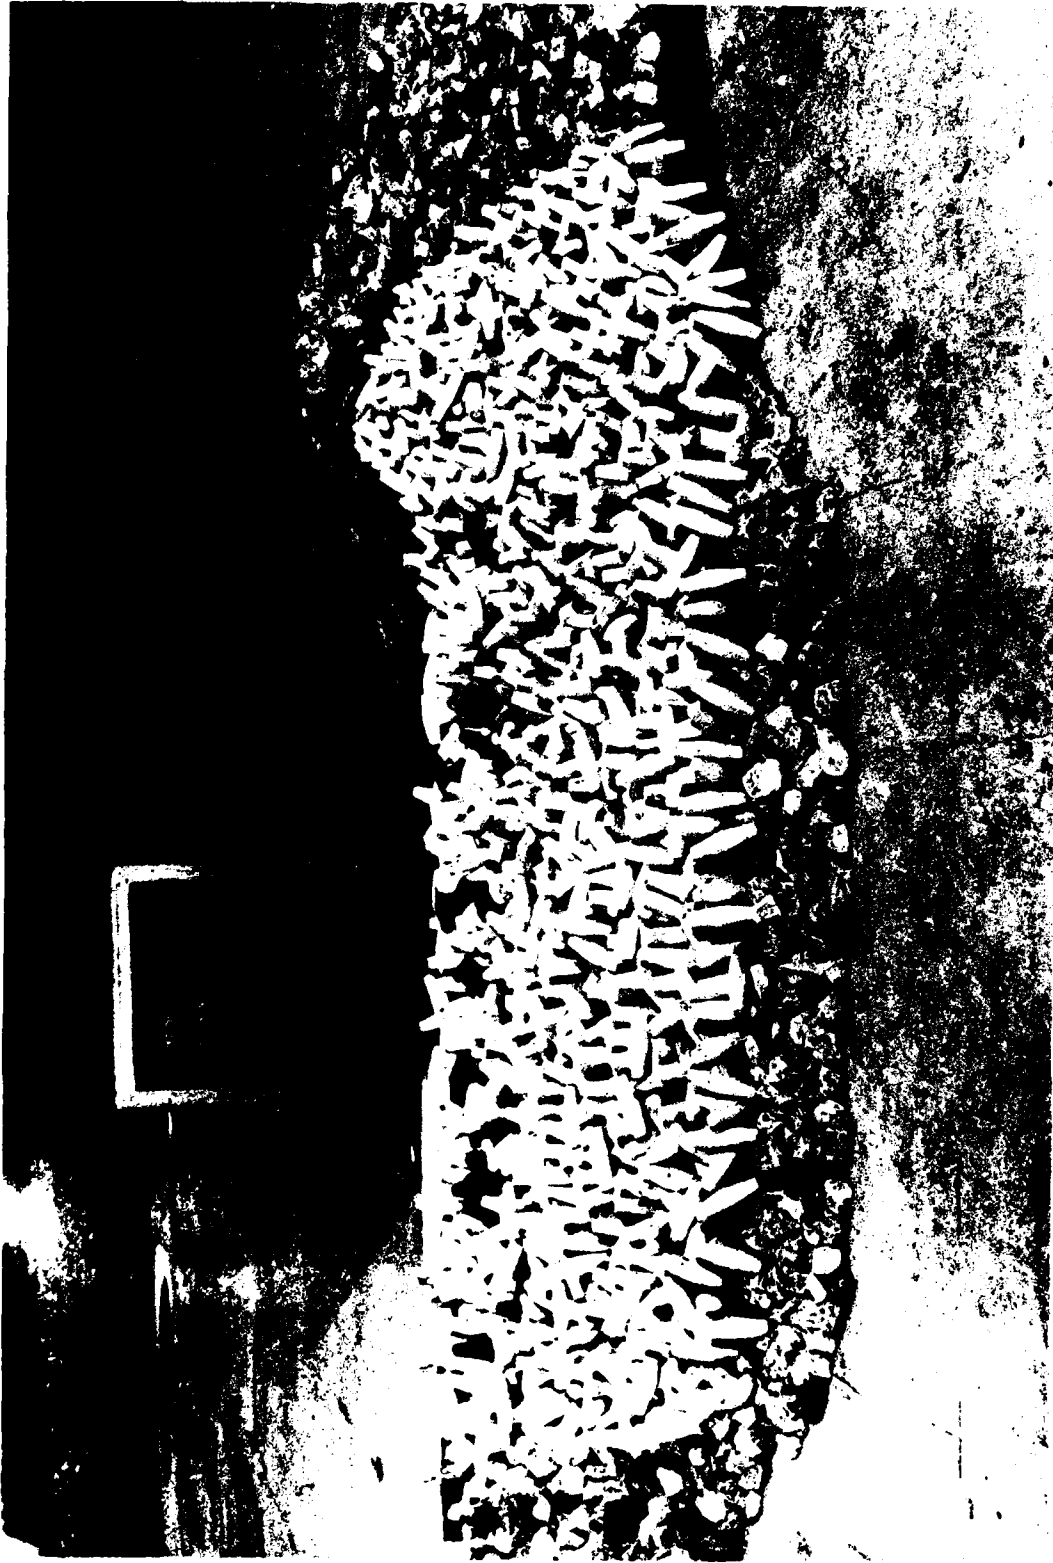
Photo 44. Seaward end view of Plan 3A after completion of abbreviated hydrograph

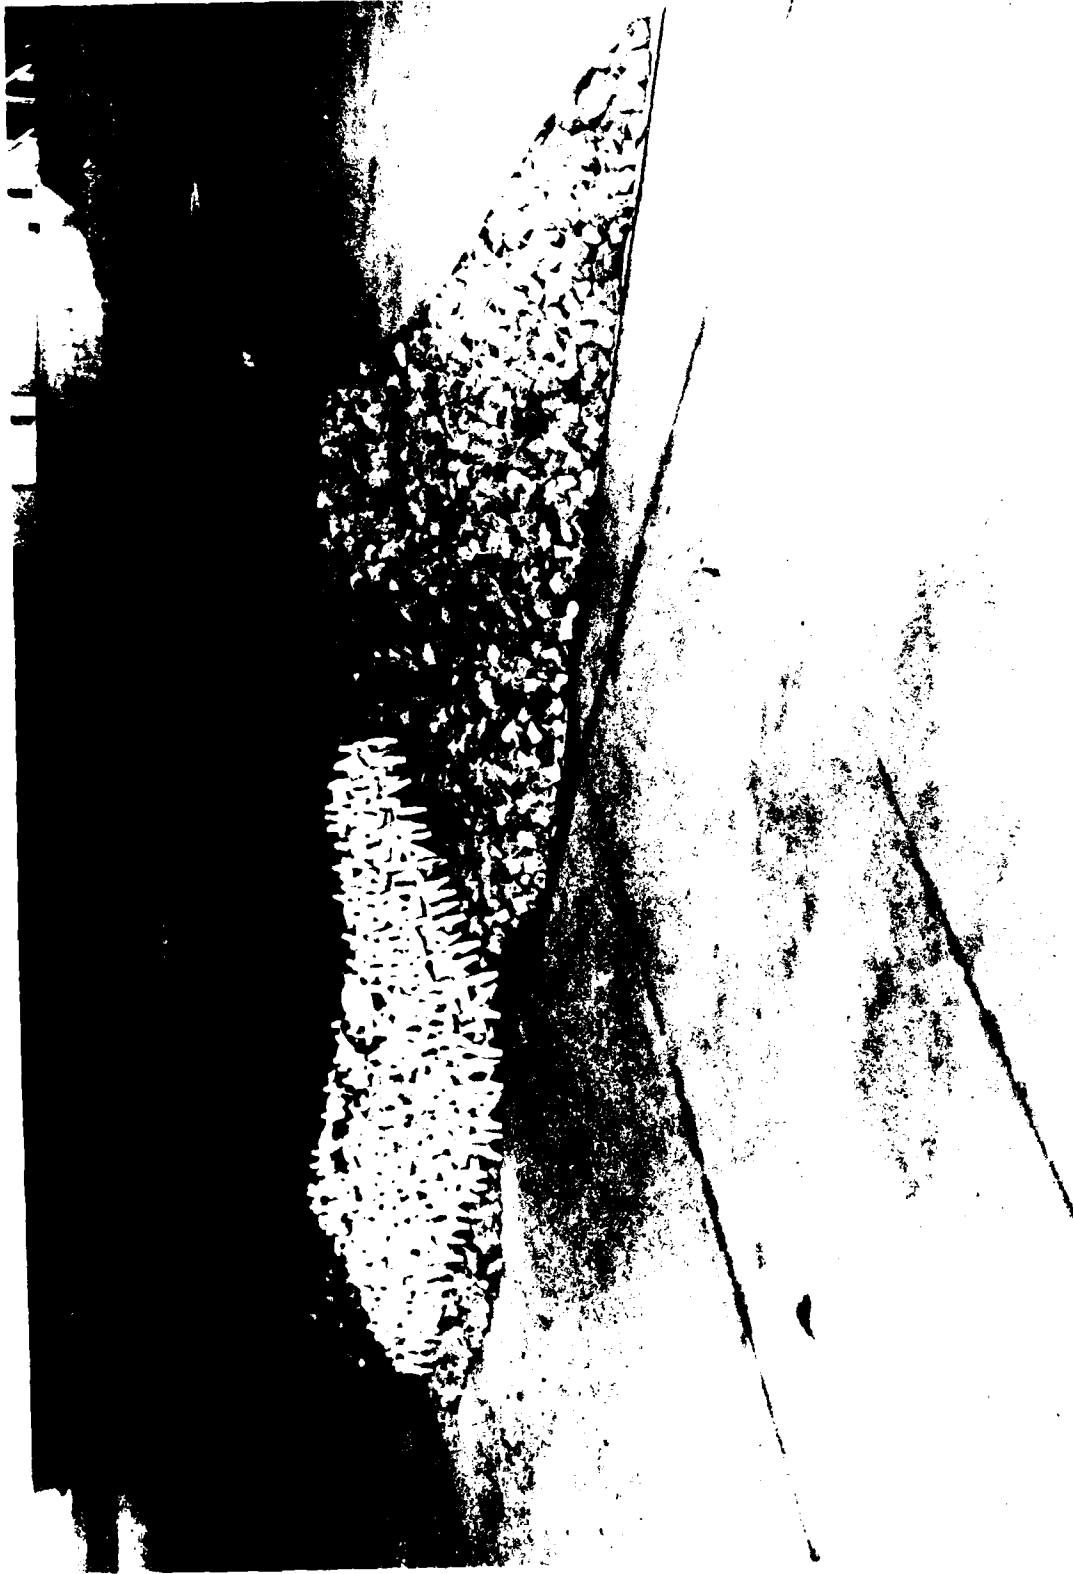
Photo 45. Sea-side view of Plan 4 before wave attack

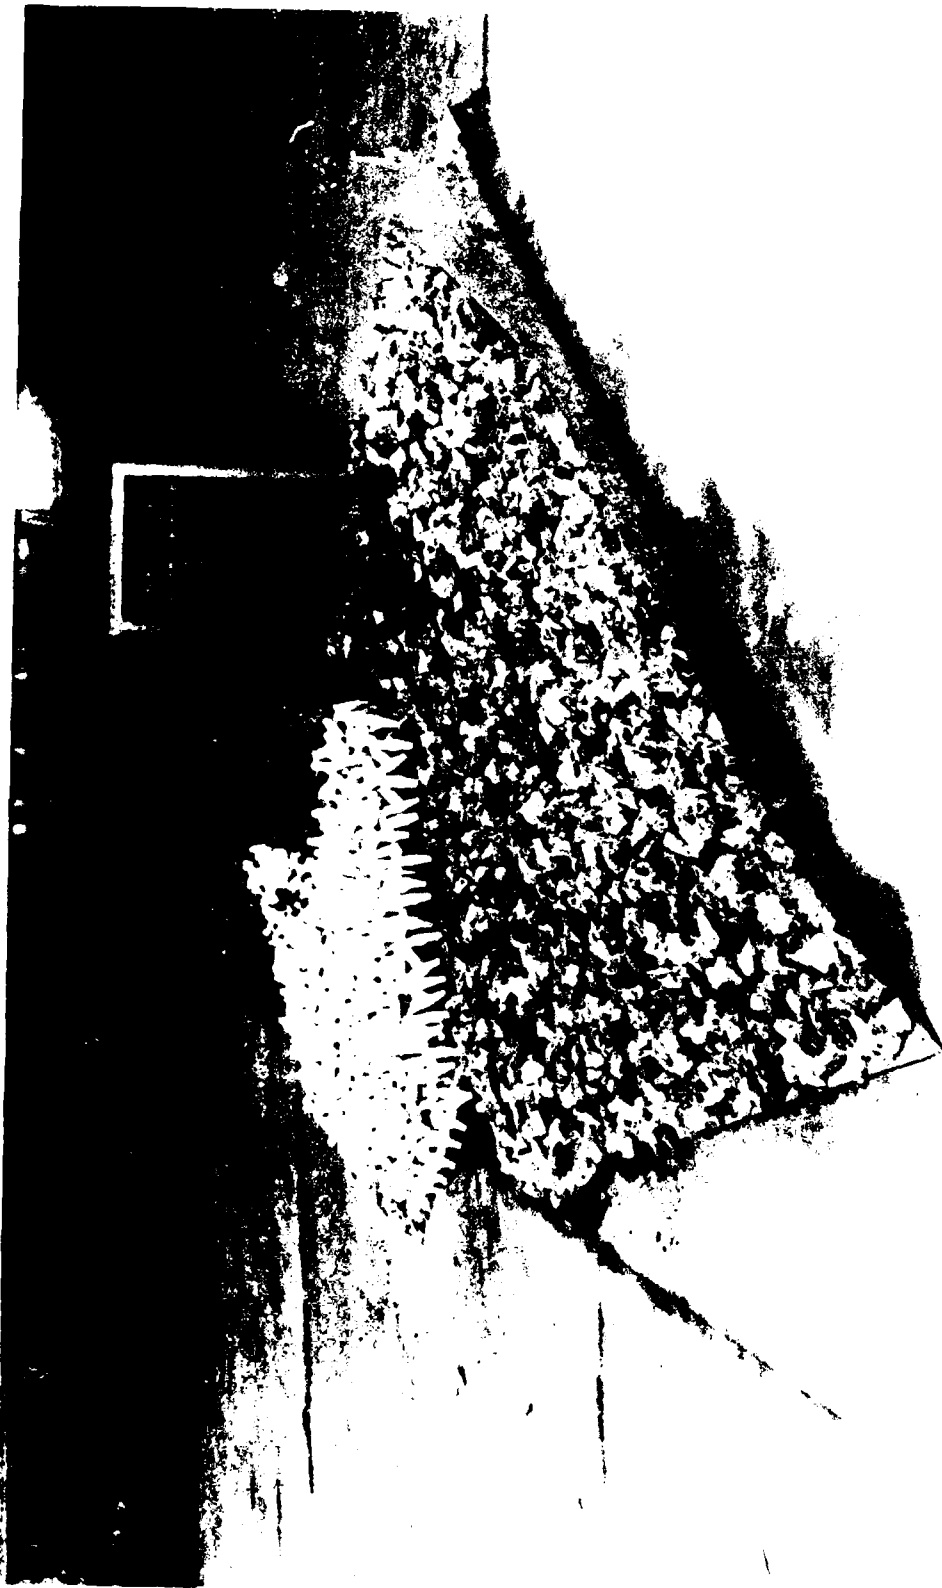
Photo 46. Seaward oblique view of Plan 4 before wave attack

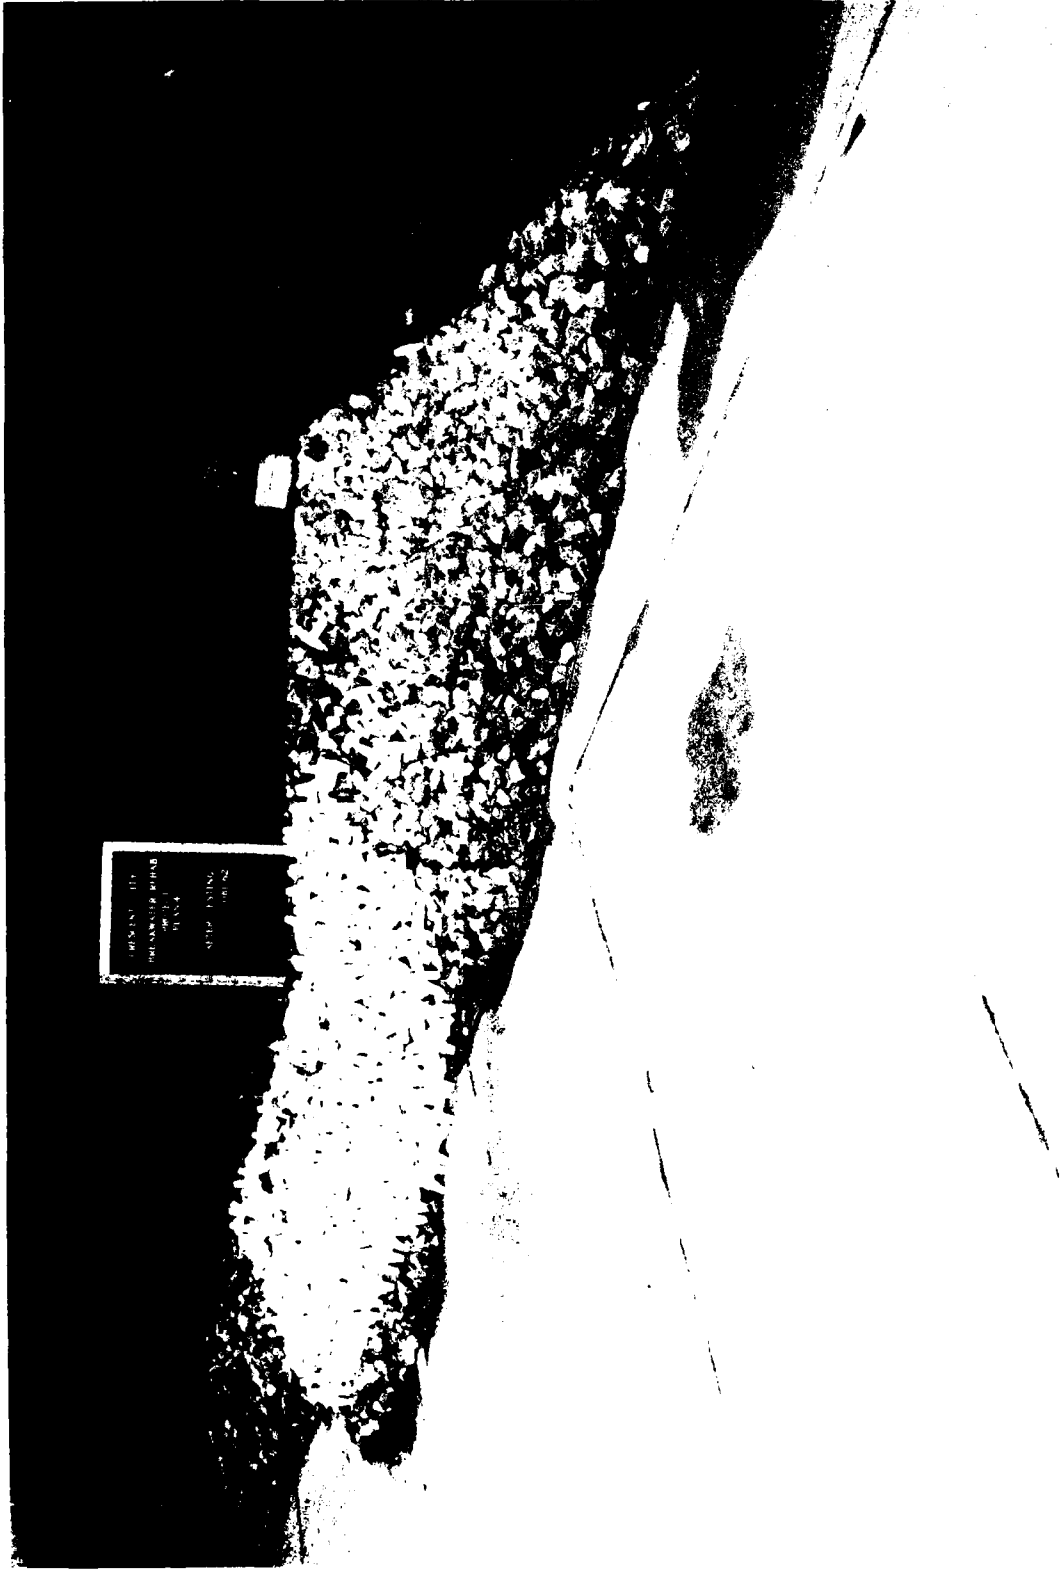
Photo 48. Sea-side view of Plan 4 after completion of abbreviated hydrograph

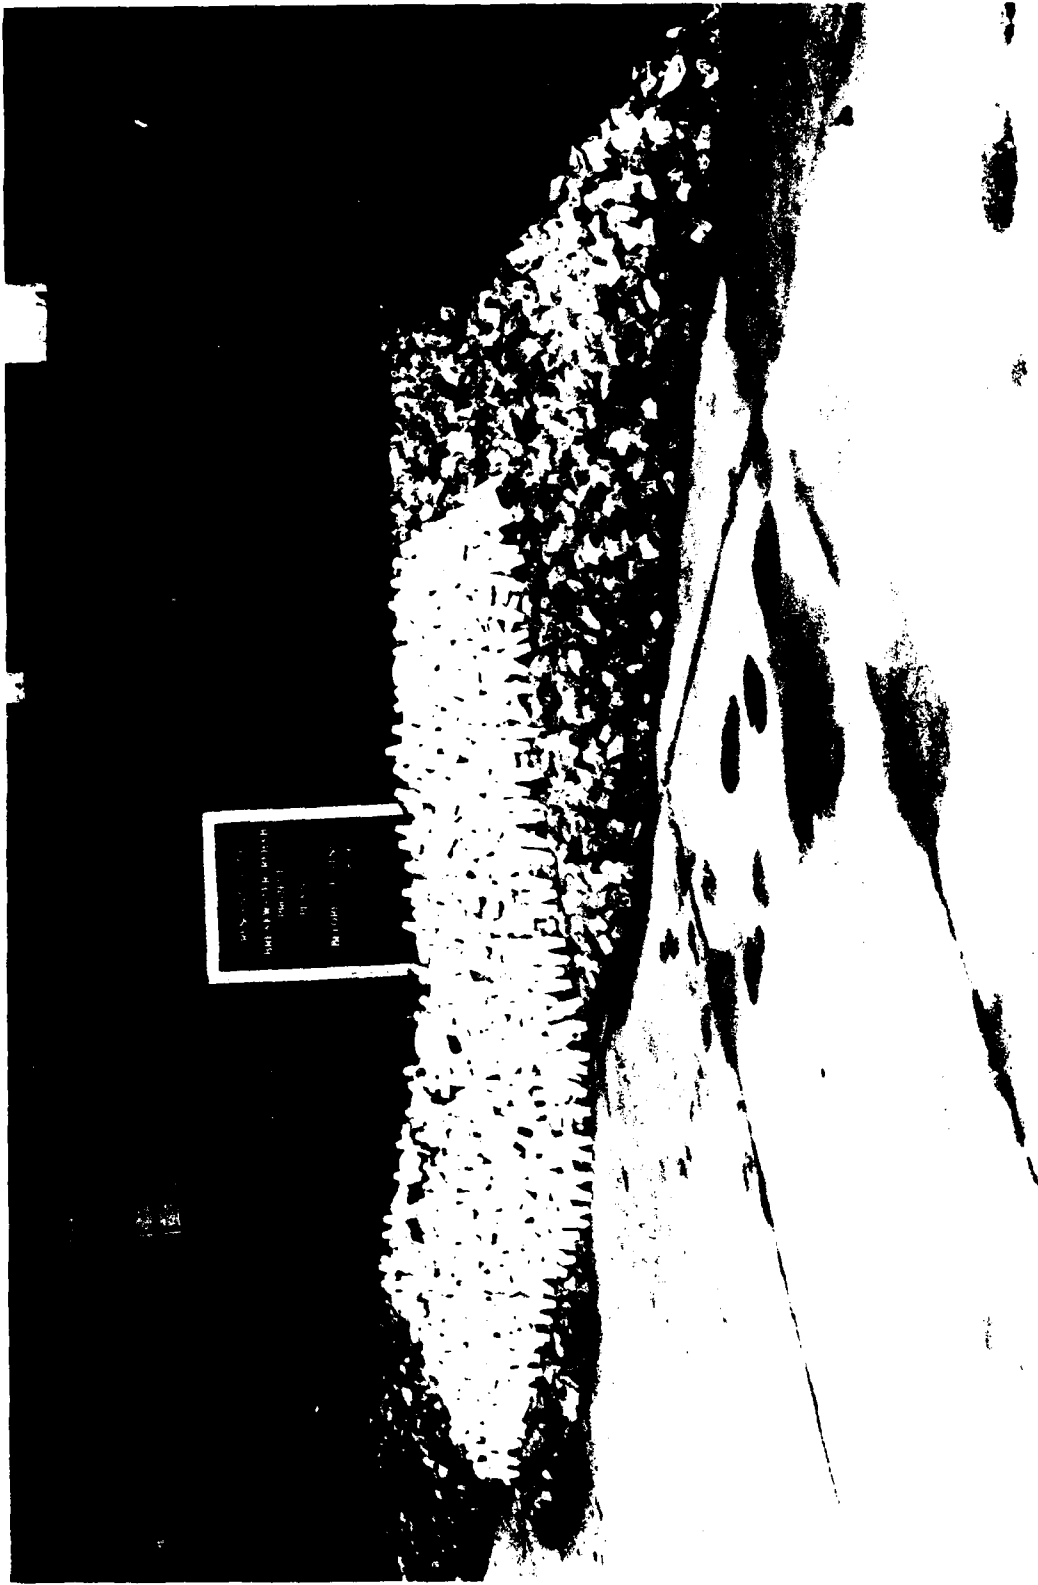
Photo 51. Sea-side view of Plan 5 before wave attack

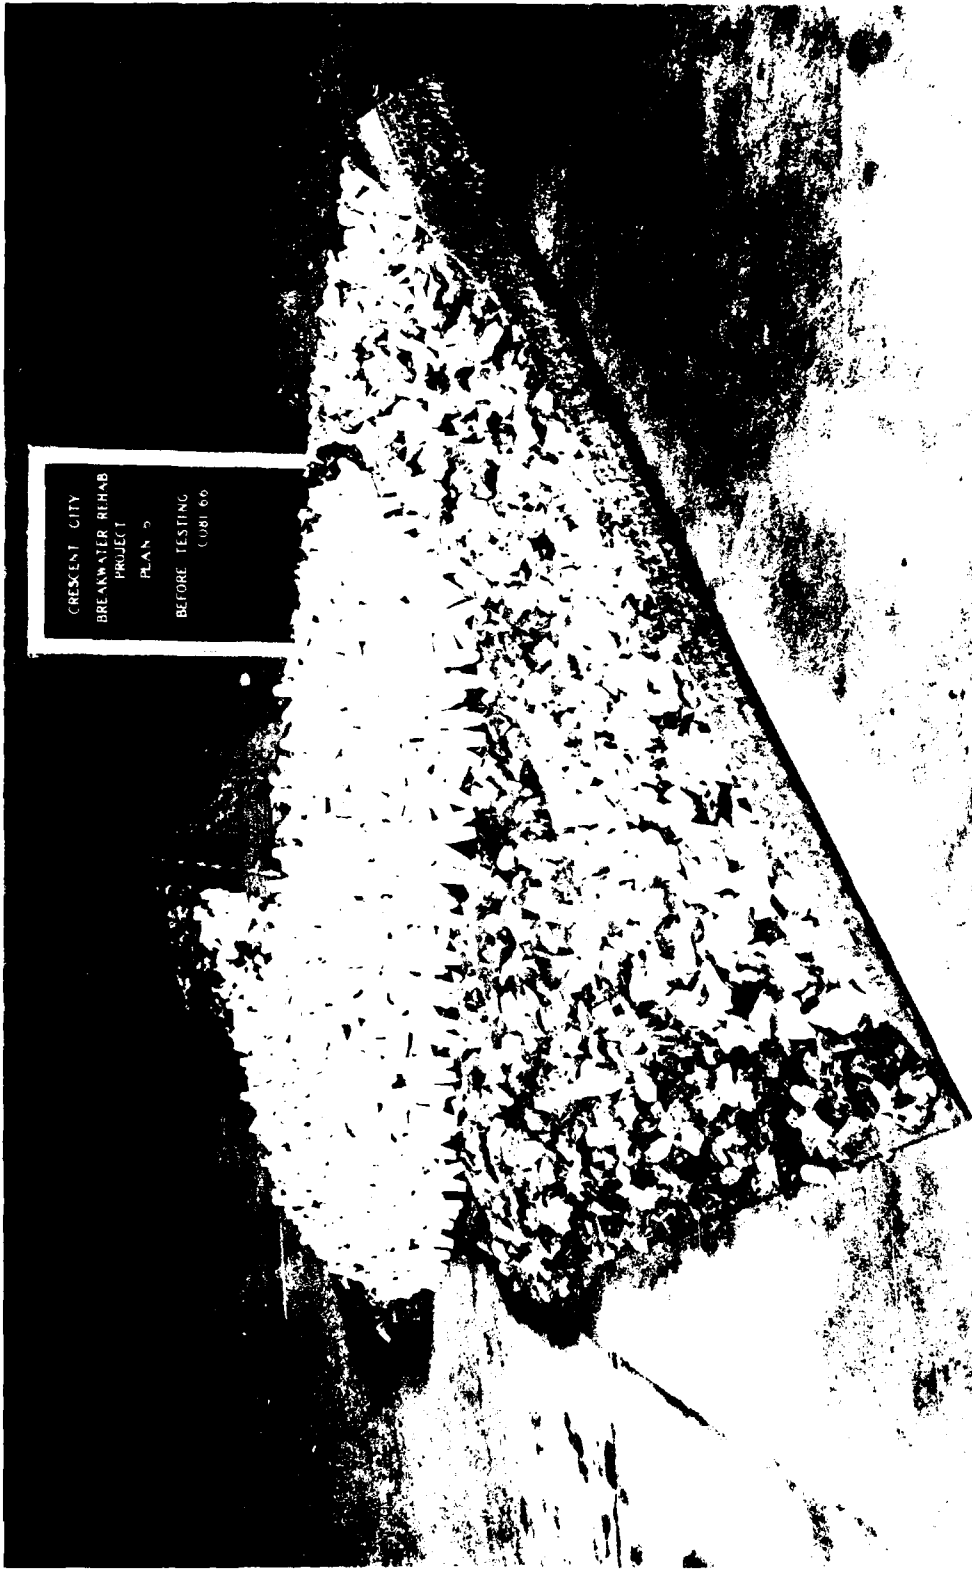
Photo 52. Seaward oblique view of Plan 5 before wave attack
