TECHNICAL REPORT CERC-85-8

# BREAKWATER REHABILITATION STUDY, CRESCENT CITY HARBOR, CALIFORNIA

## Coastal Model Investigation

November 1985

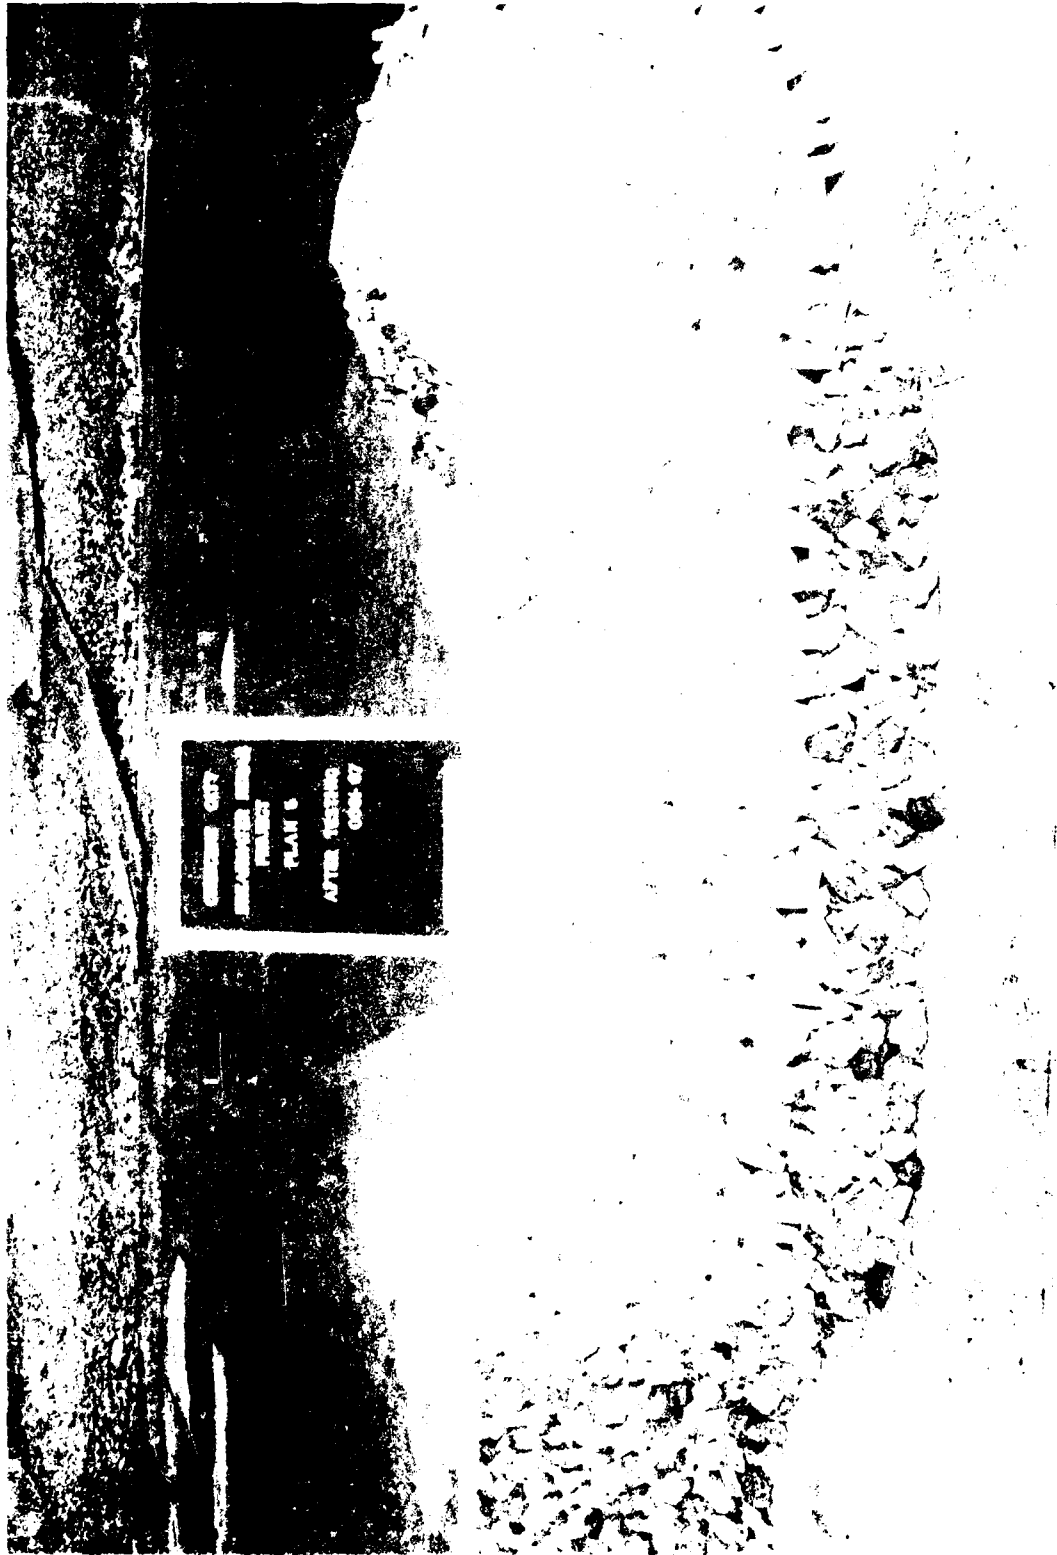
Photo 53. Seaward end view of Plan 5 before wave attack

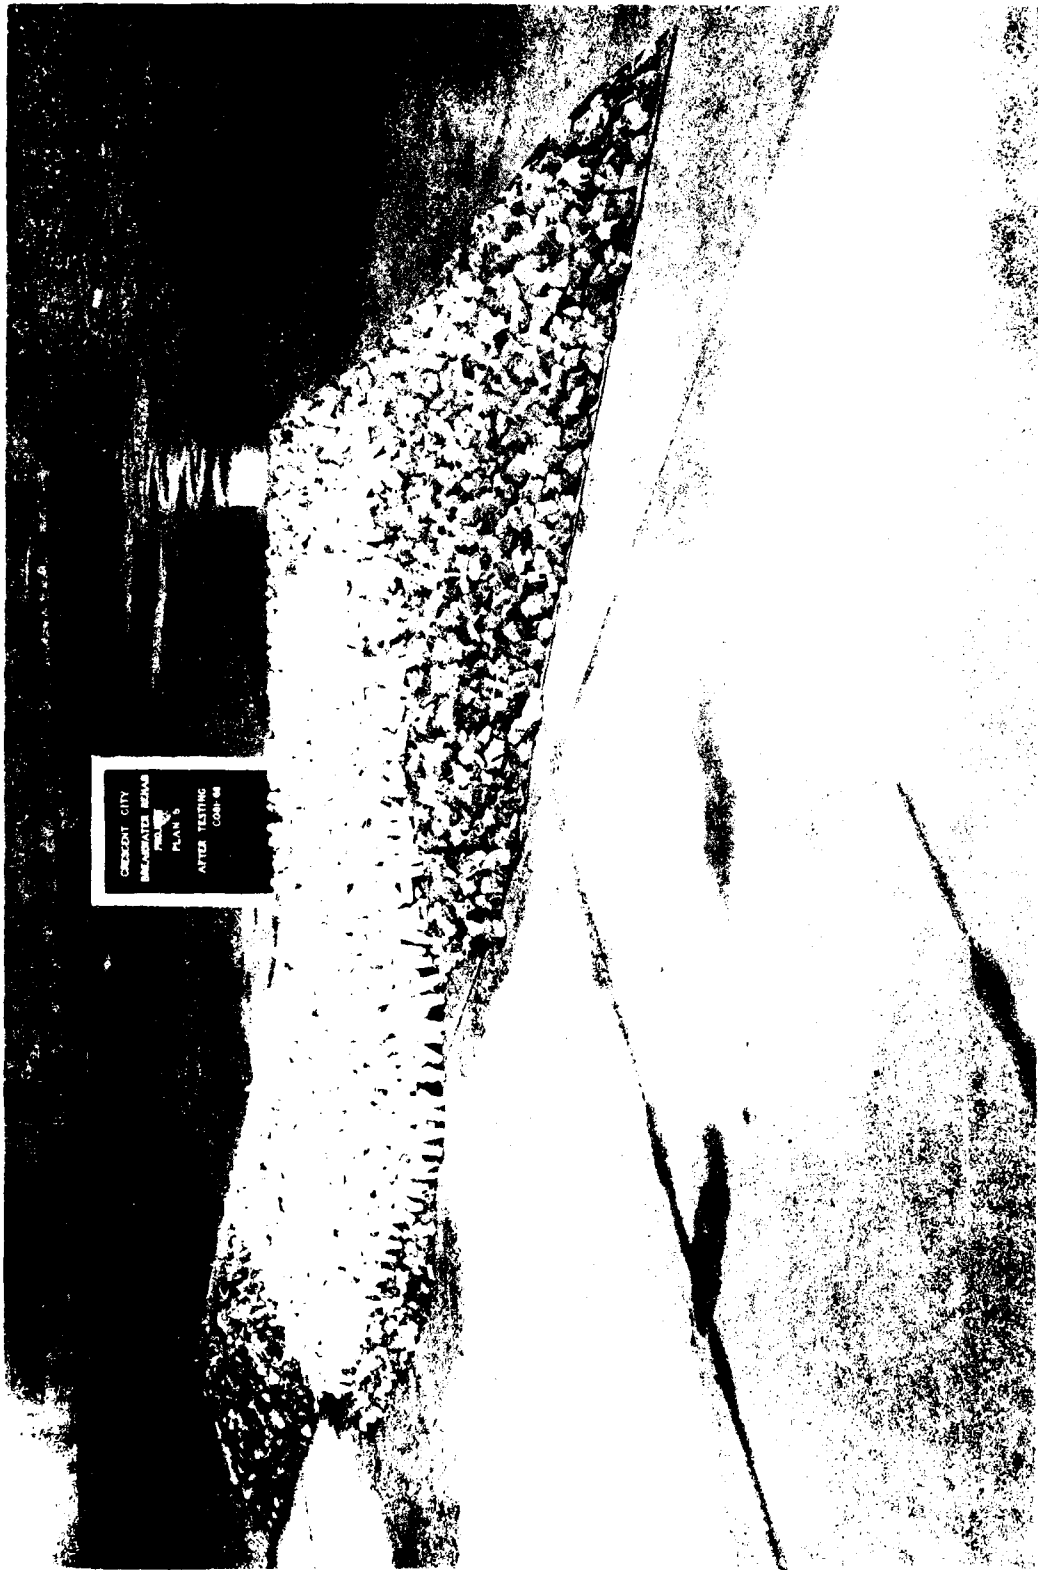
Photo 54. Sea-side view of Plan 5 after completion of abbreviated hydrograph

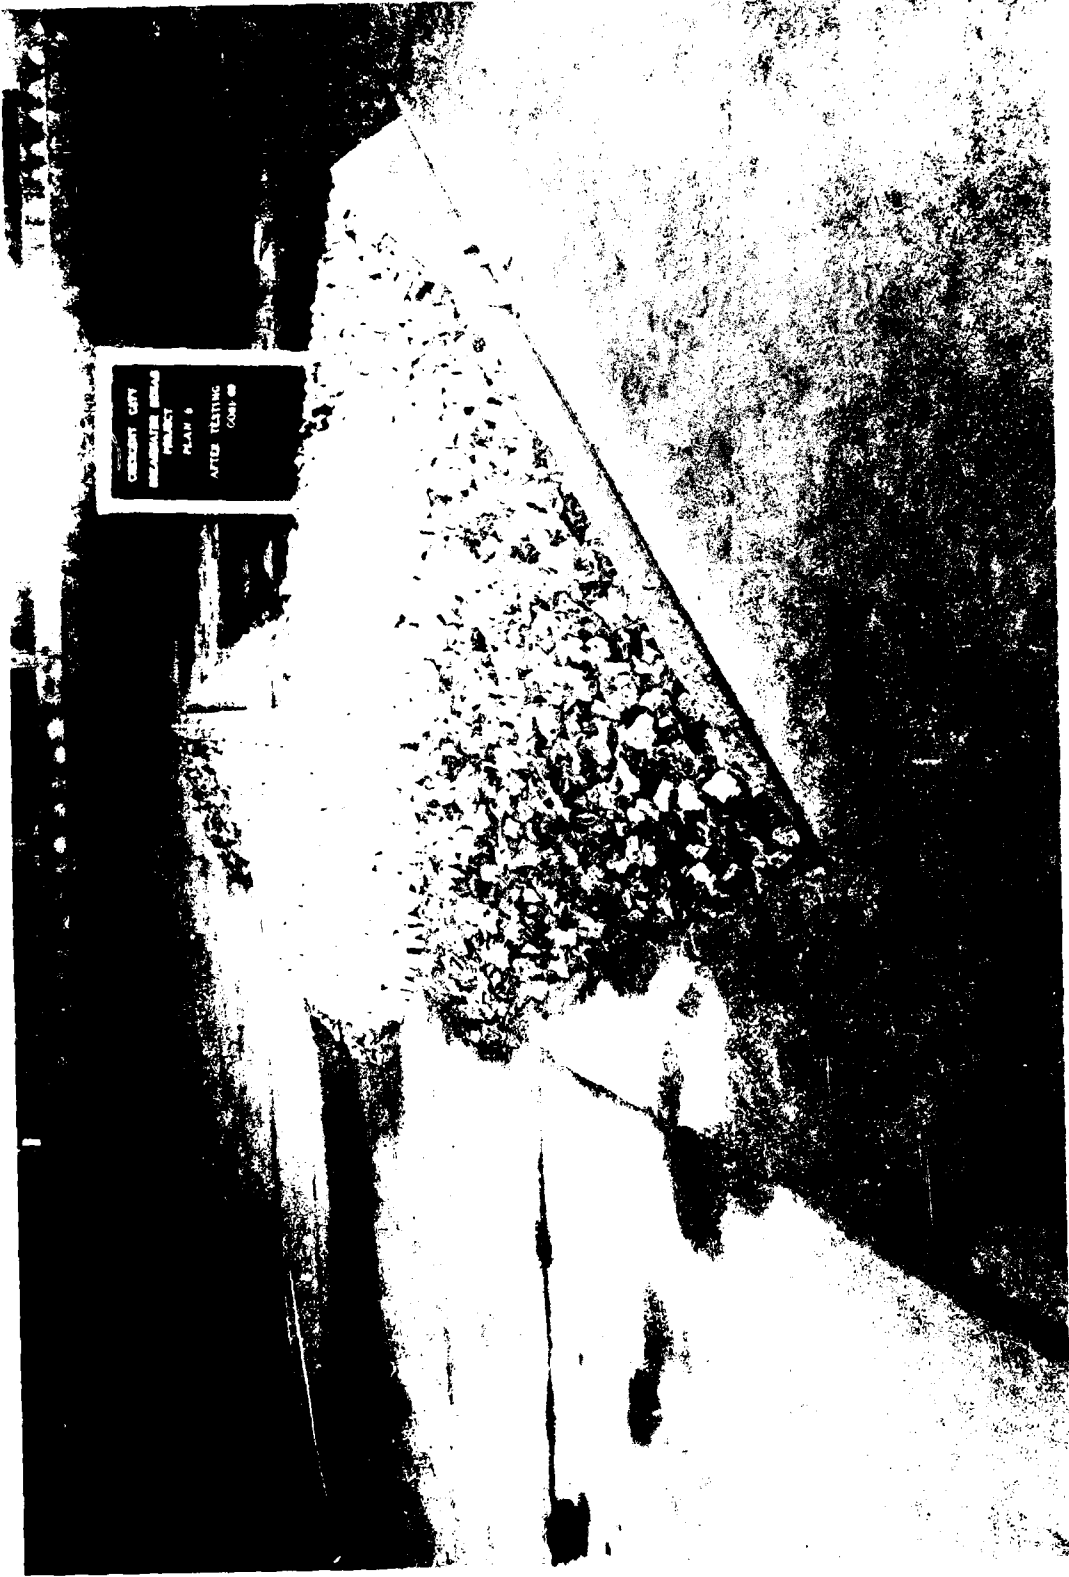
Photo 55. Seaward oblique view of Plan 5 after completion of abbreviated hydrograph

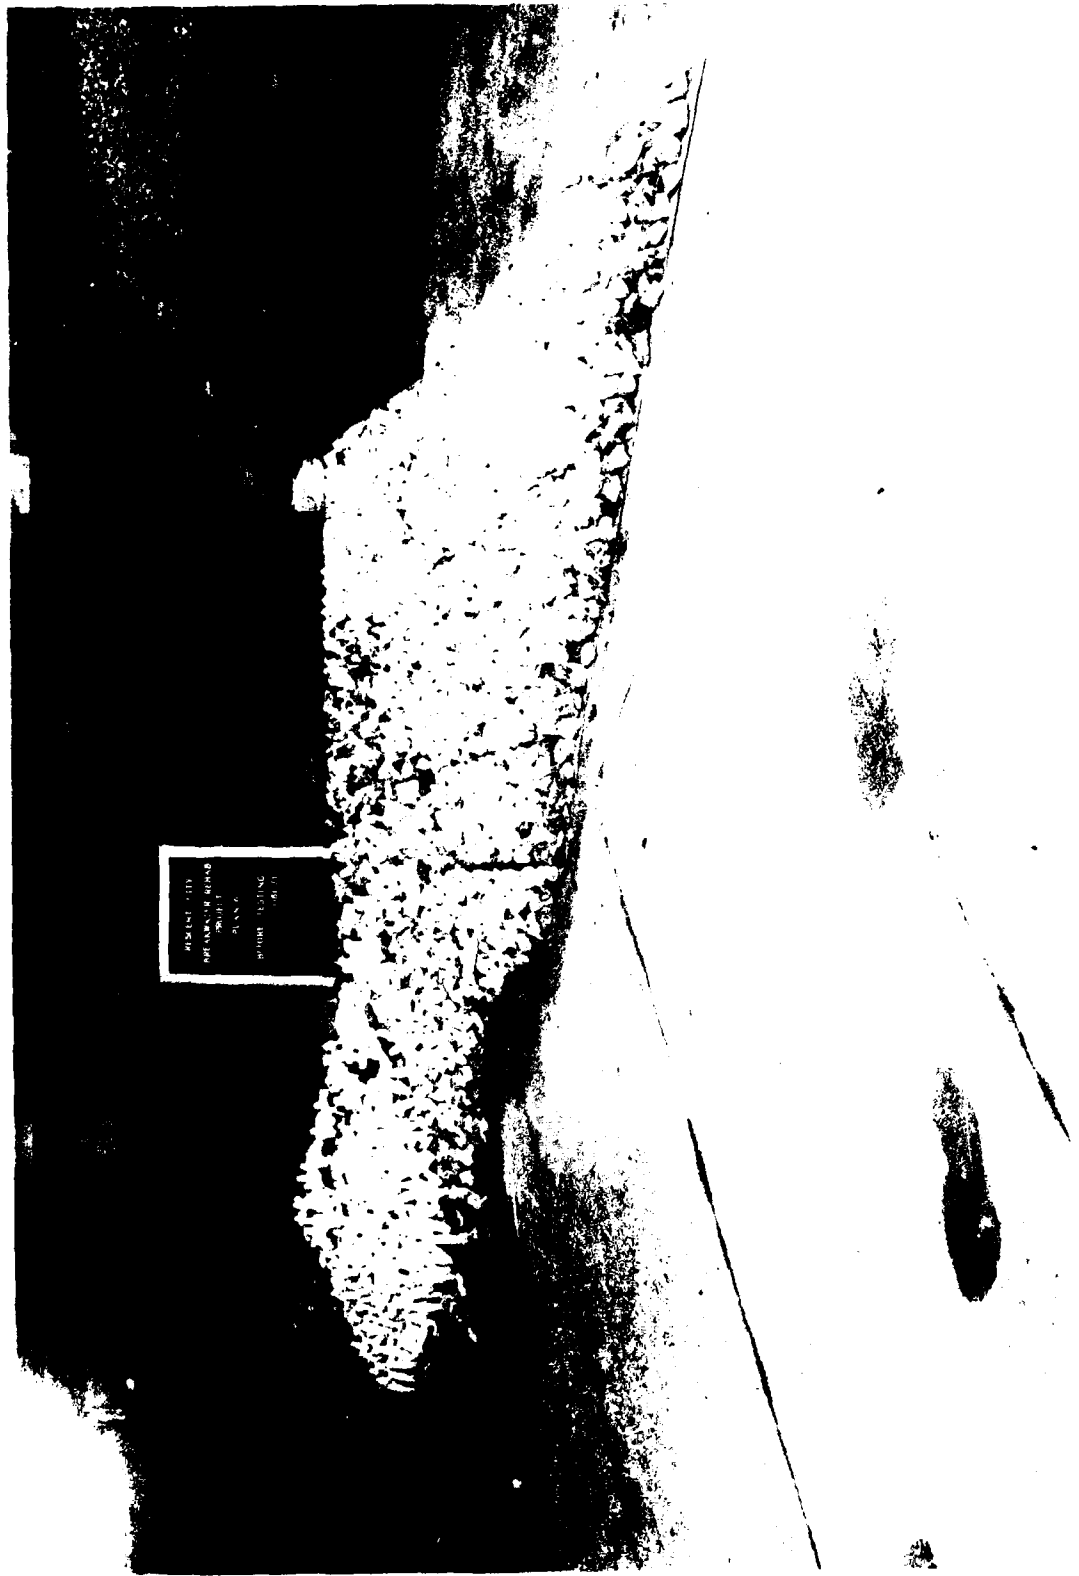
Photo 57. Sea-side view of Plan 6 before wave attack

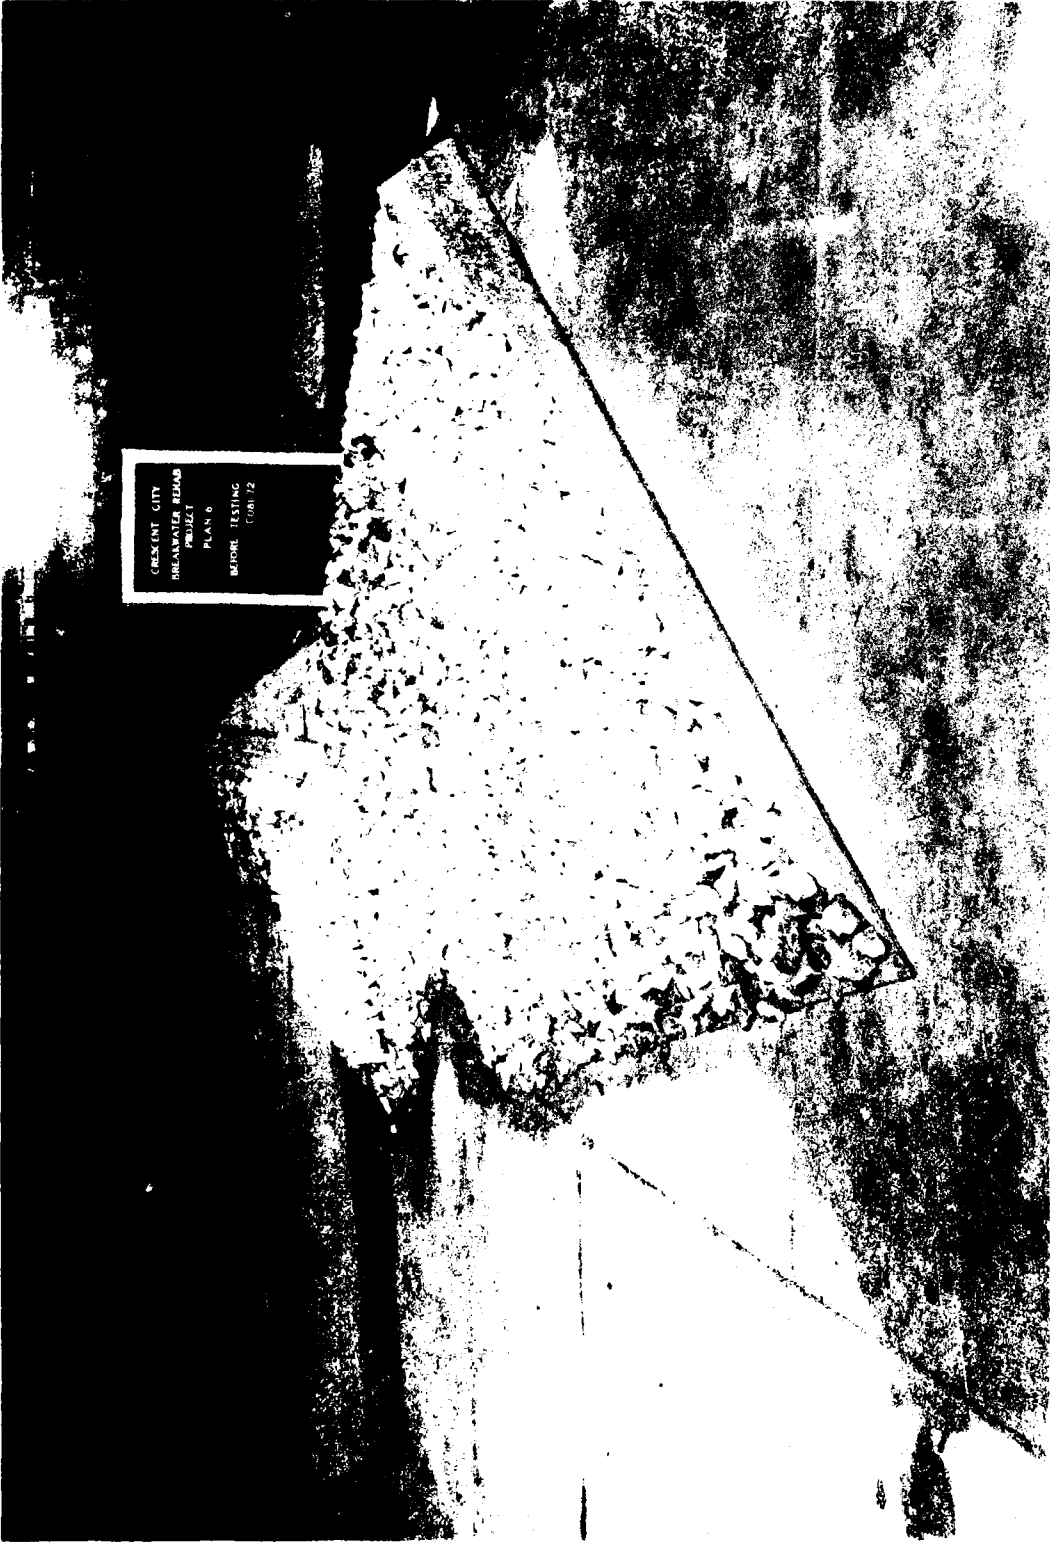
Photo 58. Seaward oblique view of Plan 6 before wave attack

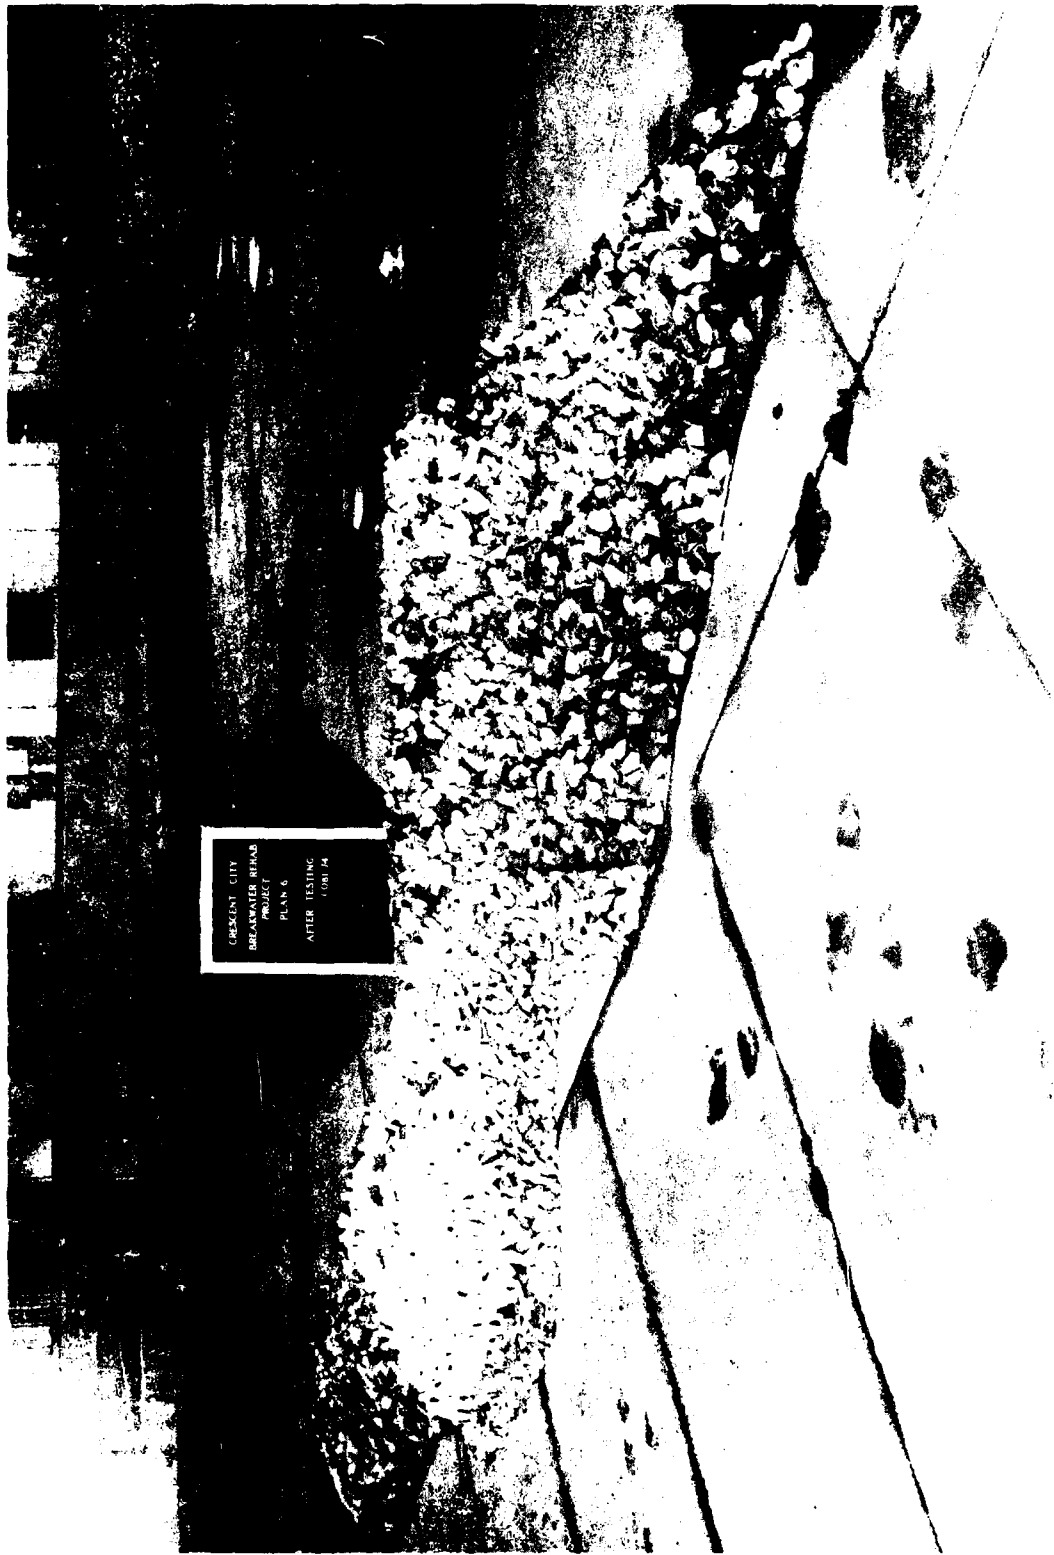
Photo 60. Sea-side view of Plan 6 after completion of abbreviated hydrograph

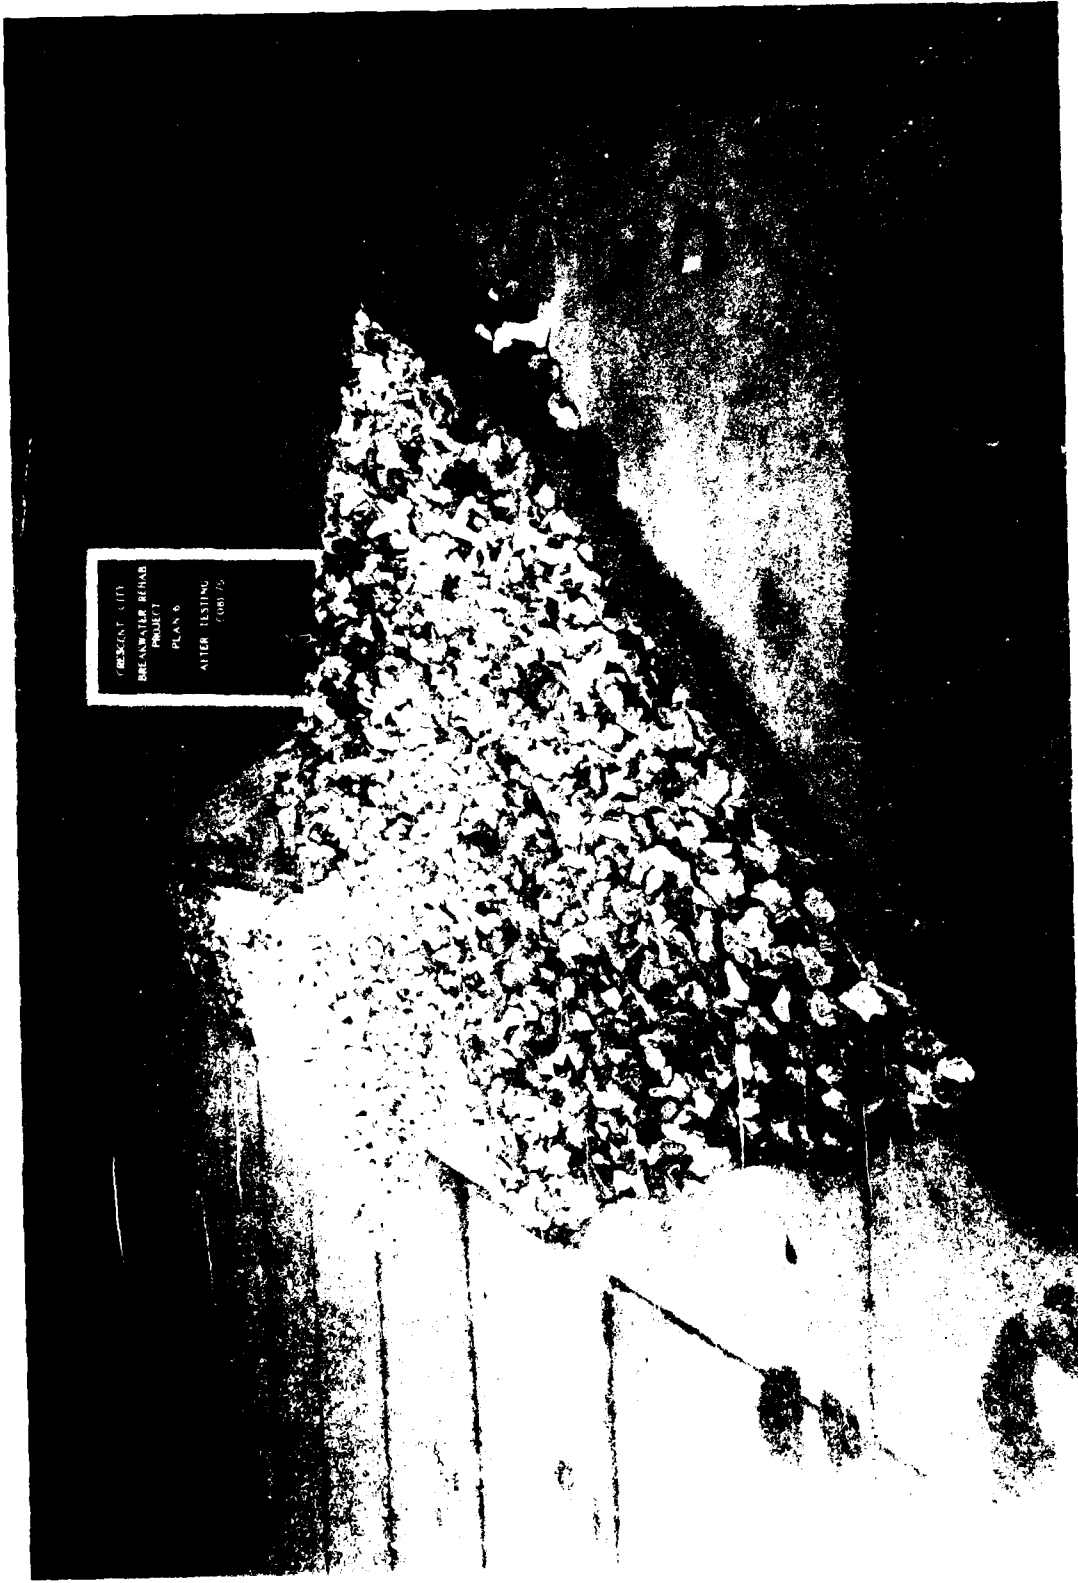
Photo 61. Seaward oblique view of Plan 6 after completion of abbreviated hydrograph

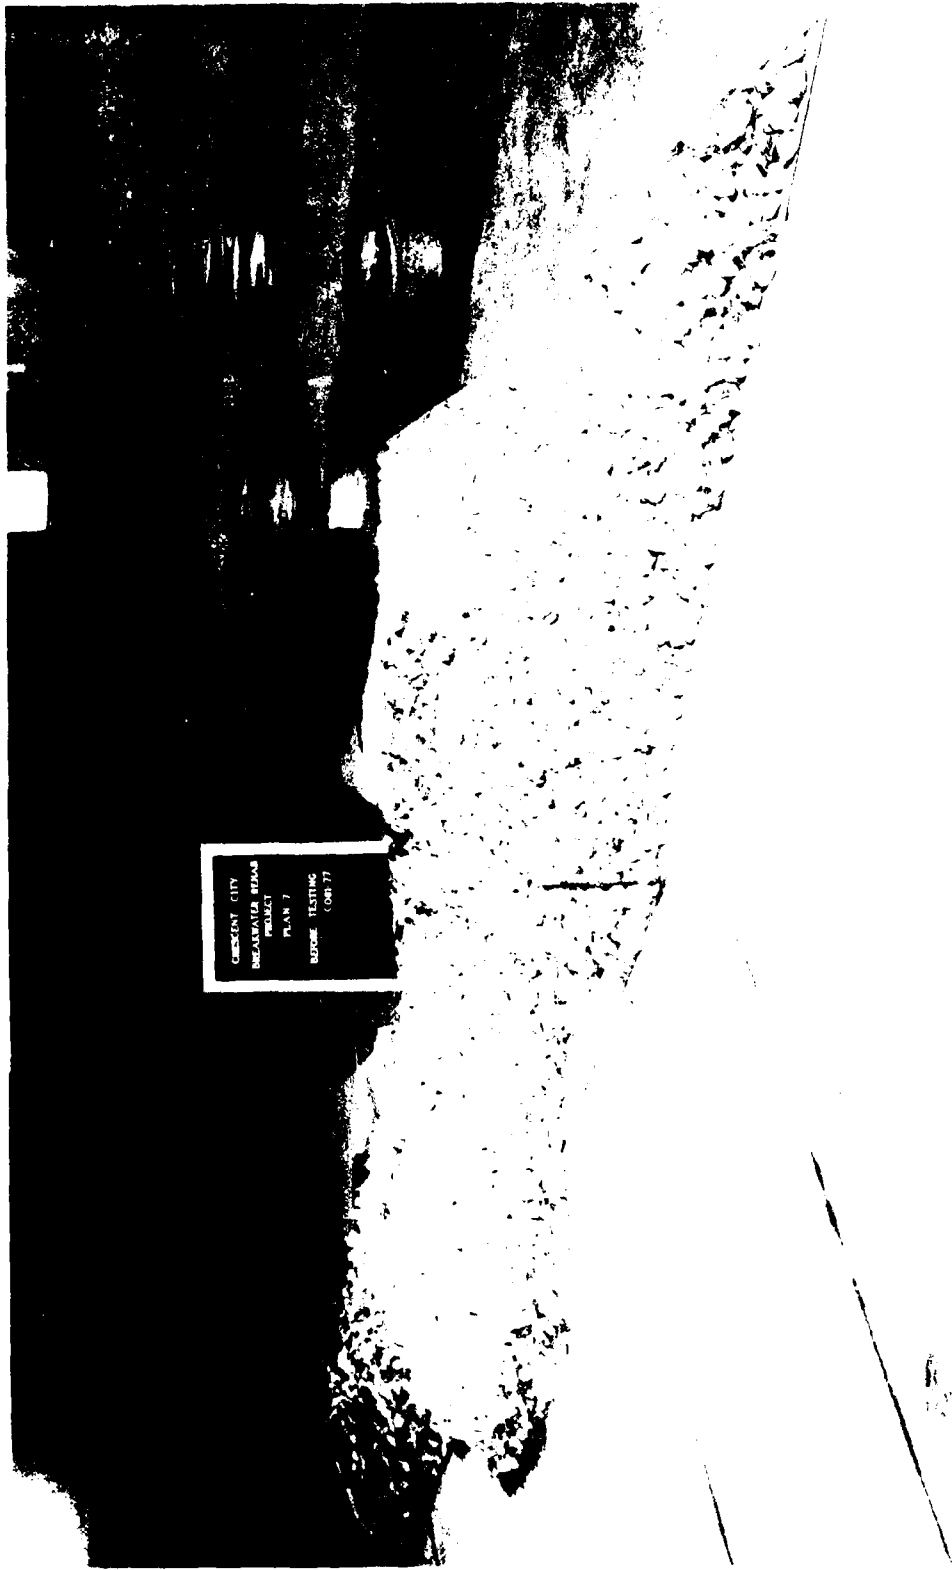
Photo 63. Sea-side view of Plan 7 before wave attack

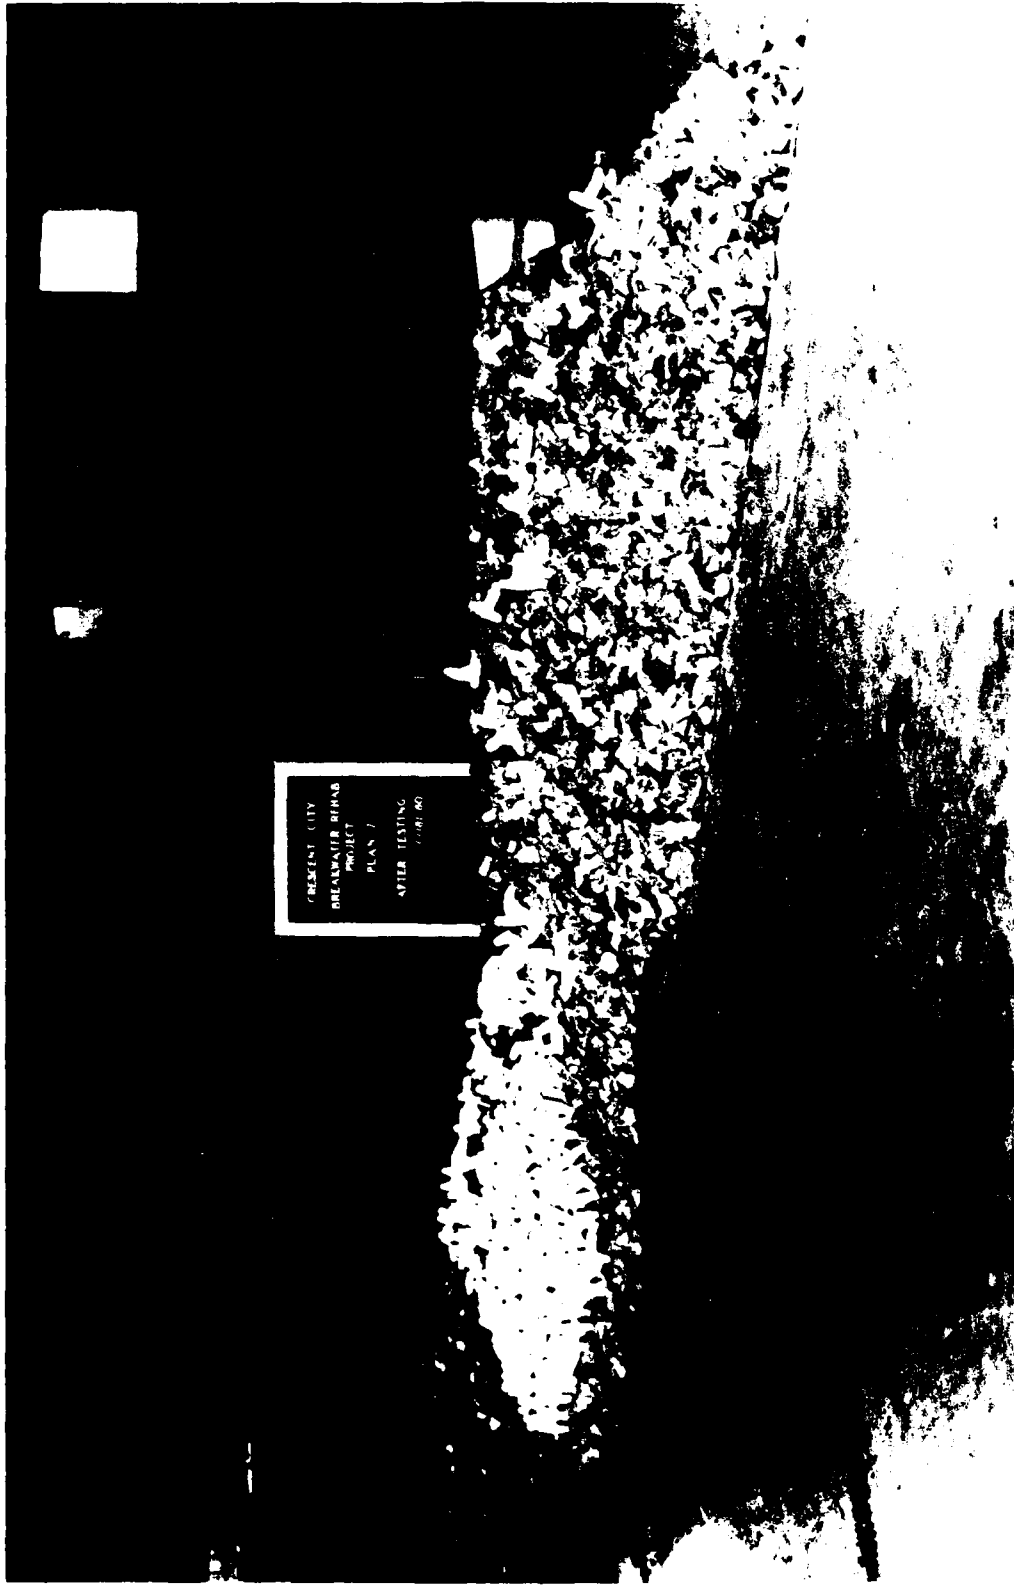
Photo 67. Seaward oblique view of Plan 7 after completion of abbreviated hydrograph

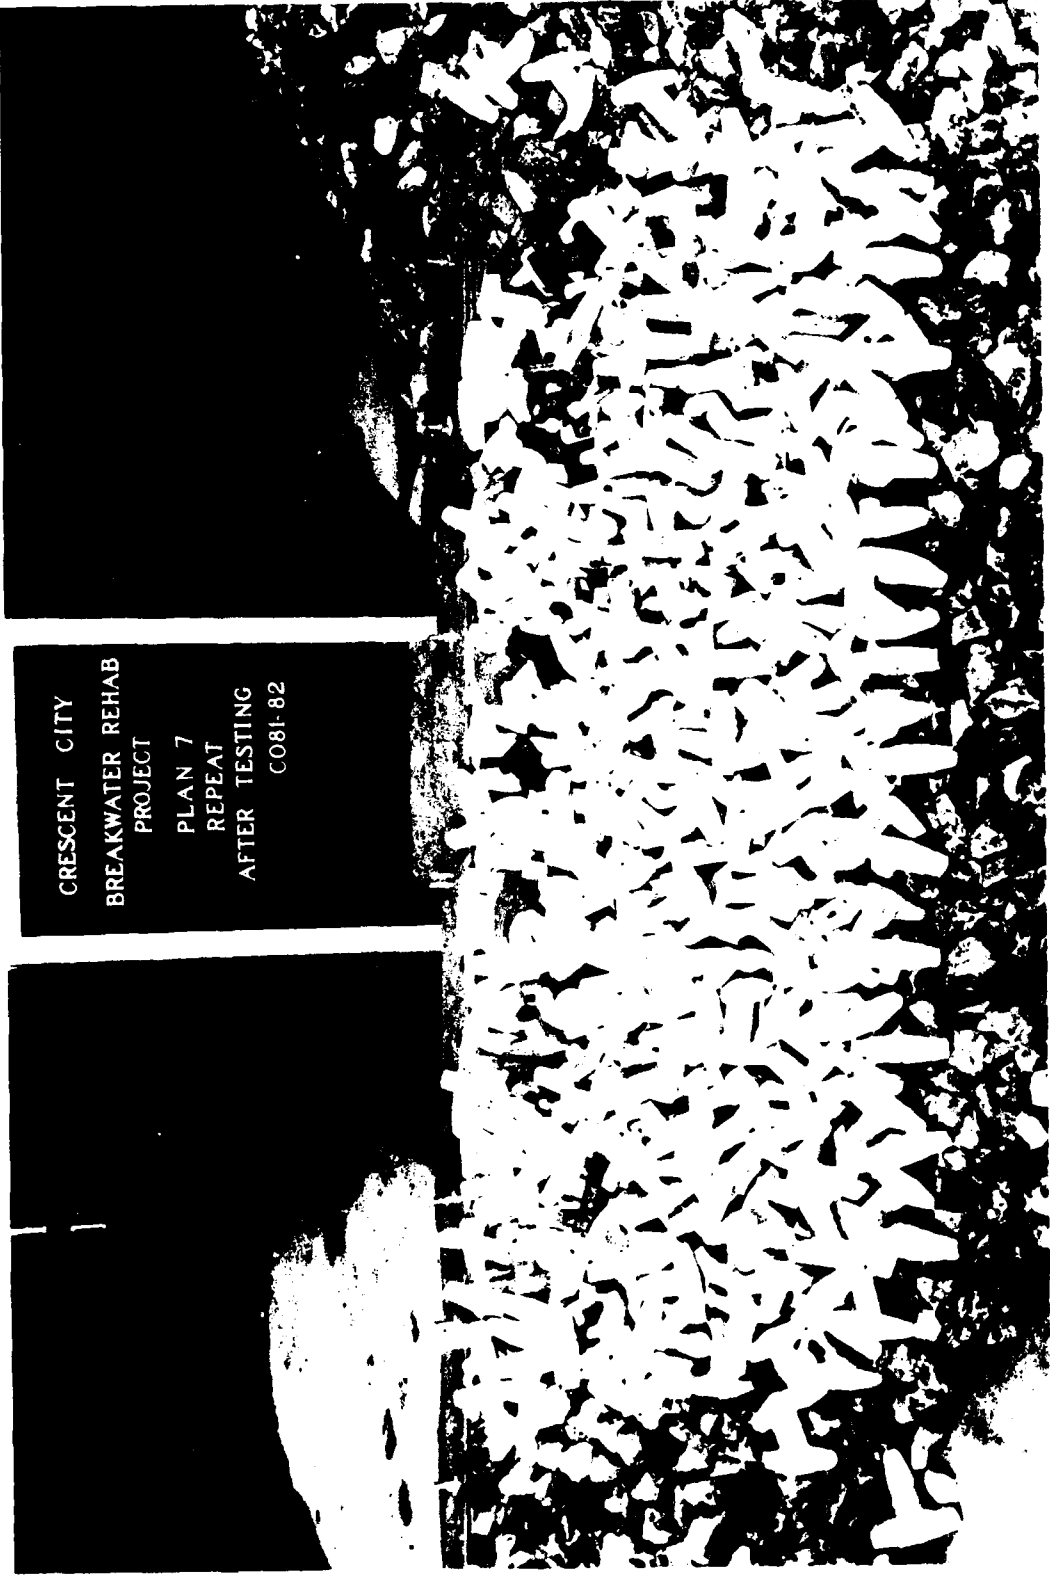
Photo 69. Sea-side view of Plan 7 after completion of abbreviated hydrograph

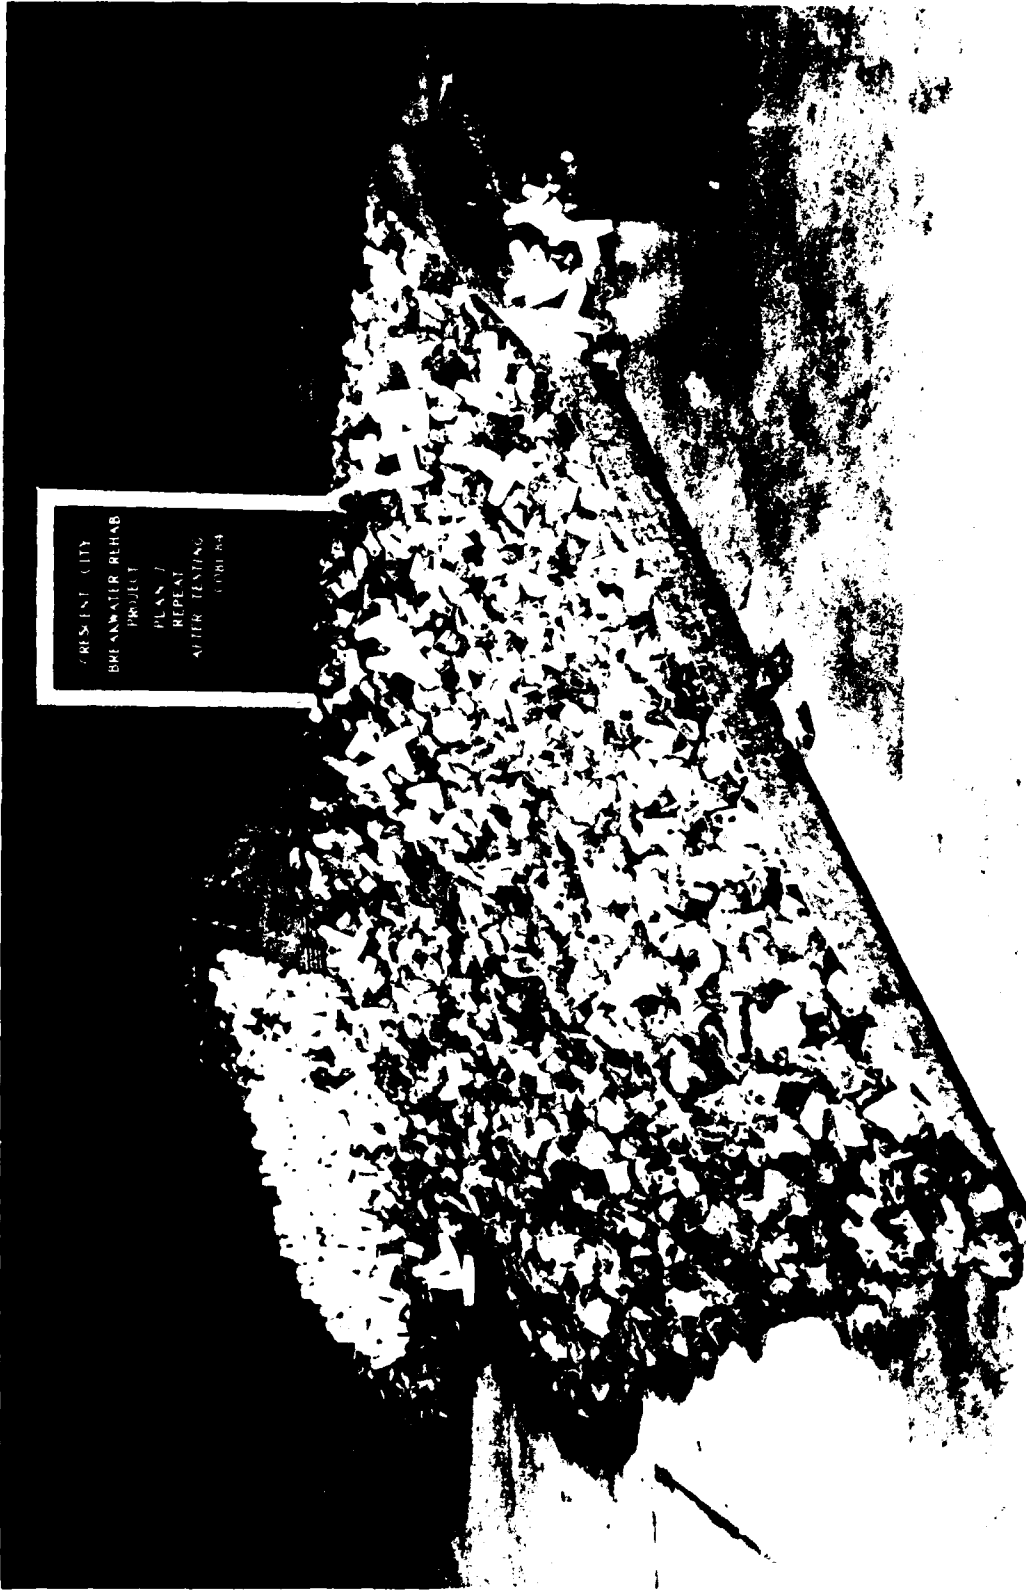
Photo 71. Seaward end view of Plan 7 repeat after completion of abbreviated hydrograph

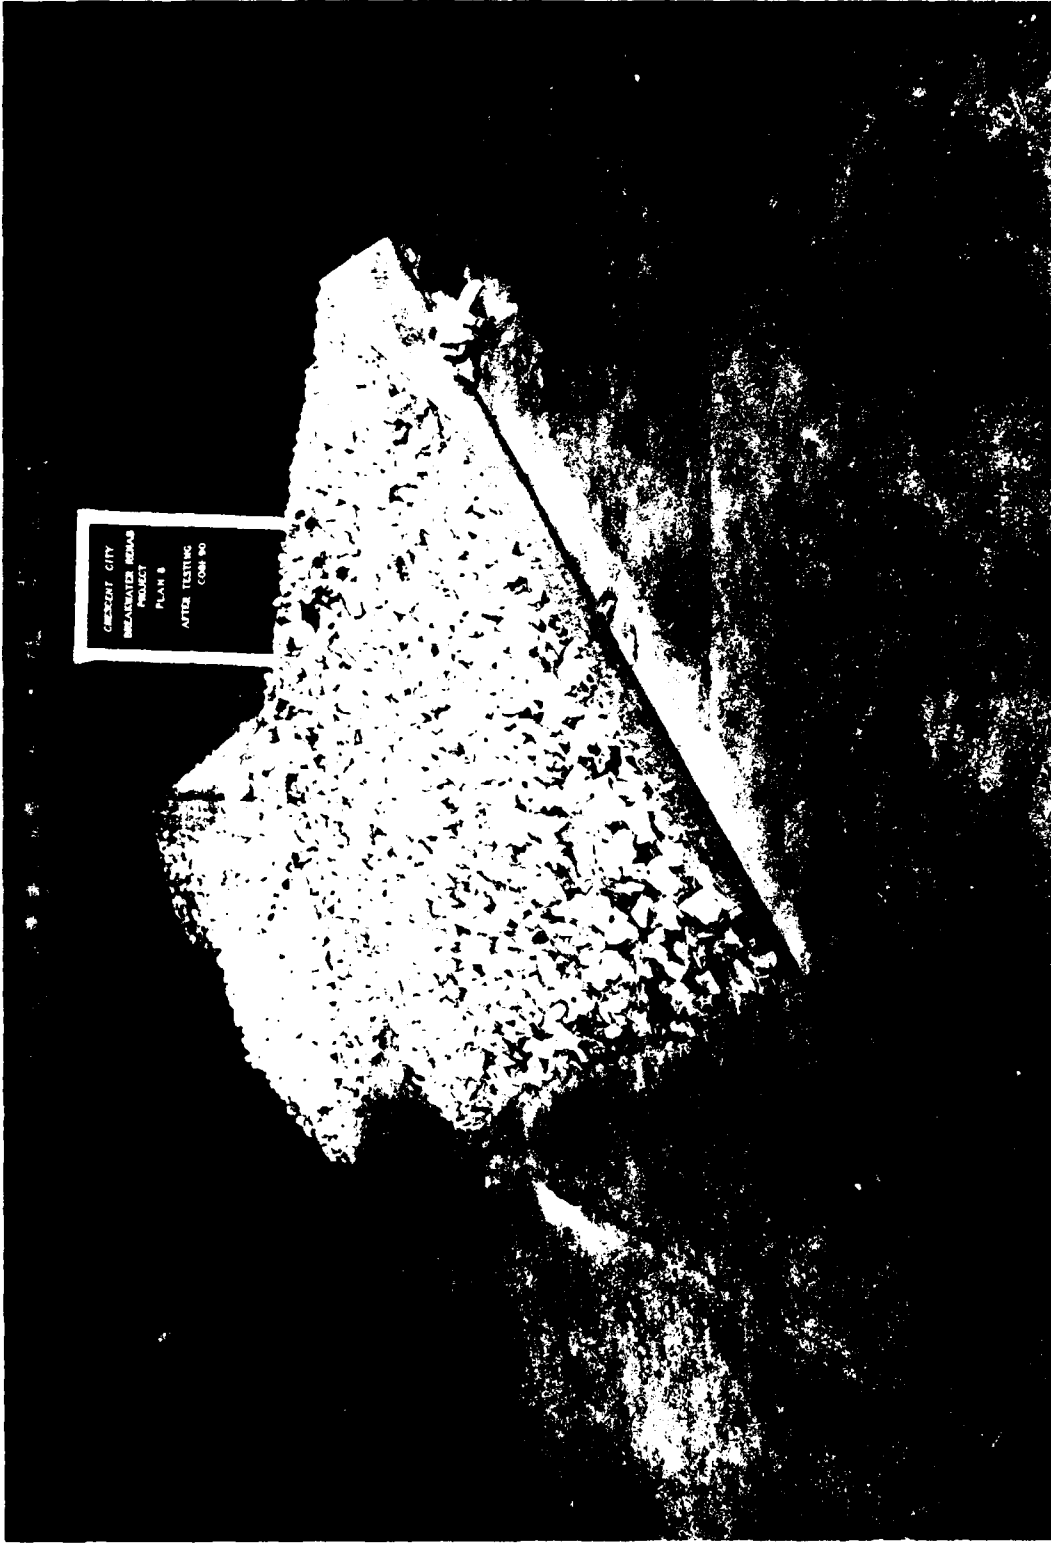
Photo 76. Seaward oblique view of Plan 8 after completion of abbreviated hydrograph.

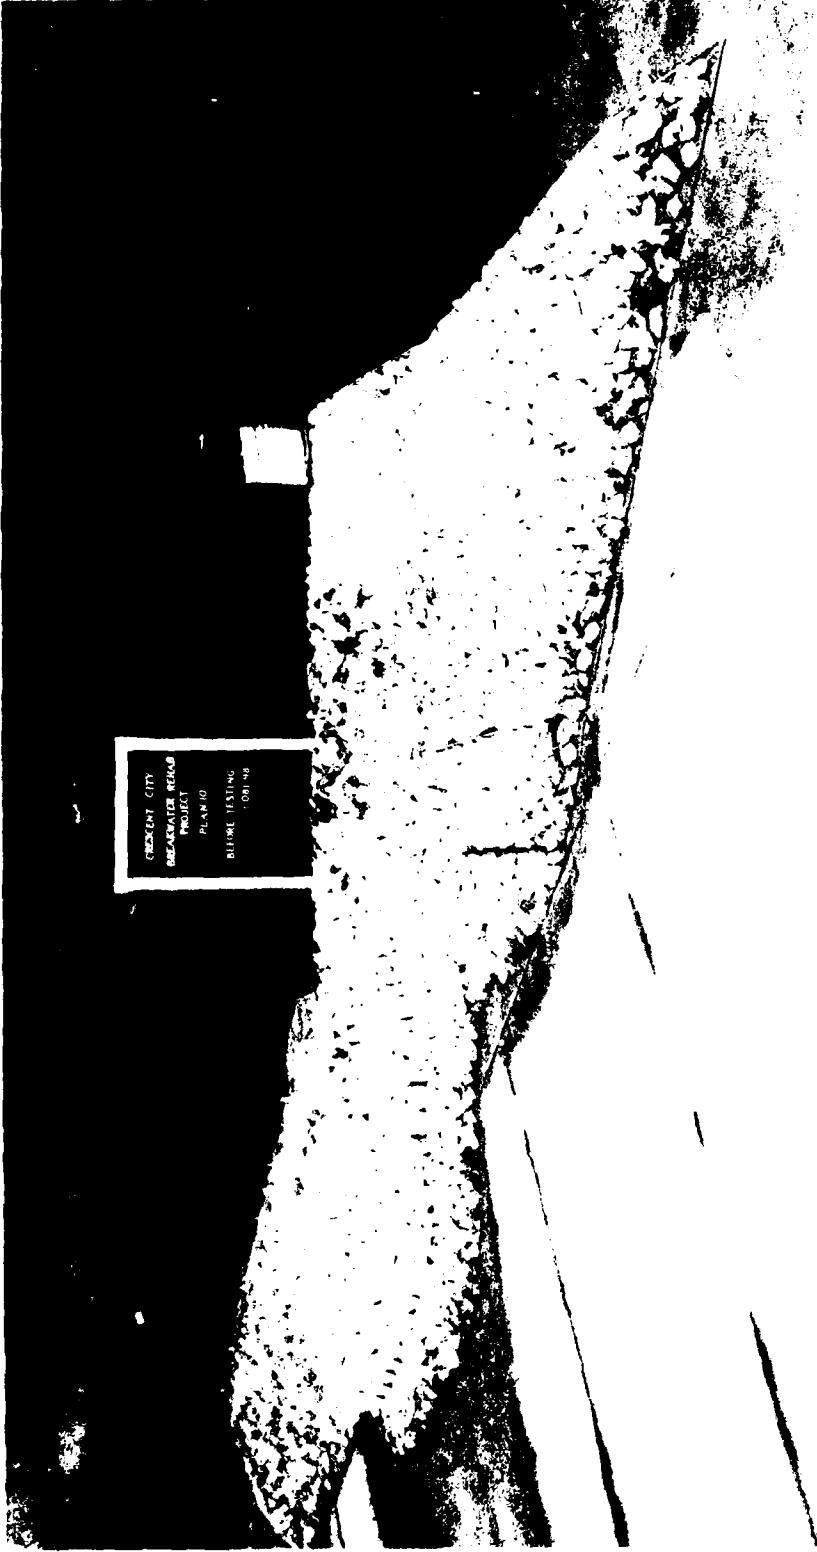
Photo 84. Sea-side view of Plan 10 before wave attack

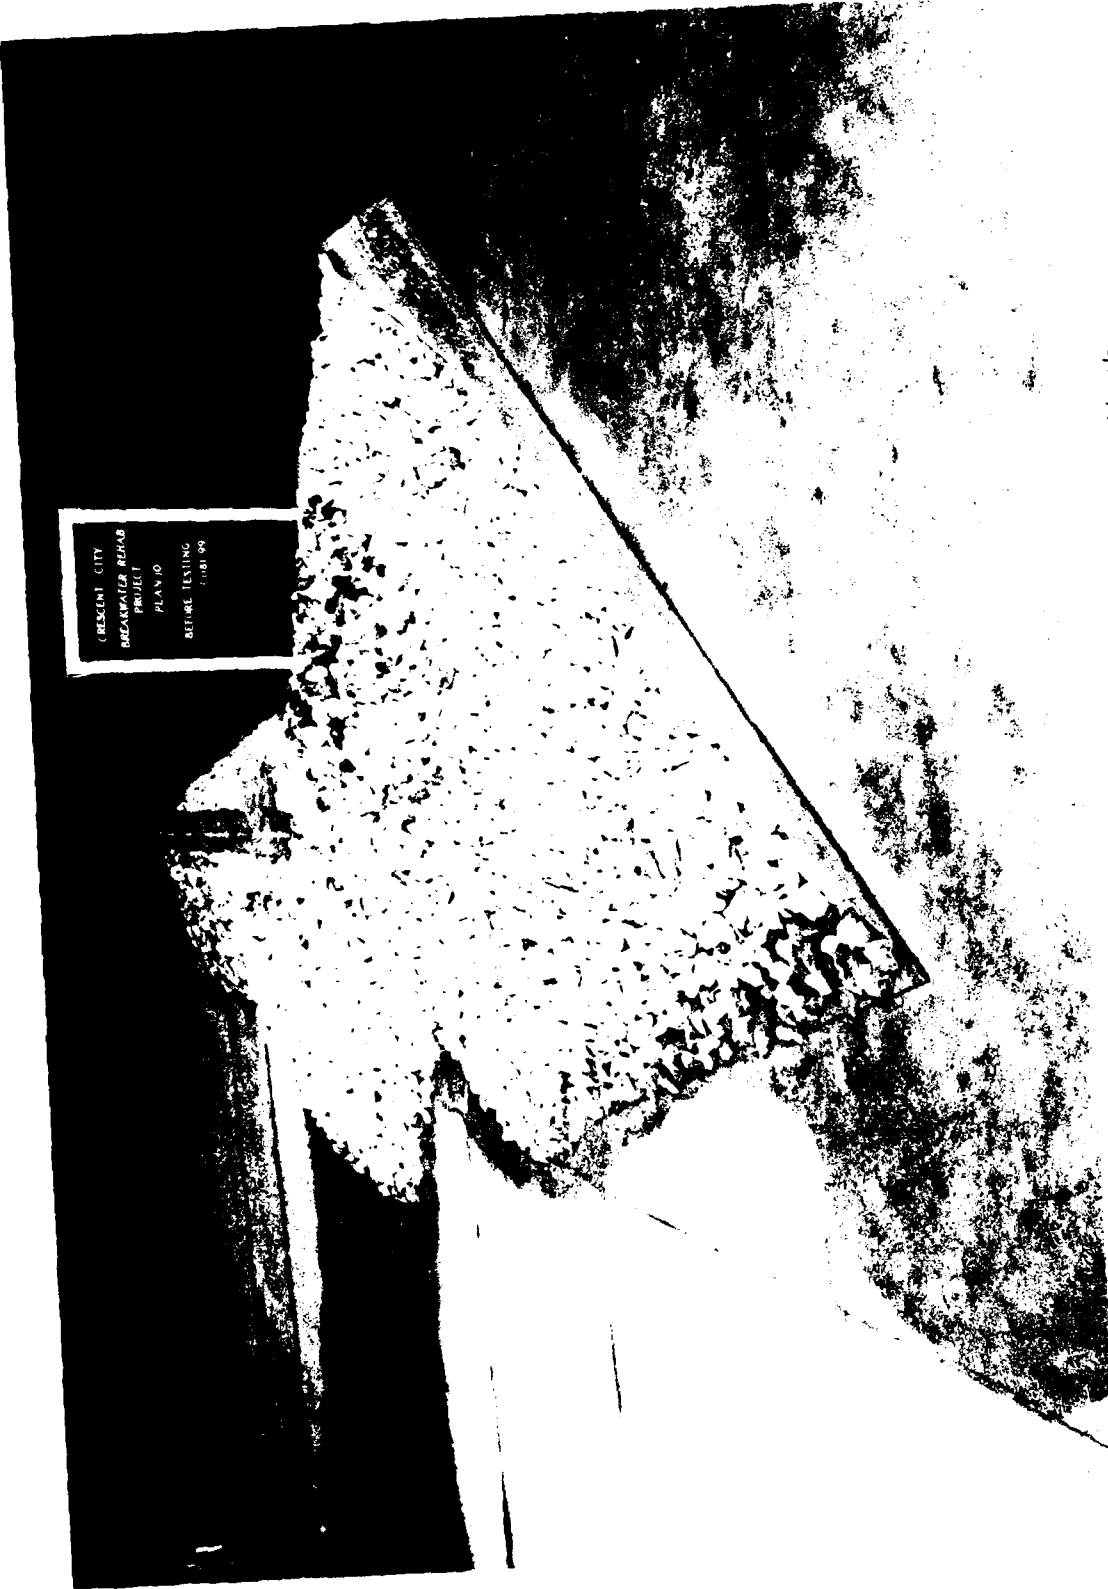
Photo 85. Seaward oblique view of Plan 10 before wave attack
