TECHNICAL REPORT CERC-85-8

# BREAKWATER REHABILITATION STUDY, CRESCENT CITY HARBOR, CALIFORNIA

## Coastal Model Investigation

November 1985

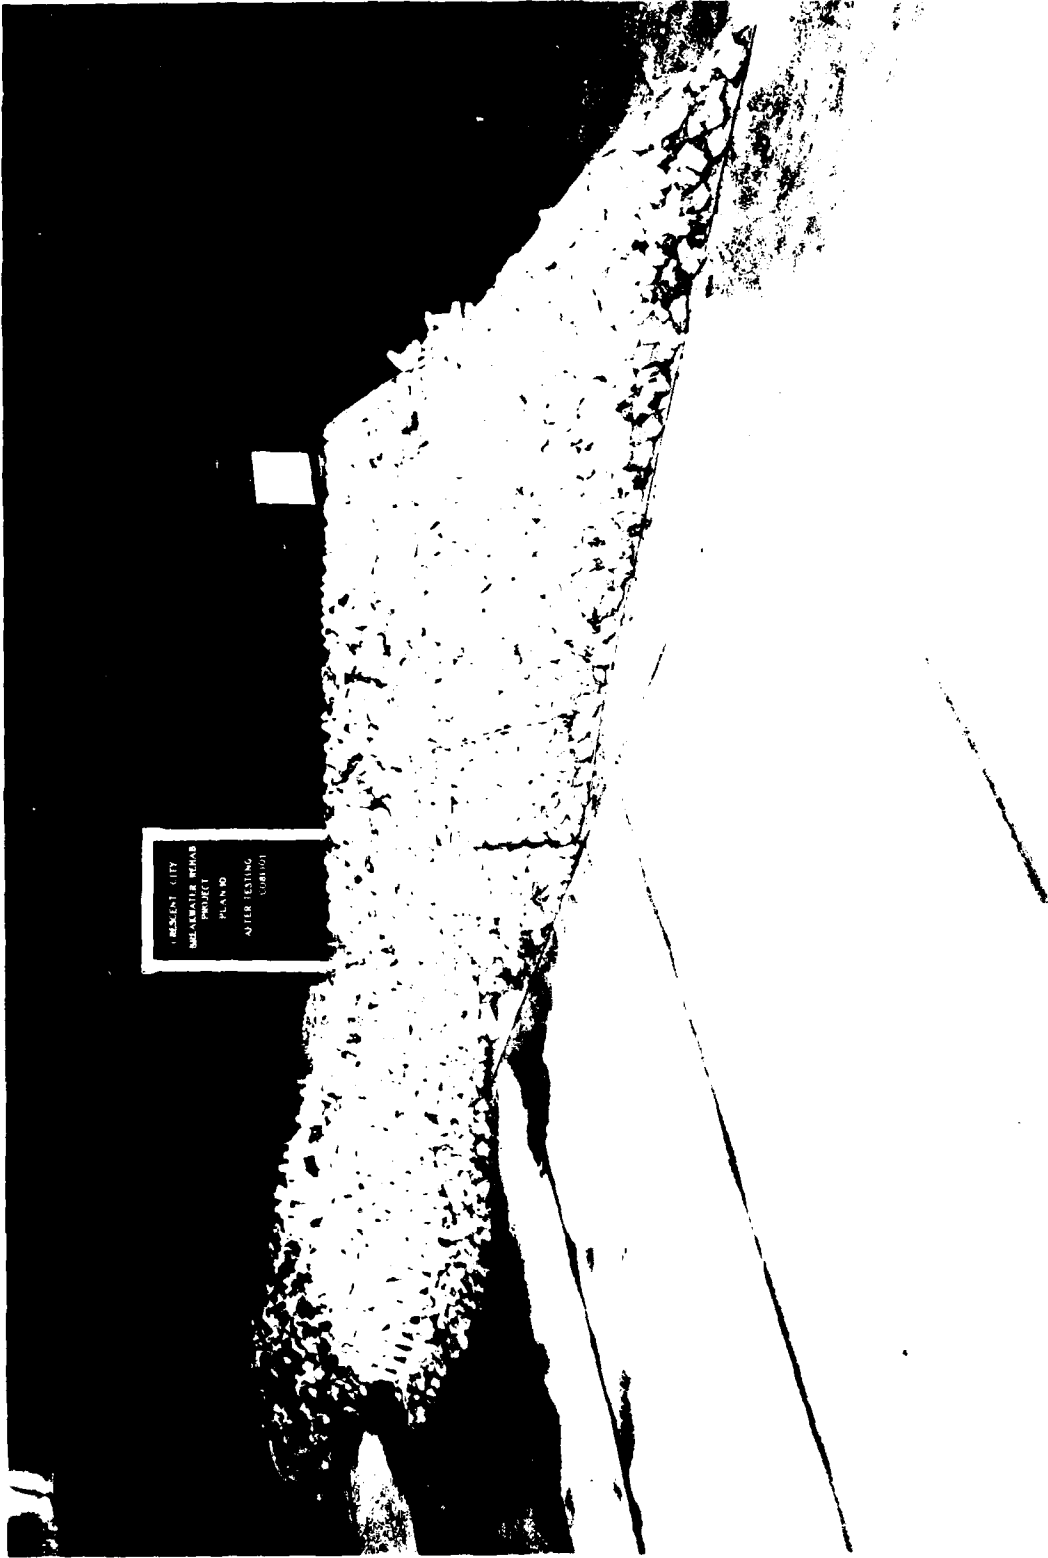
Photo 87. Sea-side view of Plan 10 after completion of abbreviated hydrograph

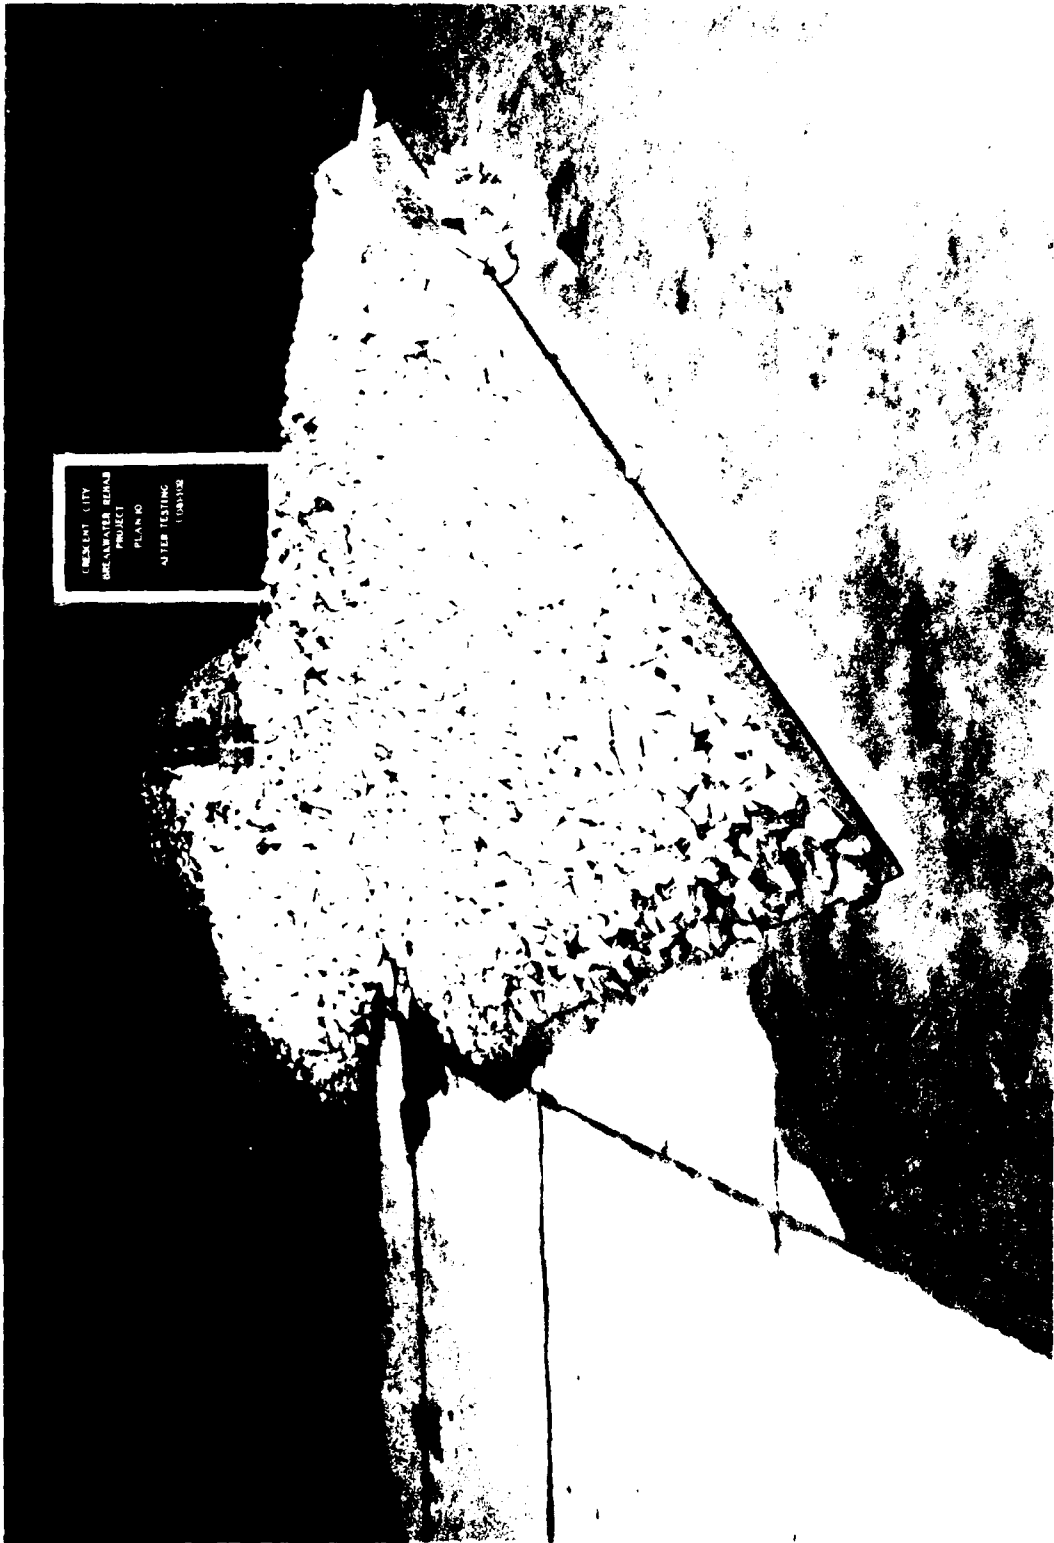
Photo 88. Seaward oblique view of Plan 10 after completion of abbreviated hydrograph

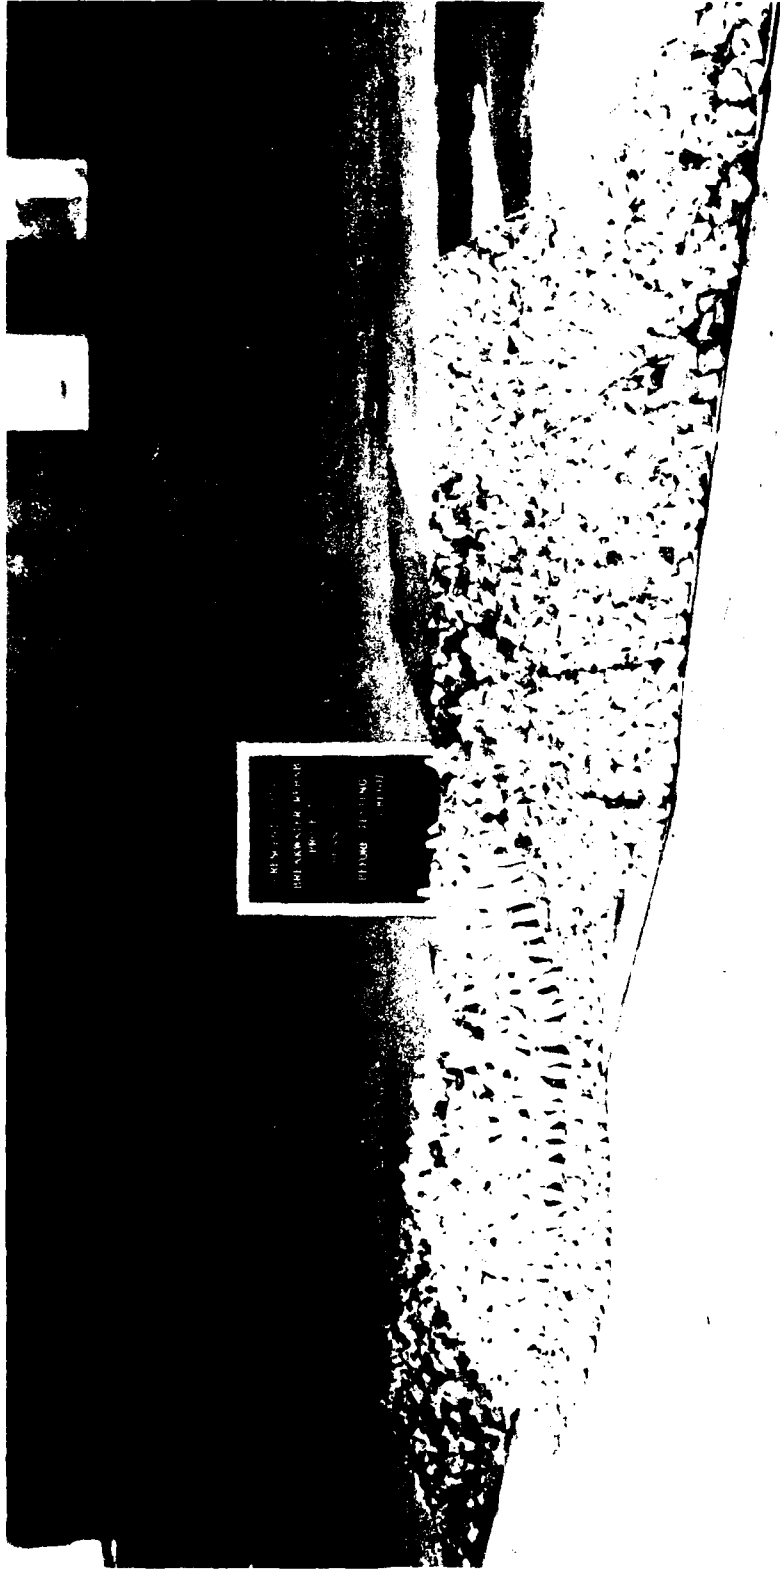
Photo 90. Sea-side view of Plan 11 before wave attack

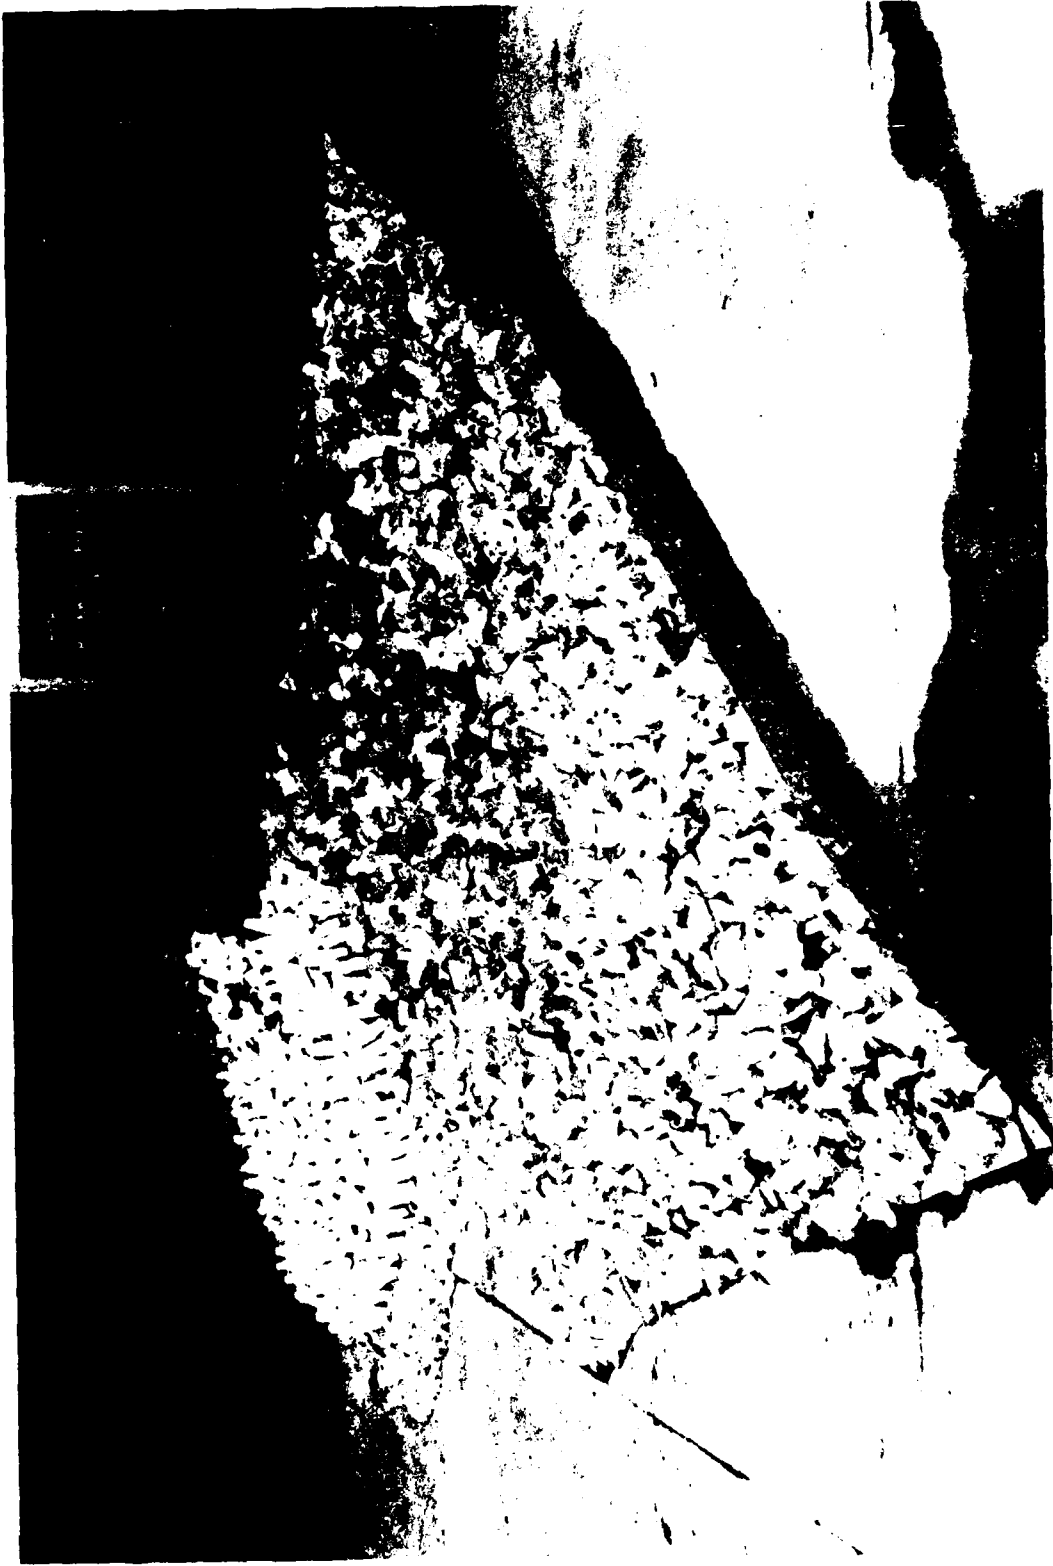
Photo 91. Seaward oblique view of Plan 11 before wave attack

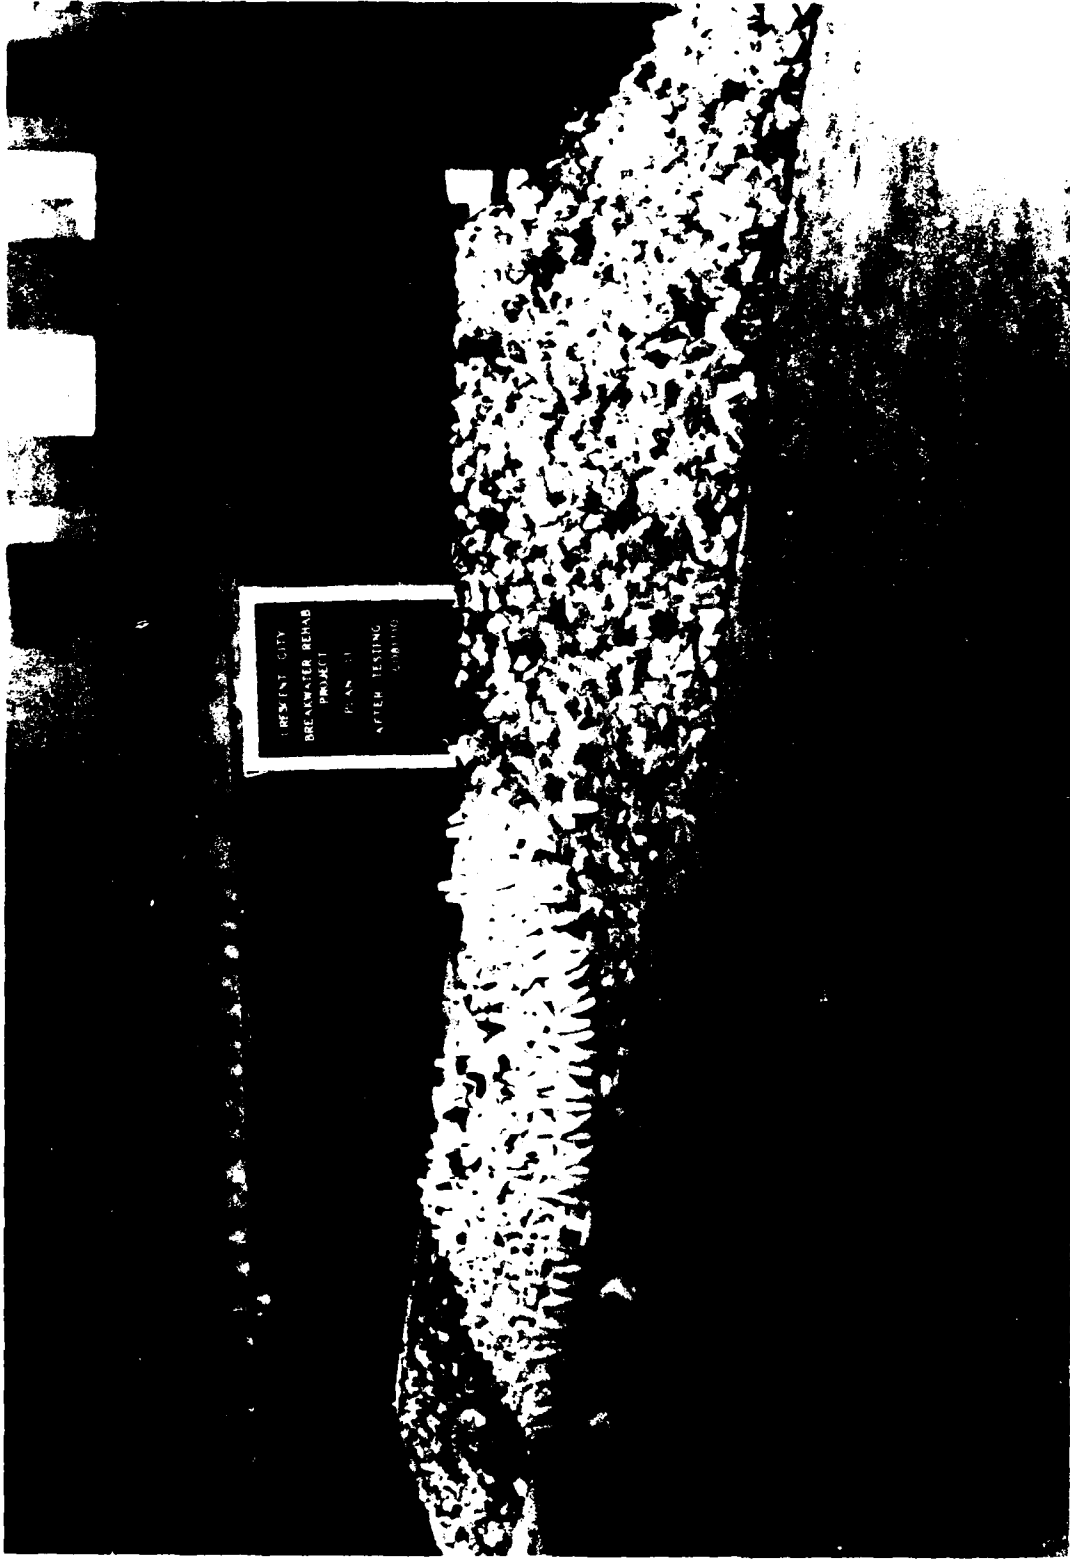
Photo 93. Sea-side view of Plan 11 after completion of abbreviated hydrograph

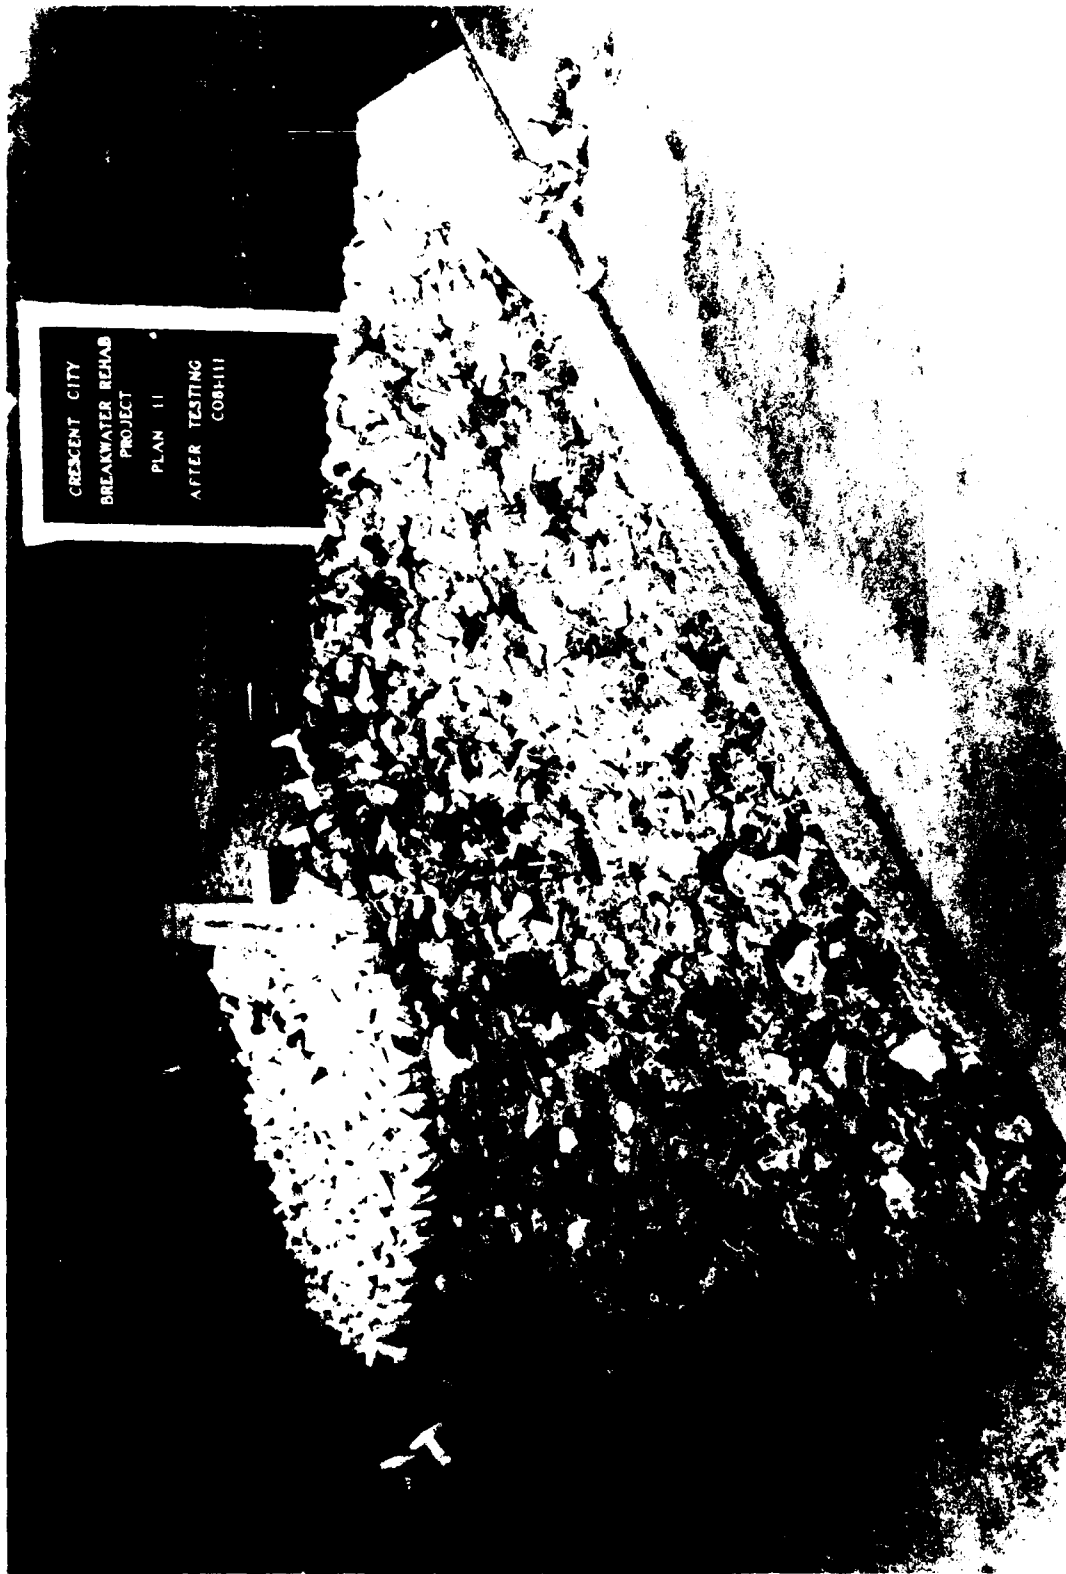
Photo 94. Seaward oblique view of Plan 11 after completion of abbreviated hydrograph

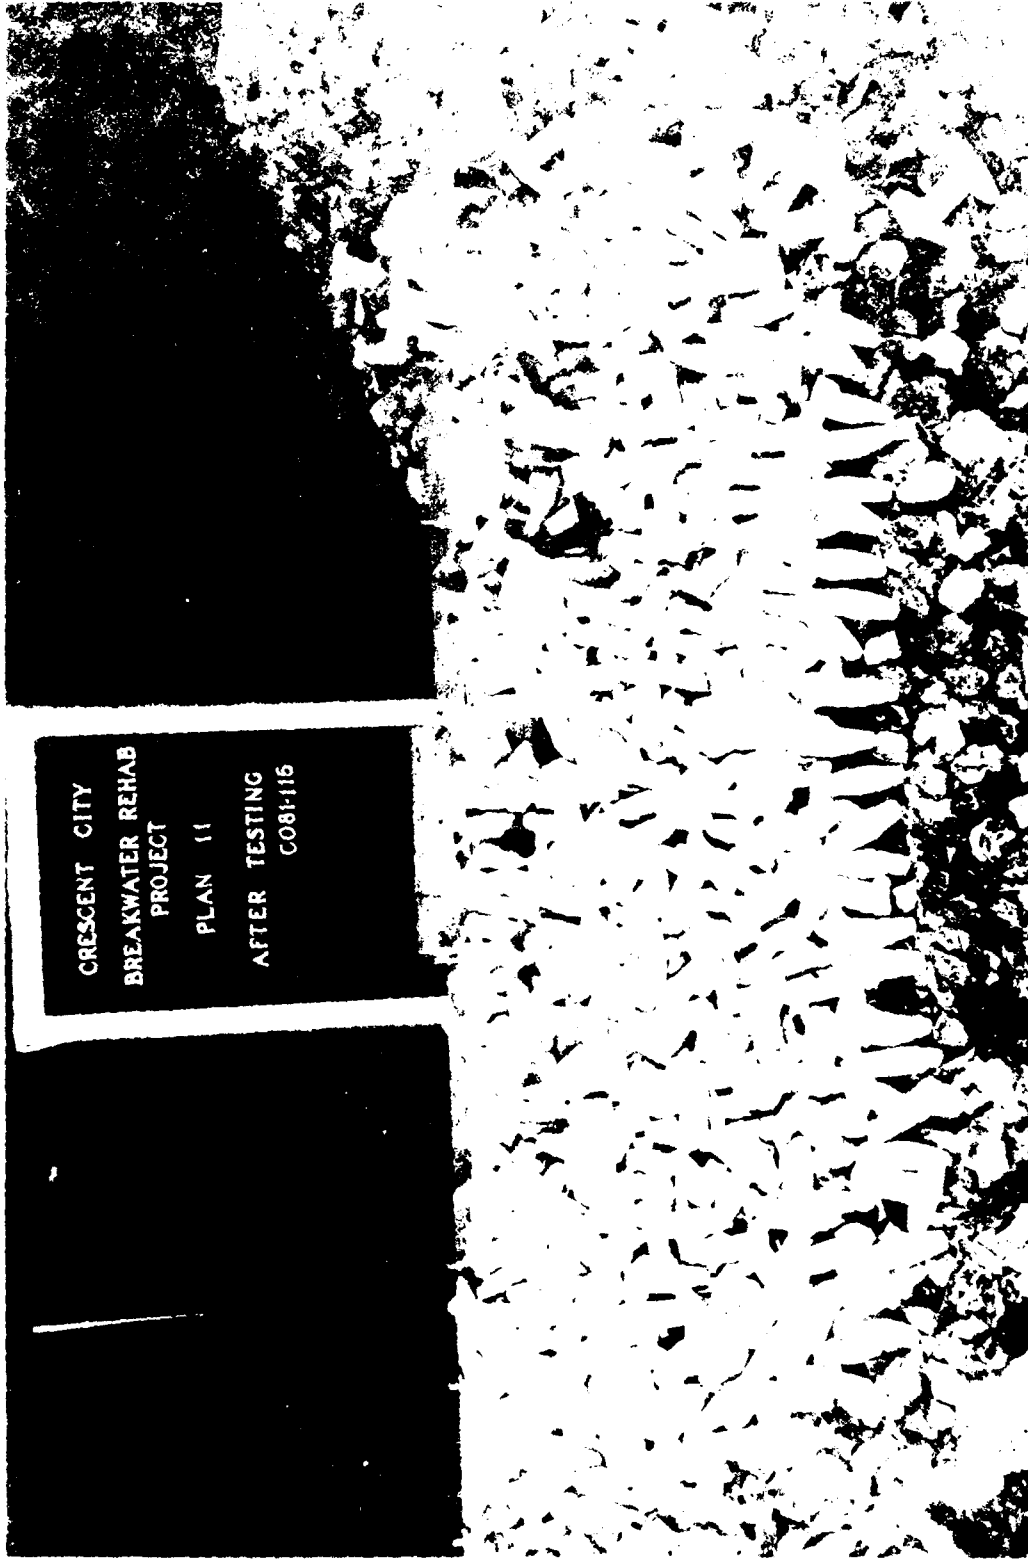
Photo 95. Seaward end view of Plan 11 after completion of abbreviated hydrograph

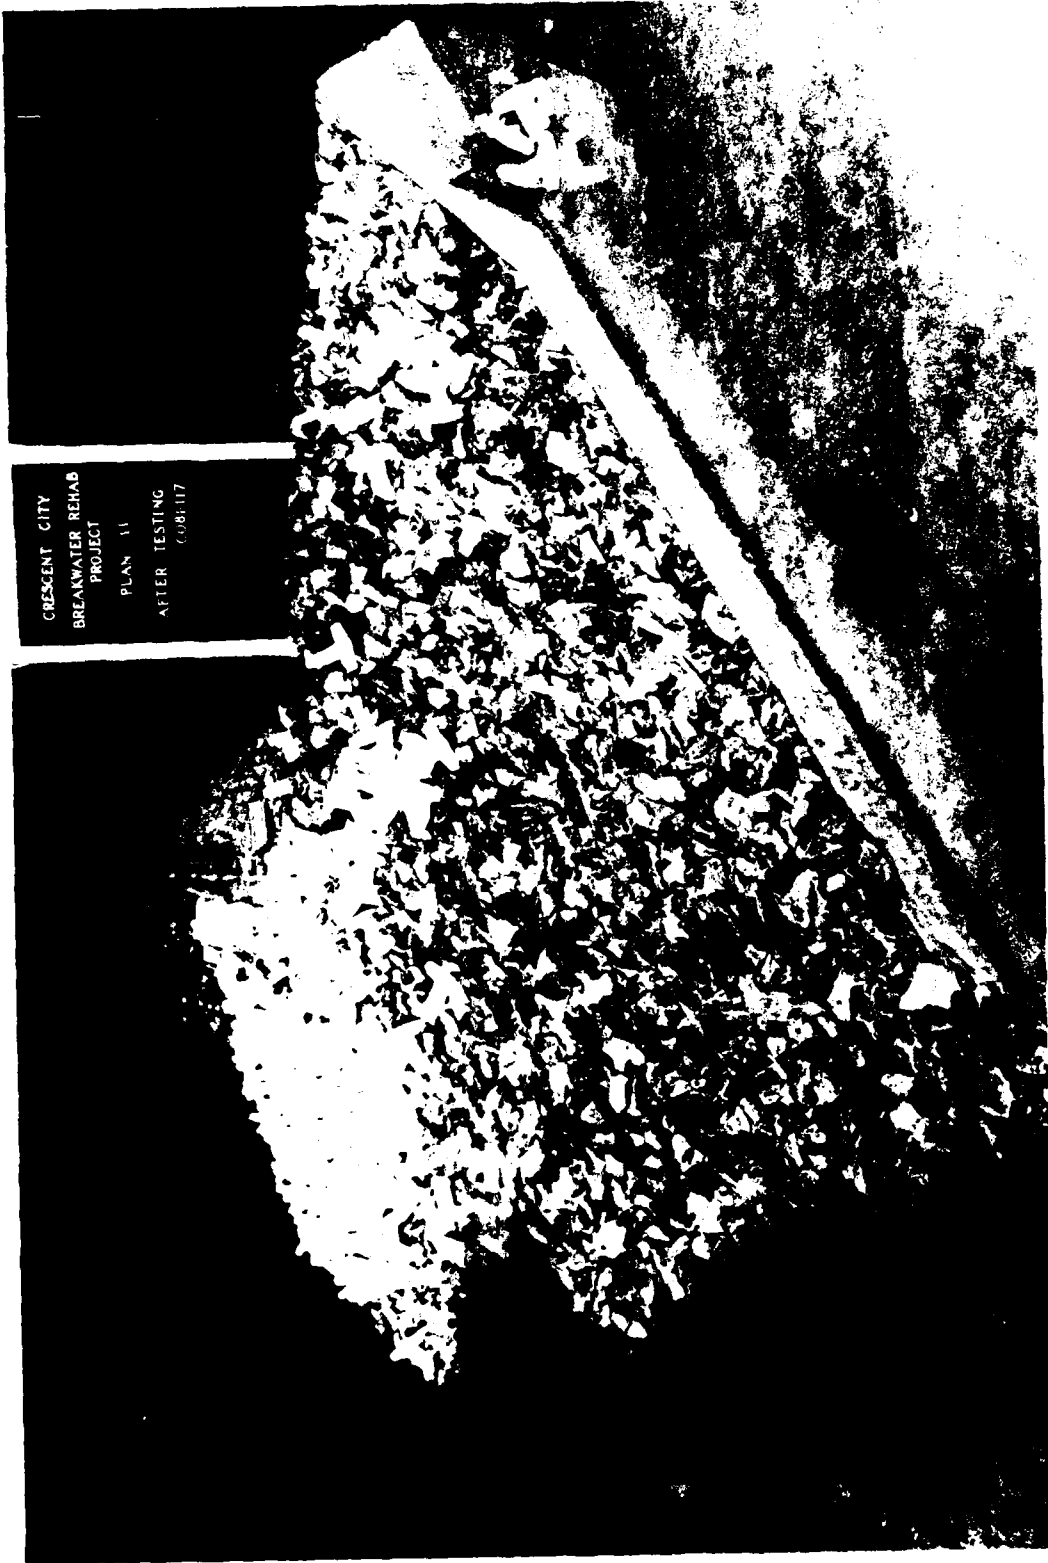
Photo 97. Seaward oblique view of Plan 11 repeat after completion of abbreviated hydrograph

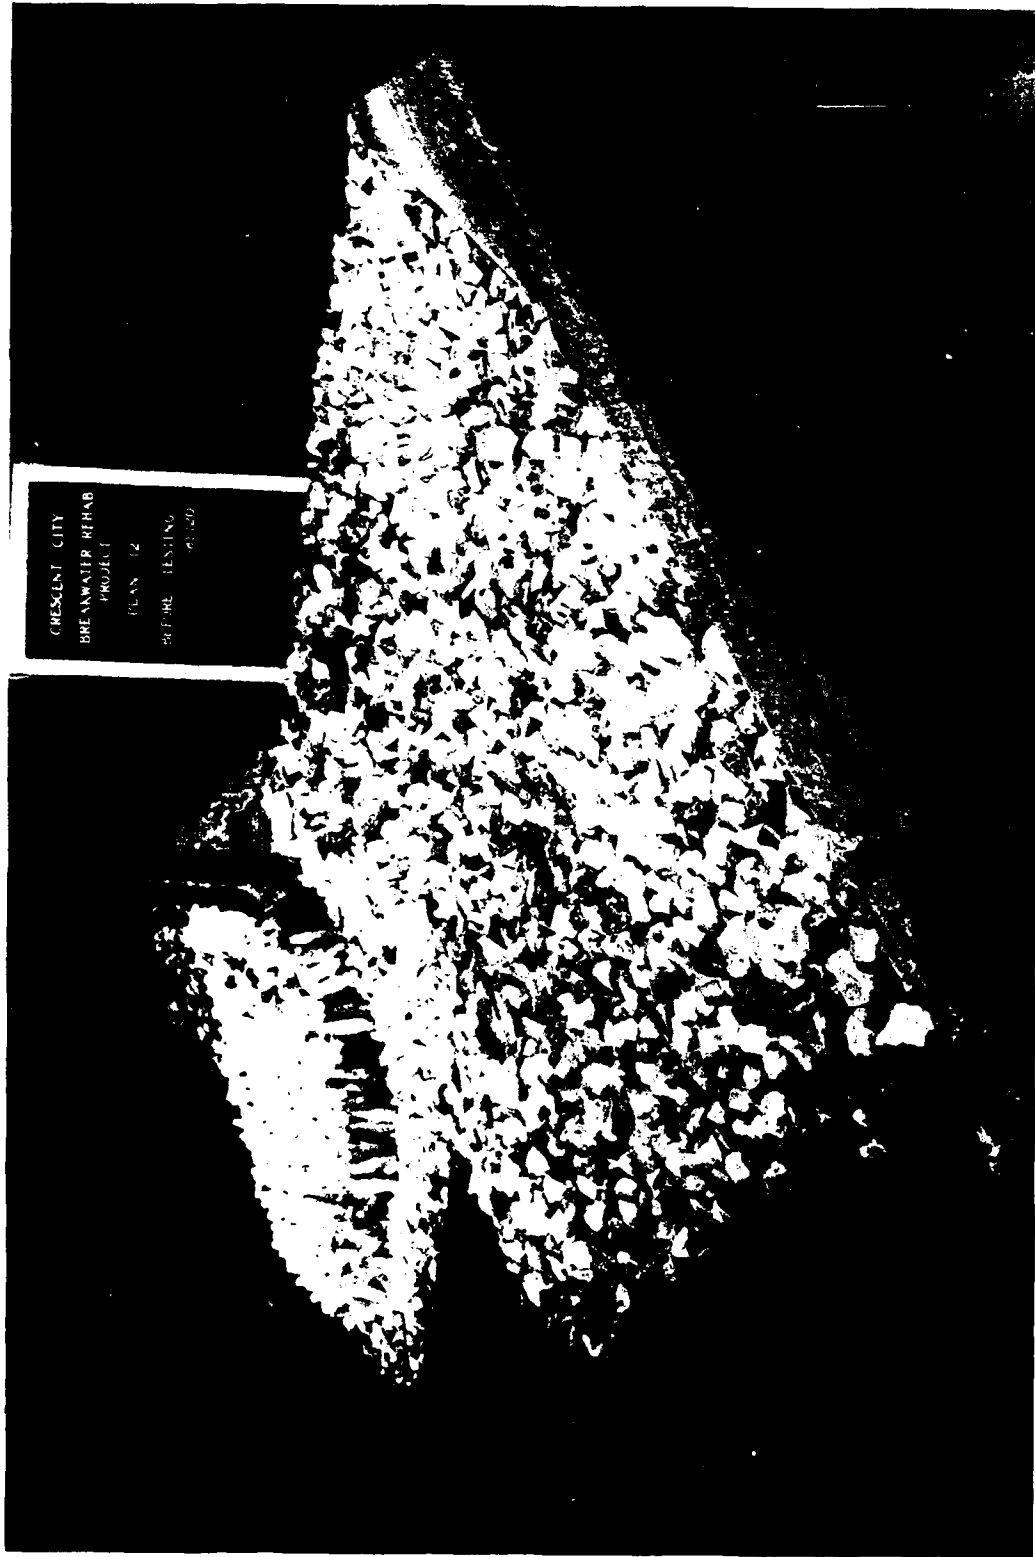
Photo 100. Seaward oblique view of Plan 12 before wave attack

42. Plan 12 (Plate 16 and Photos 99-101) was constructed with two rows of 58-ton dolosse along the seaward transition of the elbow; the 58-ton units along the toe were randomly placed. It was hoped that the heavier units would stabilize this area without trenching. A total of 46 58-ton and 319 42-ton rehabilitation dolosse were placed. The seaward transition sustained severe damage during testing. Photos 102-104 show the structure after testing.

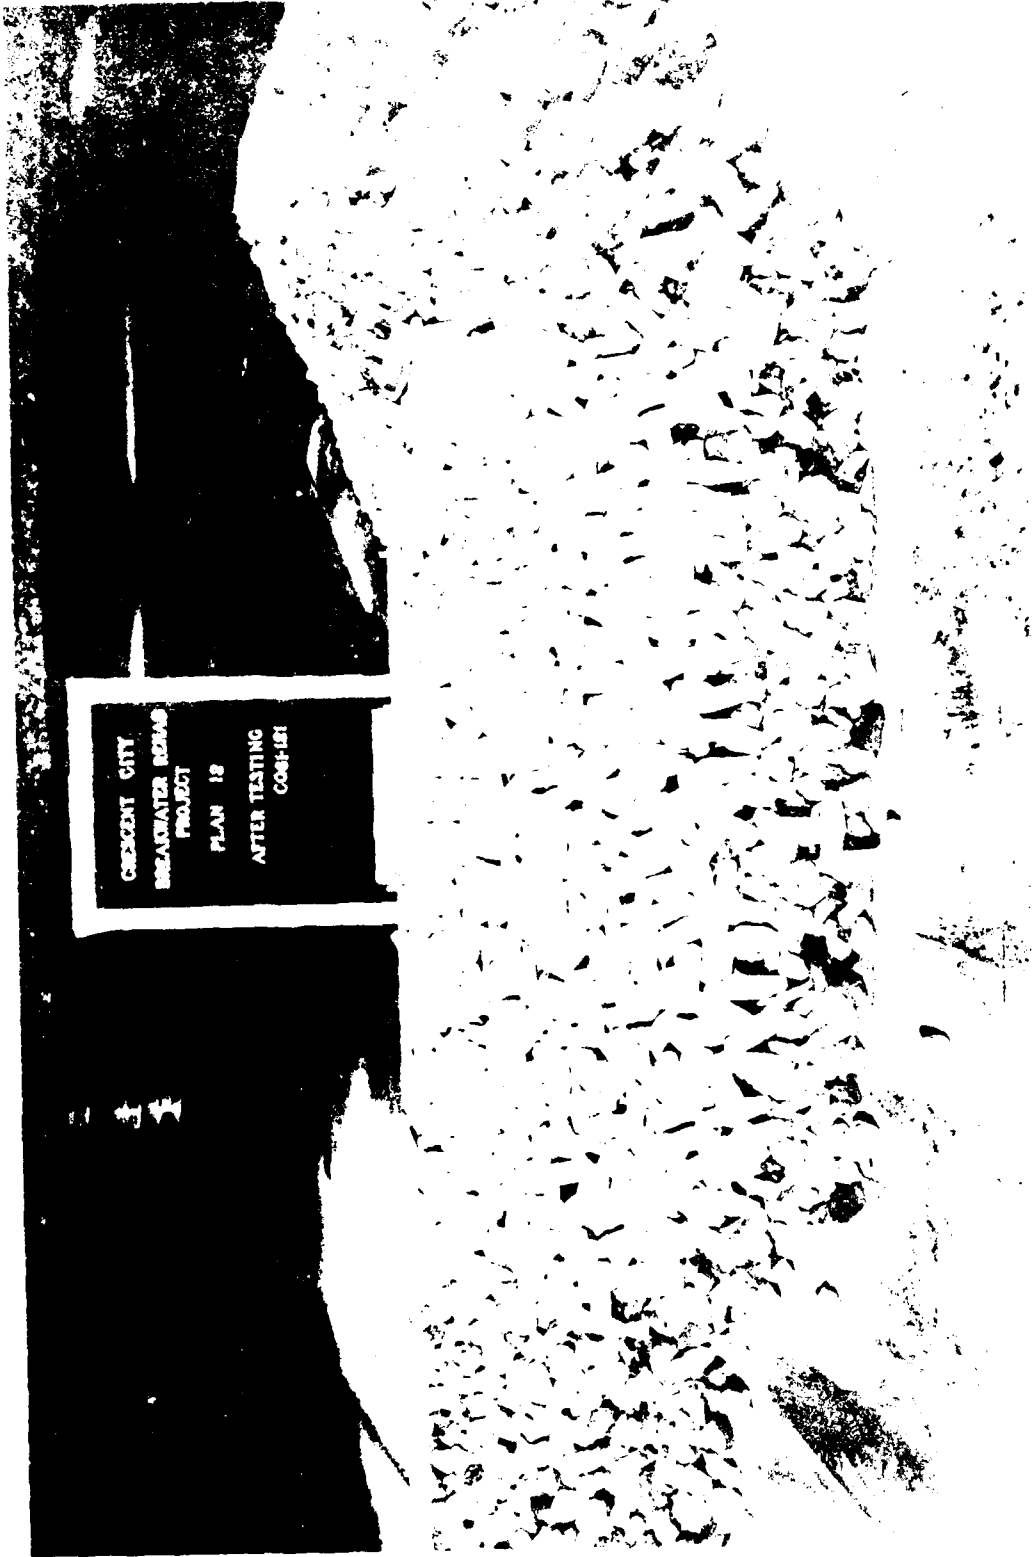
Photo 101. Seaward end view of Plan 12 before wave attack

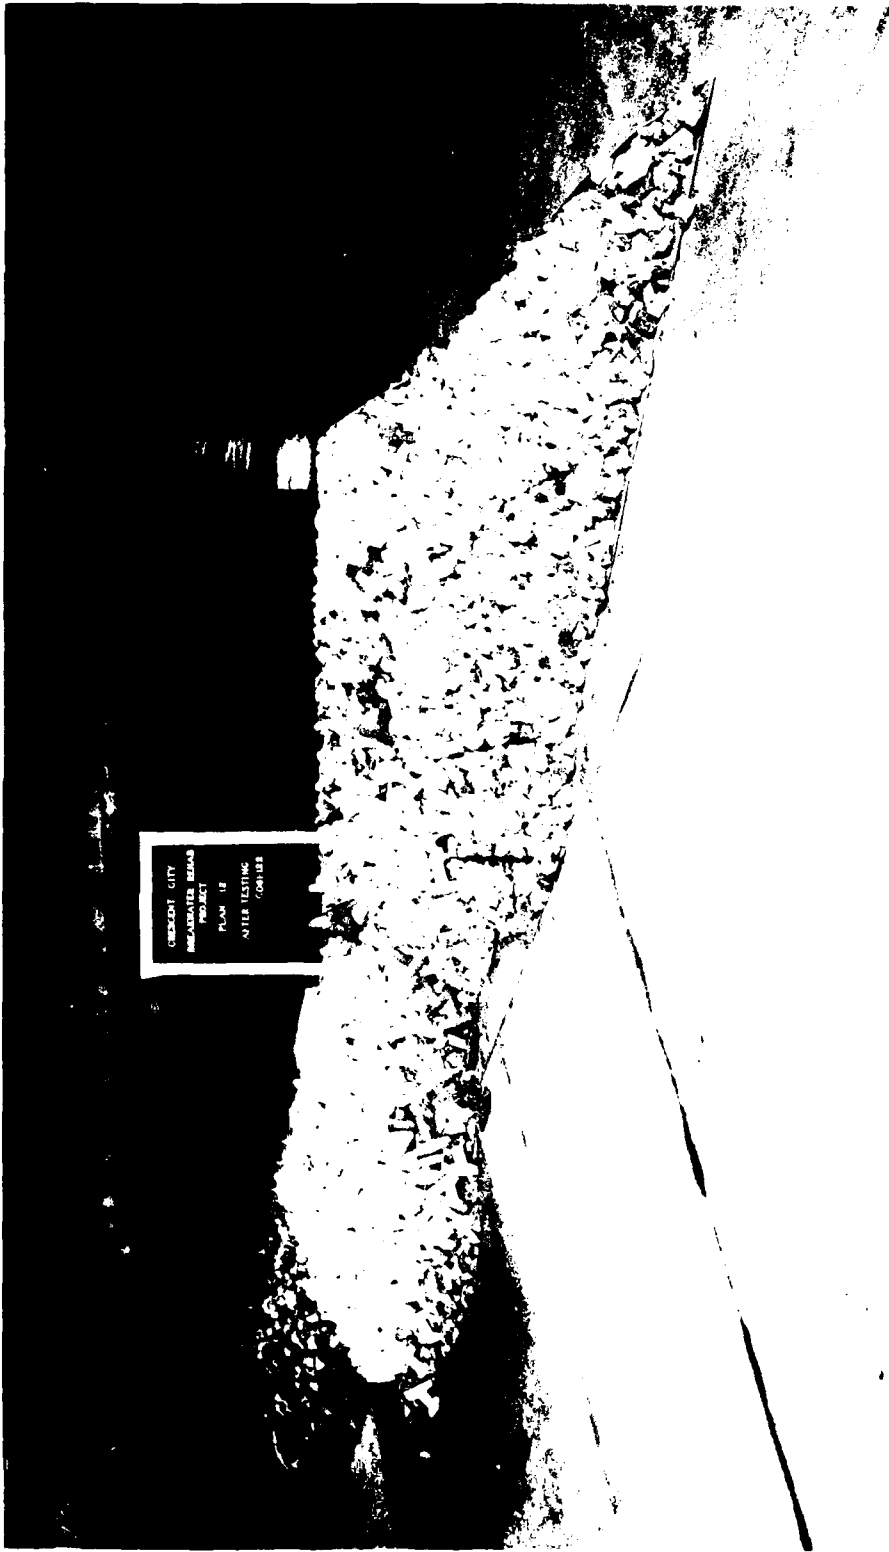
Photo 102. Sea-side view of Plan 12 after completion of abbreviated hydrograph.

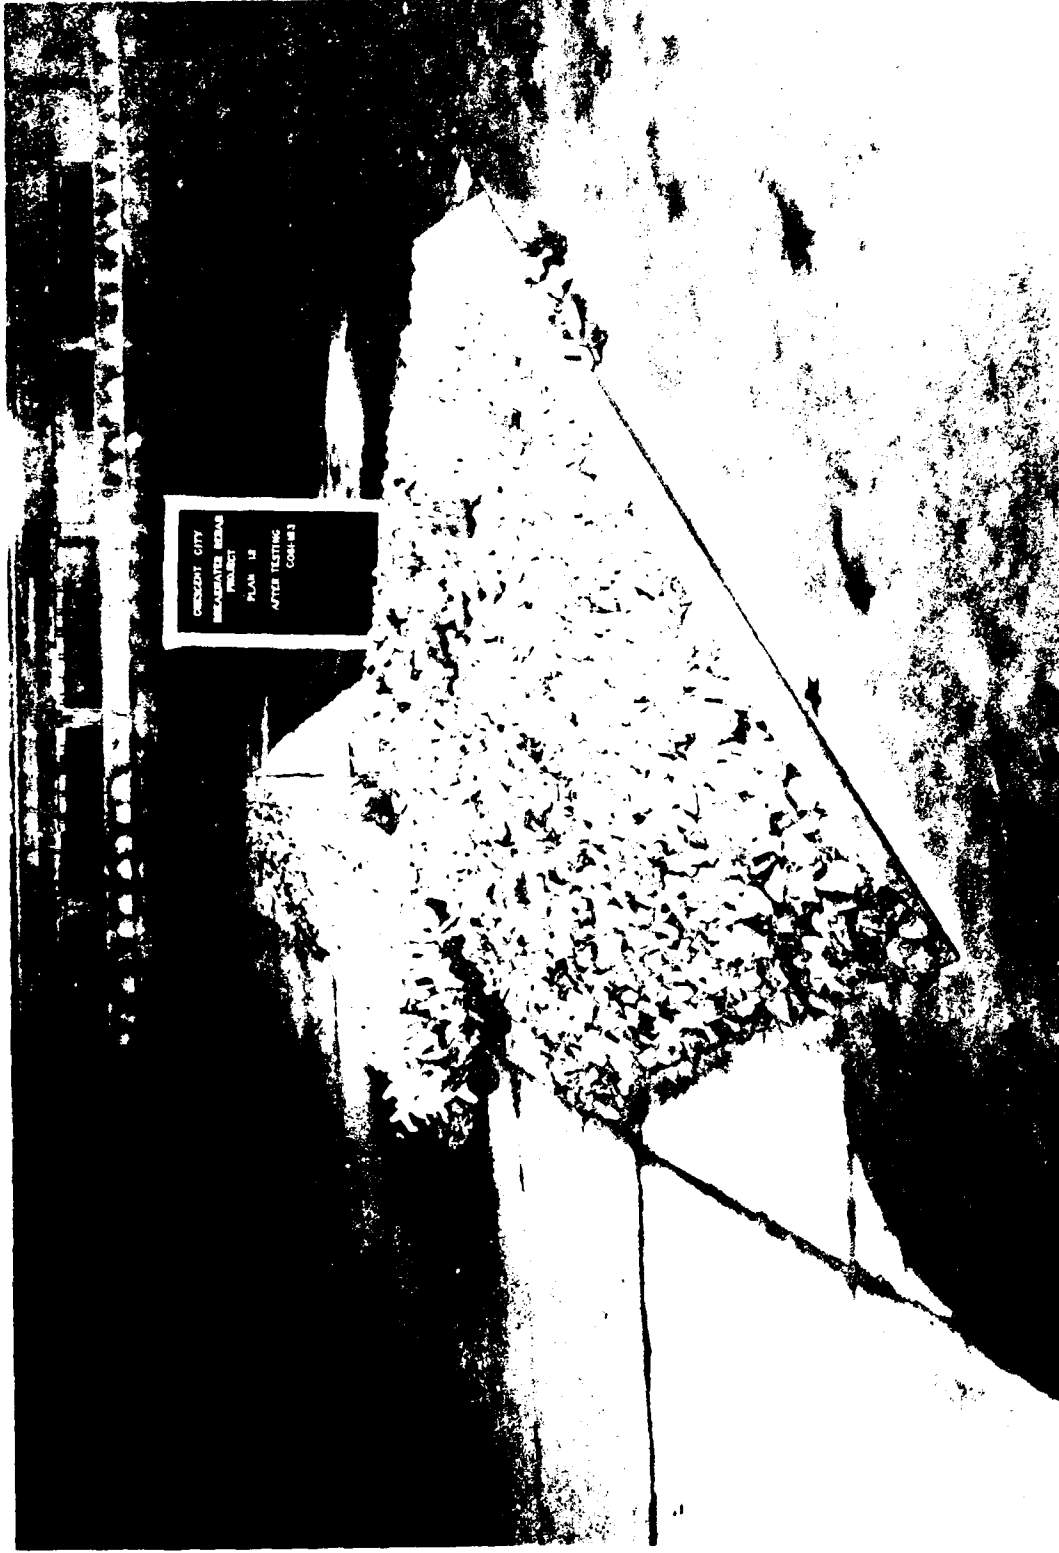
Photo 103. Seaward oblique view of Plan 12 after completion of abbreviated hydrograph

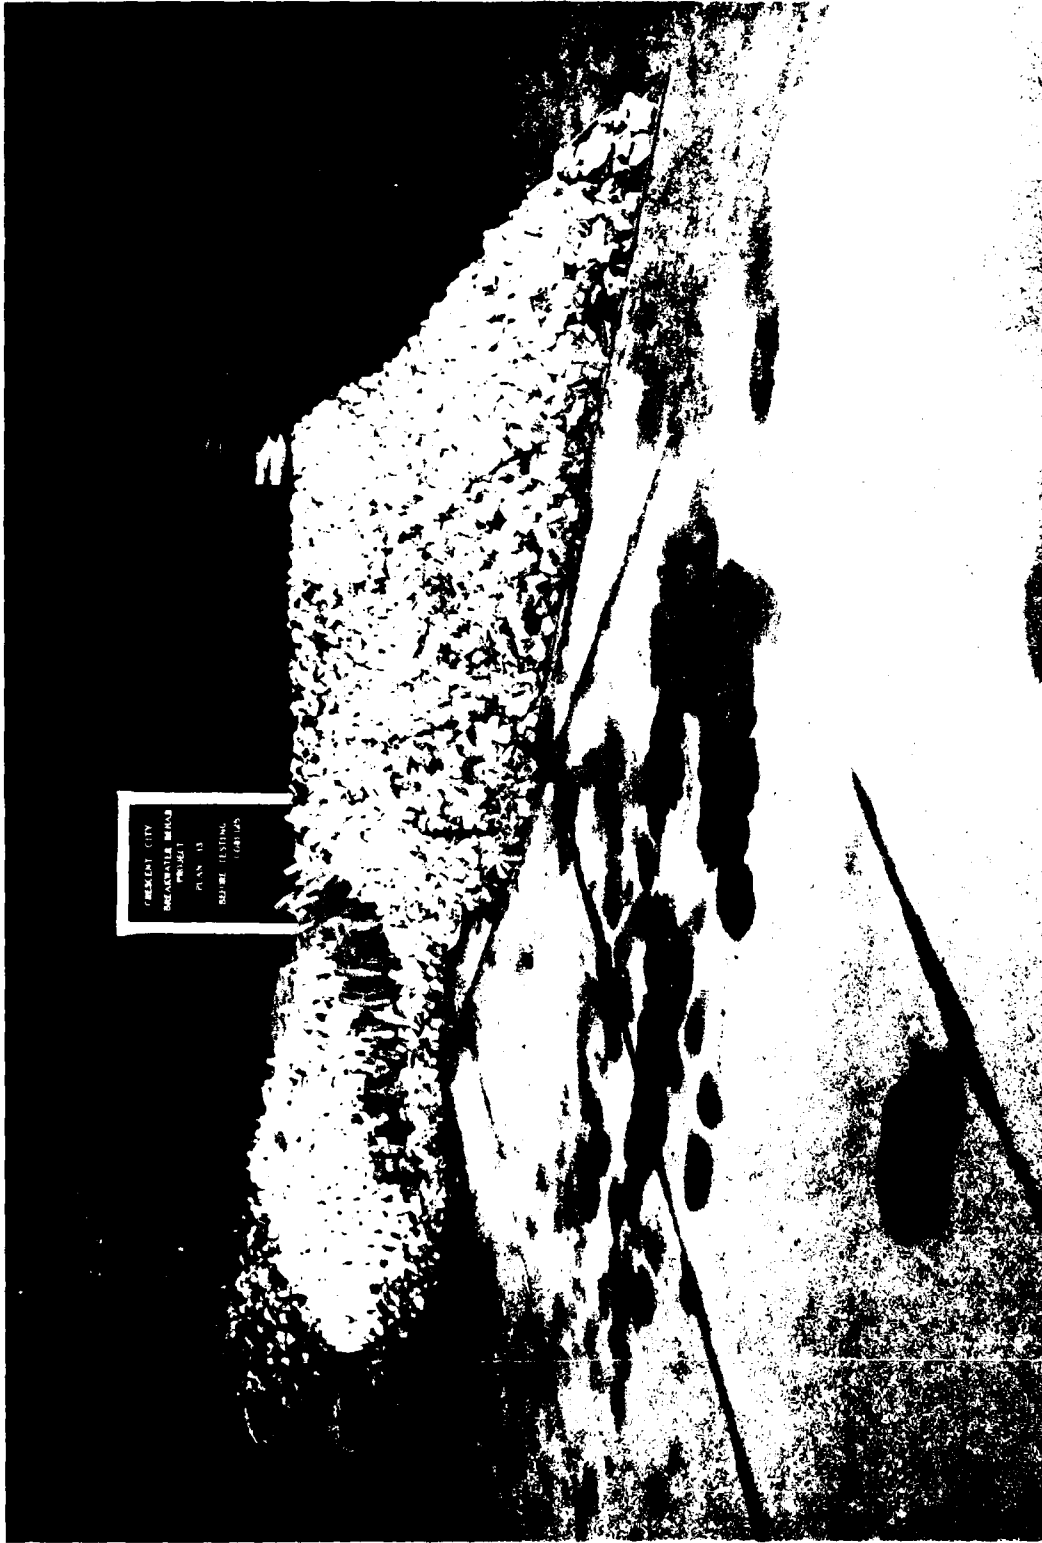
Photo 105. Sea-side view of Plan 13 before wave attack

43. Plan 13 (Plate 16 and Photos 105-107) was similar to Plan 12, except some additional 58-ton dolosse were placed. Also, special placement was used for the toe units. A total of 65 58-ton and 313 42-ton rehabilitation units were placed. The seaward transition still sustained damage during testing. Photos 108-110 show the structure after testing.

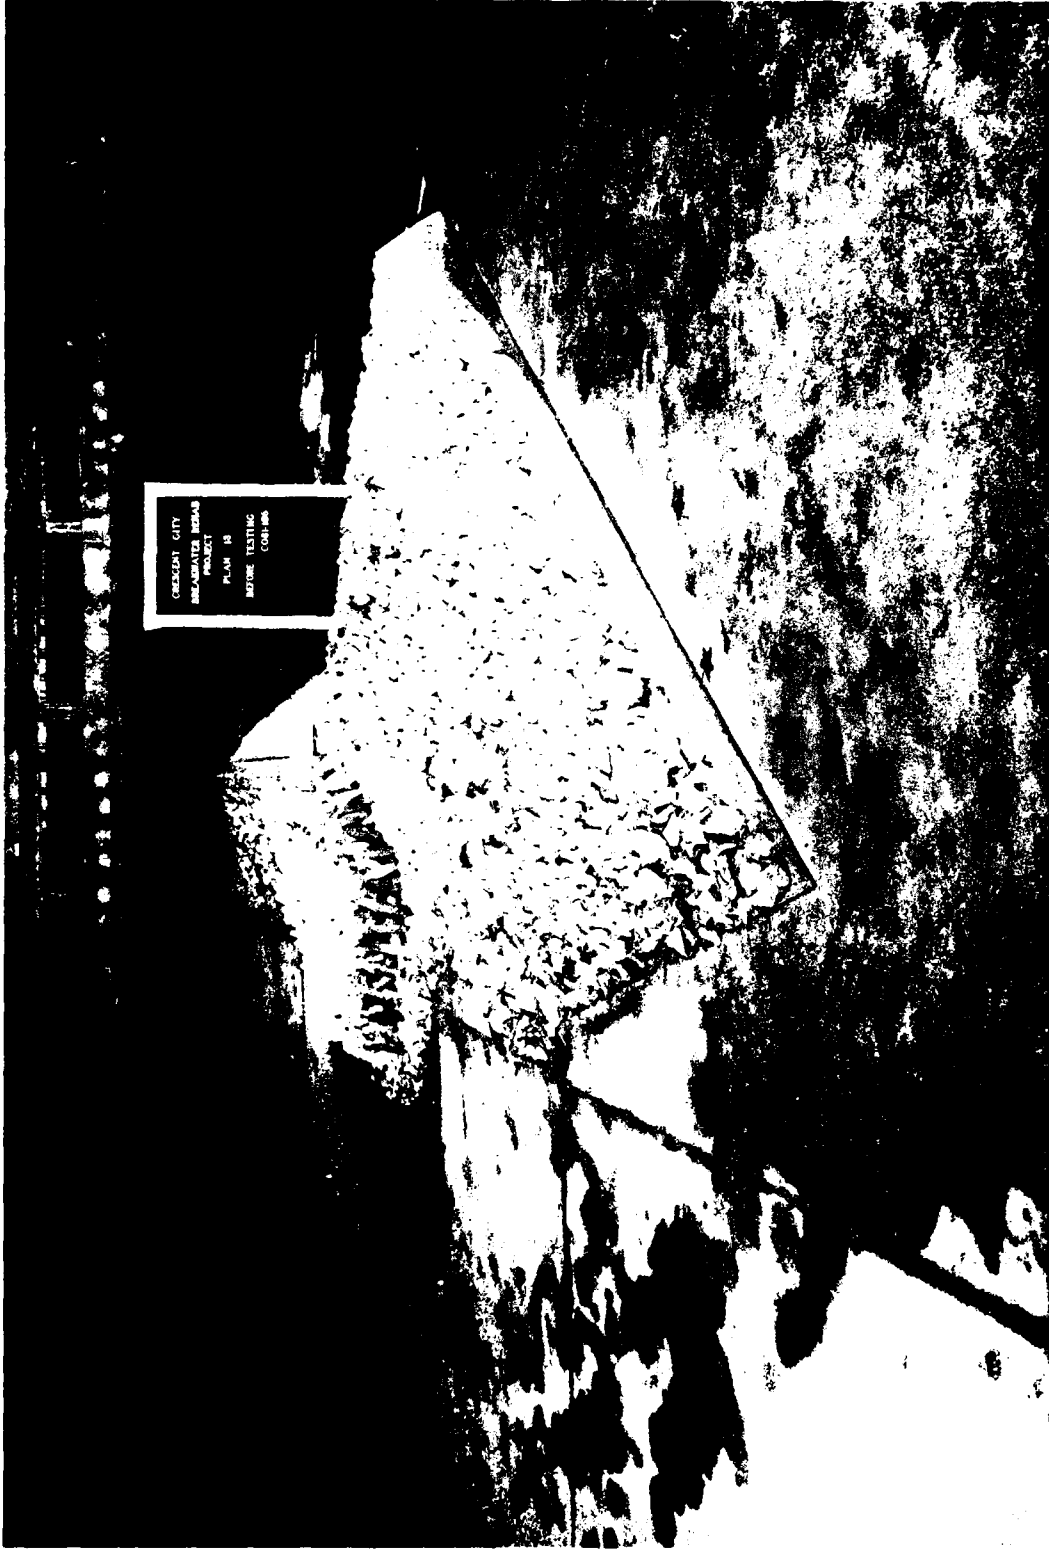
Photo 106. Seaward oblique view of Plan 13 before wave attack
