TECHNICAL REPORT CERC-85-8

# BREAKWATER REHABILITATION STUDY, CRESCENT CITY HARBOR, CALIFORNIA

## Coastal Model Investigation

November 1985

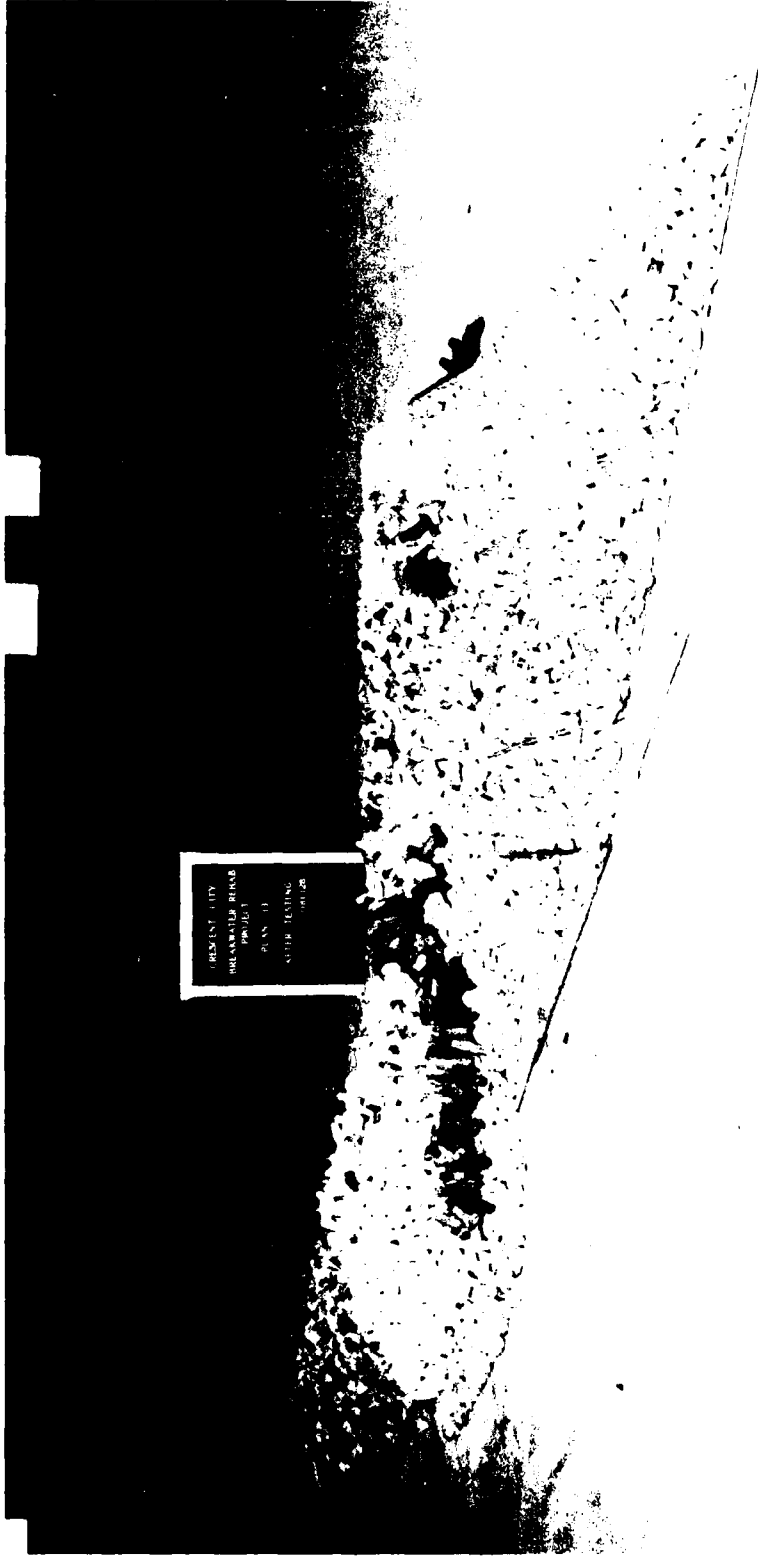
Photo 108. Sea-side view of Plan 13 after completion of abbreviated hydrograph

43. Plan 13 (Plate 16 and Photos 105-107) was similar to Plan 12, except some additional 58-ton dolosse were placed. Also, special placement was used for the toe units. A total of 65 58-ton and 313 42-ton rehabilitation units were placed. The seaward transition still sustained damage during testing. Photos 108-110 show the structure after testing.

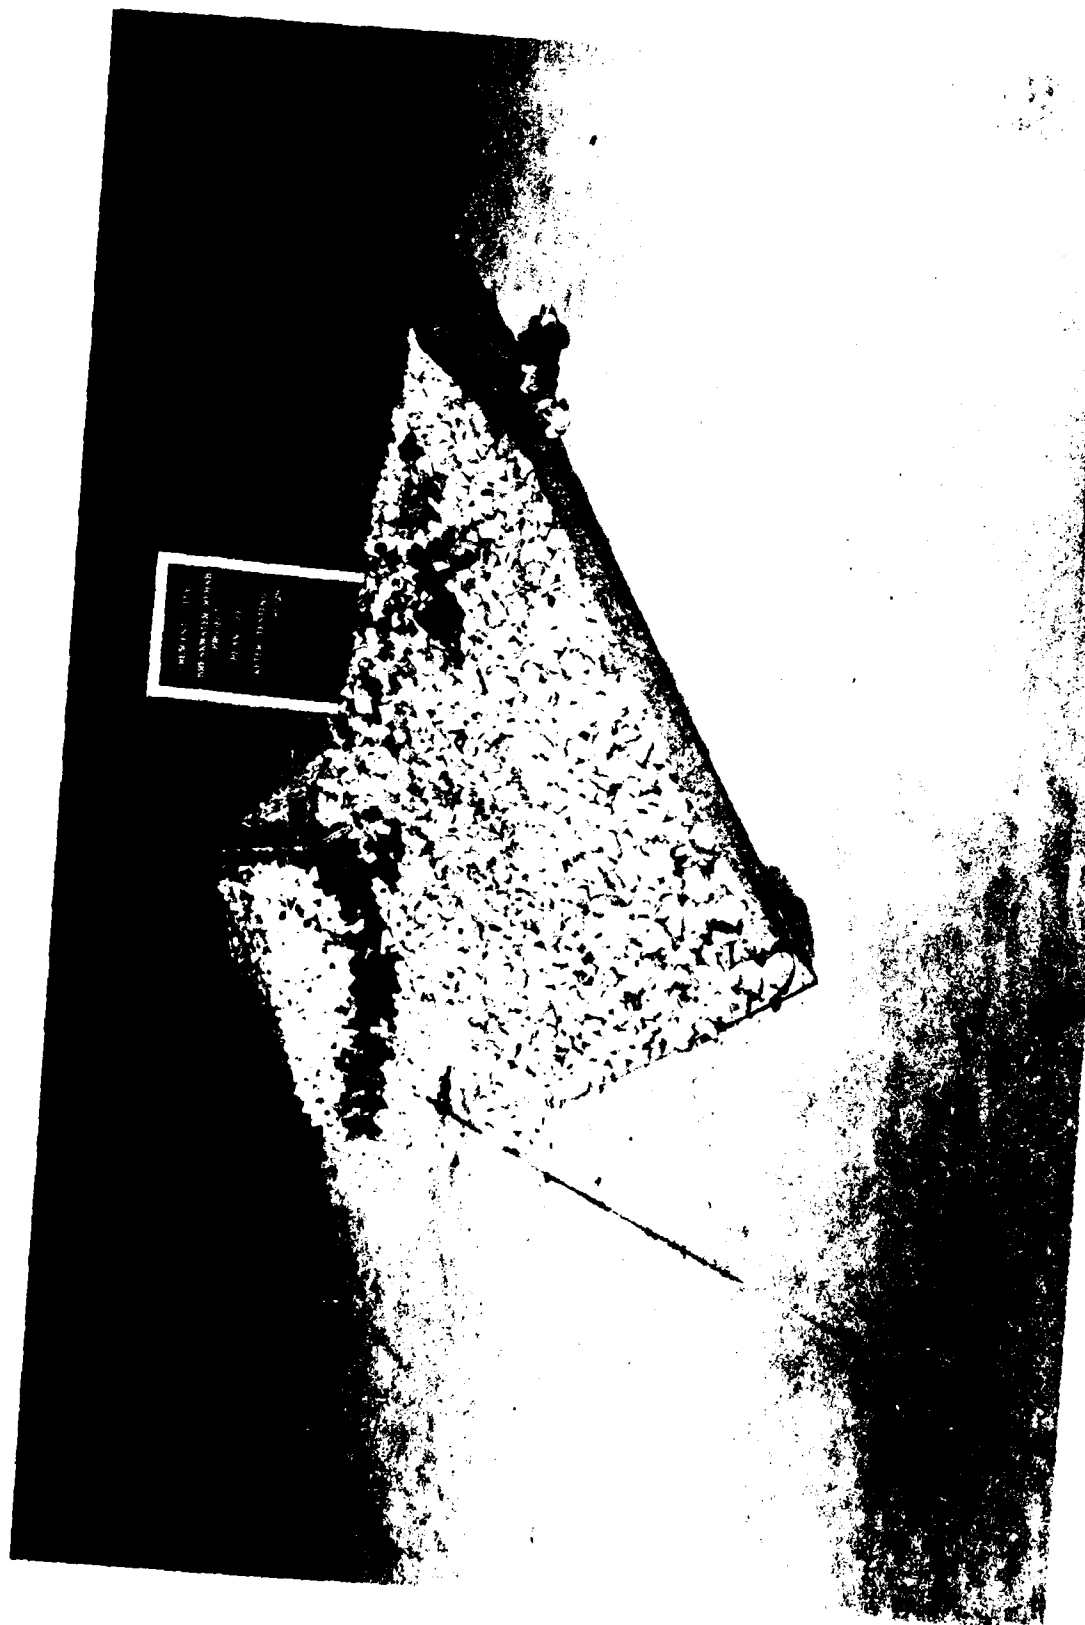
Photo 109. Seaward oblique view of Plan 13 after completion of abbreviated hydrograph

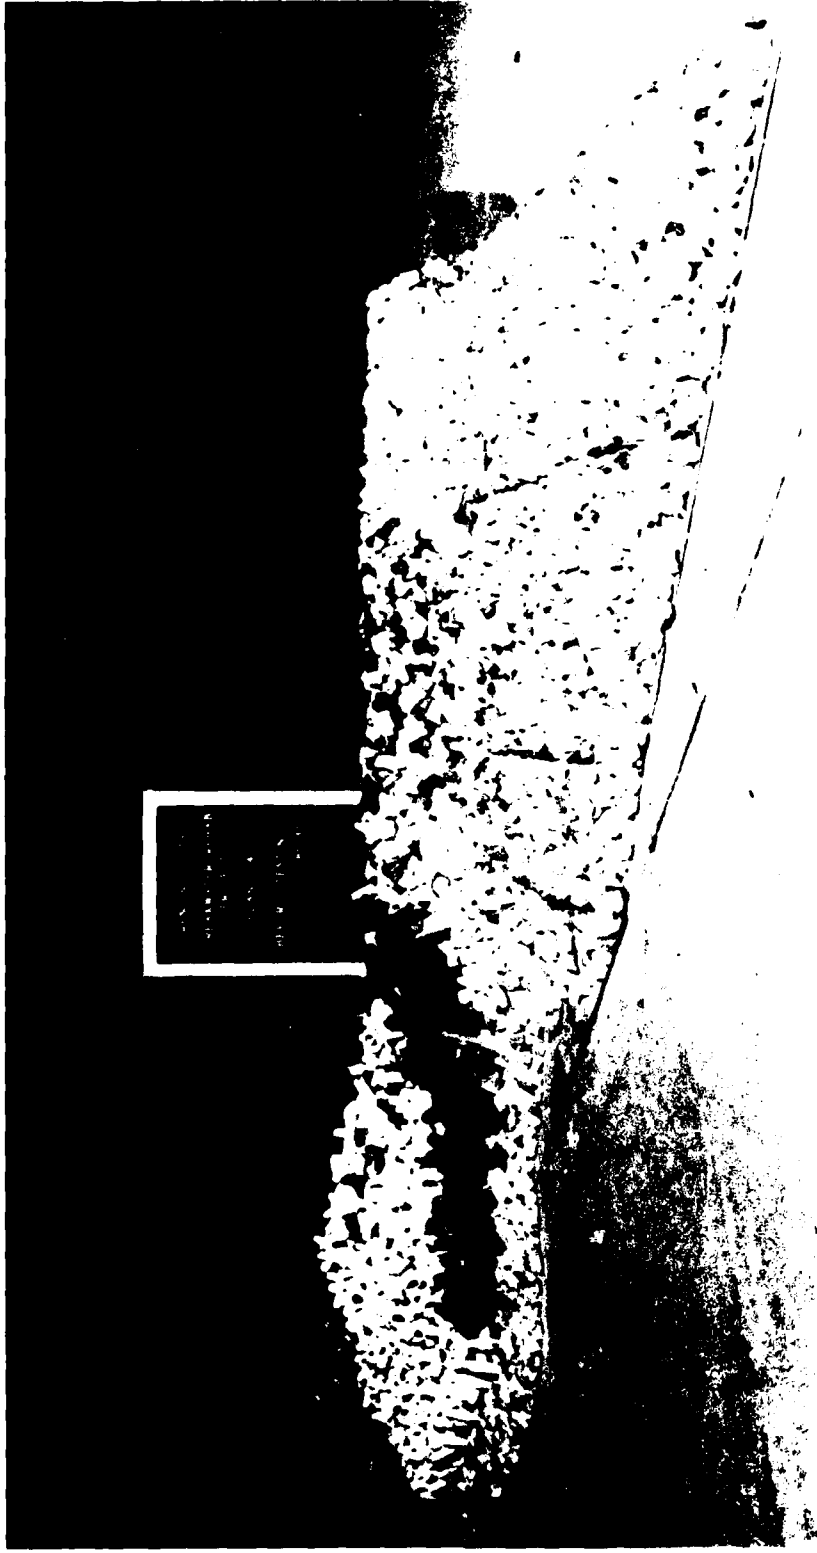
Photo 111. Sea-side view of Plan 14 before wave attack

44. Plan 14 (Plate 16 and Photos 111-113) was similar to Plan 13, except a trench was excavated along part of the seaward transition. A total of 61 58-ton and 312 42-ton rehabilitation units were placed. Again the seaward transition sustained damage during testing. Photos 114-116 show the structure after testing. At this time it was decided that the larger units exhibited more surface area for the waves to work on and were not a feasible alternative unless higher density concrete was used, which in effect, would increase the weight without increasing the surface area. Since high-density model units were not available to show this effect and the time limitation prevented making additional model units, future efforts concentrated on finding a stable section using the 42-ton dolosse.

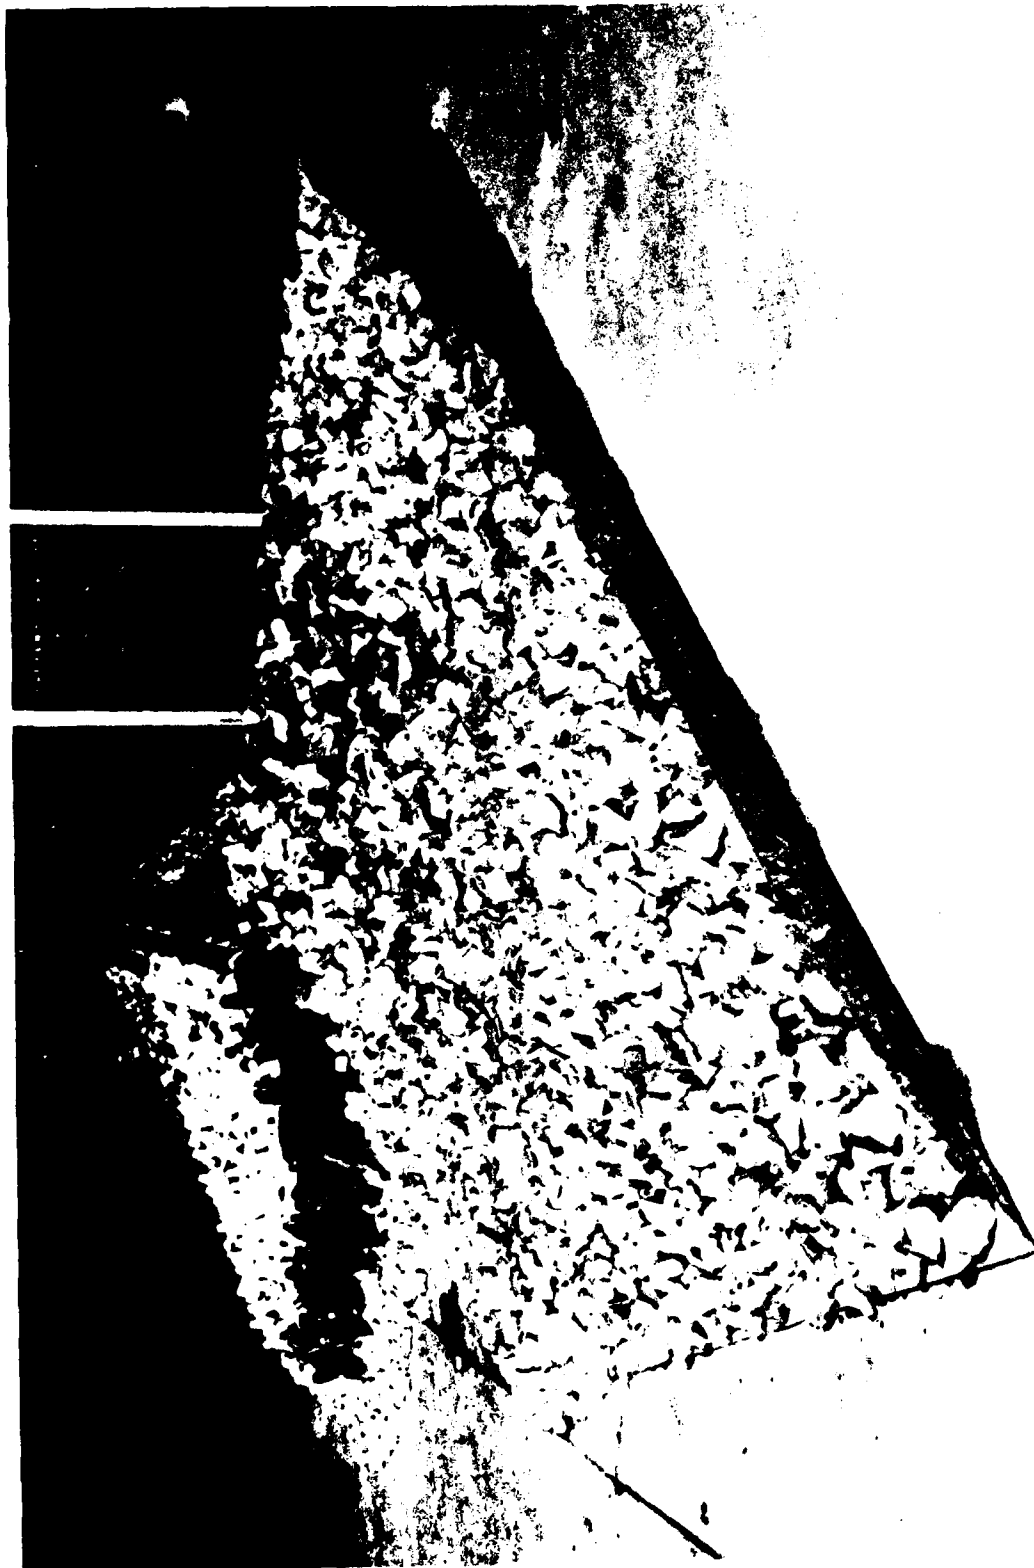
Photo 112. Seaward oblique view of Plan 14 before wave attack

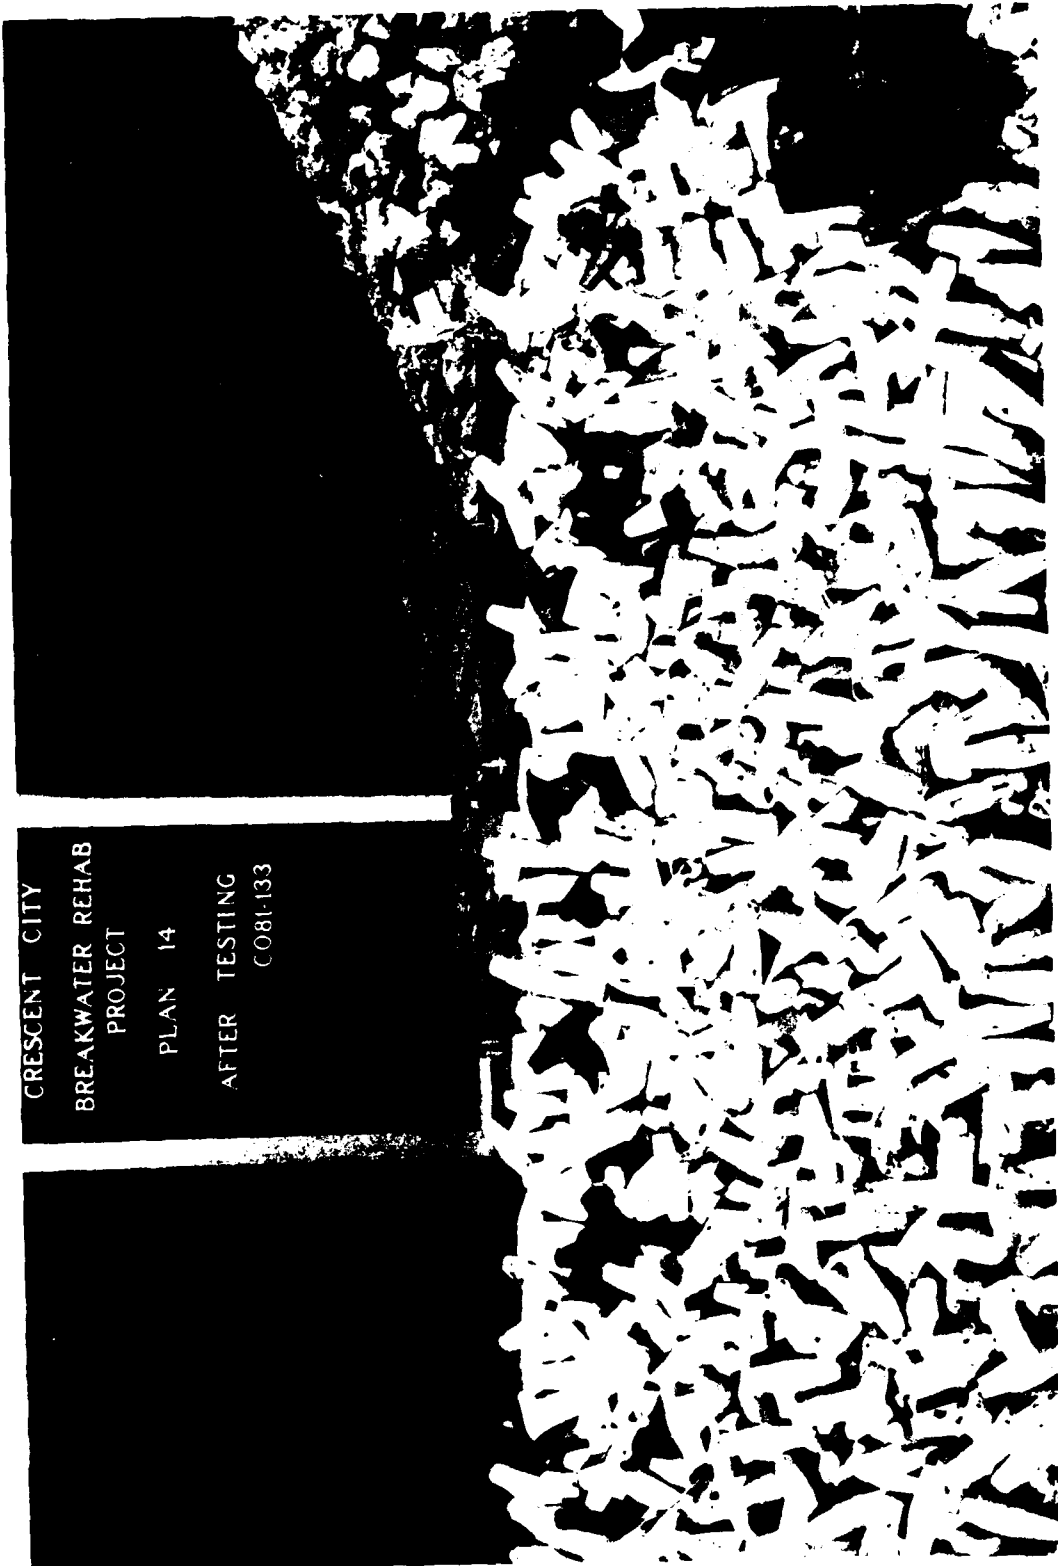
Photo 114. Sea-side view of Plan 14 after completion of abbreviated hydrograph

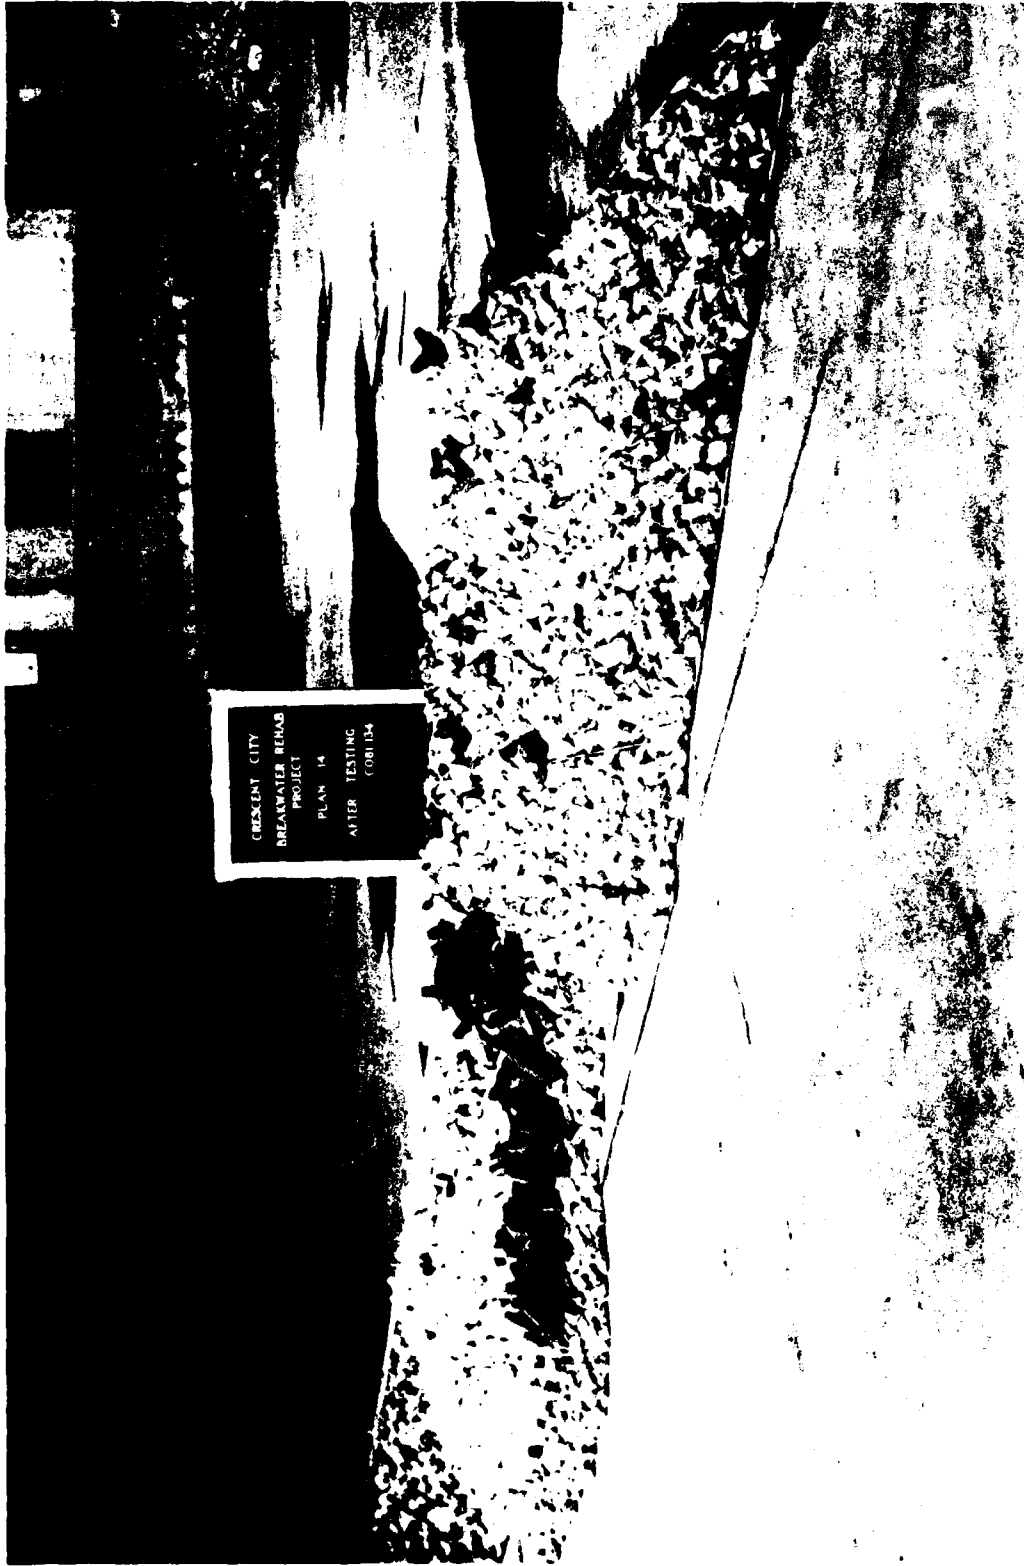
Photo 115. Seaward oblique view of Plan 14 after completion of abbreviated hydrograph

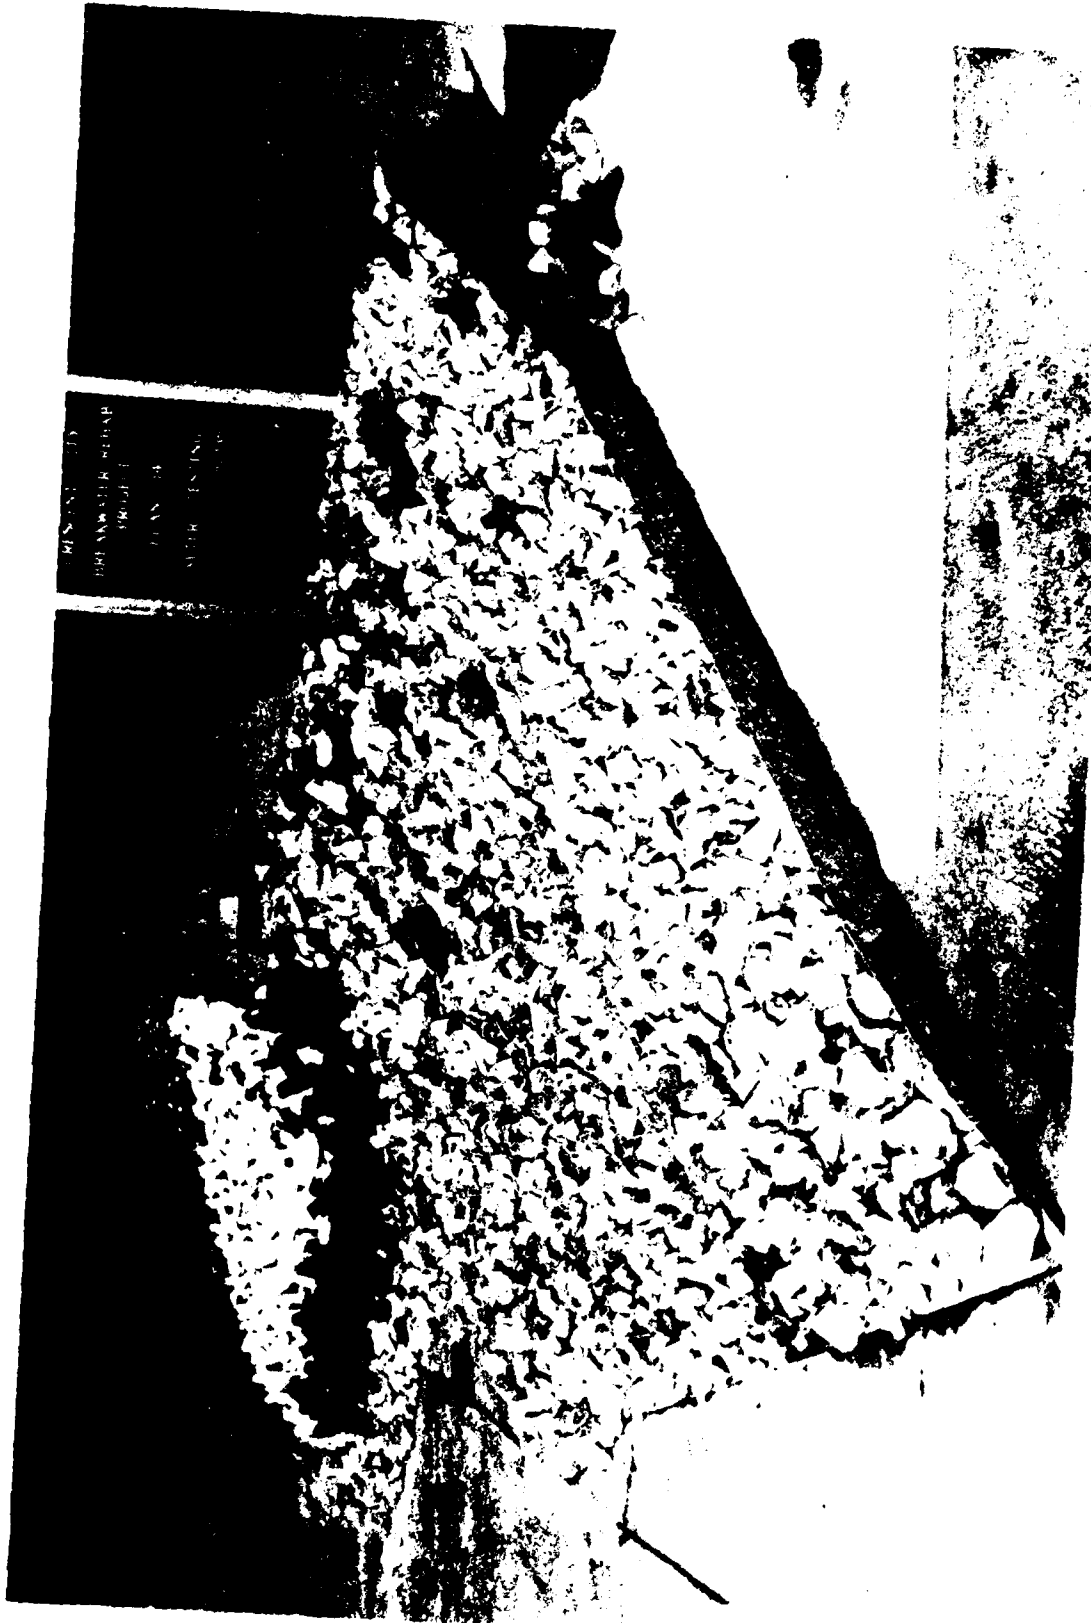
Photo 116. Seaward end view of Plan 14 after completion of abbreviated hydrograph

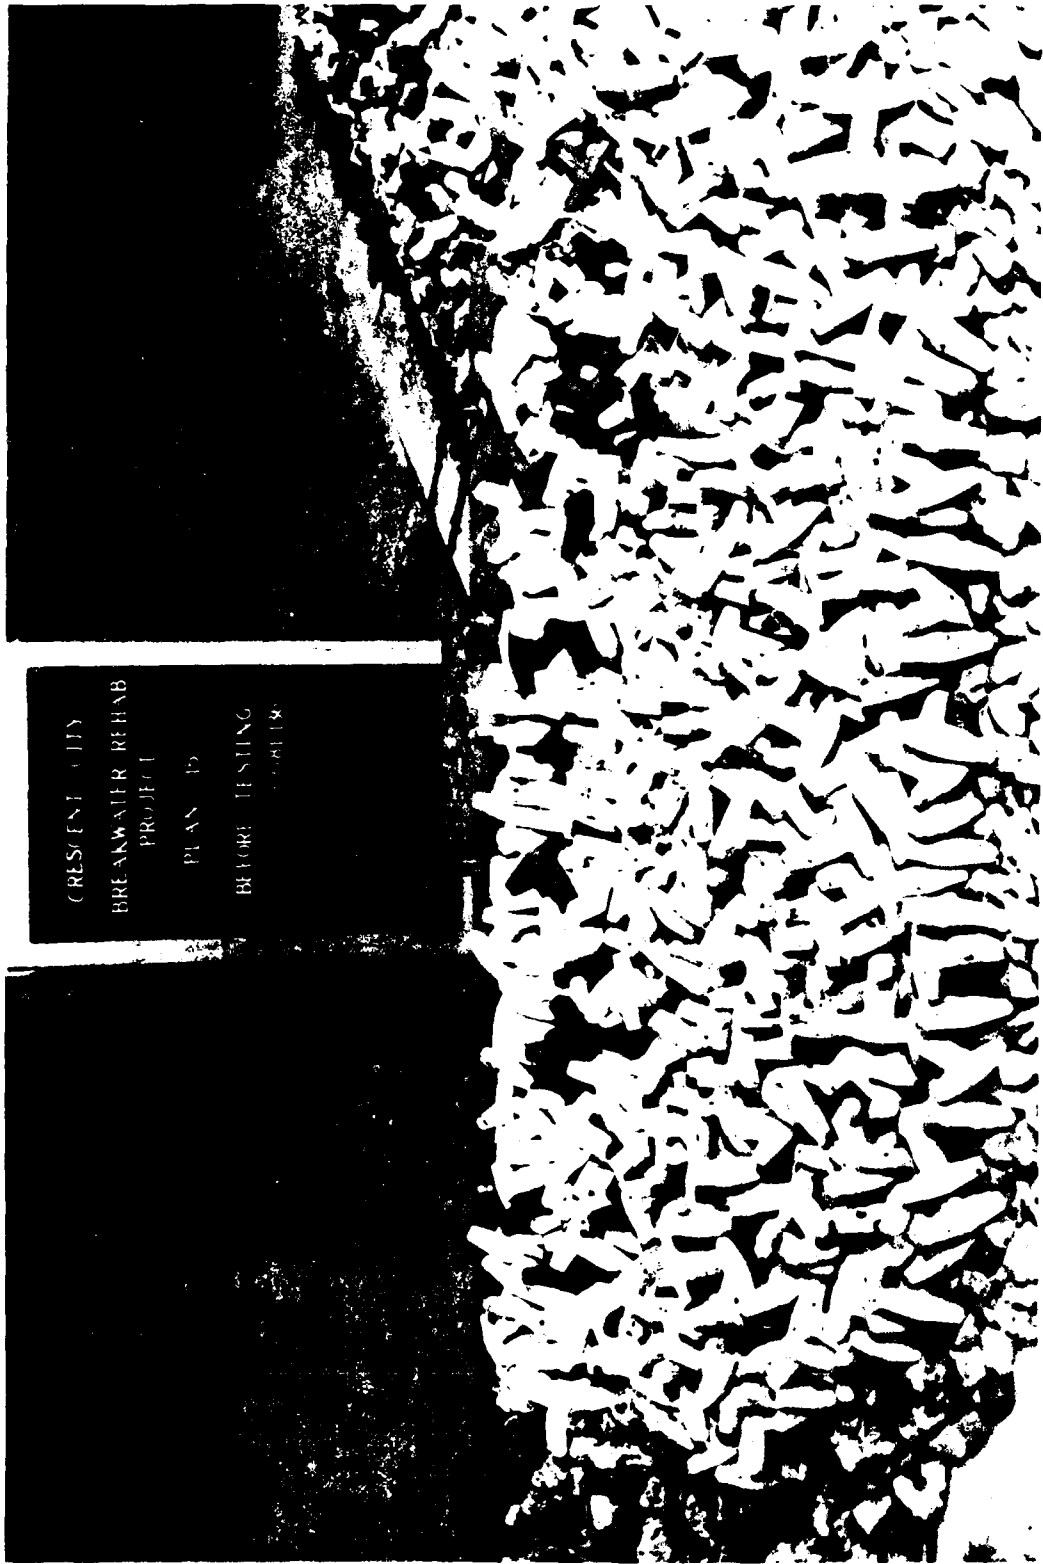
Photo 117. Sea-side view of Plan 15 before wave attack

45. Plan 15 (Plate 17 and Photos 117-119) was constructed with a trench approximately one dolos wide and about 5 ft (one-stone-diameter) deep. After the units were placed in the trench, the voids between units in the trench were backfilled with material left over from the excavation. Special placement was used for the toe units. The total number of 42-ton rehabilitation units was 373. Again damage exceeded acceptable limits. Although much of the backfill material was scoured out during testing, placement of the backfill material did improve the stability of the seaward transition. Photos 120-122 show the structure after testing.

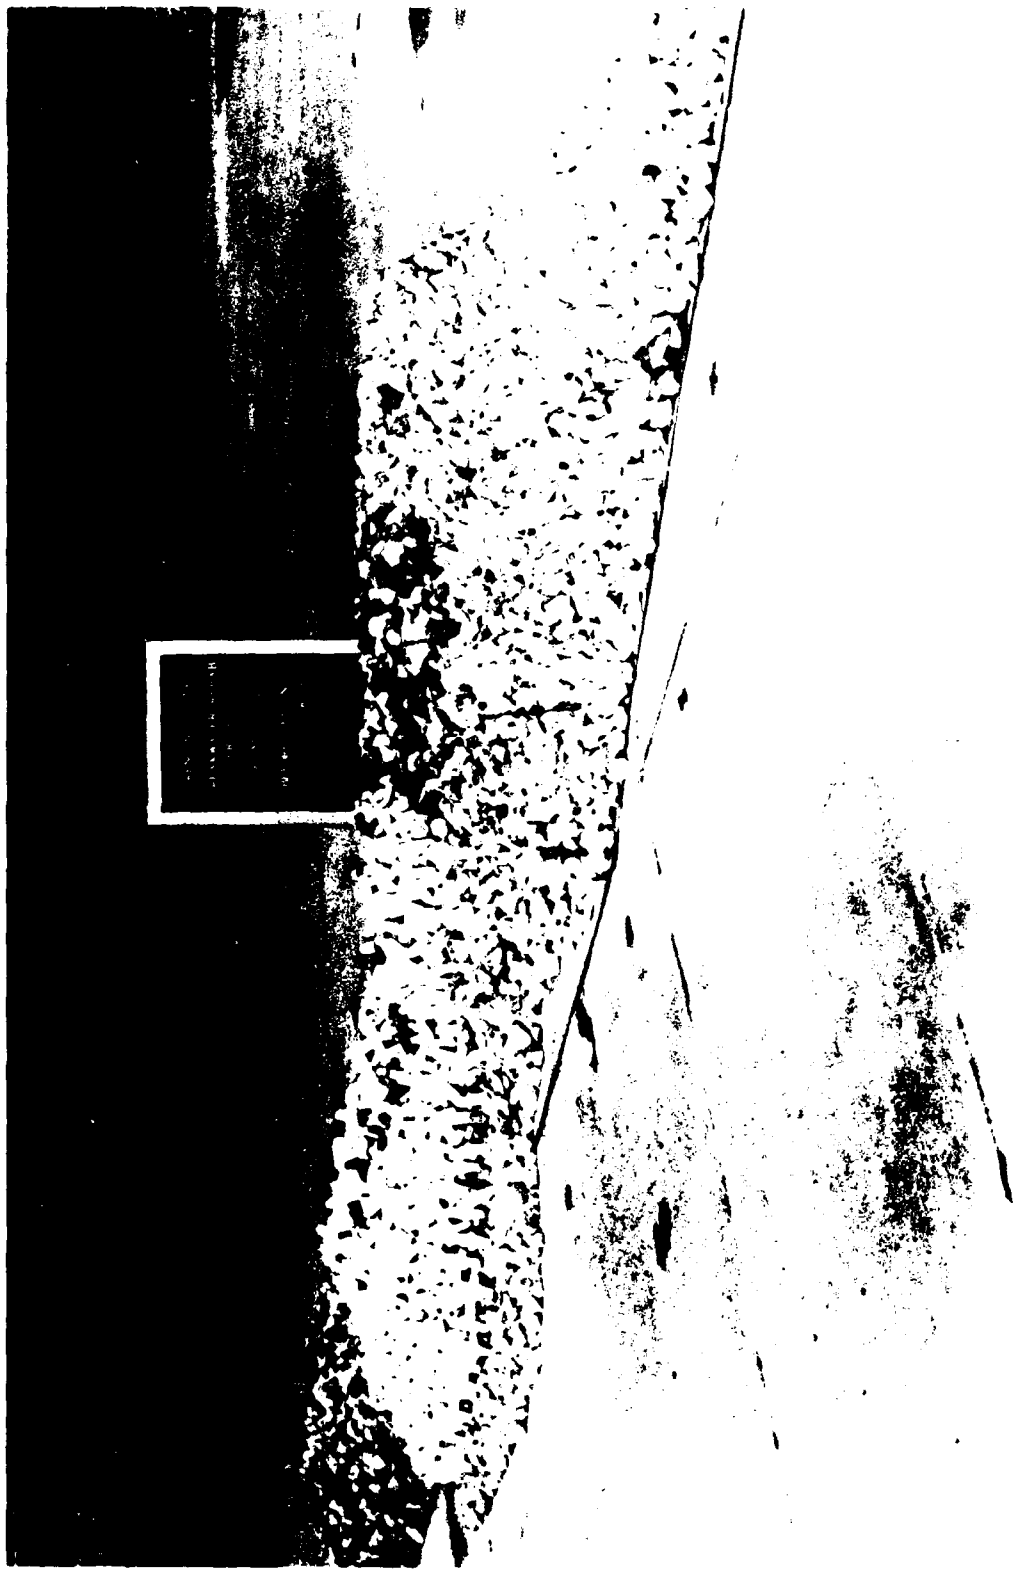
Photo 118. Seaward oblique view of Plan 15 before wave attack

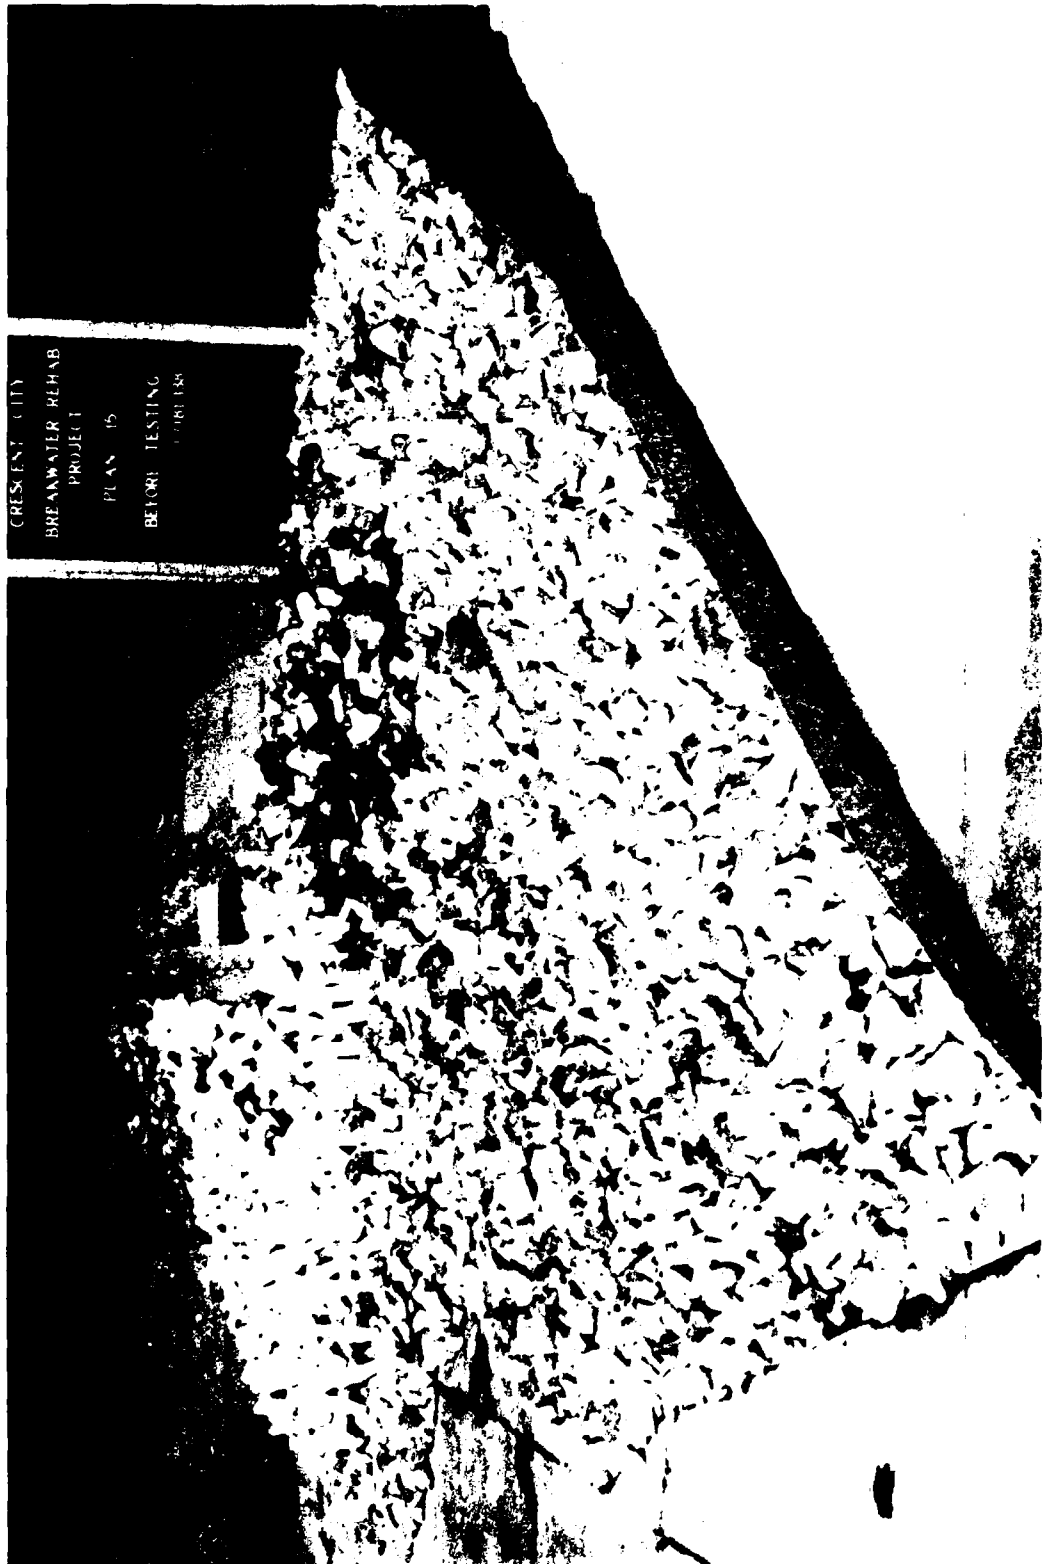
Photo 119. Seaward end view of Plan 15 before wave attack

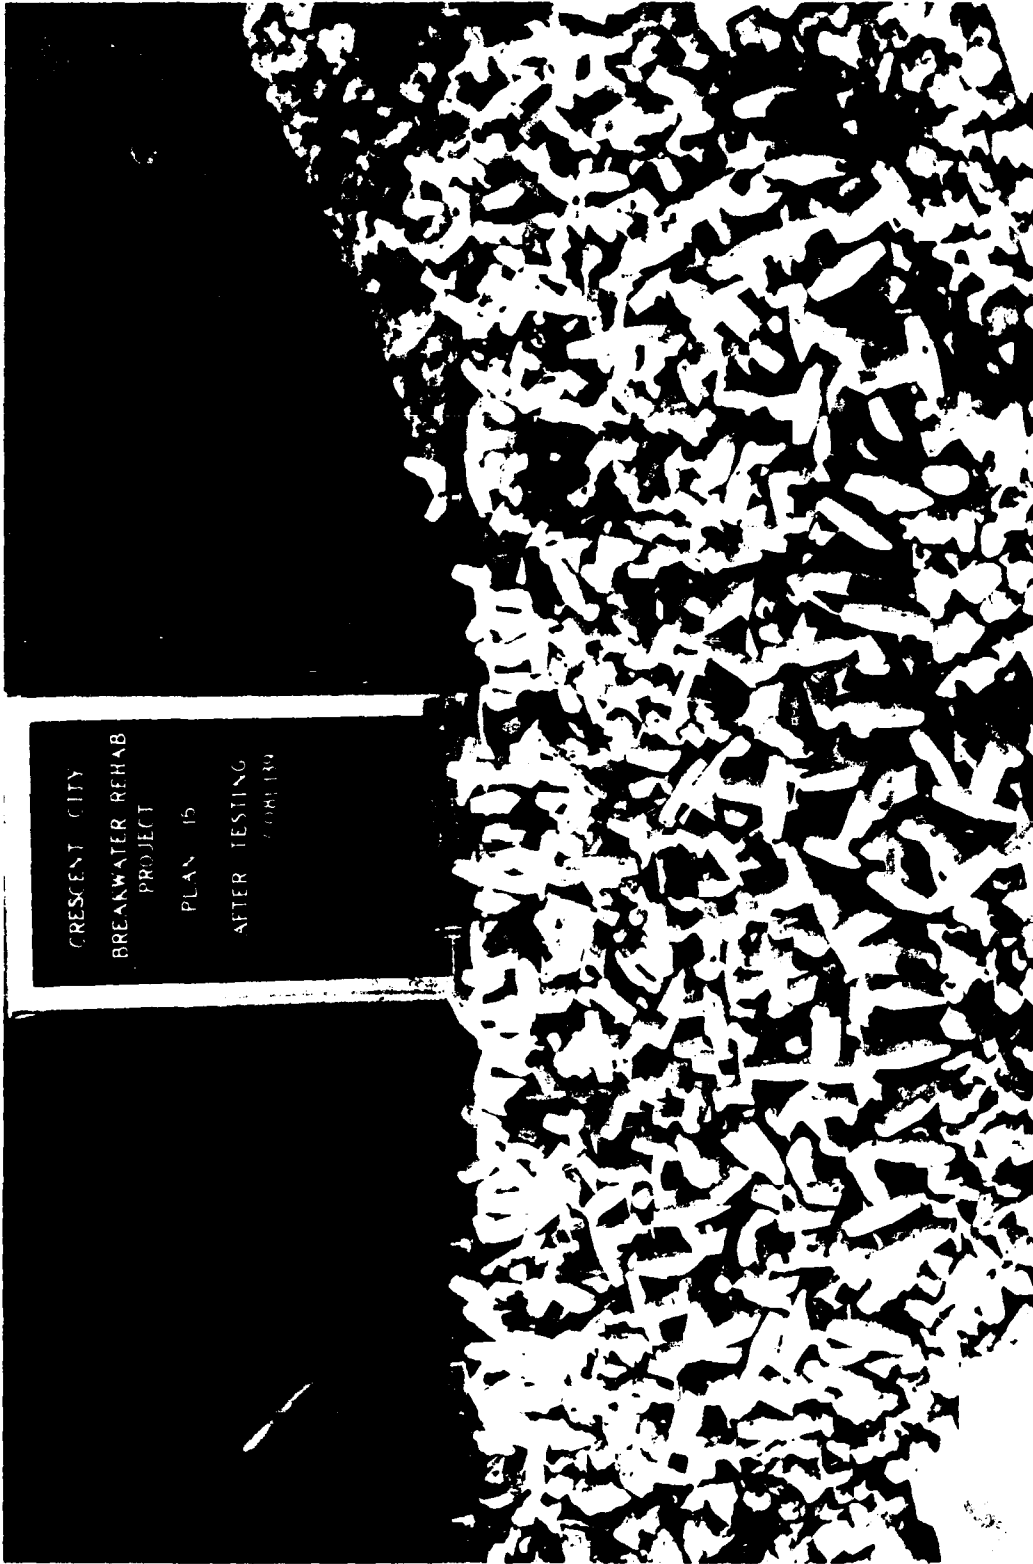
Photo 120. Sea-side view of Plan 15 after completion of abbreviated hydrograph

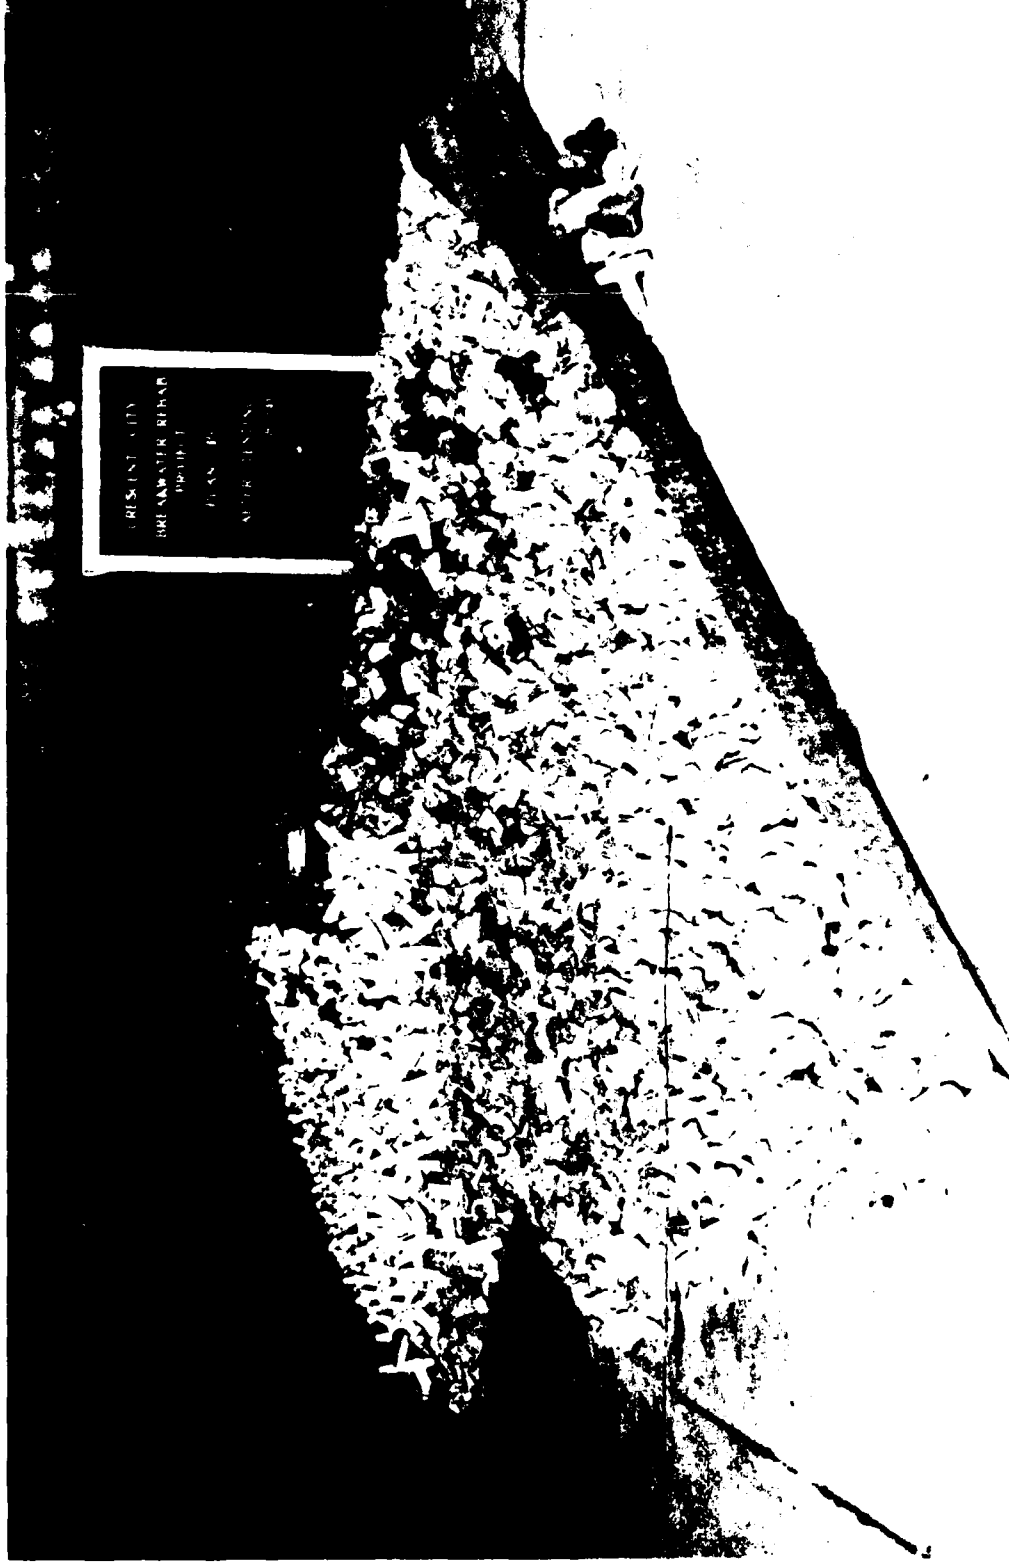
Photo 122. Seaward end view of Plan 15 after completion of abbreviated hydrograph

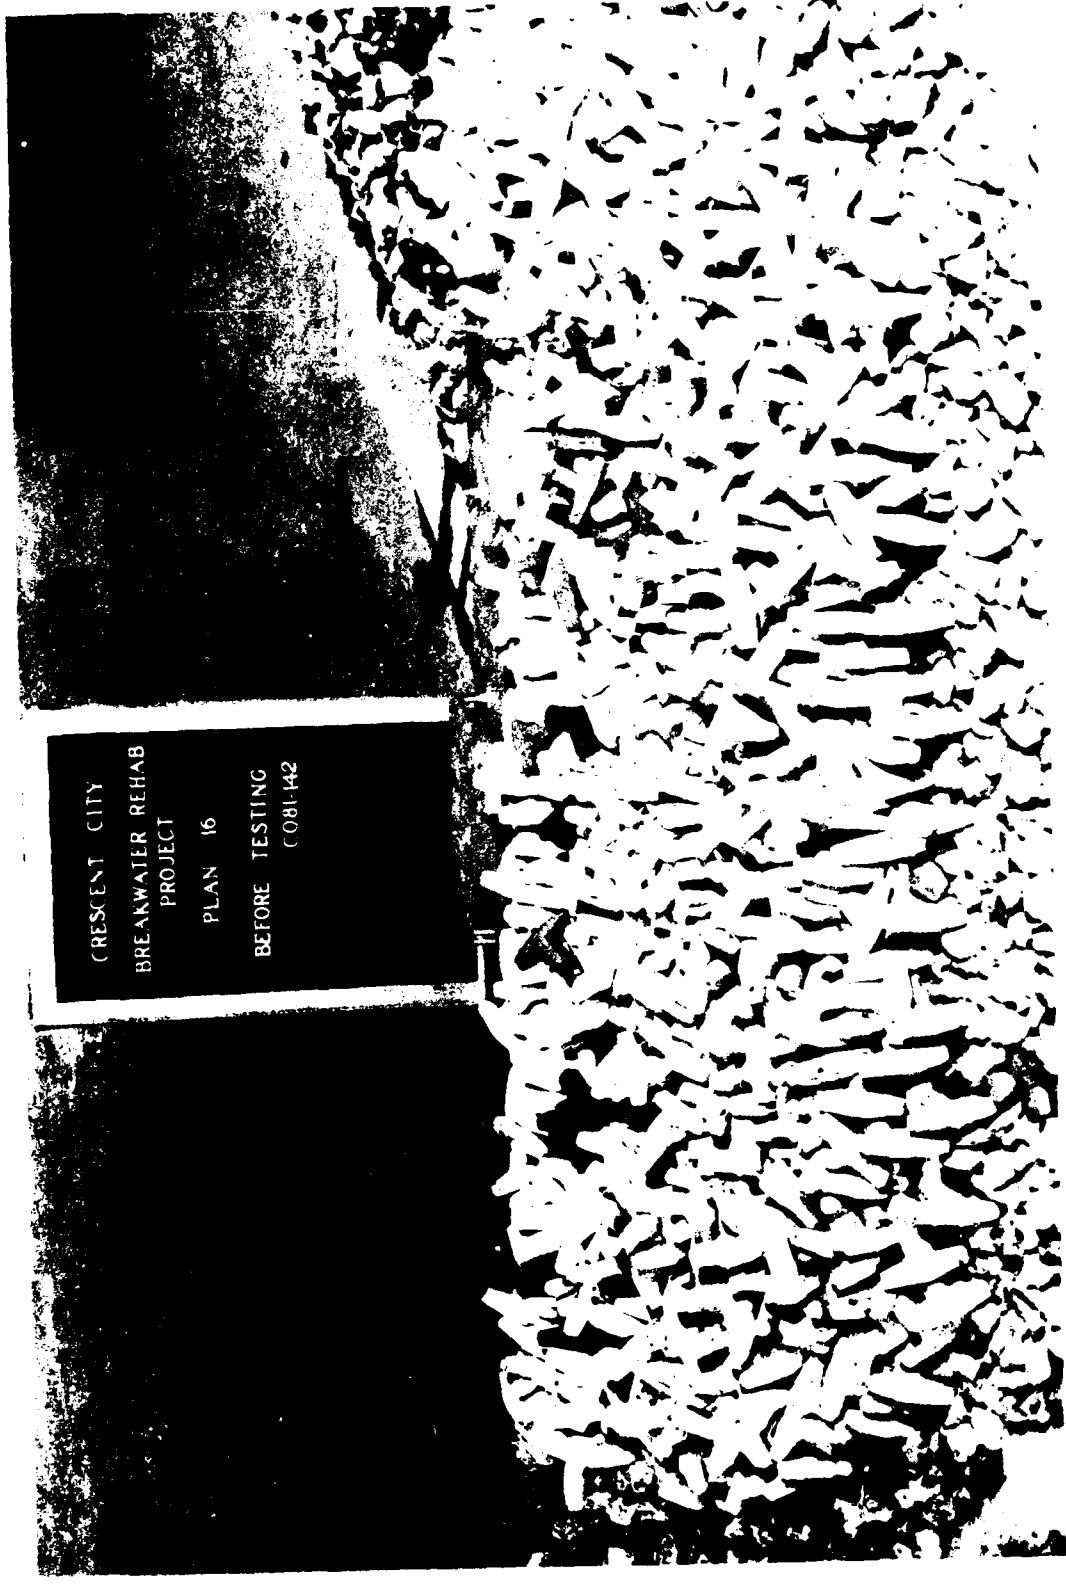
Photo 123. Sea-side view of Plan 16 before wave attack

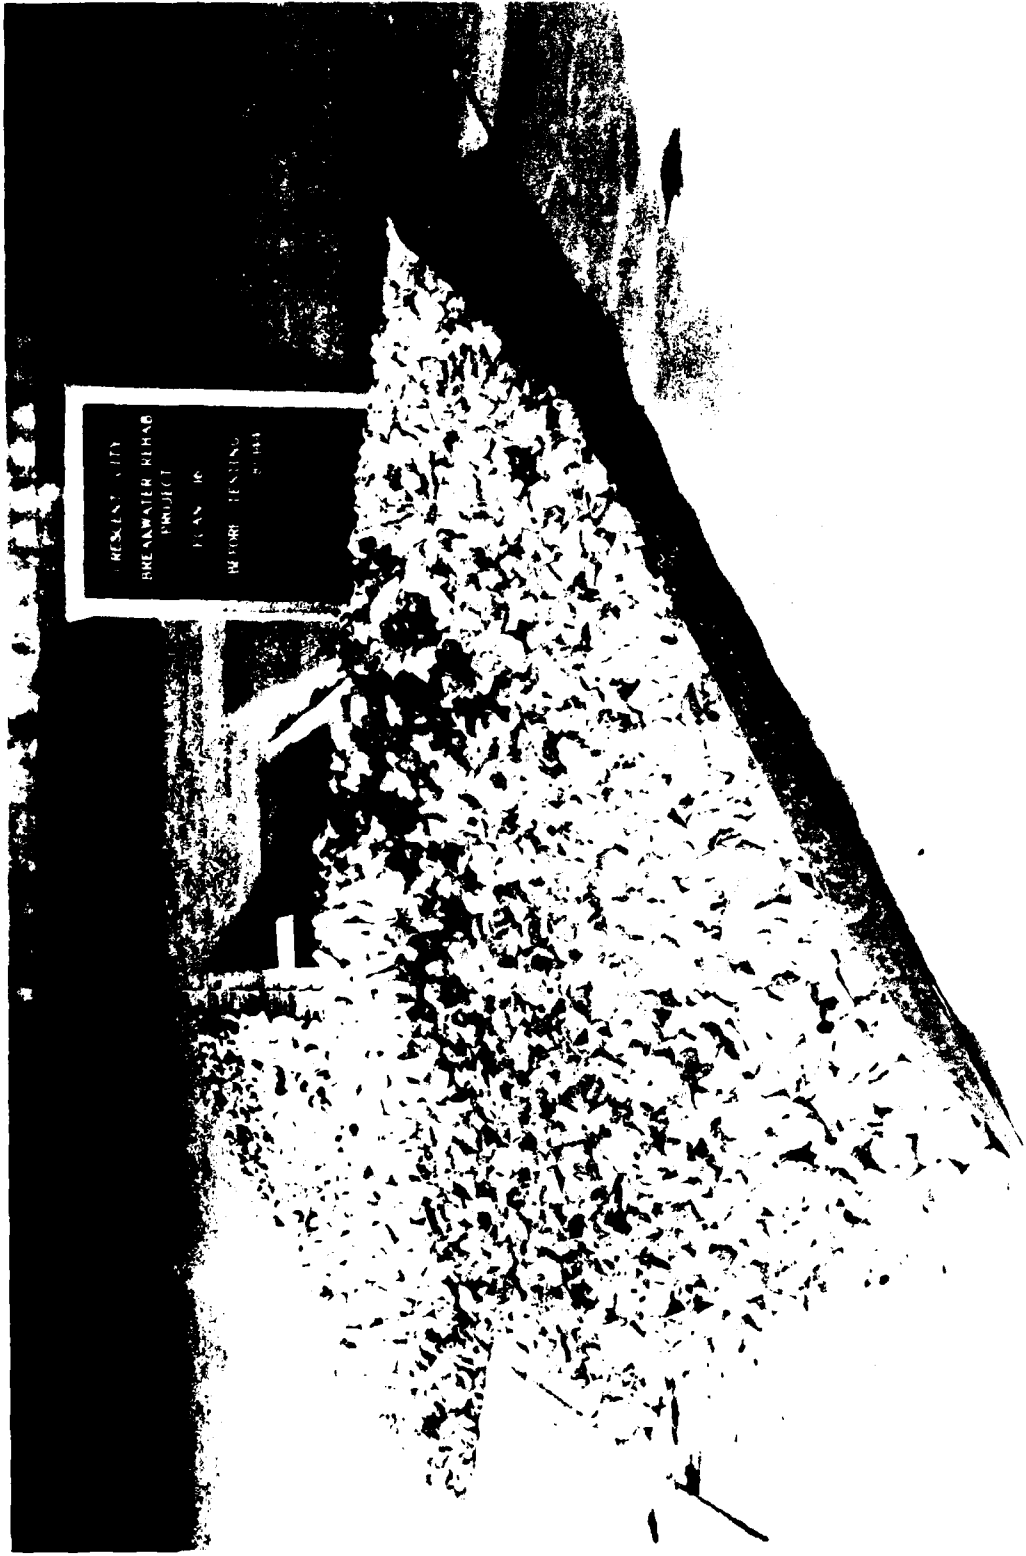
Photo 125. Seaward end view of Plan 16 before wave attack
