TECHNICAL REPORT CERC-85-8

# BREAKWATER REHABILITATION STUDY, CRESCENT CITY HARBOR, CALIFORNIA

## Coastal Model Investigation

November 1985

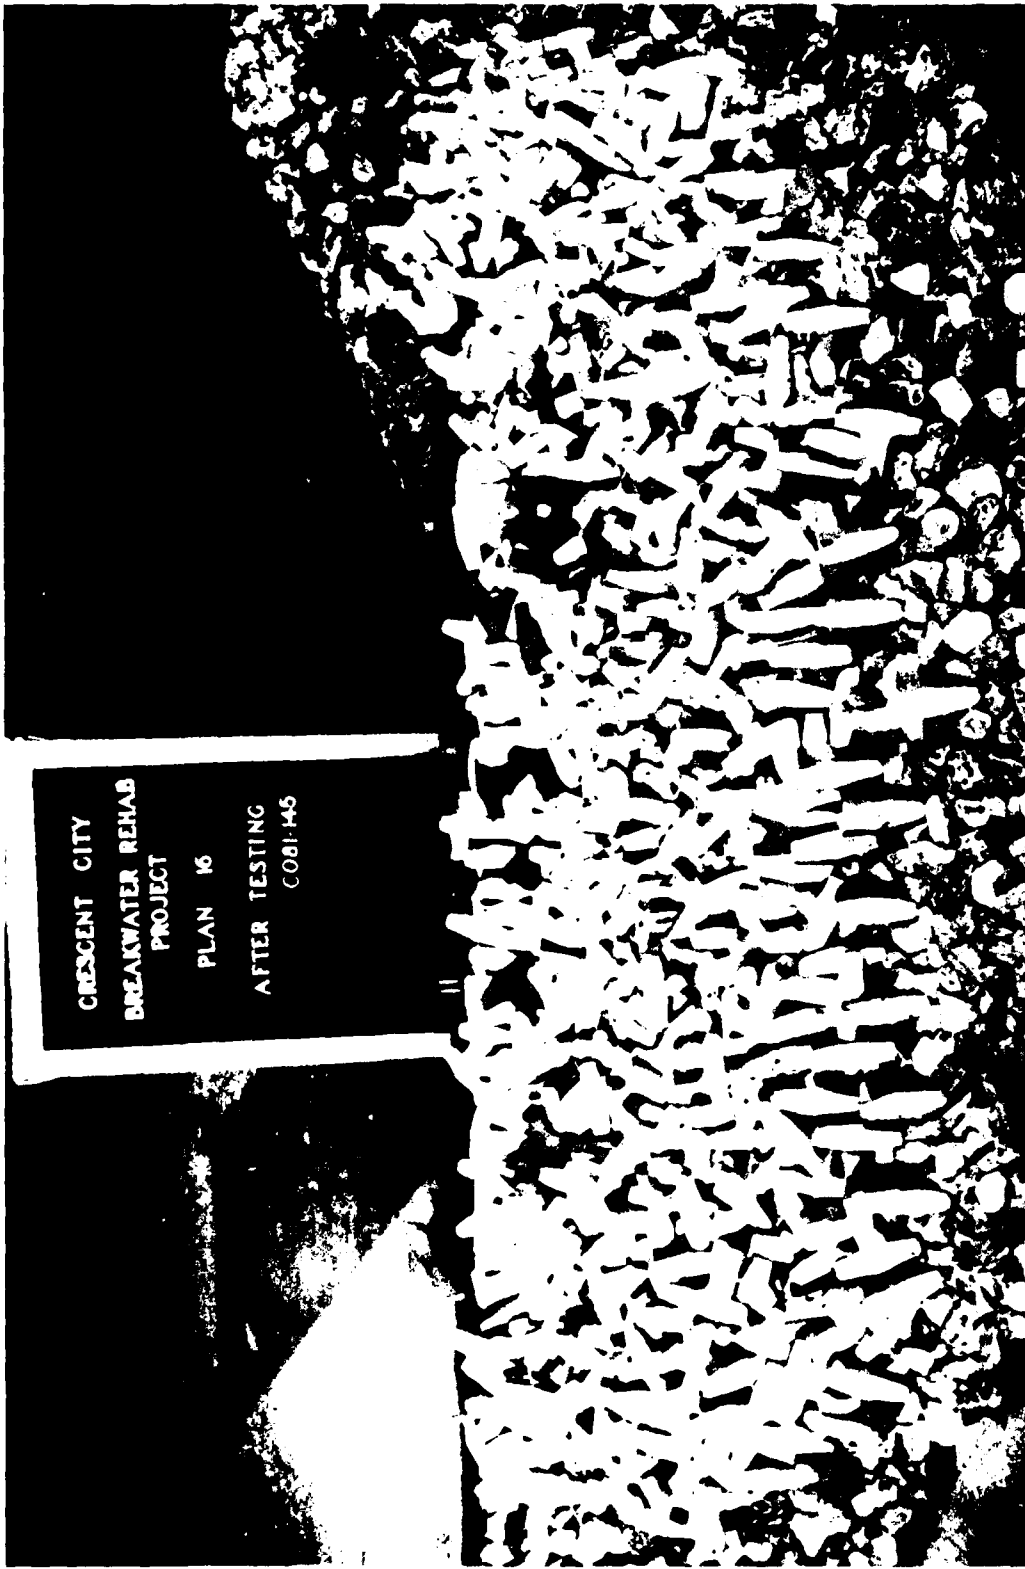
Photo 126. Sea-side view of Plan 16 after completion of abbreviated hydrograph

except the area of coverage was increased. The waves tended to break on the structure and then rush out the dogleg, and it was hoped additional units in this area would dissipate enough of the wave energy to protect the toe units in the seaward transition area of the elbow. A total of 406 42-ton rehabilitation dolosse were used. Damage of the seaward transition was still unacceptable. Photos 126-128 show the structure after testing.

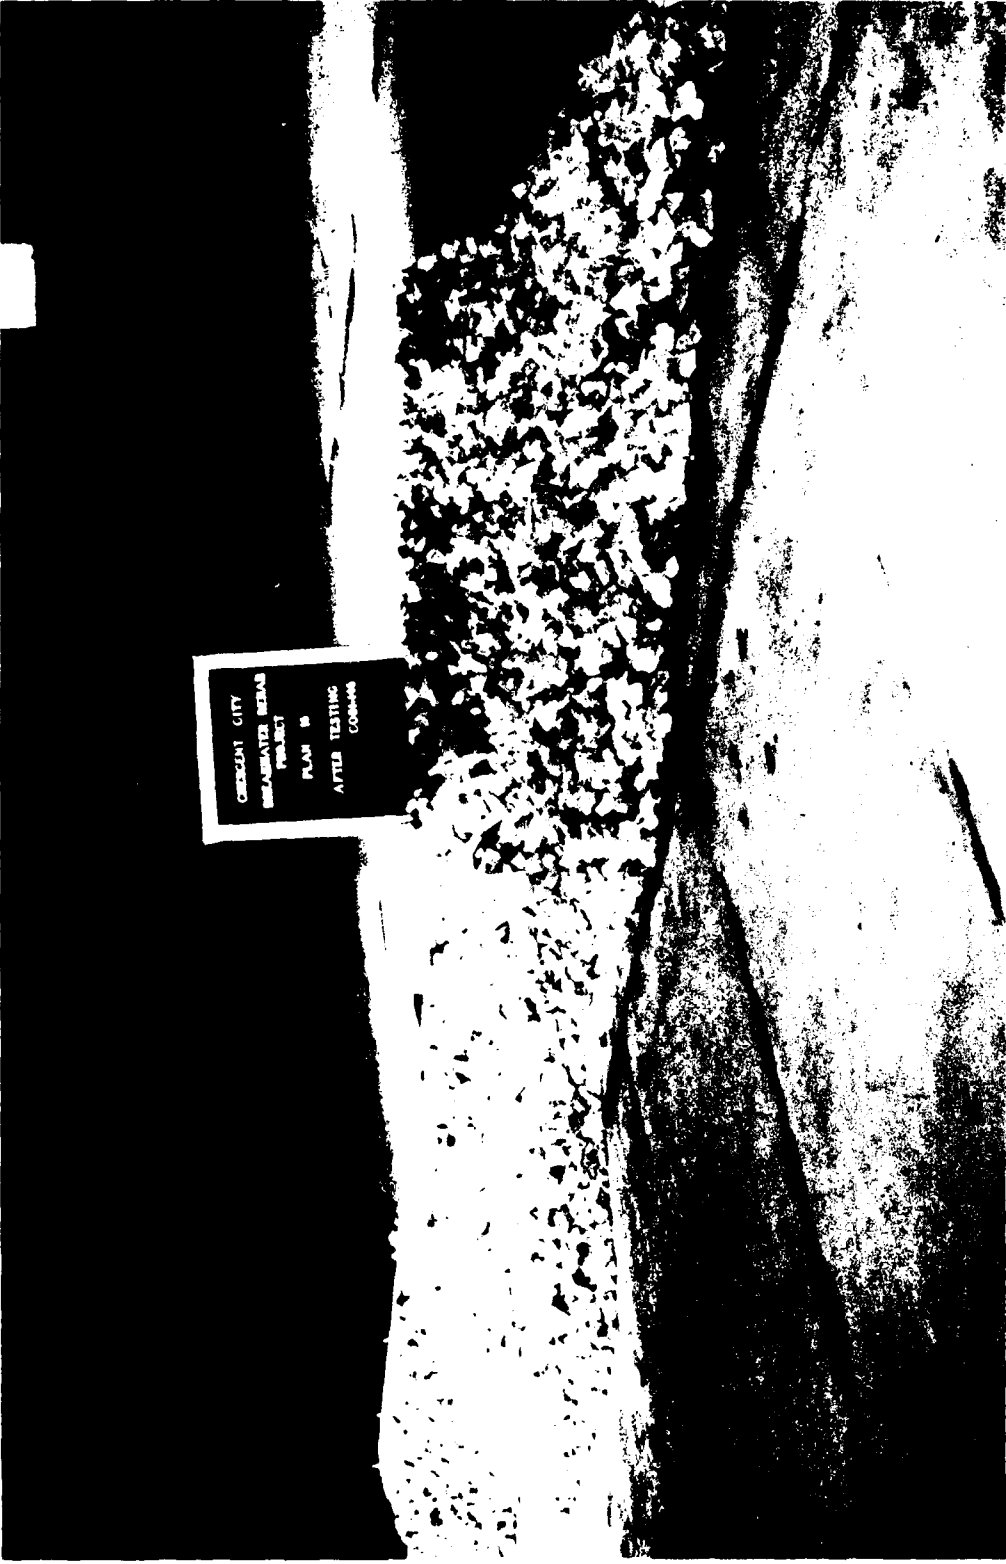
Photo 127. Seaward oblique view of Plan 16 after completion of abbreviated hydrograph

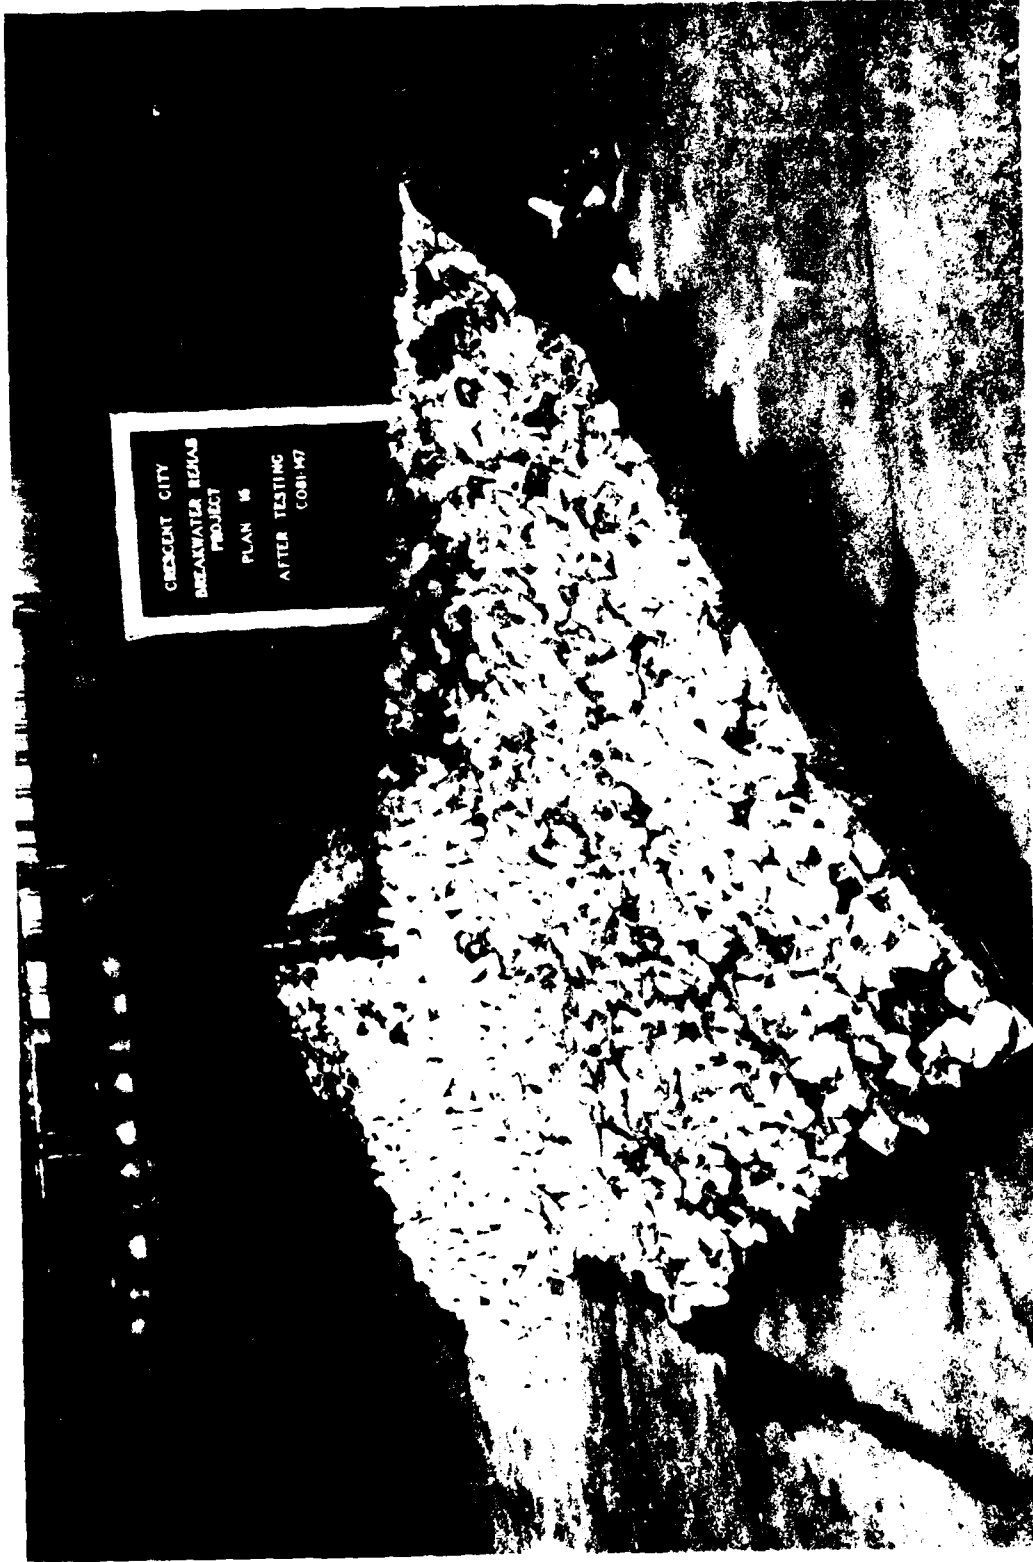
Photo 128. Seaward end view of Plan 16 after completion of abbreviated hydrograph

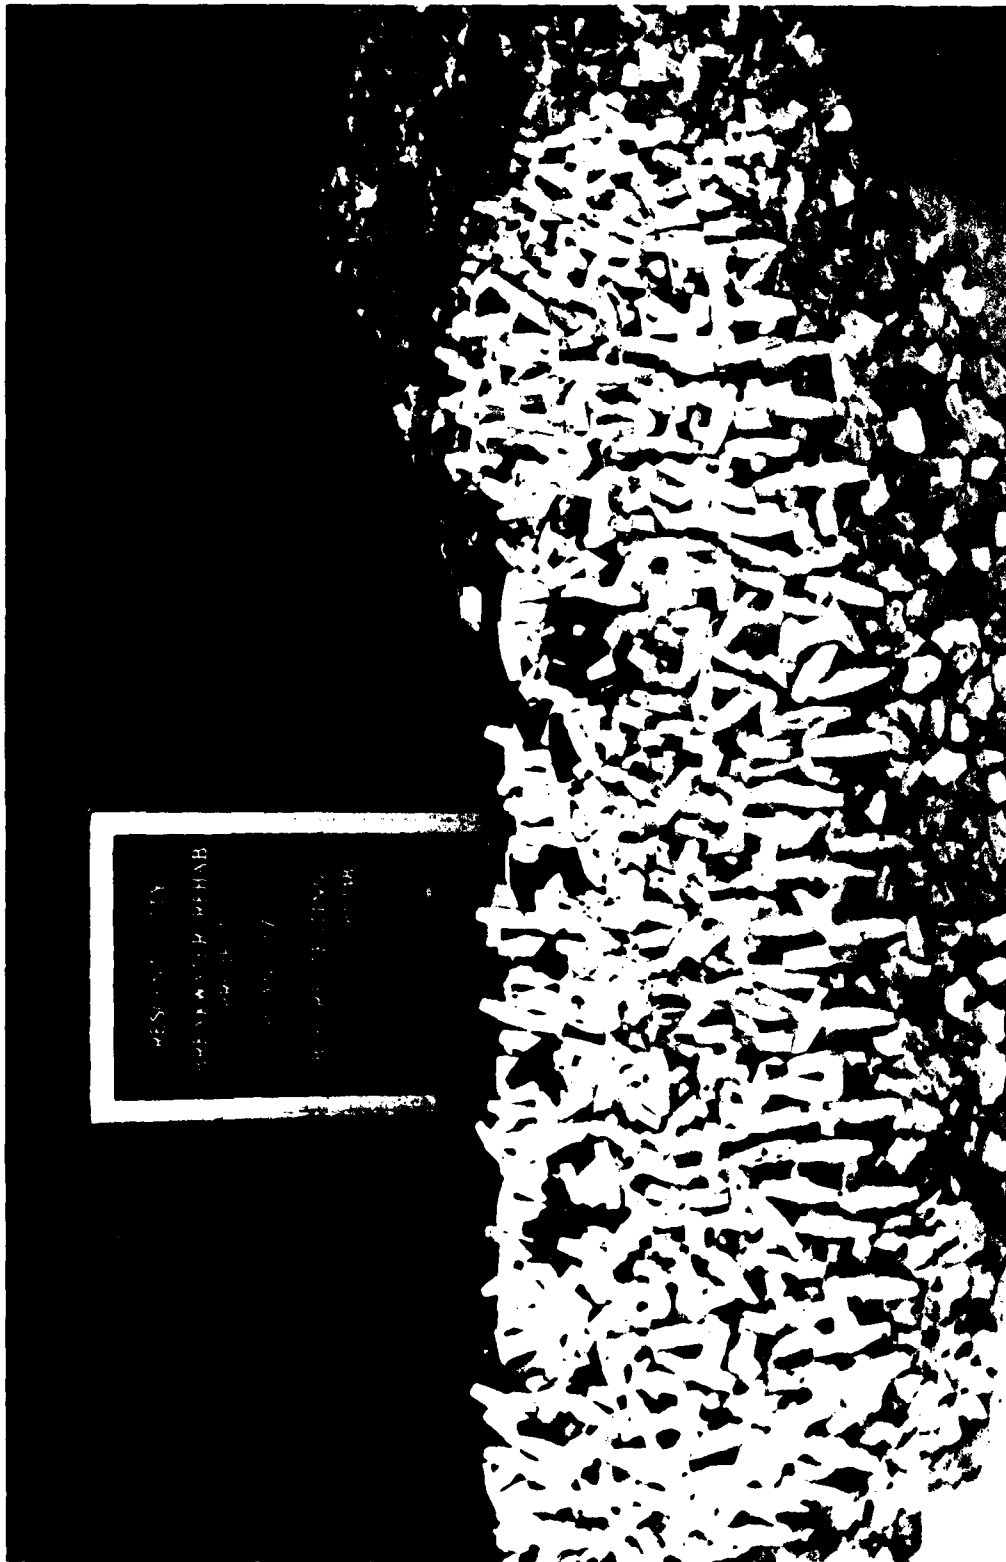
Photo 129. Sea-side view of Plan 17 before wave attack

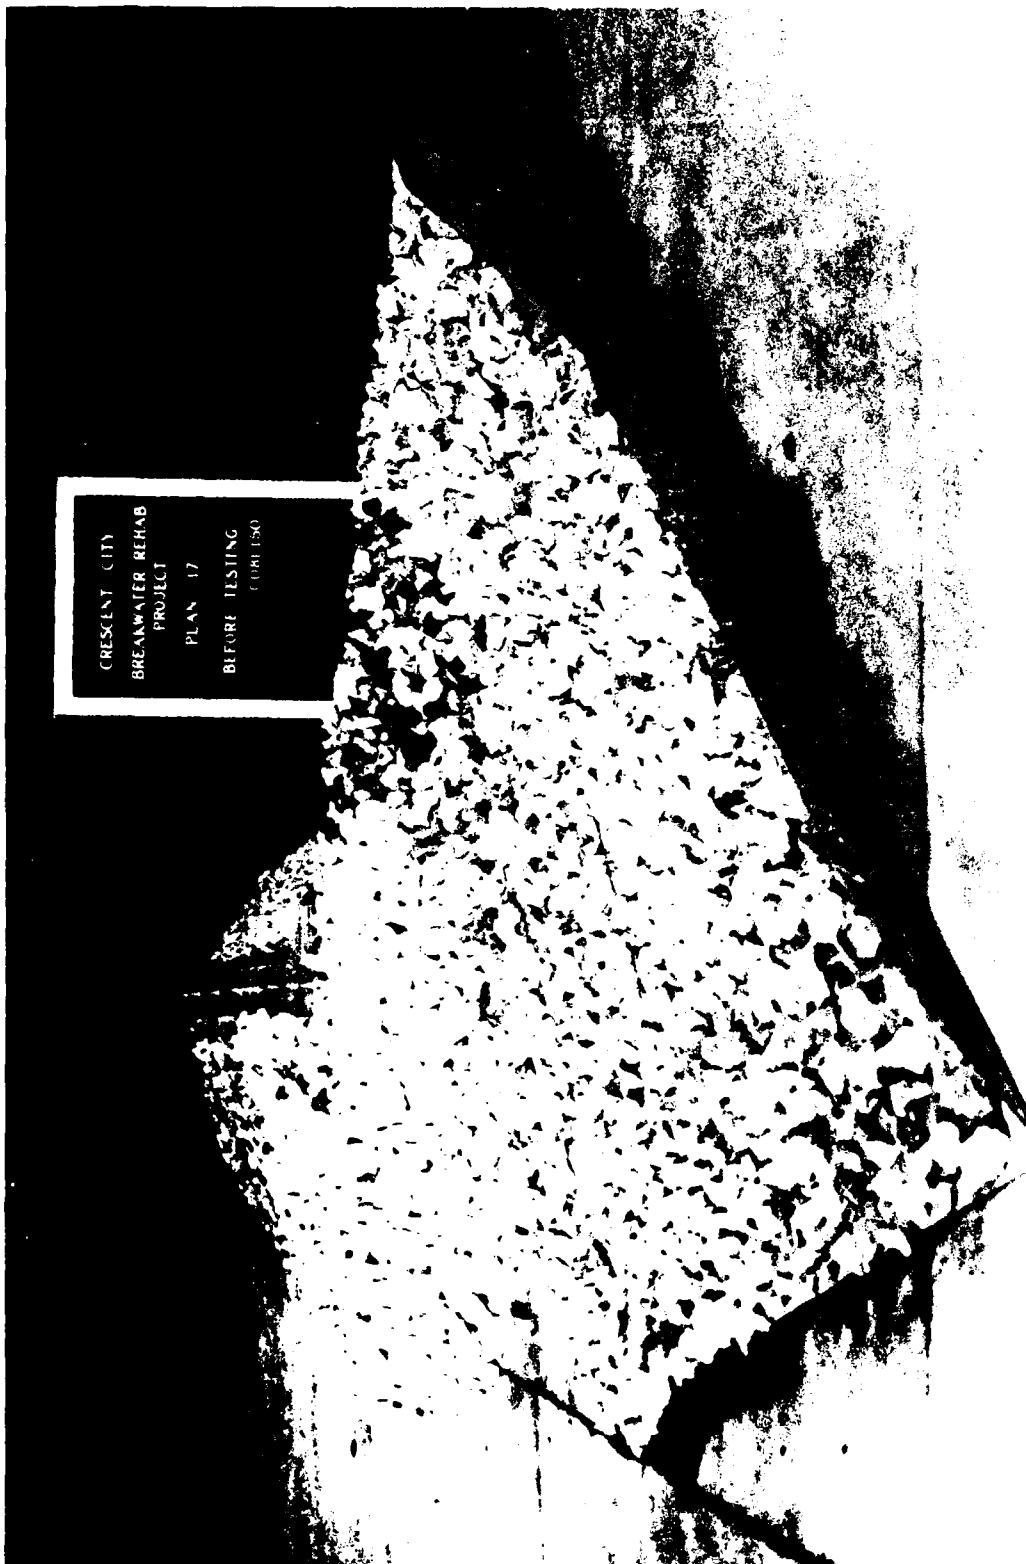
Photo 131. Seaward end view of Plan 17 before wave attack

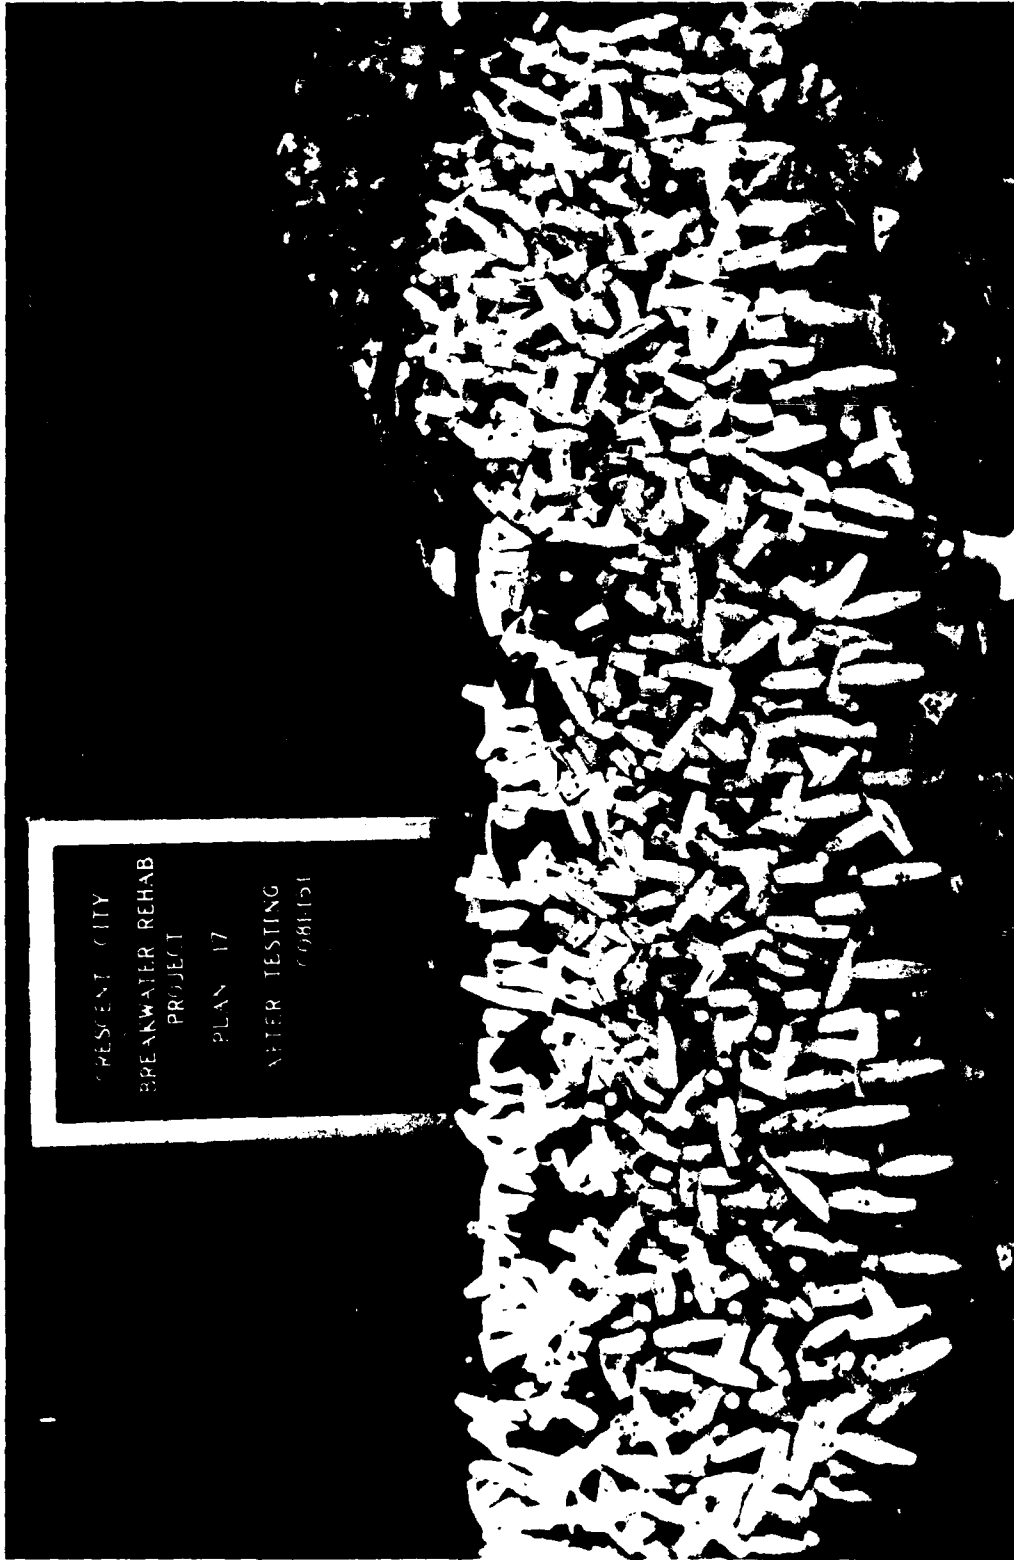
Photo 132. Sea-side view of Plan 17 after completion of abbreviated hydrograph

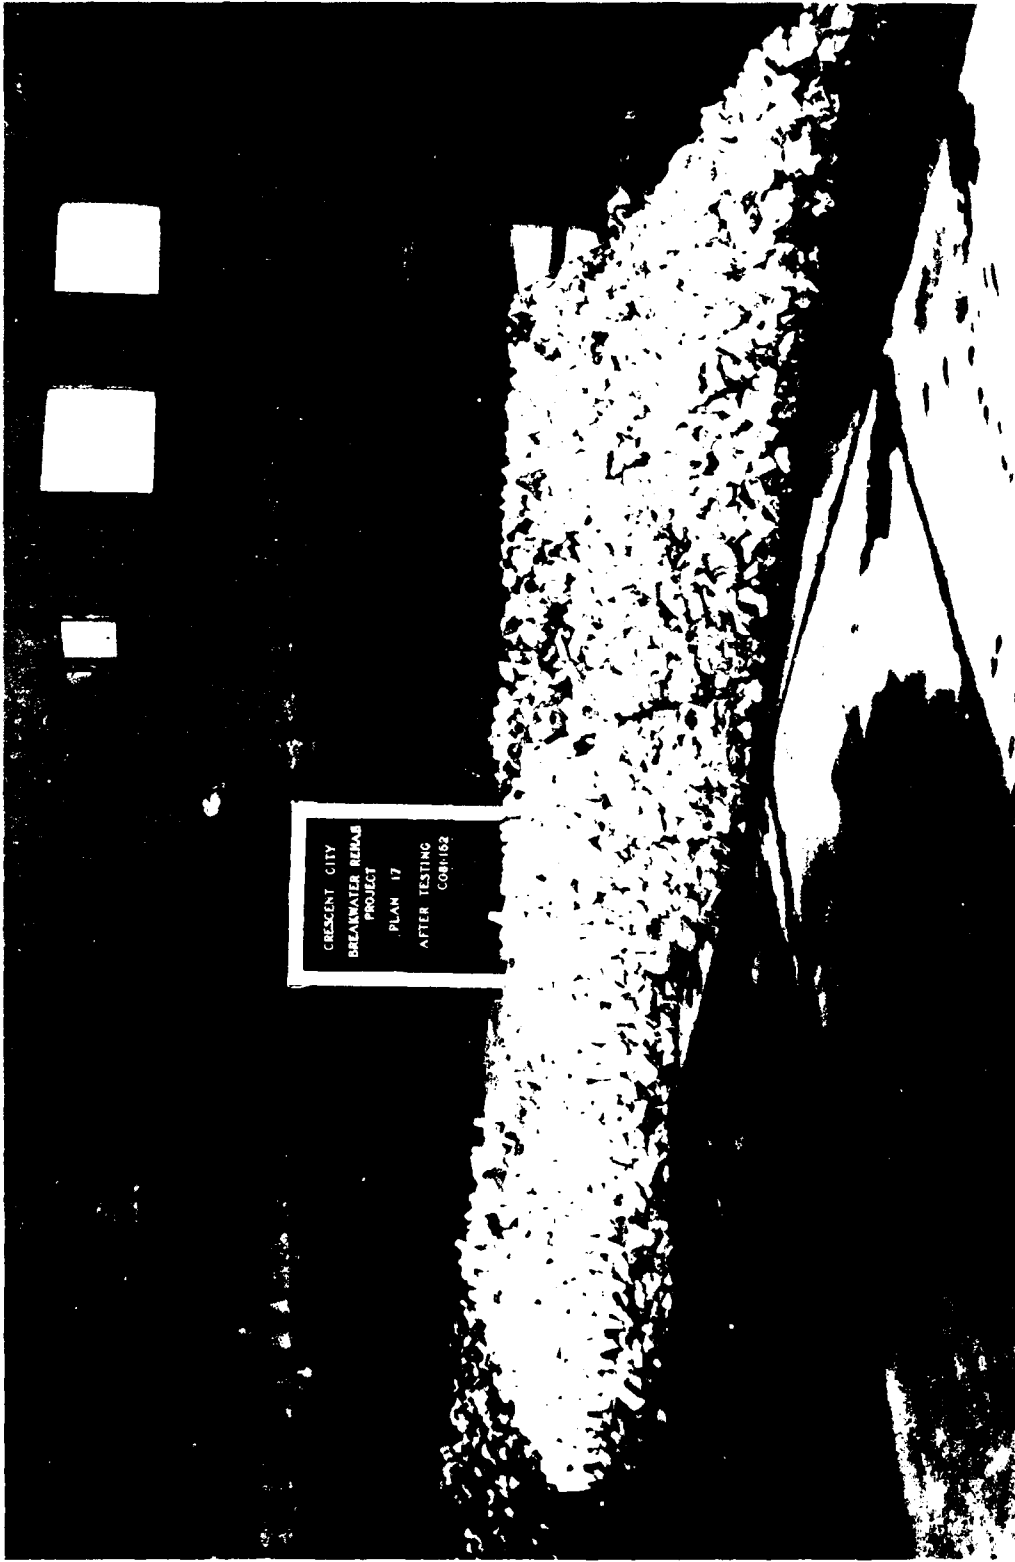
Photo 133. Seaward oblique view of Plan 17 after completion of abbreviated hydrograph

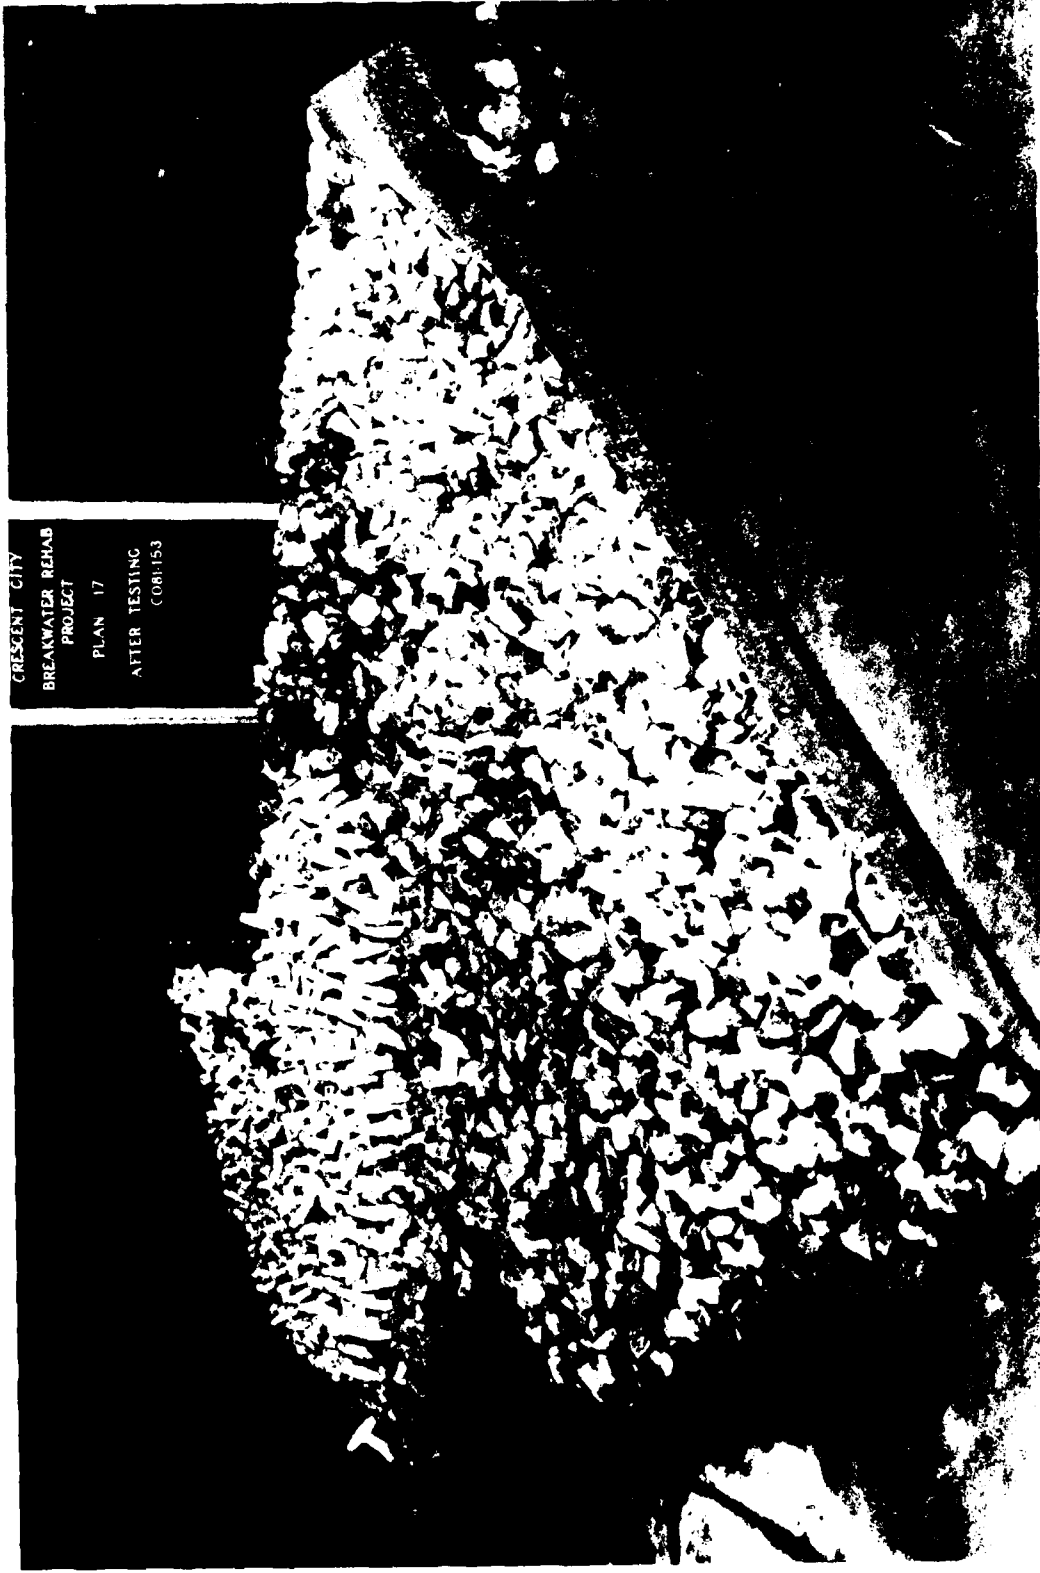
Photo 134. Seaward end view of Plan 17 after completion of abbreviated hydrograph

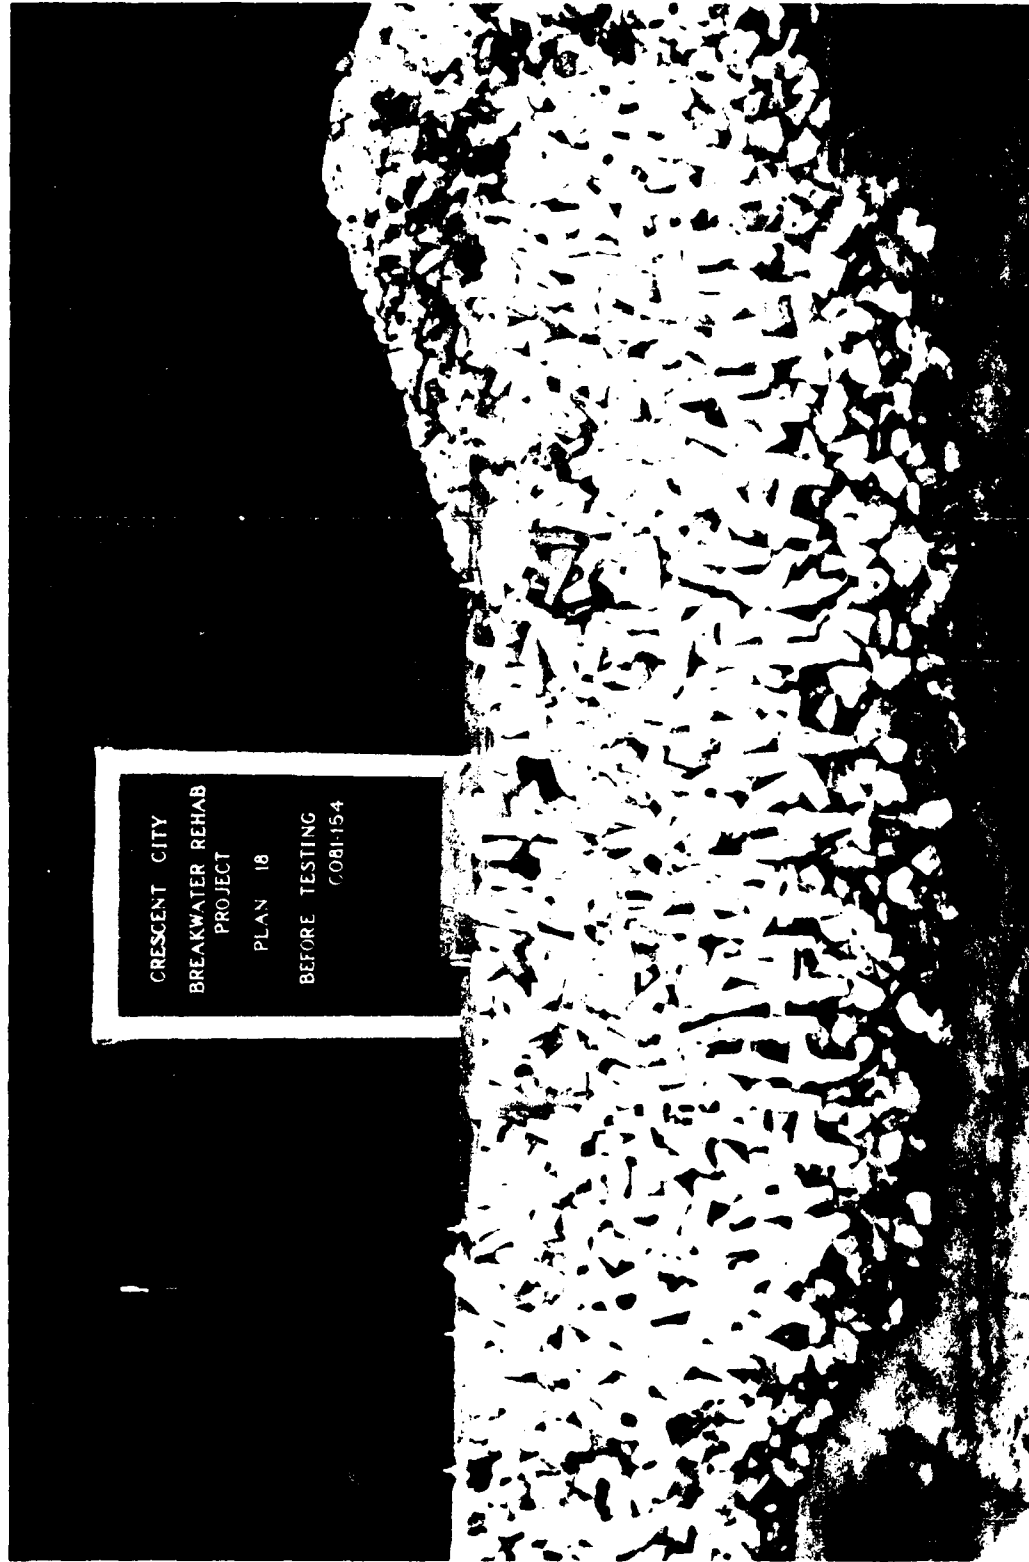
Photo 135. Sea-side view of Plan 18 before wave attack

48. Plan 18 (Plate 20 and Photos 135-137) was a refinement of Plan 17. The total number of 42-ton rehabilitation dolosse was reduced to 398 by removing units near the crown of the dogleg. Plan 18 performed satisfactorily for the abbreviated hydrograph; results are shown in Photos 138-140. The test section was rebuilt and again subjected to the abbreviated hydrograph. A total of 394 rehabilitation units were used and Photos 141-143 show the structure after the repeat test. The repeat test sustained more damage than the original, but the amount of movement was considered acceptable. Plan 18 was rebuilt and subjected to a full-length storm (Hydrograph A, Table 2). A total of 410 rehabilitation dolosse were placed. Plan 18 performed satisfactorily for the full-length storm. Photos 144-146 show the structure after testing. Concern arose as to the prototype constructability of the toe trench; therefore, it was decided to develop alternative plans.

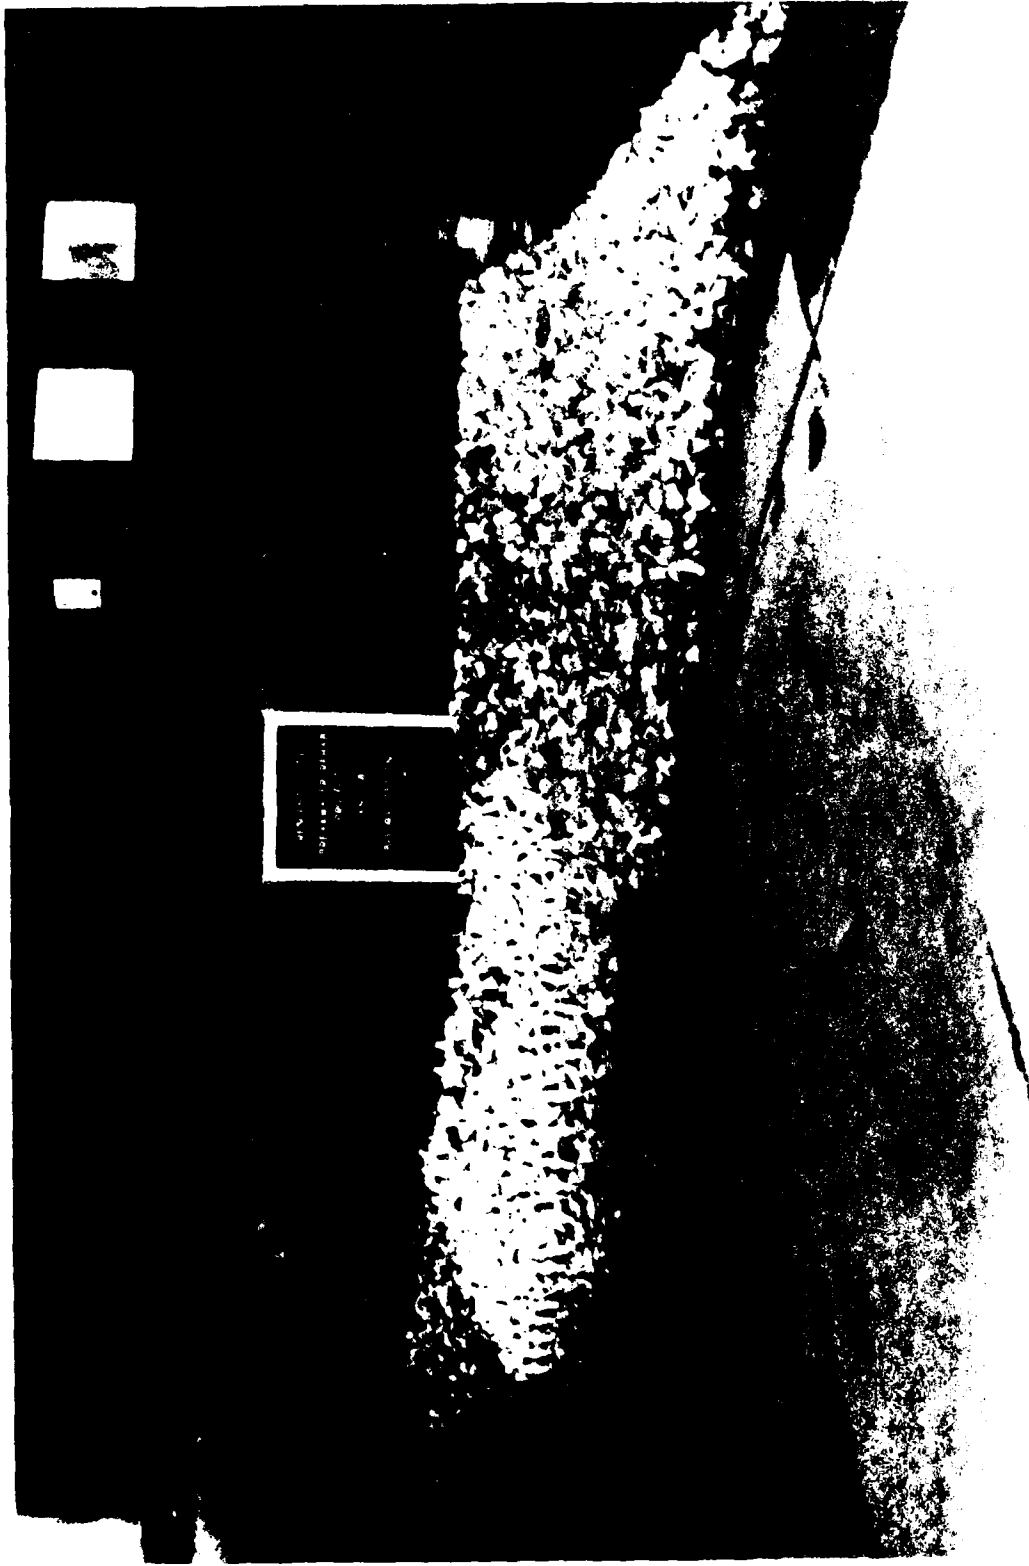
Photo 136. Seaward oblique view of Plan 18 before wave attack

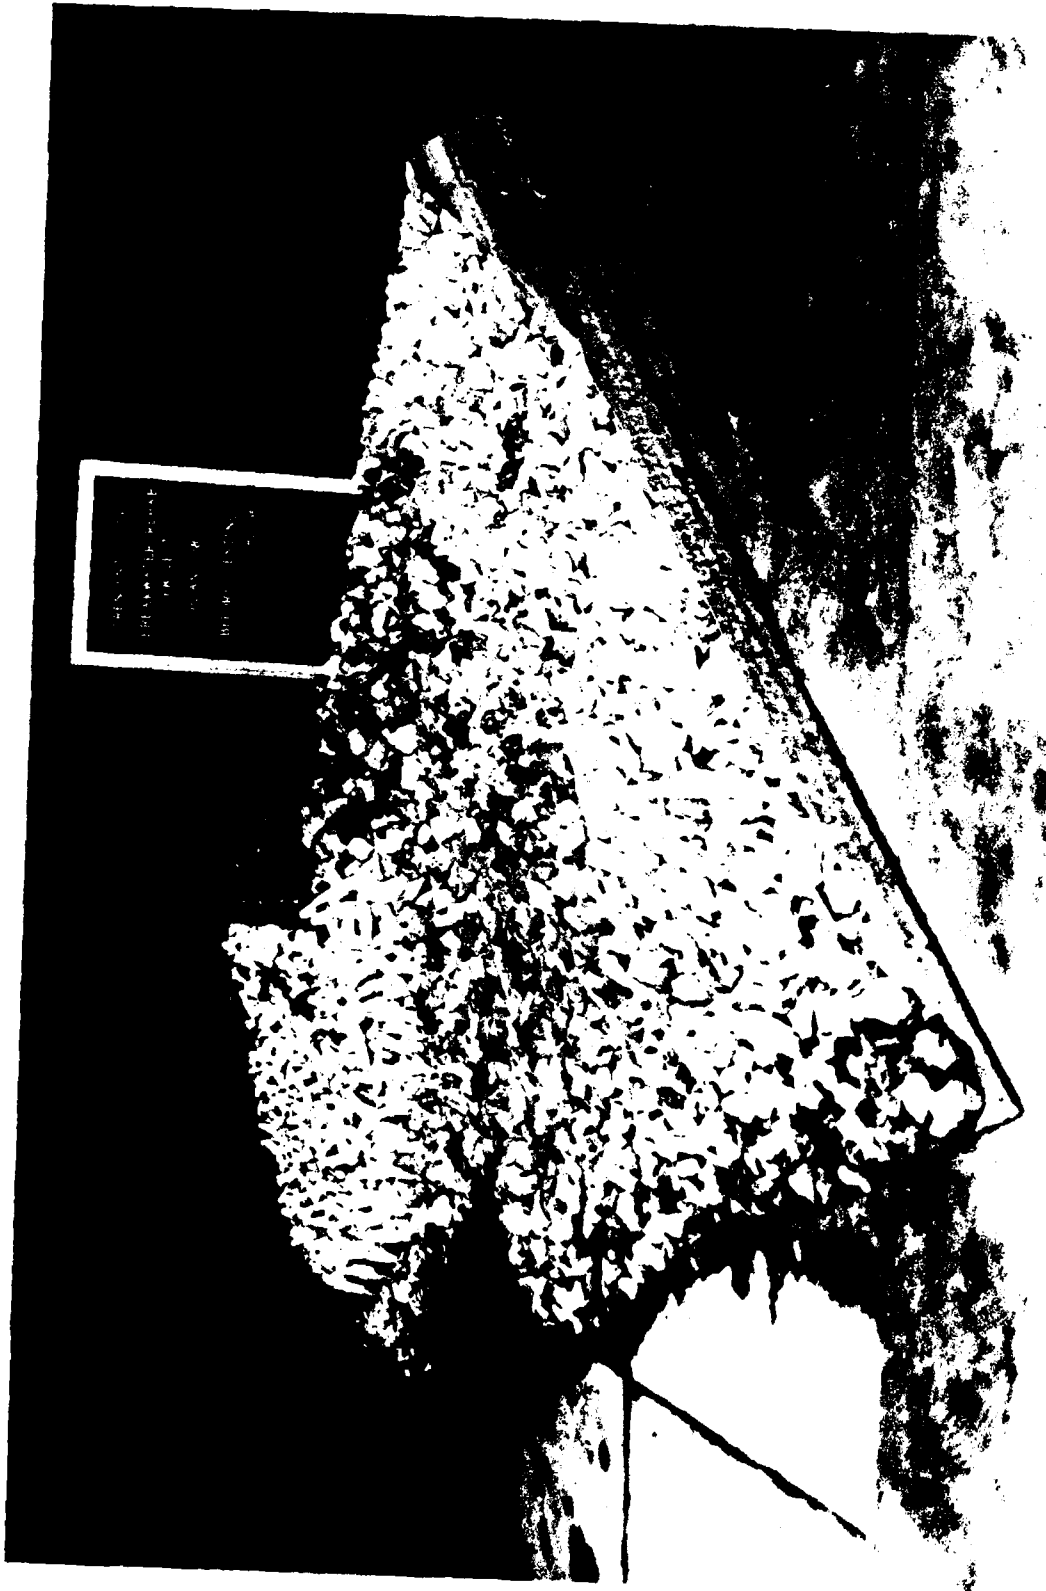
Photo 137. Seaward end view of Plan 18 before wave attack

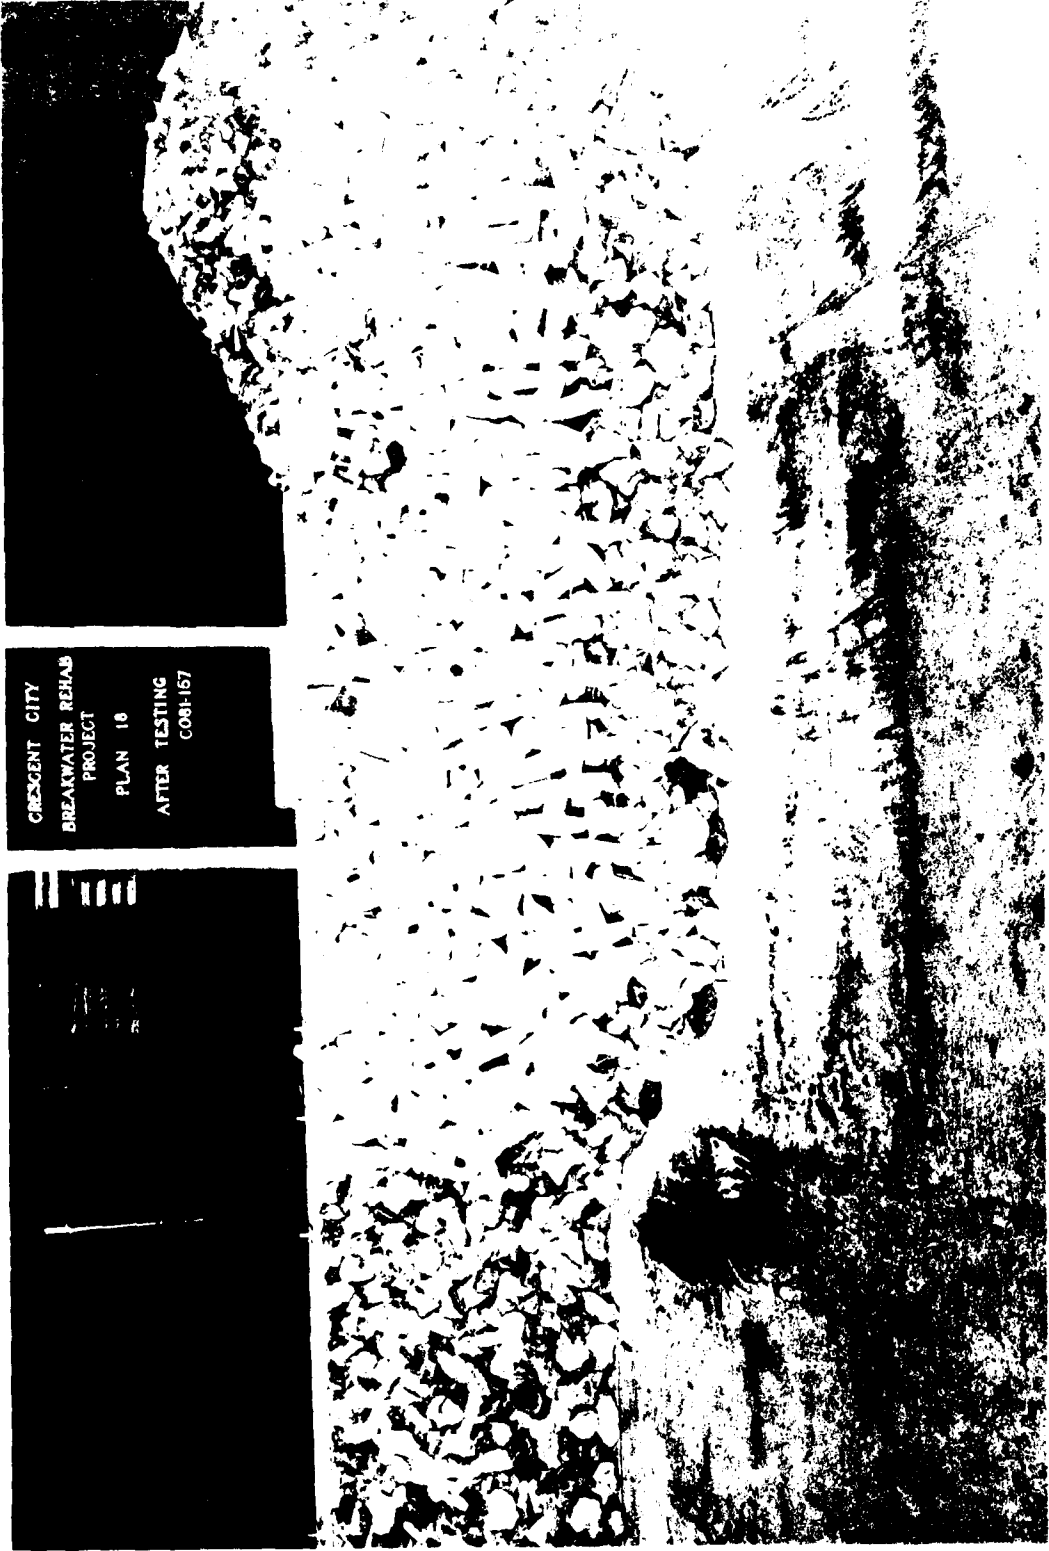
Photo 138. Sea-side view of Plan 18 after completion of abbreviated hydrograph

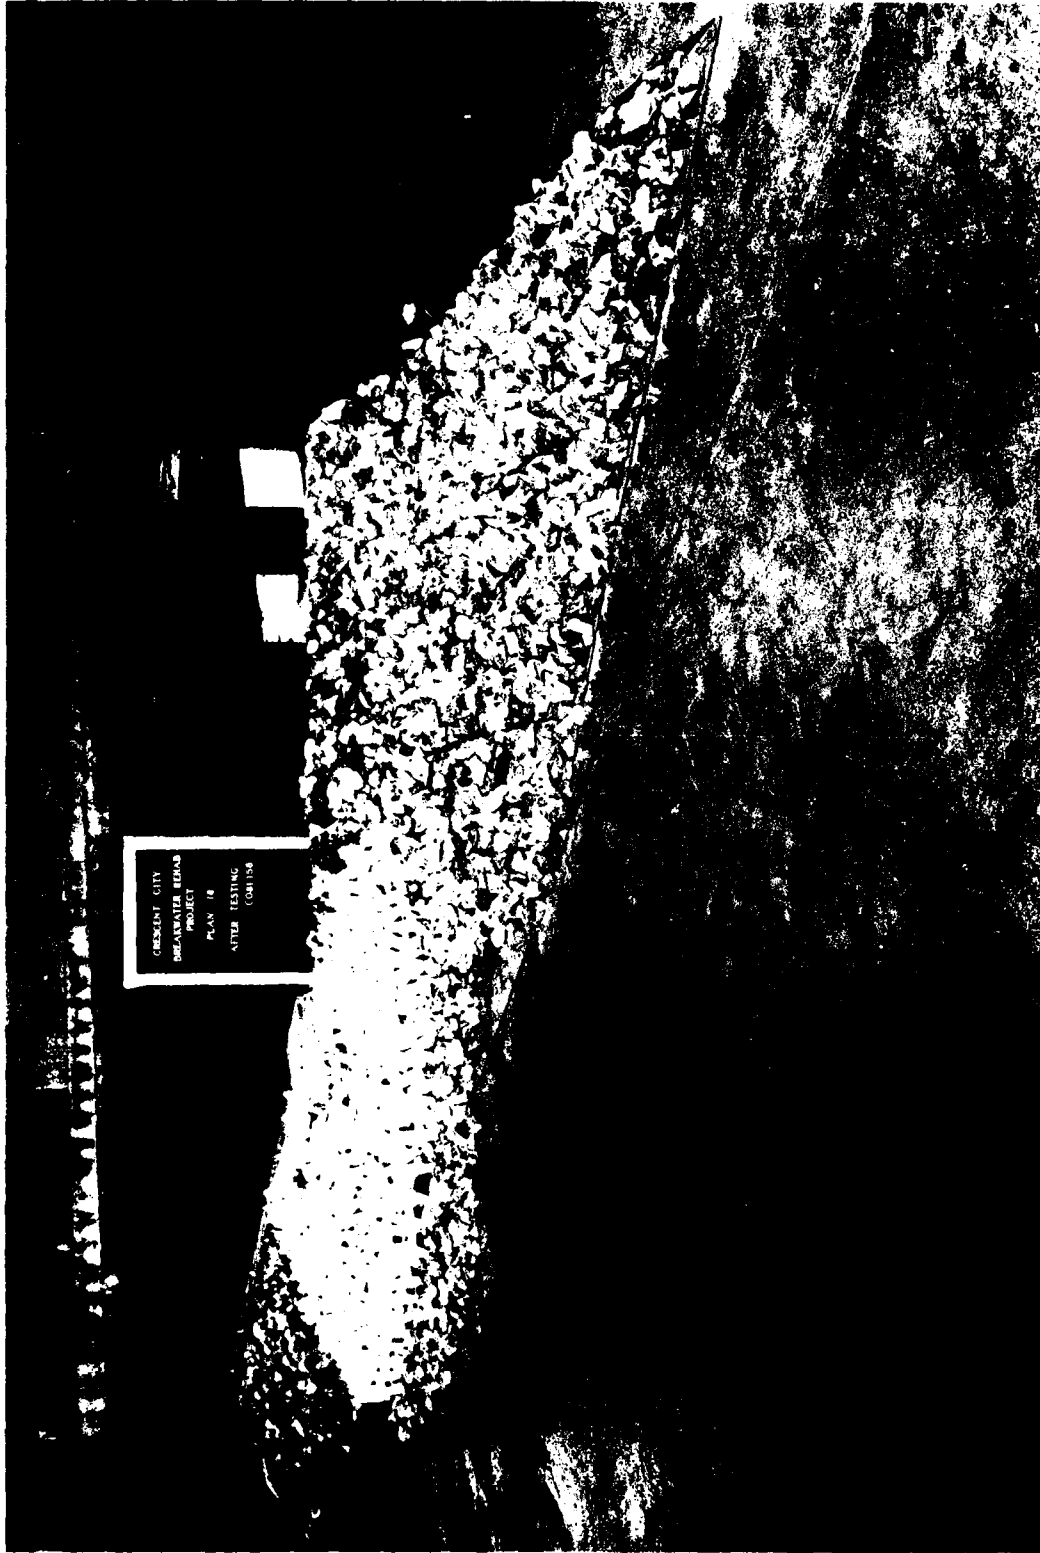
Photo 139. Seaward oblique view of Plan 18 after completion of abbreviated hydrograph

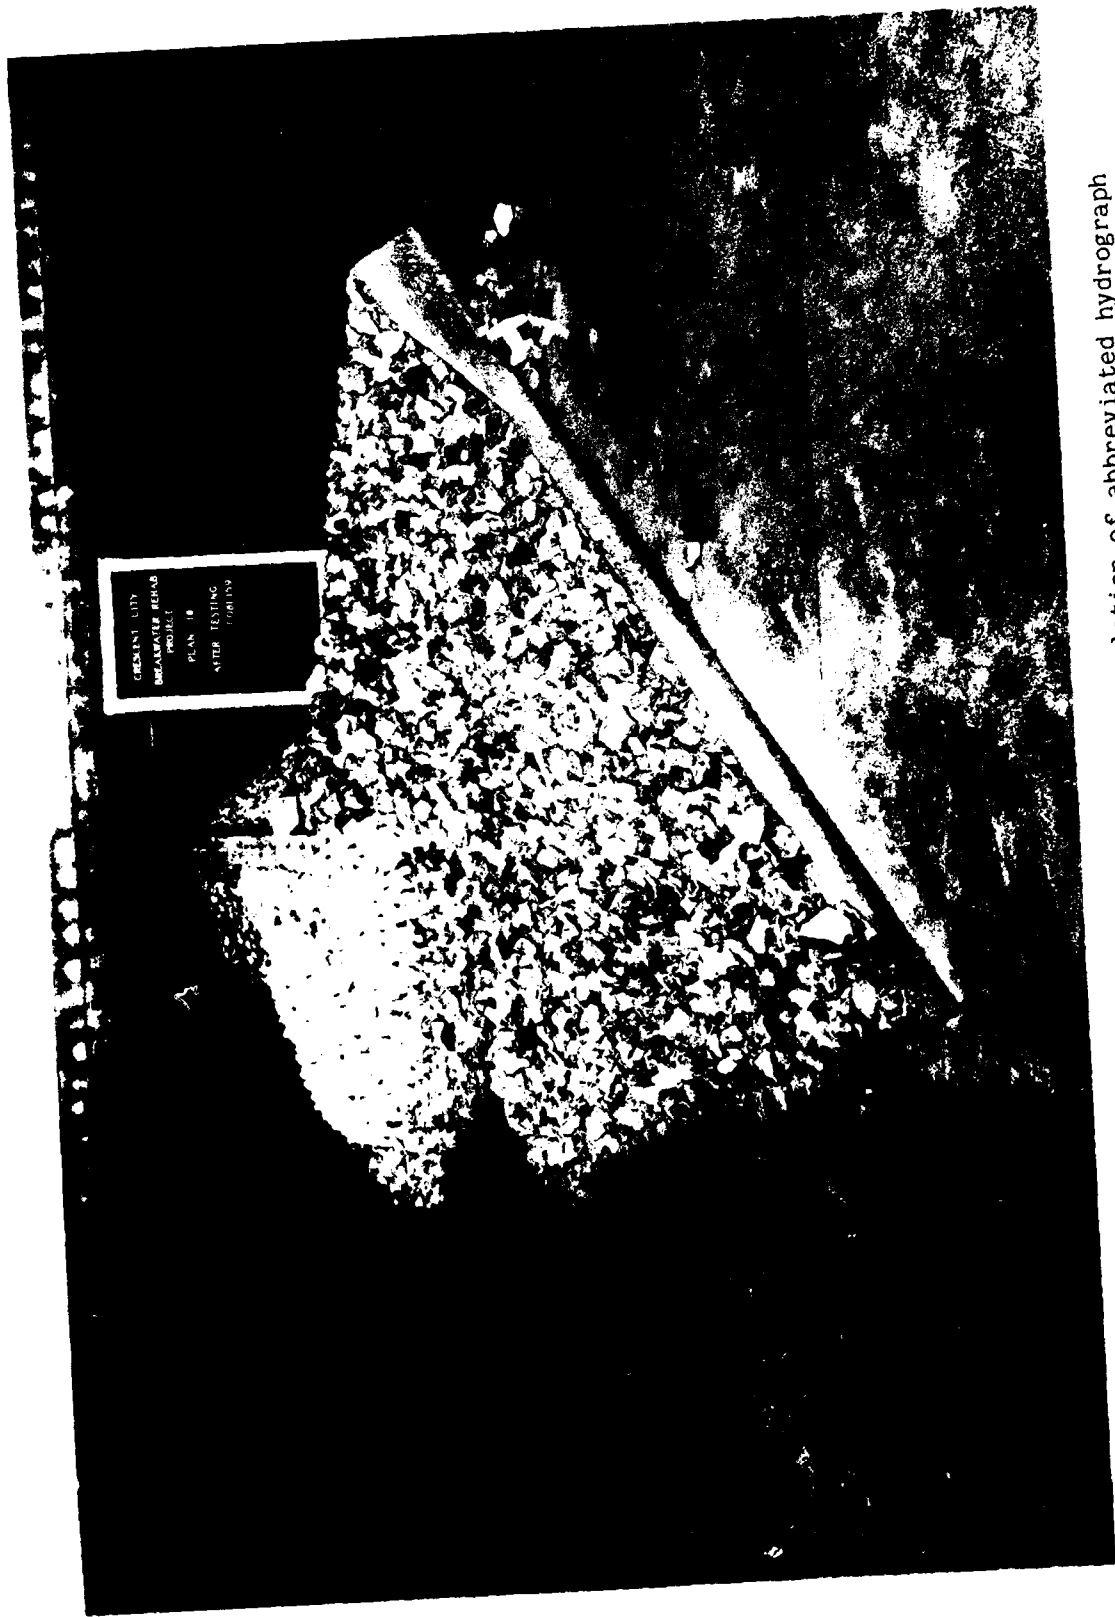
Photo 140. Seaward end view of Plan 18 after completion of abbreviated hydrograph
