TECHNICAL REPORT CERC-85-8

# BREAKWATER REHABILITATION STUDY, CRESCENT CITY HARBOR, CALIFORNIA

## Coastal Model Investigation

November 1985

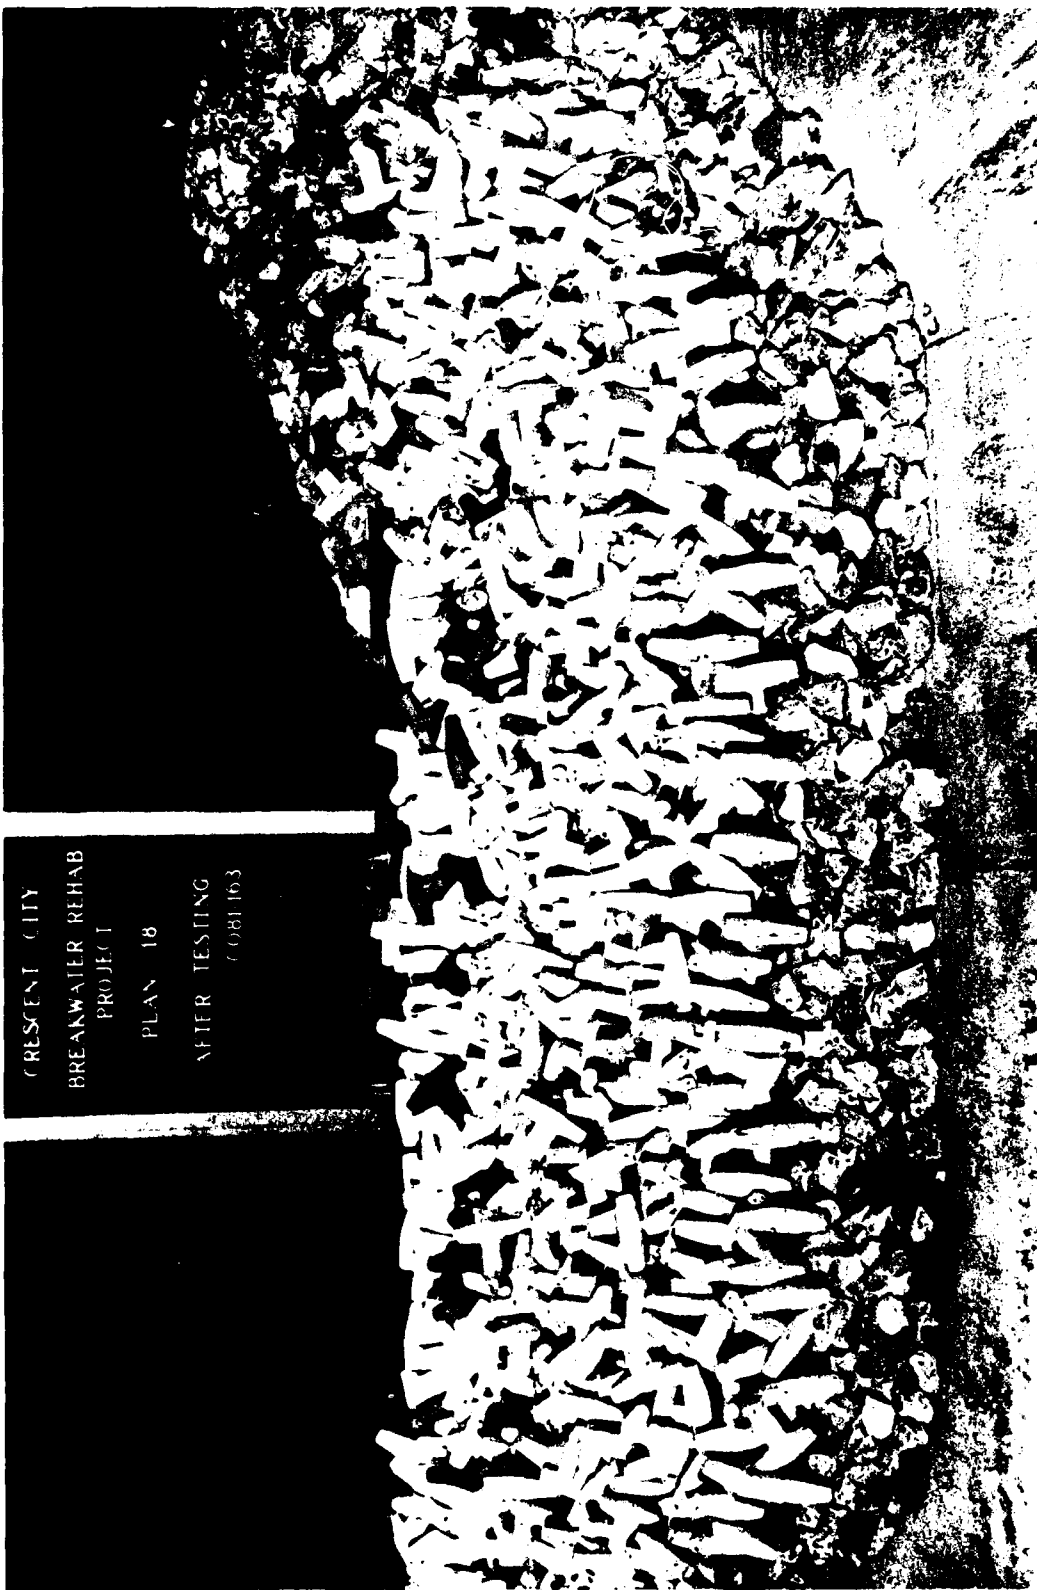
Photo 141. Sea-side view of Plan 18 repeat after completion of abbreviated hydrograph

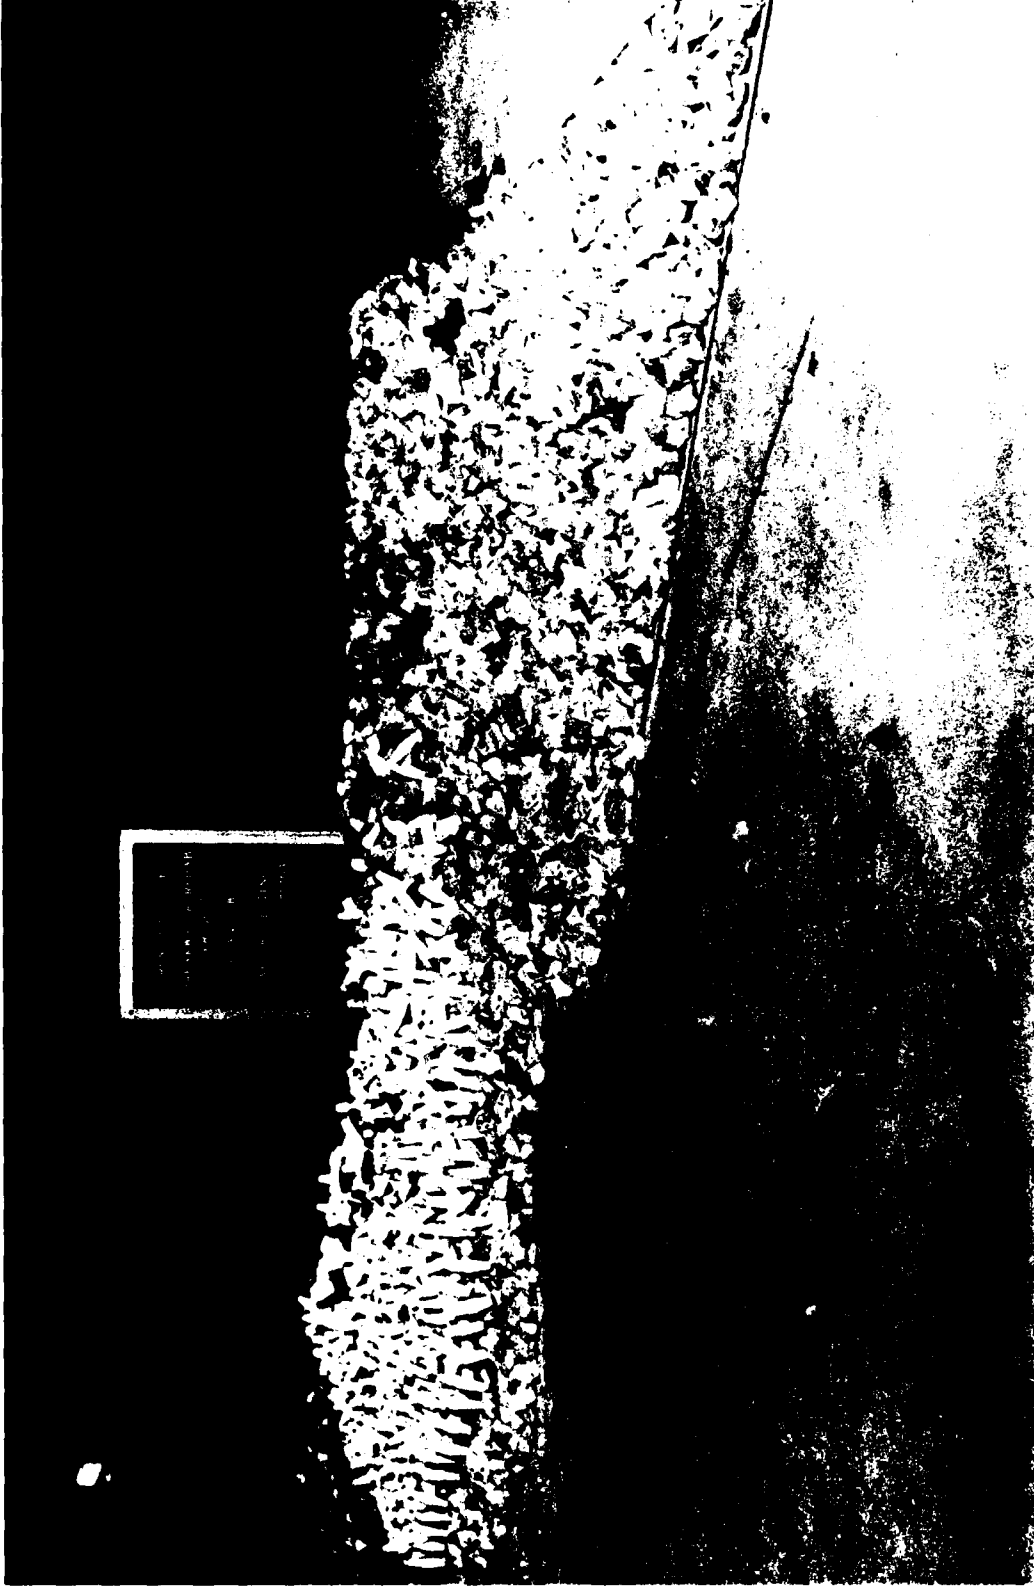
Photo 142. Seaward oblique view of Plan 18 repeat after completion of abbreviated hydrograph

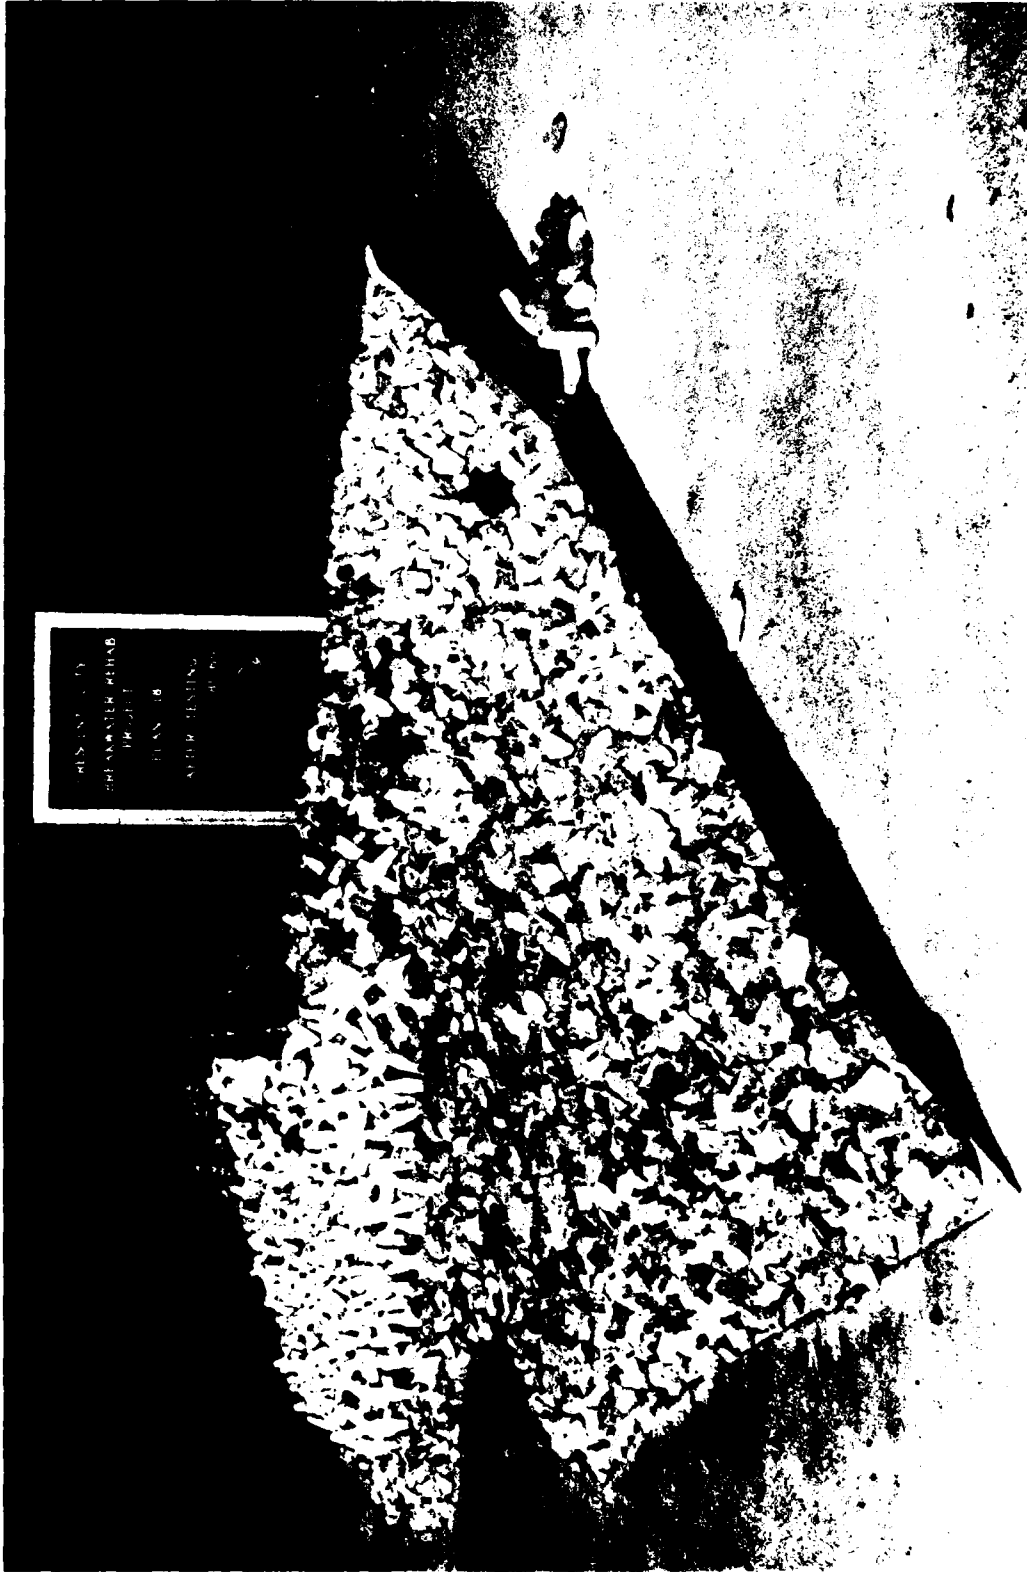
Photo 143. Seaward end view of Plan 18 repeat after completion of abbreviated hydrograph

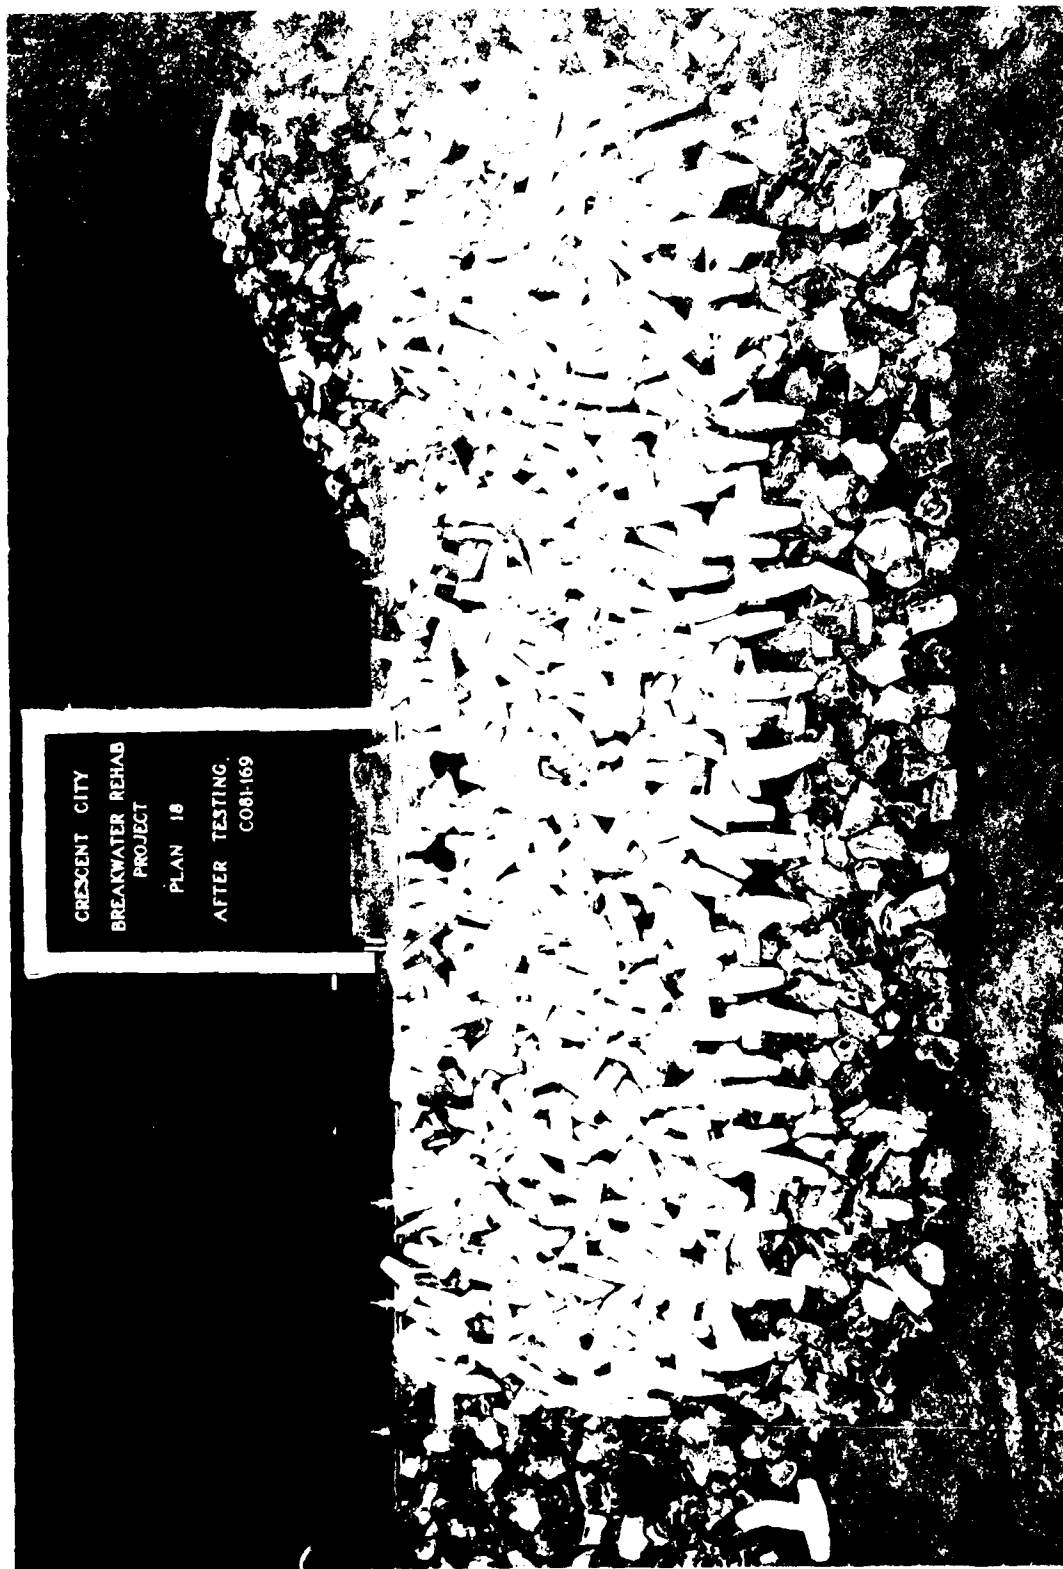
Photo 144. Sea-side view of Plan 18 after completion of Hydrograph A

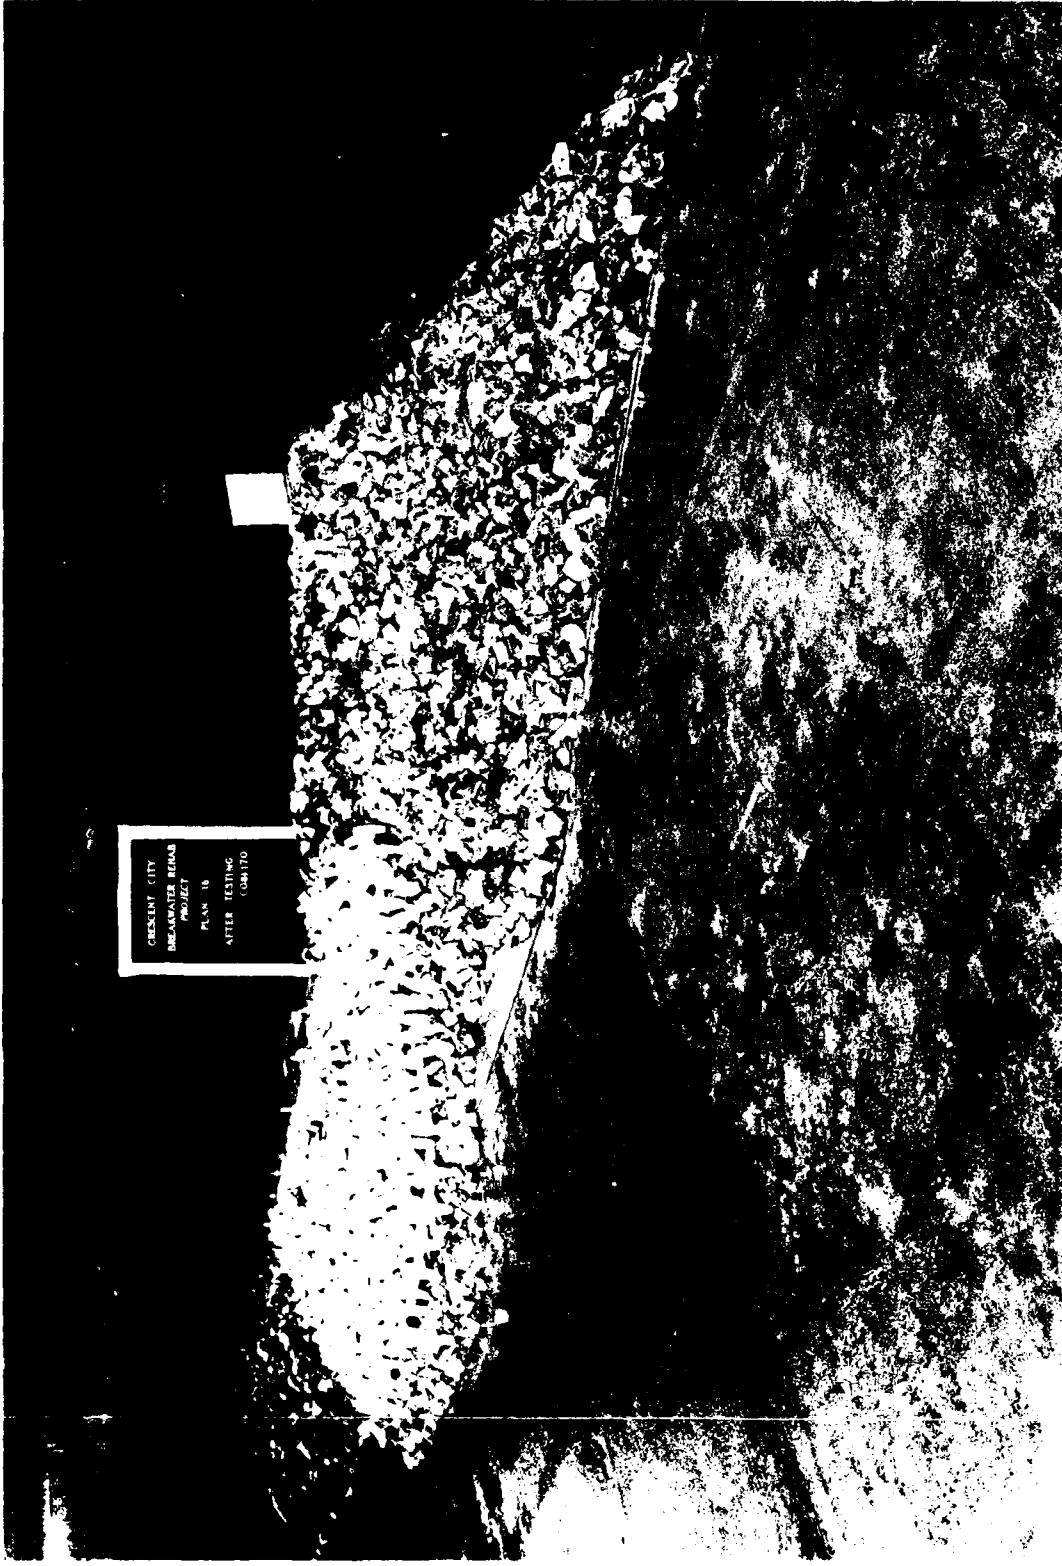
Photo 145. Seaward oblique view of Plan 18 after completion of Hydrograph A

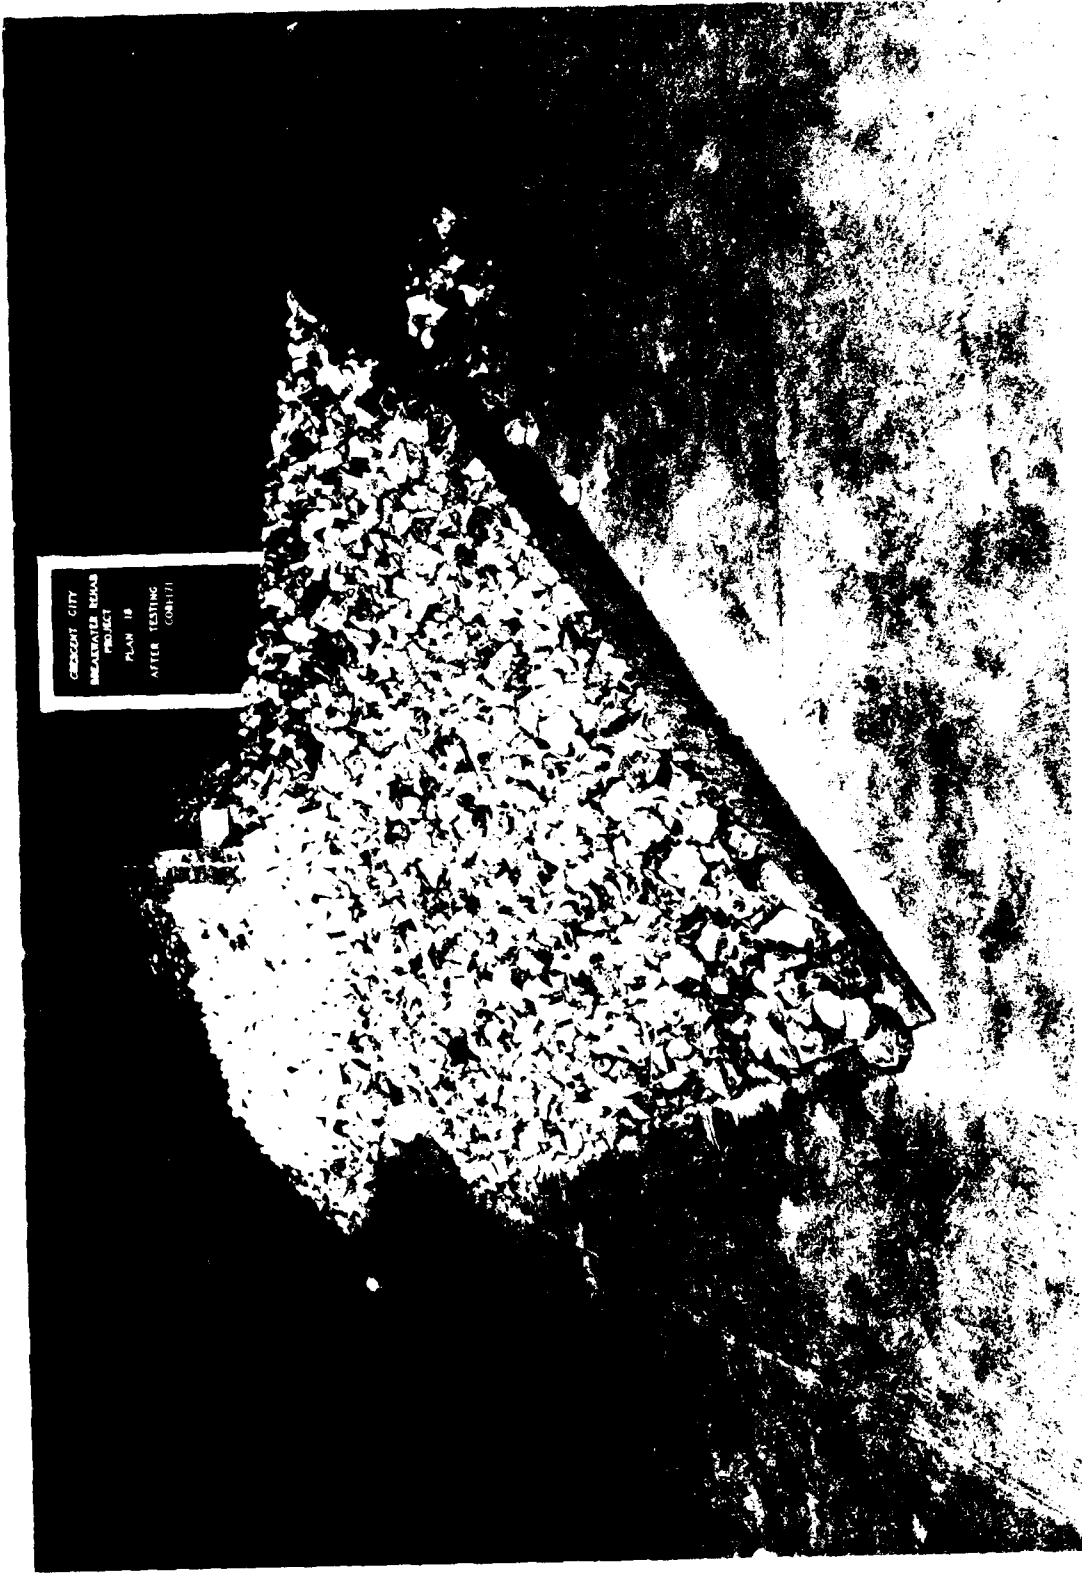
Photo 146. Seaward end view of Plan 18 after completion of Hydrograph A

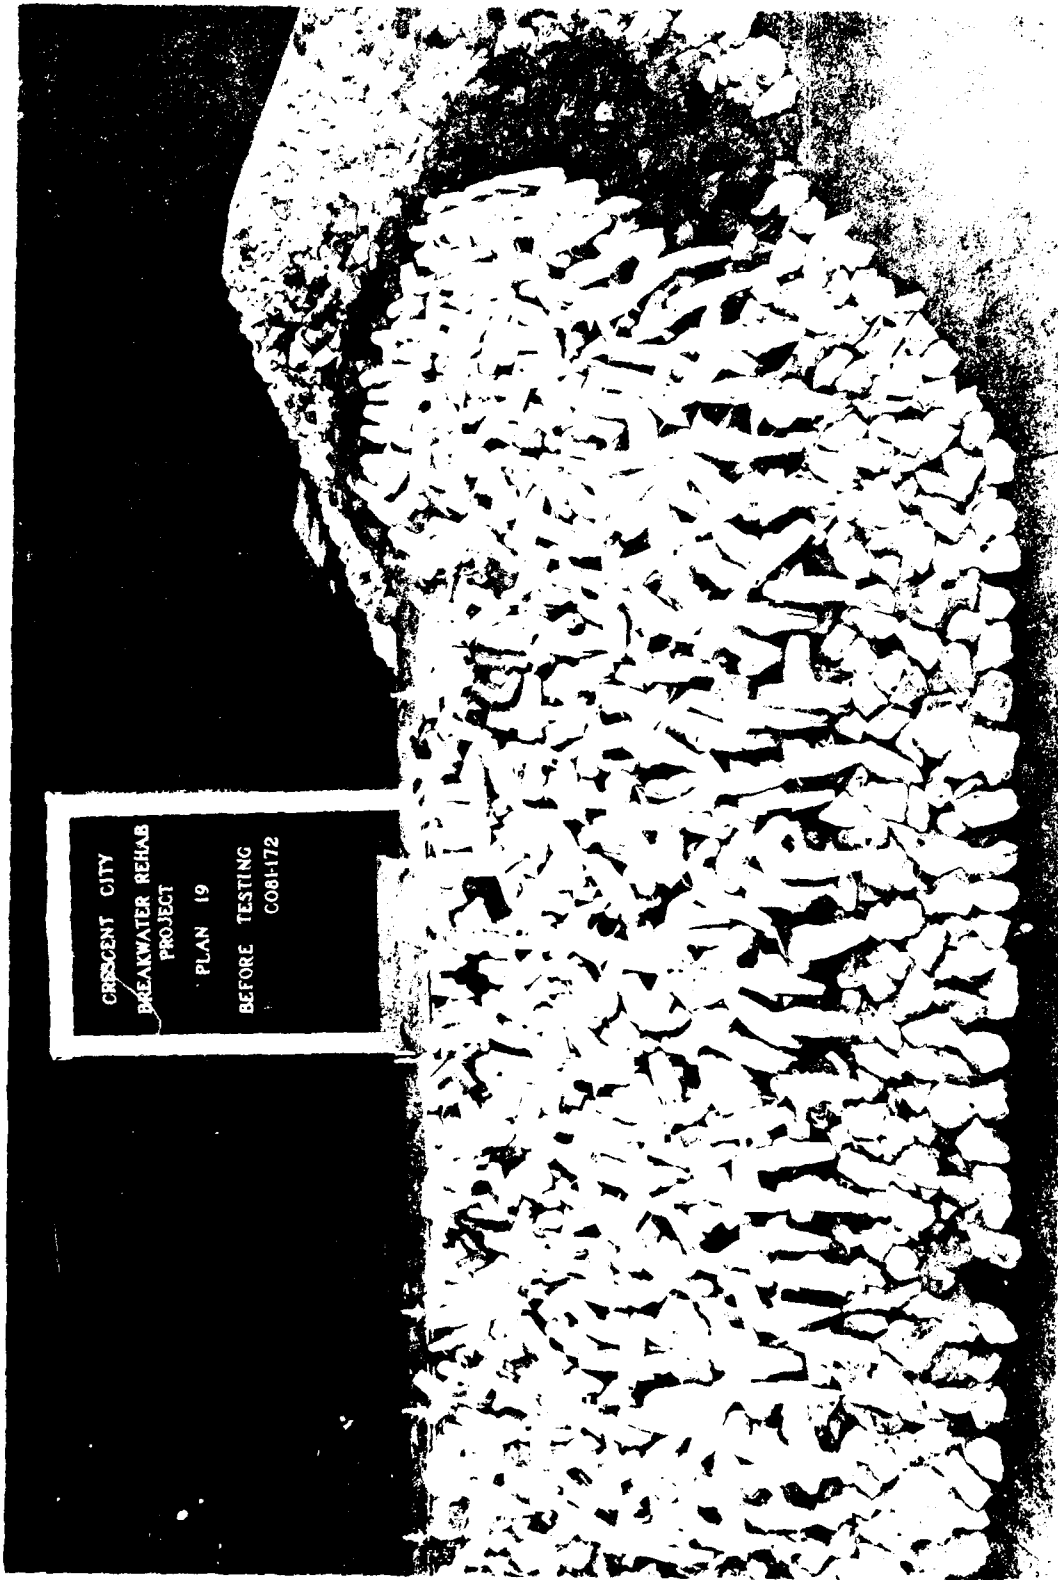
Photo 147. Sea-side view of Plan 19 before wave attack

49. Plan 19 (Plate 21 and Photos 147-149) was similar to Plan 18, except a rock buttress was placed around the outer perimeter of the seaward transition. Also three concrete blocks were added to represent remnants of the deteriorated cap of the old breakwater extension. No trenching was used for this plan, and special placement was used for the dolos toe units. The rock buttress was placed before the rehabilitation dolosse and consisted of 25-ton armor stone two layers deep and approximately 35 ft wide. The total number of armor stones added was 188; assuming a specific weight of 170 pcf and a porosity factor of 0.63, the total weight of stone used was 4,700 tons with a volume of approximately 3,250 cu yd. A total of 408 42-ton rehabilitation dolosse were used. Plan 19 was subjected to the abbreviated hydrograph. The rock buttress sloughed off in the lower region of the seaward transition and was undamaged near the crown of the dogleg where the stone was protected

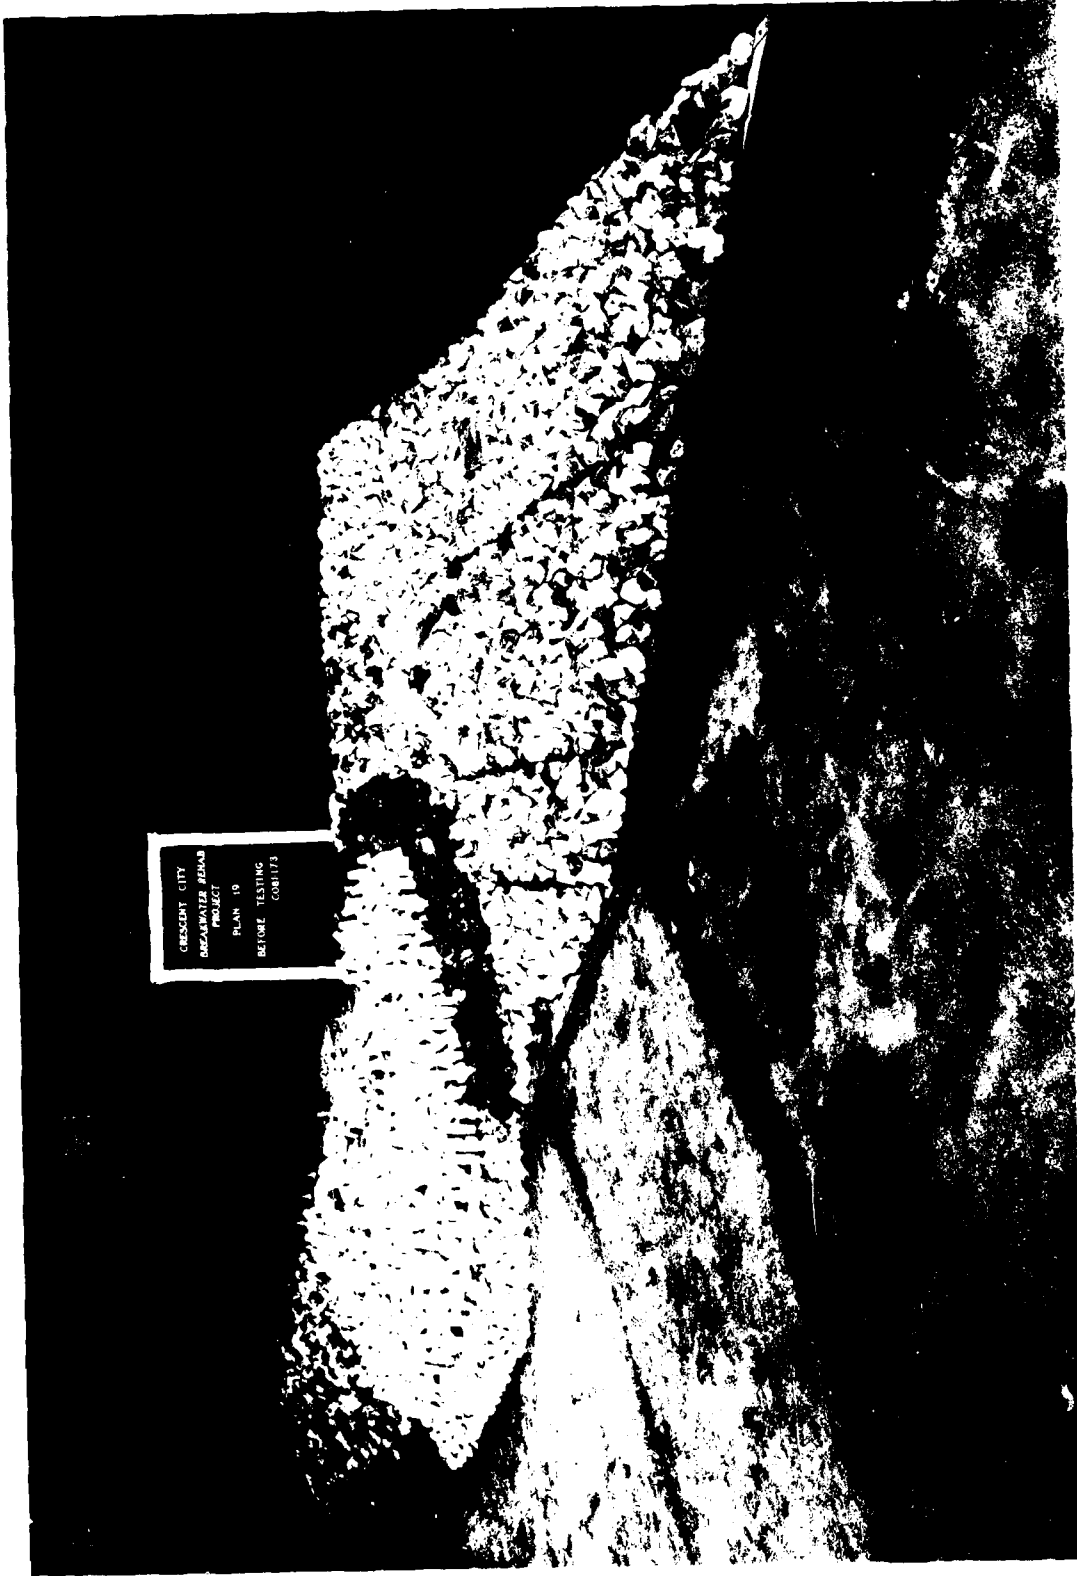
Photo 148. Seaward oblique view of Plan 19 before wave attack

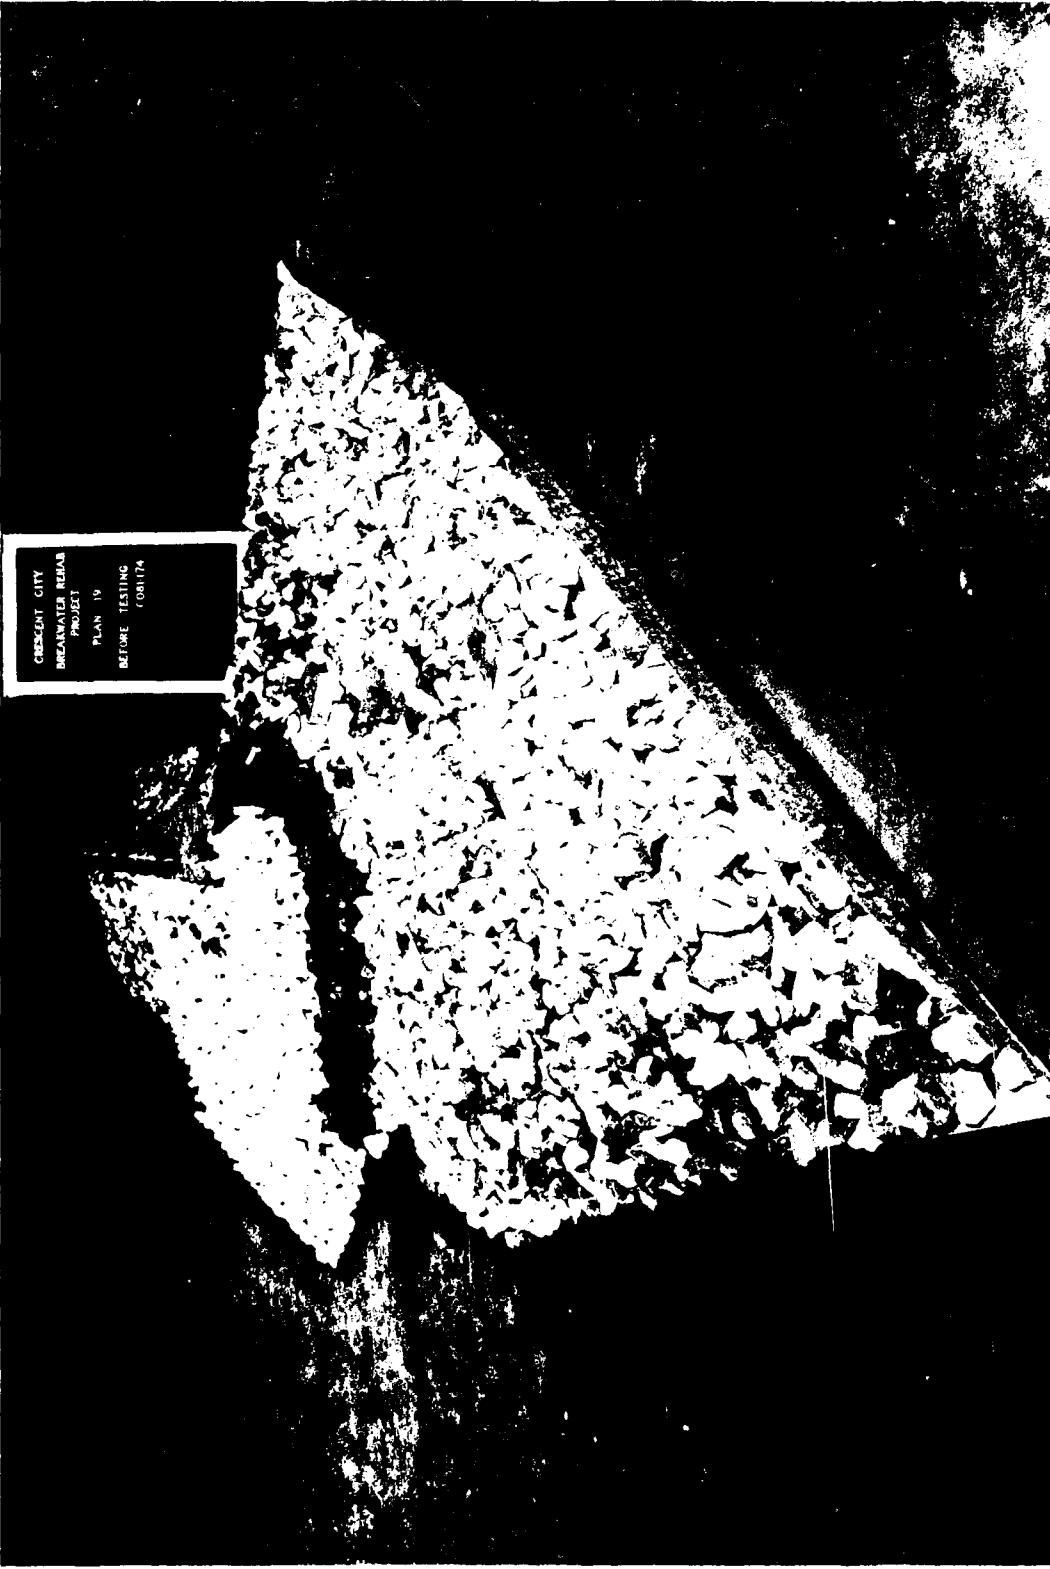
Photo 149. Seaward end view of Plan 19 before wave attack

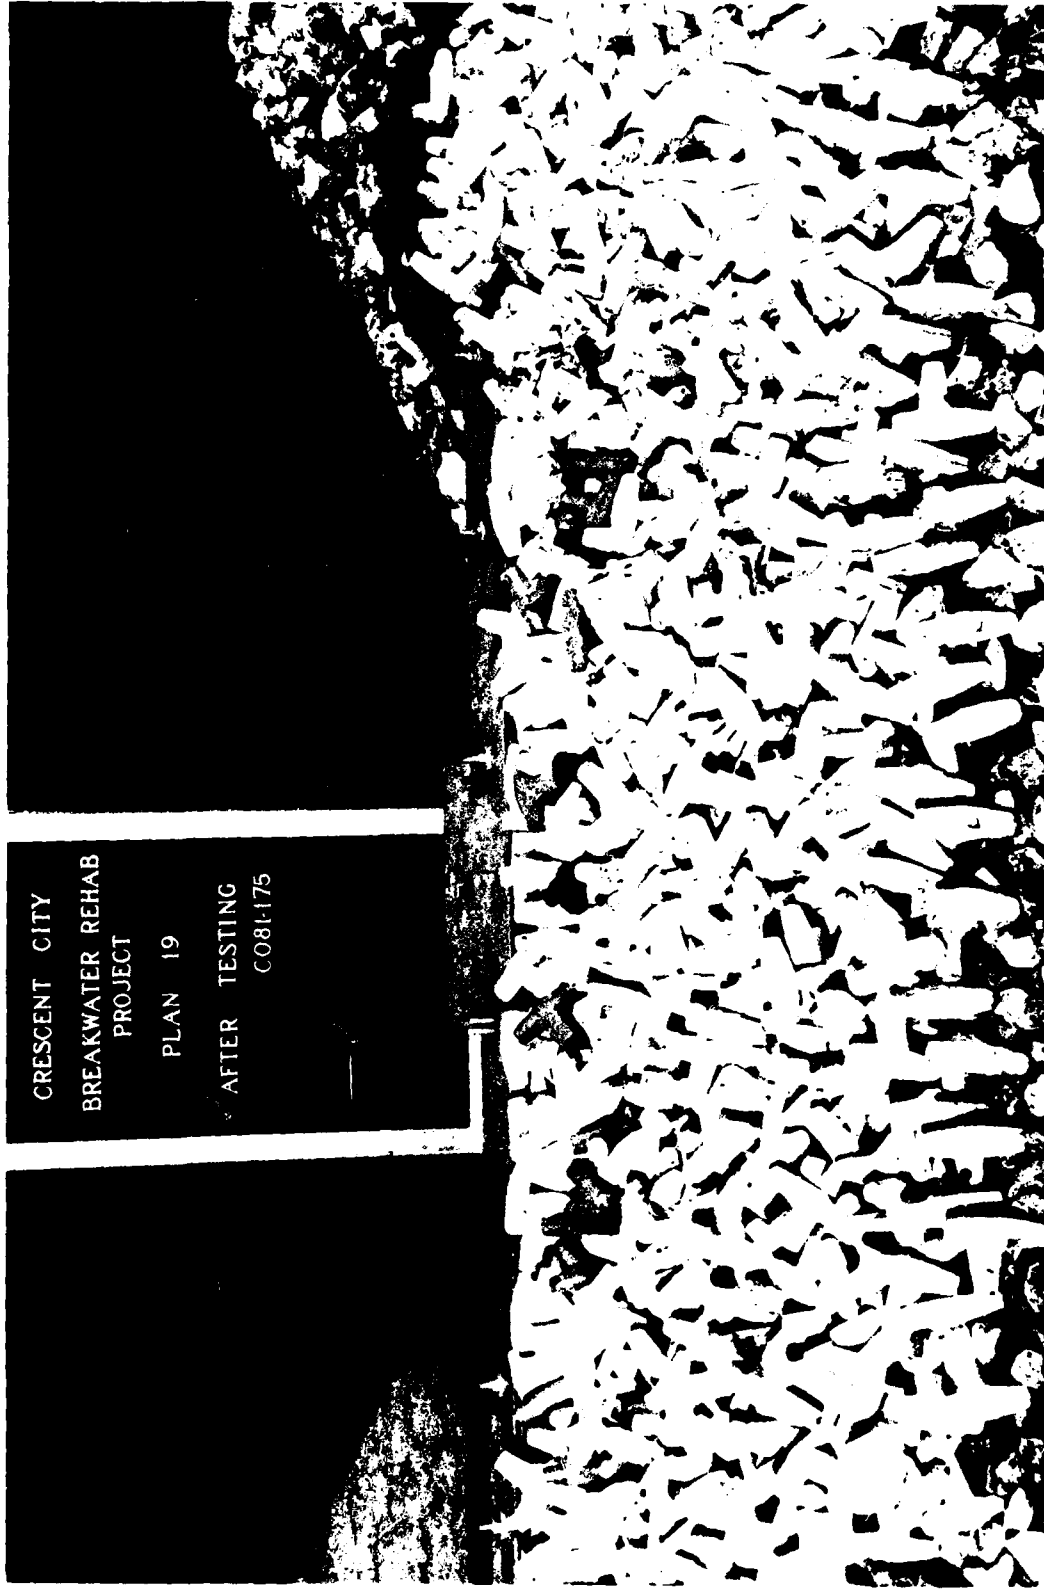
Photo 150. Sea-side view of Plan 19 after completion of abbreviated hydrograph

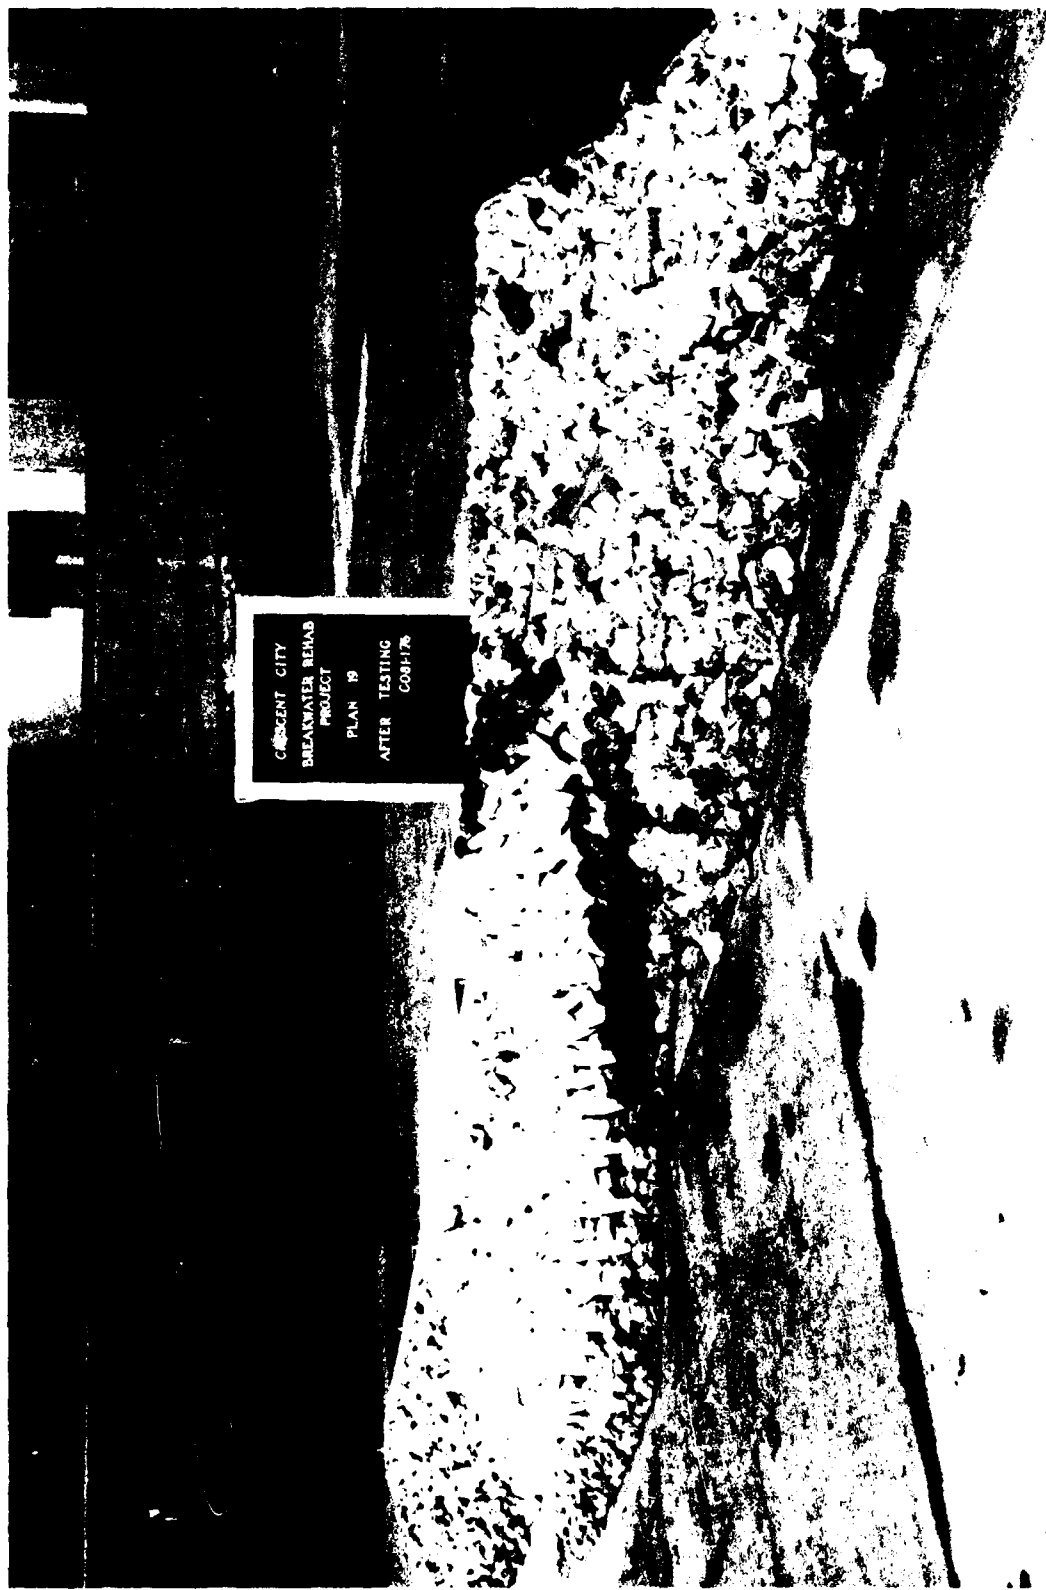
Photo 151. Seaward oblique view of Plan 19 after completion of abbreviated hydrograph

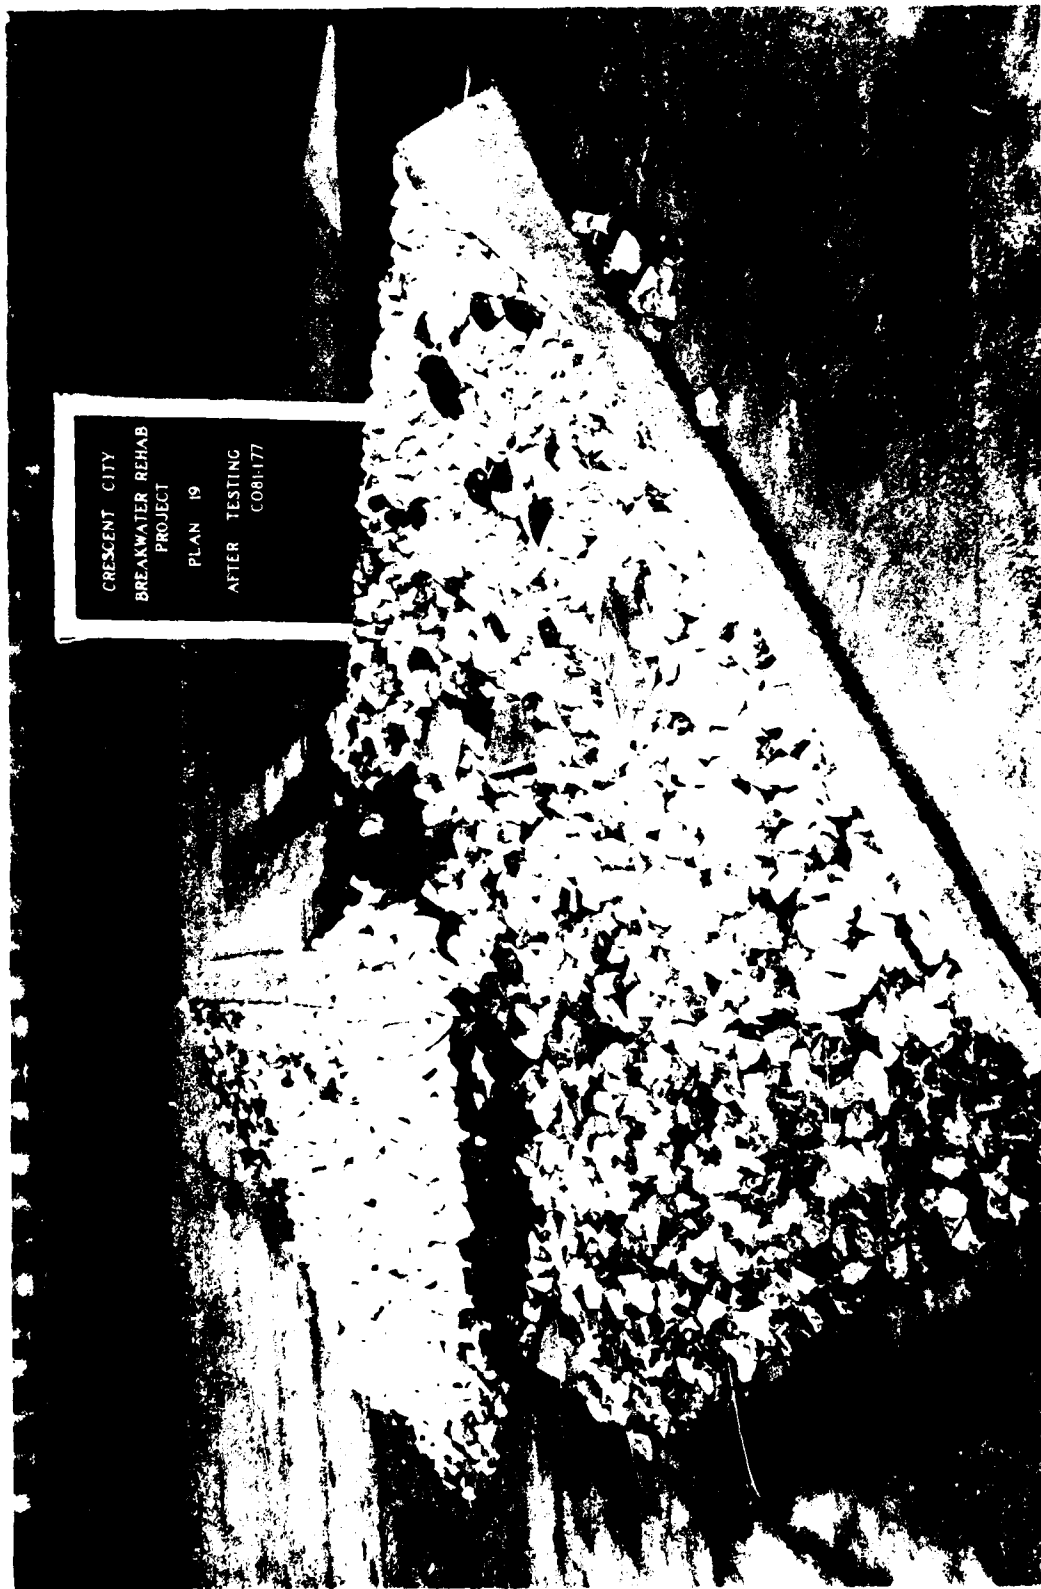
Photo 152. Seaward end view of Plan 19 after completion of abbreviated hydrograph

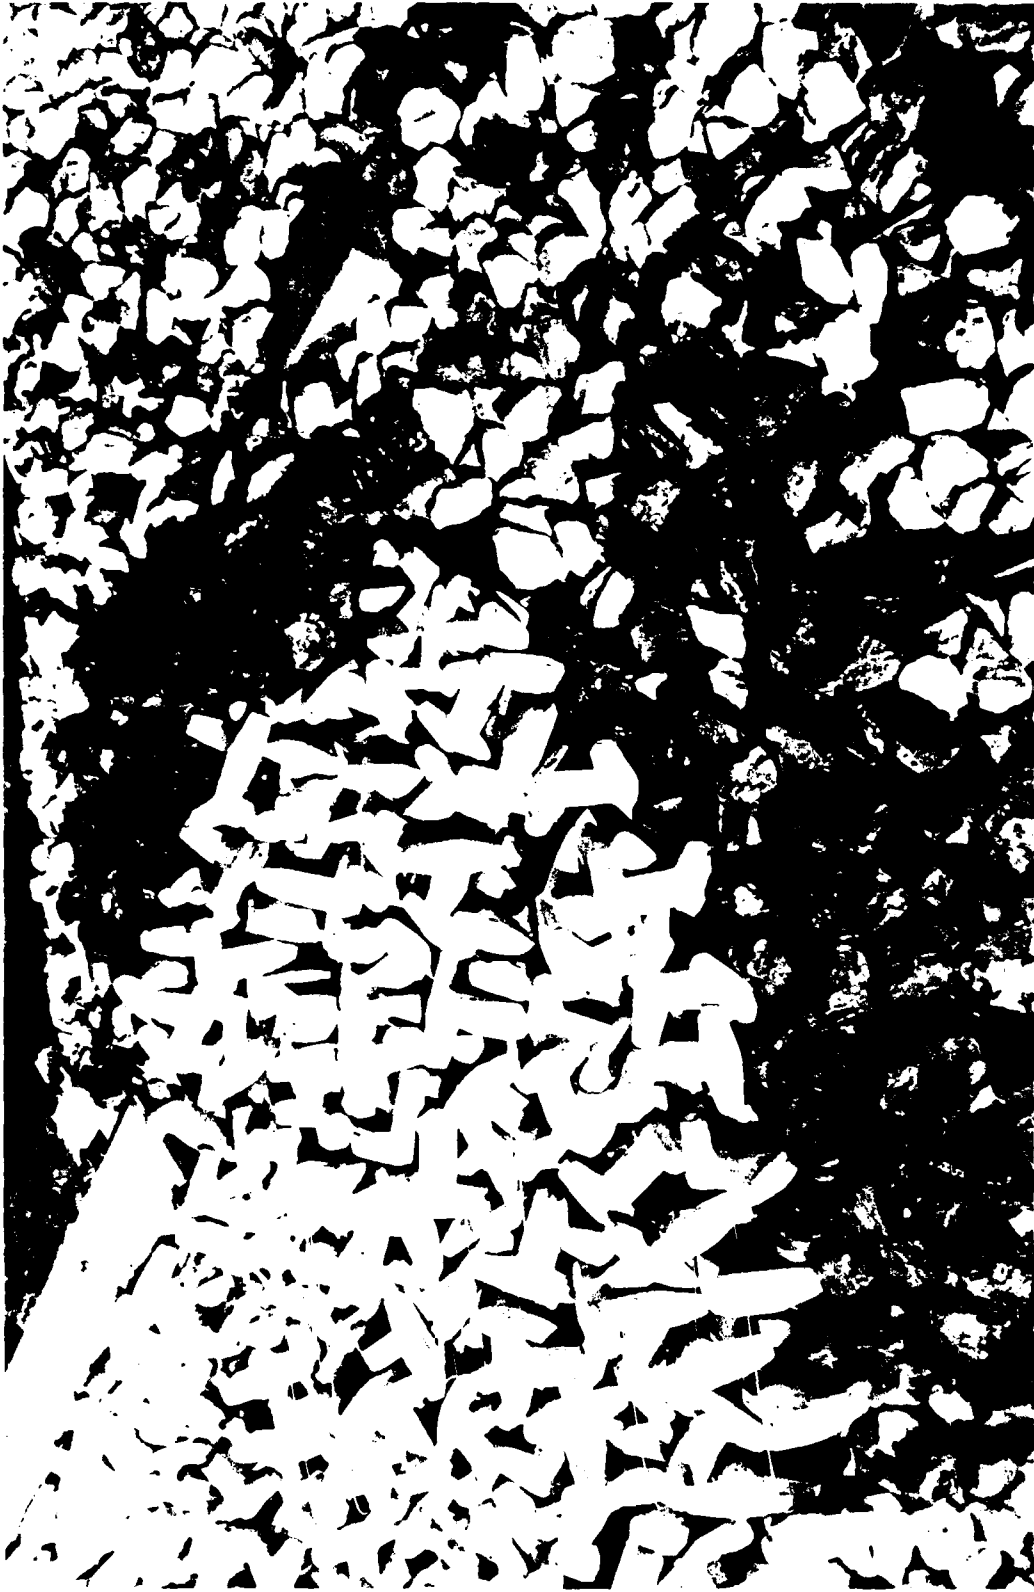
Photo 153. Closeup view of seaward transition for Plan 19 after completion of abbreviated hydrograph
